Balch Creek

by Shelley Matthews

in Portland, on Audubon Society property at 5151 NW Cornell Rd.

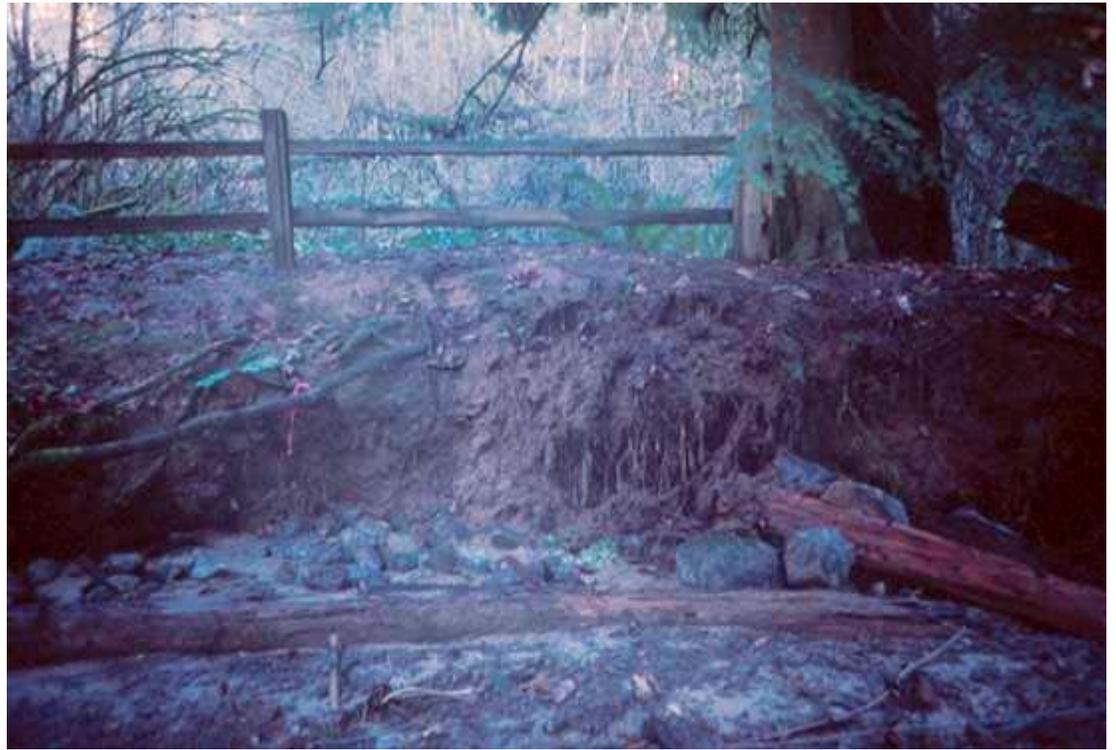
BEFORE

*Streambank
erosion and slope
instability
degrade fish and
riparian habitat*

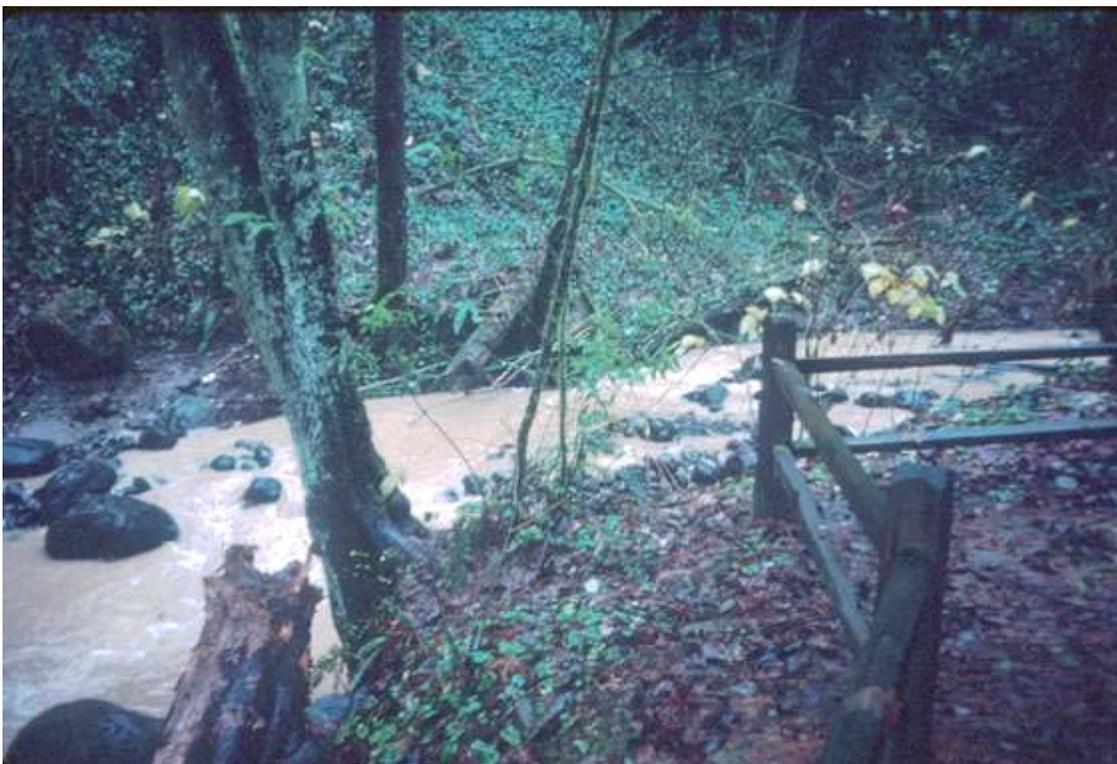
AFTER

*Bank failures
were terraced
with logs and
revegetated
with native
plants*

The goal of this project was to enhance riparian and fish habitat by stabilizing the streambed and banks in Balch and Woodpecker creeks, improving channel complexity and restoring native vegetation to the area. Woody material was salvaged and added to specific locations on both creeks to provide additional channel roughness, flow resistance, and soil stability within the stream and to provide overhead cover along the streambank. On Balch Creek, two large fallen trees were cut to 8 to 10 feet, uprighted to their previous positions along the channel, and secured in place with rock. Additional restoration efforts at Balch Creek included: 1) adding rock weirs at the tailouts of six pools to increase residual pool depth, and 2) adding rows of spaced rock to pools to increase flow resistance. On Woodpecker Creek, a culvert was removed and an existing trail and Eagle Scout bridge were relocated away from the streambank to a more stable area. Bank failures in two areas were terraced with bank logs and revegetated with native plant species. Other areas of bare soil were also replanted with natives.
