# **Narrative / Revegetation Plan**

### **Gresham Woods Wet Meadow Project**

Re: City of Gresham's Gresham Woods Wet Meadow Project Archaeological Monitoring  
AINW Report No. 1947

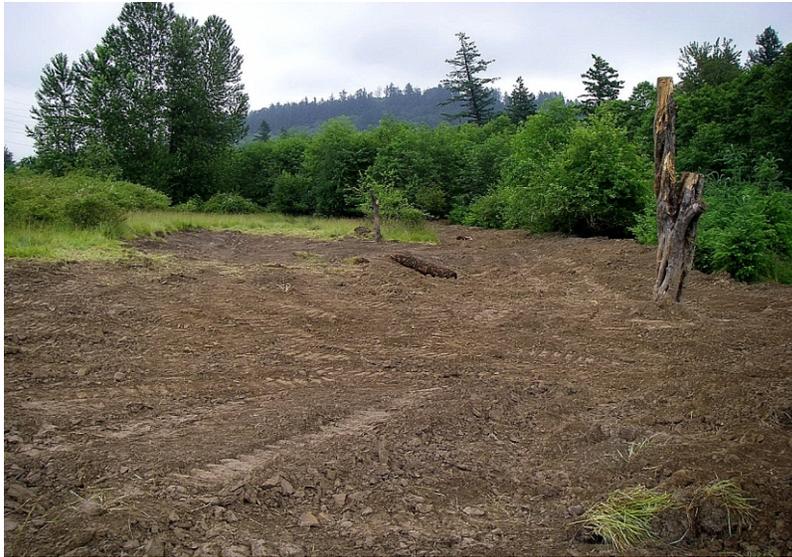
Photo 1. Mineral soil visibility at the westernmost enhancement area. The view is to the east and Johnson Creek is beyond the trees to the south.

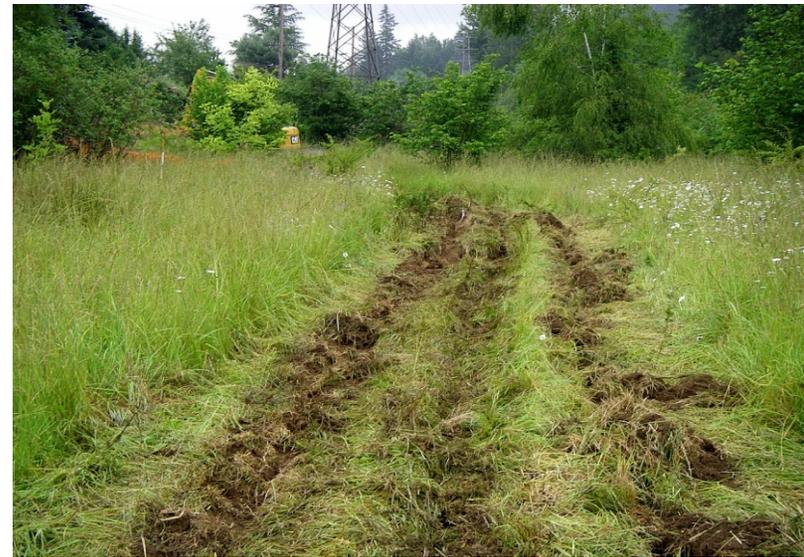
Ground surface visibility of mineral soil in the undeveloped portions of the proposed wetland enhancement area was 0% due to a thick cover of grasses, sedges, and a few patches of blackberry bushes (Photo 2). As work proceeded on the remaining areas, the excavations were examined for evidence of cultural materials. Care was taken to maintain a safe distance away from the heavy equipment while the excavation work was in process. Once an area was excavated, the monitor examined the exposed soil and the backdirt piles for evidence of archaeological deposits.

Photo 2. Vegetation and surface conditions in the unexcavated portion of the project area. The view is to the east at the east end of the project area. The Springwater Trail is located to the north and Johnson Creek is to the south beyond the trees.

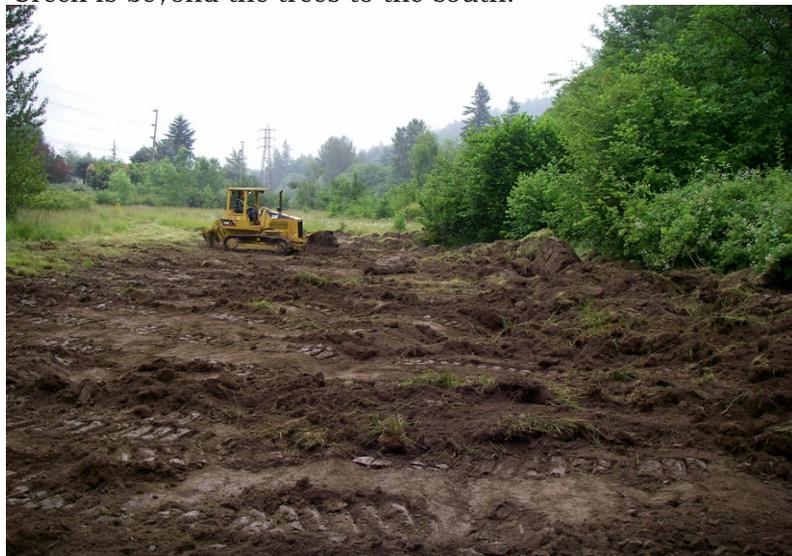
Mr. Adams monitored the excavations in the central enhancement area (Photo 3) during the morning. The excavations provided excellent opportunities to examine the mineral soils in the project area. The exposed soils were a mixture of loam and silt with a few basalt pebbles and cobbles that exhibited rounded exterior surfaces. No prehistoric artifacts or pieces of fire-cracked rock were observed. A few pieces of modern drain tile were exposed in the central wetland enhancement area, as well as a few pieces of modern plastic.

Photo 3. Excavation work in process at the central wetland enhancement area. The view is to the east.

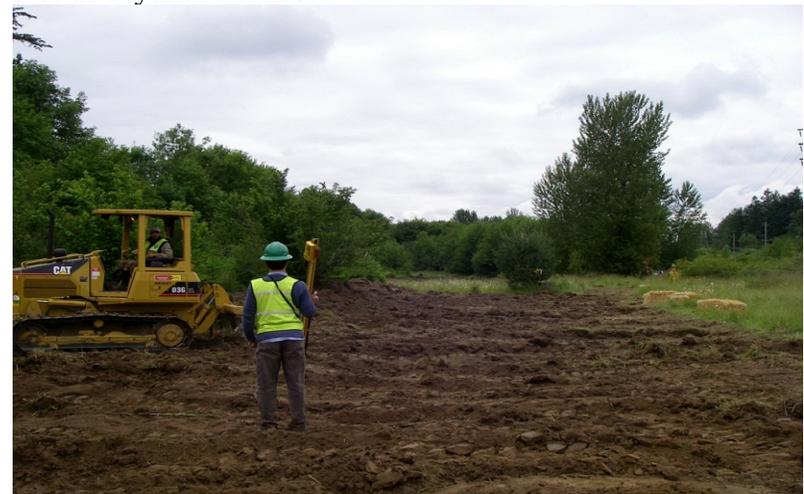
During the afternoon, Mr. Fagan took over the monitoring work and examined the completion of the central enhancement area, and the easternmost enhancement area (Photo 4). No artifacts were observed during the excavation work needed to complete the central and the eastern enhancement areas, and only a few natural basalt pebbles and cobbles and a few pieces of modern plastic were seen during the excavation work.

Photo 4. Excavation work in process at the eastern wetland enhancement area. The view is to the west.

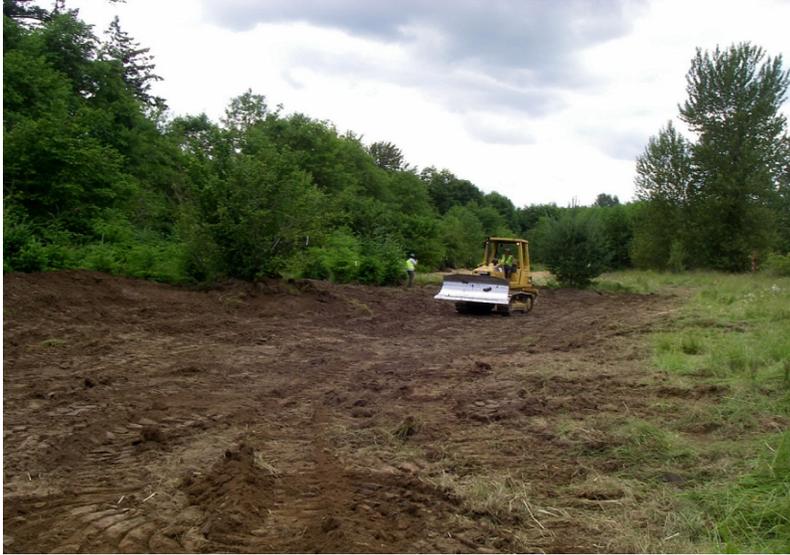
Once the appropriate depth had been reached, the excavated areas were contoured and packed down with the bulldozer (Photo 5). Snags were placed in pits excavated to an approximate depth of 1 meter (3.3 feet) (Photos 6 and 7). These deeper excavations exposed tan-colored silts that were lighter in color and more compact than the overlying deposits. When the excavations were completed, the exposed soils were covered with a layer of straw (Photo 8).

Photo 5. Contouring of the central wetland enhancement area. The view is to the west.

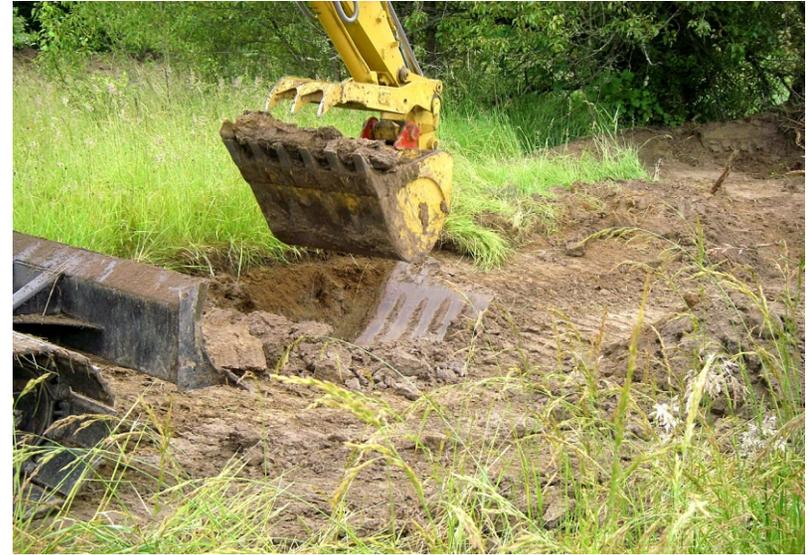
Photo 6. Excavation in process for placement of snag in the central wetland enhancement area. The view is to the southwest.

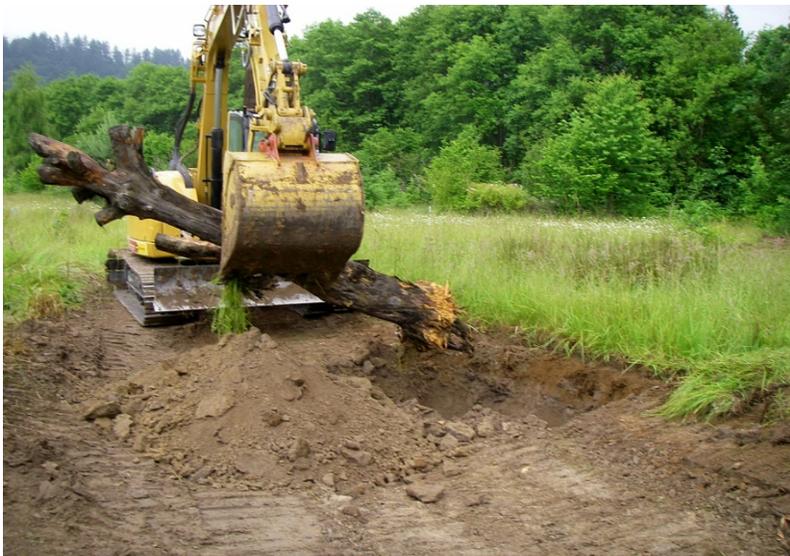
Photo 7. Placement of snag in the central wetland enhancement area. The view is to the east.

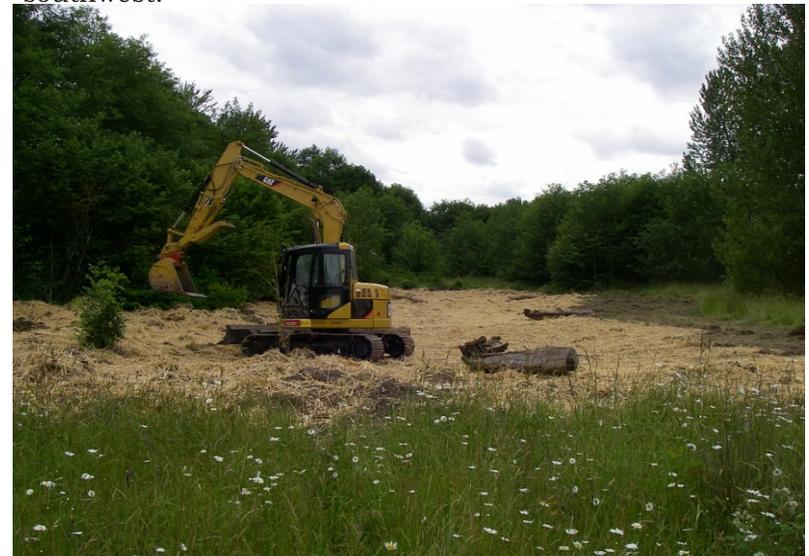
Photo 8. The central wetland enhancement area has been covered with straw. The view is to the west.
