***Assessment of salmon hatchery fishways
and barrier dams relative to adult Pacific
Lamprey passage***

Joe Skalicky

US Fish and Wildlife Service

2019 PACIFIC LAMPREY INFORMATION EXCHANGE, VANCOUVER, WA

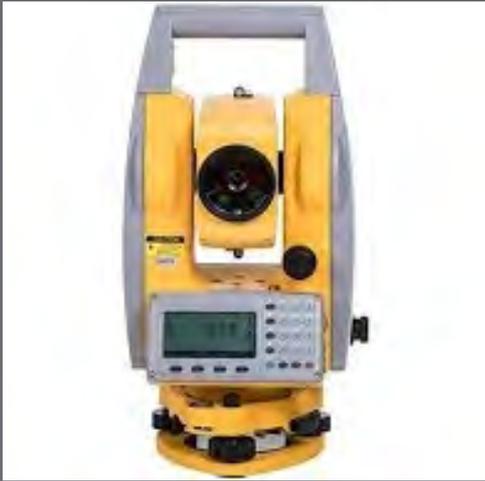
**Total
Station**

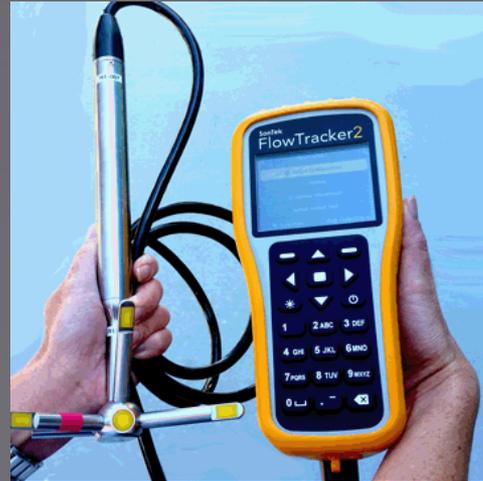
**Velocity
Meter**

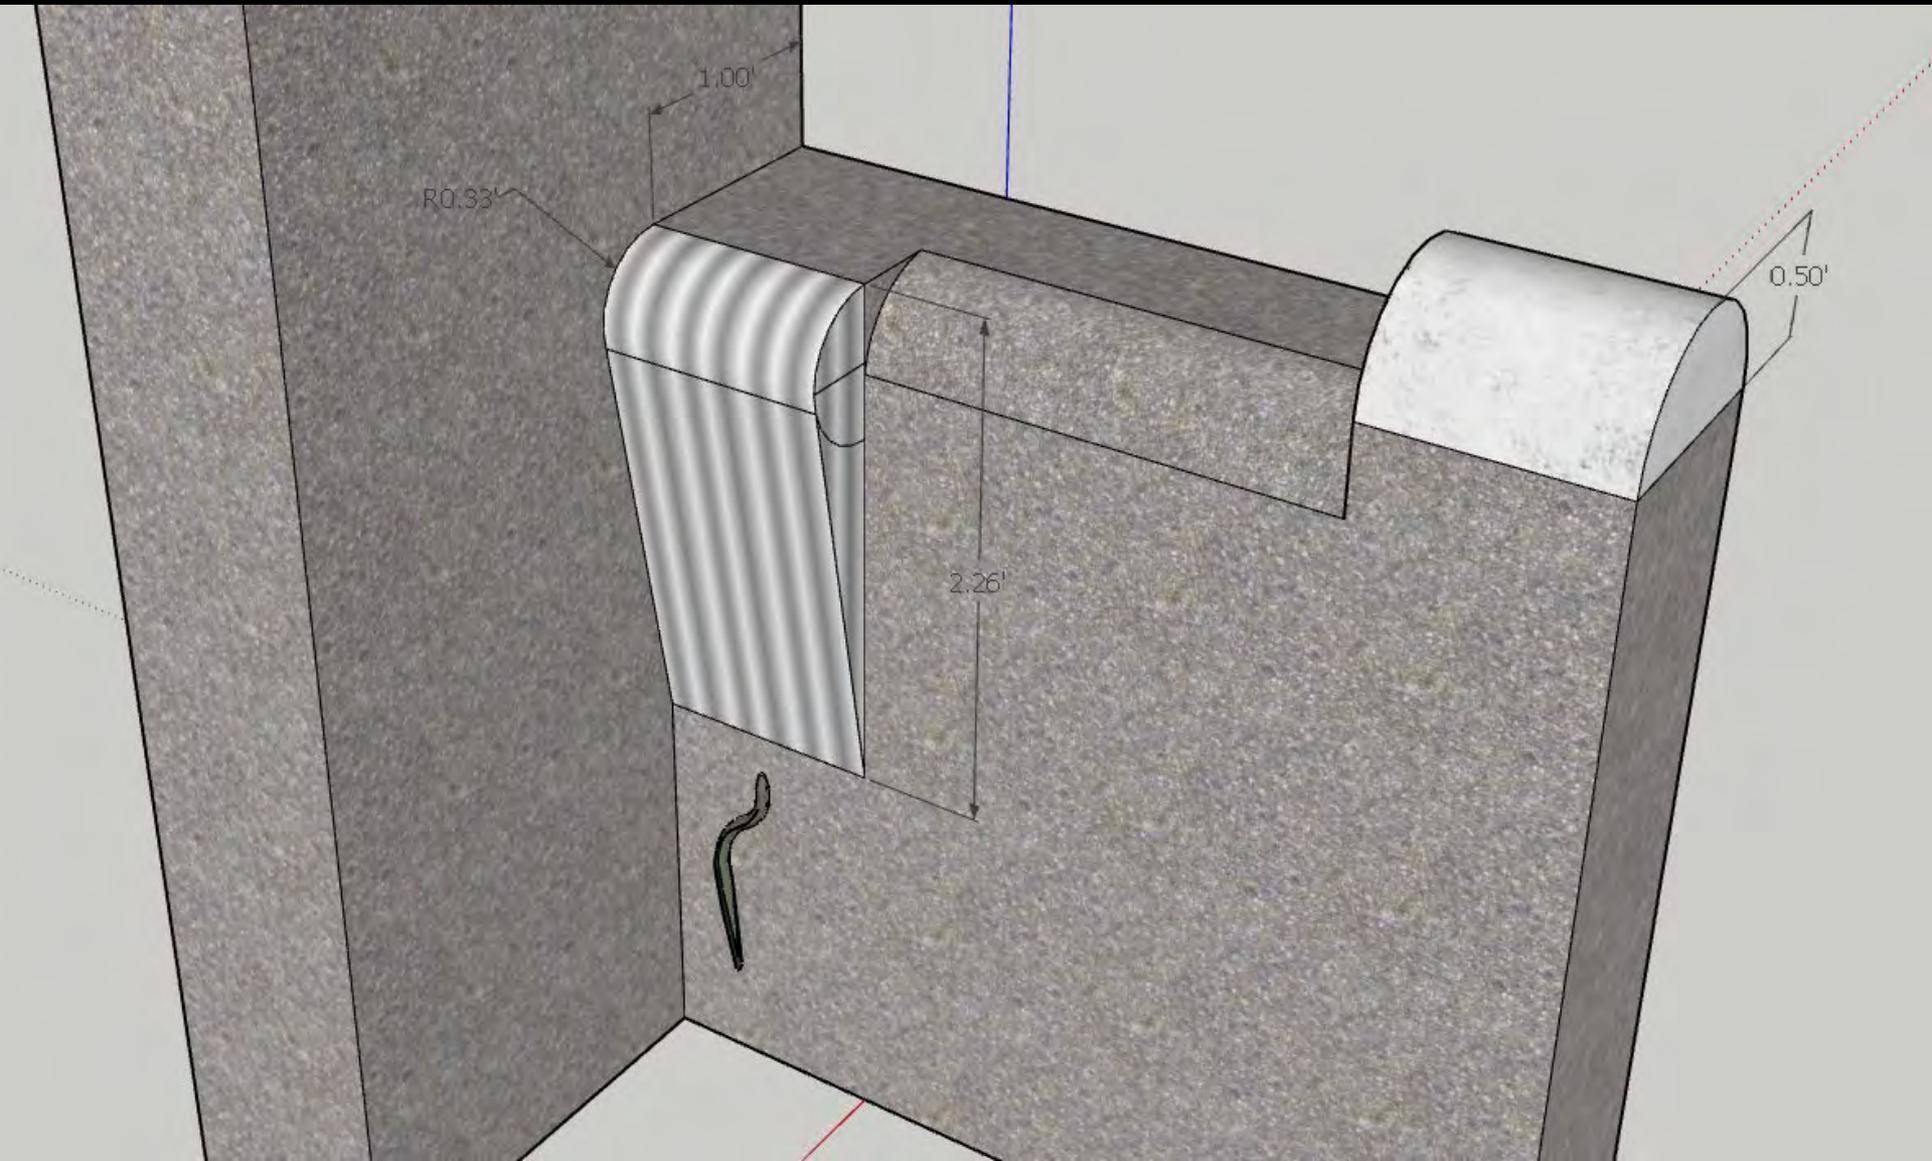
Why rounded corners matter

Fishways – 90° Options

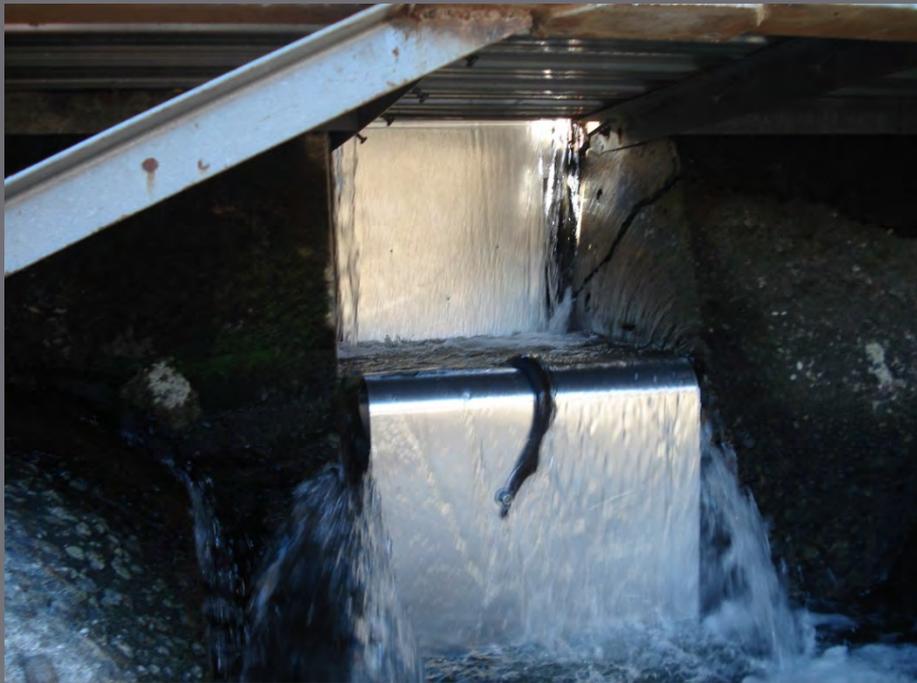
Simple Ramps & Wetted Walls

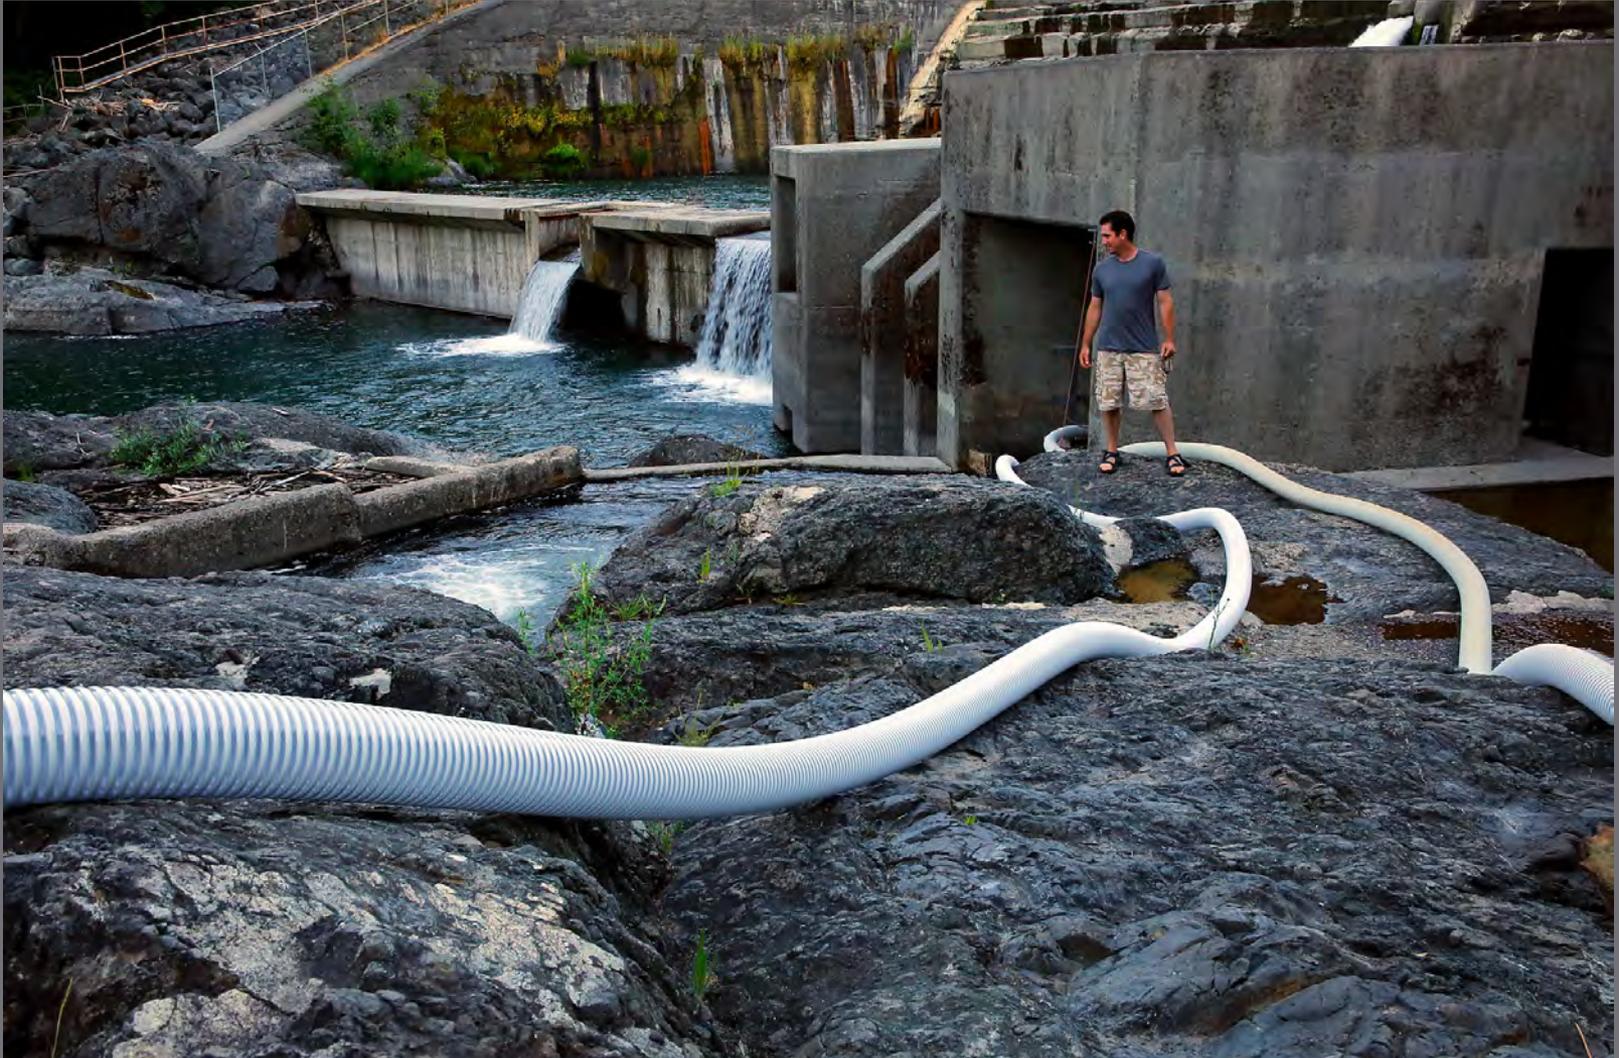
*Van Arsdale Dam- lamprey passage tube
Damon Goodman and Stewart Reid
Photo : M. Macor- The Chronicle*

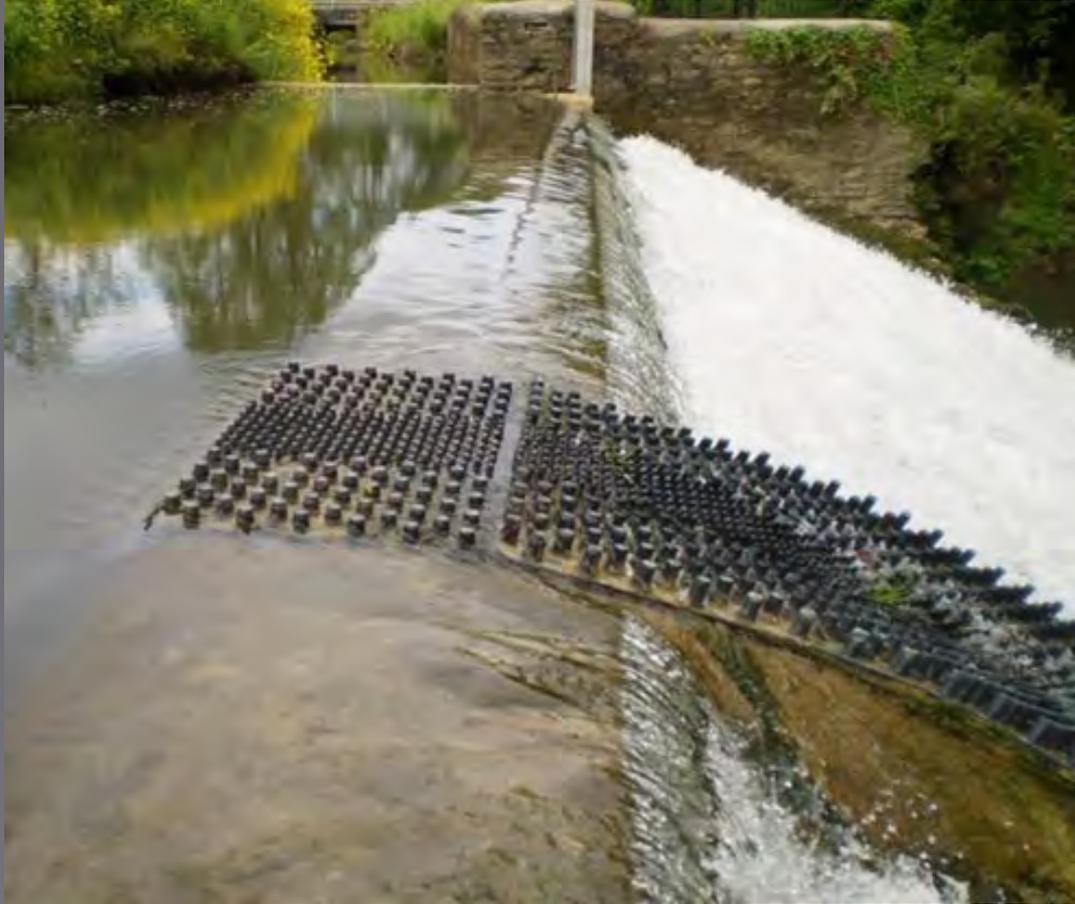
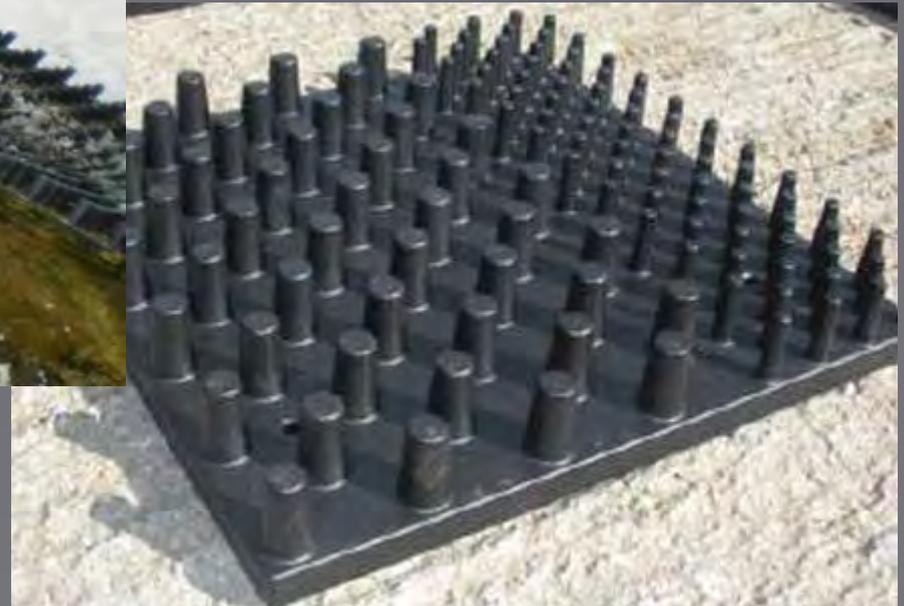
New Methods: Lamprey Tiles
