**Sediment Contaminants at Dillsboro Reservoir:  
Report on Site Assessment and Sediment Analyses**

**U.S. Fish and Wildlife Service  
Asheville, NC  
Raleigh, NC**

**January 2004 Final**

### **Abstract:**

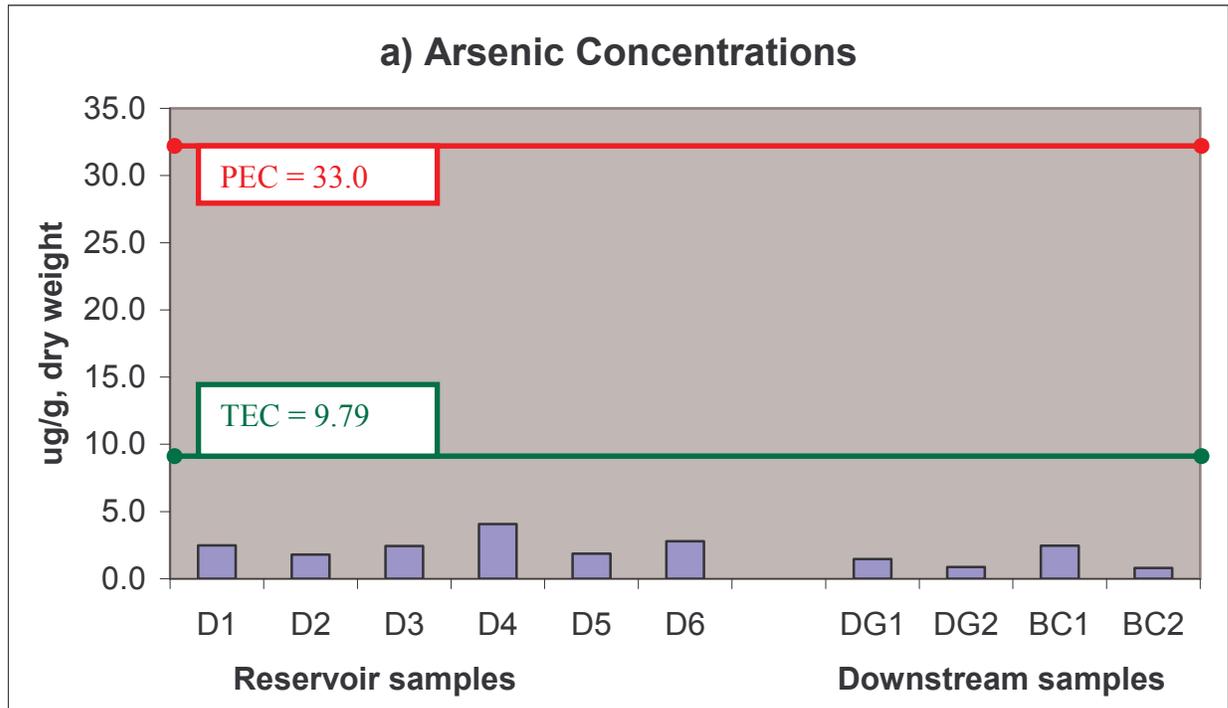
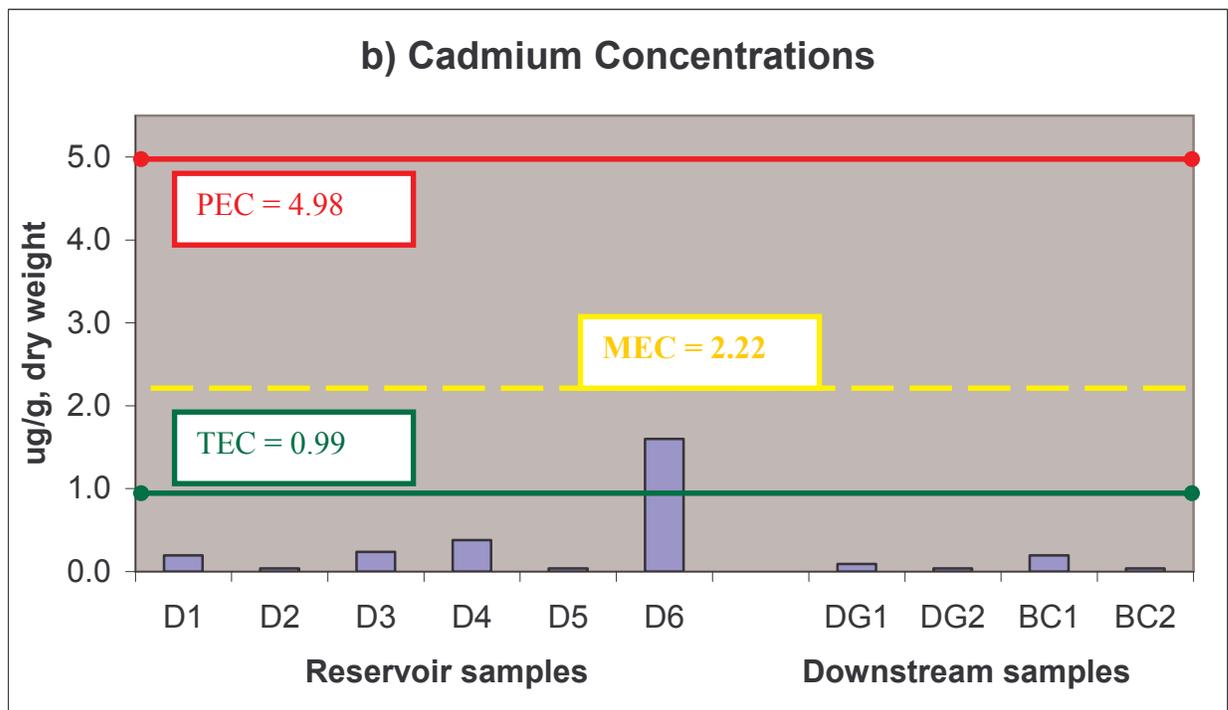
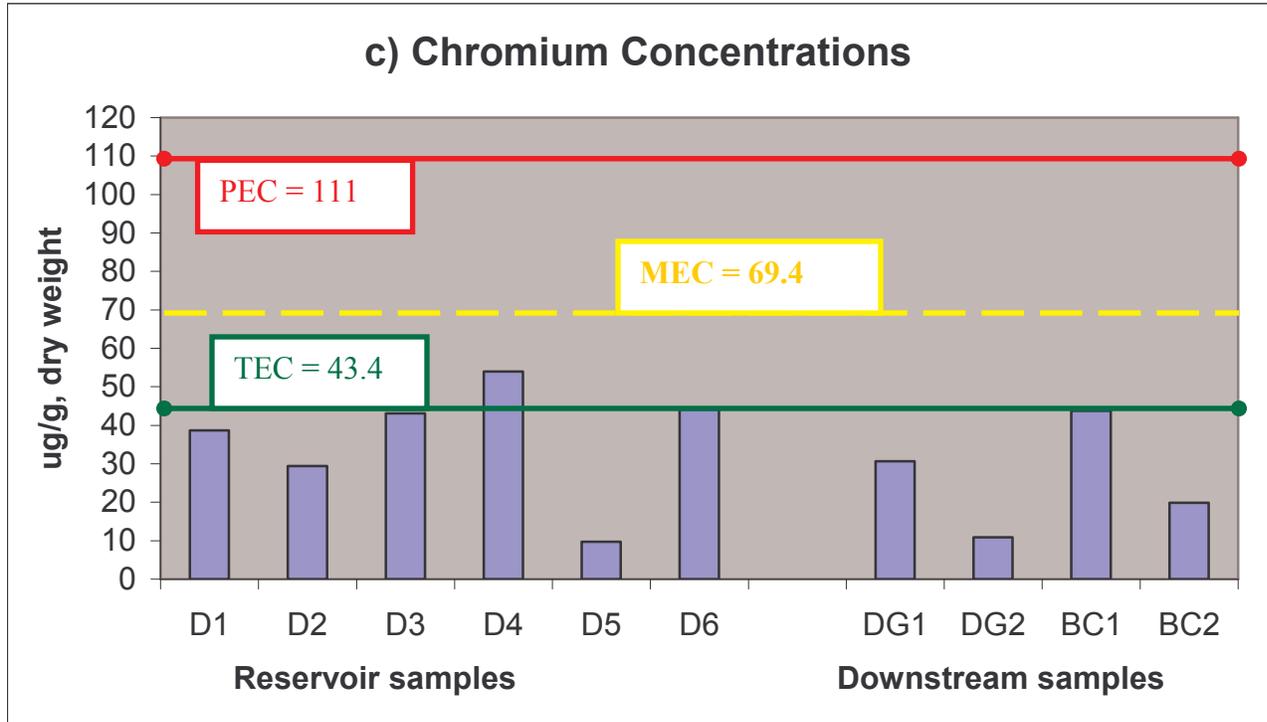
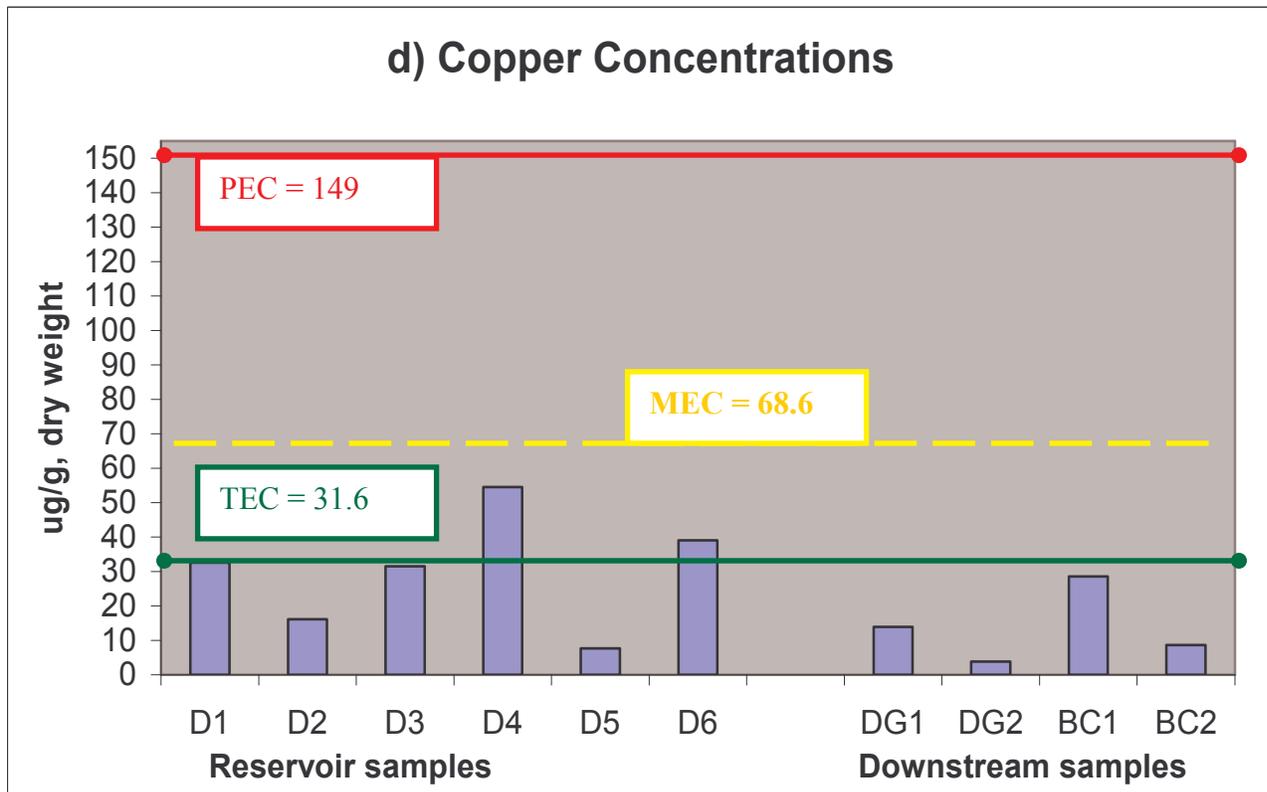
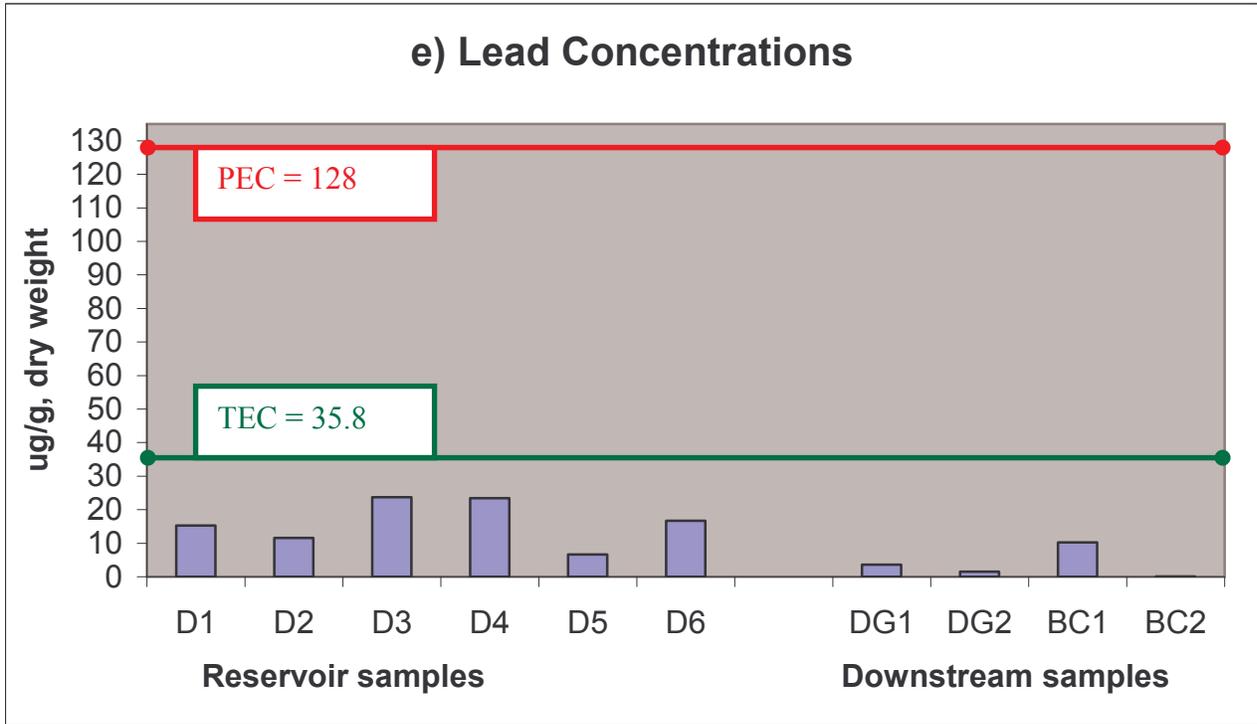
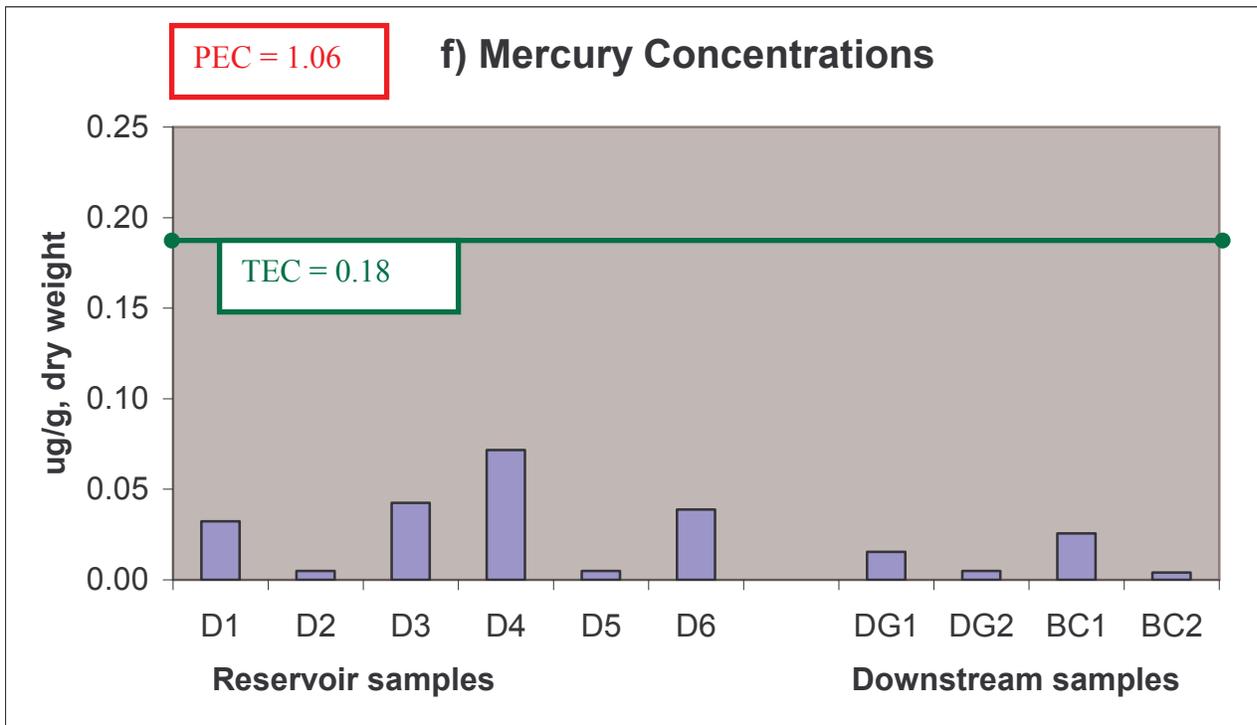
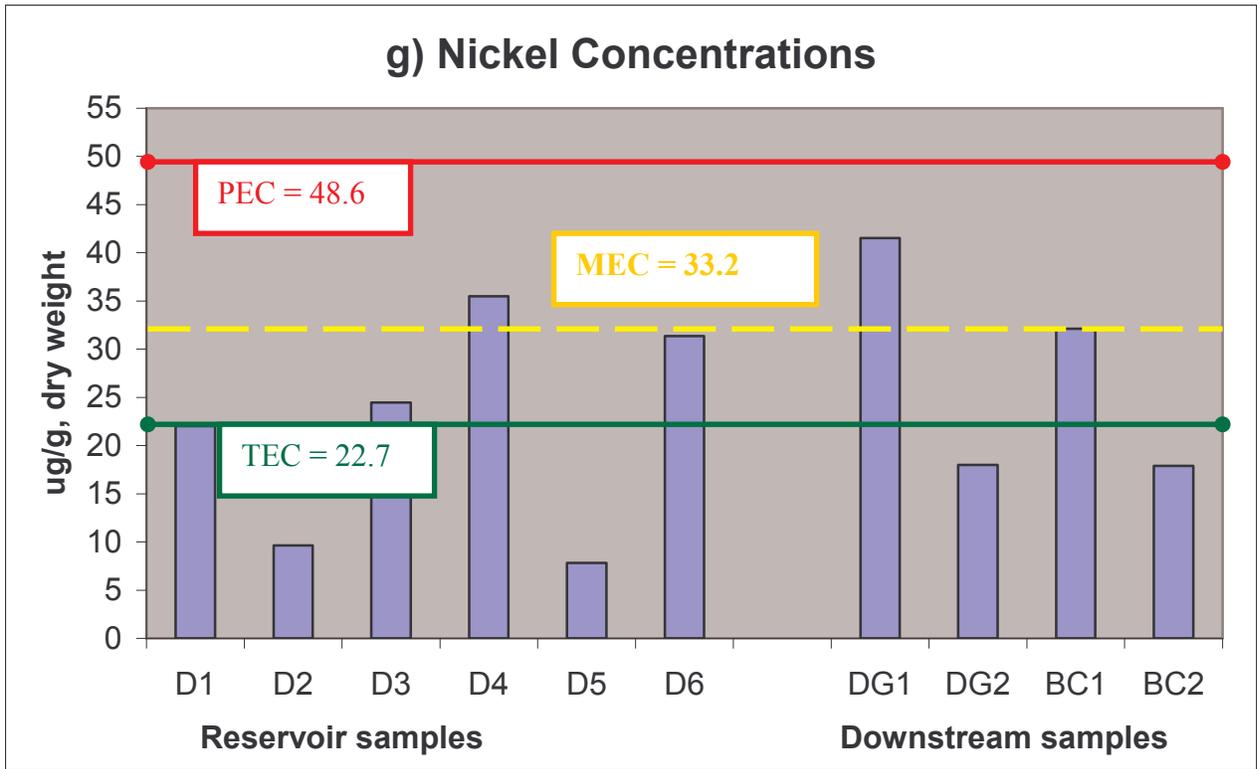
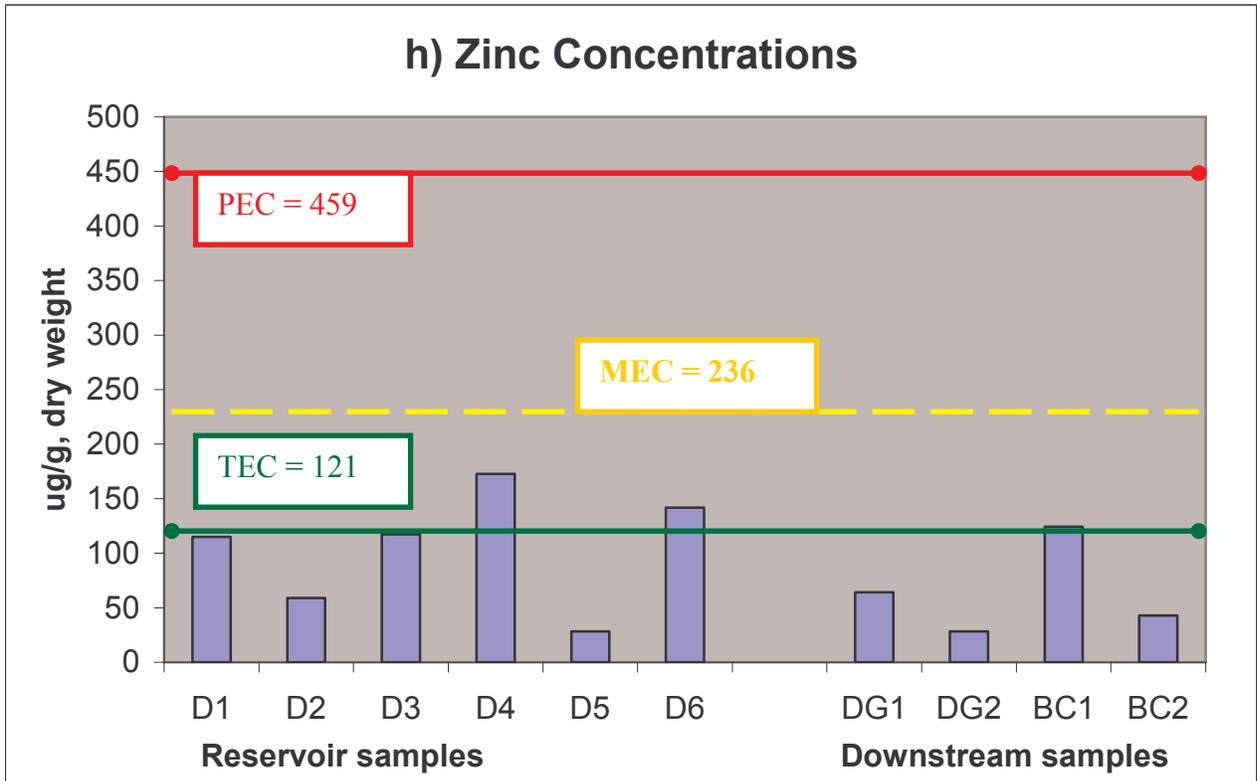
Figure 5 (a-h). Elemental contaminant concentrations of sediments collected within the Dillsboro Reservoir (D1, D2, D3, D4, D5 and D6) and downstream of the reservoir (DG1, DG2, BC1 and BC2). For each element, results are compared to threshold effects concentration (TEC) guidelines of MacDonald et al. (2000) -- values below which adverse effects to sensitive aquatic organisms should not occur, and probable effects concentrations (PECs) -- values above which adverse effects to sediment dwelling organisms may be expected (MacDonald et al. 2000). Some figures also have a “median effects concentration” (MEC), the geometric mean of the TEC and PEC, for reference.

Figure 5 (with sub-figures a-h for each element) is a comparison of the elemental contaminant results to freshwater sediment quality guidelines (MacDonald et al. 2000). These consensus-based threshold effects guidelines were established to provide lower bound concentrations below which adverse effects to sensitive aquatic organisms should not occur (Threshold Effects Concentrations, or TECs) and an upper range of concentrations above which adverse effects to sediment dwelling organisms may be expected (Probable Effects Concentrations, or PECs).

Eighty-one percent of all values evaluated were less than the TECs (i.e., presumed to be toxicologically insignificant). This category included all the data for arsenic, lead and mercury. Further, no samples exceeded the PECs for any elemental contaminant (i.e., no samples of obvious concern).

To evaluate the <20 percent of sample results that fell between the TECs and PECs for cadmium (n=1), chromium (n=3), copper (n=3), nickel (n=5) and zinc (n=3), we computed a geometric mean of the TECs and PECs for each element and defined it as a “median effects concentration”, or “MEC”. From Figure 5, it is apparent that only two sediment sample results for nickel exceeded these MECs. The two samples exceeding the MECs were collected at station D4 from within the reservoir, and DG1 from the Dillsboro gage area downstream of the dam (which had the highest overall nickel concentration). None of the few samples that exceeded the TECs for cadmium, chromium, copper and zinc exceeded the MECs, and most of the results were still relatively close to the TECs for these elements.

From Figure 5, it is apparent that none of the sediment samples from within the reservoir or downstream exceeded the PECs, indicating no sediment contaminant concentrations of obvious concern. Over 80 percent of the sediment sample results were also less than the TECs, indicating they are unlikely of toxicological significance.

In our application of the MECs, only two values (both for nickel) exceeded these levels. The highest nickel concentration (41.5 ug/g dry weight) was from a downstream river sample near Dillsboro gage, and the average of the four downstream samples (27.4 ug/g dry weight) exceeded the average concentration of the six samples collected upstream of the dam (21.8 ug/g dry weight). Accordingly, the nickel concentrations behind the dam should not be a concern relative to movement downstream where concentrations are slightly higher. Although nickel was found to be somewhat elevated relative to the screening level, nickel is a metal with little affinity for aquatic bioaccumulation, biomagnification, and mobilization in sediments (Connell and Miller 1984). Nickel also has only slight to moderate aquatic toxicity (USEPA 1986), and the concentrations observed in surface water quality monitoring of the Tuckasegee River, typically less than a 10 ug/l detection limit (NCDWQ 2000), are lower than values toxic even to very sensitive aquatic organisms (USEPA 1986, Keller and Zam 1991).

A value of one-half the method detection limit was used for the graphs in Figure 5 in the few instances of values reported as lower than detection. This should not influence the data interpretation because the detection limits were sensitive relative to the screening guidelines.
