# **Monitoring and Evaluation of the Modified Fish Ladder and Barrier Weir at the Coleman National Fish Hatchery**

U.S. Fish and Wildlife Service

March 2011

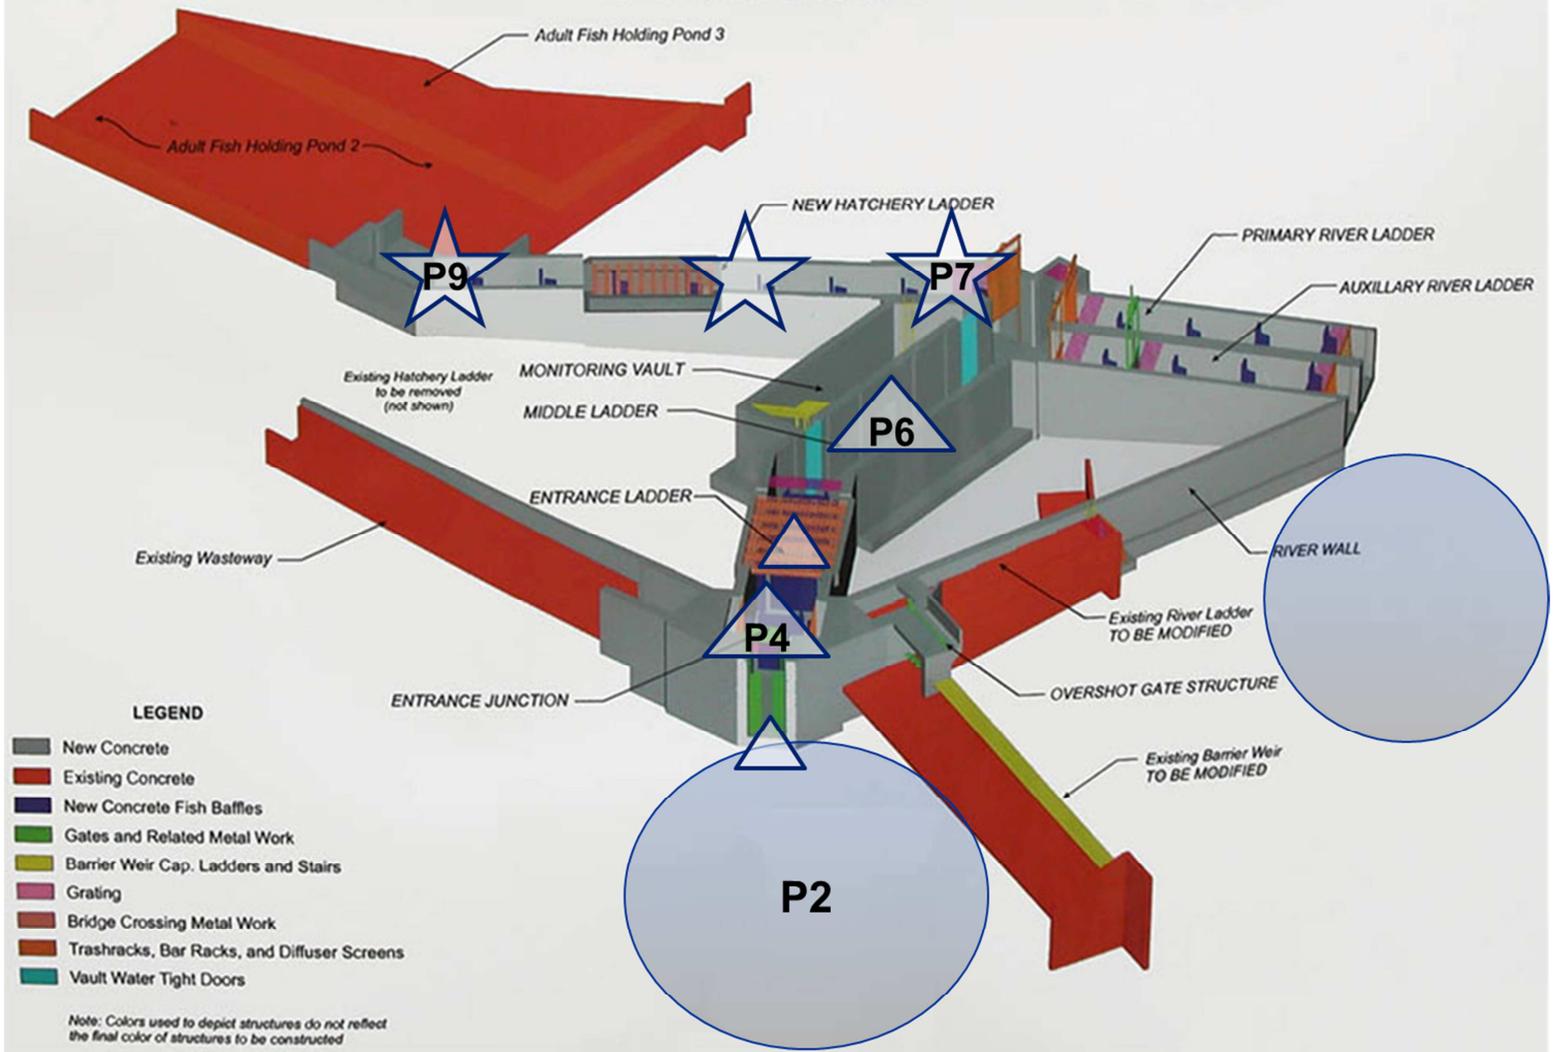
**Figure 1. Illustration of the improved fish ladder and barrier weir at Coleman National Fish Hatchery on Battle Creek. Radio telemetry antenna arrays are represented as follows: ovals = aerial Array B, triangles = underwater Array C, and stars = underwater Array D. Key locations are labeled as P2, P4, P6, P7, and P9.**

Four fixed-site antenna arrays (Figure 1) recorded the movements of tagged fish. Each array had a data-logging telemetry receiver (LOTEK® SRX400) and an antenna switch control port (LOTEK® ASP\_8). Array A was located at the release site and had two directional yagi antennas pointed upstream and downstream. Array B was located at the Coleman NFH barrier weir and consisted of two “H” short-range directional yagi antennas pointed upstream and downstream. The downstream antenna of Array B was positioned to detect fish as they approached and arrived in the immediate vicinity of the Coleman NFH barrier weir (i.e., tailrace). The upstream antenna of Array B was positioned to detect fish that jumped past the weir. Array C consisted of four underwater antennas located in the Entrance Ladder and Middle Ladder. Array C was intended to detect fish as they approached, entered, and migrated through the Entrance Ladder. Array D was added in 2010 and consisted of three underwater antennas located in the Hatchery Ladder. Array D detected salmon as they migrated through the Hatchery Ladder.

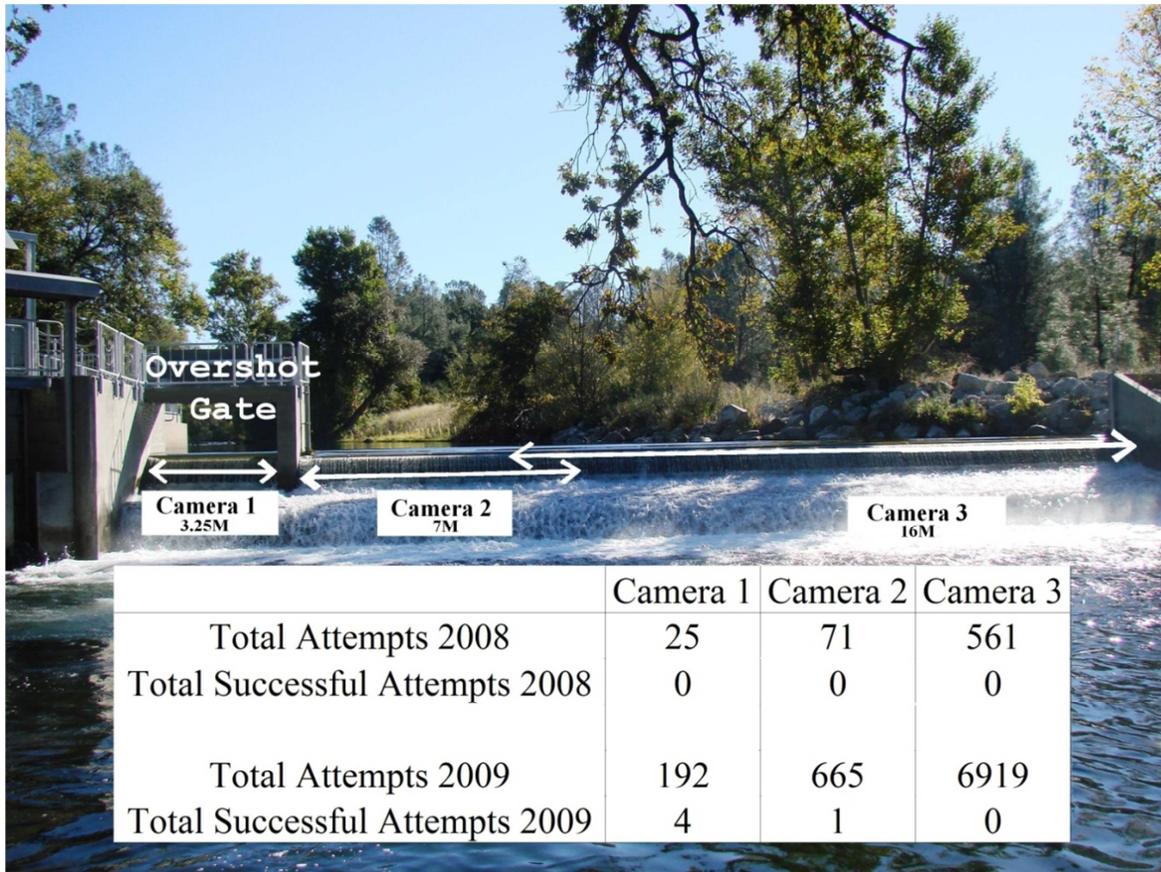
**Figure 2. Photograph of the Coleman National Fish Hatchery Barrier Weir, fish ladder, and overshoot gate. Also shown are the areas covered by the three camera's during the video monitoring aspect of this study and the distance that each camera view covered. Total attempts and successful attempts made by fish to jump over the weir are shown for two periods: 1.) from 15 October 2008 through 28 February 2009 (2008); and, 2.) from 15 September 2009 through 19 January 2010 (2009).**

Cameras were positioned to view different expanses of the barrier weir; including: the overshot gate (Camera 1), the north section of the Barrier Weir (Camera 2), and the south section of the Barrier Weir (Camera 3; Figure 2). All portions of the barrier weir that could conceivably be compromised by fishes were encompassed within the view of the cameras and some redundancy existed between the viewing areas of Camera's 2 and 3. Several times each week, video was transferred to external hard drives and brought to the Red Bluff Fish and Wildlife Office. Video recordings were viewed and numbers of jump attempts and successful jumps were recorded for each day. A jump attempt was recorded when a fish reached the velocity barrier (horizontal section) of the weir and a successful jump was recorded when a fish ascended past the upstream vertical wall of the weir. Fish jumping in the area covered by both Camera 2 and Camera 3 were only counted on Camera 3 totals.

Four of the five fish that were able to jump over the Coleman NFH barrier weir passed over the overshot gate. The overshot gate is designed to be raised or lowered to adjust the flow of water near the entrance of the fish ladder to attract fish to that location. The overshot gate does not have an overhanging lip at the crest and, therefore, does not appear to afford the same level of success at blocking passage as the main portion of the weir. The position of the overshot gate

was not recorded during this study; however, based on the position of the gate as shown in the recorded video, we believe that the gate was at or near the upright (fully closed) position when fish escaped past the structure.

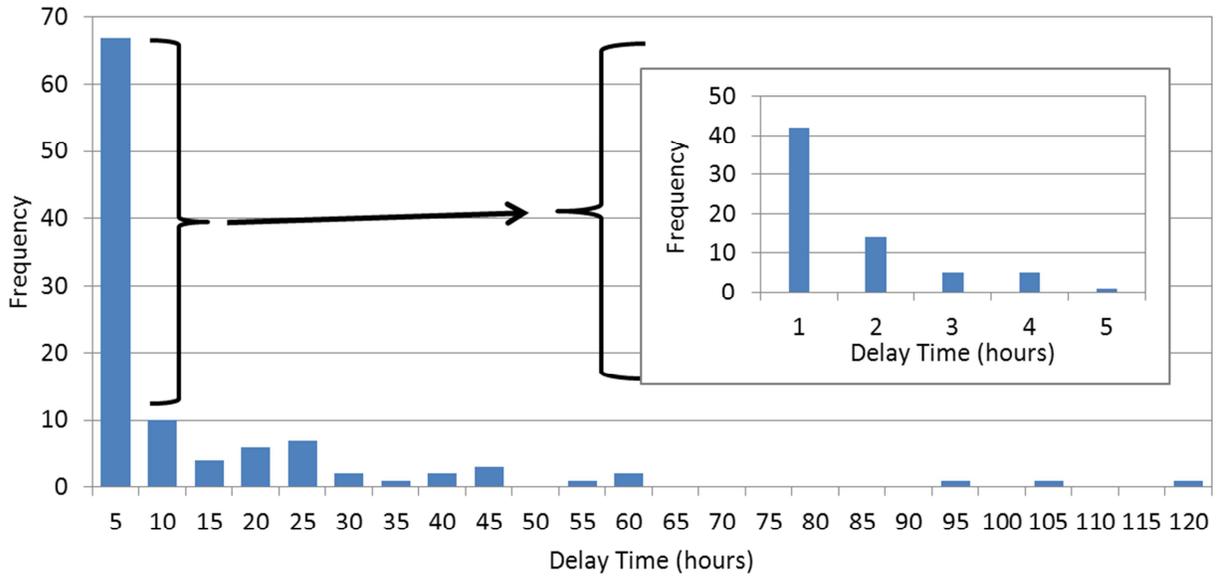
**Figure 3. The delay-frequency distribution for radio tagged Chinook salmon entering the improved fish ladder at Coleman National Fish Hatchery. Delay time is the time duration from arrival at the barrier weir tailrace to entrance into the fish ladder.**

The median time required for radio tagged fish to move upstream 0.5 miles to the barrier weir tailrace was 55.7 h (Table 1). Once at the tailrace, the median and mean time required for fish to enter the fish ladder was 1.7 h and 11.4 h, respectively (Table 1). The relatively large difference between the median and mean indicates the presence of outliers (Figure 3). For example, a few salmon moved downstream after arriving at the tailrace but before entering the fish ladder. The maximum amount of time to move from the tailrace into the fish ladder was 116.8 hours. A “mean” is highly influenced by outliers in which case the “median” is the more robust and accurate measure of central tendency. Removing data associated with fish that moved

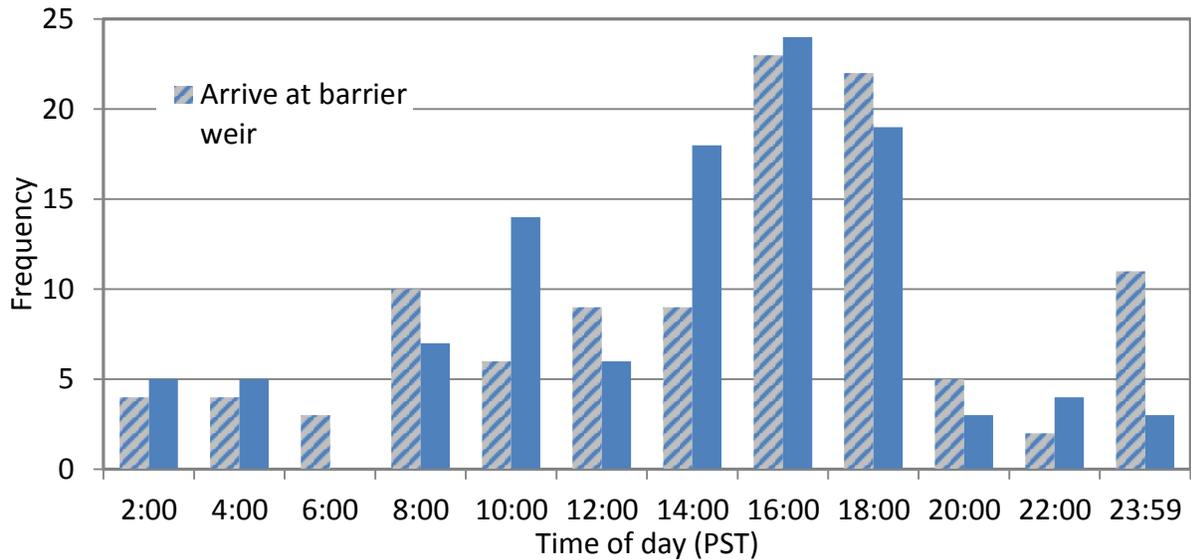
**Figure 4. Diel time-frequency distribution for first detection (1) at the barrier weir tailrace and (2) immediately inside the entrance to the fish ladder.**

Radio tagged salmon exhibited a clear diel pattern with regard to time of first arrival at the tailrace and time of first entry into the fish ladder. Salmon entered the fish ladder primarily during daylight hours and peak movement into the ladder occurred during the 14:00-16:00 PST period (Figure 4). Some salmon arriving at the tailrace at night delayed entry into the fish ladder until daylight hours. This behavior is illustrated in Figure 4 by showing a moderate spike in movement to the tailrace during the period 22:00-24:00 but no corresponding spike in movement into the ladder.

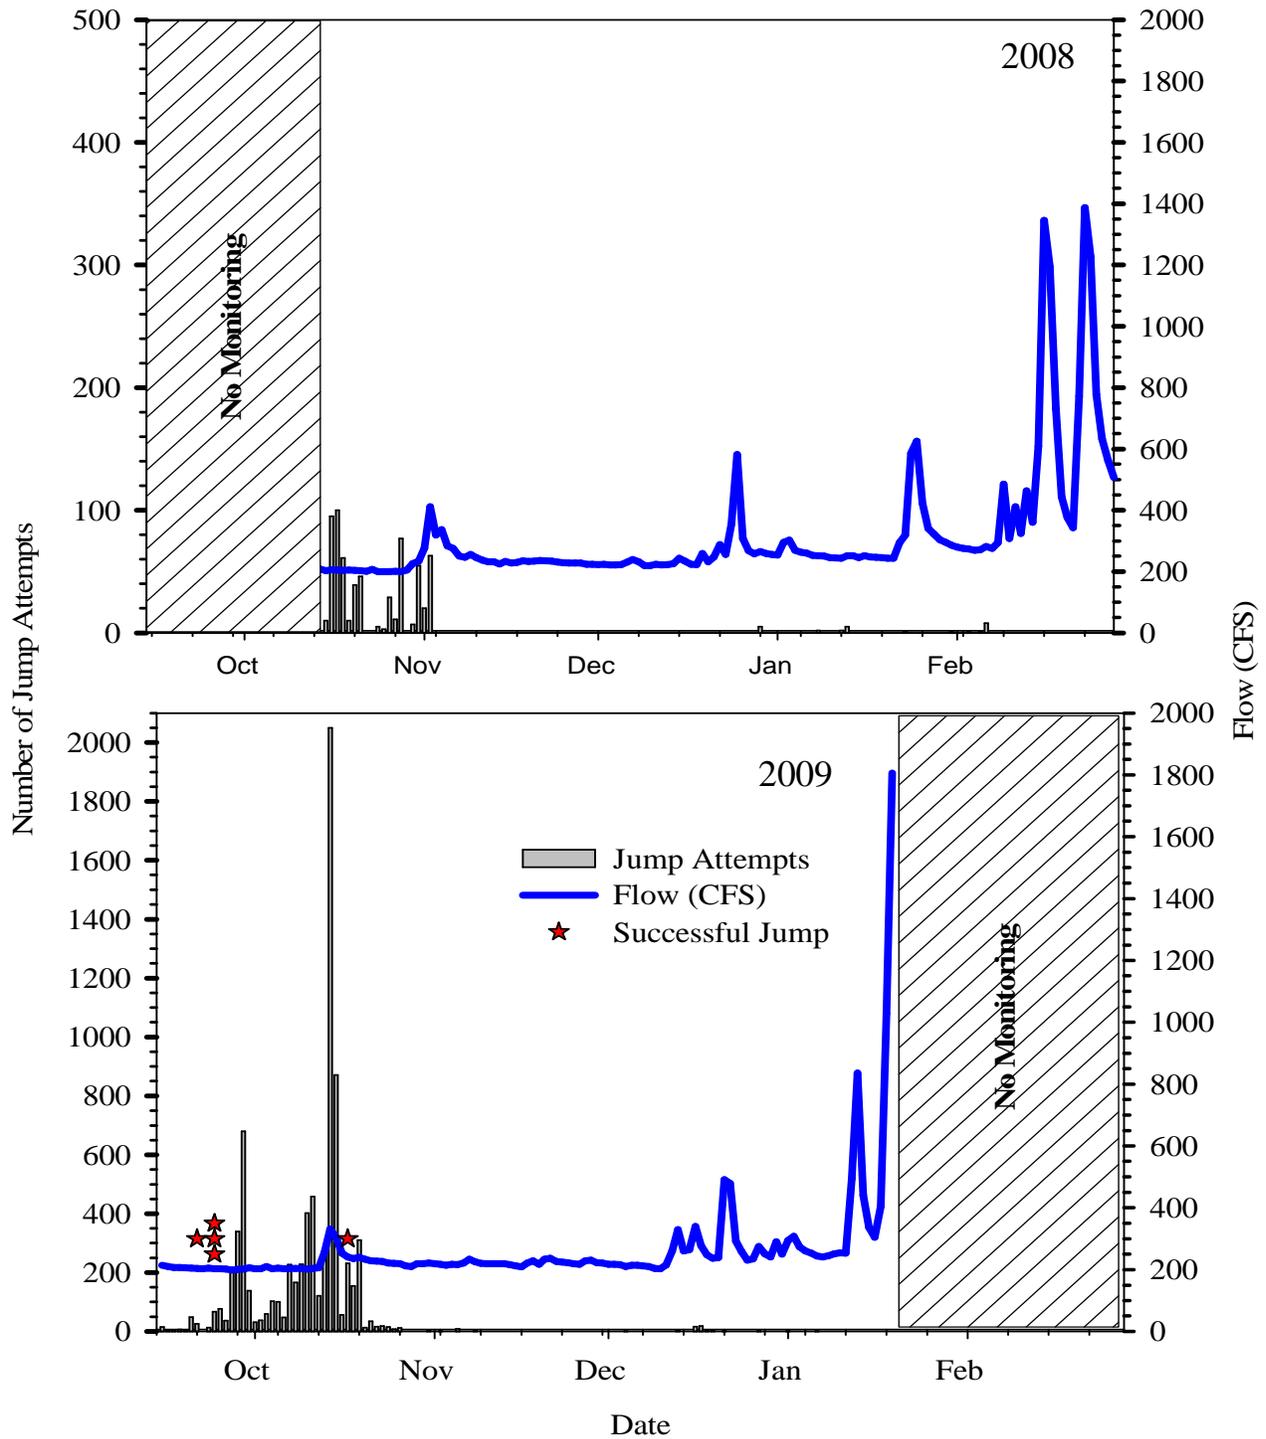
Figure 5. Number of jump attempts and number of fish that successfully jumped over the Battle Creek Barrier Weir. The line shows the amount of Battle Creek flow in cubic feet per second (CFS).

We observed 8,433 jump attempts at the Coleman NFH barrier weir; 657 in 2008-2009 and 7,776 in 2009-2010. Most jump attempts occurred prior to the end of fall Chinook spawning (i.e. the end of November; Figure 5). More jump attempts were made in 2009-2010 compared to 2008-2009, even when accounting for the later start date in 2008-2009 (Figure 5). The south end of the weir received more jump attempts in both years (Table 2). Zero of the 135 radio tagged fish were detected upstream of the Coleman NFH barrier weir. Zero fish were observed on recorded video ascending over the Coleman NFH barrier weir in 2008-2009 and five fish migrated past the weir in 2009-2010. All successful jumps over the Coleman NFH barrier weir occurred in the late-afternoon to early-evening, between 3:38 pm and 7:20 pm, and most successful jump attempts occurred early in the fall Chinook migration period (Table 3). The first

Flows ranged from 200 to 1,387 cubic feet per second (cfs) in 2008-2009 and 199 to 1,806 in 2009-2010 (Figure 5). All successful jumps over the Barrier Weir occurred at low flows (i.e. 203 – 205 cfs; Table 3; Figure 5). We were not confident in our abilities to observe fish that may have passed over the weir at flows exceeding approximately 800 cfs.

We recorded substantially more jump attempts in 2009-2010 compared to 2008-2009 (Figure 5) despite smaller run sizes of both fall and late-fall Chinook salmon in Battle Creek (Fall Chinook in Battle Creek: 10,639 in 2008-2009 and 6,152 in 2009-2010; Late-fall Chinook in Battle Creek: 6,429 in 2008-2009 and 5,505 in 2009-2010). It is likely that environmental conditions, such as water temperature and stream flow, influence the numbers of jump attempts. Particularly noteworthy is the flow increase in Battle Creek that occurred after a rainstorm in mid-October 2009 and the corresponding increase in jump attempts. Chinook salmon migration typically increases during the period of increasing flows and turbidity associated with rainstorms, which would be expected to increase the number of fish encountering the weir resulting in more jump attempts. It is also possible that operation of the fish ladders may have affected jumping attempts. We speculate that salmonids that do not have access to a fish ladder may demonstrate increased attempts to circumvent the weir by jumping; however, we were not able to demonstrate this during this study. Ladder operations during the fall and late-fall Chinook spawning periods are shown for 2008-2009 and 2009-2010 in figures 6 and 7.

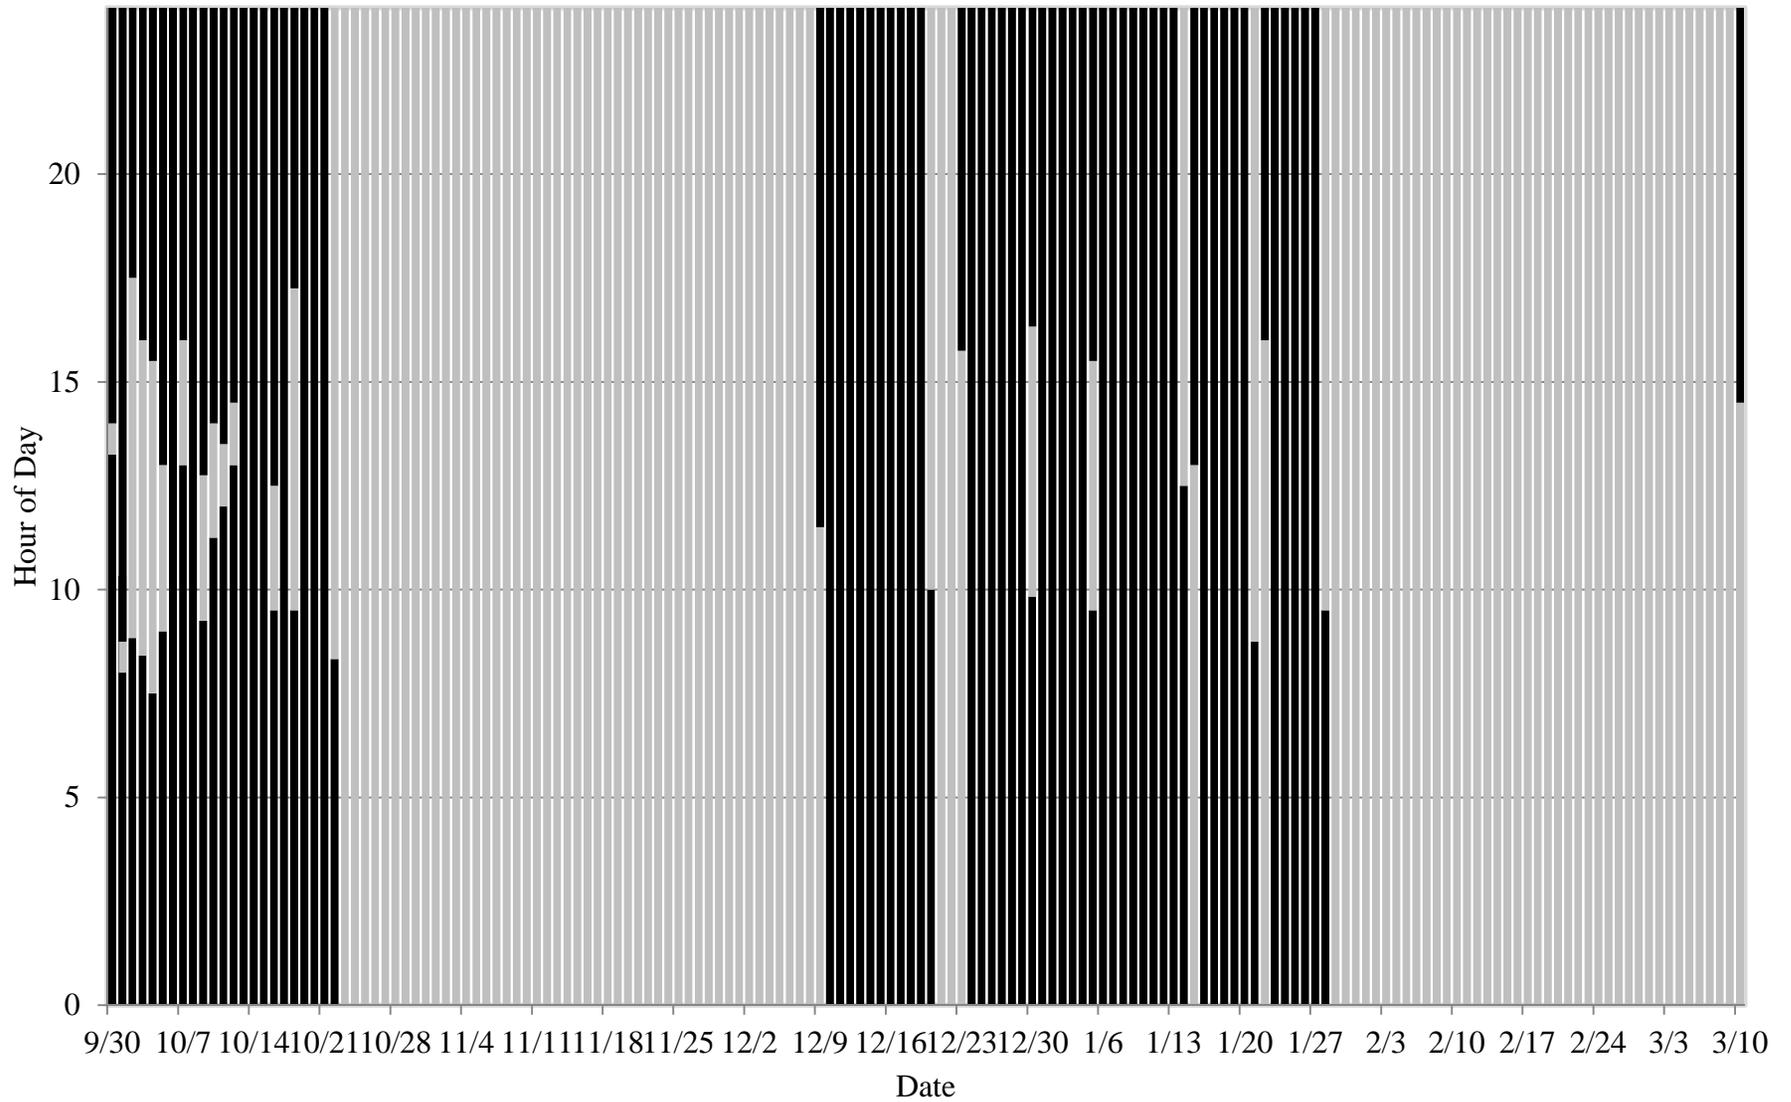
**Figure 6. Daily operation of the Coleman NFH barrier weir fish ladder during fall and late-fall Chinook salmon broodstock collection, 2008-2009. Black bars indicate that the fish ladder was closed and gray bars indicate fish ladder was open.**

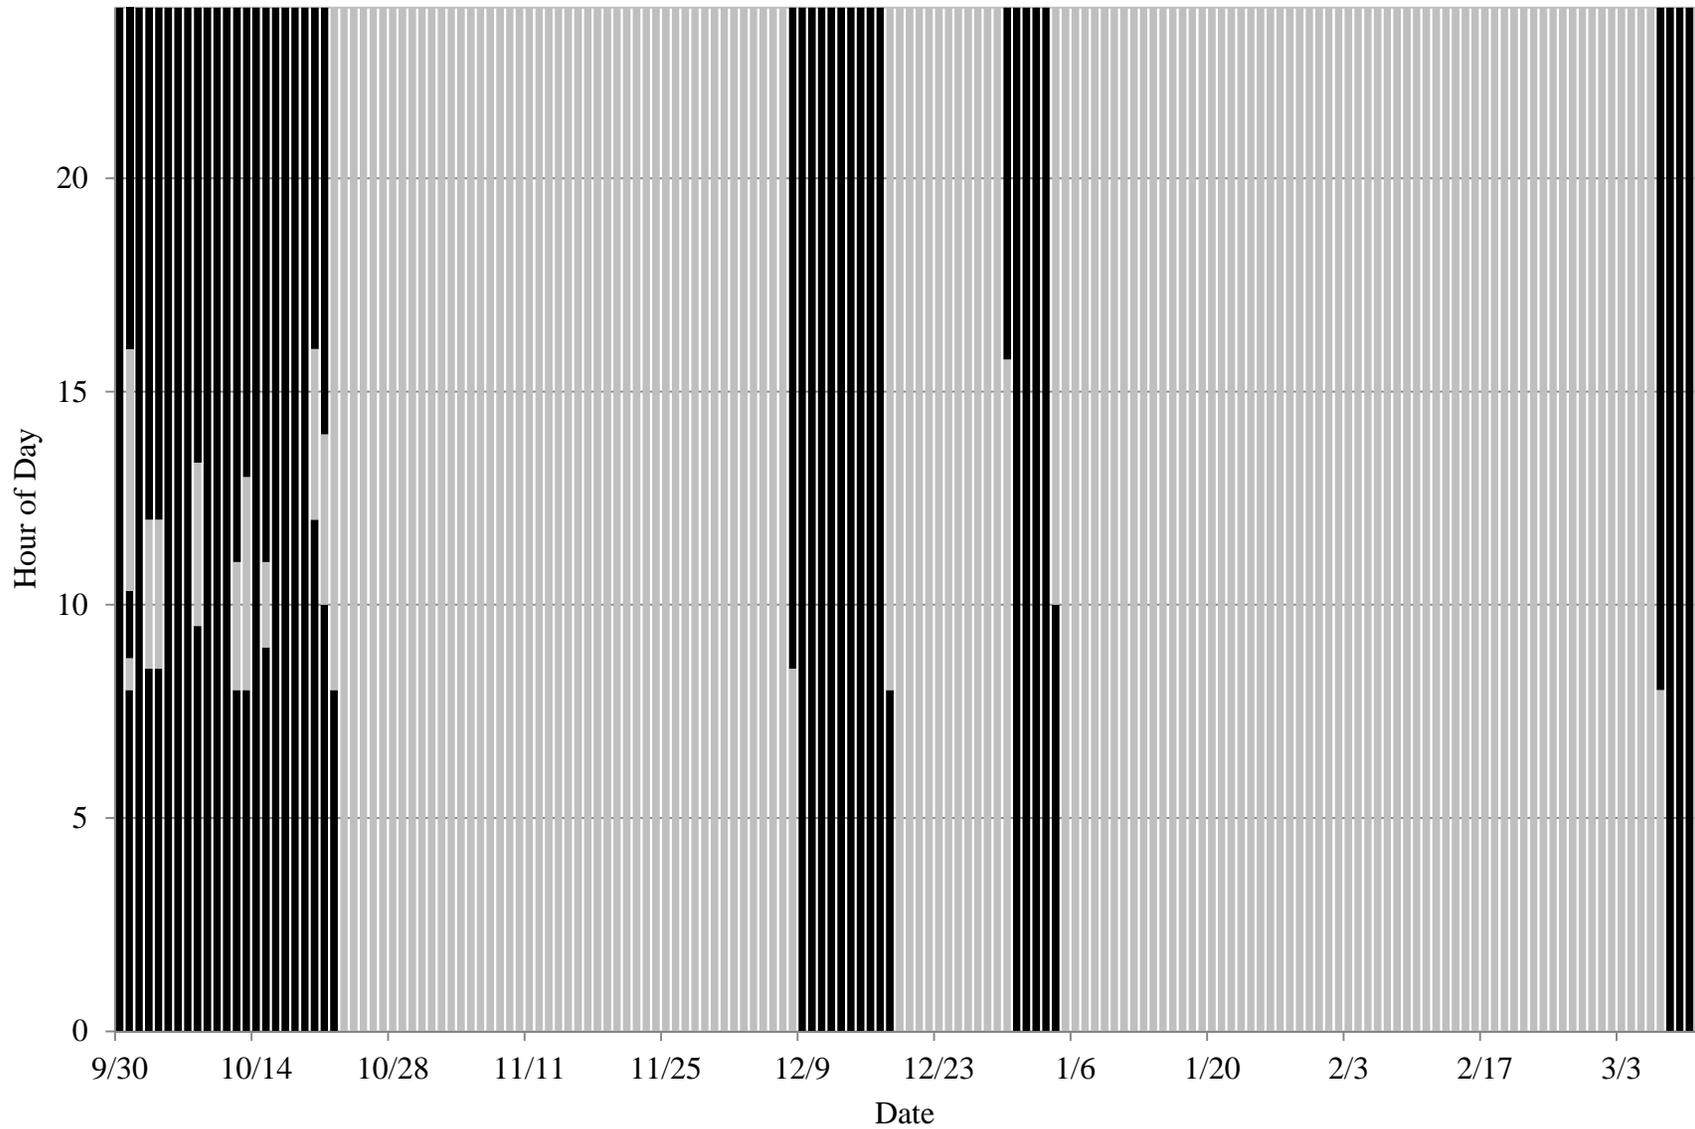
**Figure 7. Daily operation of the Coleman NFH barrier weir fish ladder during fall and late-fall Chinook salmon broodstock collection, 2009-2010. Black bars indicate that the fish ladder was closed and gray bars indicate fish ladder was open.**

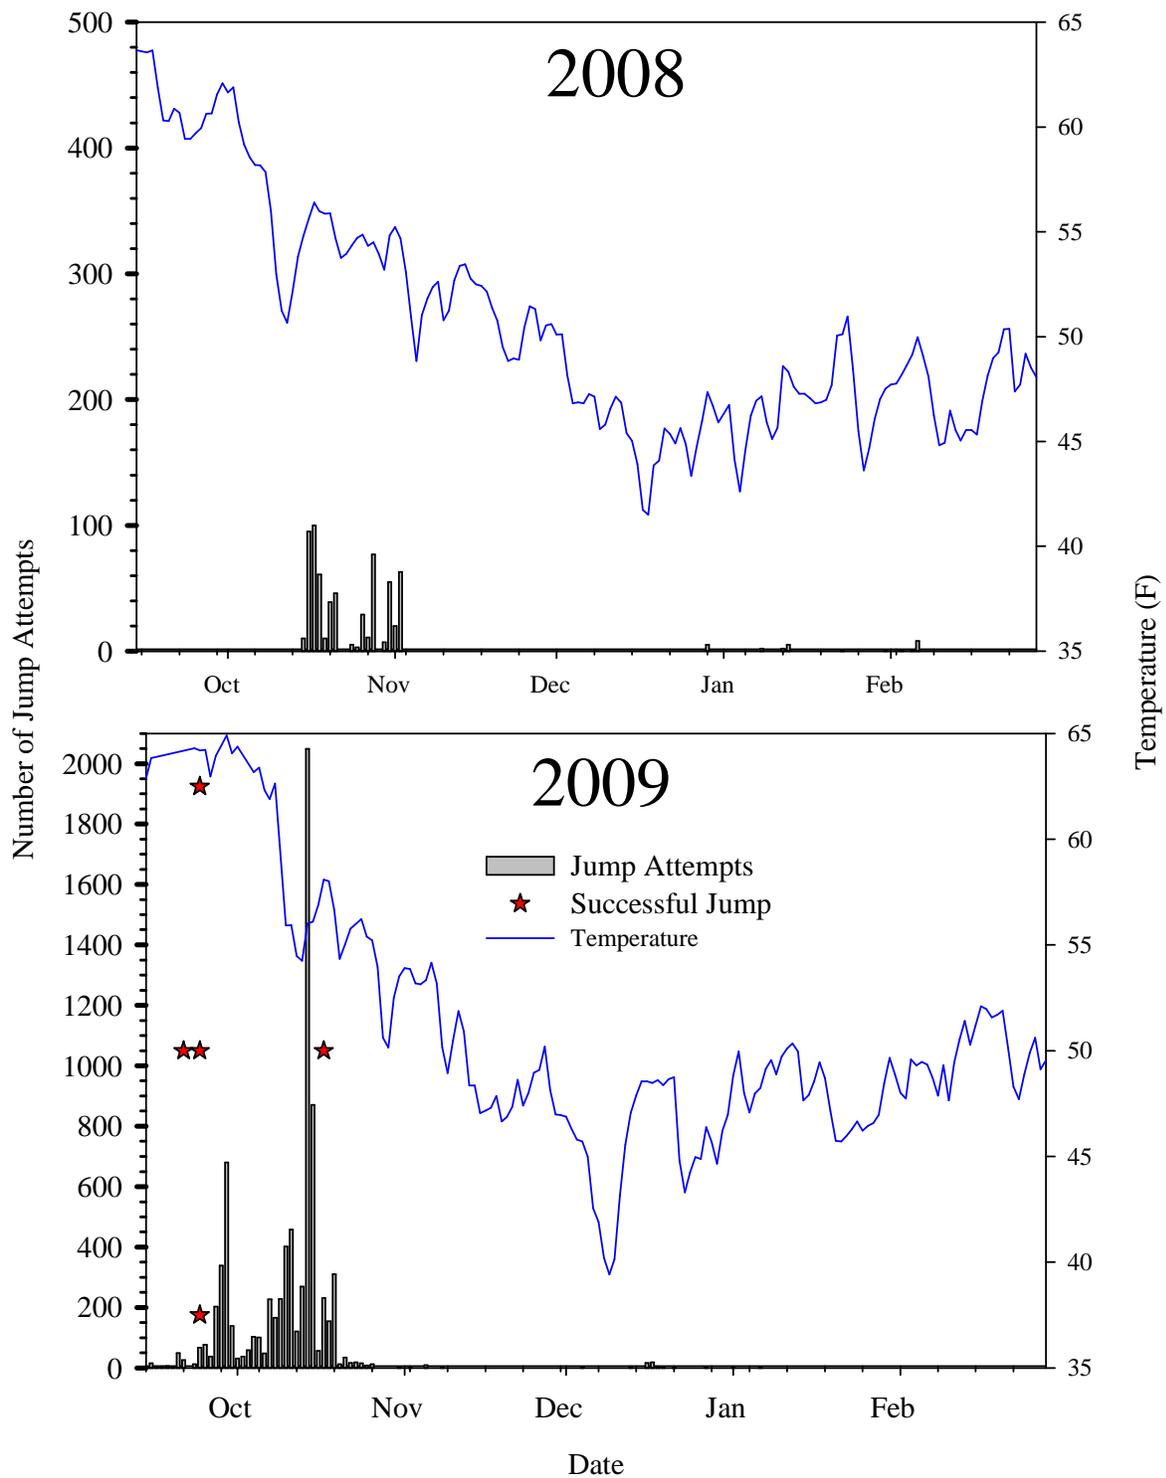
**Figure 8. Number of jump attempts and number of fish that successfully jumped over the Battle Creek Barrier Weir. The line shows the temperature of Battle Creek flow in degrees Fahrenheit.**

We speculate that the reduced jumping activity in late-November through February was a result of fewer fish in the vicinity of the Barrier Weir and lower water temperature in Battle Creek (figure 8). The relative abundance of Chinook salmon in the vicinity of the Barrier Weir is typically highest during the peak of migration of fall Chinook (October) and declines markedly thereafter, typically remaining relatively low throughout the late-fall Chinook migration season. Warmer water temperatures earlier during the years also likely contributed to more successful jumps. Although we could not conclusively relate jumping activity to water temperatures in this study, we consider it likely that fewer jump attempts are made when the water temperature in Battle Creek is lower. It is important to note that video monitoring early during the monitoring period, when we believe fish are most likely to successfully jump over the Coleman NFH barrier weir, did not occur in 2008-2009. Therefore, some successful jumps may not have been observed.
