***Historical Resource Investigation for the
U.S. Fish and Wildlife Service, Red Bluff Fish
and Wildlife Office, Lower Deer Creek Falls
Fish Passage Replacement Project,
Tehama County, California***

February 22, 2016

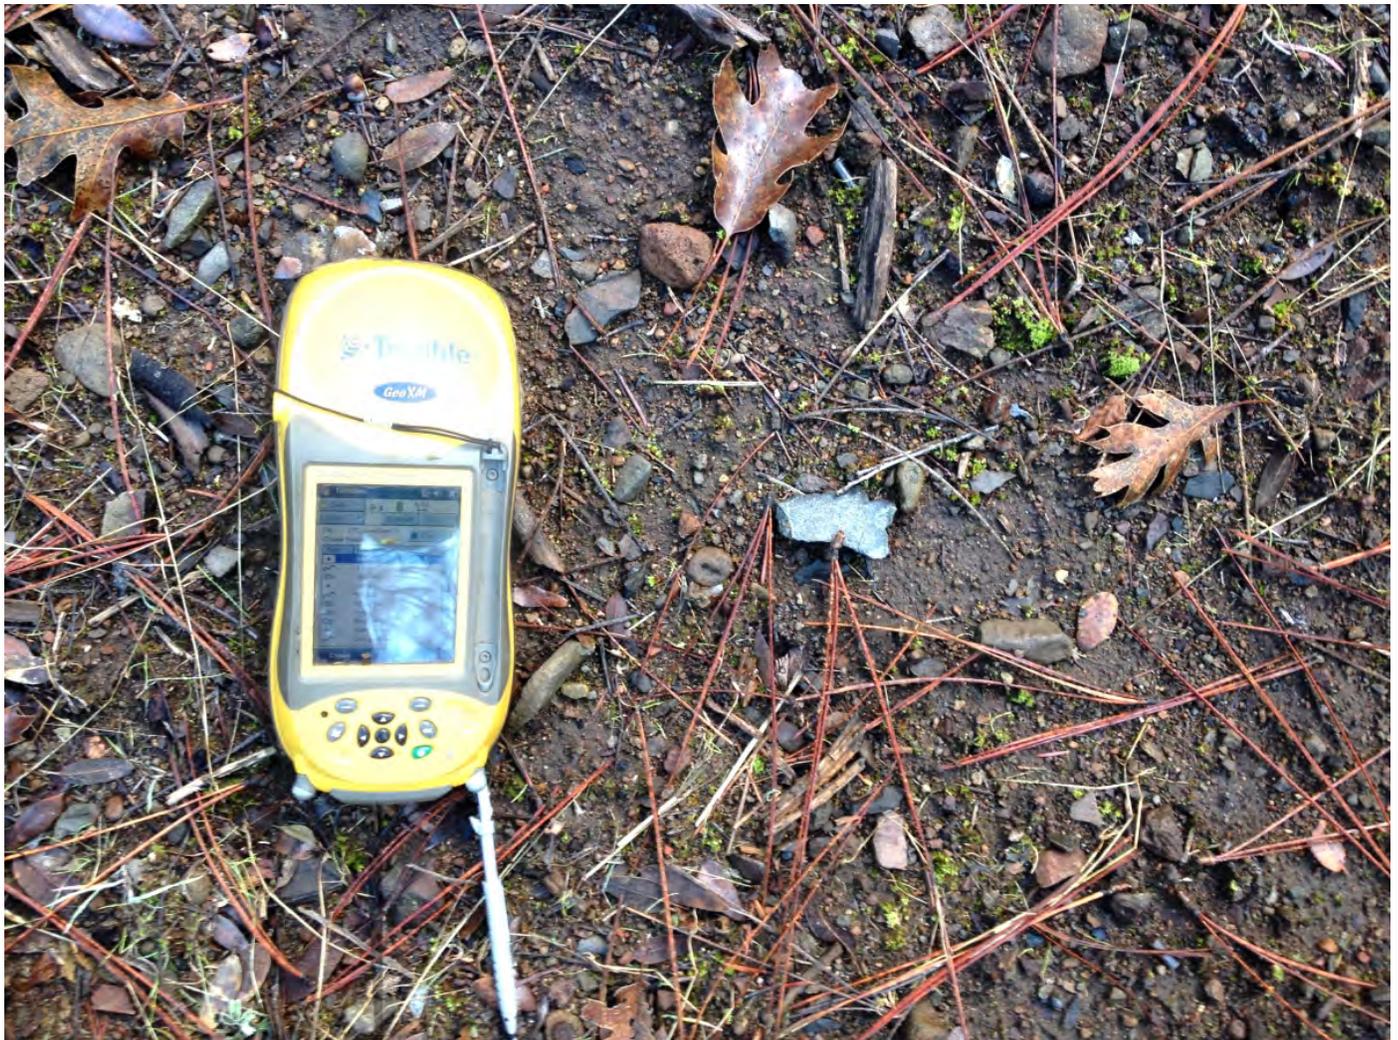
View of coarse-grained basalt and fine-grained metavolcanic flakes on the midden area surface.

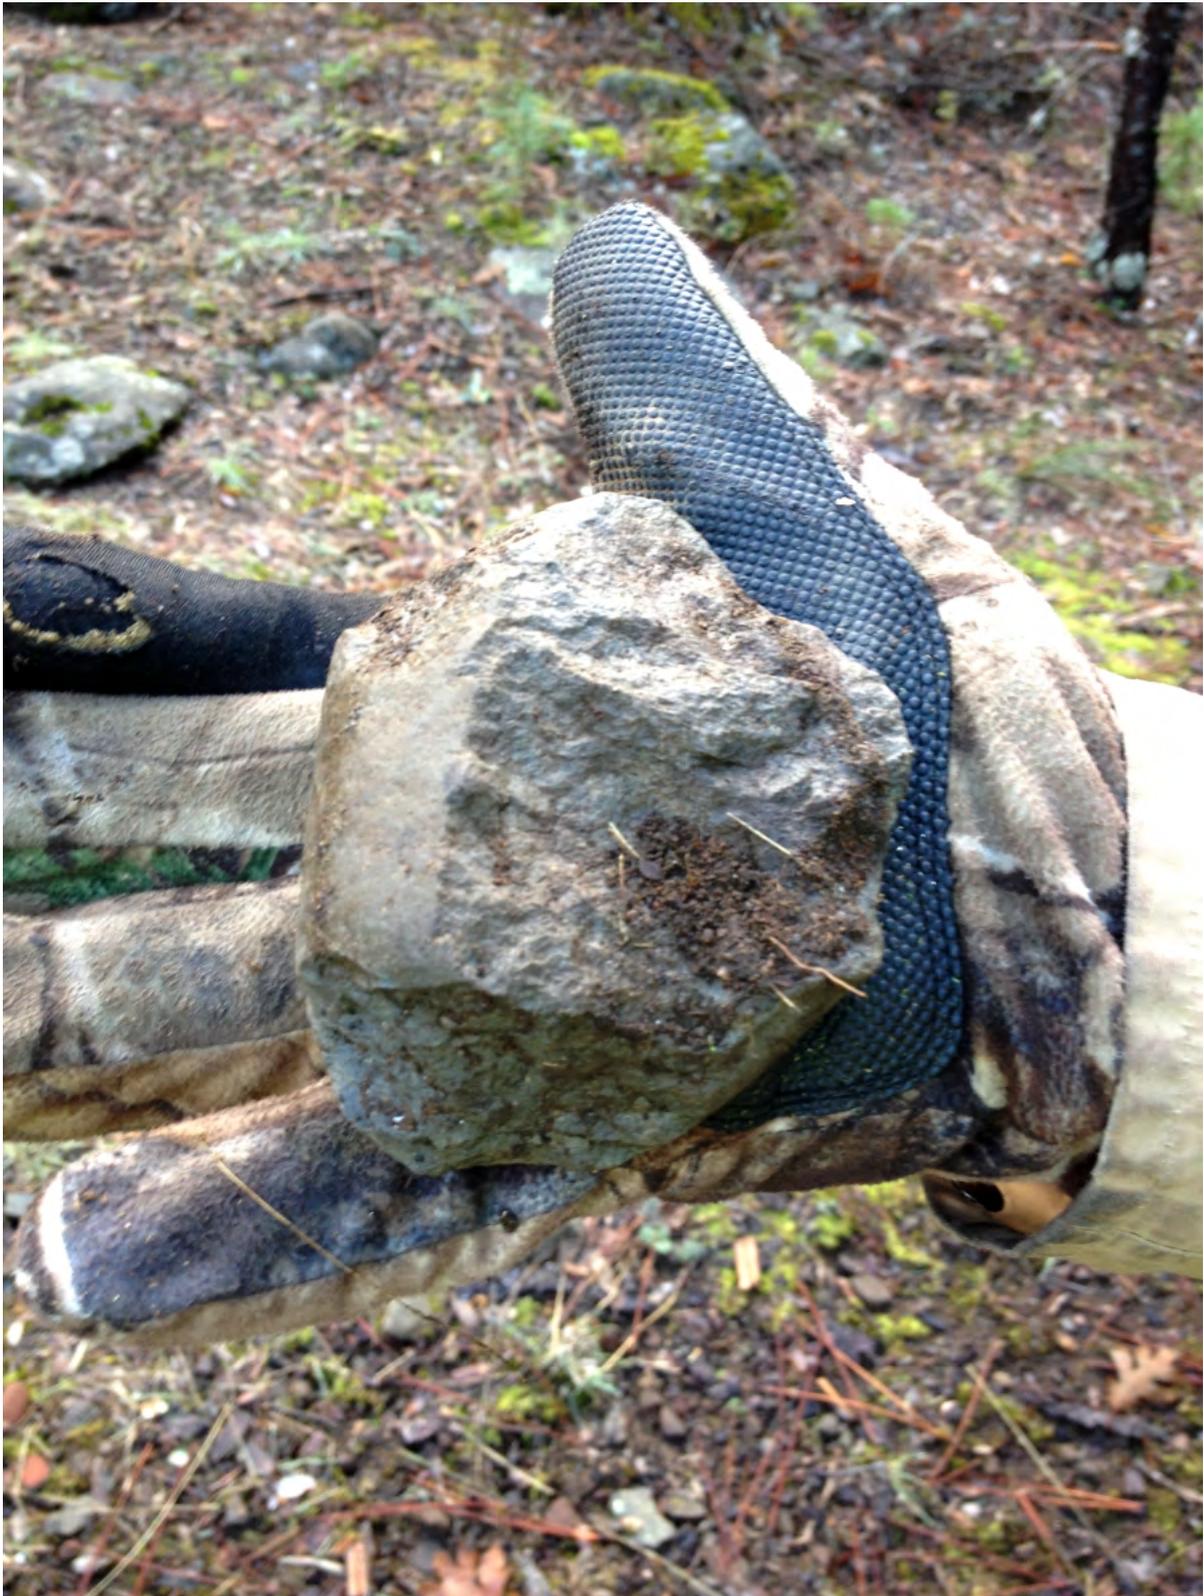
Large metavolcanic core tool.

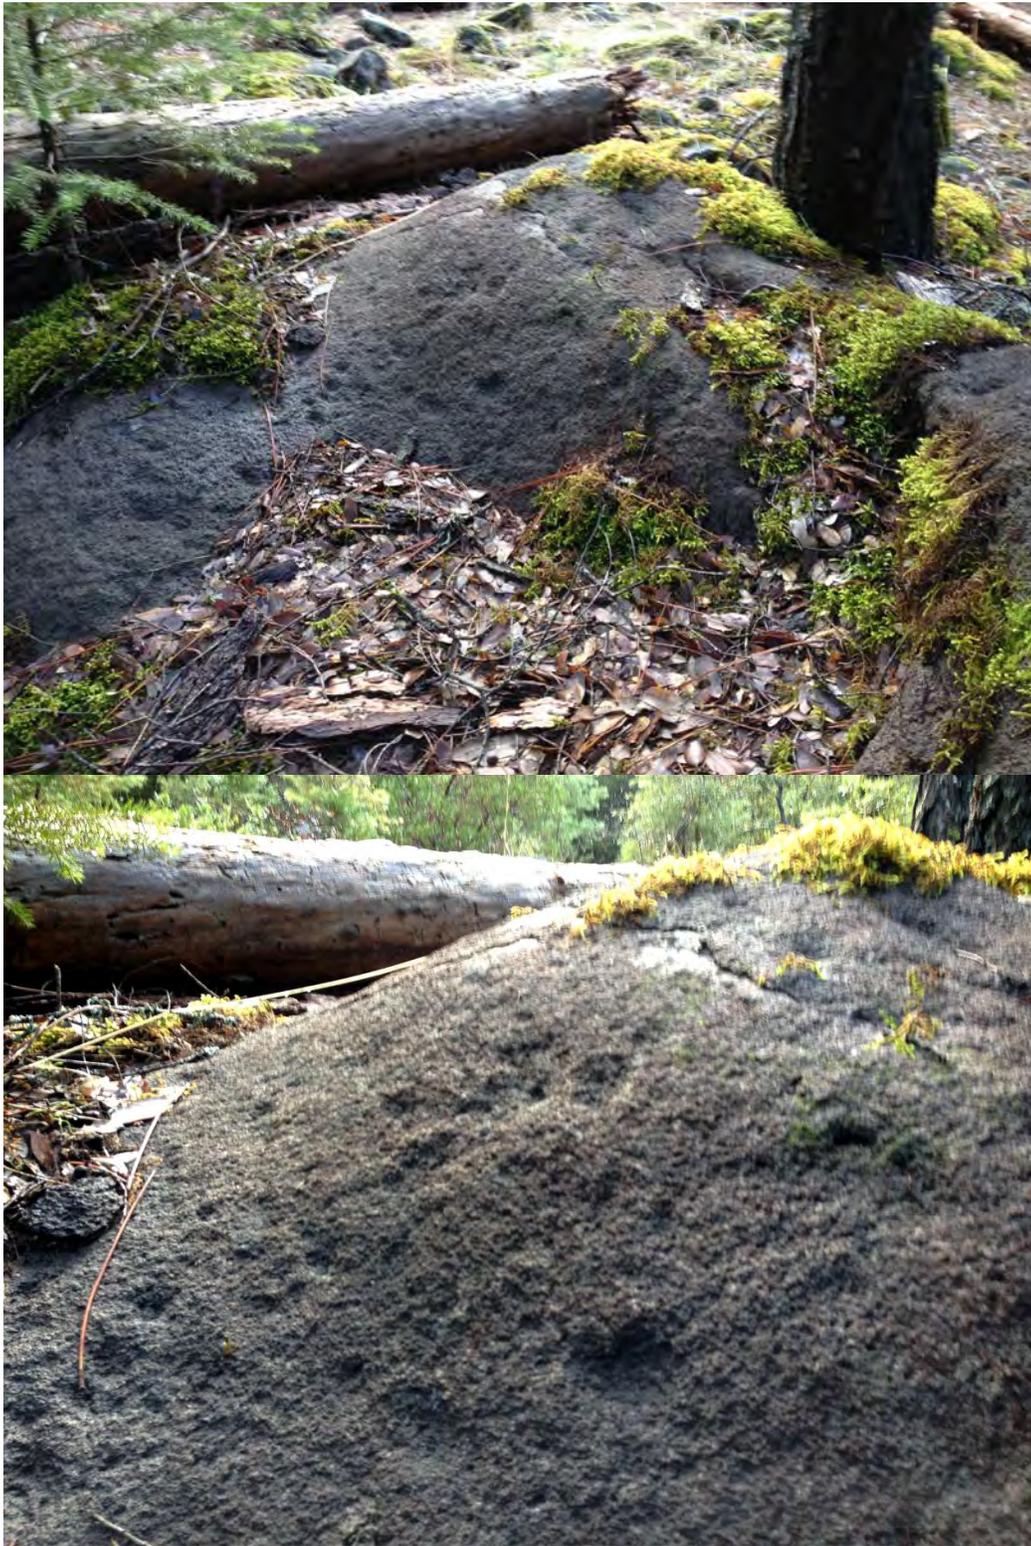
Possible petroglyph boulder showing possible weathered cupules. Overview (top), Closeup (bottom)

One possible petroglyph boulder was observed. The boulder is located on the edge of the high bench overlooking Deer Creek on the east end of the site, associated with a low-density lithic scatter. The feature consists of a large, irregular, water-rounded boulder of grainy breccia measuring approximately 3 meters (10 feet) in diameter, just its top exposed above ground. The prominent face of the boulder is tilted toward the center of the site and catches the angled sunlight, highlighting three large (3–4 cm diameter) and approximately 20 small (2–3 cm diameter) round, cup-shaped depressions 0.5–1.0 centimeter deep. The depressions lack indisputable evidence that they were deliberately manufactured, and two lines of evidence point toward their production by natural forces: (1) the boulder is part of the Pleistocene-aged sediment forming the substrate of the high bench and the pitting may have accrued when the boulder tumbled into place, and (2) the depressions are heavily weathered and lack the sharp relief and obvious pecking scars that might positively indicate that they were deliberately manufactured. However, two characteristics point toward deliberate cultural activity: (1) each depression stands to some degree alone from the others, and (2) the depressions are not random but appear to occur in clusters and alignments. In my opinion, the latter two attributes cast the weight of the evidence in favor of these being actual cultural petroglyph features; their lack of sharp relief may be considered a product of significant age and heavy weathering.

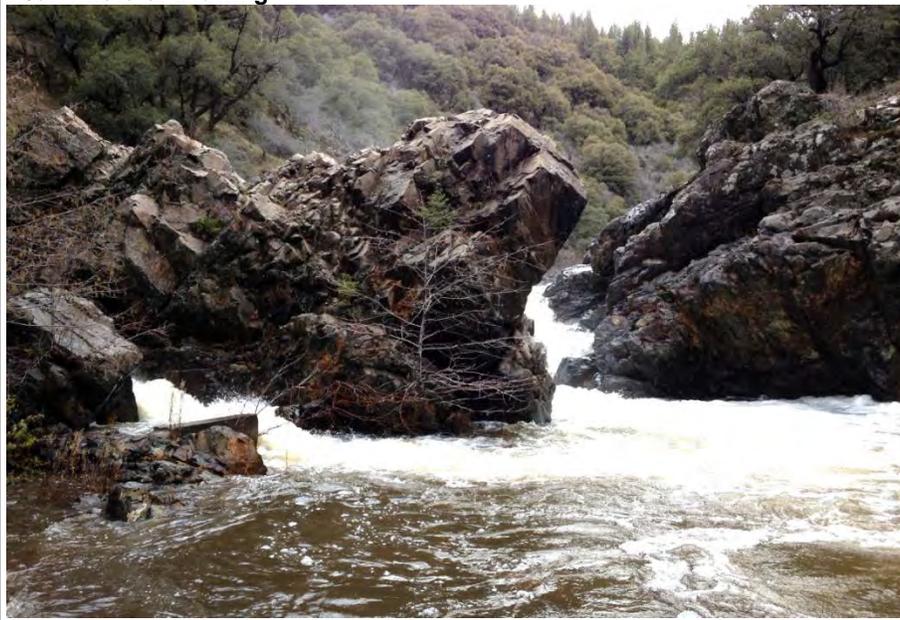
P5b. Description of Photo: View looking north toward Lower Deer Falls; fishway entrance visible in the left foreground.

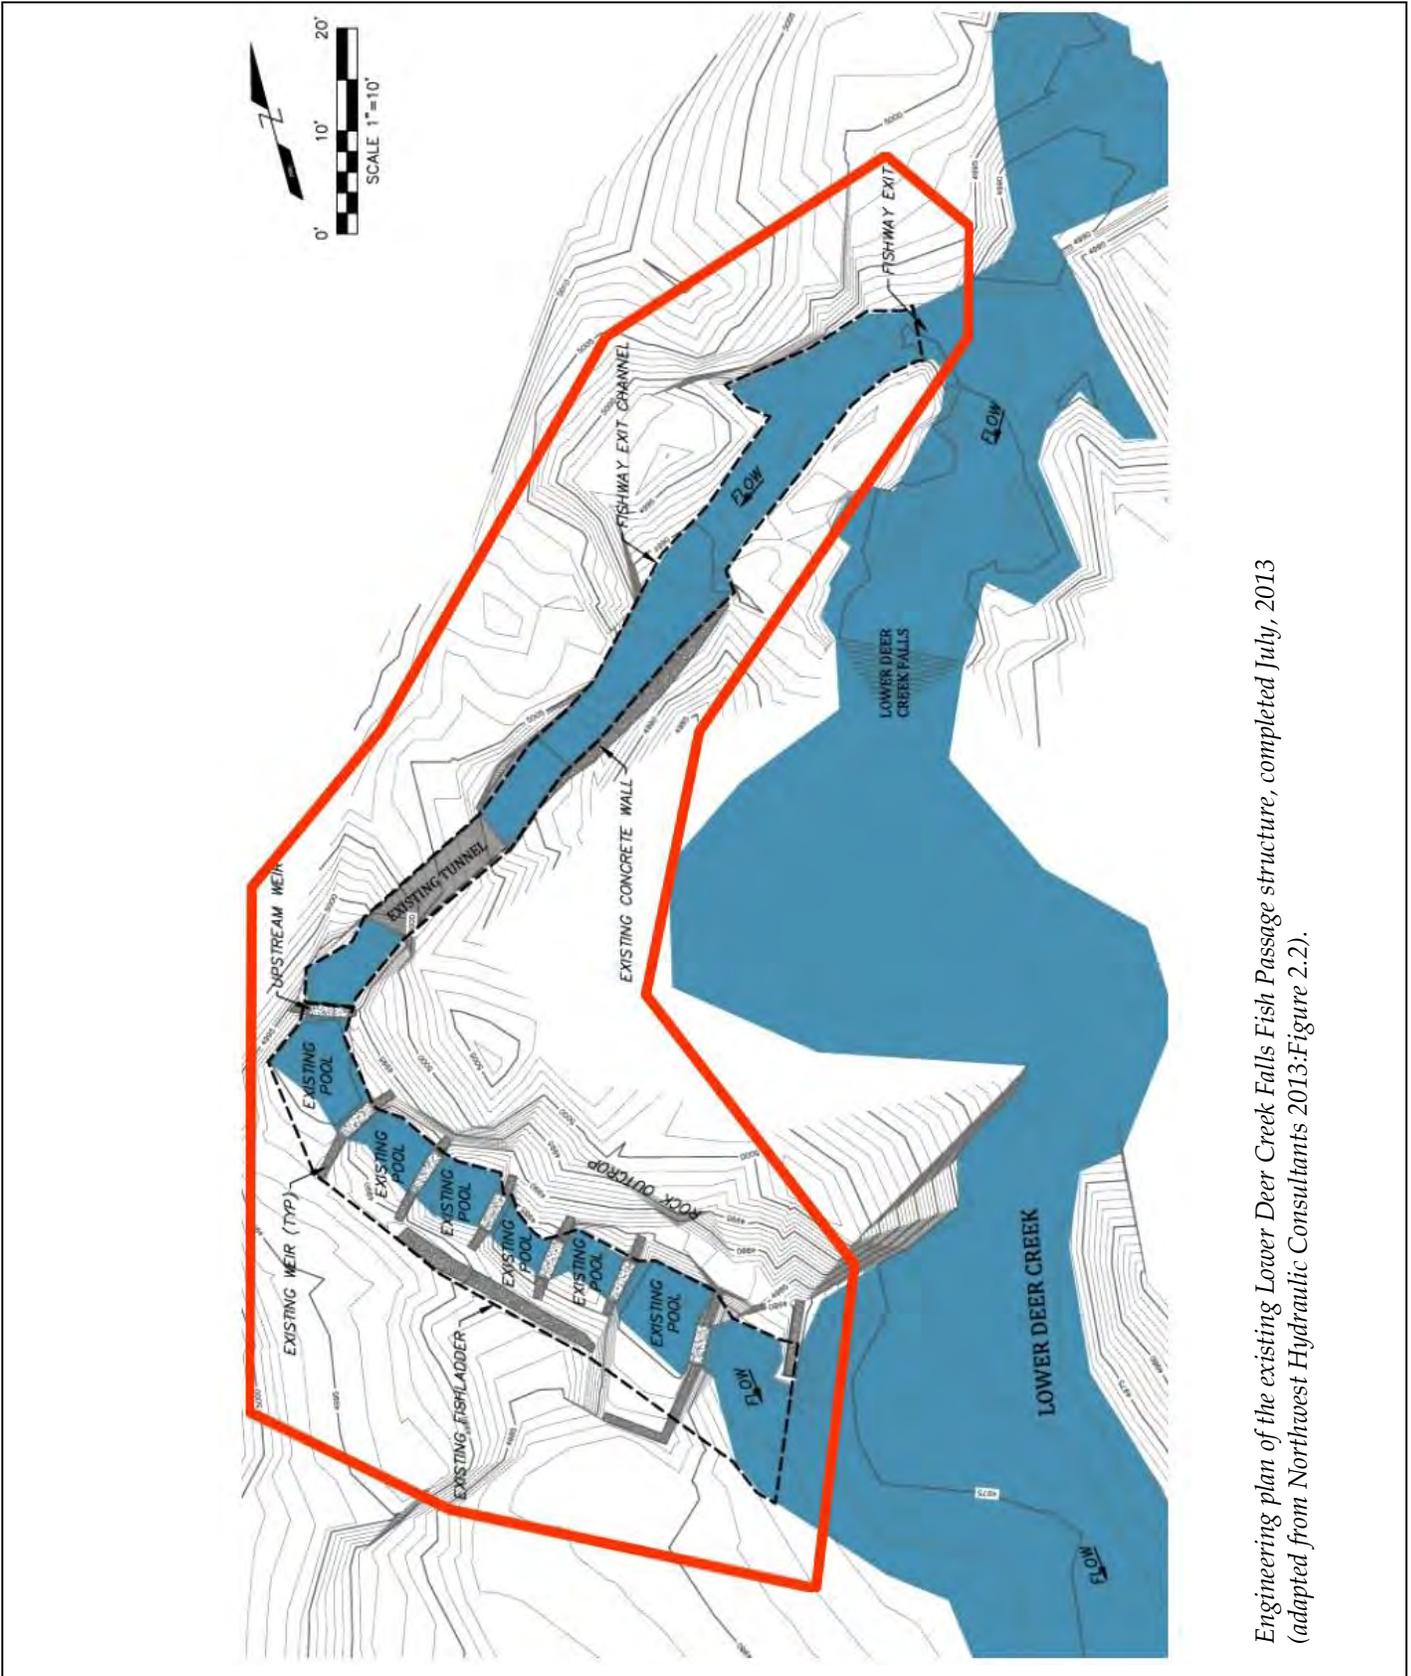
Engineering plan of the existing Lower Deer Creek Falls Fish Passage structure, completed July, 2013
(adapted from Northwest Hydraulic Consultants 2013:Figure 2.2).

Lower Deer Creek Falls is located in a narrow notch-shaped, rocky gorge formed by the impingement of breccia and basaltic bedrock and massive, loose boulders. The falls is marked by a vertical drop of 15 feet across a section of channel measuring approximately 35 feet, terminating in a large, 125 foot (38 meter) long pool. This section of Deer Creek flows roughly north-to-south, and the existing fish passage structure redirects to the west, routed through boulders and bedrock around the falls.

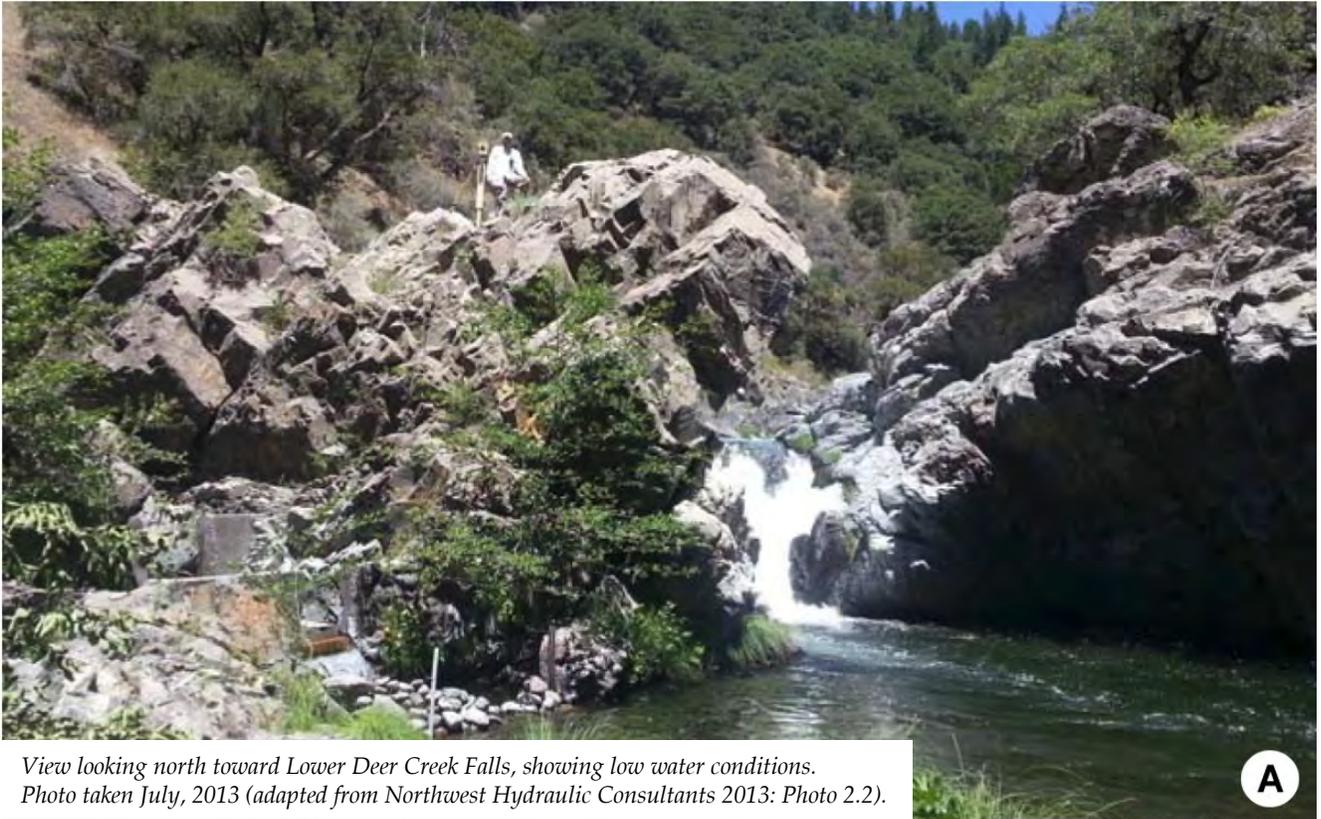
*View looking north toward Lower Deer Creek Falls, showing low water conditions.
Photo taken July, 2013 (adapted from Northwest Hydraulic Consultants 2013: Photo 2.2).*

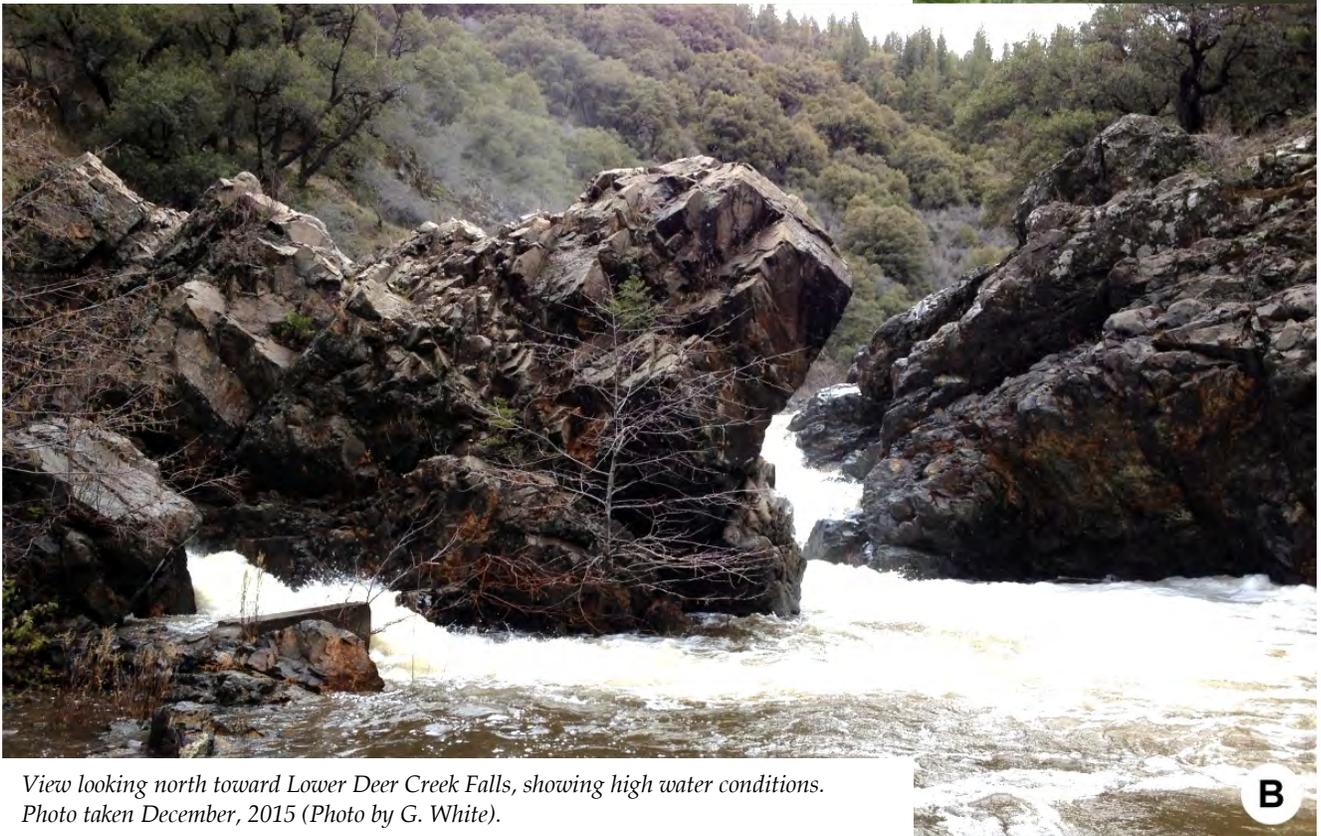
*View looking north toward Lower Deer Creek Falls, showing high water conditions.
Photo taken December, 2015 (Photo by G. White).*

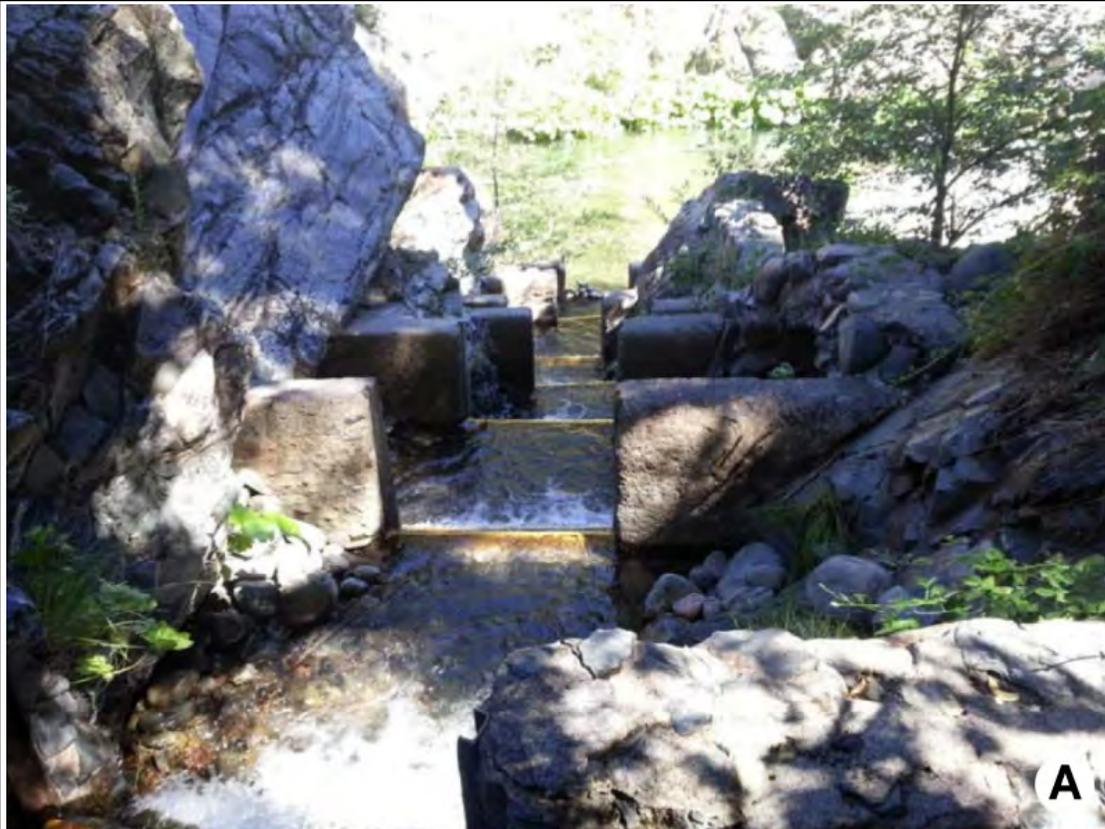
View looking east, down the fish ladder from the turning pool, showing low water conditions. Photo taken July, 2013 (adapted from Northwest Hydraulic Consultants 2013: Photo 2.3).

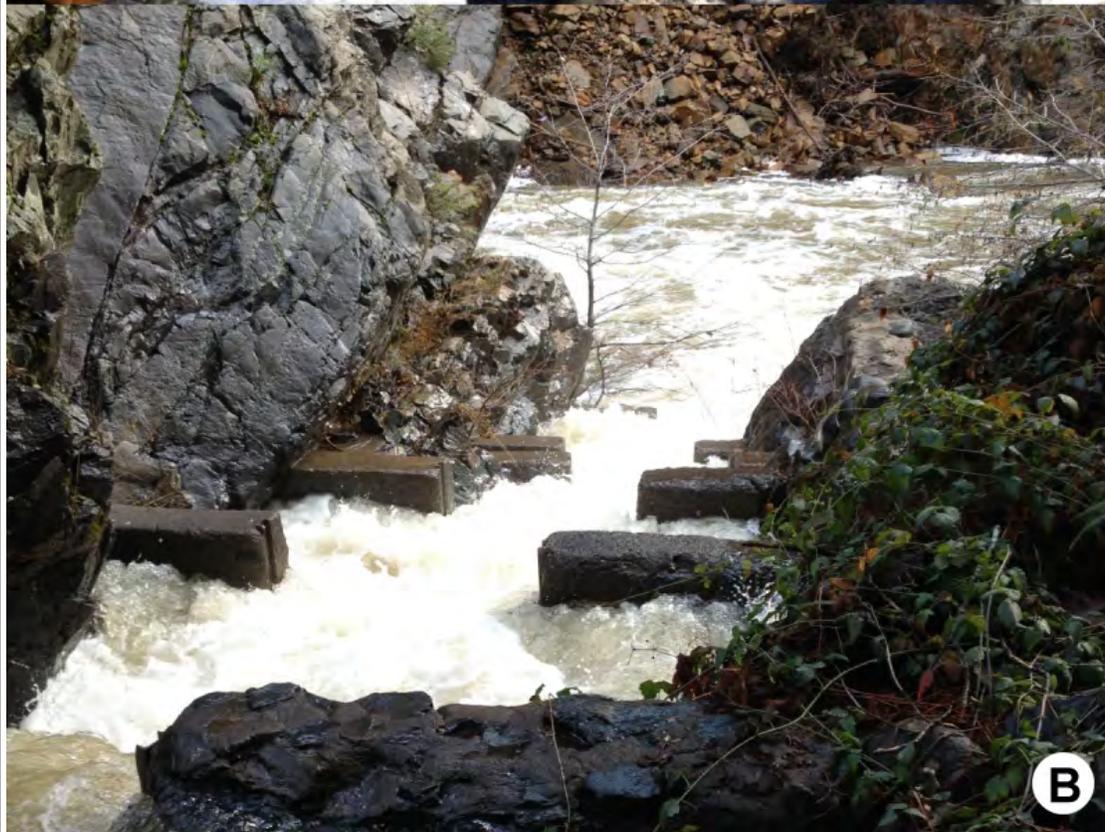
View looking east, down the fish ladder from the turning pool, showing high water conditions. Photo taken December, 2015 (Photo by G. White).

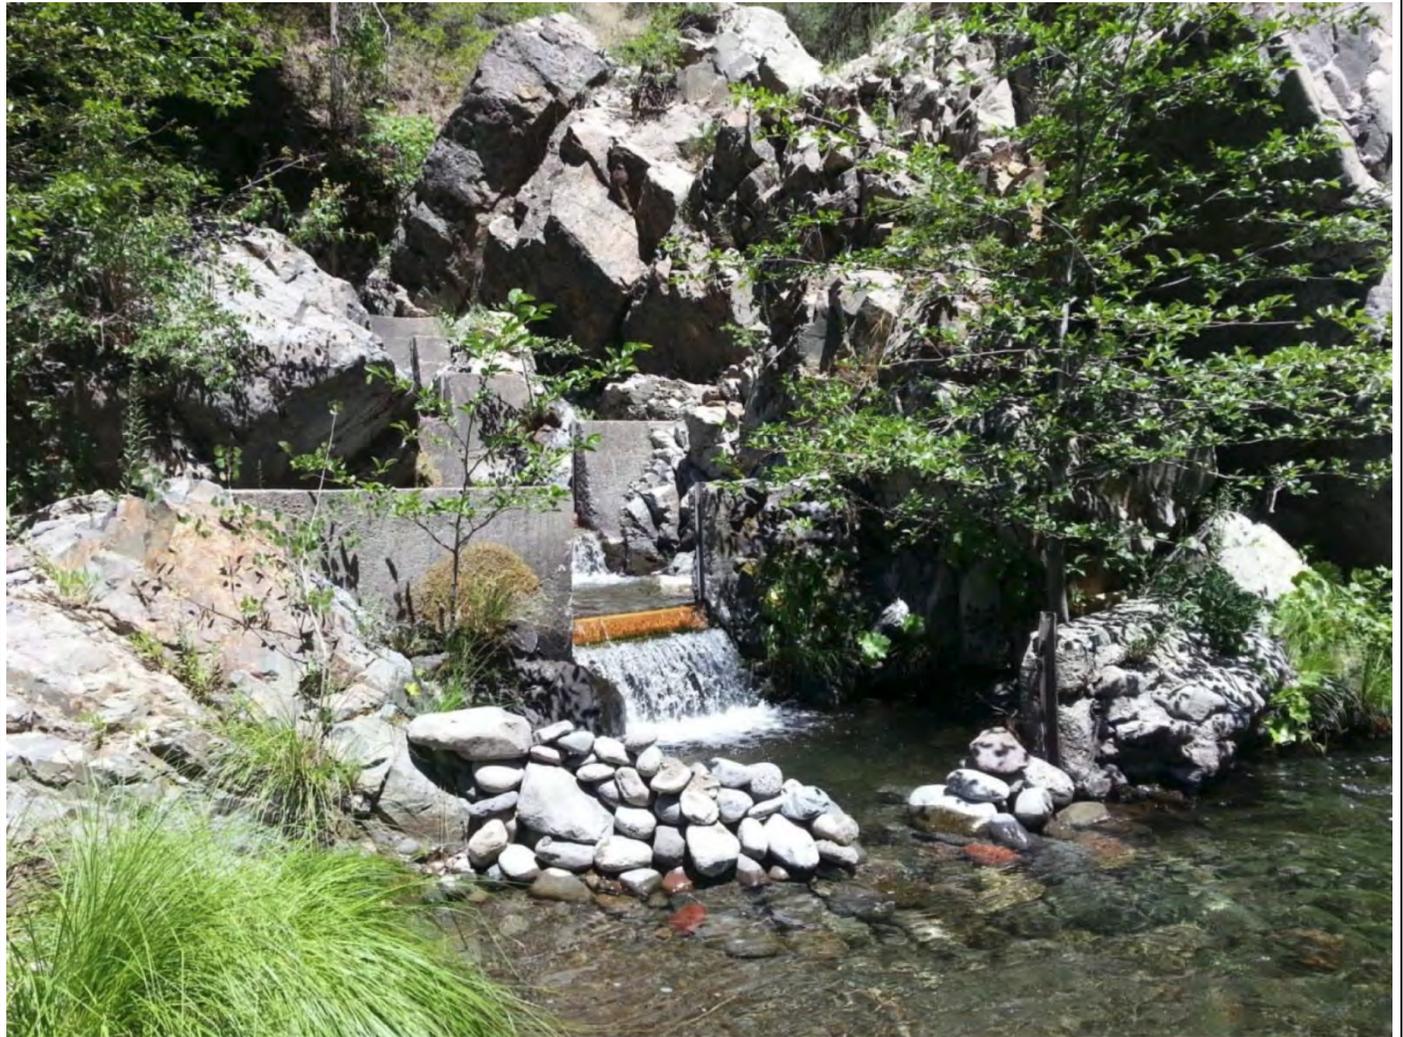
View looking north-northwest from the edge of the pool below the falls toward the mouth of the fish ladder, showing erosion of the first tier weir wings and the first tier temporary rock structure (adapted from Northwest Hydraulic Consultants, Incorporated 2013:Photo 5.1).

Weathering of concrete and steel features of the structure was observed consistent with the age of the structure and the pounding it receives from water and water-borne sediment, evident during the December 22nd – 23rd field visit. Concrete walls were generally characterized by loss of surface finish and differential weathering along batch lines, resulting in notable crimped joints on the wings of lower tier weir structures and on the stream-side face of the fish passage exit channel high concrete retaining wall. The first, lowermost weir step was significantly altered, with one wing entirely missing and the other heavily sculpted and partially undermined by stream scouring. Absence of this first weir meant that the lowermost step of the ladder was missing and resulting in a double-high step to the second tier. The California Department of Fish and Wildlife monitors and maintains the structure two to three times annually, and in recent years addressed the first tier blowout by building a temporary rock wall dam to retain an approximation of the first pool.

albeit weathered. As noted above, the concrete walls of the structure were characterized by loss of surface finish and differential weathering along batch lines, resulting in notable crimped joints on the wings of lower tier weir structures and on the stream-side face of the fish passage exit channel high concrete retaining wall. Bi-annual maintenance visits by California Department of Fish and Wildlife personnel regularly involve clearing of alluvium and woody debris from the structure, and generally, the weir pools are filled with alluvial sediment. Currently, the fishway exit channel is jammed by two large logs. Further, the first, lowermost weir step which is the feature most vulnerable to main channel erosion has been heavily impacted by ongoing hydrological weathering; one wing is entirely missing and the other heavily sculpted and partially undermined by stream scouring. Nevertheless, overall few features of the original structure have been significantly adapted, restored, or rehabilitated in the years since construction. A recent geotechnical engineering review of the integrity of the structure is pertinent here:

Overall, the existing fish passage features appeared to be performing well and did not exhibit obvious signs of distress or stability concerns. The concrete appeared to be well adhered to the surrounding rock. However, we did observe that sections of the wall that formed the lowest pool in the downstream section were missing and had been replaced with loosely stacked cobbles and boulders. It is possible that the original walls were founded on recent alluvial deposits, and became undermined and washed out during high flows. These recent alluvial deposits are prone to the effects of scour during high creek flows (Sage Engineers, Incorporated 2013:5).

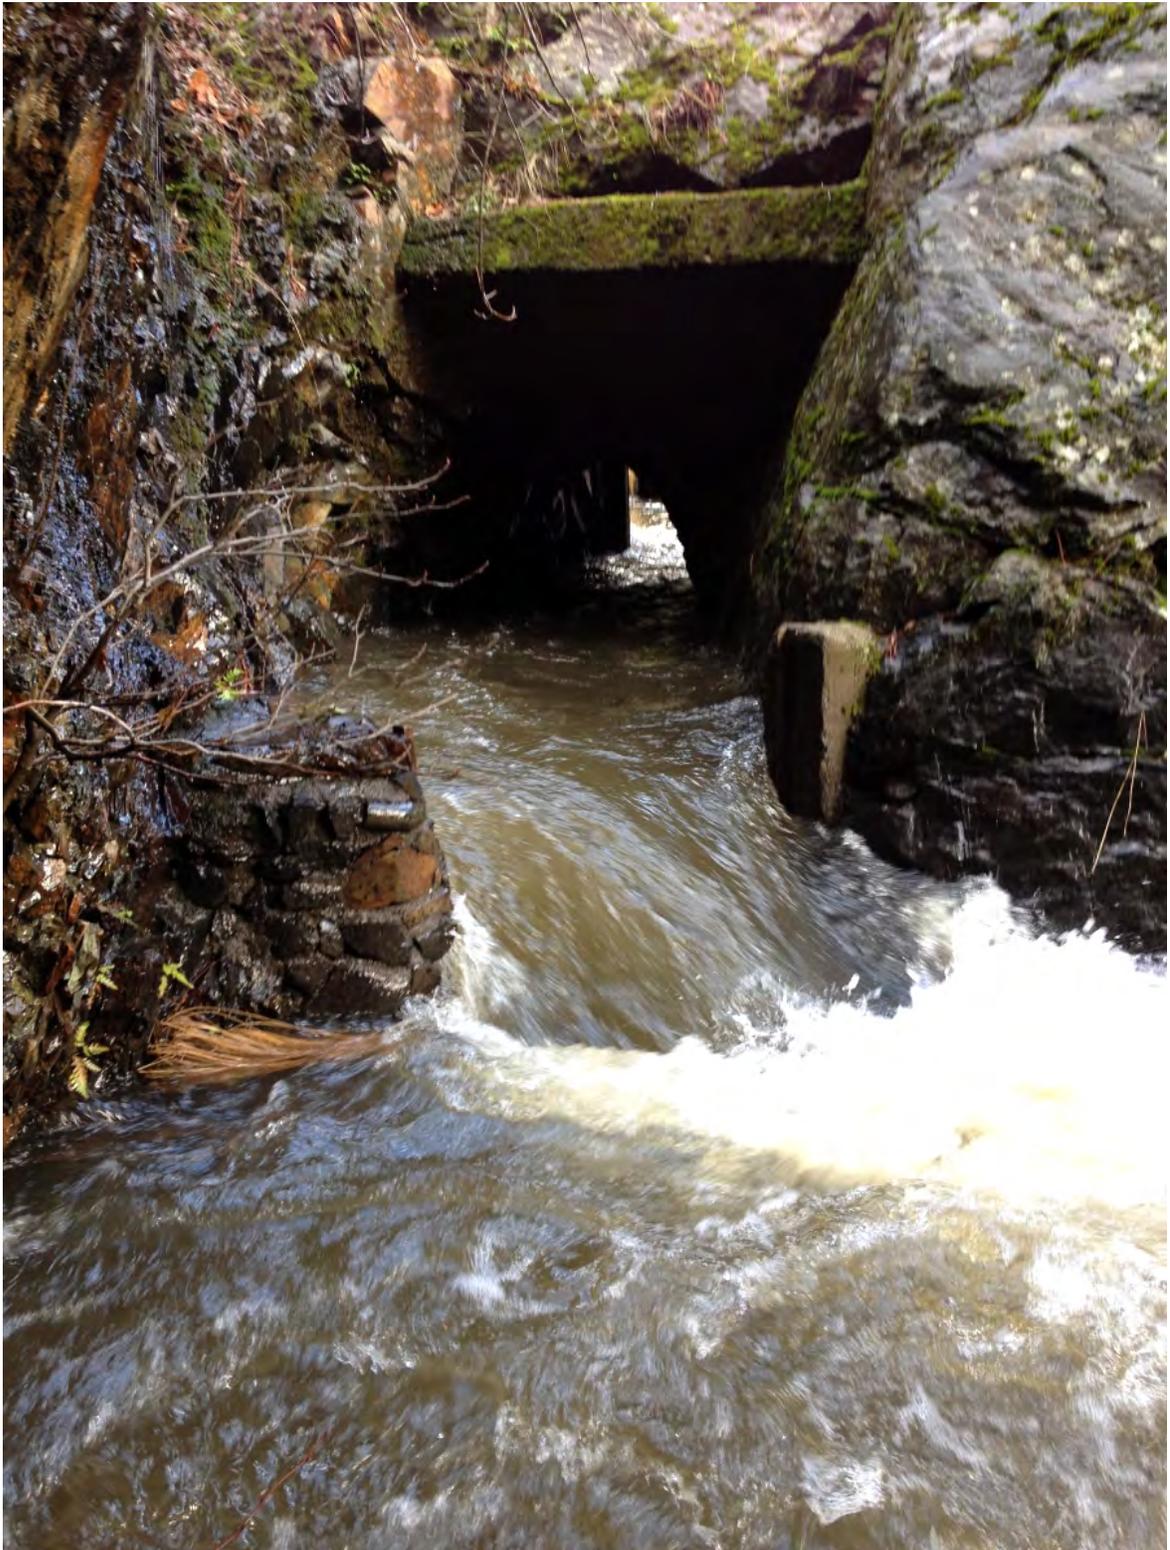
View north from the turning pool toward the entrance to the fish passage exit tunnel, showing concrete rockwork on the exit channel weir.

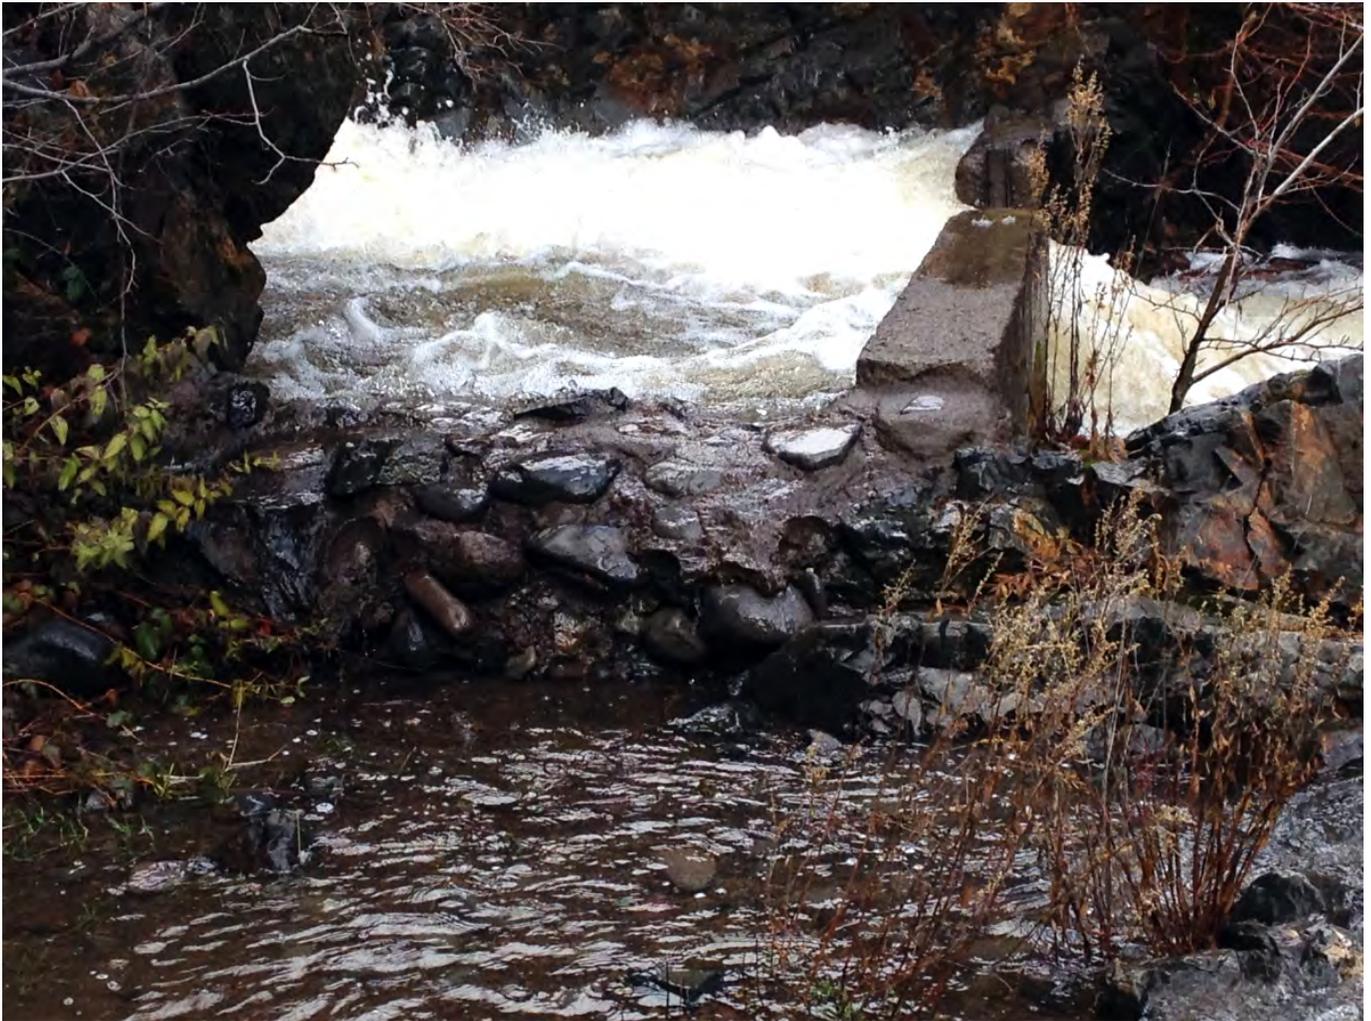
View looking north of the south, exterior wall of the third tier weir pool wall, showing concrete and rock work.
