COTTONWOOD CREEK SEDIMENT BUDGET: 2010-2014

FINAL REPORT

REVISED -- June 2015

Prepared by:
Graham Matthews and Associates
PO Box 1516
Weaverville, CA 96093

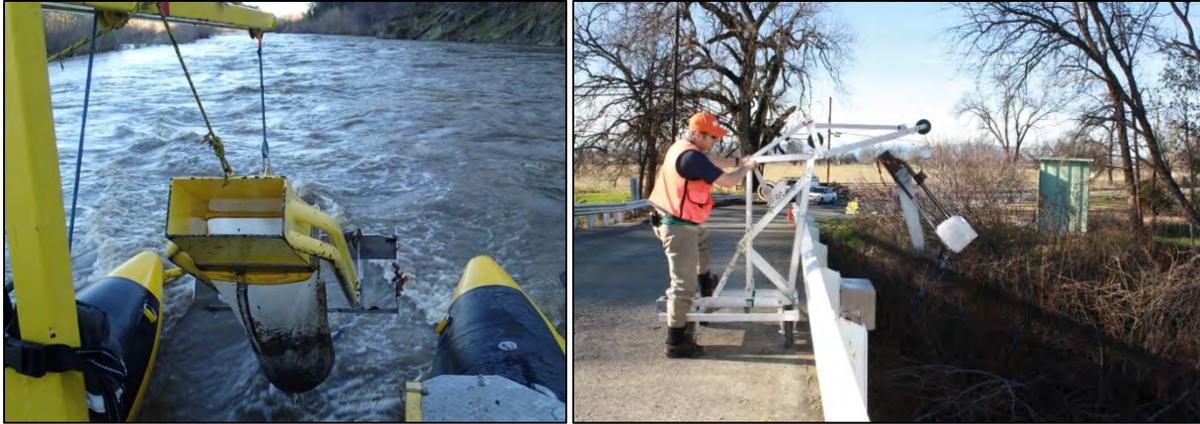
Figure 3. Bedload sampling from a cataraft using the 6x12 inch TR2 and from a bridge crane utilizing the 2/3 scale Elwha bedload sampler with a 4x8 inch aperture.

Beginning and end stations, sample interval, sample duration, start time and end time, beginning and end gage height, and pass number were recorded. All bedload sample data are stored together in Excel workbooks. Bedload samples were processed at the GMA coarse sediment lab in Placerville, California. Processing involves sieving and computing the percent retained in each sieve class as determined by weight. These data are entered into Excel spreadsheets for subsequent conversion to the cumulative percentage finer (by weight) than the corresponding sieve size.

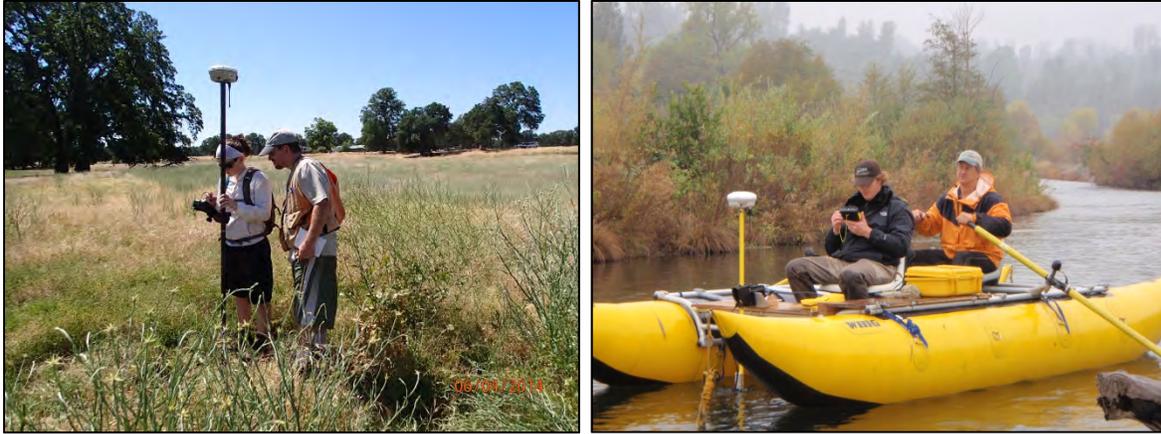
Figure 4. Terrestrial topographic surveying with GPS/RTK and bathymetric surveying with a cataraft equipped with a depth sounder coupled with GPS/RTK.

In July of 2011 GMA re-surveyed the longitudinal profile from 2,500 ft above Little Dry Creek (approximately 5 miles upstream of the South Fork, see yellow trace in Appendix 4-1) to the confluence of the Sacramento River. For the most part, the survey follows the thalweg (deepest portion), though in some deep areas it is impossible to discern the thalweg, thus we refer to this as a longitudinal profile. The profile survey was conducted using a single-beam sonar system that was deployed from a 19-ft Sotar Cataraft (Figure 4). Geodetic control was provided using a shore-based Trimble R8 Model 3 GNSS receiver broadcasting RTK corrections to the survey vessel by UHF radio link. The survey vessel was equipped with an Ohmex Sonarmite MilSpec portable single-beam sonar and a Trimble R8 Model 3 GNSS receiver. The sonar data and RTK GNSS data were combined in a ruggedized laptop computer running Hypack hydrographic surveying software.

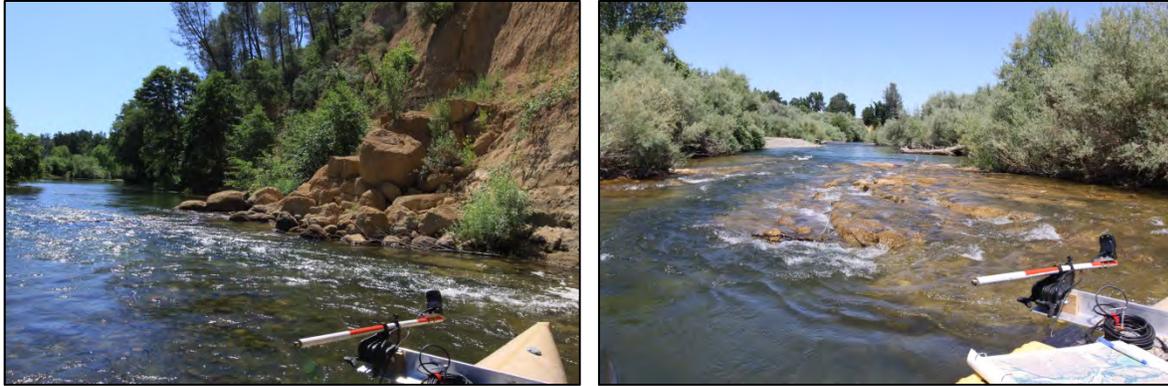
Figure 5. Two types of claypan (Tehama Formation) along lower Cottonwood Creek: adjacent cliffs, slowly retreating due to undercutting along the toe, and substrate exposure along the streambed.

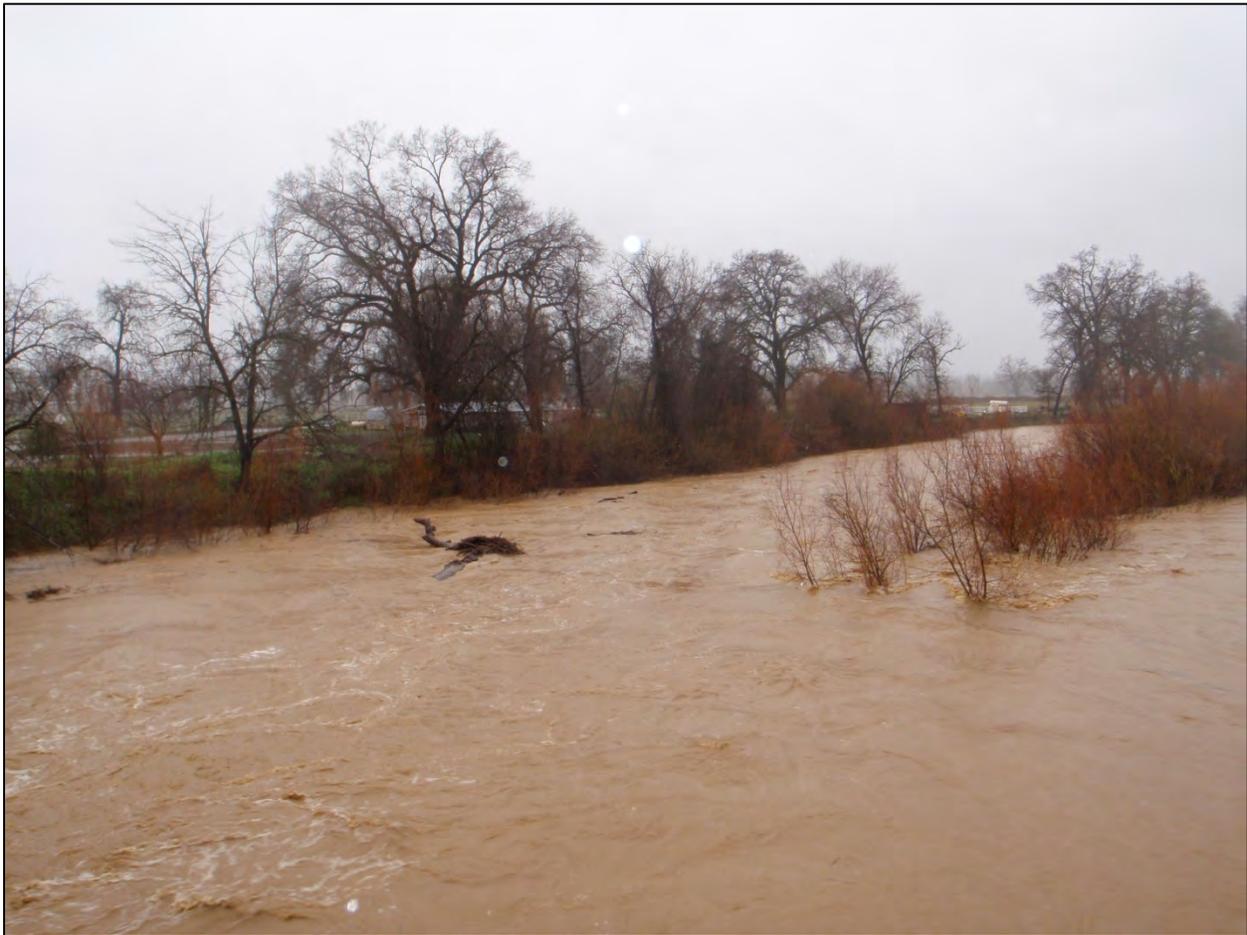
Figure 19. South Fork Cottonwood at Evergreen Road, January 20, 2010. Downstream view at approximately 10,000 cfs.

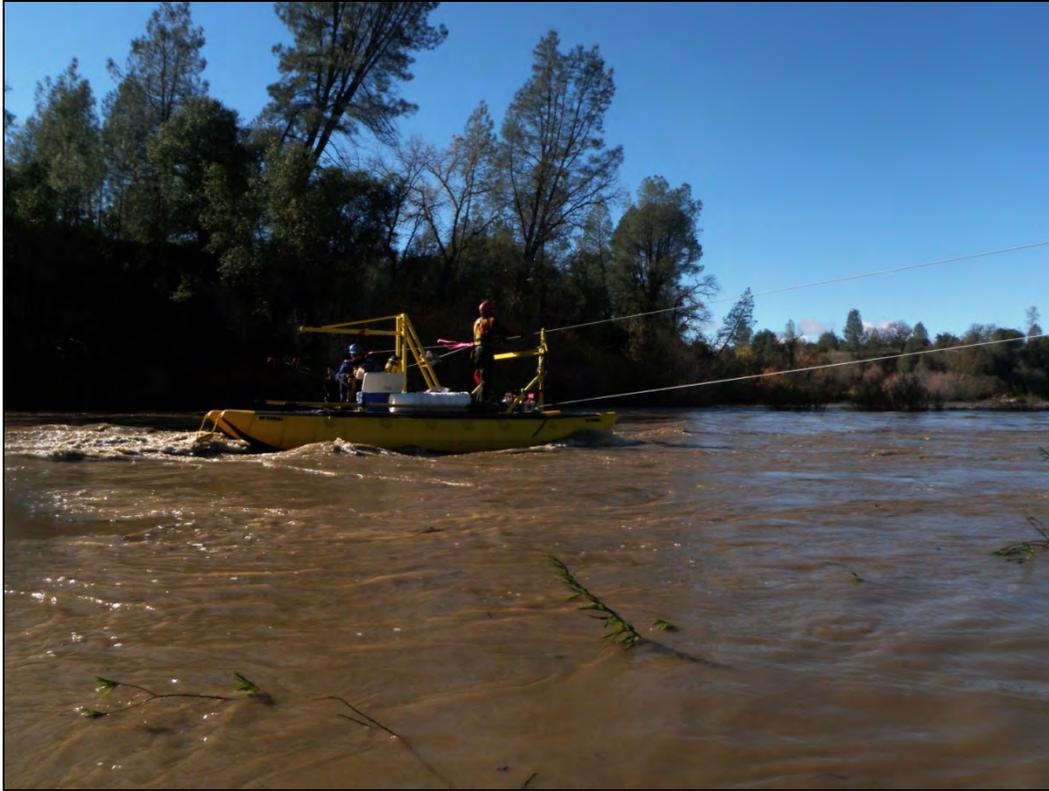
Figure 21. Cataraft sampling at 8,000 cfs at Cottonwood Creek near Olinda during the December 2-3, 2012 peak flow event.

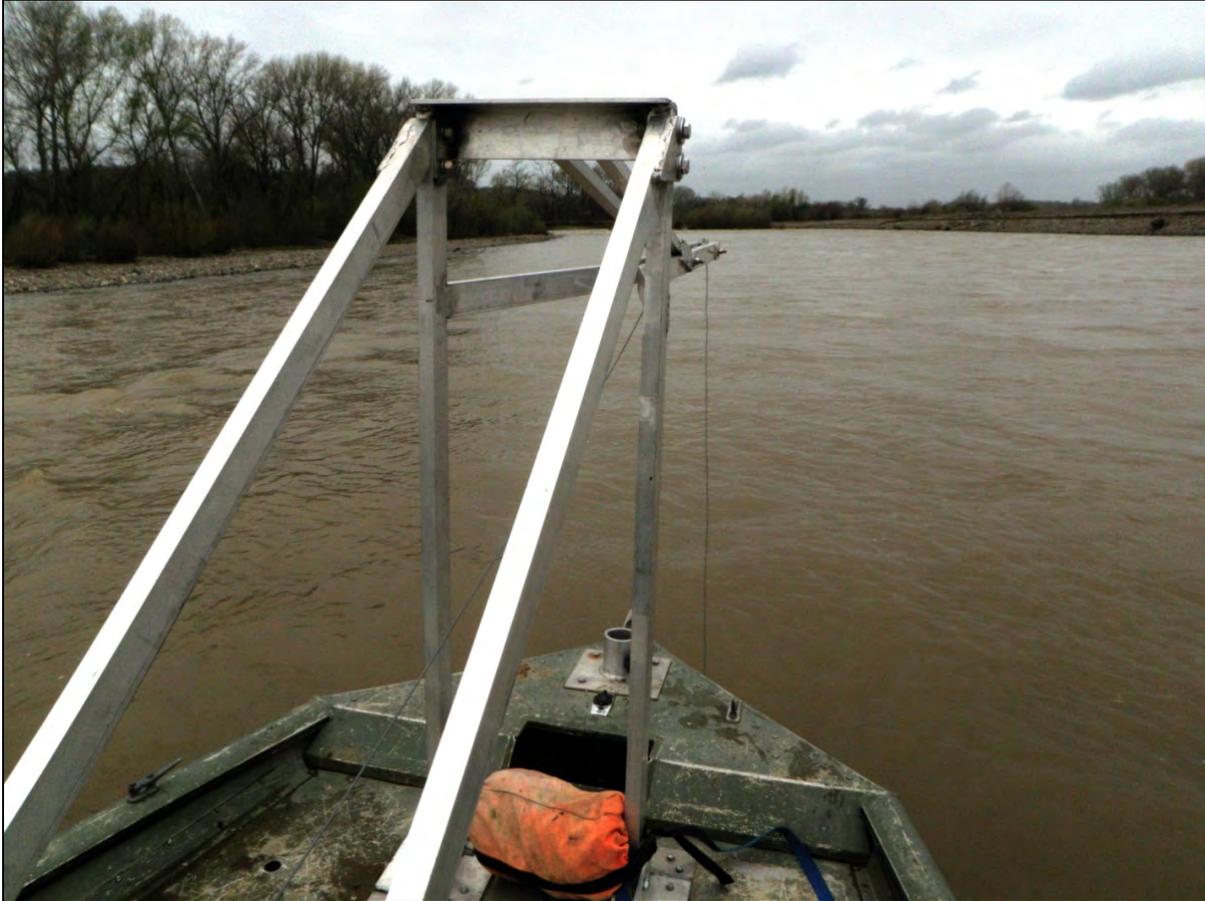
Figure 24. Sediment sampling from a jet boat on the mainstem Cottonwood Creek during the March 28-29, 2012 storm, downstream of the USGS (11376000) gaging station.

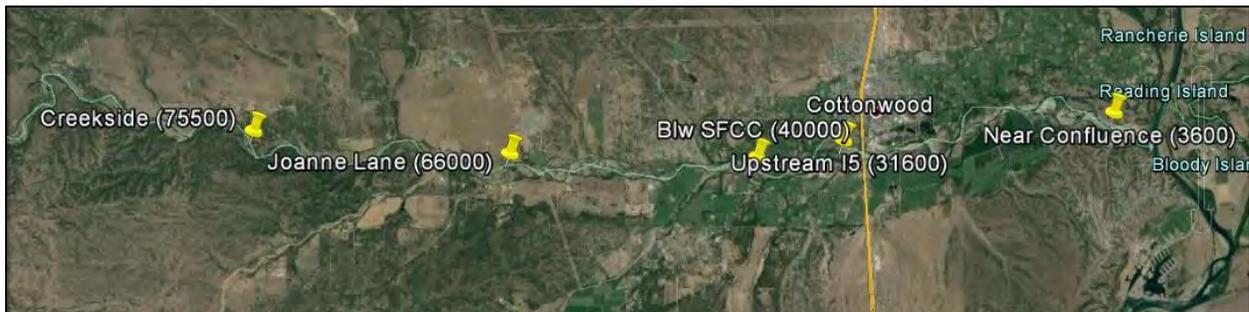
Figure 34. Distribution of claypan exposure study sites. Google Earth 2014 image. North is toward top of page.

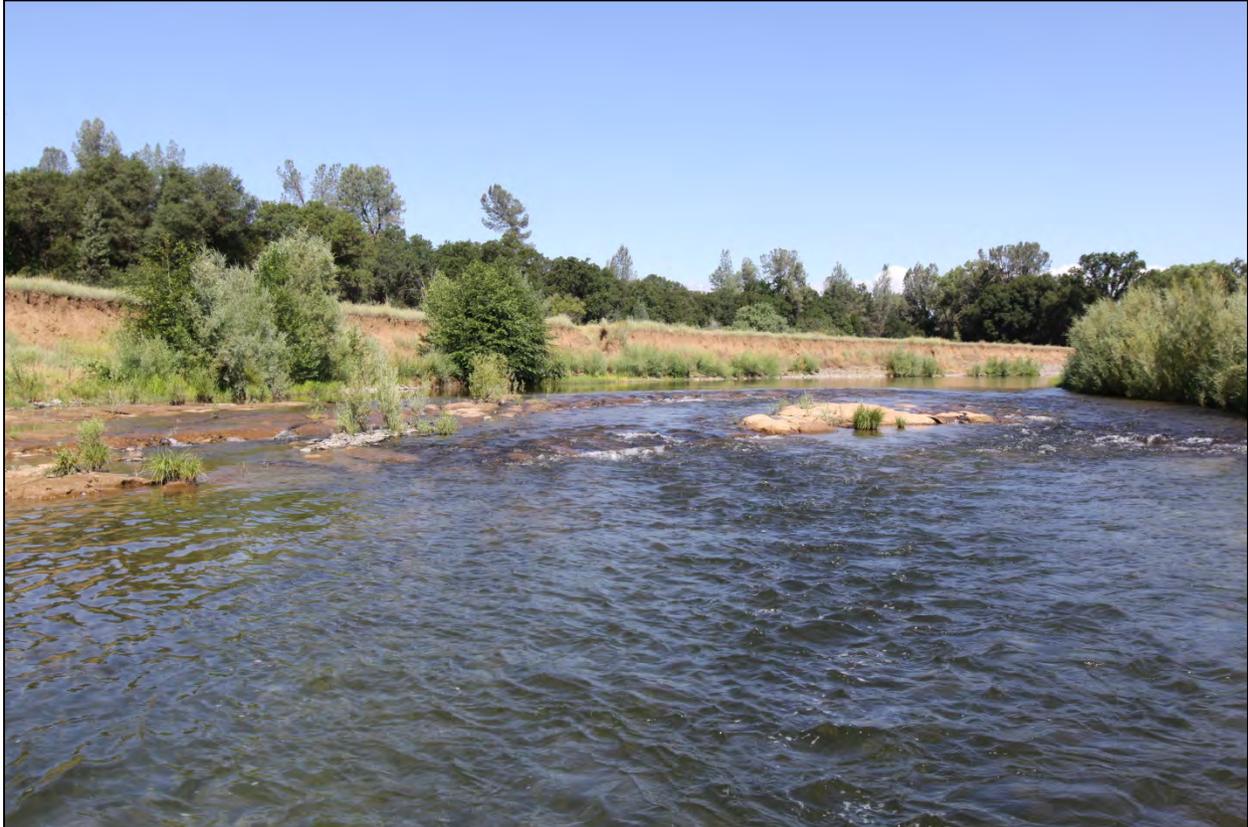
Figure 35. Upstream view of the (upper) Creekside claypan exposure. July 19, 2011.

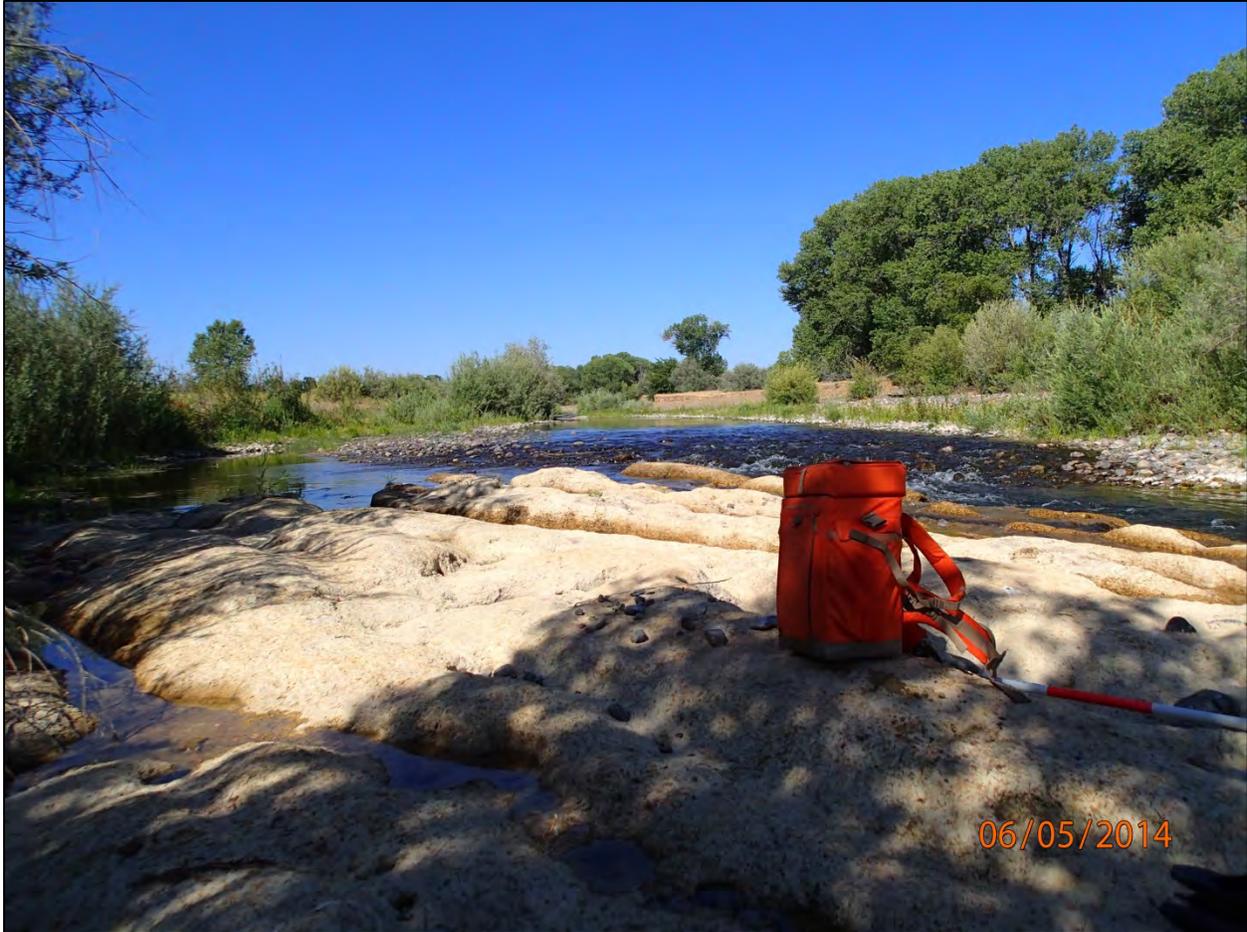
Figure 36. Upstream view of the Joanne Lane claypan exposure in June 2014. Note the fluting evident beyond the backpack.

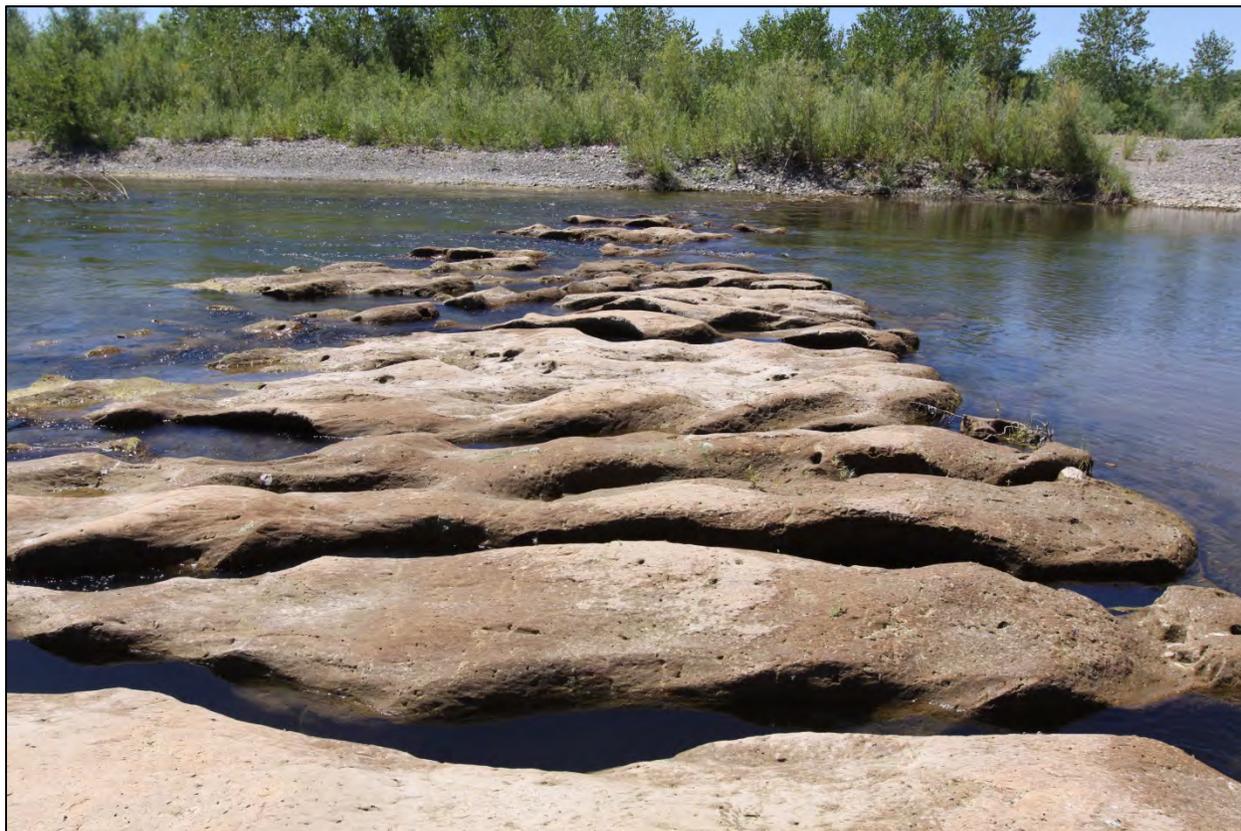
Figure 37. Claypan “reefs” protruding from the active channel below South Fork Cottonwood Creek, July 20, 2011.

more deeply fissured and claypan appears to occur along the length of the riffle (Figure 37). By 2013, each of these attributes is even more pronounced (Appendix 4-10).

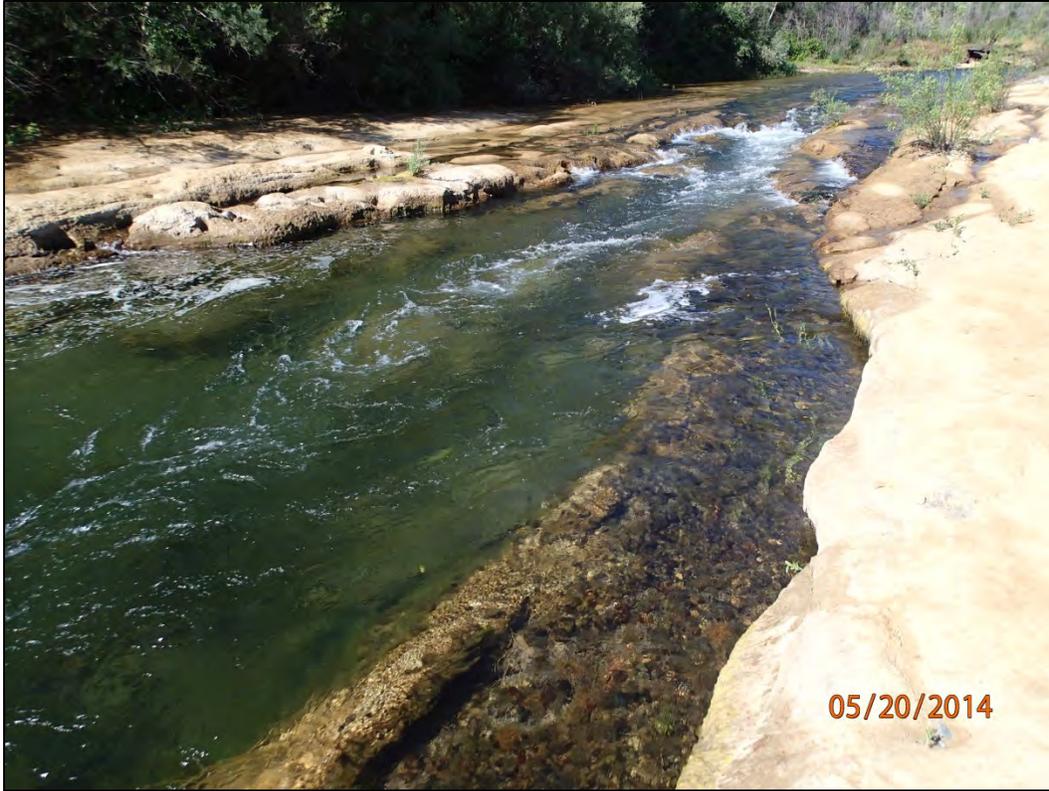
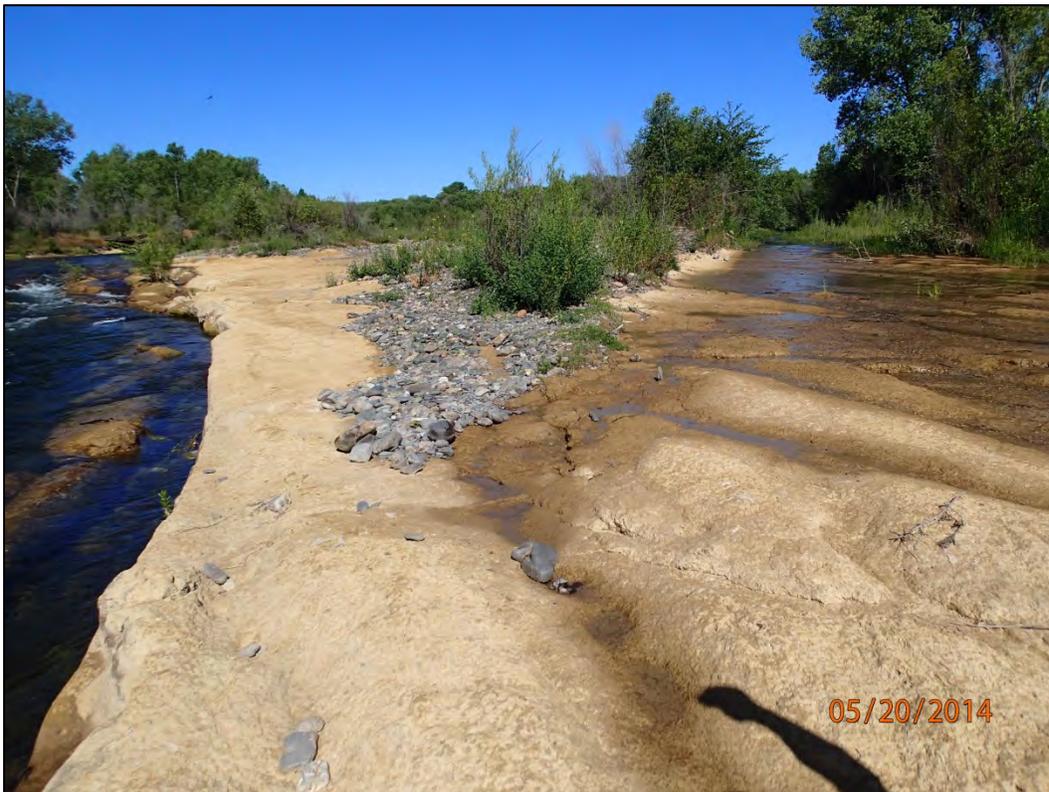
Figure 38. Ground photos of the claypan upstream of I5 showing (1) fluting and streamflow capture common to claypan areas within lower Cottonwood Creek, and (2) bedload arrested in motion as it slides over claypan exposure.

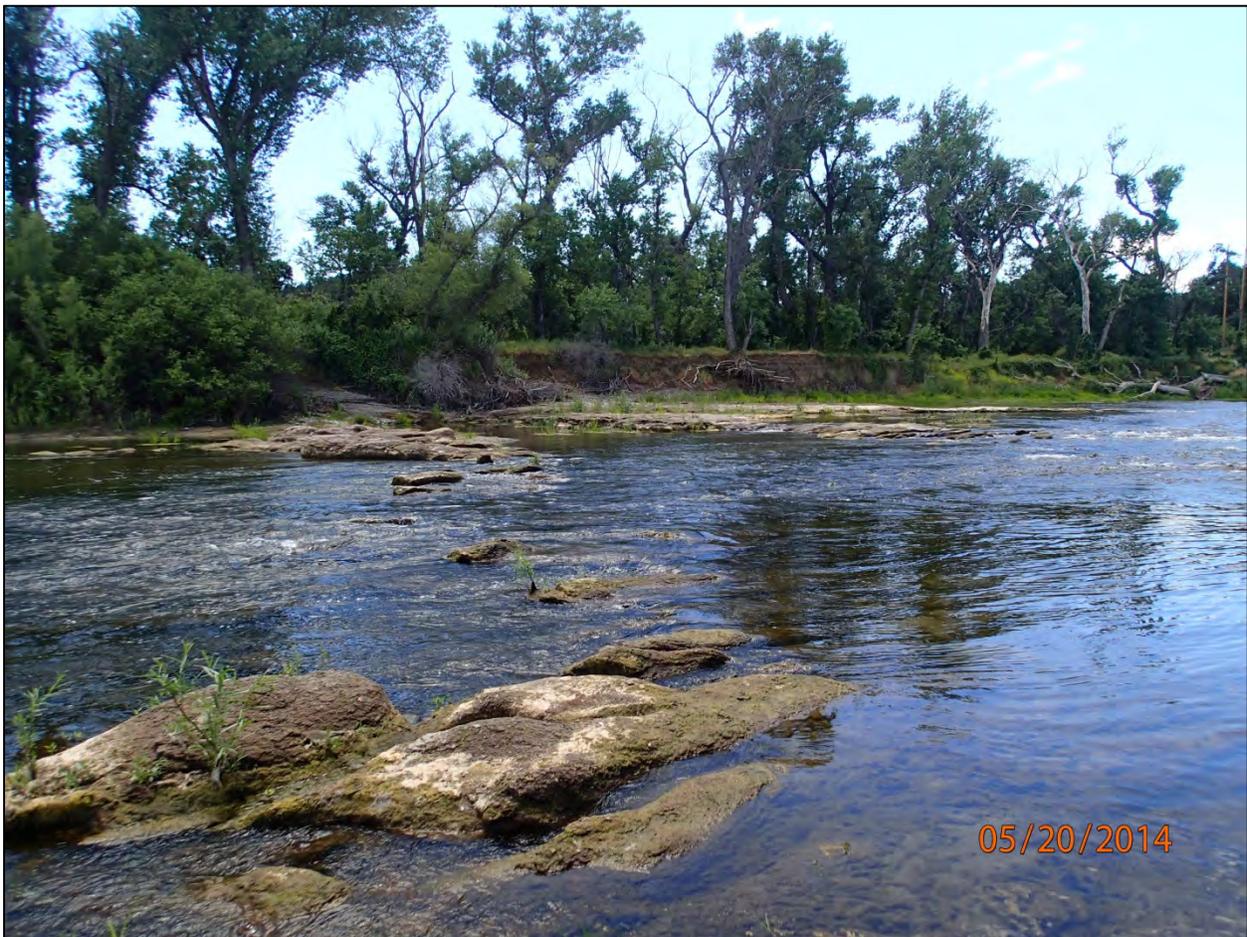
Figure 39. The Confluence site is the downstream most appearance of claypan, 3,600 feet upstream of the Sacramento River.

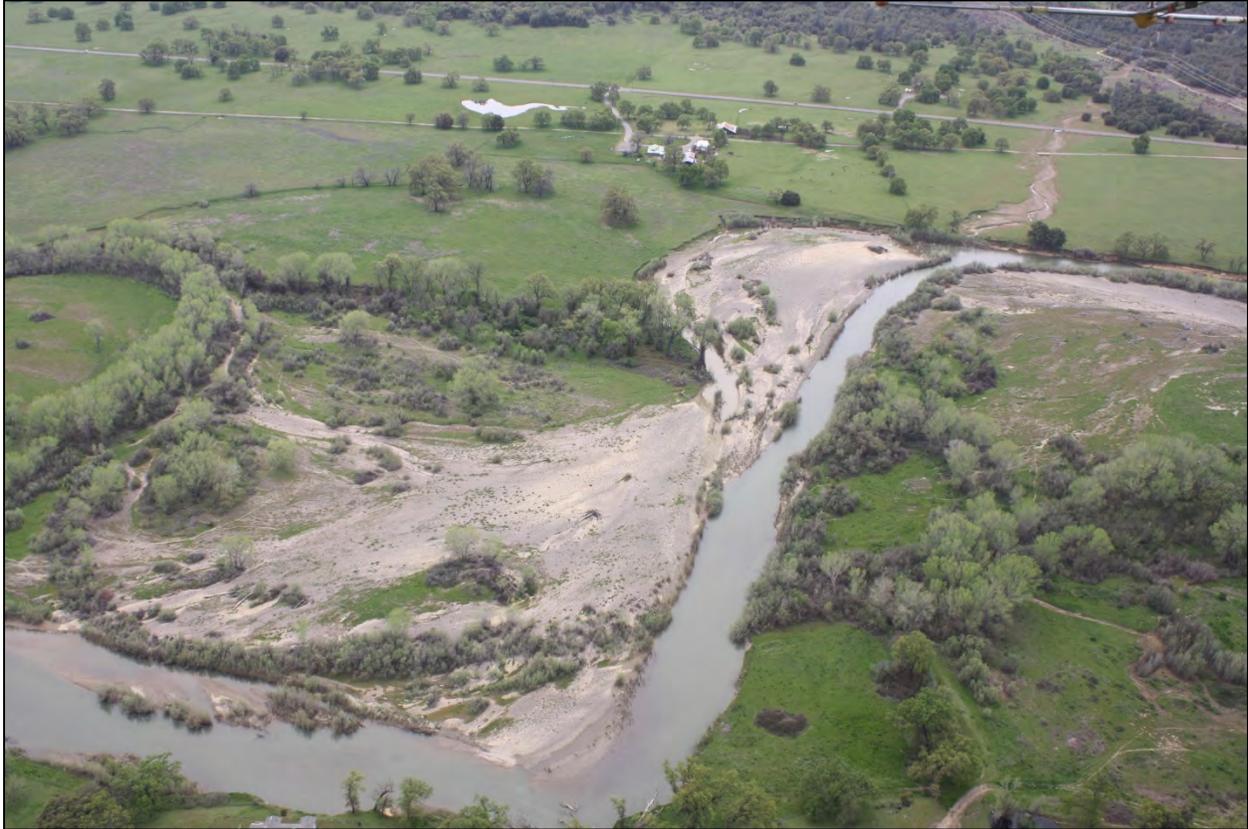
Figure 40. Upstream view of the Baker Ranch study site, April 18, 2012 (1,150 cfs at USGS 11376000). The primary area of interest is the eroding bend at the top of the photo, along the south bank. CDFW-sponsored flight, courtesy P. Bratcher.

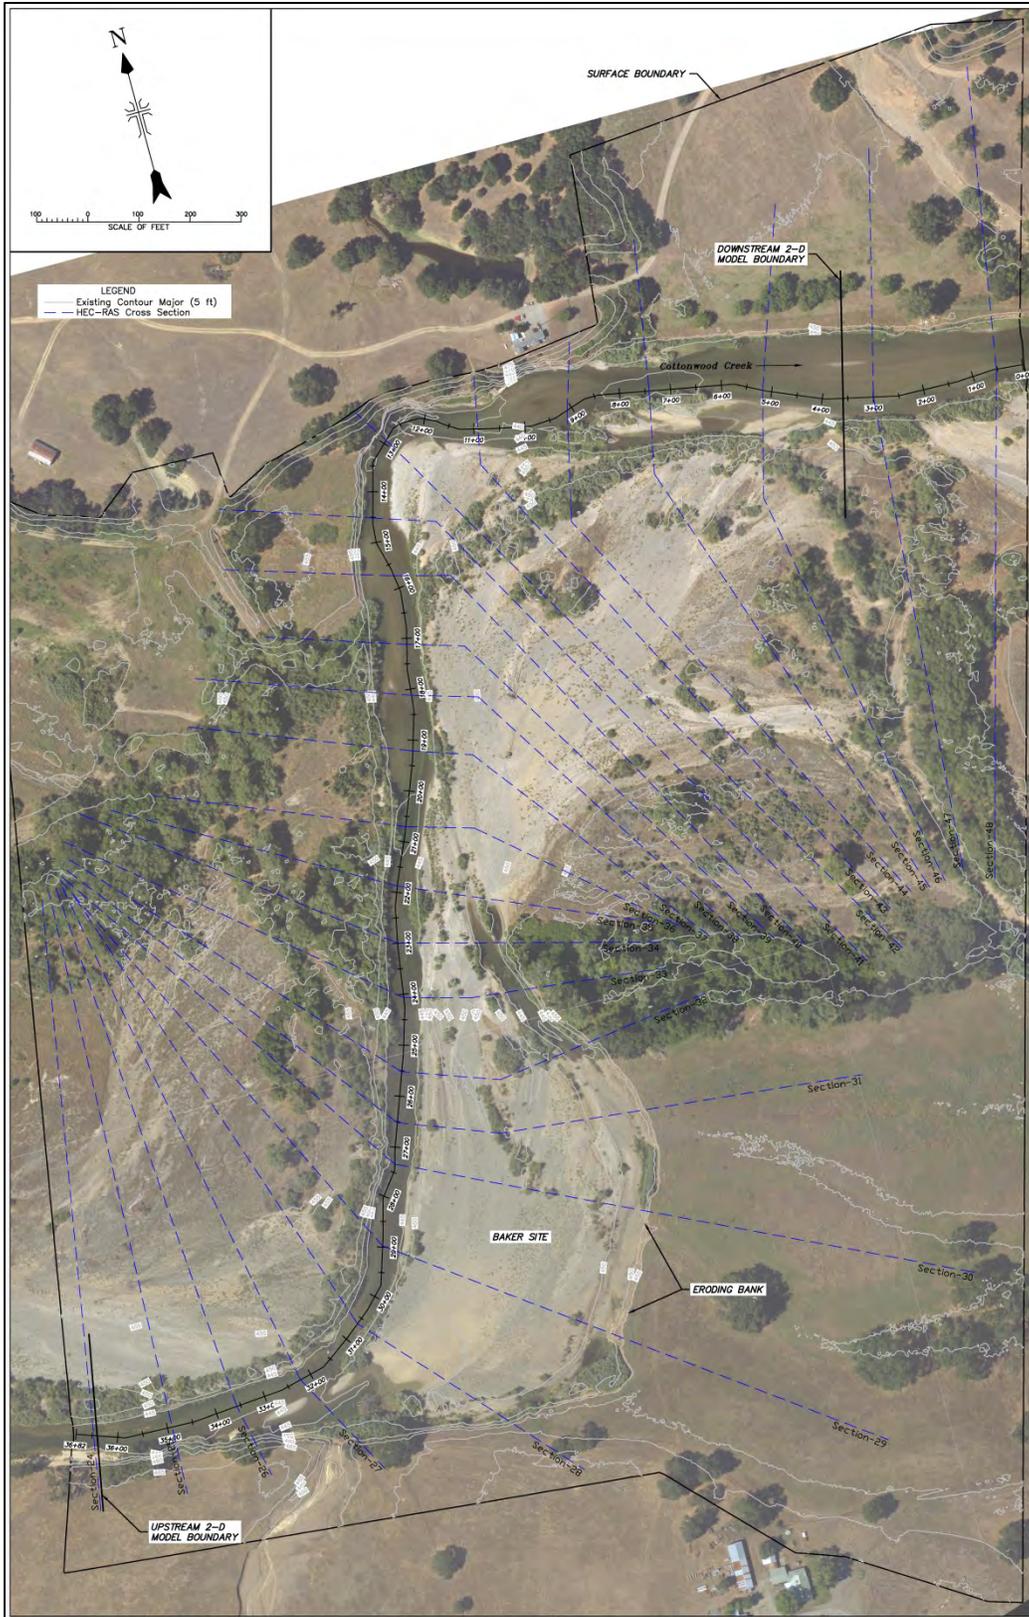
Figure 41. Hydraulic modeling project location map, 1-D HEC-RAS cross sections and stationing, 2-D modeling boundaries, and existing ground contours at the Baker site on Cottonwood Creek.

Downstream boundary conditions were developed using rating curve developed in HEC RAS (Figure 41). An example of the 2-D model depth results is provided in Figure 42 for 4,800 cfs for existing conditions

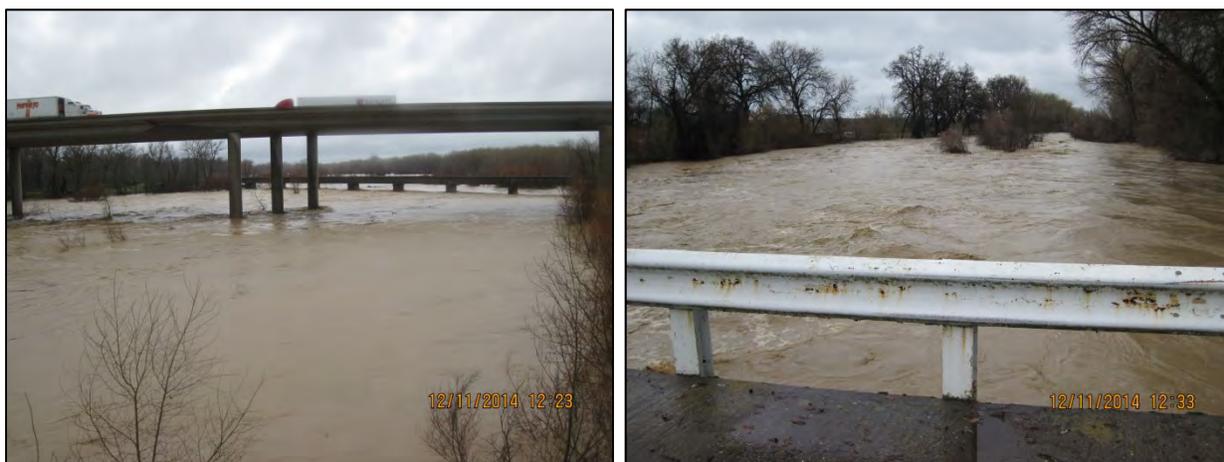
Figure 43. Views on Cottonwood Creek during the rising limb on December 11, 2014. (L) upstream view toward the I5 and SPRR bridges, (R) downstream view from the south side of the Evergreen road Bridge along the South Fork. Flow is approximately 38,000 cfs in the mainstem (assuming a 30 minute lag to USGS 11376000). Photos courtesy P. Bratcher, CDFW.
