# Oil and Gas

## *Leaking Oil in a River Floodplain*

### Patoka Refuge

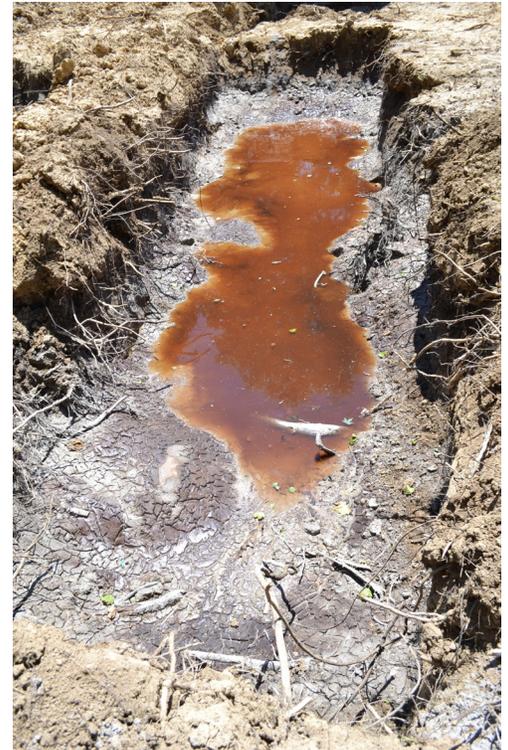
*Open pit awaiting burial/USFWS*

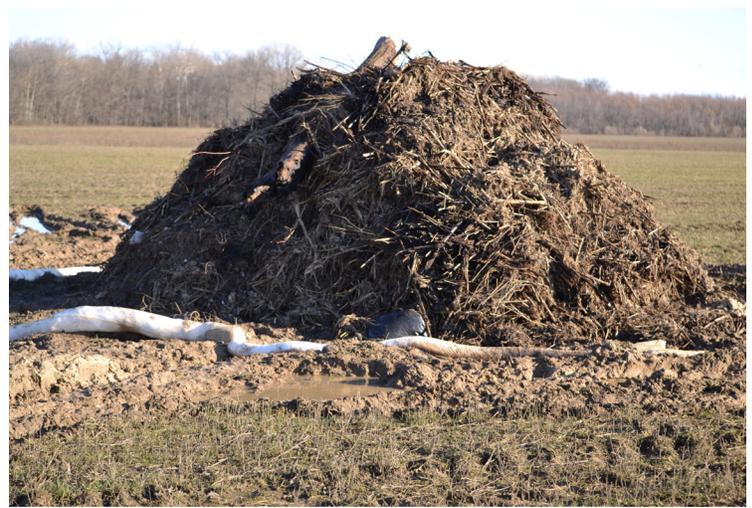
to the Natural Resource Conservation Service. Oil was deposited all through the property, with oil rings on all the trees and oil in the nearby slough that drained into the Patoka River. The spill was

*Oil rings evident on trees and structures after flood waters receded. According to IDEM the responsible party hired a cleanup contractor that used manual labor to rake, pick up, and dispose of oiled vegetative debris; pads were used to soak up puddles of oil/USFWS*

*The stockpile of oiled debris including that at the tank battery were removed and disposed according to IDEM/USFWS*
