New Zealand Mudsnail Surveys at Lower Columbia River Basin National Fish Hatcheries 2008

Jeff Hogle
February 2009

Columbia River Fisheries Program Office
United States Fish and Wildlife Service
1211 SE Cardinal Court, Suite 100; Vancouver, Washington 98683.

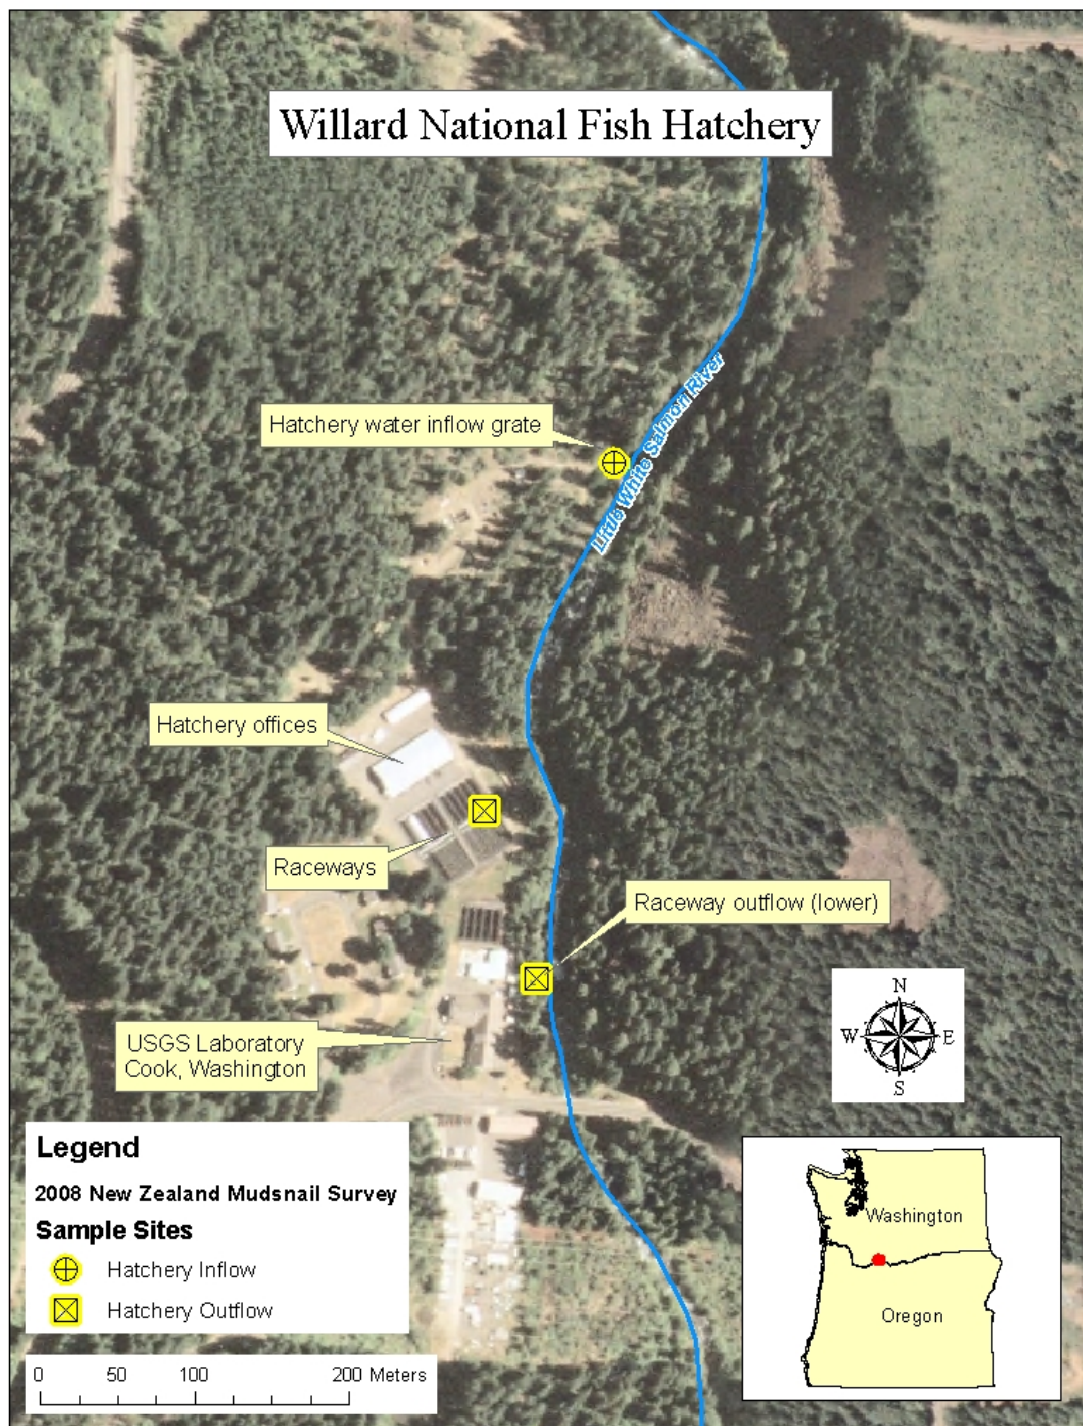
Figure 7. Willard NFH 2008 New Zealand mudsnail survey sample sites.

Three sites were surveyed including habitat surrounding the water intake grate and the bedrock substrate along the water stream of the downstream most water outflow pipe where river access was not possible in the large bedrock pool. Also sampled was the lining of aquatic vegetation along the water discharge exit of the North bank of raceways.

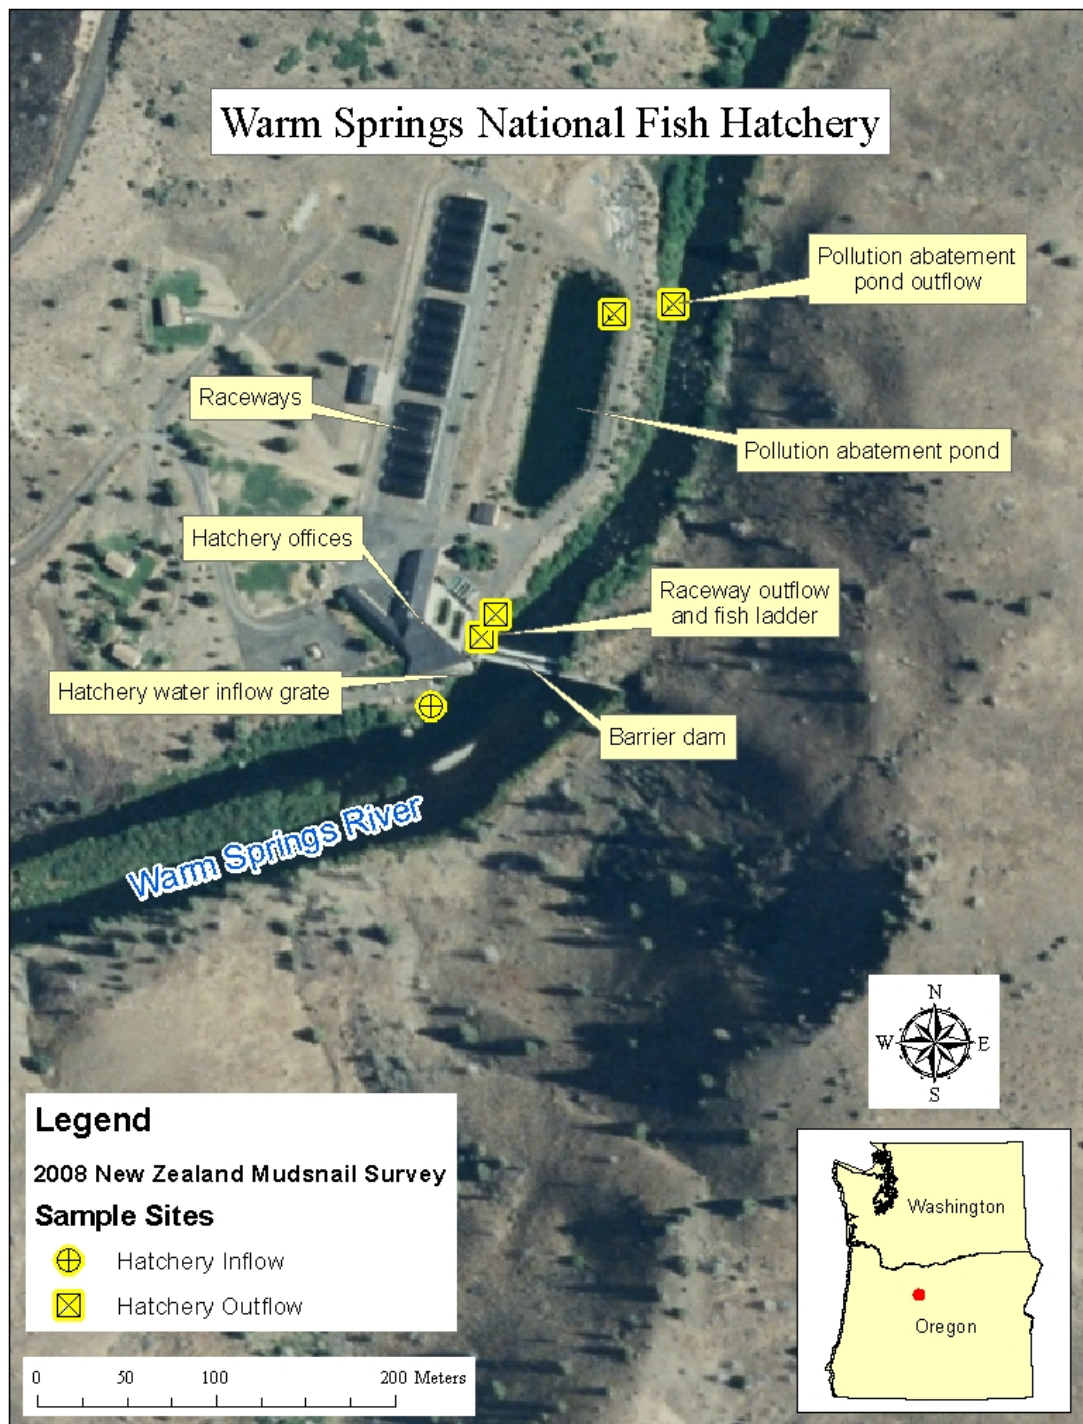
Figure 8. Warm Springs NFH 2008 New Zealand mudsnail survey sample sites.

One inflow and four outflow sites were surveyed. The inflow sample site was along the northwest river edge approximately 30 m upstream of the water intake grate. Outflow sample sites included the pollution abatement pond outflow standpipe and the river edge discharge point as well as the top surface of the raceway outflow grate next to the fish ladder entrance.
