**To: Gwen Pipkin, FDOT District One**

**From: Mark Easley, KCA**

**RE: FINAL REPORT  
ROADSIDE ANIMAL DETECTION SYSTEM (RADS)  
US 41 AT TURNER RIVER ROAD  
COLLIER COUNTY**

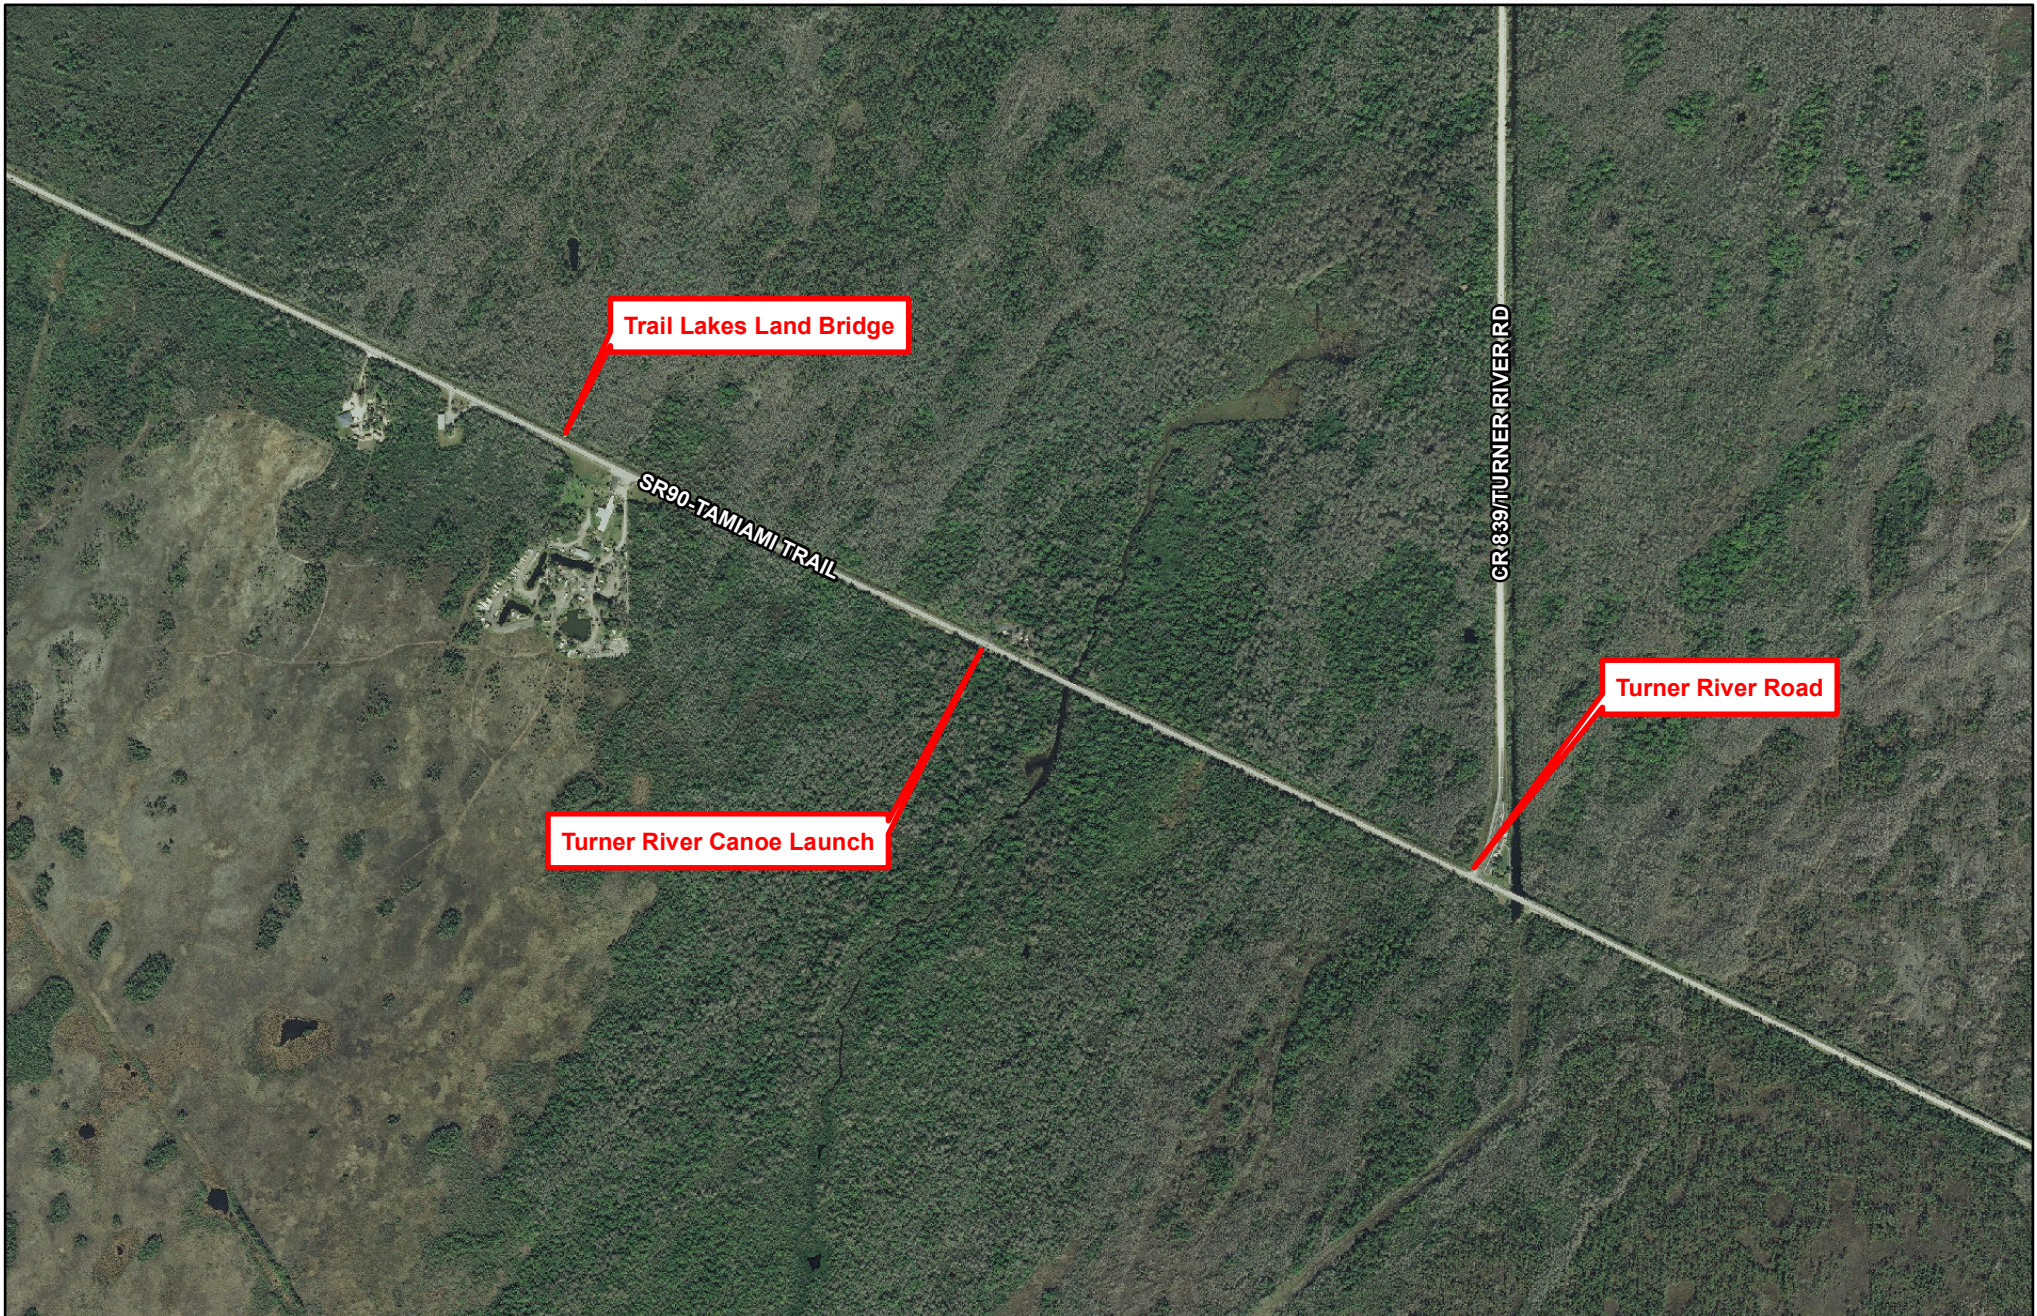
Figure 2

From review of the information collected and presented in the report, there appears to be three primary locations along the project corridor where panthers and other wildlife typically cross US 41. These locations include: the Trail Lakes land bridge (located near the western end of the study area), the Turner River canoe launch (located near the middle of the study area), and Turner River Road (located near the eastern end of the study area). The northern boundary of the study area is bordered by the Tamiami Canal and these three locations provide upland (dry) access across this canal. There locations are shown in Figure 2.

**Primary Wildlife Crossing Locations**

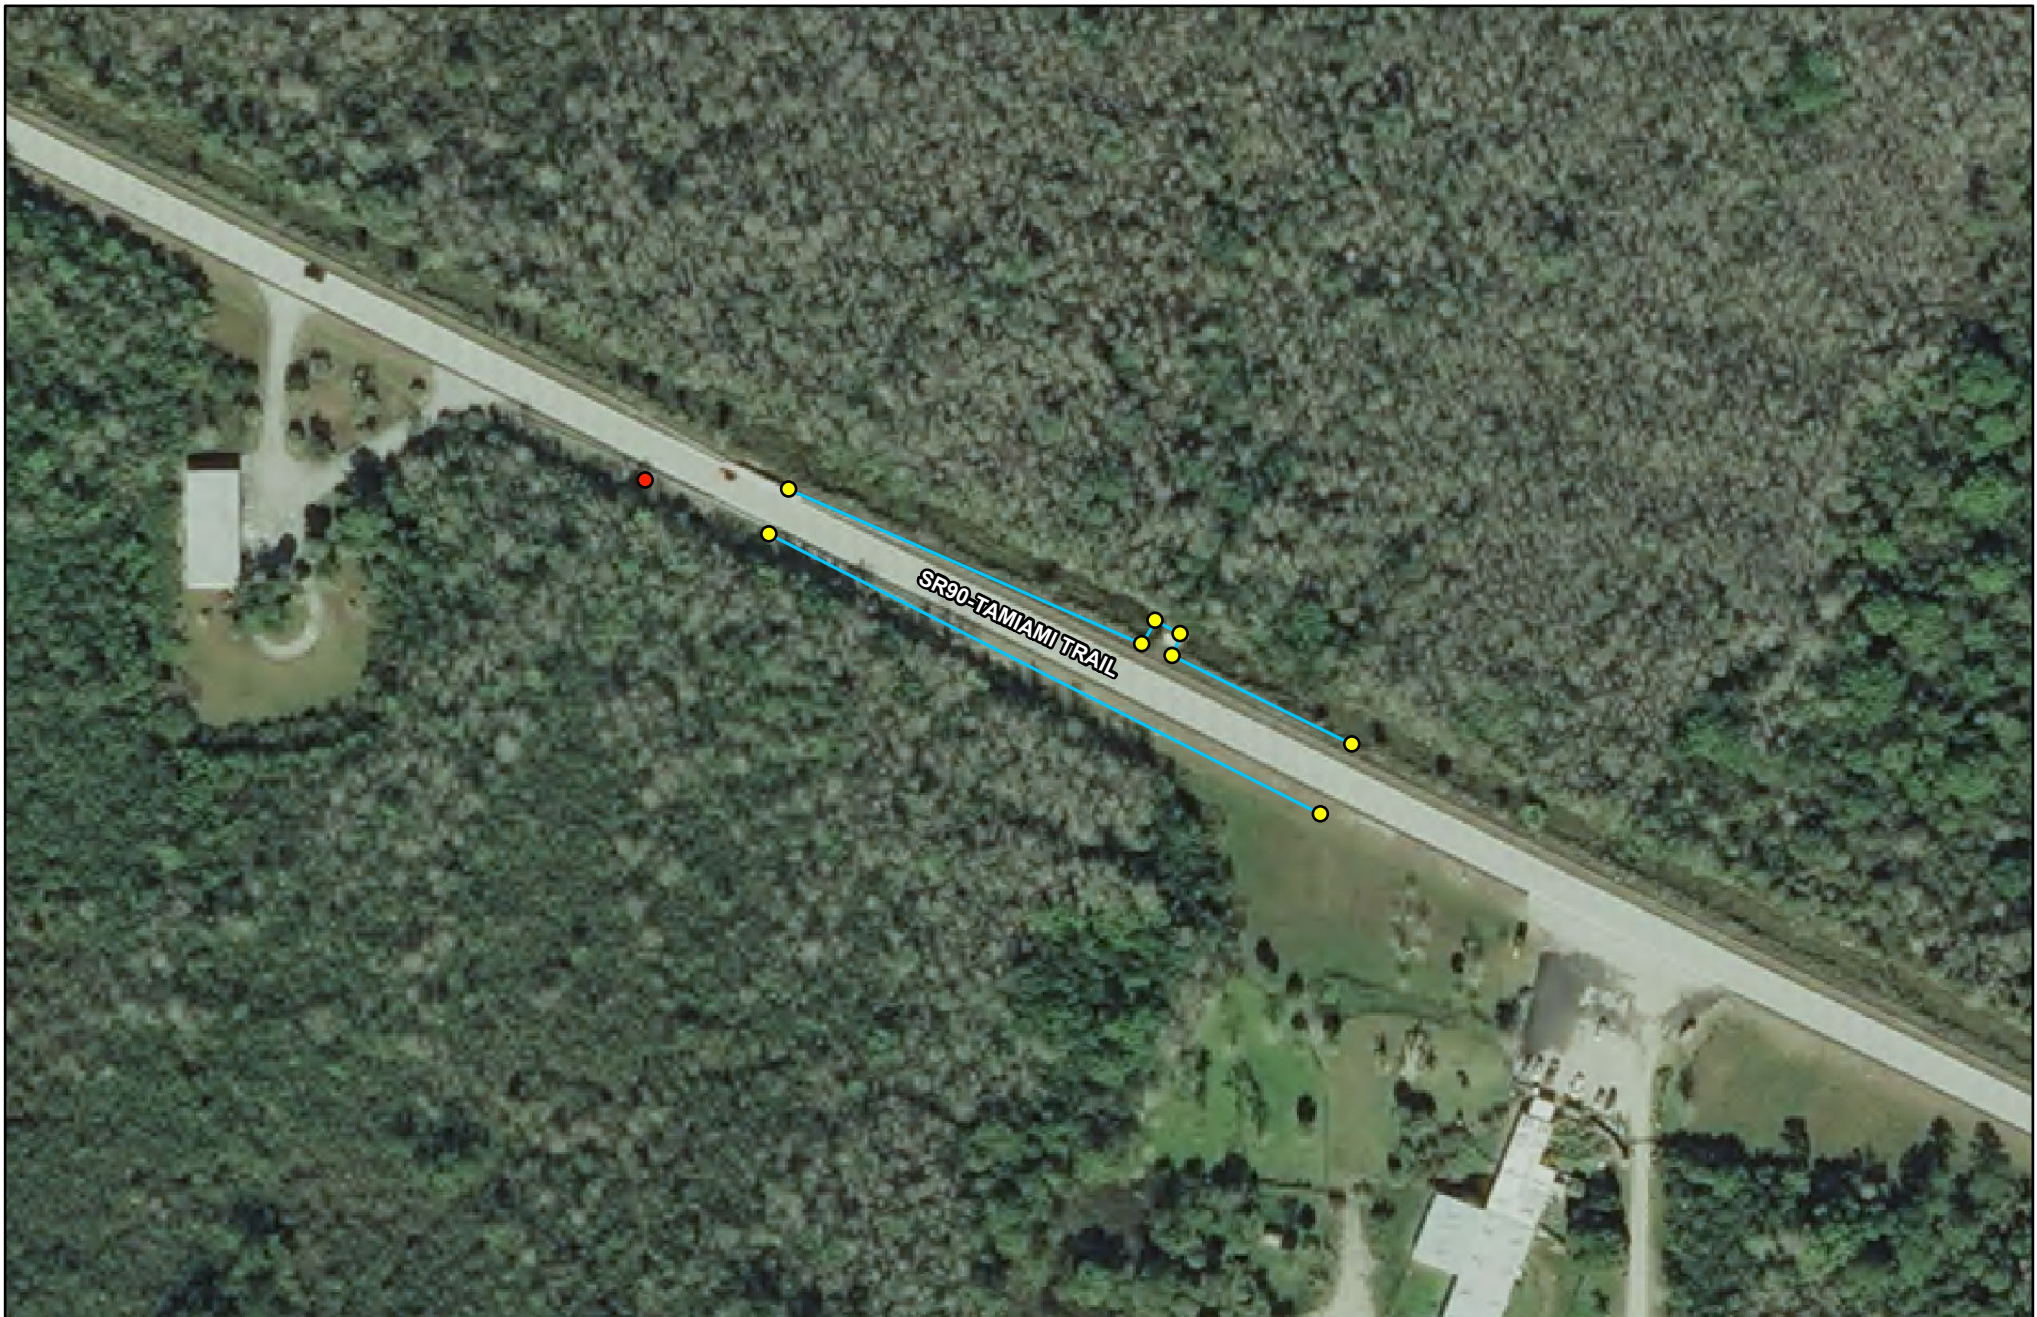
Because these three locations represent the majority of the US 41 crossings, we would recommend that the overall area covered by the RADS system be reduced to these locations. While this reduction in coverage may result in some missed crossings, it should also greatly reduce the number of false positives. Figures 3 through 5 show potential sensor arrays for the Trail Lakes land bridge, Turner River canoe launch, and Turner River Road locations, respectively. The sensor array shown for the Trail Lakes land bridge (Figure 3) would require approval for use of federal

lands, as the two most northern sensors (located on the land bridge) would be located outside of FDOT right-of-way.

**Proposed Sensor Array  
Trail Lakes Land Bridge**

- Additional warning signs should be added approximately 0.25 miles west of the western most detection device at the Trail Lakes land bridge (see Figure 3 for location of detection device), and 0.25 miles east of the eastern most detection device at the Turner River Road (see Figure 5 for location of detection device). For traffic moving at 45 miles per hour, this would provide a 20 second advanced warning to motorists. From review of the locations of existing warning signs, it appears that the first warning signs for both east and west bound traffic is approximately 400 feet from the first detection devices. This provides only a 6 second advanced warning to motorists. We would also recommend maintaining all of the existing warning signs at their present locations.

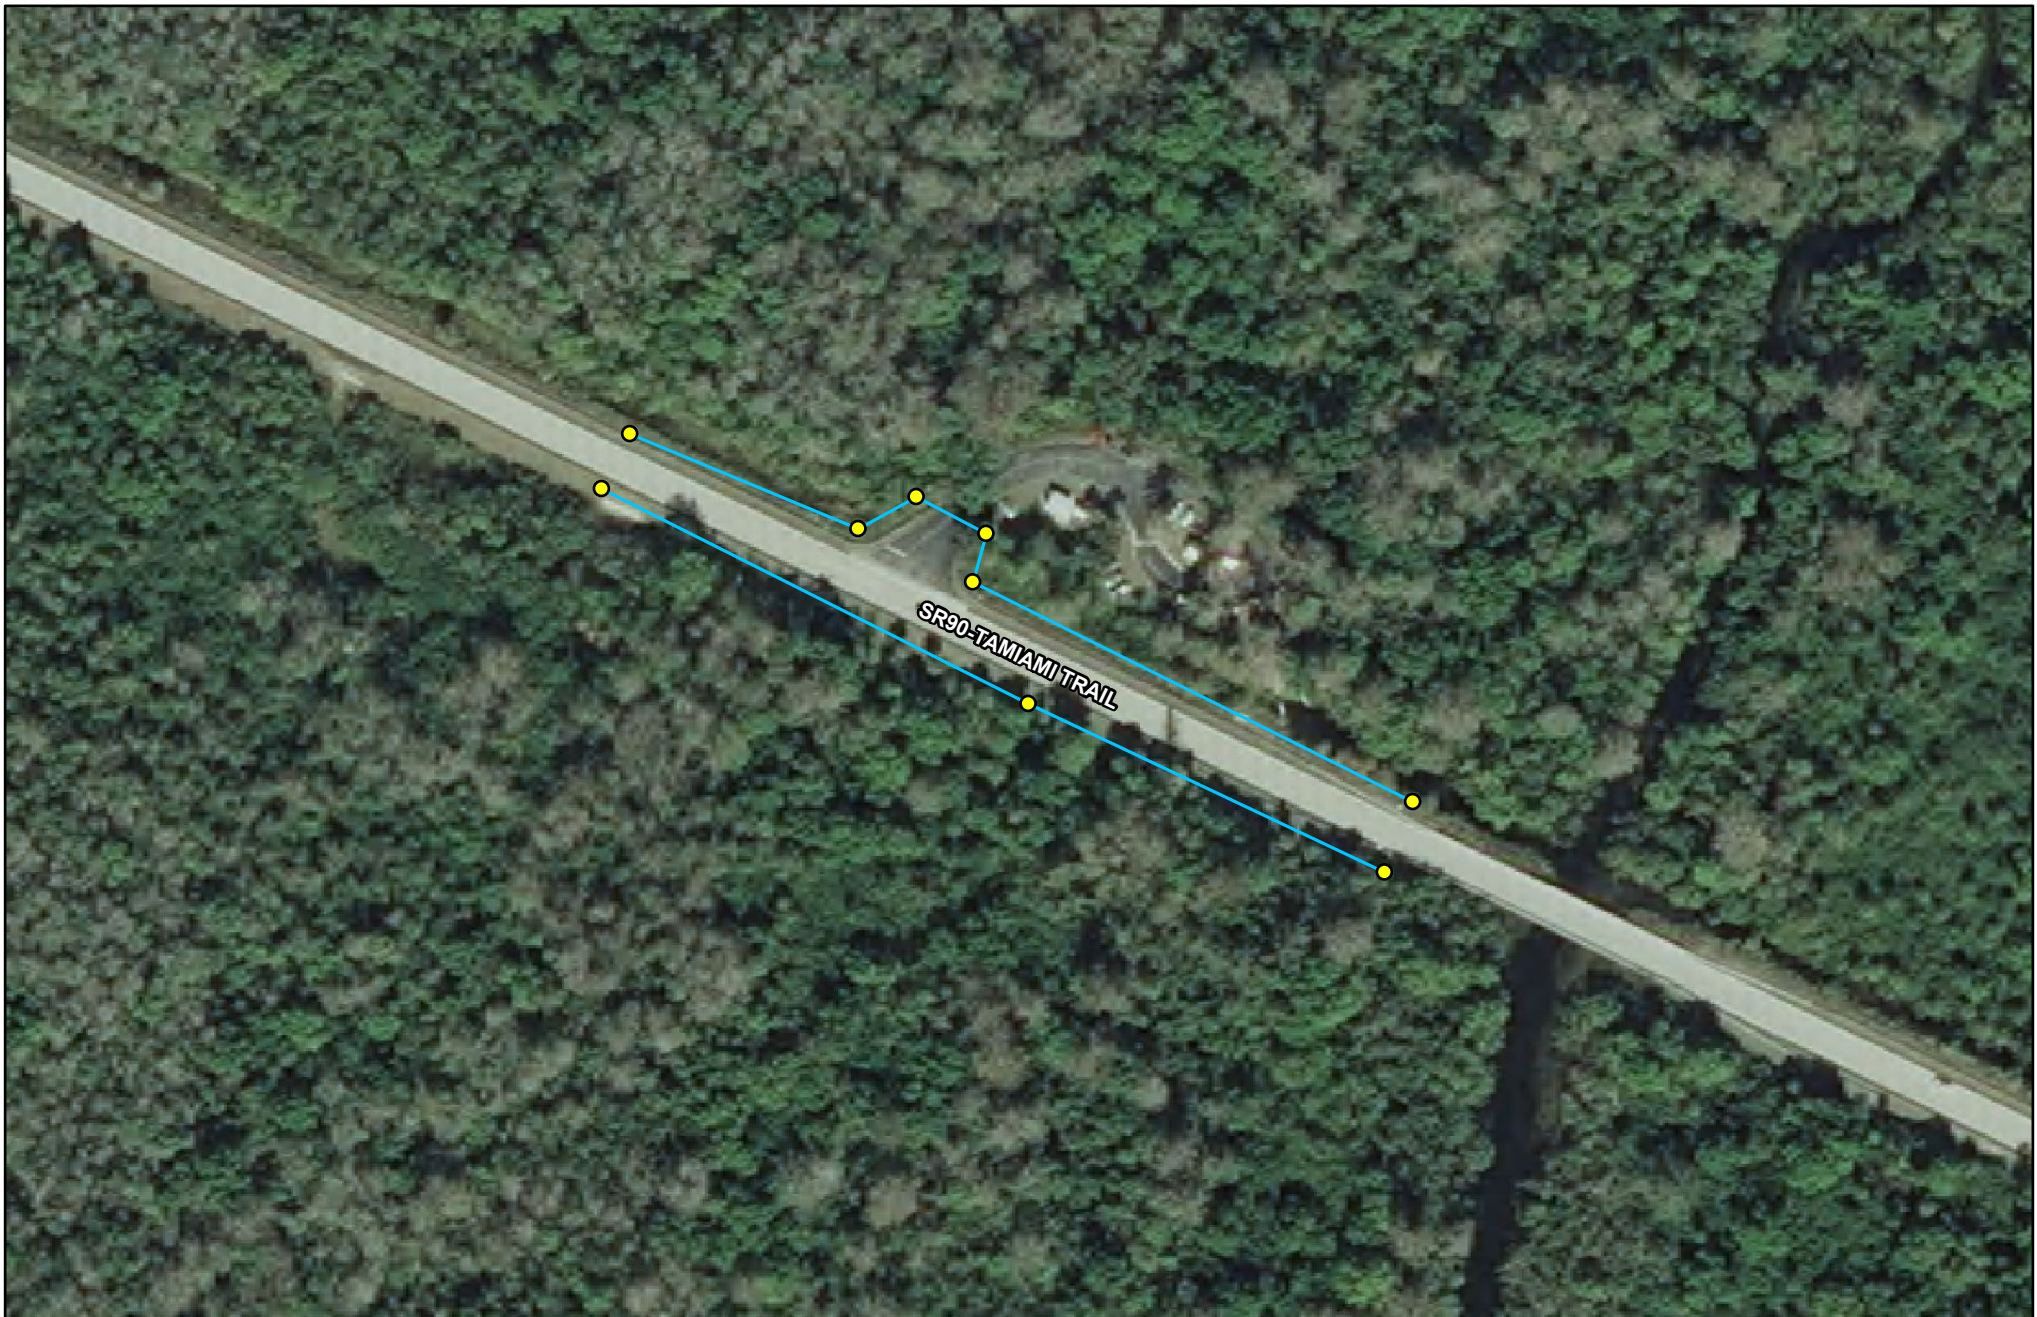
Figure 4

**Proposed Sensor Array  
Turner River Canoe Launch**  
Roadside Animal Detection System (RADS)  
US 41 at Turner River Road  
Collier County, Florida

- Based on the proposed location of the sensor arrays at the Turner River canoe launch and Turner River Road locations, the magnetic loop found at these two locations will need to be relocated. This will allow the system to not be activated by cars at these locations.

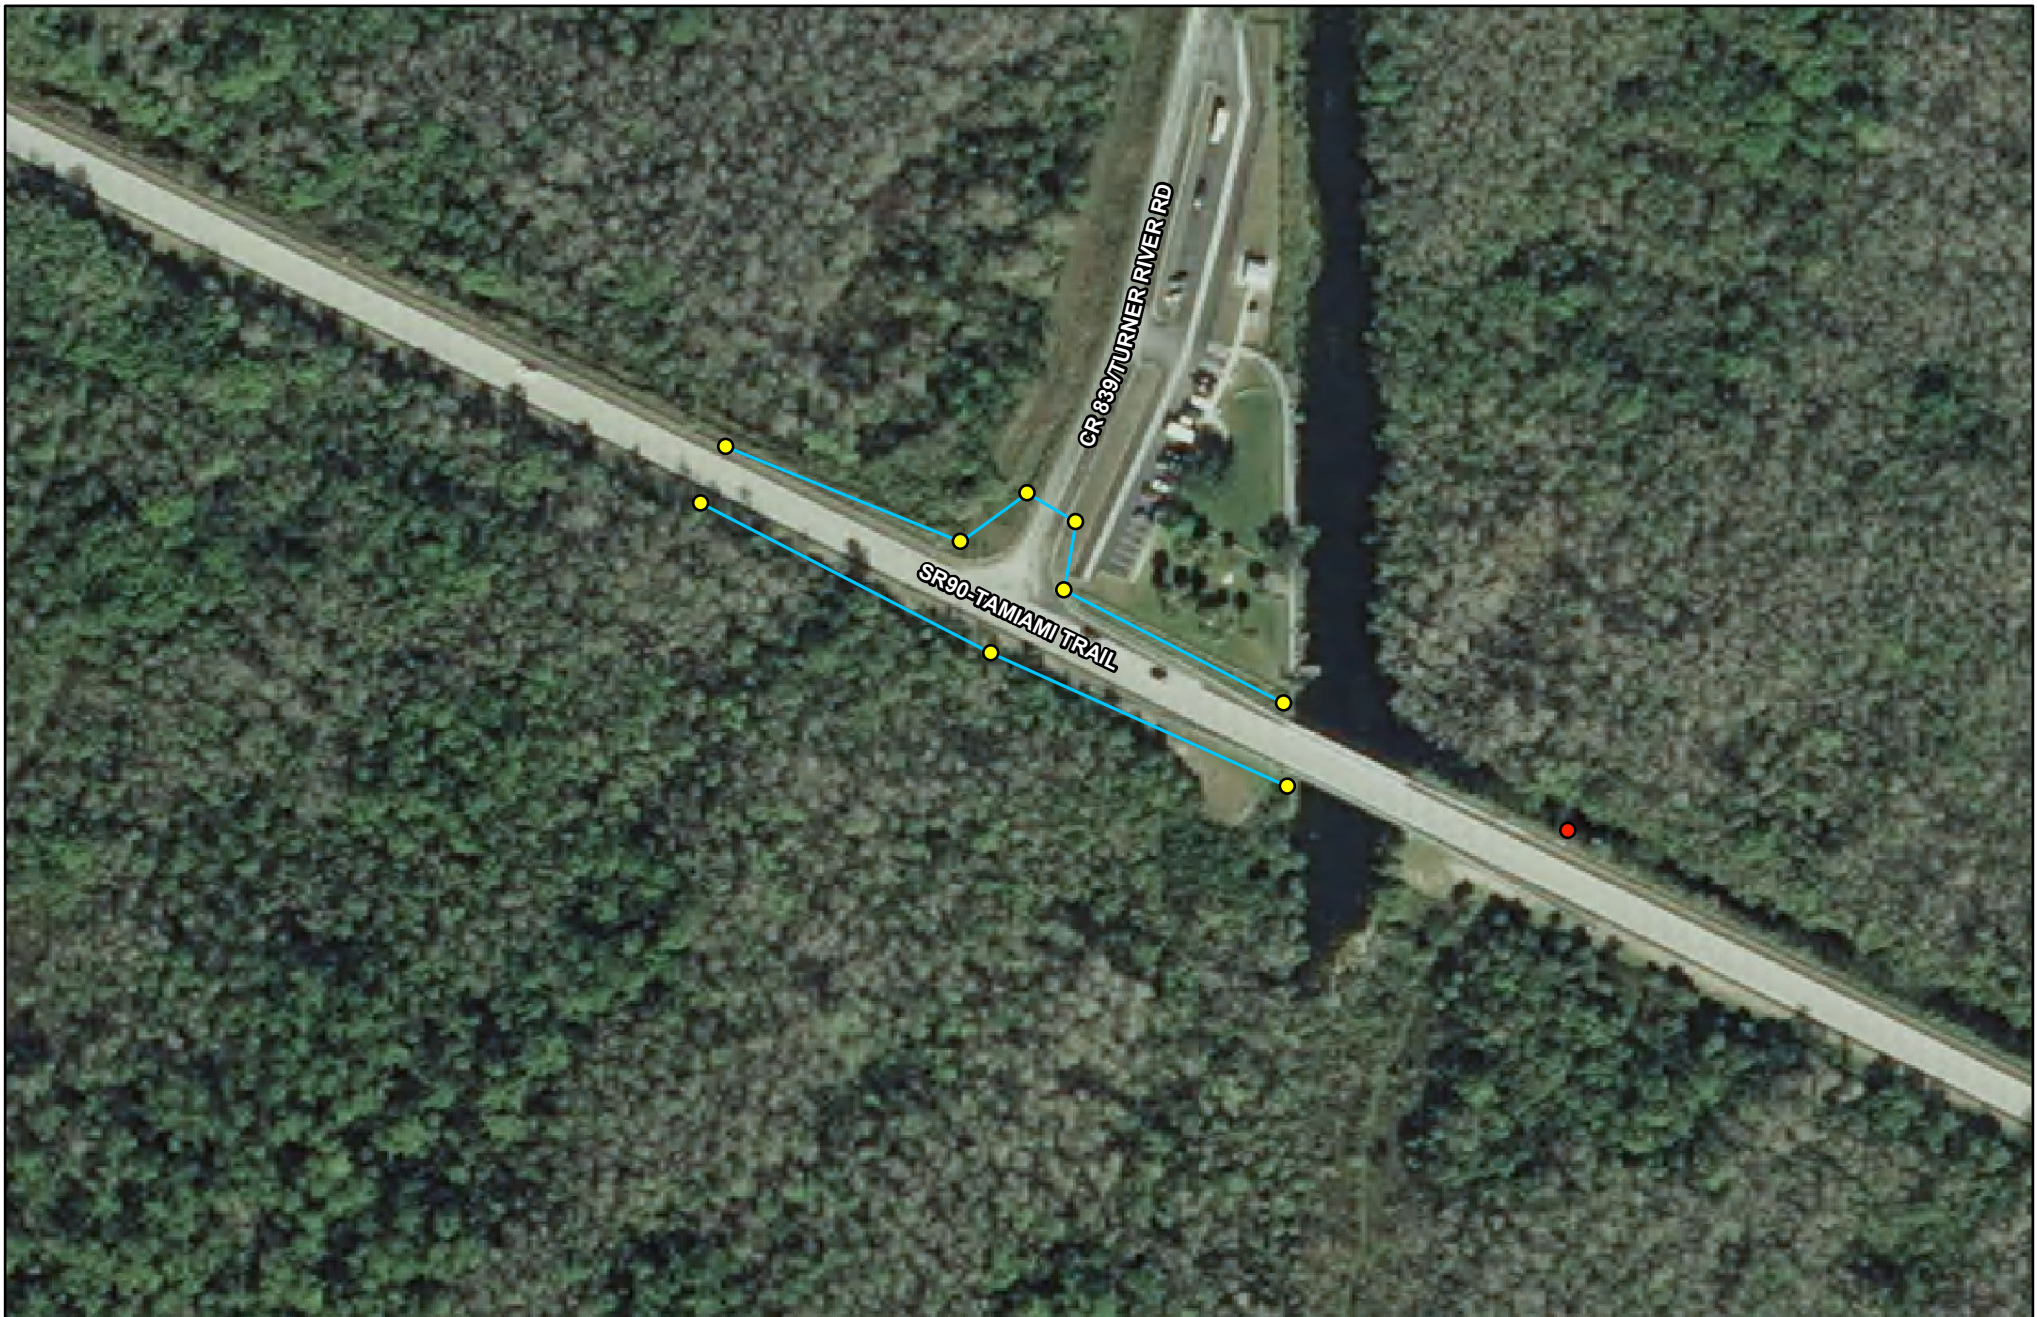
Figure 5

**Proposed Sensor Array  
Turney River Road**

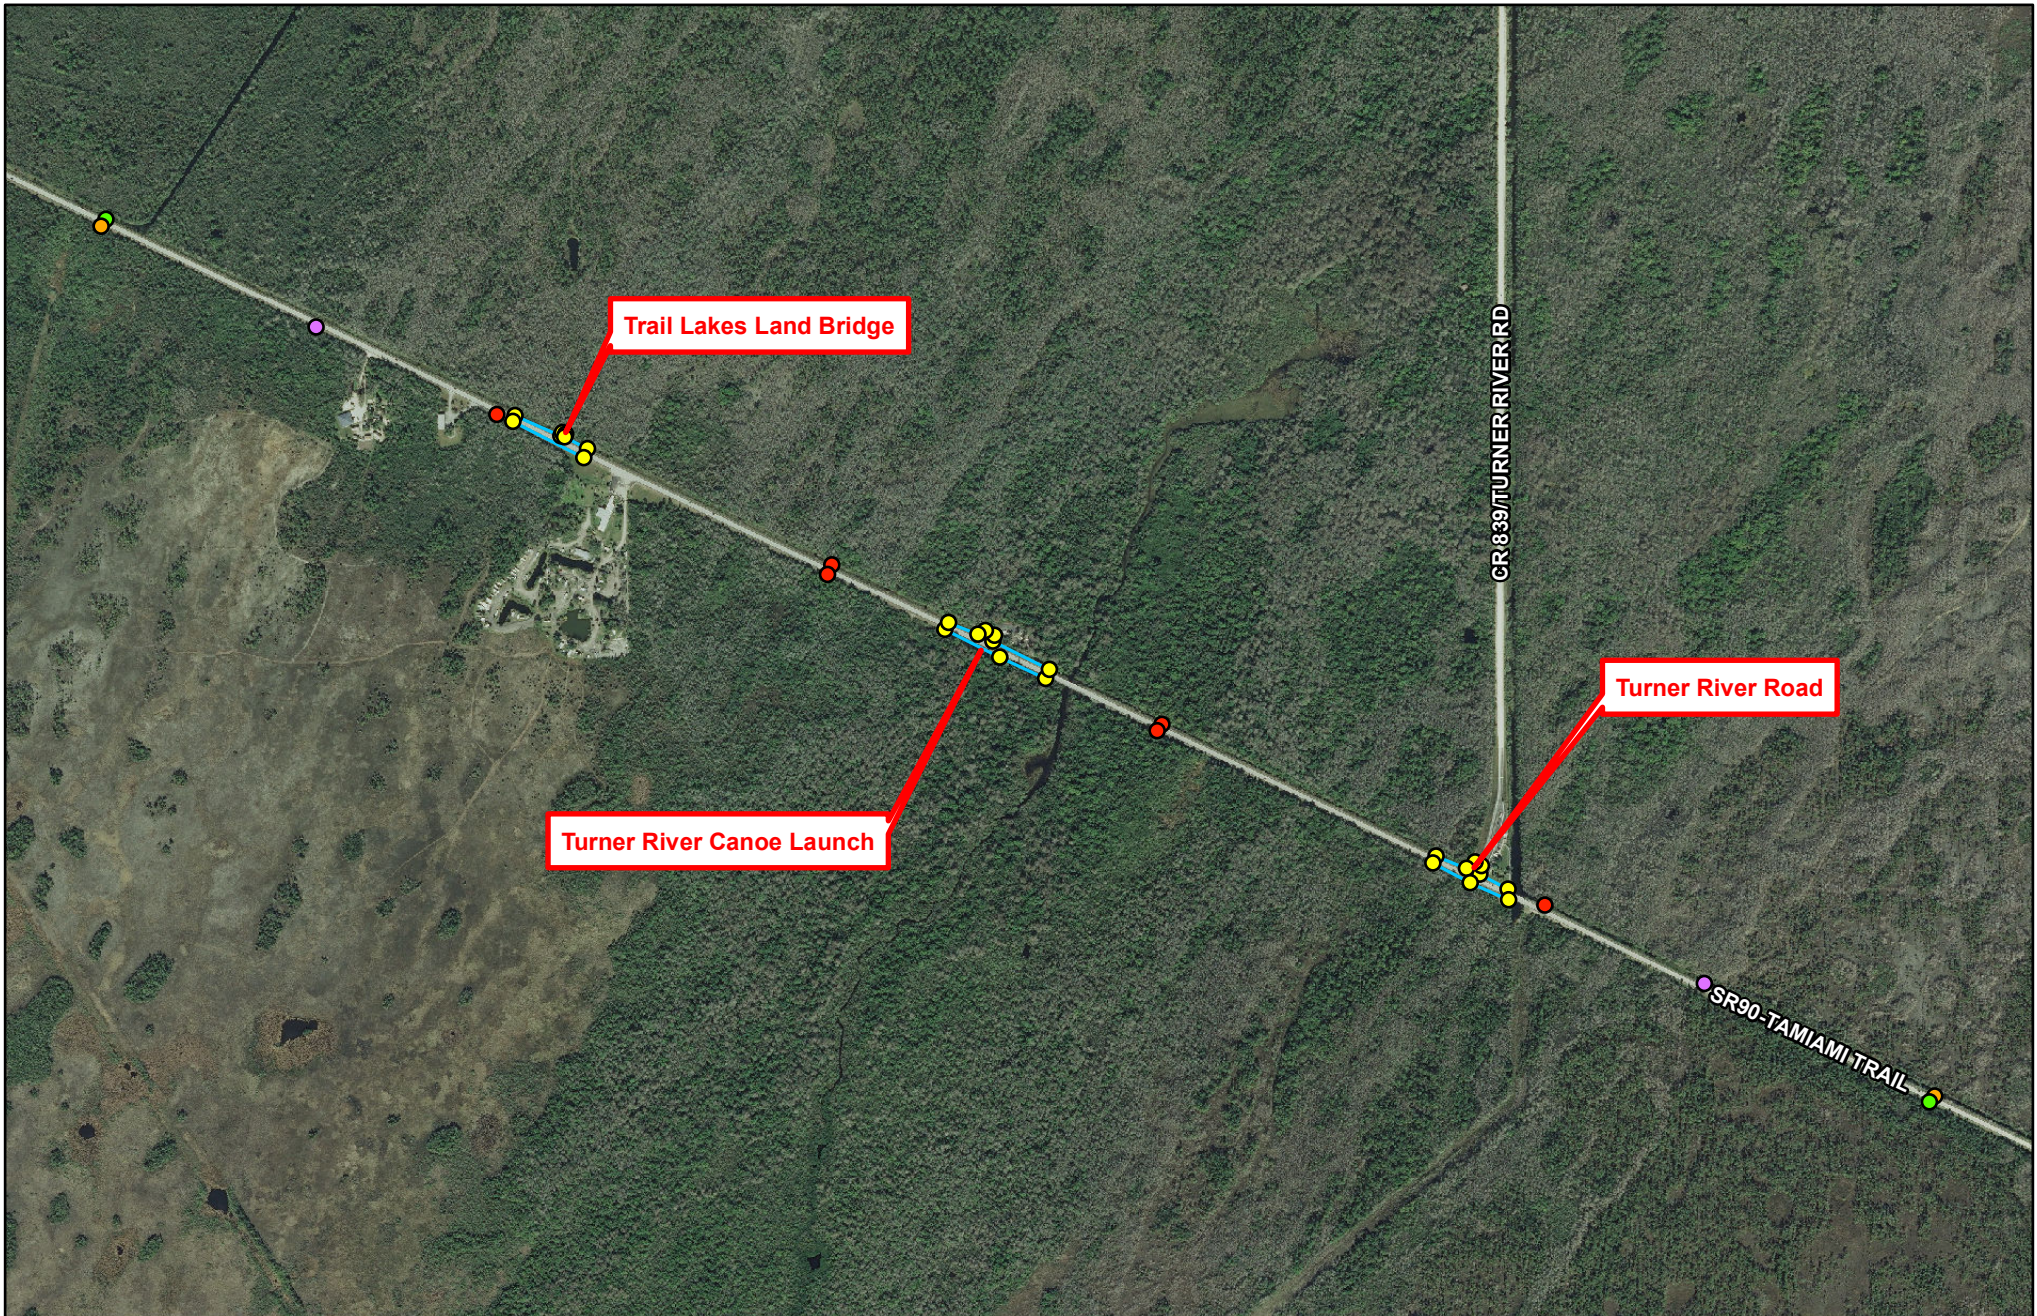
Figure 6

The overall layout of the proposed revised RADS system along US 41 in the area of Turner River Road is shown in Figure 6. This figure shows the proposed relocation of sensors, the location of existing warning signs (to remain), and the location of proposed new warning signs.

**Project Overview**
