Restoration of R61B Road Nevada Test and Training Range to Benefit the Mojave Desert Tortoise

Anna Johnson Nellis Air Force Base Nellis Natural Resource Program

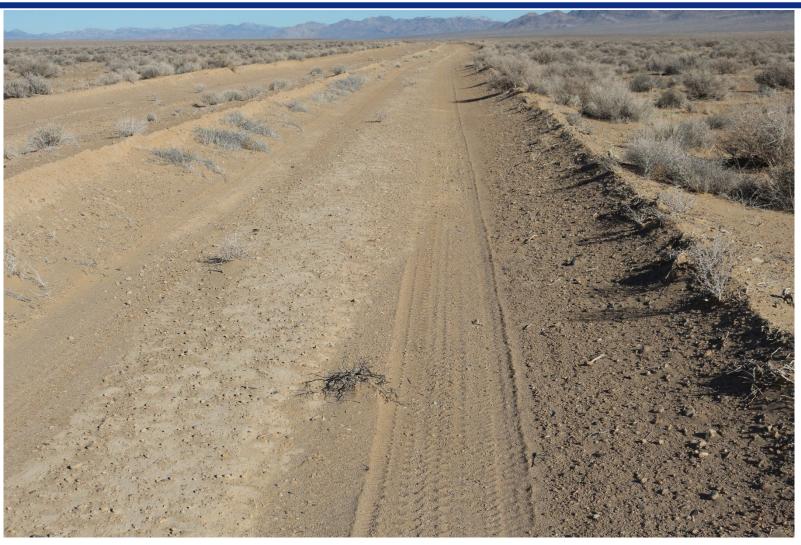
- 2018, the NTTR Environmental Liaison had an idea for a restoration location.
 - Desert tortoise habitat
 - 8-mile road on west side of range
- The problem
 - Sections of the roadway bed are a mix of silt and clay which reduces mobility of vehicular traffic. Vehicles would get stuck in the fine soils, which resulted in widening of the roadway where vehicles have driven around impassible portions.
- Range is typically used for helicopter training and Search and Rescue

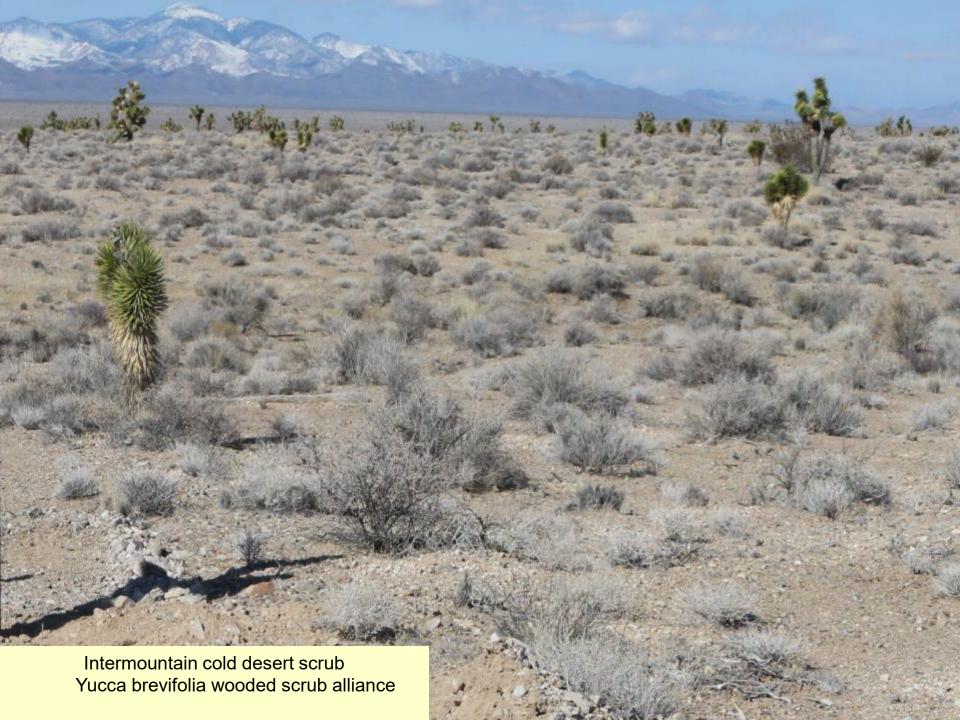
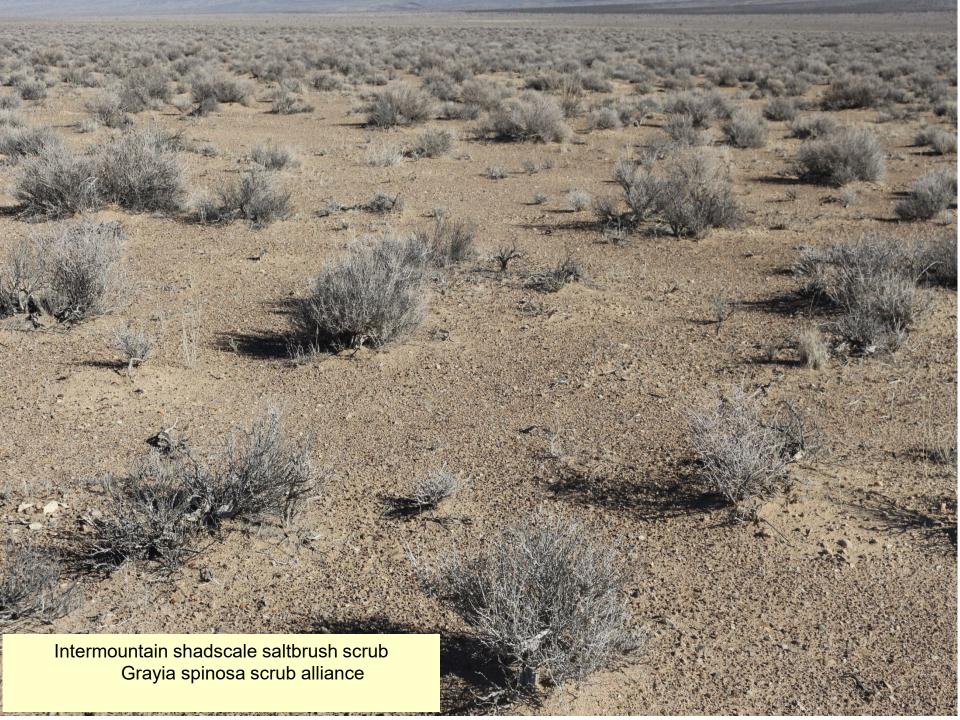
- Aug 2021
- Participants: Nellis AFB, Desert NWR, BLM-WF Module Lead, CSU
- Evaluate soil compaction and soil drainage availability
- Discussed equipment needs/options
- Vegetation classification species list
- Restoration approaches
- Number and placement of road closure signage/barriers

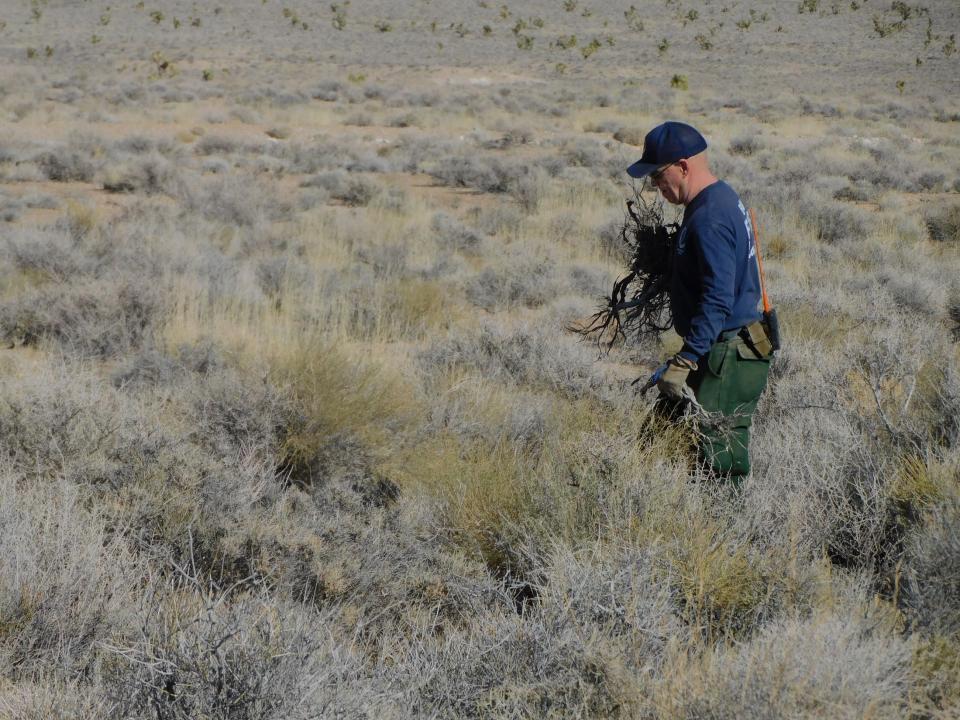
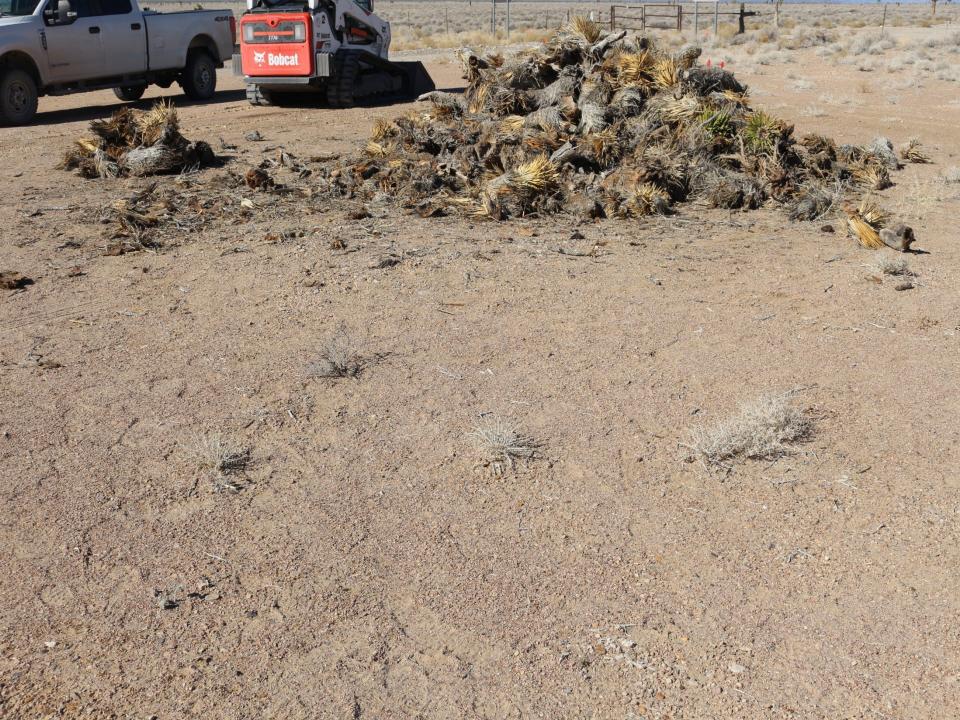
- Within proximity of project, collect up to 10% of dead plant biomass such as shrub branches, litter, and Joshua tree limbs, as well as rock substrate material
 - Stage at the start of the roadway
- Submit a Dig Permit required for any project if digging more than 2"
 - Surveys for underground utilities, fiber optic lines, etc
- Unexploded ordnance sweep of road and shoulders
- Stage equipment (bobcat)
- Signs
- Purchase supplies (signposts, wood posts, concrete, fuel...
- Desert tortoise clearance surveys

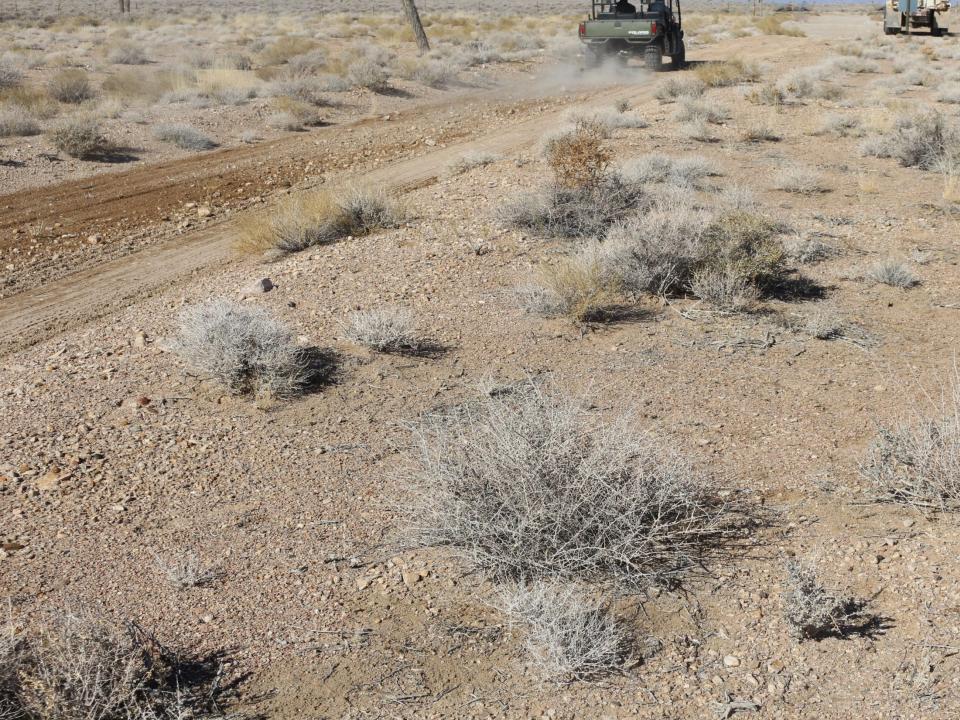
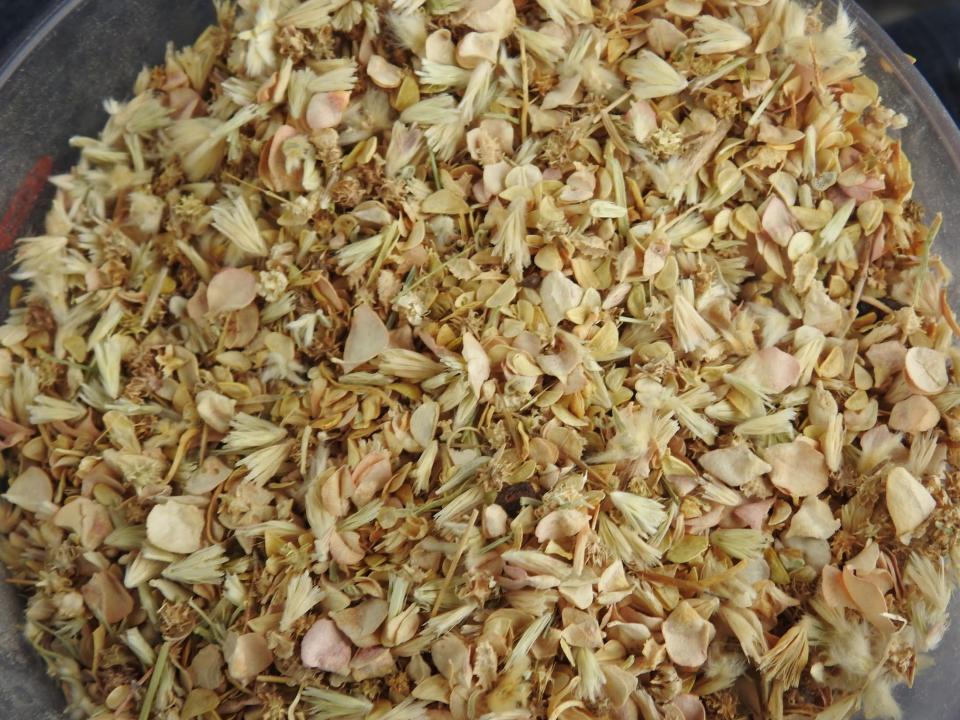
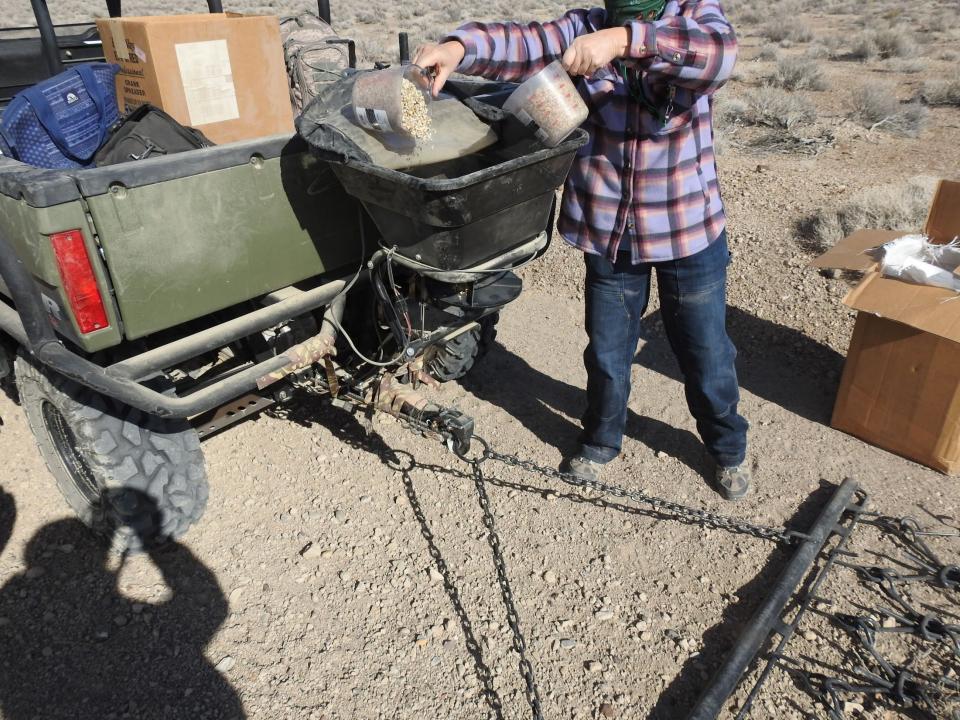
Phase 1

- Level out-side some higher road berms and north road blocking berm
- De-compact the entire road using an ATV and chain harrow to decompact soils down to 4"
- Broadcast seed blend within the roadway using an ATV with seed spreader
- Flip harrow to smooth side and drag along roadway to cover seeds to a shallow depth

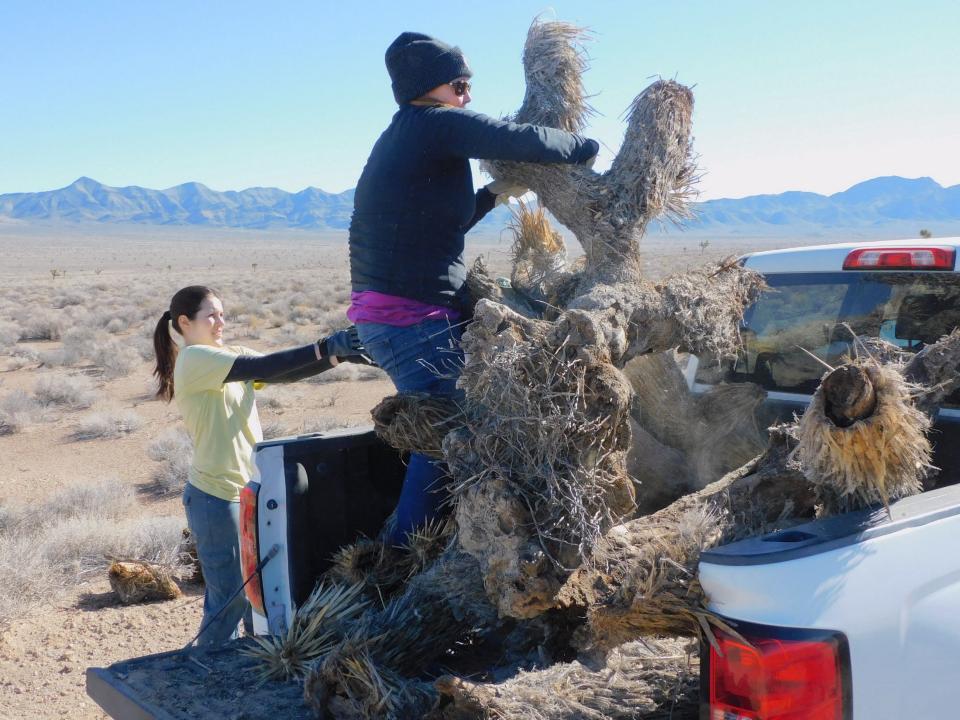
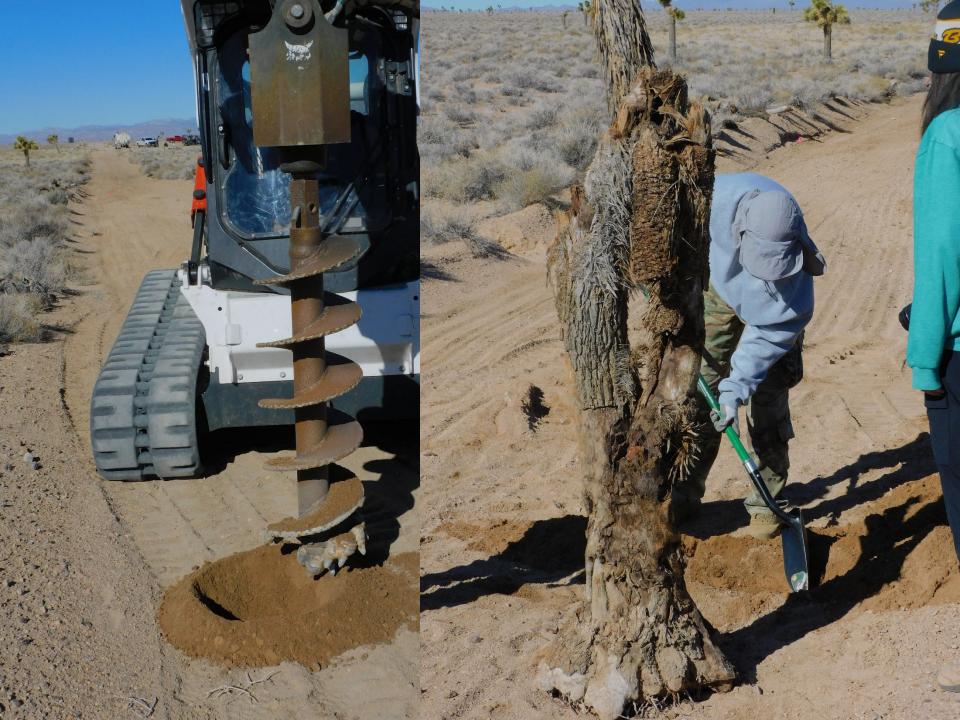
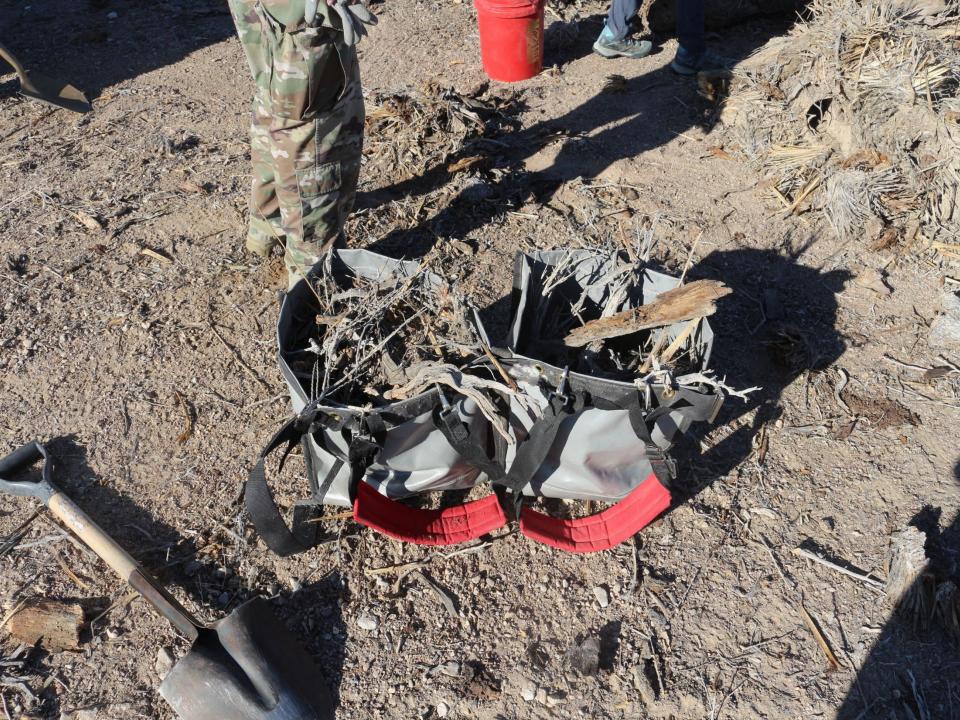
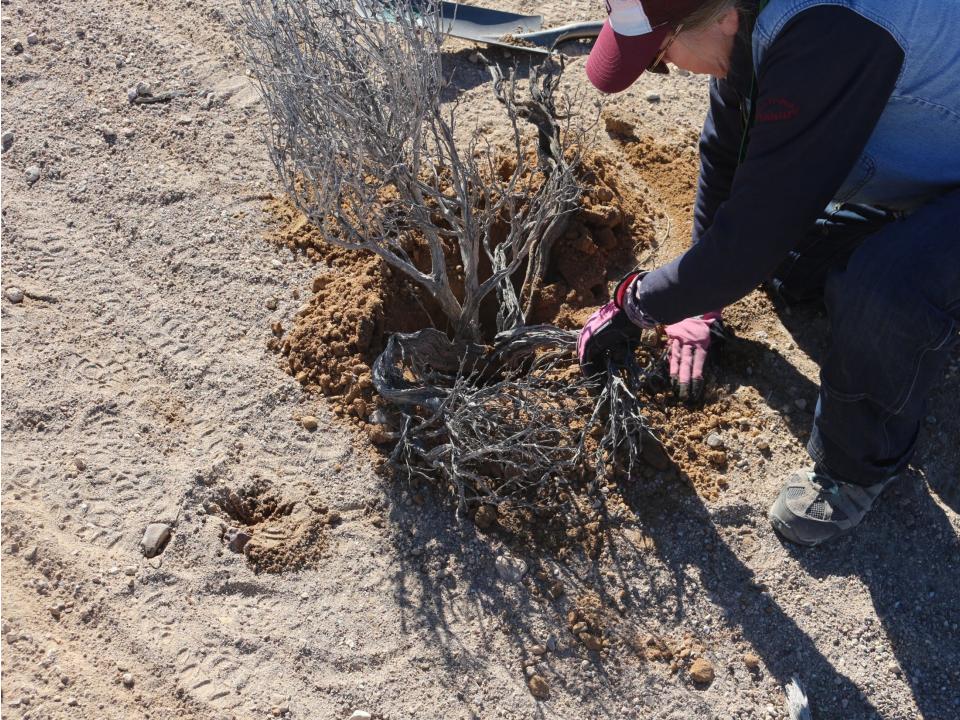
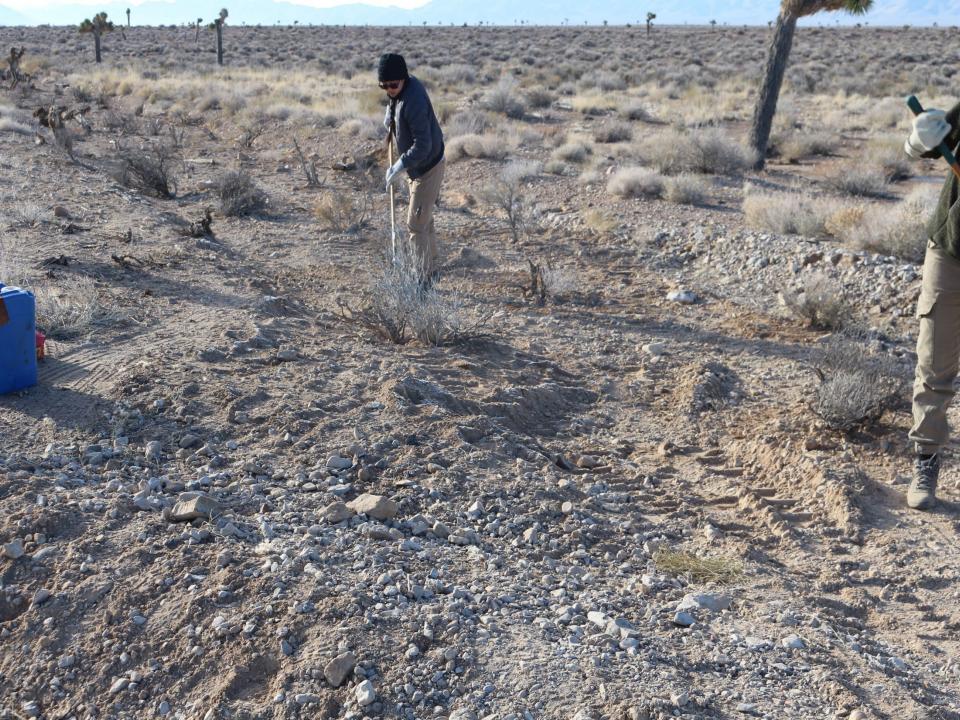
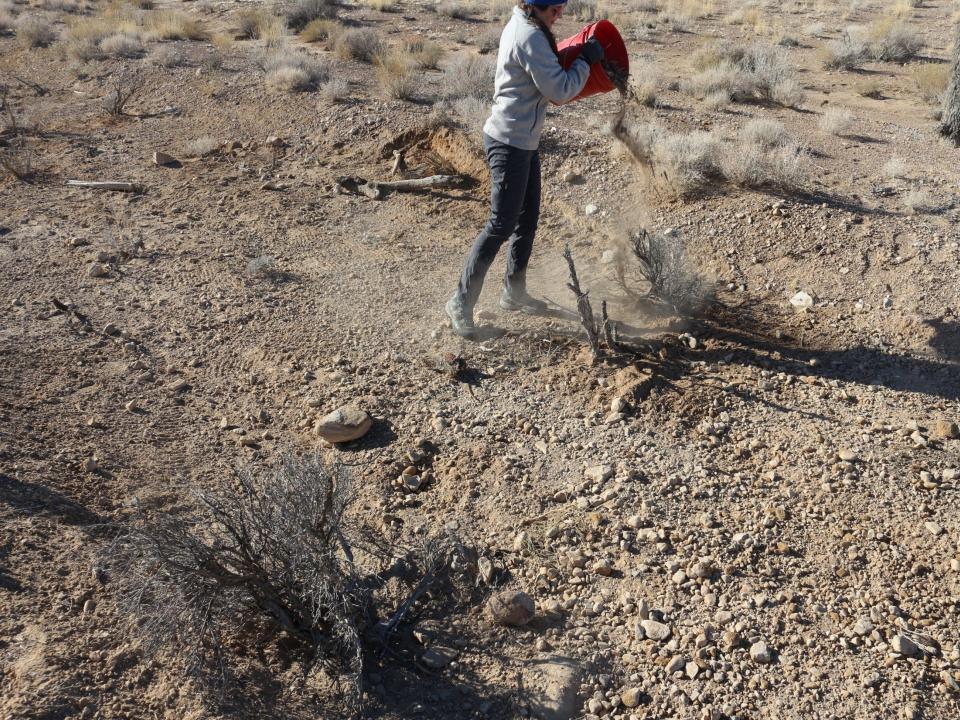
Phase 2

- Used locally sourced materials to re-establish native habitat structure and reduce line-of sight for the first 800' of the northern end and 300' on the southern end of the roadway
- Determine landscape locations within the disturbed roadway to place the materials to give the area an integrated habitat appearance (i.e vertical and horizontal mulching)
- Dig holes 12-18 inches at select locations to "plant" the biomass to resemble live shrubs (vertical mulching)
- Arrange other dead biomass and rocks (horizontal mulching) to reduce the appearance of the roadway
- Hand broadcast the seed blend within the mulched area and gently rake the soils to incorporate the seeds

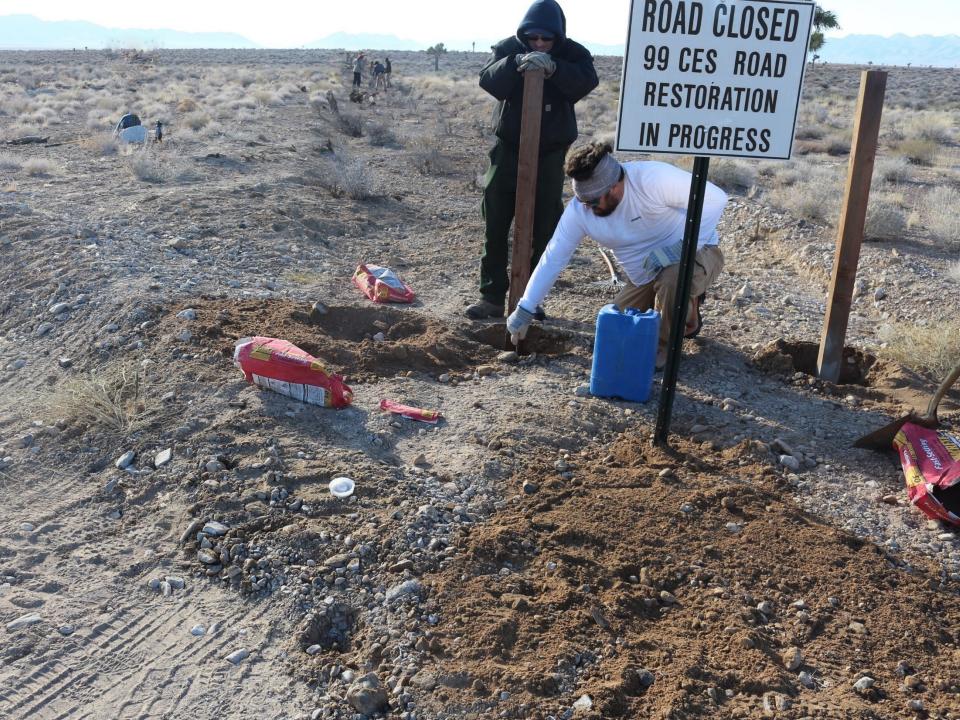
Phase 3

- Place 3 "Road Closed Restoration in Progress" signs with wooden posts on either side of sign at the ends of the northern, southern, and northeast side bypass locations
 - To deter vehicular access in perpetuity
 - Holes dug by Bobcat with post hole digger
