Operation of a Removable Lamprey Barrier **in Morpion Stream - 2023**

BJ Allaire, Fish Biologist

U.S. Fish and Wildlife Service

Lake Champlain Fish and Wildlife Conservation Office

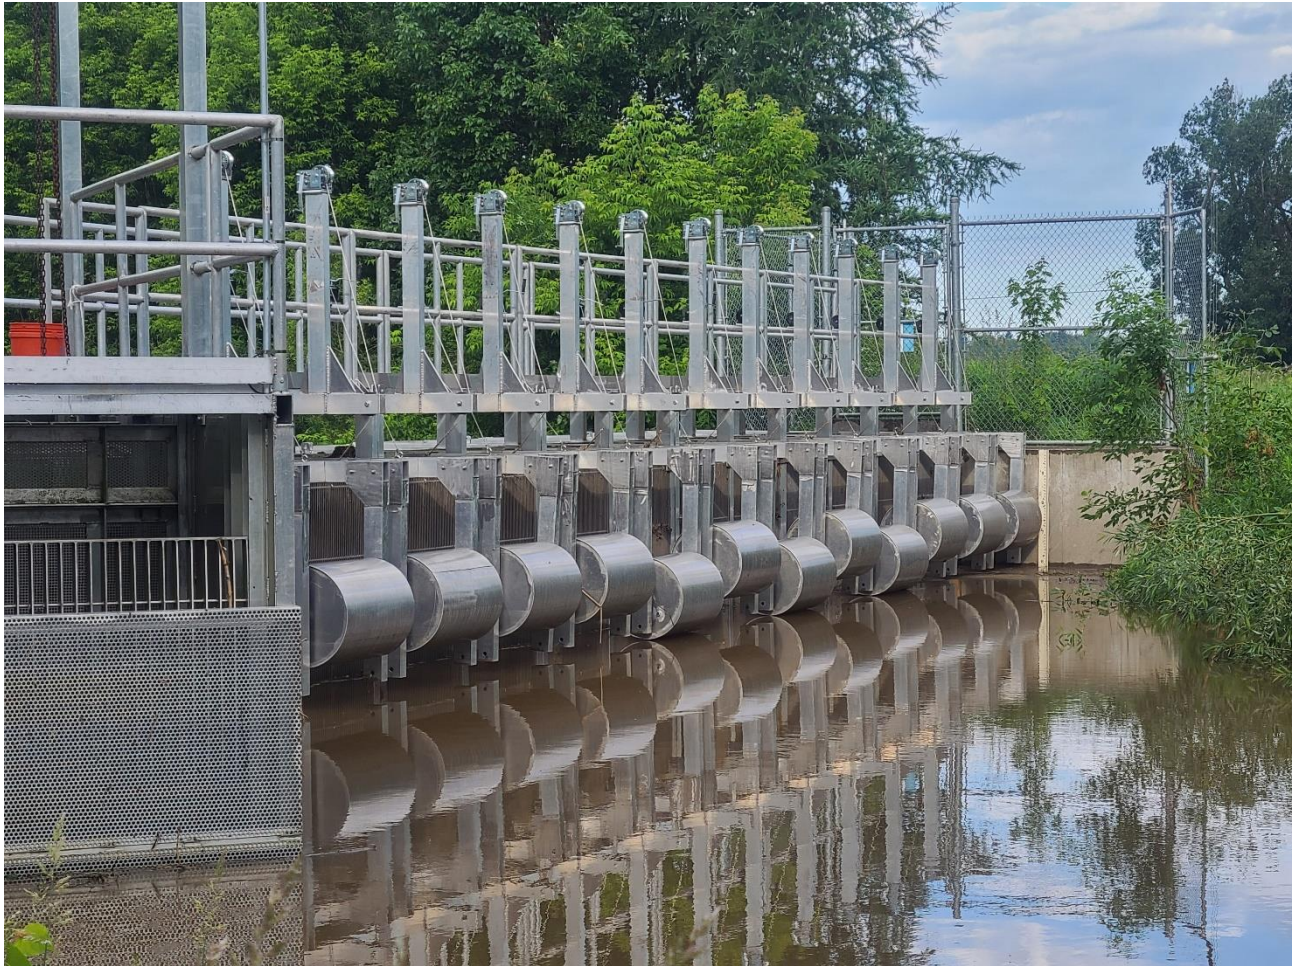
Figure 1. A picture of the barrel floats on the Morpion Stream sea lamprey barrier. This picture is looking downstream towards the barrier. This is considered high water (approximately 2 meters deep) When the water levels reach approximately 2.3 meters deep the lower barrels (3) will trip allowing those grates to drop downstream allowing the water level to drop. If the water level continues to rise additional barrels (9) will trip.

One of the most important and innovative features of the Morpion Barrier is its ability to be installed in the spring, prior to adult lamprey retuning to spawn, and removed from the stream once the spawning season is complete. This allows the stream to remain free flowing for nearly 10 months of the year. The barrier consists of a walkway above a series of screen panels or “grates” that are placed side by side and raised from the streambed forming the face of the barrier. Each individual grate has an attached float barrel mechanism (Figure 1) so that if the water rises high enough for the barrel to float, it will automatically trip, allowing the grate to be released and return to the streambed. This feature allows the water and any debris that has accumulated to pass downstream. The barrier has 12 vertical grates that are placed at a 60-degree angle to stream flow. This increases the surface area of the barrier, while also directing fish that encounter the barrier while moving upstream into the trap.

We will always be at the mercy of the weather such that, during high flow events, the grates will trip and if lamprey are migrating upstream during that time, they may get past the barrier before we have a chance to raise the grates back up. We can only hope that these events are few and far between. Recent high-water events have shown that the barrier does operate as designed, with floats tripping and grates being lowered automatically during these events. During the 2023 trapping season water levels rose after heavy rains on several occasions, but only once did they rise high enough to trip one of the lower most barrels. This allowed enough debris and water to pass that no additional barrels were tripped. This is how the barrier was designed to operate.

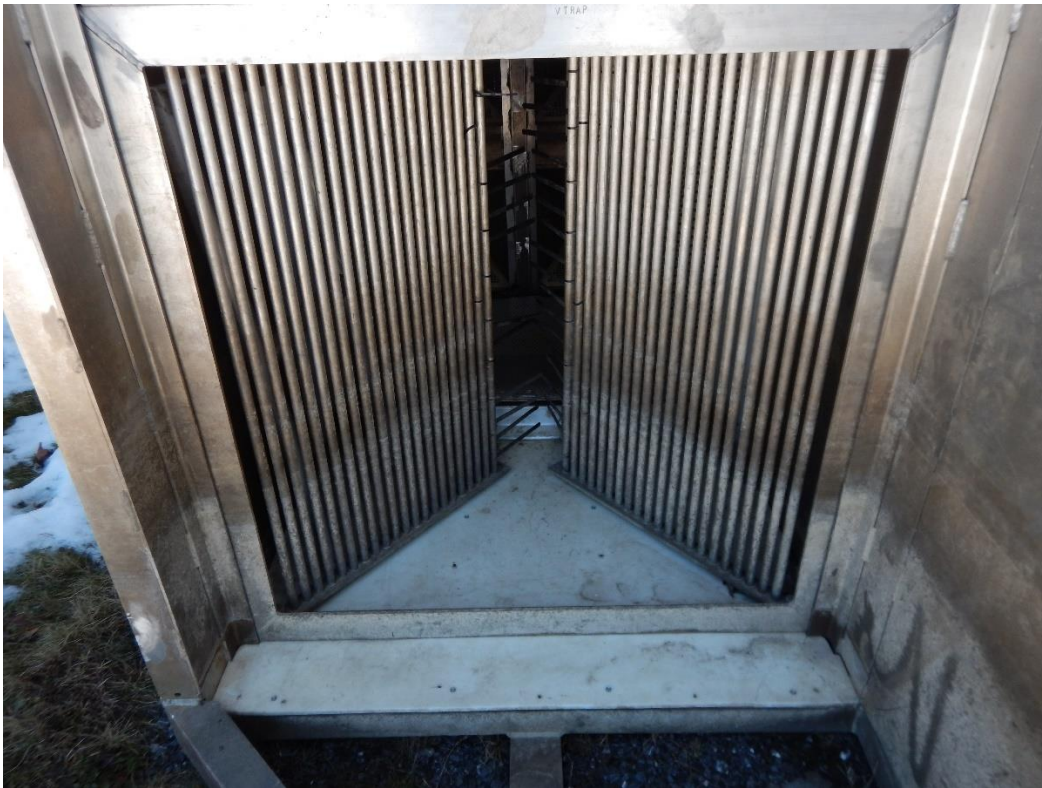
Figure 2. Entrance to the first stage of the trap (Vee-Trap section) of the Morpion Stream sea lamprey barrier.

The trap is a two-stage trap with larger fish being collected in the first stage, and smaller fish and lamprey being collected in the second stage. To enter the first stage of the trap, also known as the “Vee – Trap”, fish must pass through the V-shaped notch (Figure 2). This Vee - Trap consists of two bar racks oriented vertically and can be adjusted to allow larger fish to enter, or closed to allow only smaller sized fish

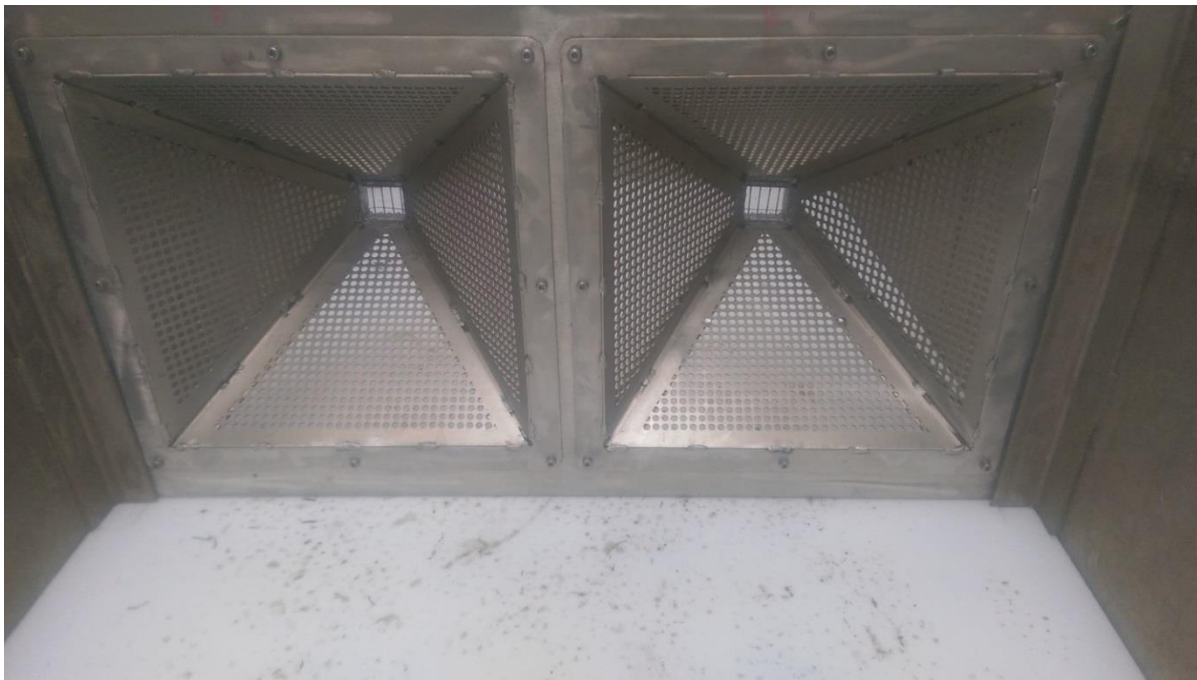
Figure 3. A picture of the funnels that separate the first and second stage of the lamprey trap in Morpion Stream. In addition to the two funnels shown in this picture, two additional funnels are stacked on top.

to enter. The second stage of the trap is where the lamprey and smaller fish are collected. To pass from the Vee – Trap into the second stage trap, fish must make their way through one of four funnels. The narrow end of the funnels have a 64mm (2.5 inch) square opening (Figure 3). This two-stage trap is designed to facilitate the passage of fish that encounter the barrier, while also allowing for easier processing by separating out lamprey and smaller fish into the second stage of the trap.

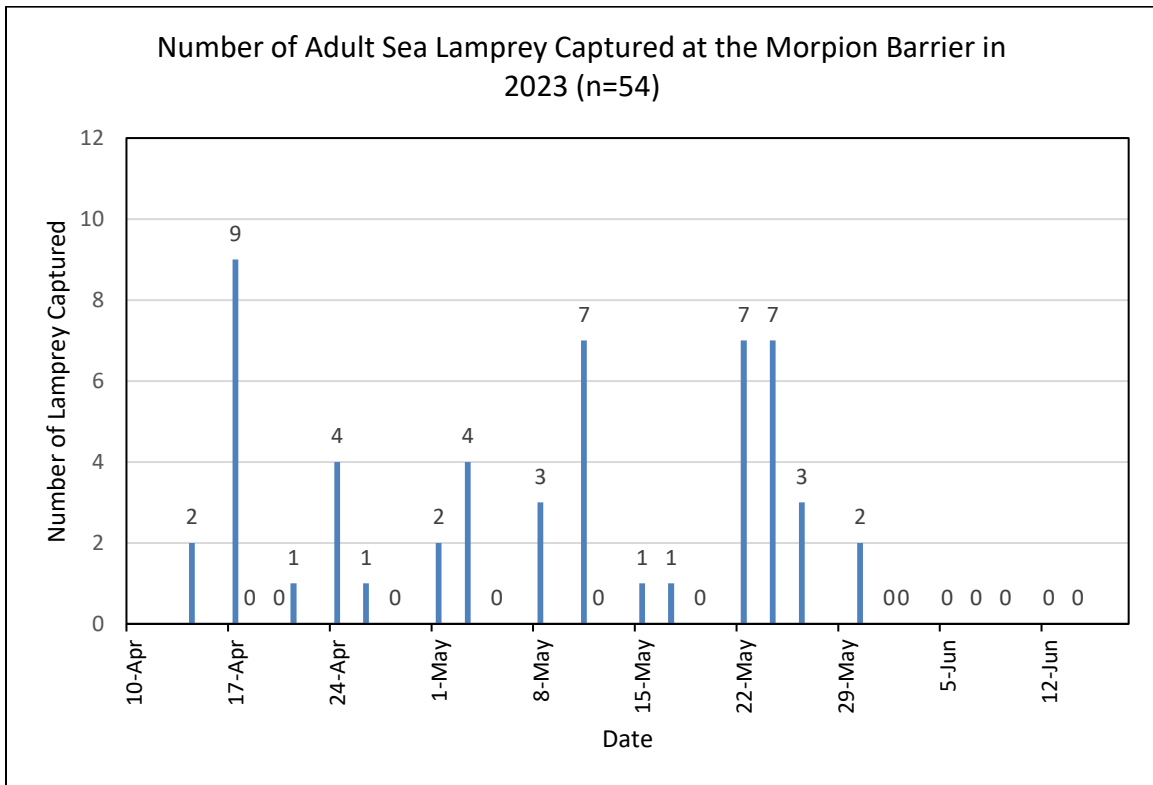
Figure 4. Dates and the numbers of adult sea lamprey captured at the Morpion Stream sea lamprey barrier during the spring of 2023.

The first adult sea lamprey (2) were captured on April 14th (Figure 4), which was the first date that the trap was checked in 2023. Lamprey have been caught during the first trap check every year except 2014, a year when lamprey were able to escape from the trap. The last adult sea lamprey (2) were caught on May 30th. For the season, a total of 54 adult sea lamprey were captured. This number is below the previous 7-year average of 122.

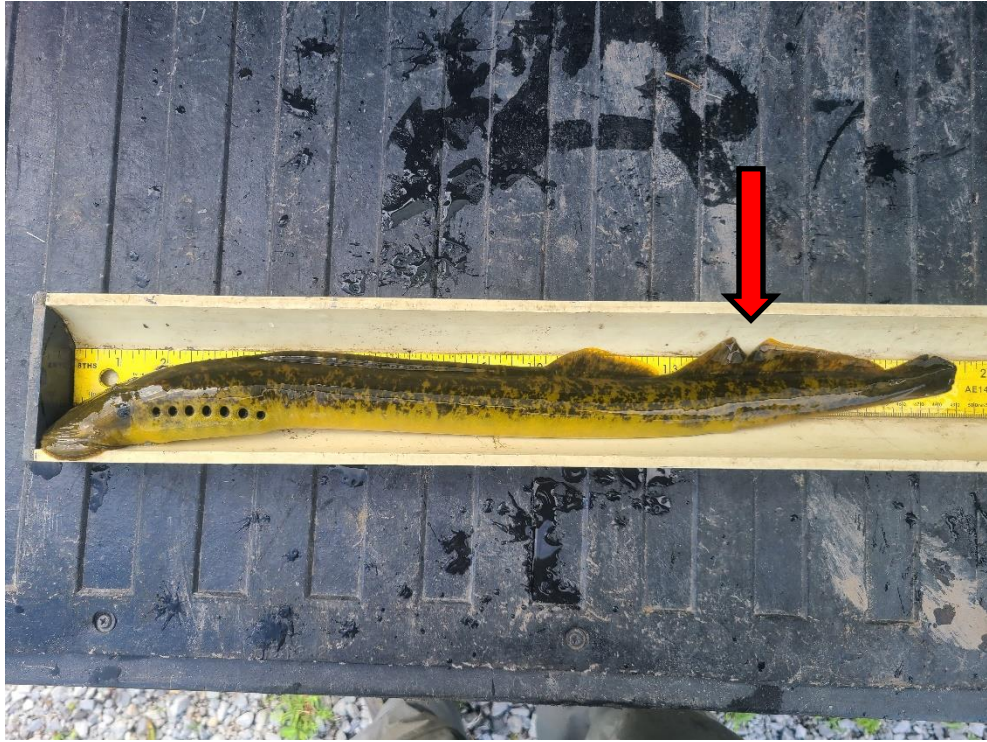
Figure 5. Picture of an adult sea lamprey collected at the Morpion Barrier and given a fin clip to the second (posterior) dorsal fin as part of a mark-recapture program to estimate the size of the spawning population.

In 2022, we began a mark-recapture program on a number of rivers and streams throughout the Lake Champlain Basin. This includes Morpion Stream. Lamprey that are collected at the trap are given a single fin clip (Figure 5) and released downstream, just above the covered bridge at St. Charles Road. This is approximately 2.4km (1.5 miles) downstream. If lamprey are recaptured at the barrier they are then removed from the population. In 2023, no sea lamprey were released after May 26th as it is believed that lamprey were transitioning from their migratory-phase to their spawning-phase with a decreased urge to migrate.

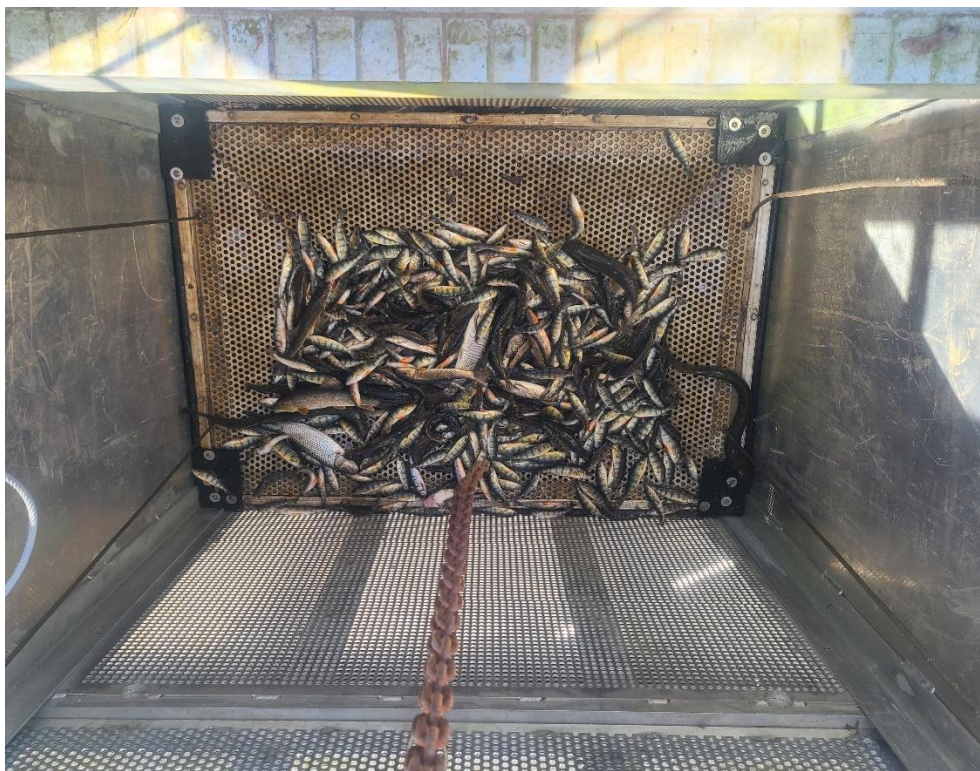
Figure 6. A picture of the second stage trap of the Morpion Barrier being raised to be sorted.

Prior to the 2017 trapping season, we installed a new raisable floor (Figure 6) in the bottom of both the first stage (Vee-Trap) and second stage of the trap. Prior to this we would empty the trap by lowering a ladder down into each section and passing fish and lamprey up one net full at a time. Between 2014 and 2016, we captured a total of just 13 non-targets in the Vee-Trap section. In 2023, we captured 190 non-targets in the Vee-Trap section. Since 2014 we have captured 36 different fish species at the Morpion Barrier. We observed no new species at the barrier in 2023.
