RESTORATION

Salt Marsh Habitat Restoration on Parker River National Wildlife Refuge

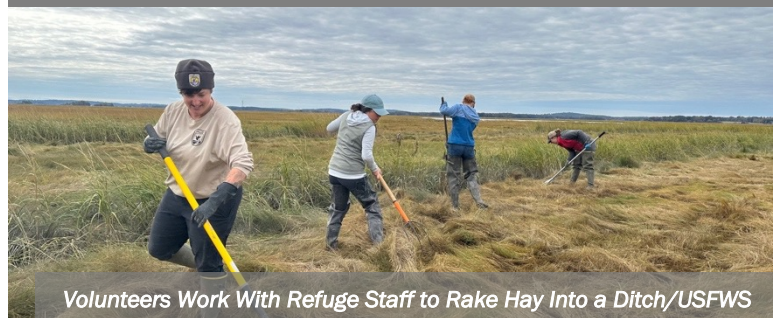
Volunteers Work With Refuge Staff to Rake Hay Into a Ditch/USFWS

Healing Ditches with Hay: From 2014-2017, scientists added bundles of native salt marsh hay to 17 ditches to encourage peat soil development and vegetation growth. By 2017, the ditches increased in elevation by 15 cm on average. Salt marsh grass grew in treated ditches shallower than <15 cm (Burdick et al., 2017). In 2022, refuge staff remediated 30 additional ditch segments.
