RESTORATION

Tidal Marsh and Dune Restoration on Prime Hook National Wildlife Refuge

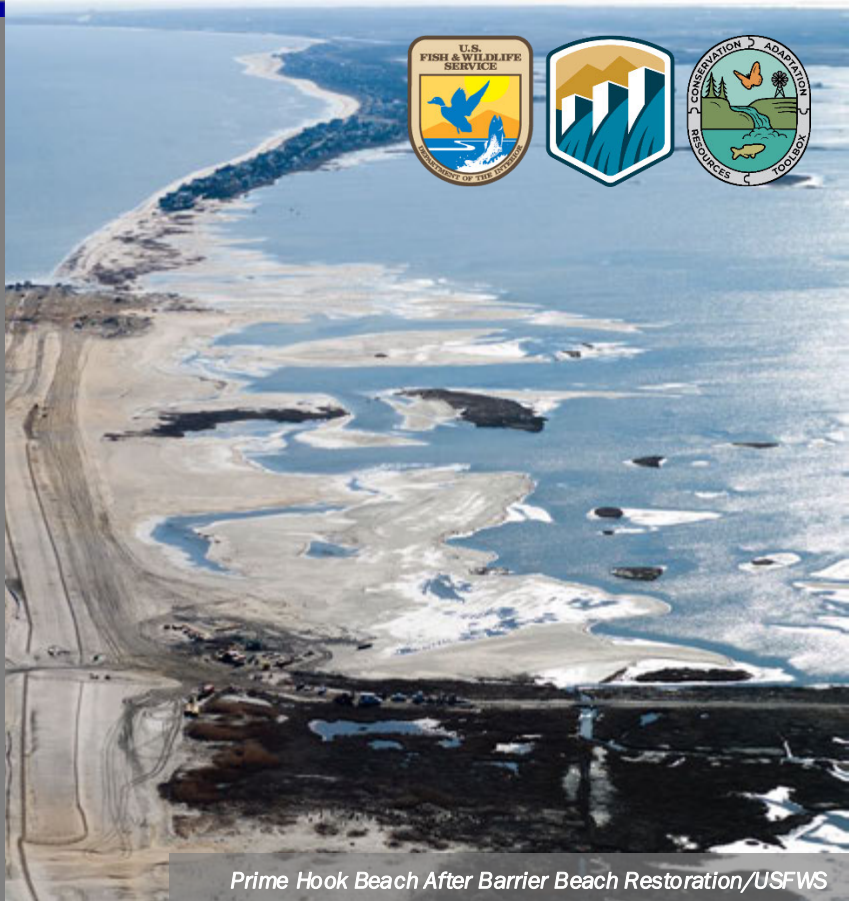
Prime Hook Beach After Barrier Beach Restoration/USFWS

Marsh and Barrier Beach Re-Stabilization: PHNWR staff filled in two miles of shoreline with 1.4 million cubic yards of sand directly dredged from Delaware Bay to restore and reshape the eroded dune system. Staff constructed sand fencing and planted plugs of brackish dune and marsh species to stabilize the back-barrier and create high marsh habitat.

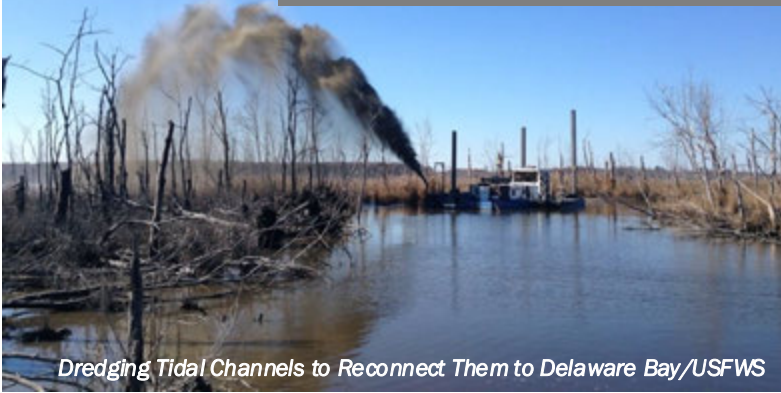
Dredging Tidal Channels to Reconnect Them to Delaware Bay/USFWS

Tidal Marsh Hydrologic Restoration: Tidal marsh restoration at PHNWR involved dredging 25 miles of channels across 4,000 acres of former freshwater impoundments. The dredged channels slowed water exchange and distributed flow throughout the marsh, lowering the water level to expose subaqueous soils.

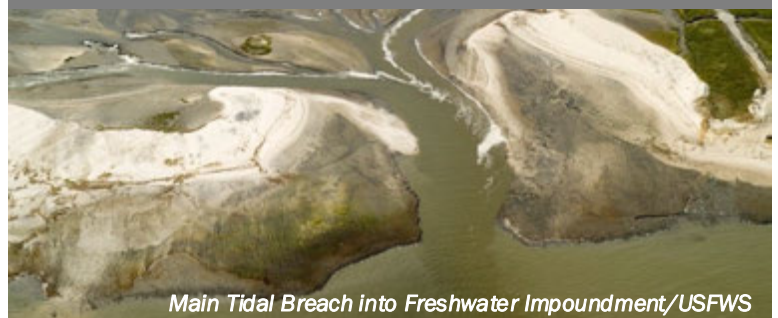
Main Tidal Breach into Freshwater Impoundment/USFWS

Dune erosion has made PHNWR vulnerable to saltwater intrusion. Saltwater intrusion into freshwater habitat creates unlivable conditions for some freshwater species such as pintails, wood ducks, teal, largemouth bass, and pickerel, leading to ecosystem and species changes as the habitat transitions to saltwater.
