RESTORATION

Using Woody Materials to Restore Crooked Creek

CCAST Author: Lindsey Smith, Miami University, March 2023.

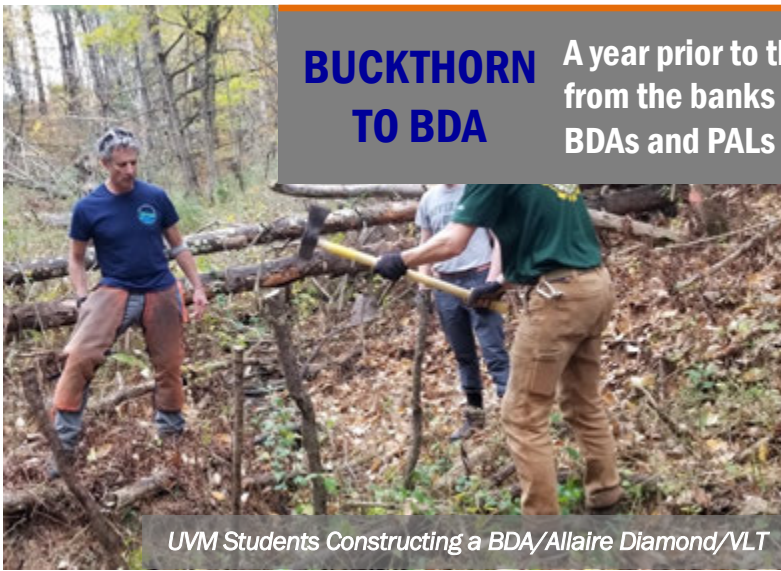
UVM Students Constructing a BDA/Allaire Diamond/VLT

A year prior to the restoration, partners cleared invasive buckthorn from the banks of Crooked Creek. This wood was used to build the BDAs and PALs installed in the creek.

Restoration Day Results: Partners worked with student volunteers from the University of Vermont. Together, they built 24 structures in four hours, including nine BDAs and 15 PALS, structures that are designed to hold more wood and silt in the waterway. The team built the structures using hand tools and woody material sourced from the site. Students also conducted twelve cross-section surveys along the creek to provide a baseline for measuring changes to erosion levels as the creek responds to the restoration.

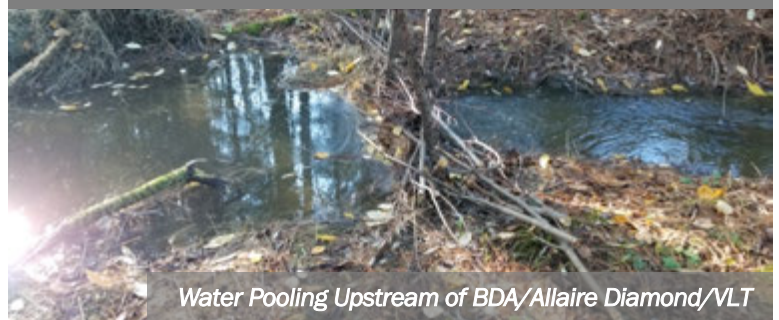
Water Pooling Upstream of BDA/Allaire Diamond/VLT

Restoring Hydrological Function: Post-implementation, the structures are collecting and slowing water, allowing water to spread into the floodplain. As more water is slowed with each rainfall and additional natural wood is caught in the installed structures, more natural structures will build up in the waterway.
