HYDROLOGICAL RESTORATION OF THE BRAZORIA NATIONAL WILDLIFE REFUGE WETLANDS

Ducks Unlimited, Inc.

December 17, 2020

FREESE AND NICHOLS, INC.
10431 Morado Circle, Suite 300
Austin, Texas 78759
512-617-3100

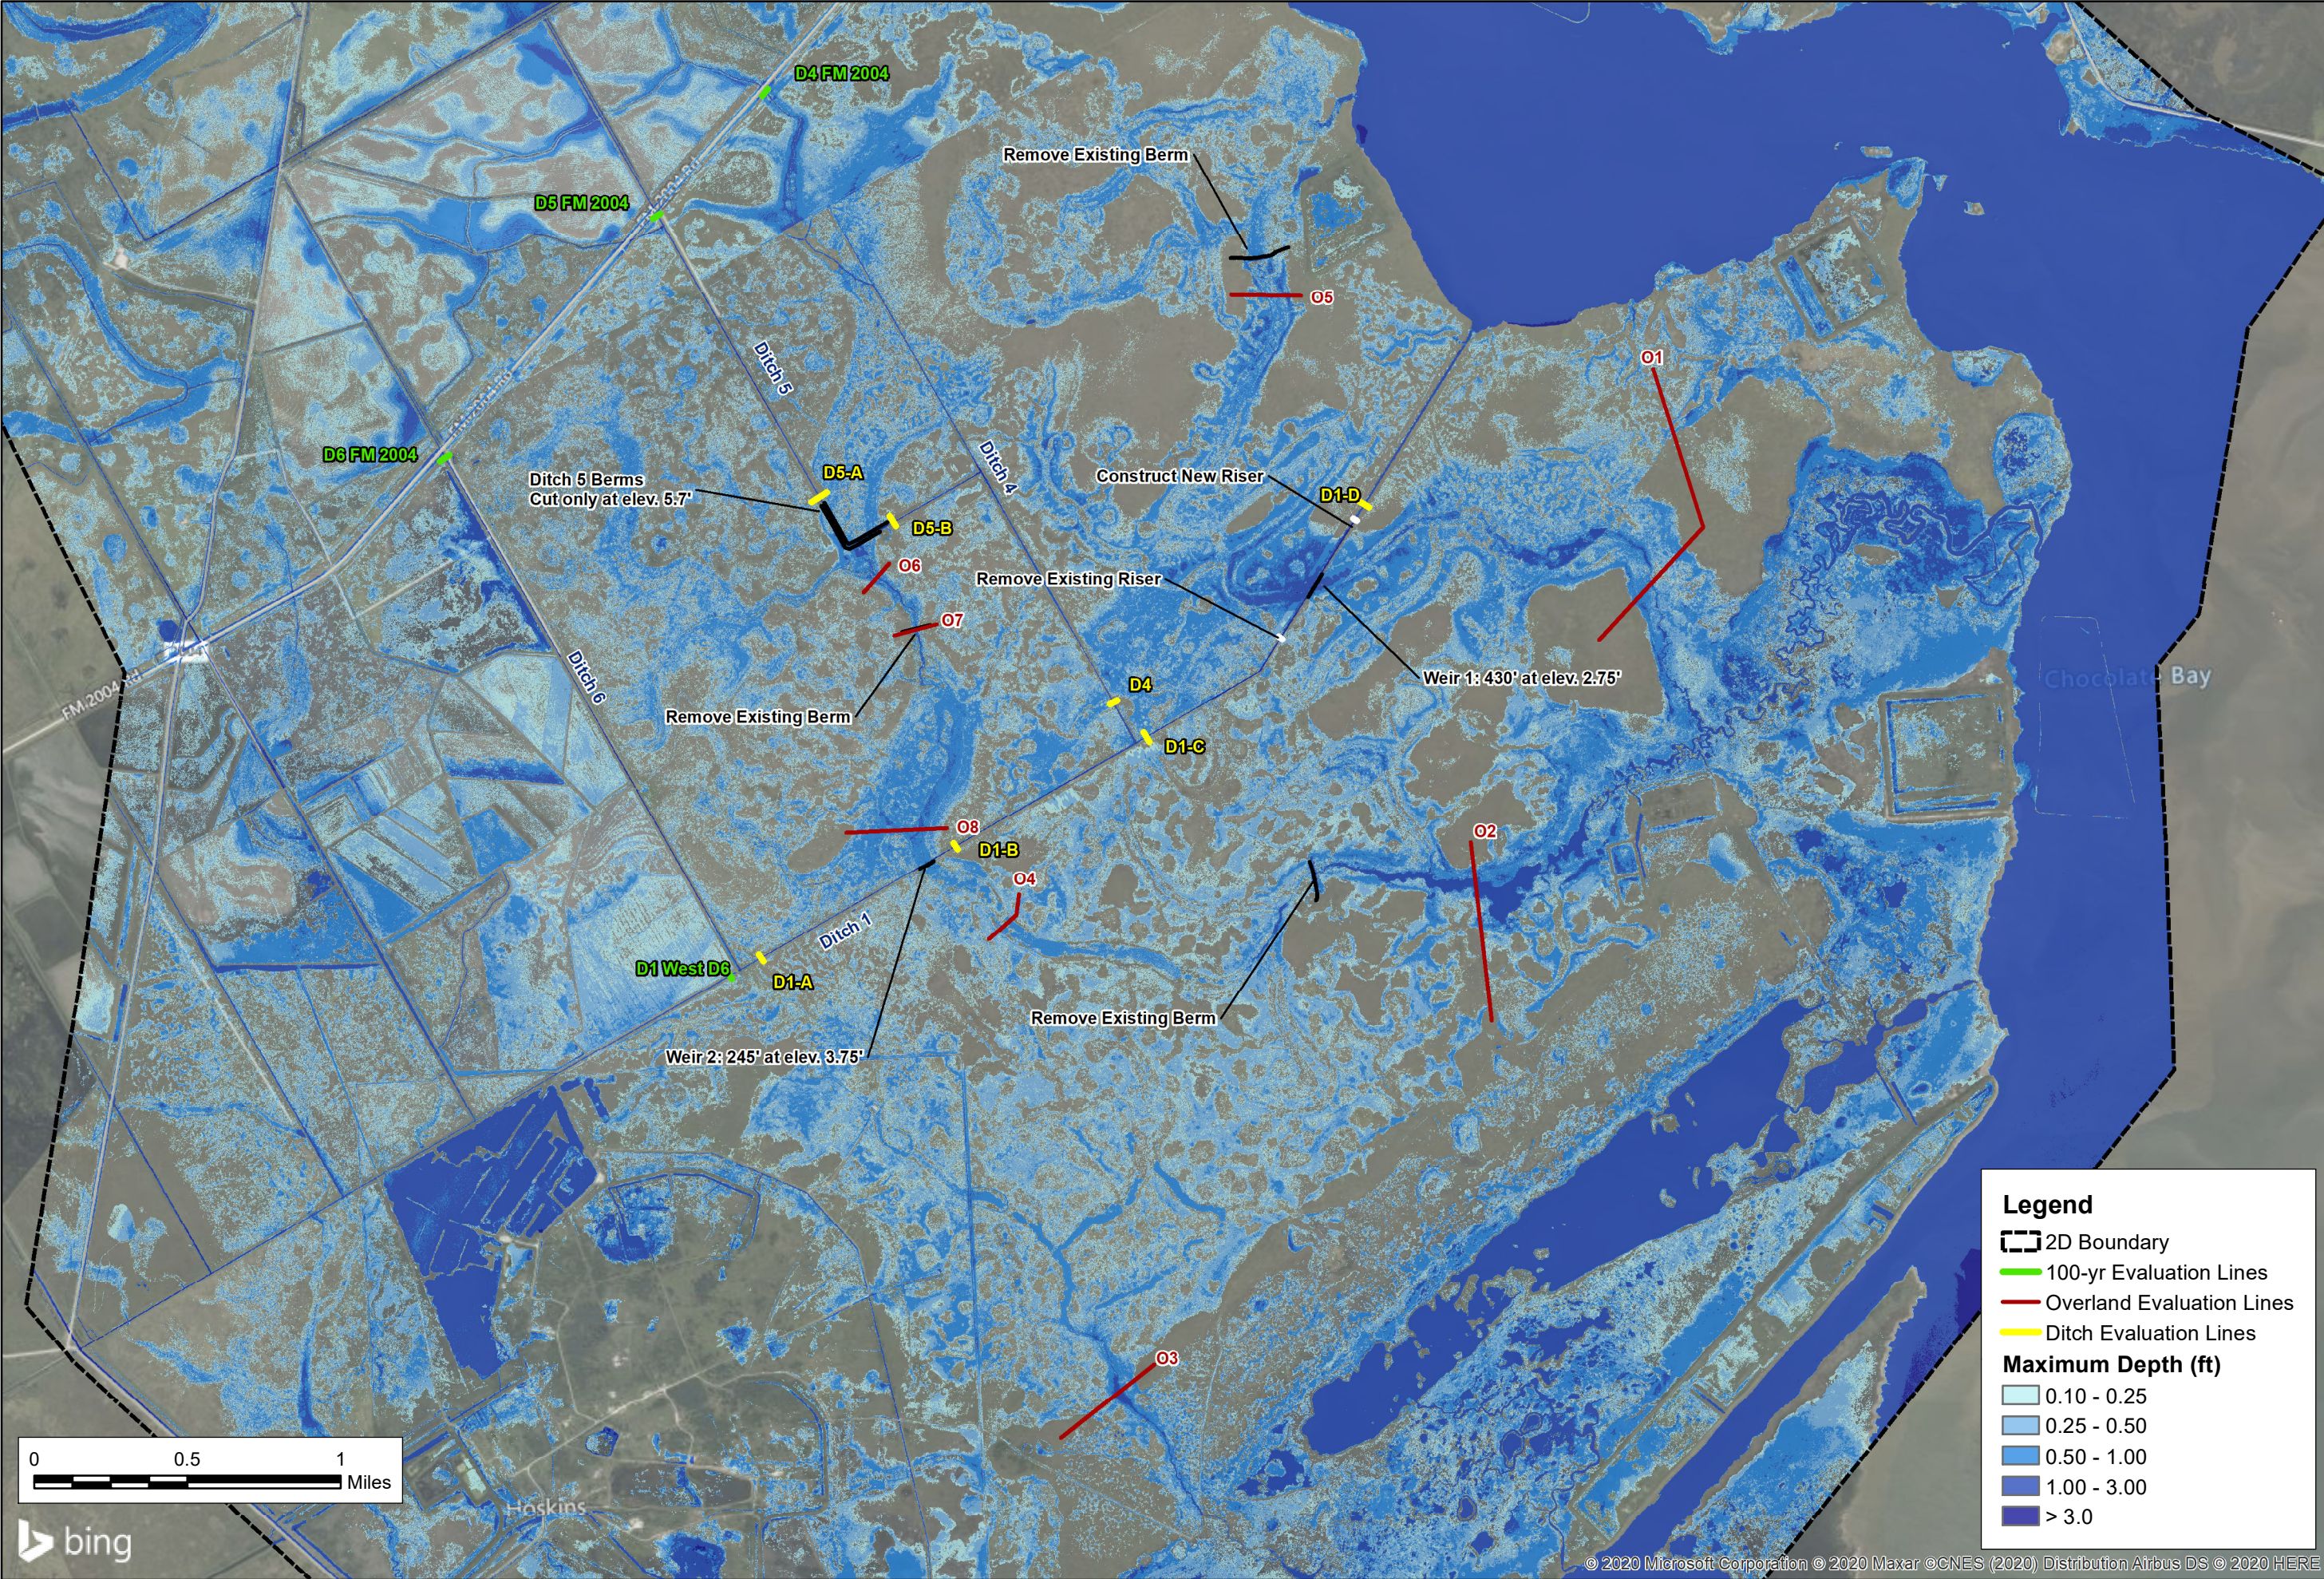
Figure 25: Alternative 1 – Weir 2

Alternative 1 includes Weir 1, a 430' long weir at Slough A cut down to elevation 2.75, and Weir 2, a 245' weir at Slough B cut down to elevation 3.75. The weir notch depths at Weir 1 and Weir 2 are approximately four and two feet, respectively. Each weir will tie in with natural ground via 8:1 side slopes. The weirs will also need to be sufficiently armored to prevent erosion from vehicle access or flooding events. The construction of Weir 2 represents approximately 200 CY of cut volume. The construction of Weir 1 represents approximately 300 CY of cut volume. **Figure 24** and **Figure 25** show the location of each proposed weir. An overview of the complete Alternative 1 layout is shown on **Figure 26**.
