## New Jersey Guidance on Surveying Buildings/Structures for Evidence of Bat Occupancy

For reporting bat presence/absence to the U.S. Fish and Wildlife Service's New Jersey Field Office (Service) and NJDEP Fish and Wildlife's (NJFW) Endangered and Nongame Species Program (ENSP)

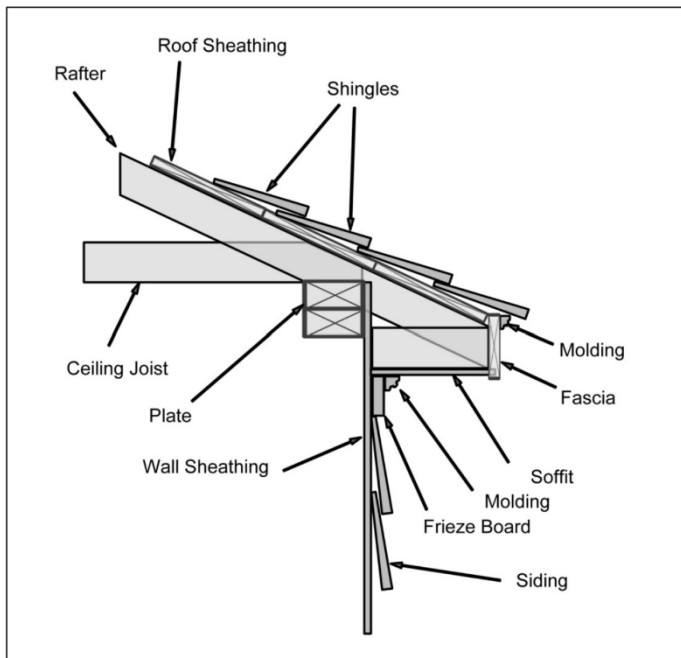
**Figure 1.** Illustration of basic home architecture terms (Image source: Wikipedia)

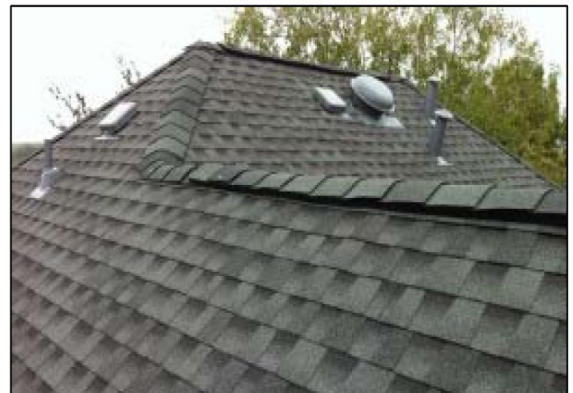
**Figure 2.** Roofing with ridge vent (Image source: ABARoofing.net)

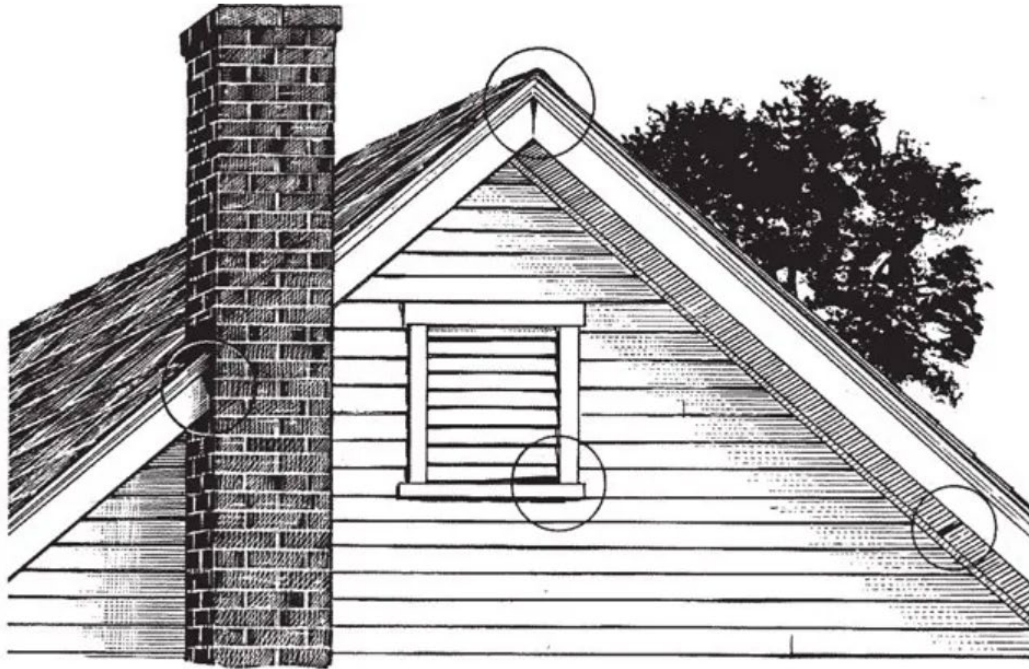
**Figure 3.** Bats can enter a building through small gaps at points where materials have warped, shrunk, or are not adequately sealed. Some common bat access points are illustrated here, including louvred attic vents with loose/missing screening, at the roof peak, where the chimney meets the eaves or siding, gaps in the soffit, and in areas where flashing or trim has pulled away from the siding. (Image source: [PennState Extension: A Homeowner's Guide to Northeastern Bats and Bat Problems](#))

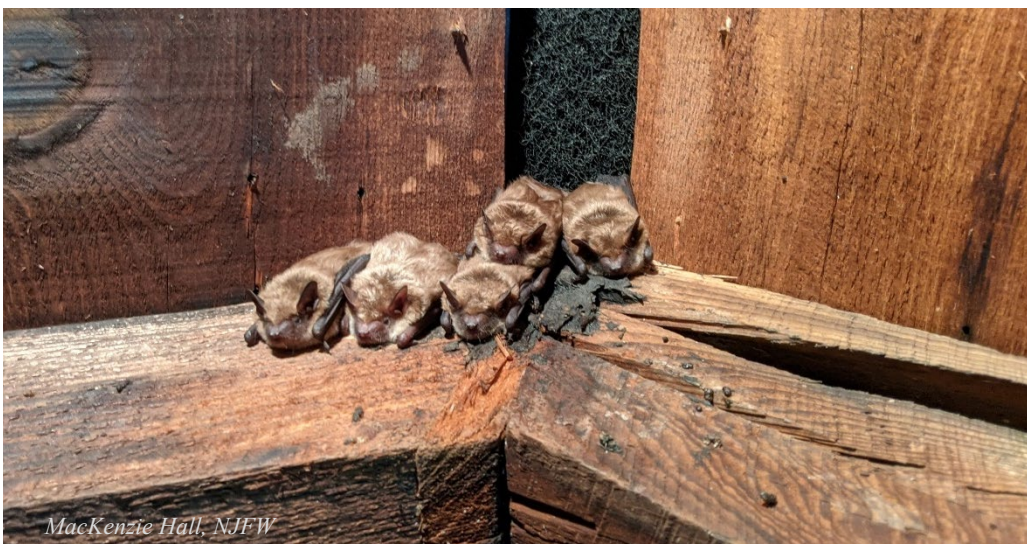
**Figure 4.** Here, five big brown bats (*Eptesicus fuscus*) are roosting on rafters at the peak of an attic ceiling.

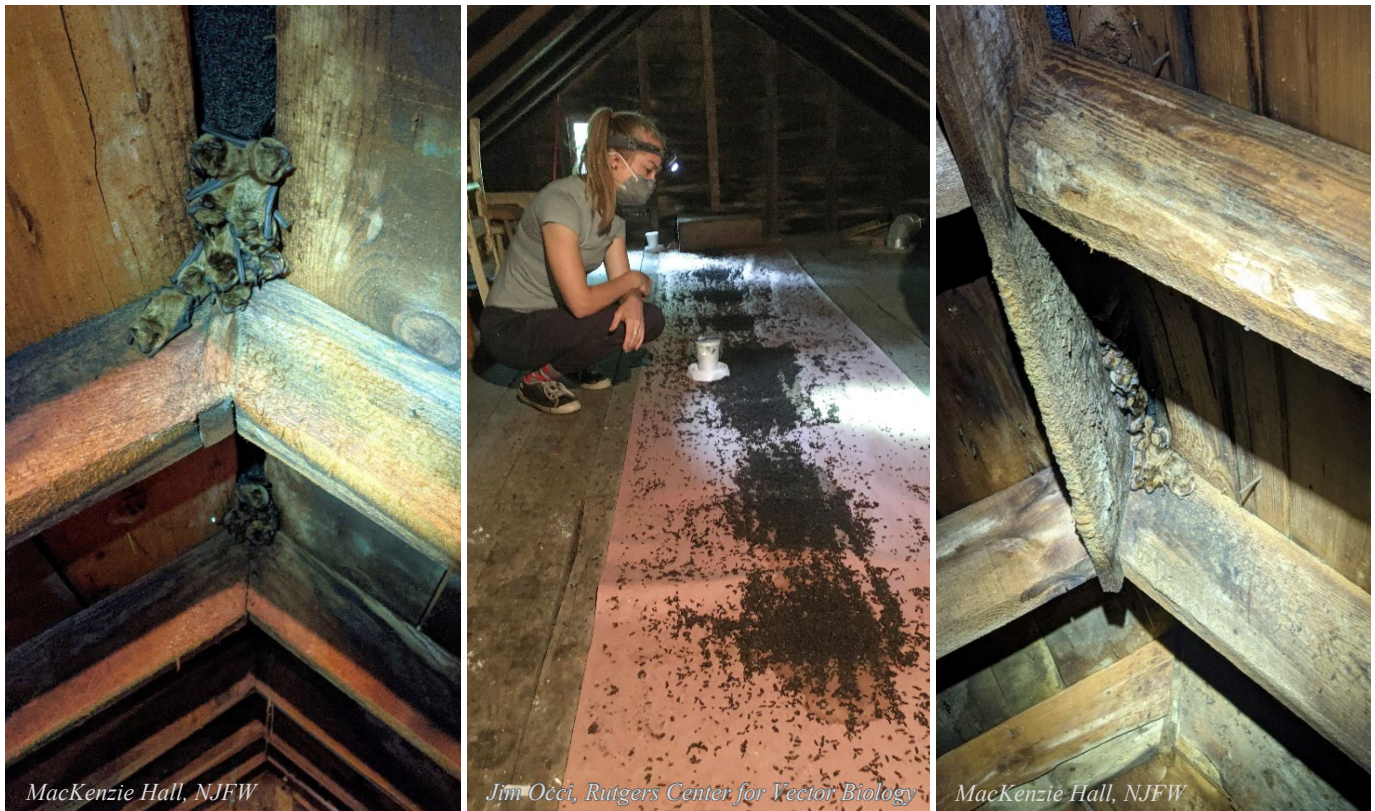
**Figure 5** (left). Another example of big brown bats clustered on attic rafters and roof sheathing.

**Figure 6** (center). Accumulated guano on the attic floor beneath bats roosting along the peak line at the site shown in Fig. 5.

**Figure 7** (right). Significant wearing of the board just below a group of roosting bats, from bats landing on and climbing across it for many years. This amount of wear suggests that this attic roost has been used by a sizable long-term colony.

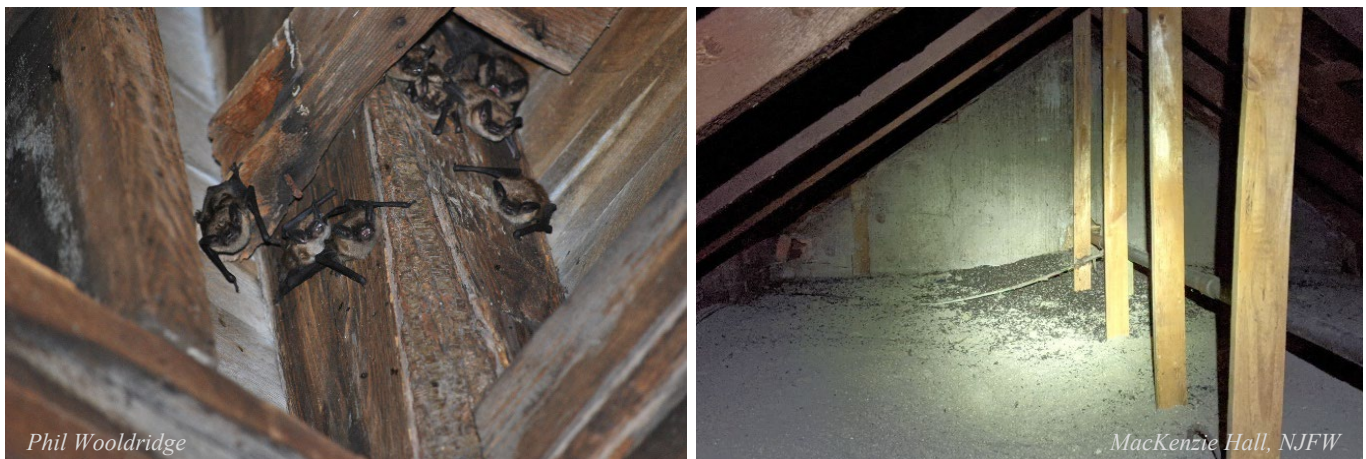
**Figure 8** (left). Big brown bats roosting on a corner beam in a church attic.

**Figure 9** (right). Guano accumulated at the far end of an attic indicates a favored roost area.

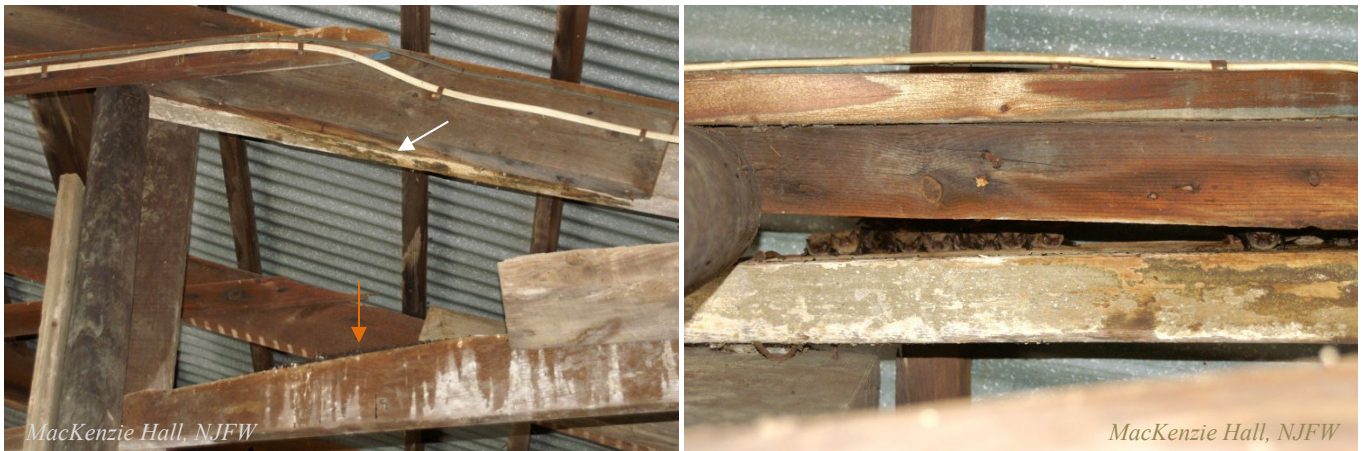
**Figures 10 and 11.** A colony of little brown bats (*Myotis lucifugus*) roosting in a gap between rafters in a machine shed. In Fig. 10, possible moisture and mineral buildup from the bats' urine is visible on the underside of the roost gap (white arrow), and droppings are perched on the horizontal beam below (orange arrow).

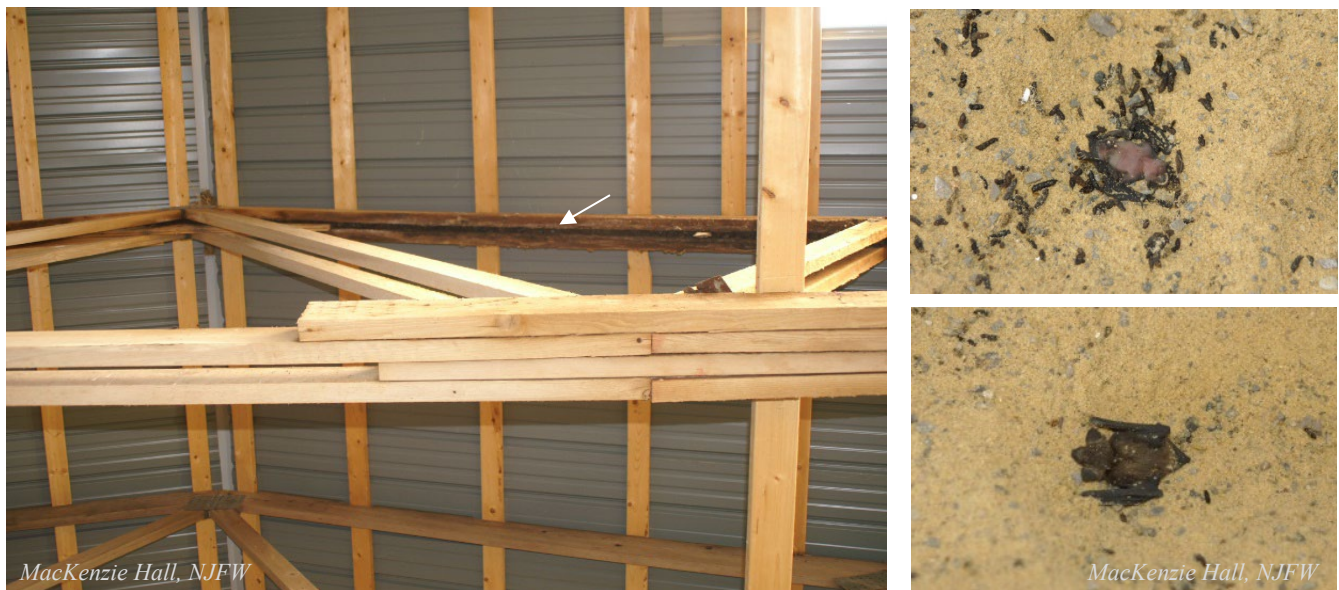
**Figure 12 (left).** Another example of a crevice between rafters – this time in a barn – being used as a roost by little brown bats. **Figures 13 (upper right) and Figure 14 (lower right).** Two bat pups were found grounded beneath this roost, as can happen to flightless young. One (Fig. 13) was still furless, just a few days old; the other was approx. 2-3 weeks old. Bat pups are fully developed and beginning to fly at just over 1 month old.

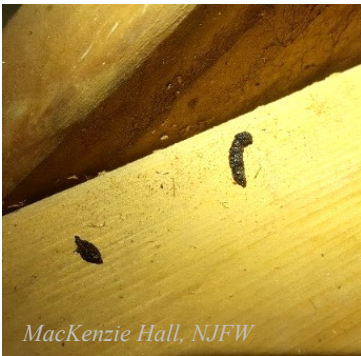
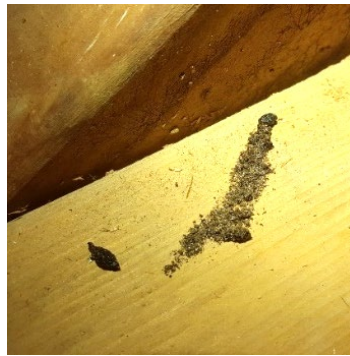
**Figures 15 (left) and 16 (right).** When just a few droppings are found, the “crush test” can be used to tell bat guano from small rodent droppings by applying pressure to a sample. Bat guano breaks down easily into fine, shiny particles of undigested prey (insect) parts (Fig. 16), whereas rodent droppings are generally hard and fibrous and do not readily break apart.

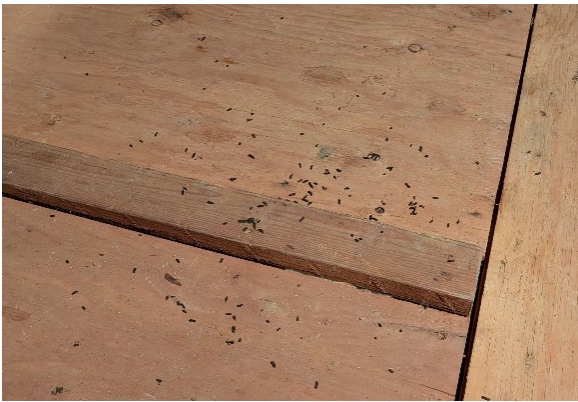
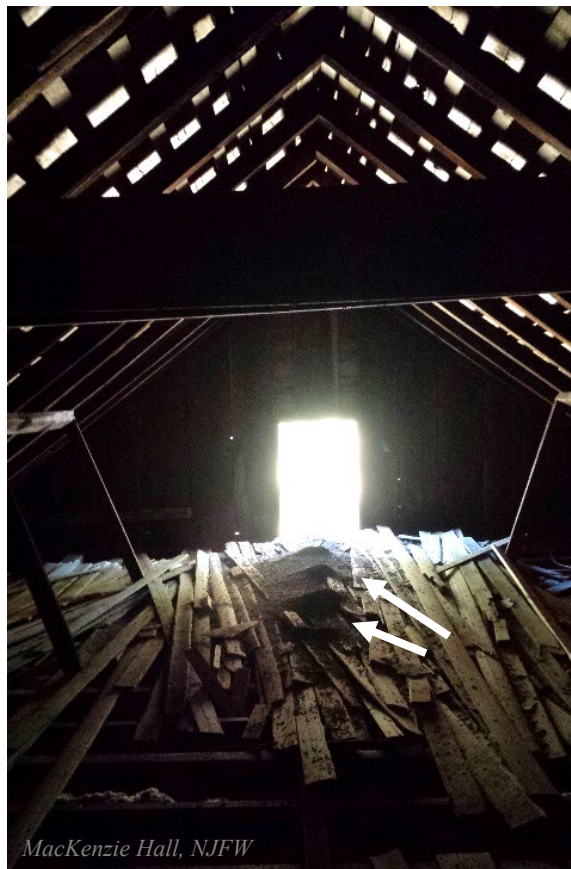
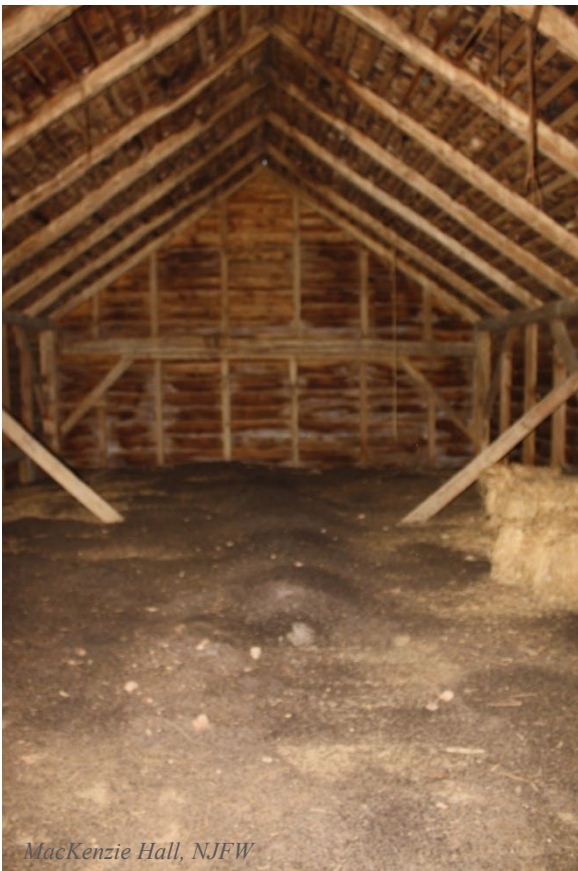
**Figures 17 (upper left), 18 (right) and 19 (lower left).** The amount of guano present can give an indication of the bat colony size and/or length of time they've been using a structure. In these examples, Fig. 17 shows a sprinkling of bat droppings indicating a few bats, or possibly just one, using this attic; Fig. 18 shows moderate piles (white arrows) of guano in an attic used by approx. 50 bats for several years; Fig. 19 shows a deep layer of guano across the entire floor of a barn loft historically used by more than 1,000 little brown bats.

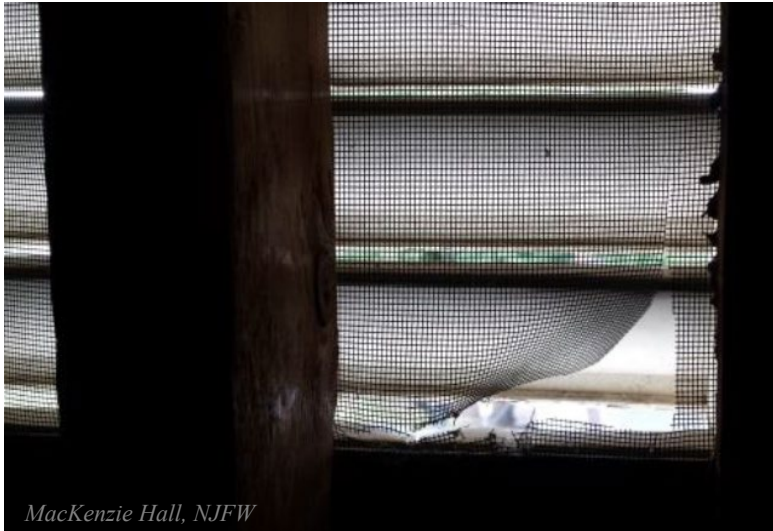
**Figure 20** (left). Bats often enter attic spaces through louvred vents with missing or loose screening.

**Figure 21** (right). Bats may also roost behind the louvres by gripping the screen, like the colony seen here near the top of photo. In this example, guano can also be seen accumulating at the base of the screened vent.

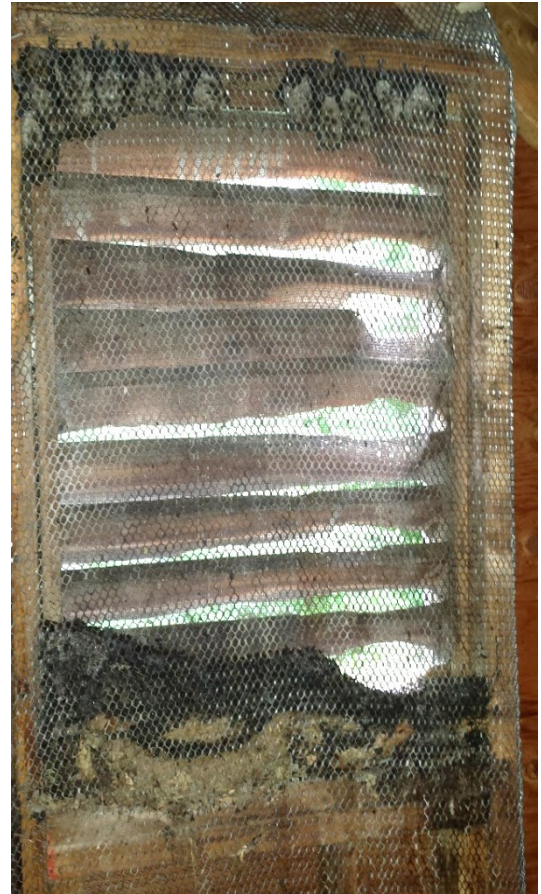
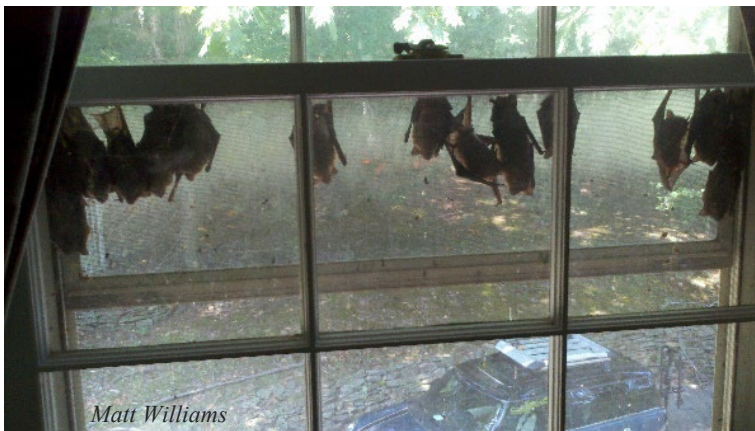
**Figure 22** (left). Less commonly, bats may roost between window panes. In this example, a maternity colony of big brown bats roost every summer between the gridded window and partially raised storm window (allowing the bats to come and go). They hang from the window screen, which is easy for the bats to grip.

**Figure 23** (right). The dirty appearance of this shutter is from the guano of bats roosting in the narrow space behind it.

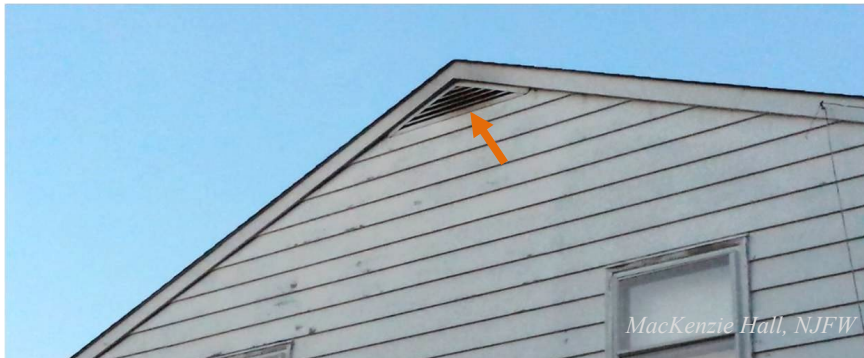
**Figure 24.** On the exterior of a structure (orange arrow), brownish staining is sometimes visible at the bats' entry/exit point, from their body oils rubbing against the surface as they leave and re-enter the roost nightly during the warm months.

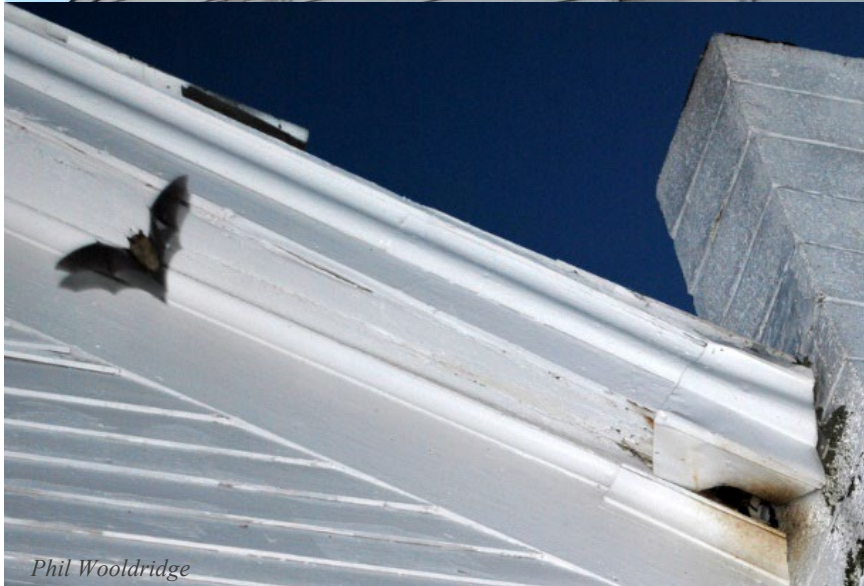
**Figure 25.** A bat photographed emerging at dusk from the eave of a church. Staining is visible around the entry/exit point where the eave meets the chimney. The eave had rotted at this junction, and the flashing used to cover it is warped from bats coming and going over the years.

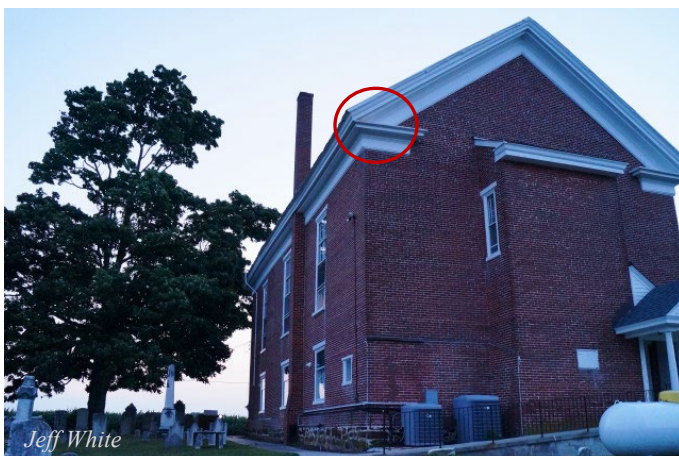
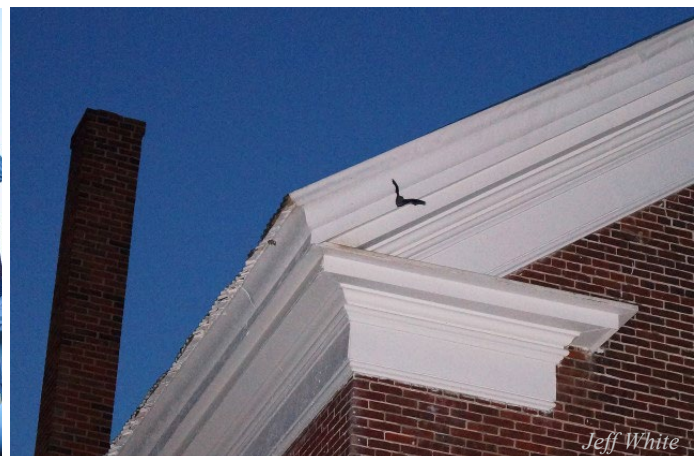
**Figure 26** (left) and **27** (right). Keep in mind that potential bat access points may not be obvious or even visible from the ground. In this example, an emergence survey reveals bats exiting through a gap in the trim board above the second story of a church. Inside, this is the far corner of the attic floor.
