WETLAND RESTORATION RECOMMENDATIONS AT THE ROCHESTER EMBAYMENT AREA OF CONCERN IN SUPPORT OF THE LOSS OF FISH AND WILDLIFE HABITAT BUI REMOVAL

FINAL STATUS REPORT

Prepared By:	U.S Fish and Wildlife Service, New York Field Office
Contributors:	Dan Gefell, Emily VanWyk, Gian Dodici, Anne Secord, Nick Vermeulen, Carl Adams, Carl Schwartz
Prepared For:	U.S. Environmental Protection Agency, Great Lakes National Program Office
Funded by:	U.S. Environmental Protection Agency, Great Lakes Restoration Initiative

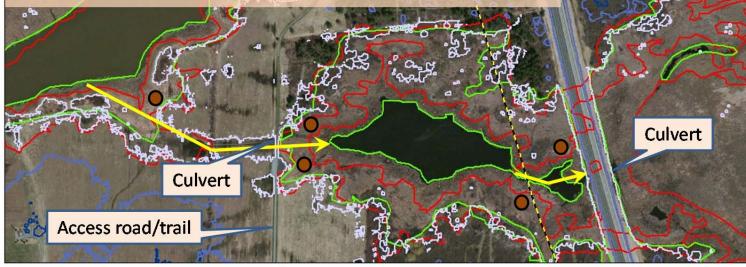
- Excavate channels approximately 2600 ft channel from creek to Parkway culvert, via pond
- Cattail root mass removal around ponded area, within 1951 open water area
- Cover cattails (not floating mats) with hillocks using soil from channels.
- · Plant excavated areas with native species, and hillocks with grasses/woody veg
- Potential culvert replacement at access road
- Flowing water would enhance northern pike habitat within the USACE enhancement area

Symbol Explanation: yellow arrows are proposed new surface water connectors and flow direction; brown ovals are proposed new habitat mounds *Legend Explanation:* contours are from LiDAR data (presumably feet above mean lake level); 2011 and 1951 Extent are emergent wetland boundaries developed in the wetland assessment project; Sampling Stations are also from the wetland assessment project *Narrative Explanation:* In 1951, prior to the Lake Ontario State Parkway (major road in aerial image), several natural, connected open water areas existed, interspersed within the wetland. This project is intended to restore some of that former surface water connectivity and channeling, and increase topographic and vegetative complexity.

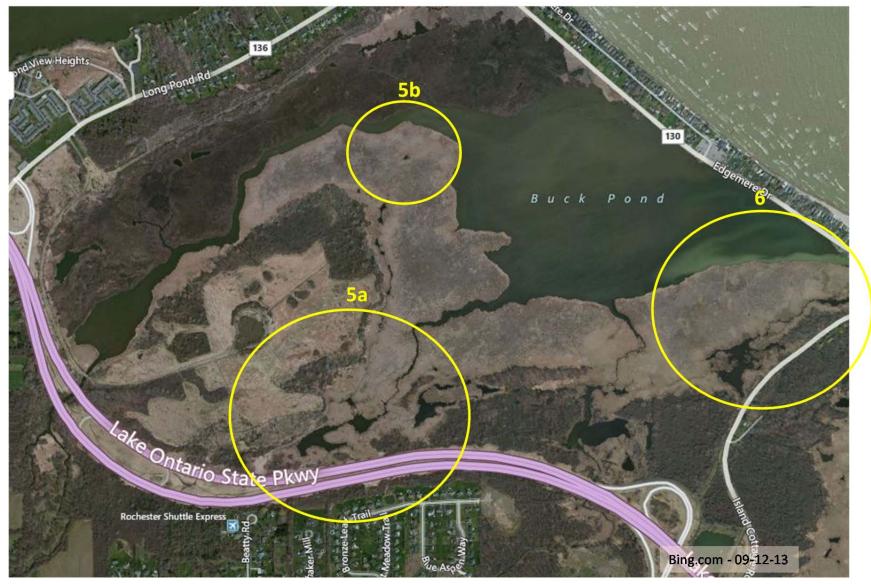
SITE 5: BUCK POND WEST SITE 6: BUCK POND EAST

Legend Explanation: contours are from LiDAR data (presumably feet above mean lake level); 2011 and 1951 Extent are emergent wetland boundaries developed in the wetland assessment project; Sampling Stations are also from the wetland assessment project

Symbol Explanation: blue arrows indicate presumed current flows; yellow arrows are proposed new surface water connectors and flow direction; blue ovals are proposed new potholes; brown ovals are proposed new habitat mounds

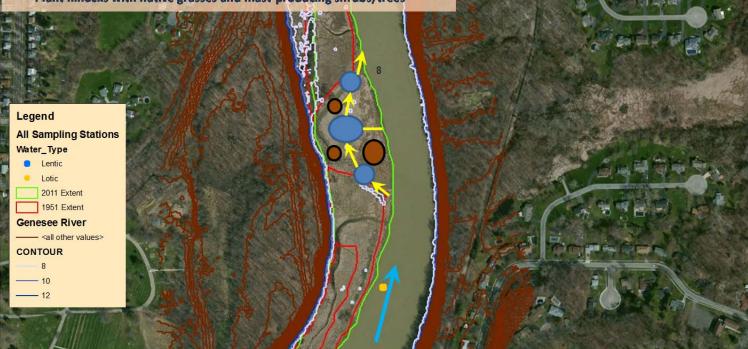
Conceptual Alternatives SITE 8: GENESEE RIVER – UPSTREAM

- Excavate large potholes within cattail with thru-flow channels (1800 ft)
- Build up or connect apparently existing hillocks with on-site materials
- Plant hillocks with native grasses and mast-producing shrubs/trees

Symbol Explanation: blue arrows indicate current flows; yellow lines are proposed new surface water connectors and flow direction; blue ovals are proposed new potholes; brown ovals are proposed new habitat mounds

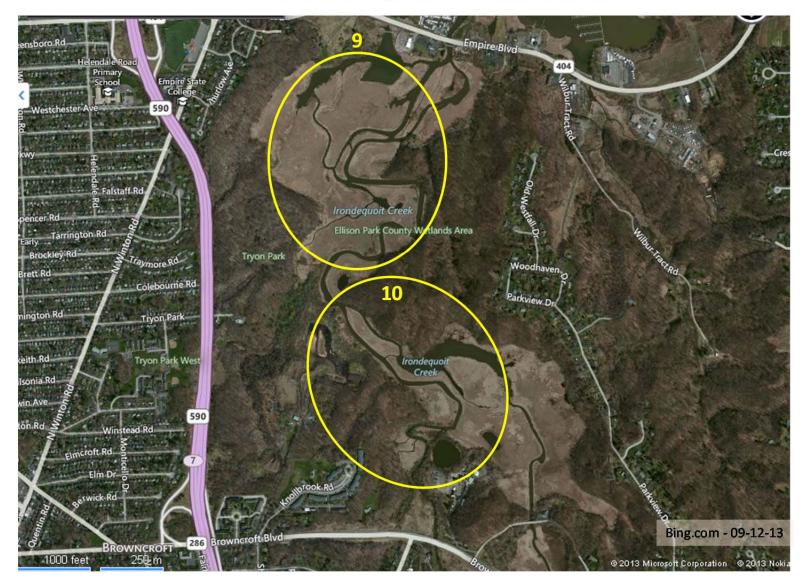
SITE 9: IRONDEQUOIT CREEK DELTA SITE 10: IRONDEQUOIT CREEK SOUTH

Legend Explanation: contours are from LiDAR data (presumably feet above mean lake level); 2011 and 1951 Extent are emergent wetland boundaries developed in the wetland assessment project; Sampling Stations are also from the wetland assessment project

Conceptual Alternatives SITE 9: IRONDEQUOIT CREEK – DELTA

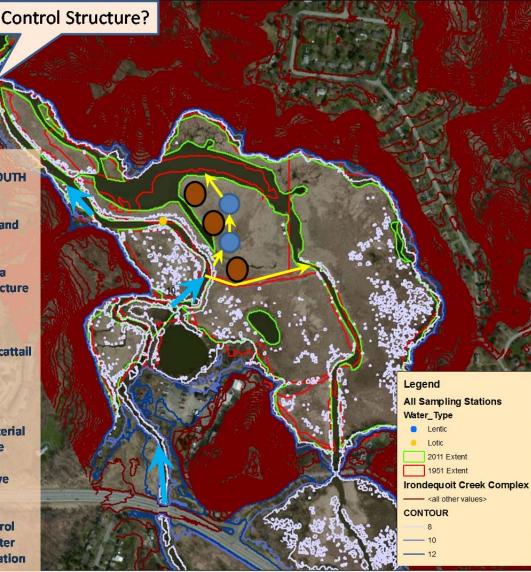
- Excavate large potholes within cattail monoculture
- **Excavate channels to connect** existing open water with flowthrough water from creek
- Create hillocks with on-site material
- **Boulder mounds within invasive** plant stands adjacent to creek
- Plant islands/hillocks with native grasses and mast-producing shrubs/trees
- **Possibly reconstruct water control** structure to retain water in winter and promote muskrat re-population

Symbol Explanation: blue arrows indicate presumed current flows; yellow arrows are proposed new surface water connectors and flow direction; blue ovals are proposed new potholes; brown ovals are proposed new habitat mounds

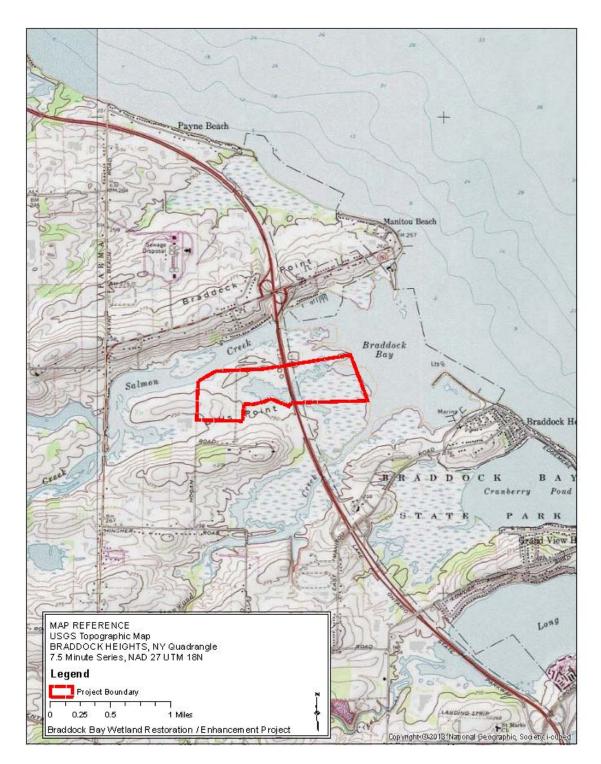
Attachment 5 – Initial Construction Sketches for the Lower Salmon Creek and Braddock Bay Emergent Wetland Sites

(modified as required by on-site conditions, in consultation with NYSDEC and collaborators)
