## APPENDIX E. PERSONAL ACCOUNTS OF PREVIOUS FLOODS AT LEAVENWORTH NFH

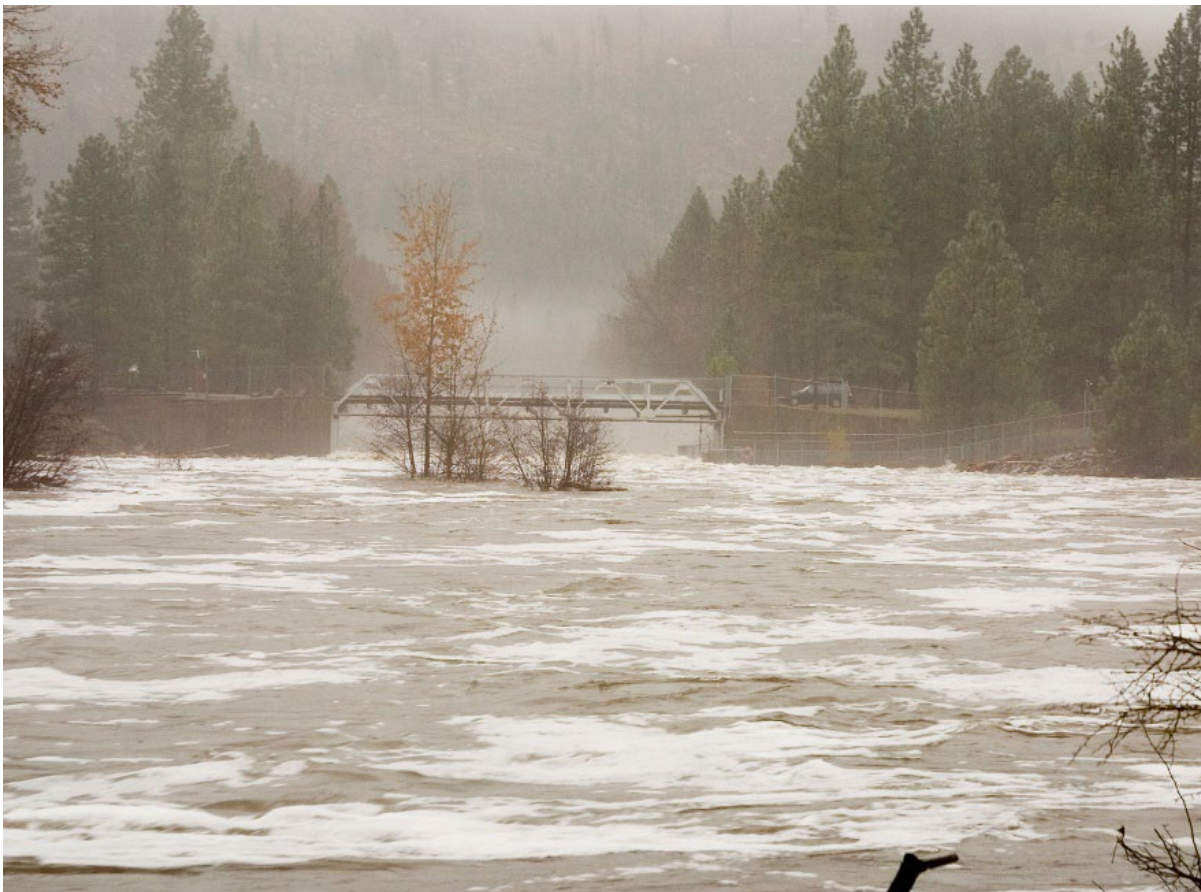
**Figure E1.** High water of Icicle Creek on November 6, 2006 (~14,700 cfs) looking upstream towards the bypass canal and dam (under and behind the bridge). The cyclone fence next to the fish ladder is visible to the right of the bridge below the parked vehicle. The water level downstream of the dam is nearly even with the water level in the canal upstream of the dam. See also Figures E2, E3, and E4.

The water level at the hatchery was even with the top of the adult [holding] pond (ground level), and there was a huge back eddy in Icicle Creek just below the concrete dam [of the bypass channel] where hundreds of logs and floating debris collected. The circle effect of the back eddy caused debris and logs to take out the cyclone fence and many yards of soil next to the fish ladder. Consequently, the fish ladder was filled with the soil, mud, gravel and debris. The water was so high, logs floating down river would launch off the dam [of the bypass canal] and hit the bridge crossing over the dam (see Figure E1).

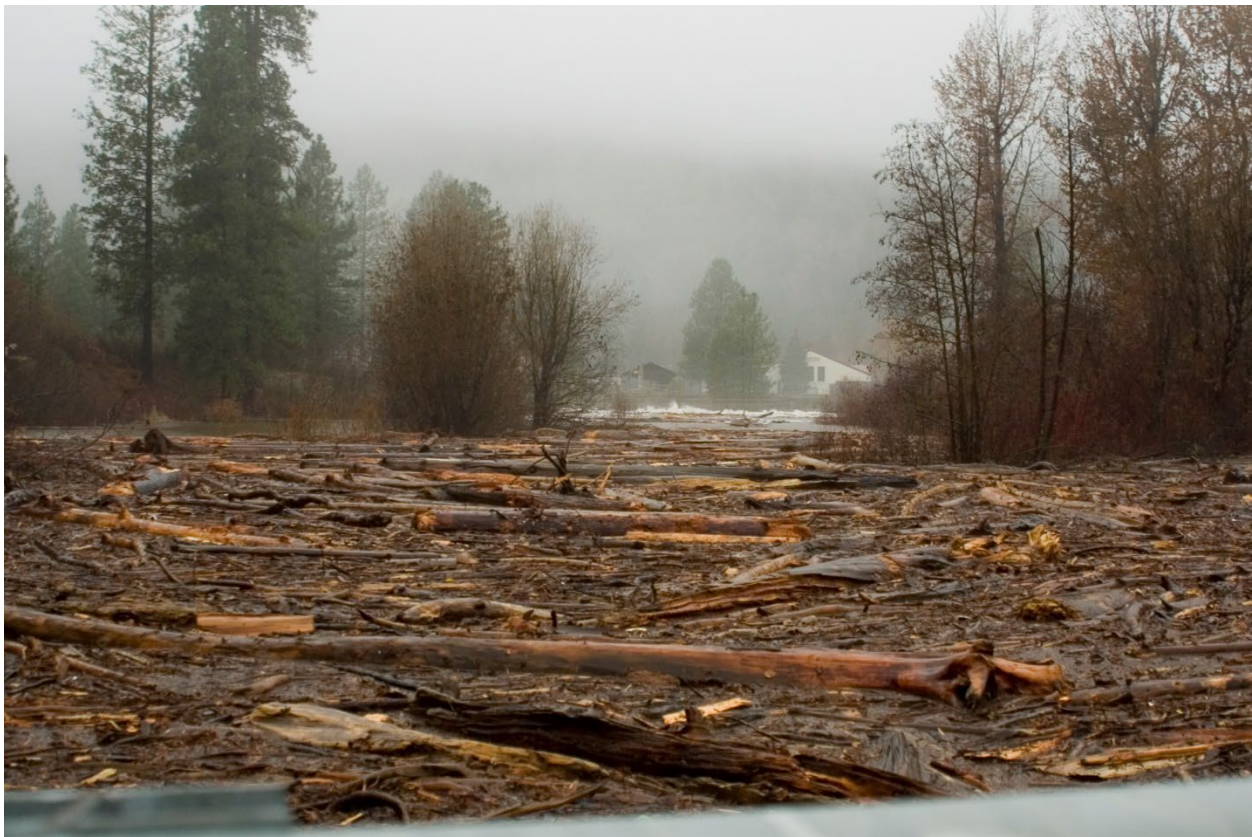
**Figure E2.** The old stream channel of Icicle Creek looking downstream from Structure 5 towards the tailrace area downstream of the canal dam during the high water event of November 6, 2006 (see also Figures B2 and B3, Appendix B). The spawning shed and main hatchery building can be seen in the far distance to the left and right, respectively, of the large conifer trees.

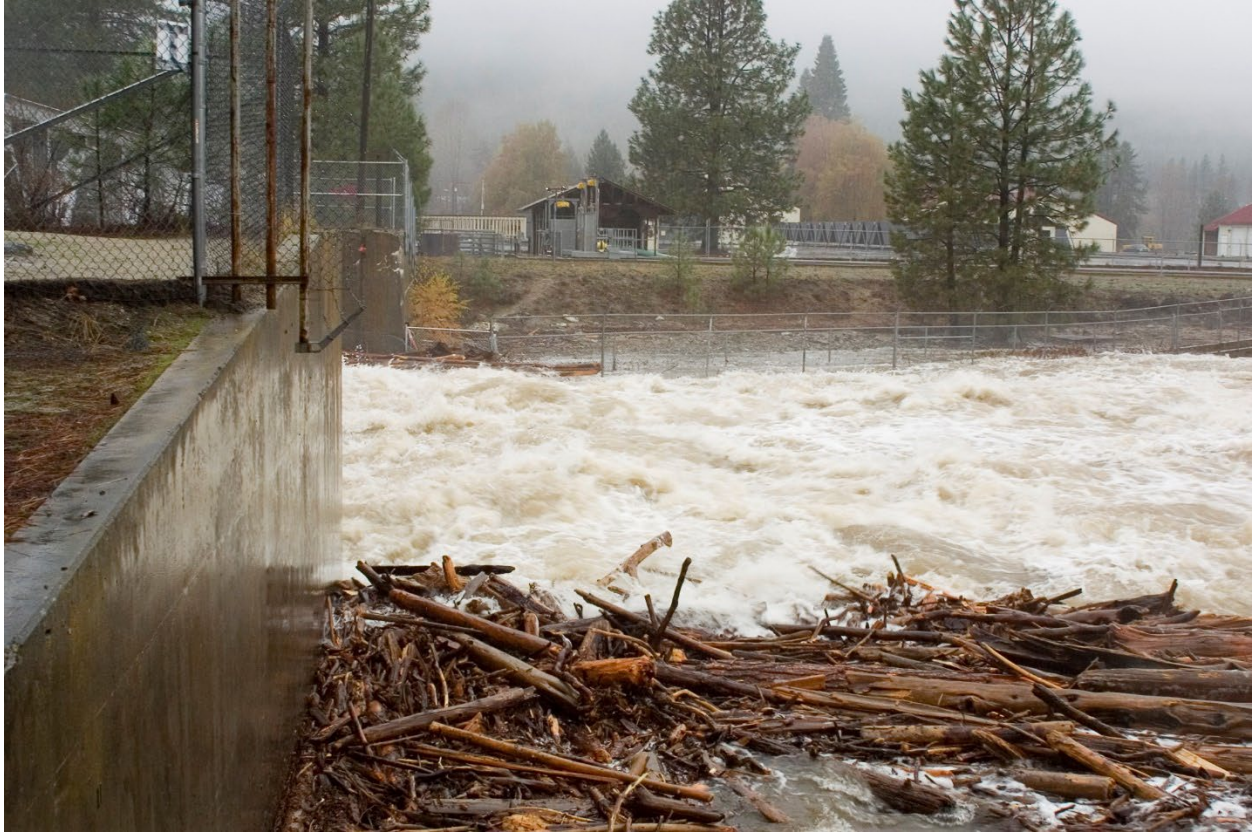
**Figure E3.** Icicle Creek in the tailrace area immediately downstream from the canal dam looking towards the fish ladder (marked by the cyclone fence) and spawning shed during the high water event of November 6, 2006. The superstructure of the bridge over the dam is visible near the upper-left corner of the photograph (compare to Figure E1).

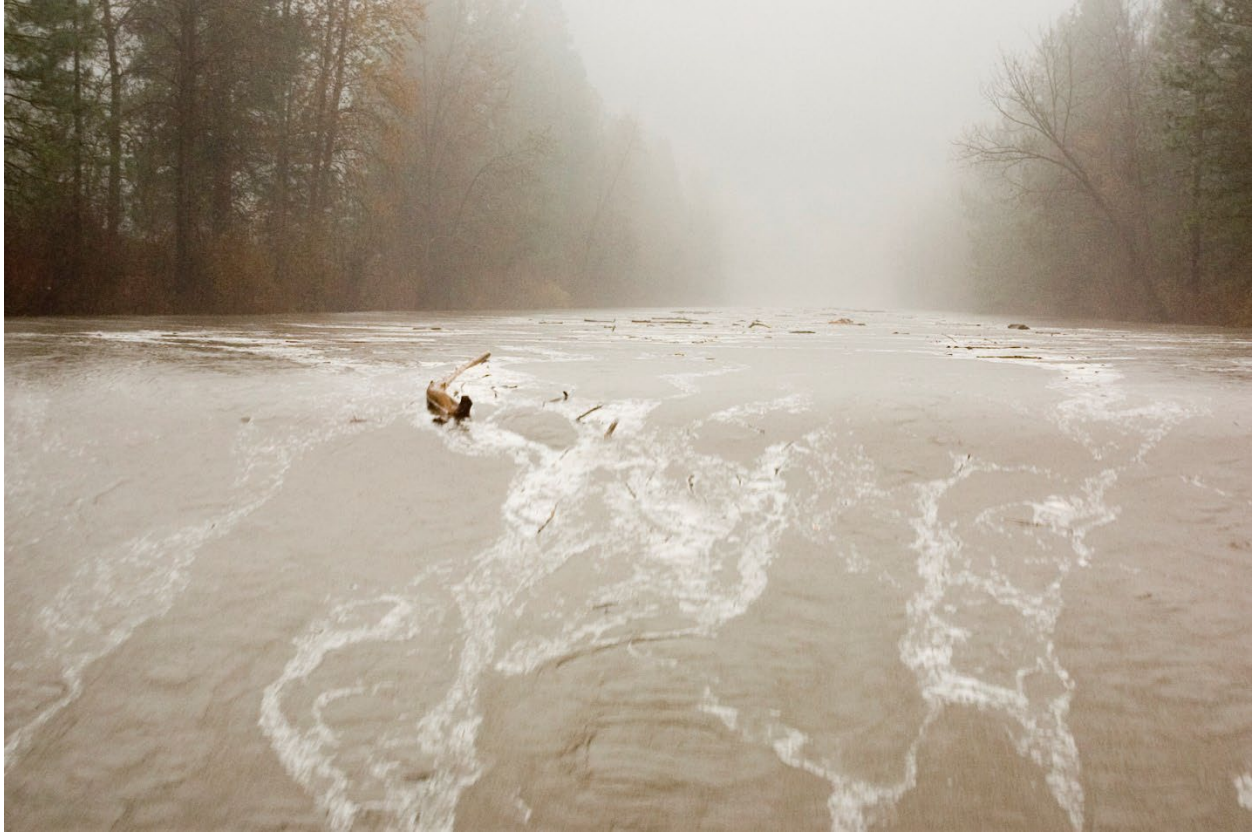
**Figure E4.** Icicle Creek looking upstream from the bridge in front of the canal dam during the high water event on November 6, 2006. The lip of the dam is barely discernible because the water level downstream of the dam is nearly even with the water level in the canal (compare to Figure E1).
