**Sediment Mobility and River Corridor Assessment for a
140-Kilometer Segment of the Main-Stem Klamath River
Below Iron Gate Dam, California**

Open-File Report 2020–1141

By Jennifer Curtis, Travis Poitras, Sandra Bond, and Kristin Byrd

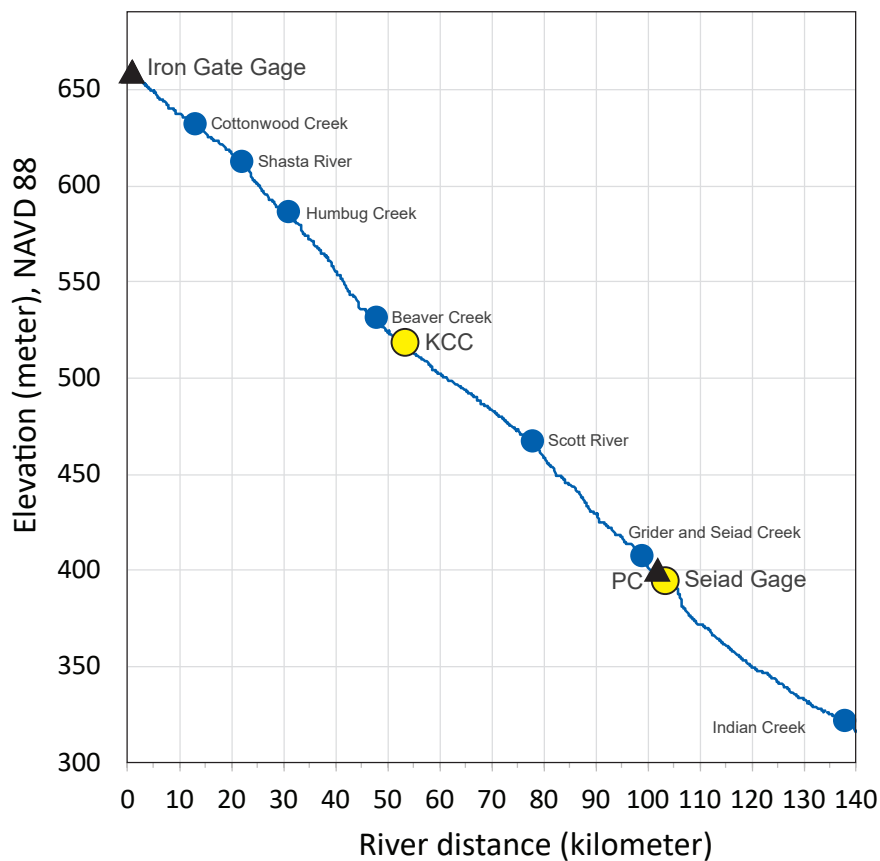
Figure 4. Depictions of the 140-kilometer study reach along the main-stem Klamath River below Iron Gate Dam, California, as A, shaded-relief map; and B, longitudinal profile of water surface elevation. Locations are shown for two gaged sites (Iron Gate Dam, USGS 11516530; Seiad Valley gage, USGS 11520500) and two sediment-sampling sites (Portuguese Creek, PC; Klamath Community Center, KCC).

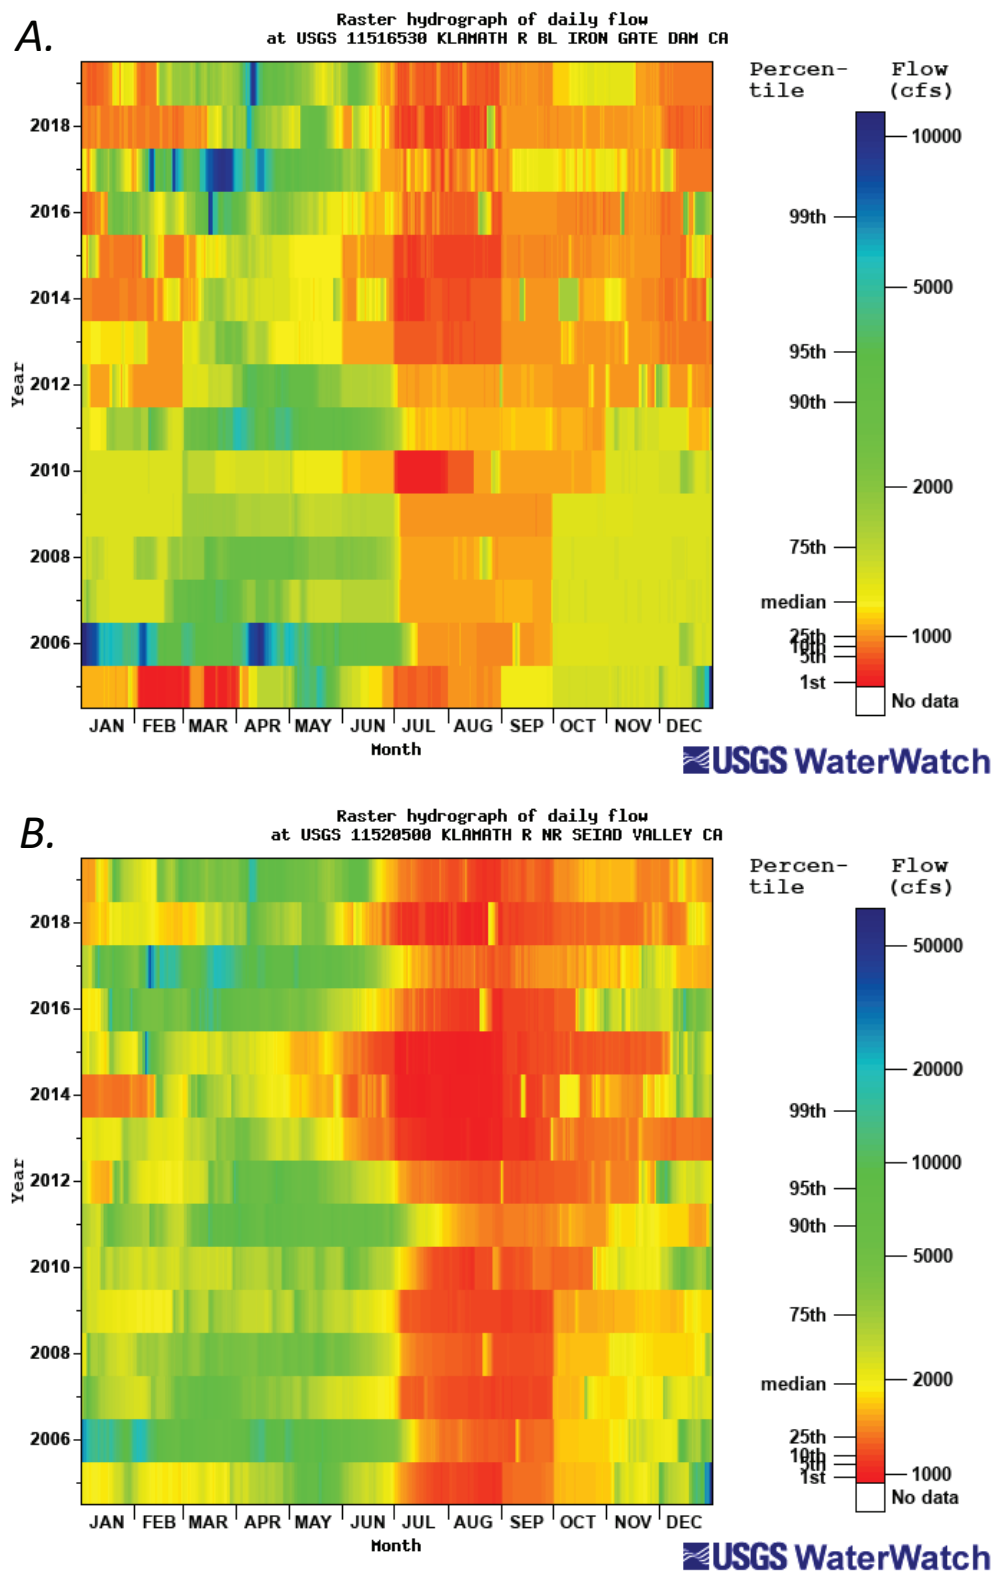
Figure 5. Raster hydrographs for A, Klamath River below Iron Gate Dam (USGS 11516530); and B, Klamath River near Seiad Valley (USGS 11520500) for water years 2005–19. Water year is depicted on the vertical axis, months and days are depicted on the horizontal axis, and mean daily streamflow is depicted by the color. (Data available at <https://waterdata.usgs.gov/nwis>. See fig. 4 for gage location and table 2 for gage descriptions.)

Streamflow in the upper basin, above Iron Gate Dam, is produced primarily from groundwater and snowmelt discharge and is heavily regulated by flow management associated with the Reclamation’s Klamath Irrigation Project (National Research Council, 2004; National Marine Fisheries Service and U.S. Fish and Wildlife Service, 2013). In the lower basin, below Iron Gate Dam, streamflow is produced primarily by flows from the upper basin during the low-flow season and by rainfall-runoff during the remainder of the water year (Thorsteinson and others, 2011). The study reach (fig. 4) includes two U.S. Geological Survey (USGS) streamflow gaging stations (Klamath River below Iron Gate Dam CA, USGS 11516530 [IGD]; Klamath River near Seiad Valley CA, USGS 11520500 [SEIAD]; U.S. Geological Survey, 2020). Large interannual and intra-annual variations in streamflow are common and increase with distance downstream from Iron Gate Dam (fig. 5).

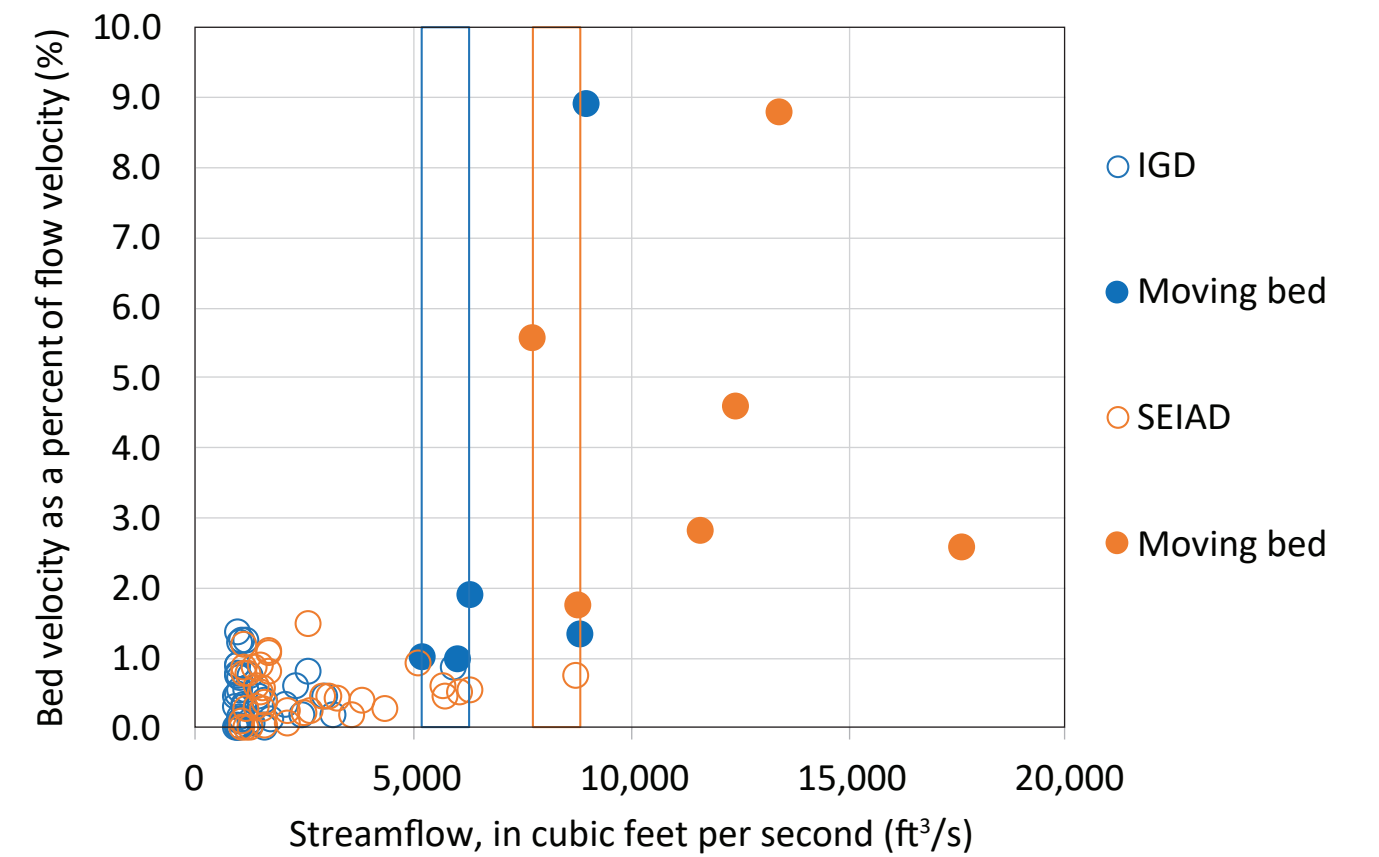
Figure 7. Relation of streamflow rate to bed velocity as a percentage of flow velocity, defined as percent moving bed, for cross-sectional discharge measurements made using an acoustic Doppler current profiler with bottom tracking at two U.S. Geological Survey (USGS) gaging stations: Klamath River below Iron Gate Dam, CA (IGD; USGS 11516530) and Klamath River near Seiad Valley, CA (SEIAD; USGS 11520500) during water years 2016–19. (Boxes delineate sediment mobility thresholds defined at 5,200–6,000 ft³/s for IGD and 7,700–8,800 ft³/s for SEIAD. See [fig. 4](#) for gage locations and [table 2](#) for gage descriptions.)

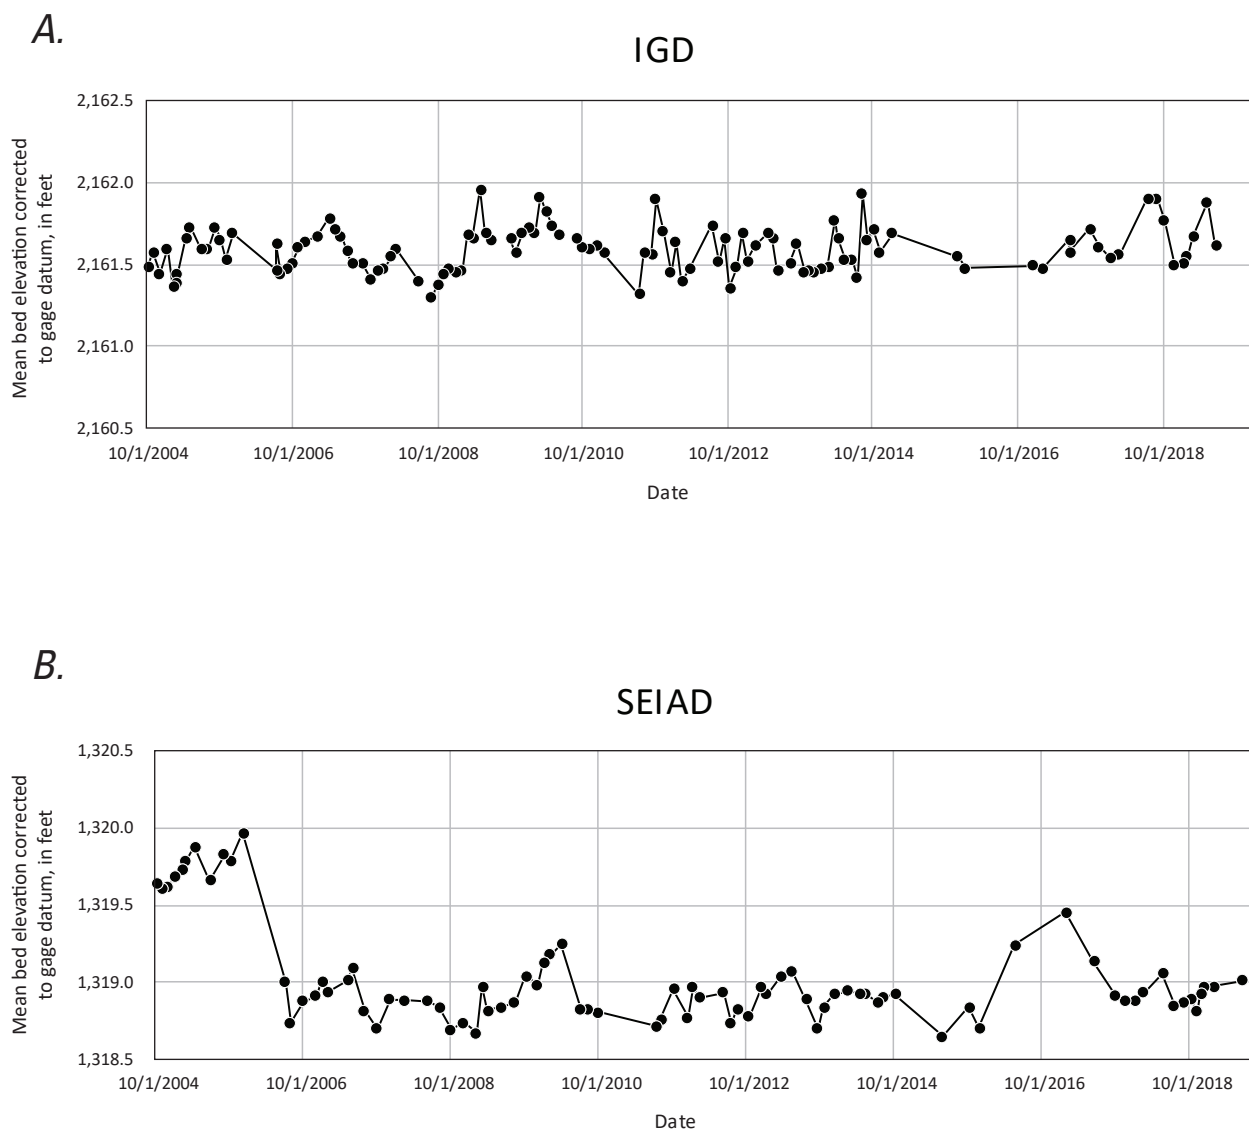
Figure 8. Changes in mean bed elevation relative to the National Geodetic Vertical Datum of 1929 (NGVD 29) at two U.S. Geological Survey (USGS) gaging stations for *A*, Klamath River below Iron Gate Dam, CA (IGD; USGS 11516530); and *B*, Klamath River near Seiad Valley, CA (SEIAD; USGS 11520500), estimated using discharge measurements made during water years 2005–19. (Data available at <https://waterdata.usgs.gov/nwis>. See [fig. 4](#) for gage location and [table 2](#) for gage descriptions.)

The 2006 scour event at the Seiad Valley gage, with a peak flow magnitude of 74,000 ft^3/s and recurrence interval of greater than 10 years (table 2), resulted in approximately 1.0 ft of bed degradation between discharge measurements made on December 7, 2005, and July 6, 2006. Since 2006, smaller magnitude flows with recurrence intervals of 2–5 years (table 2) produced episodic scour and fill that resulted in synchronous, but transient, changes in mean bed elevations at both gages.

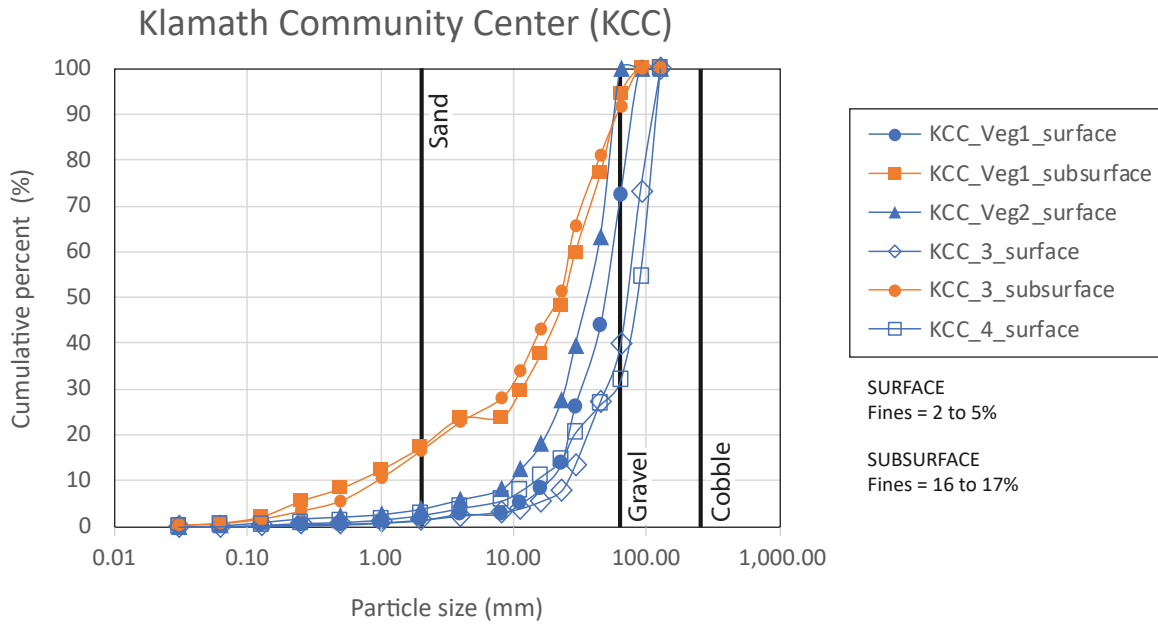
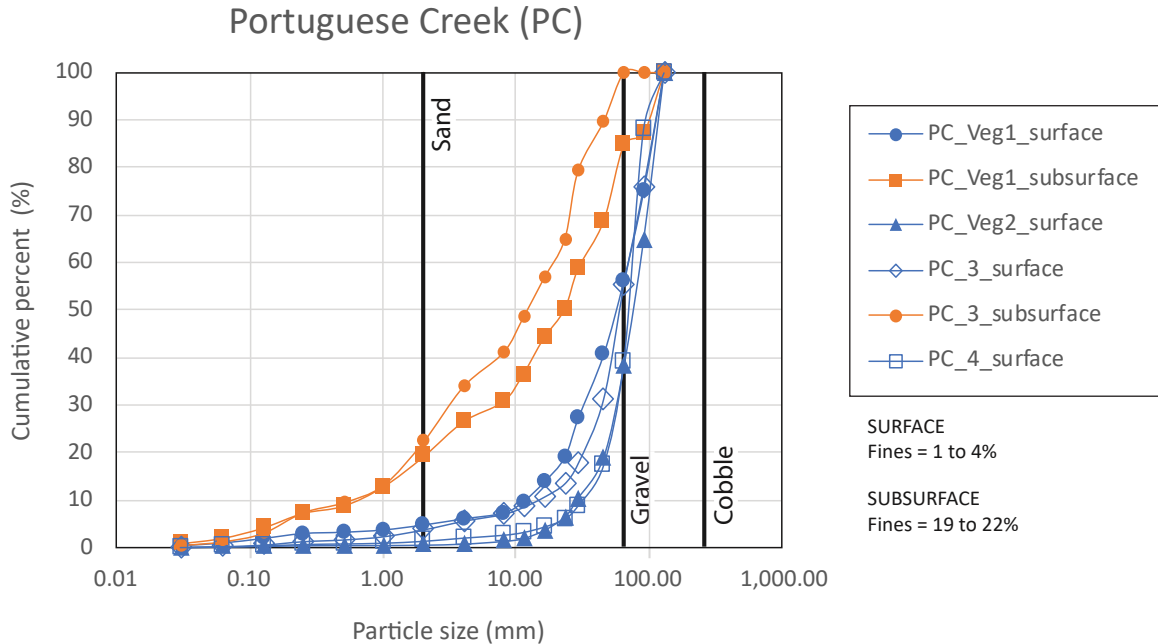
Figure 9. Substrate grain-size distributions for bulk surface and subsurface samples collected from low elevation bars in vegetated and unvegetated plots collected in September 2018 at two ungaged sites along the main-stem Klamath River below Iron Gate Dam, California. (See [fig. 4](#) for site locations. Data available in [tables 8](#) and [9](#).)

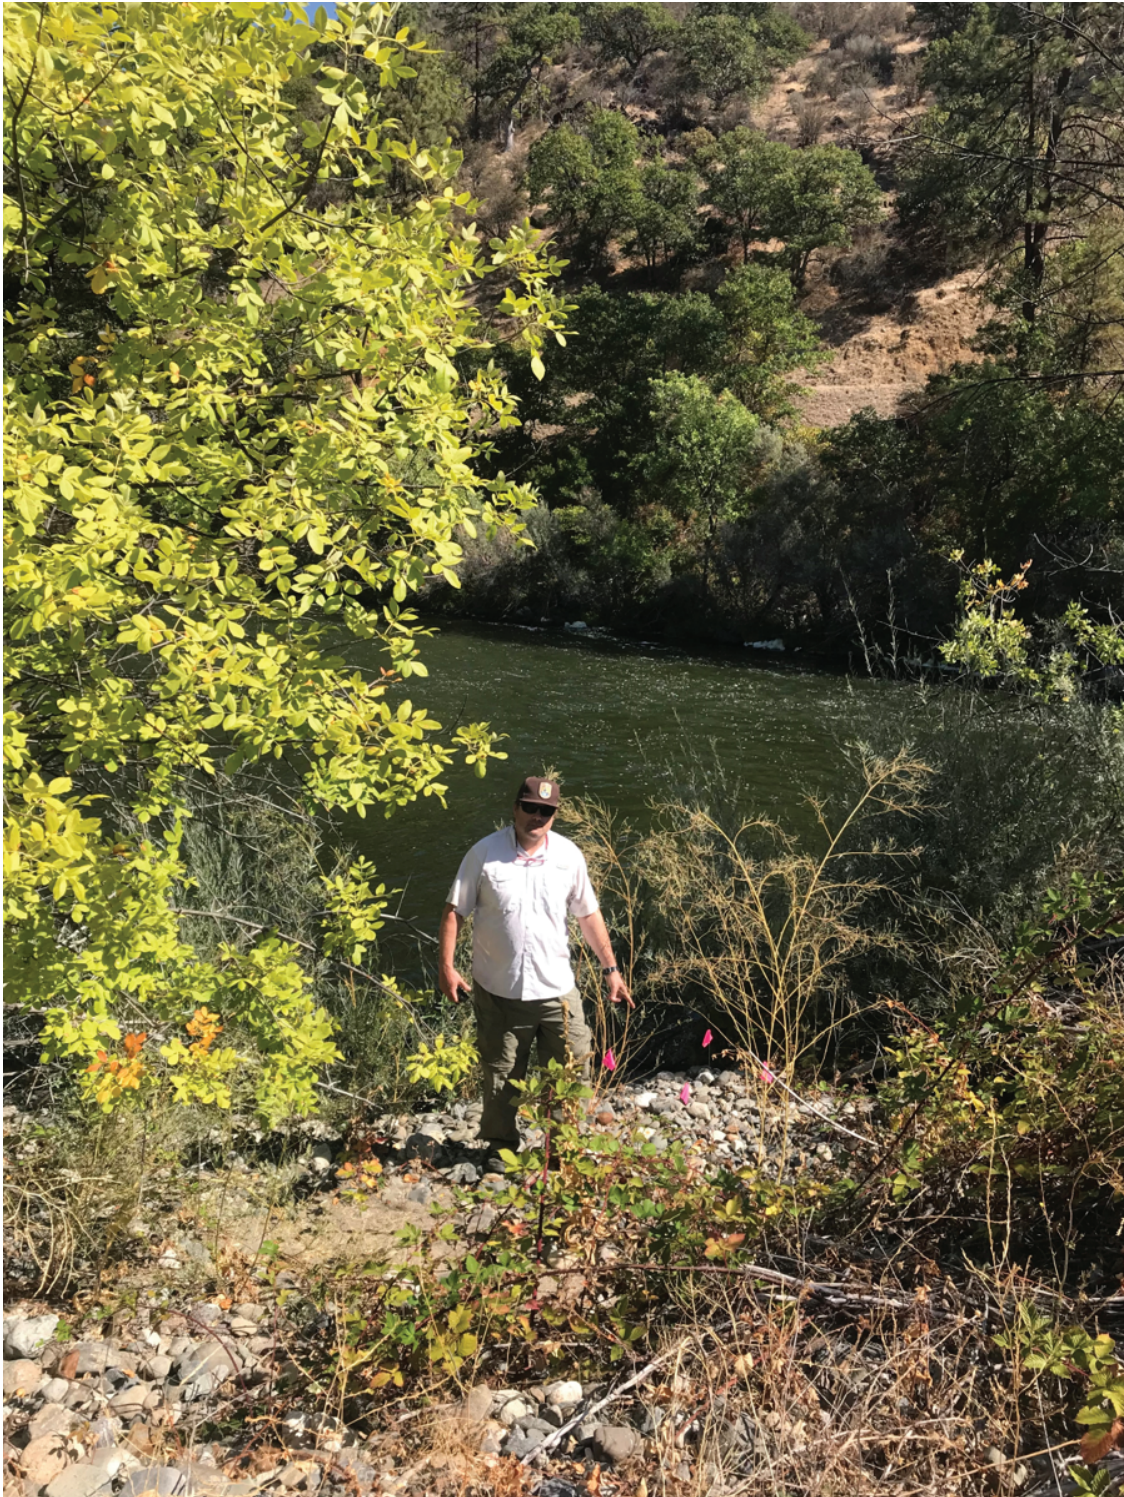
Figure 10. U.S. Fish and Wildlife employee and a substrate grain-size plot (KCC_Veg1), showing evidence active bedload transport along a densely vegetated channel margin, collected in September 2018 at Klamath Community Center (KCC), located 53 kilometers downstream from Iron Gate Dam along the main-stem Klamath River, California. (See [fig. 9](#) and [table 8](#) for grain size distributions and [fig. 4](#) for site location). Photograph taken by Jennifer Curtis, U.S. Geological Survey.

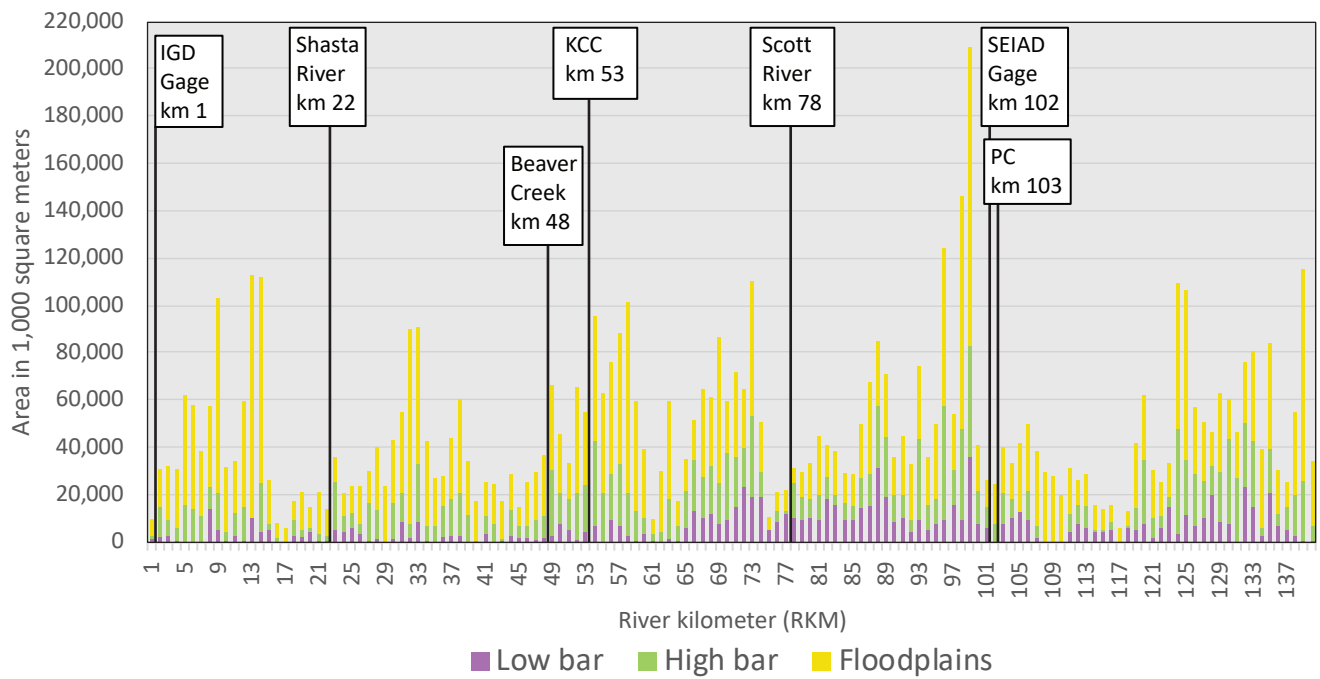
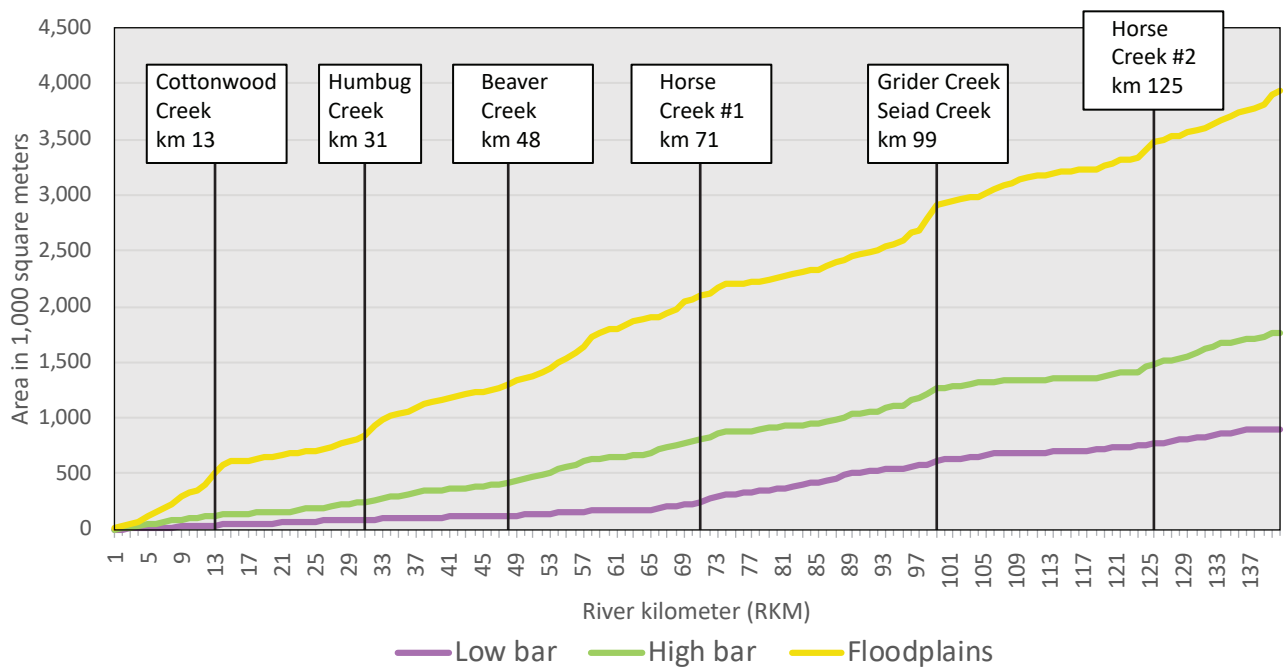
Figure 12. Longitudinal summaries of sediment storage in bars and floodplains along 140 kilometers of the main-stem Klamath River below Iron Gate Dam, California, 2010, by *A*, area per discrete 1-km reach; and *B*, cumulative area.

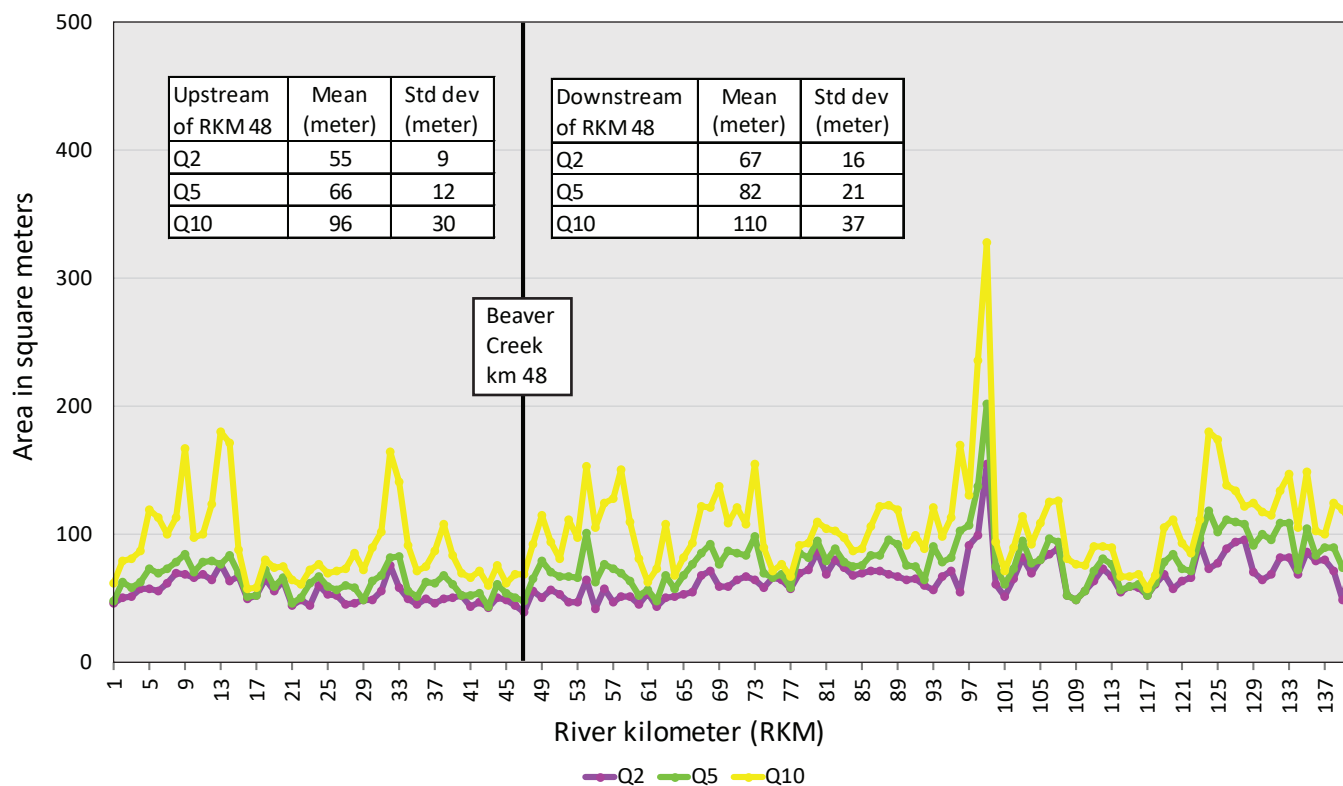
Figure 13. Reach-averaged widths of inundation boundaries for floods with recurrence intervals of 2 years (Q2), 5 years (Q5), and 10 years (Q10), along 140 kilometers of the main-stem Klamath River below Iron Gate Dam, California, 2010.

Sediment storage increases downstream from Beaver Creek (RKM 48), which suggests a transition from supply limited to equilibrium or transport-limited conditions. Reach-averaged channel widths (fig. 13) estimated using the Q2, Q5, and Q10 flood-inundation boundaries also increase downstream from RKM 48. Two-tailed t-tests of mean widths upstream and downstream from RKM 48 indicate a statistically significant difference in mean channel widths for the Q2 (p-value less than 0.0001), Q5 (p-value less than 0.0001), and Q10 (p-value equal to 0.0014) boundaries even without the influence of large alluvial features upstream of the Seiad Valley gage (RKM 102). This transition is also apparent on the longitudinal profile (fig. 4), which shows an aggradational reach between Beaver Creek (RKM 48) and the Seiad Valley gage (RKM 102).

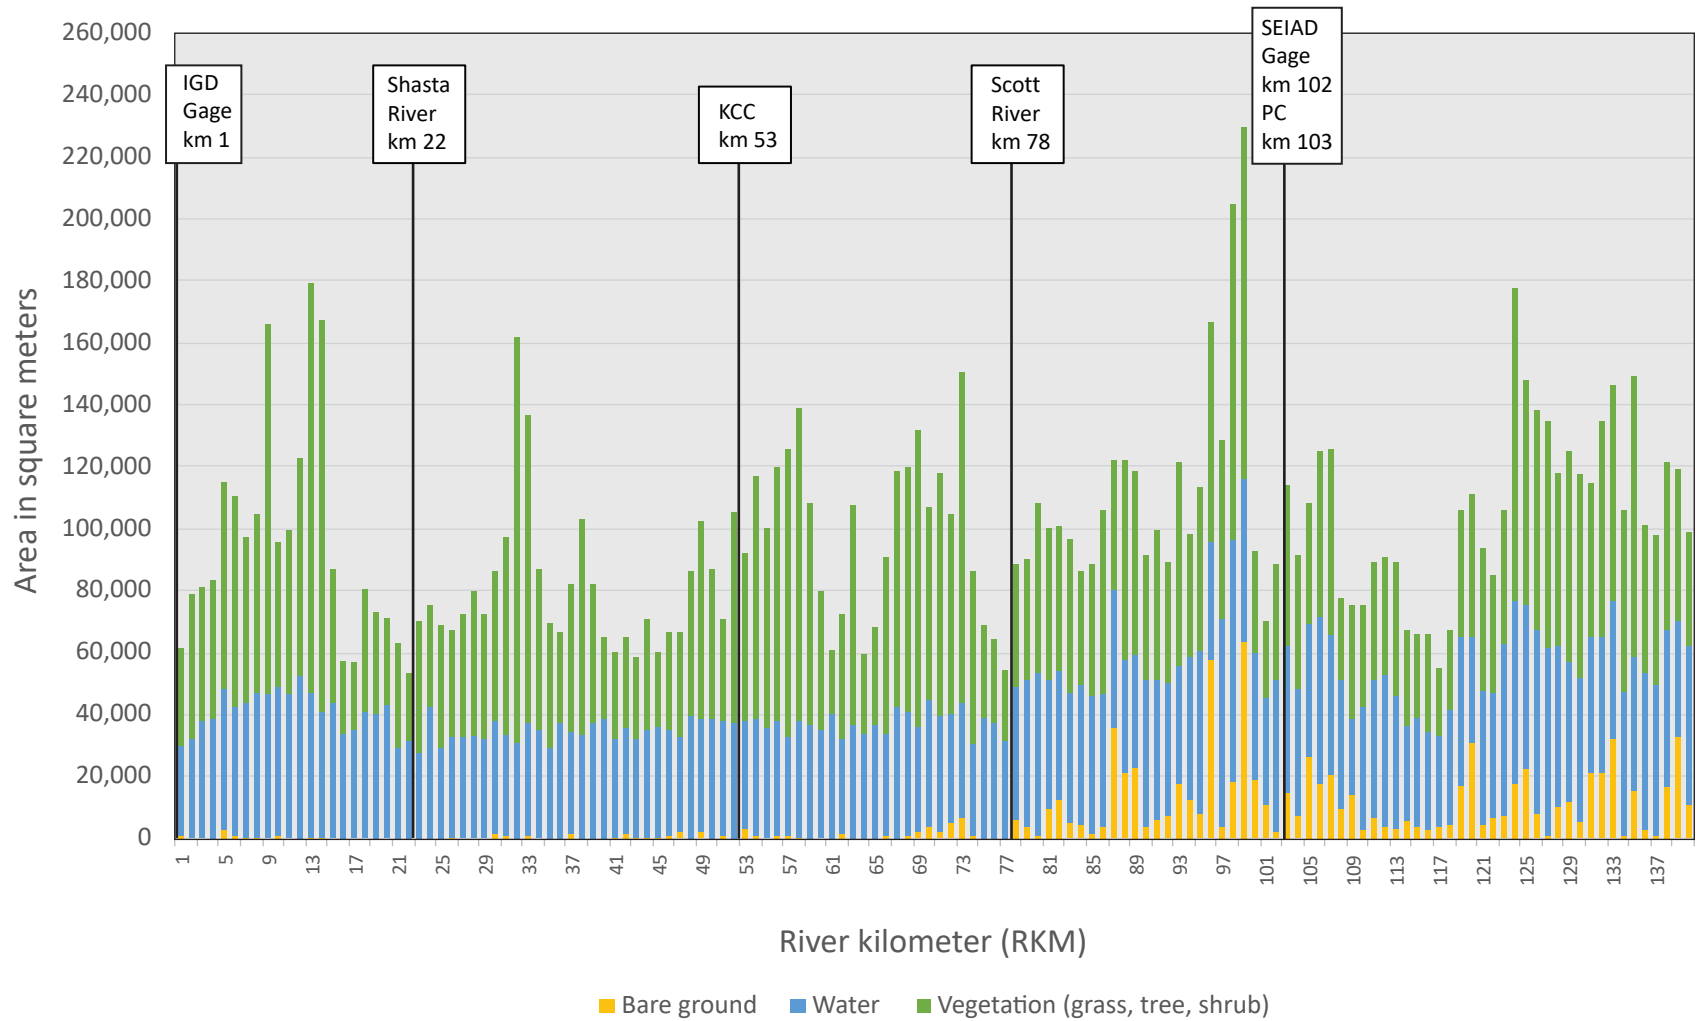
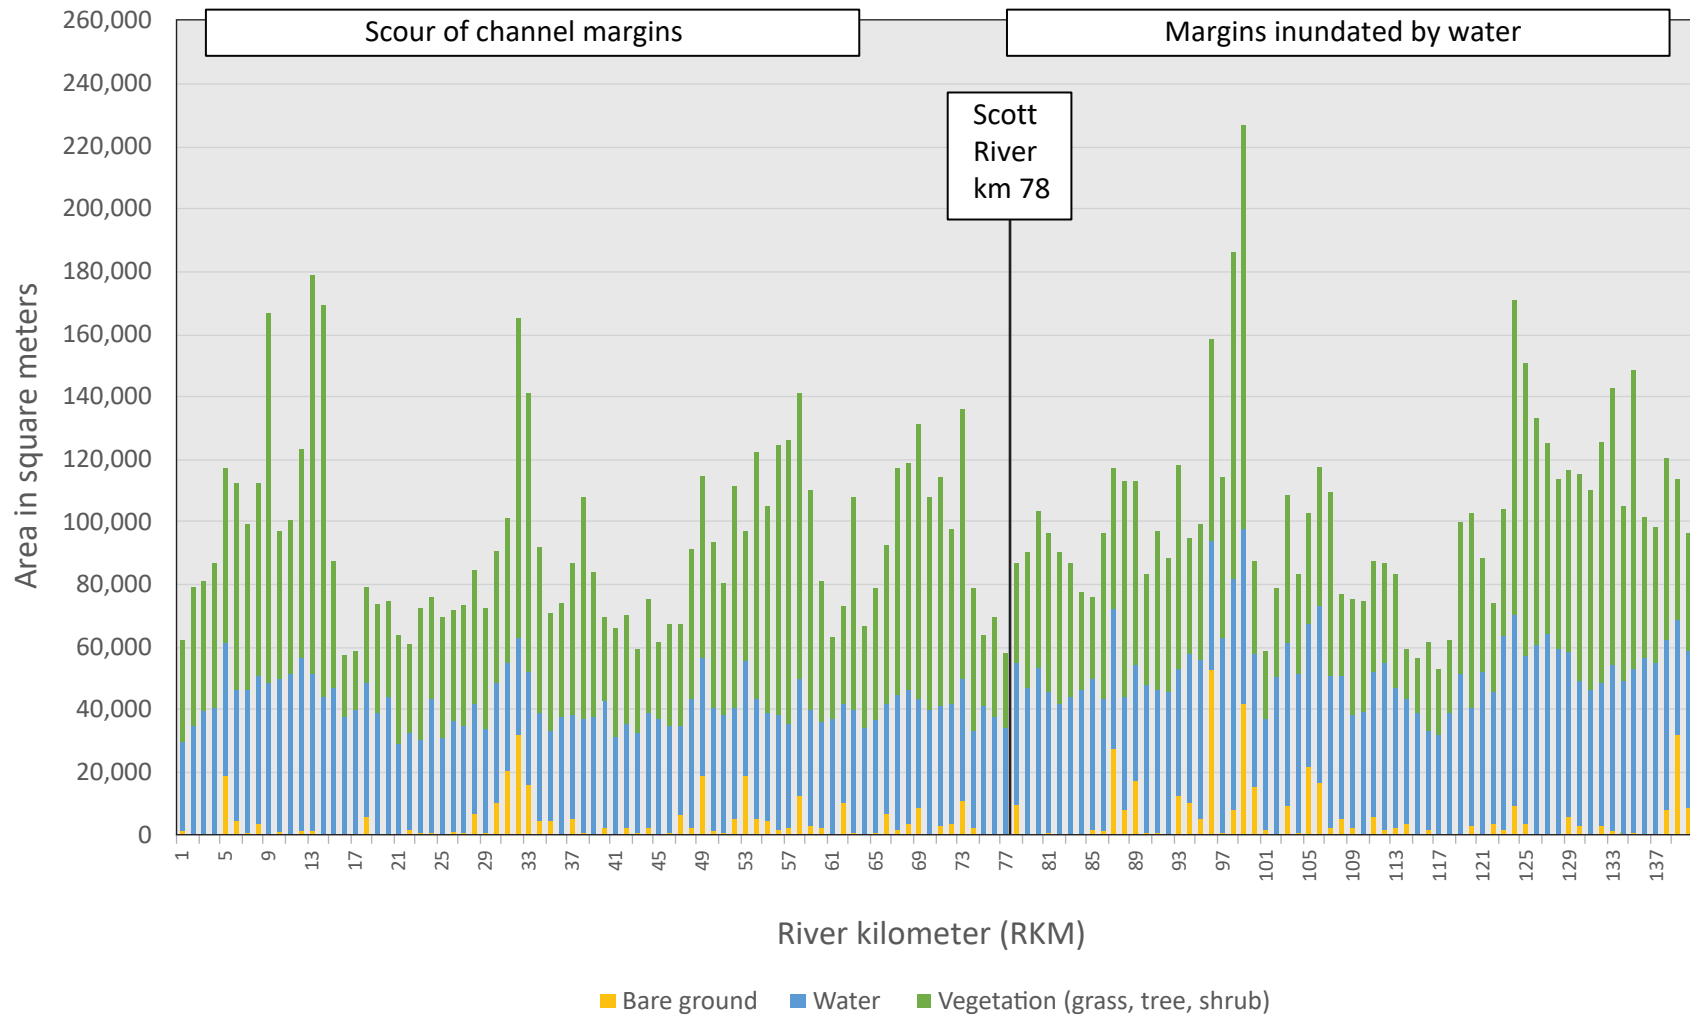
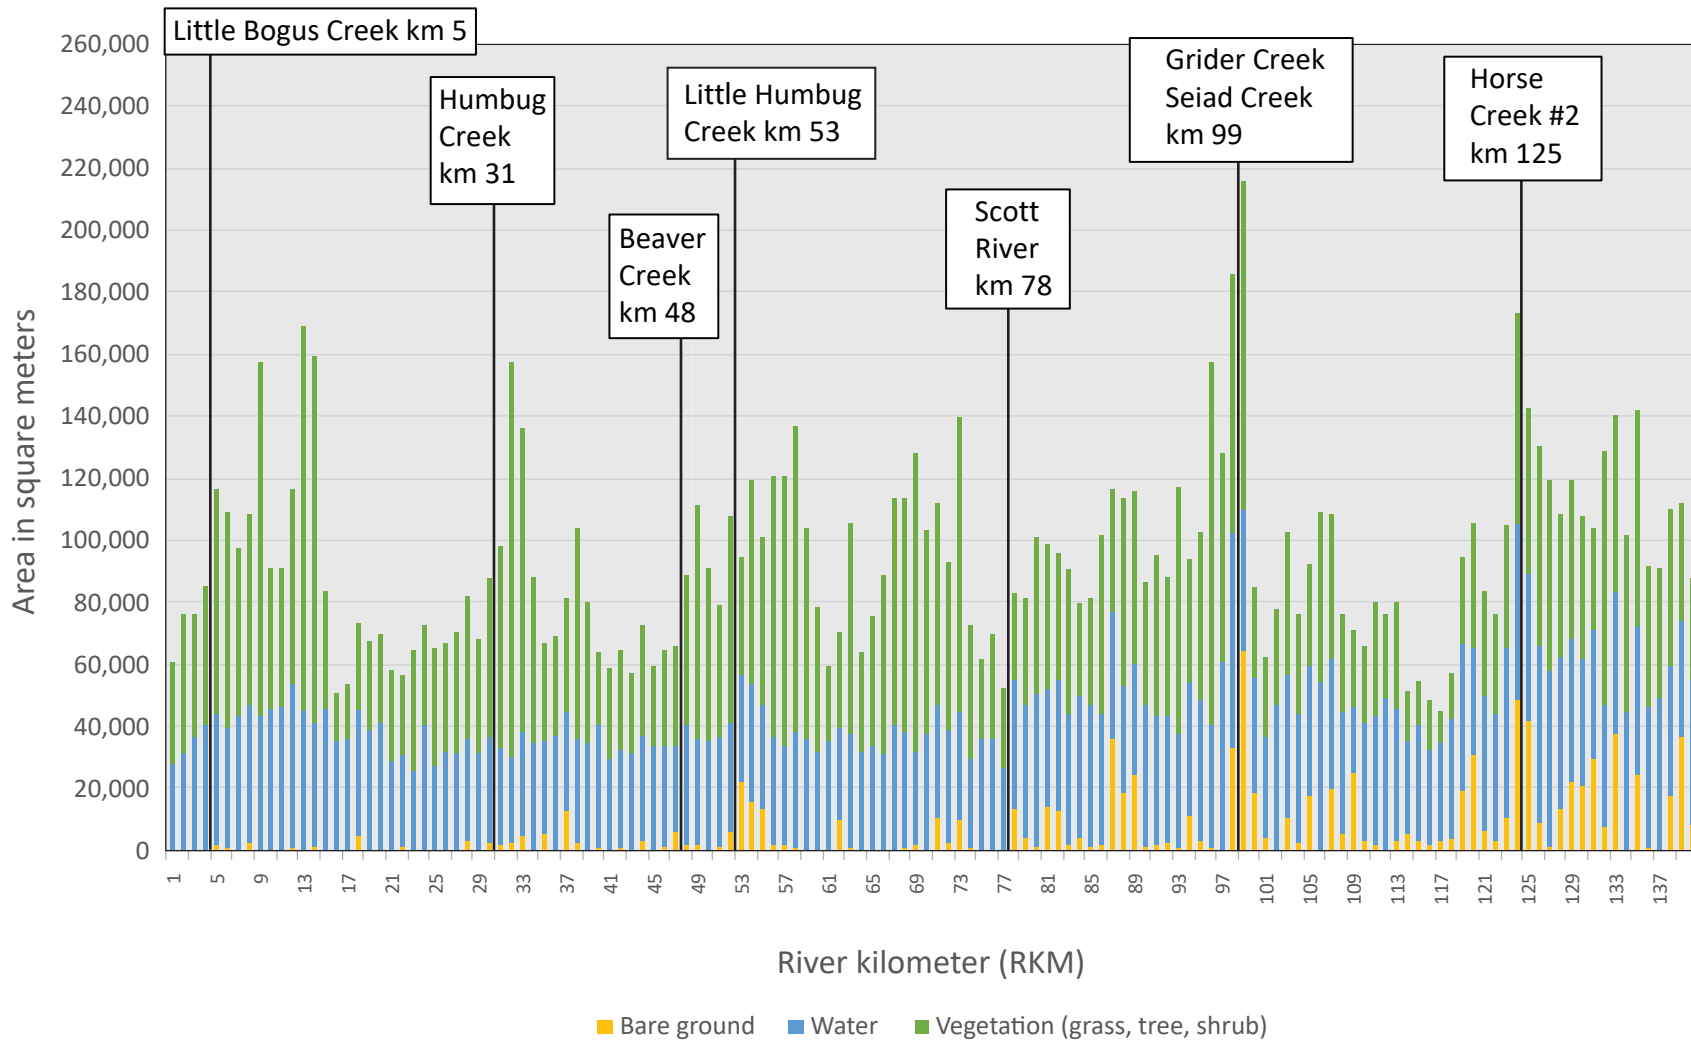
Figure 15. Longitudinal summaries of water, bare ground, and vegetation for *A*, 2005; *B*, 2009; and *C*, 2016 within the Q10 flood-inundation boundary along 140 kilometers of the main-stem Klamath River below Iron Gate Dam, California.
