From: [Fernandez, Juliette](#)
To: [Radke, Bill](#); [Harden, Tasha](#)
Subject: Can you look at this and adjust as necessary?
Date: Friday, February 14, 2020 9:45:47 AM
Attachments: [Hay Hollow Wash.docx](#)

Hay Hollow Wash at San Bernardino National Wildlife Refuge

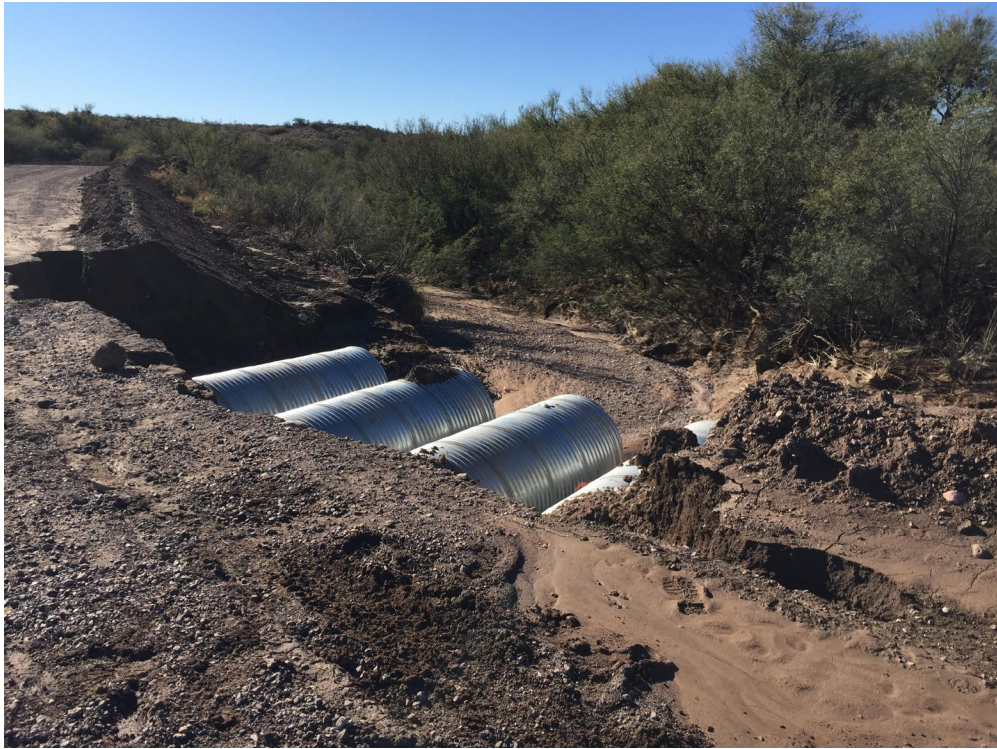
- Contractors built a culvert crossing on Glenn Ranch land immediately upstream from San Bernardino NWR to bridge Hay Hollow Wash (See map below).
- A November flood event, not unusual for Hay Hollow Wash during the summer and winter rainy seasons, mobilized and piled brush and other debris against the upstream end of the culverts - effectively damming the flow until the road crossing ultimately failed. (Picture 1)

Picture 1. November 2019. Post flood event blow out of Hay Hollow Crossing

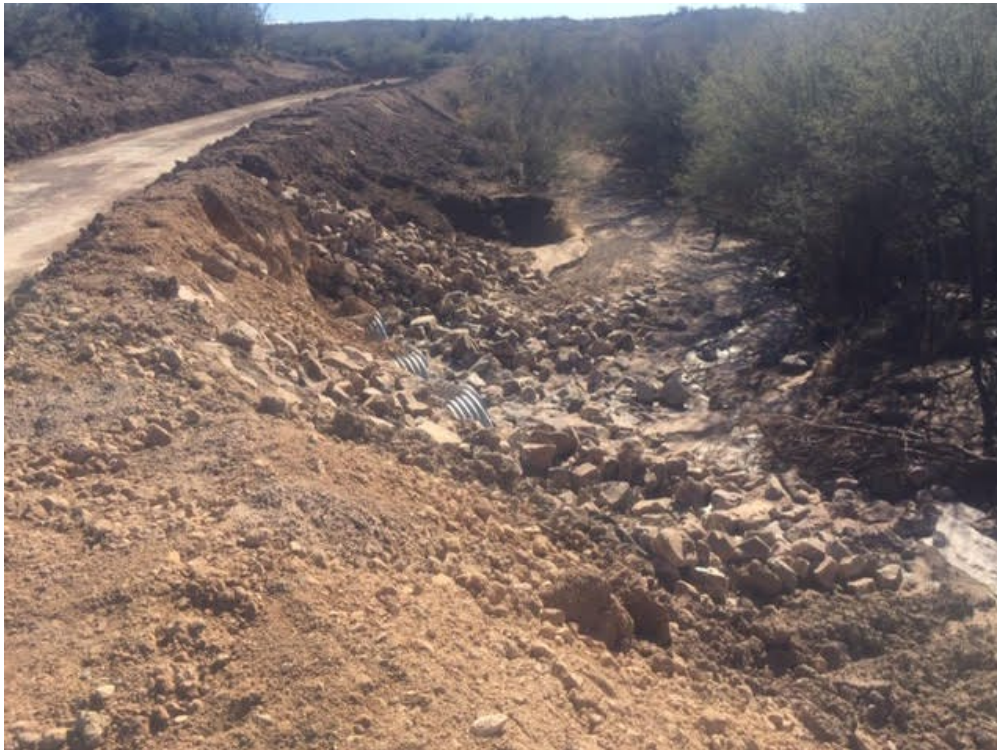
- The road crossing and culverts were reconstructed mid-December. Adjustments included additional dirt and rip rap at the base. There has not yet been another flood event to test the strength of the new crossing. (Picture 2)

Picture 2. December 2019- New Hay Hollow Crossing

- Substantially fortify the Hay Hollow crossing.
- If a site visit is beneficial, the San Bernardino NWR staff will gladly provide details.

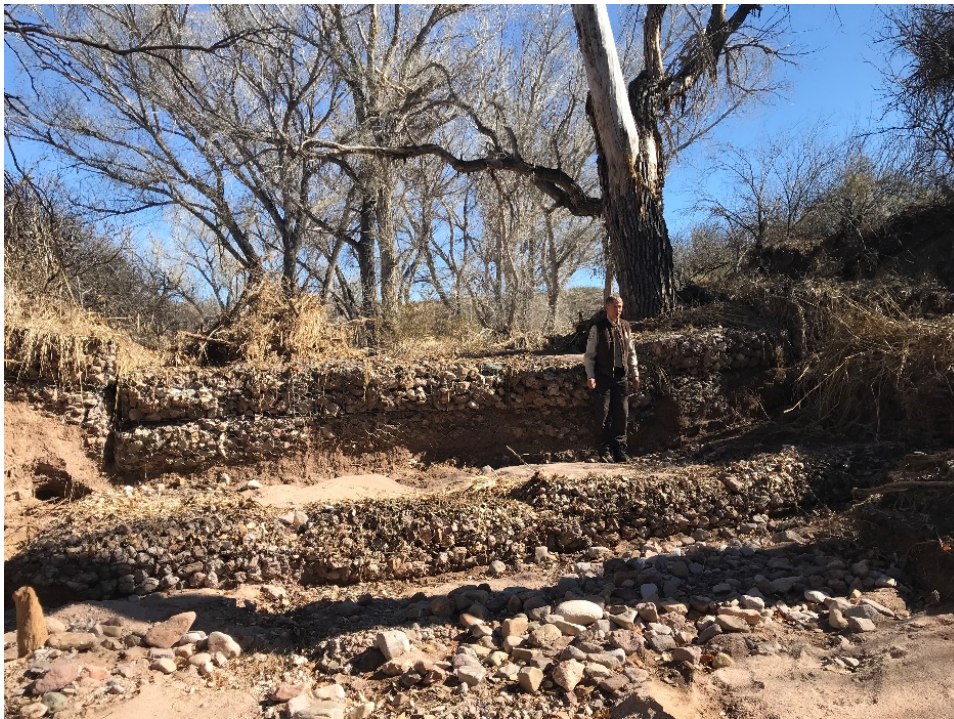
Gabion 1 – January 2020. Gabion 1 persisted through the November 2019 flood event however large amounts of sediment filled the pool at the base. This pool had provided critical habitat for endangered fish for over a decade.

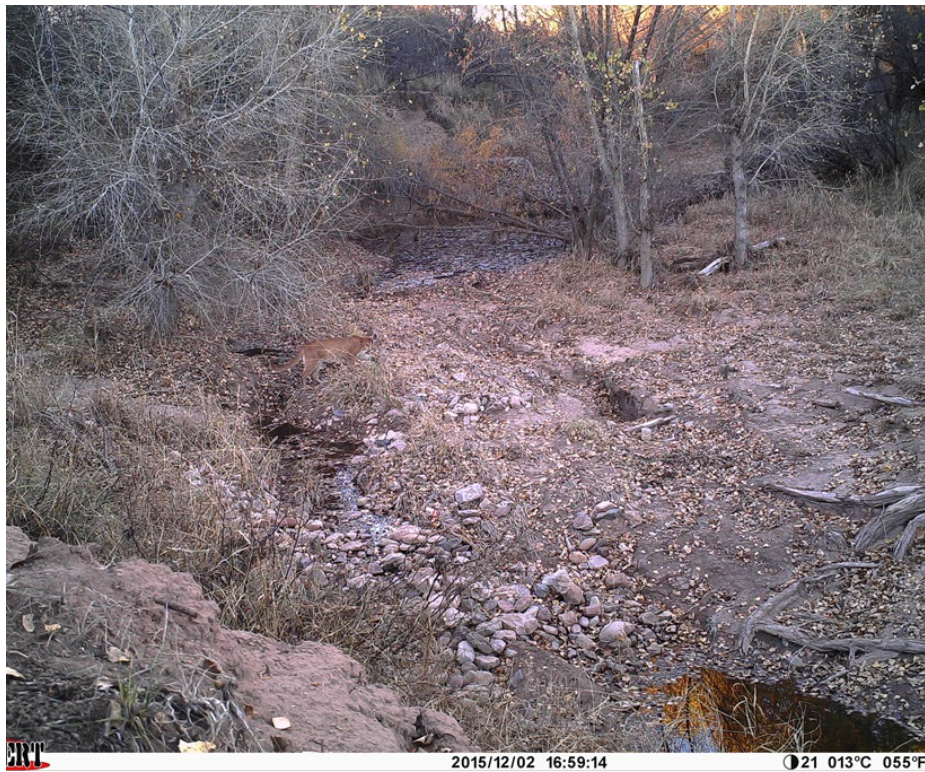
Gabion 2 – Year 2002. Gabion 2 ensured year-round water at its base which supported critical habitat for Yaqui chub , Yaqui topminnow, and Huachuca water umbel. Despite multiple flood events, this structure persisted until the Hay Hollow crossing failed upstream November 2019.

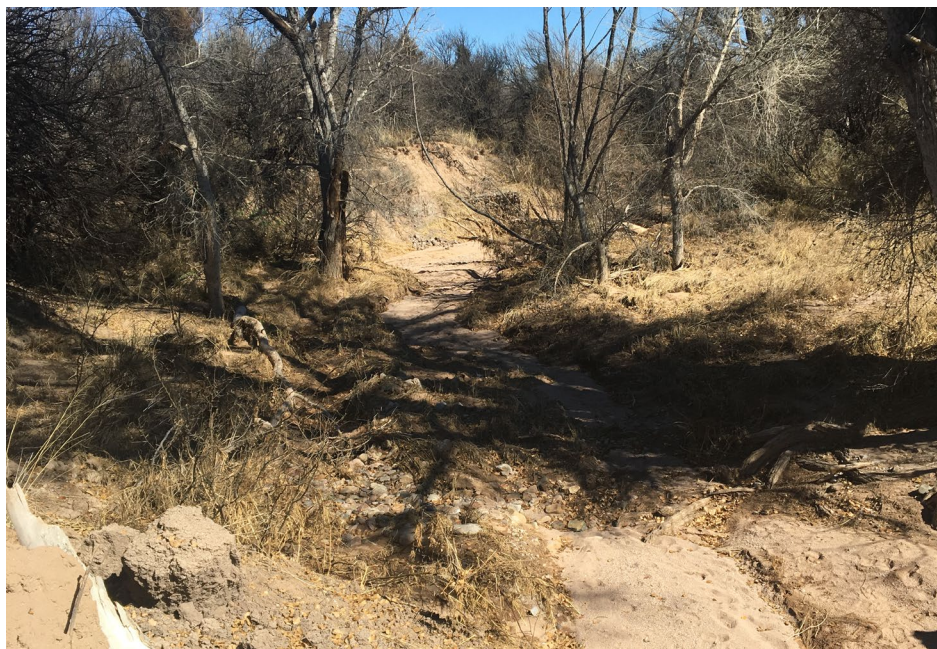
- The resulting wall of water then travelled rapidly downstream and rushed refuge infrastructure.
- This damaged and/or washed out two refuge gabions (rock-filled wire-caged erosion control structures that have been in place for decades) and downcut the refuge stream bed by six feet, which will require repair.

Gabion #2 – January 2020. Six feet of gabion wall fell during the flood event, washing sediment and rock downstream. It is no longer a functional gabion for future flood events.

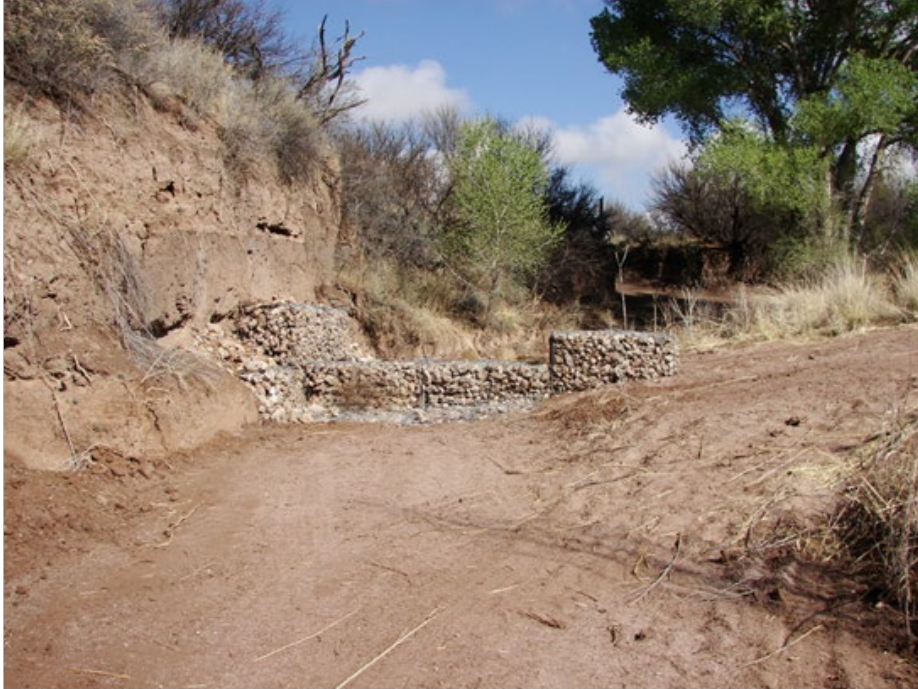
Gabion 3 – March 2009. Photo taken looking north. The west side of the gabion is flush against the tall bank.

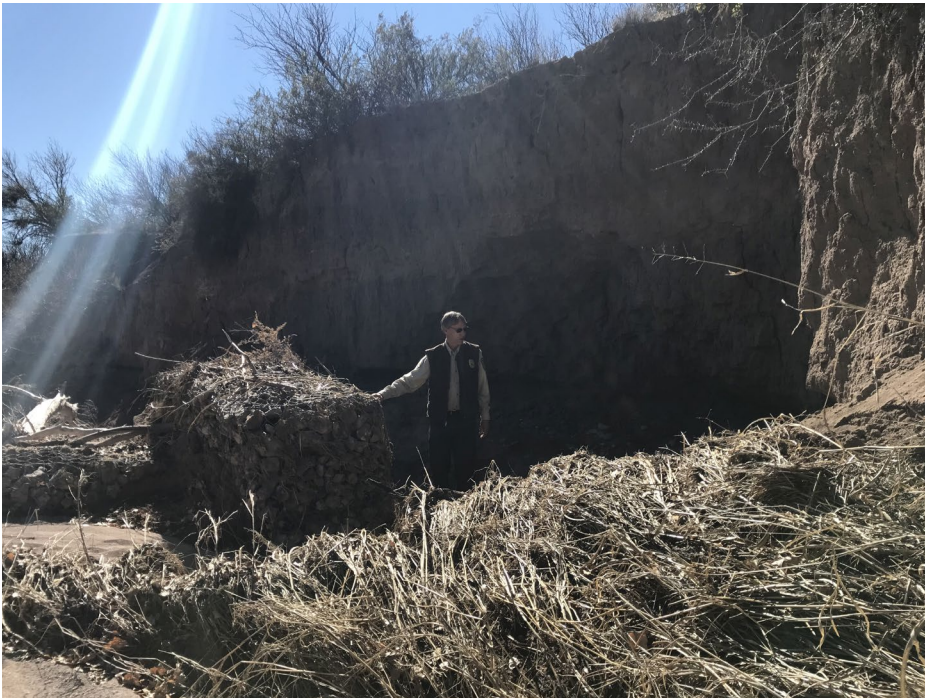
Gabion 3 – January 2020. Photo taken looking south. Due to the significant pulse of water released upstream, the bank on the west side of the gabion eroded significantly.
