Draft Environmental Assessment

Seney National Wildlife Refuge Structural Improvements to the Show Pool Historic Wildlife Observation/Picnic Shelter (Show Pool Shelter)

June 2022

Environmental Assessment for Structural Improvements to Seney National Wildlife Refuge's Show Pool Shelter

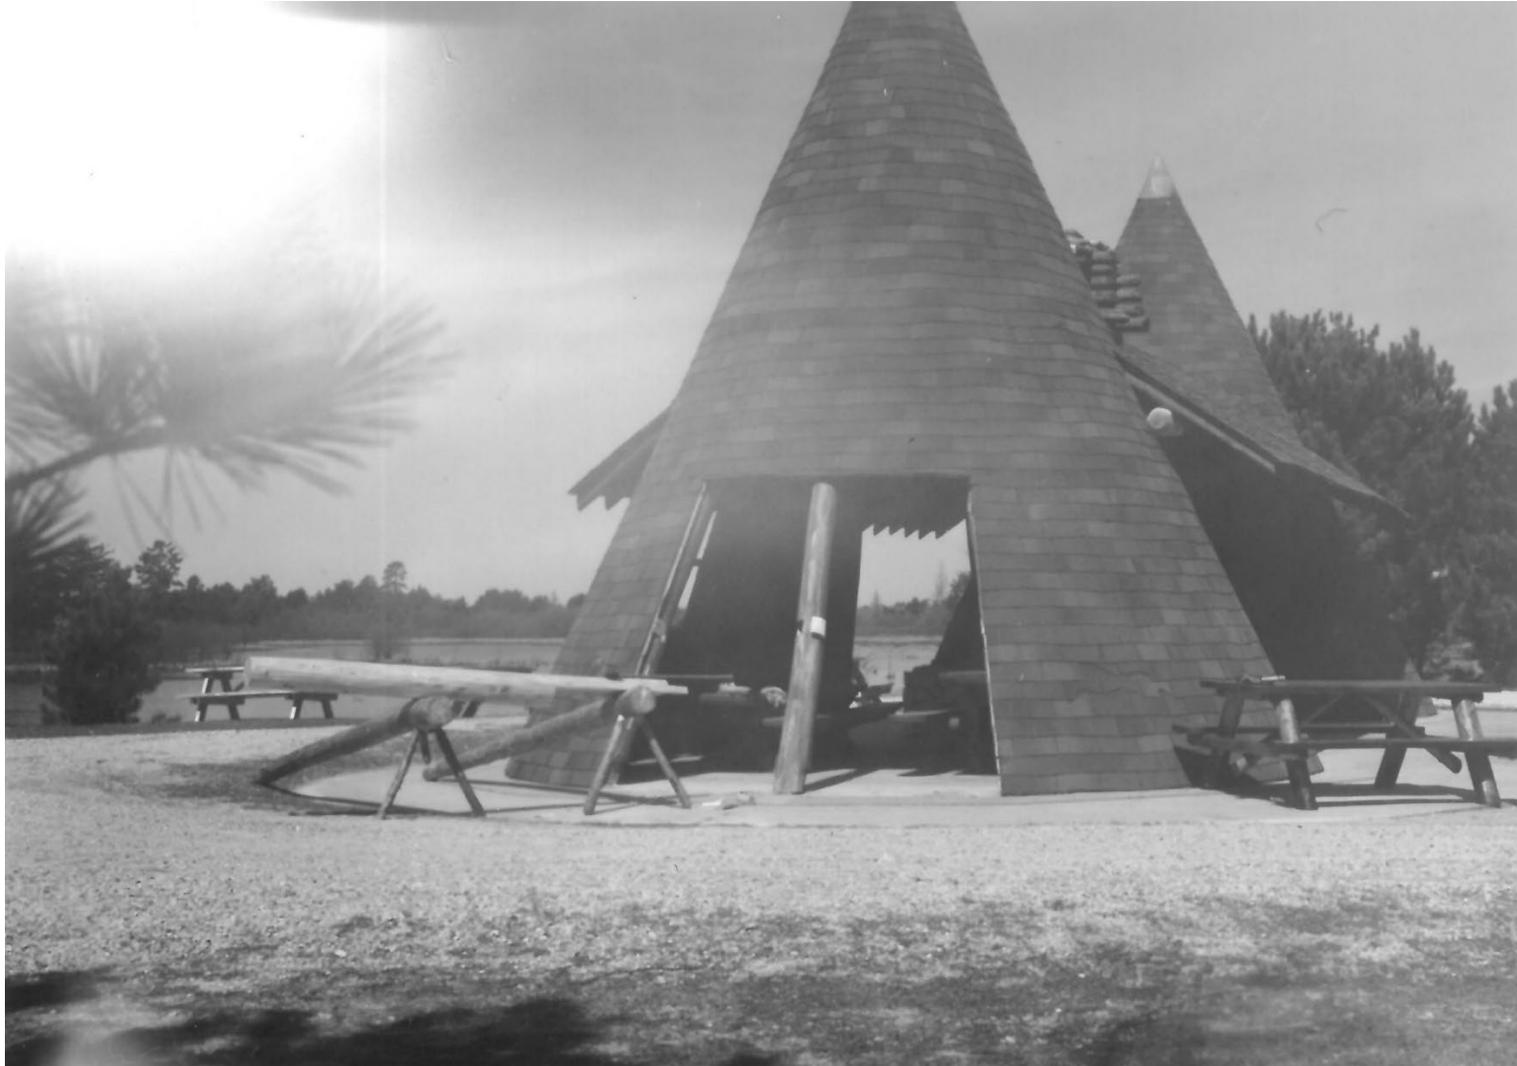
Photo 3: The Show Pool Shelter in 1955. The end doors have been added. It is now covered in asphalt shingles.

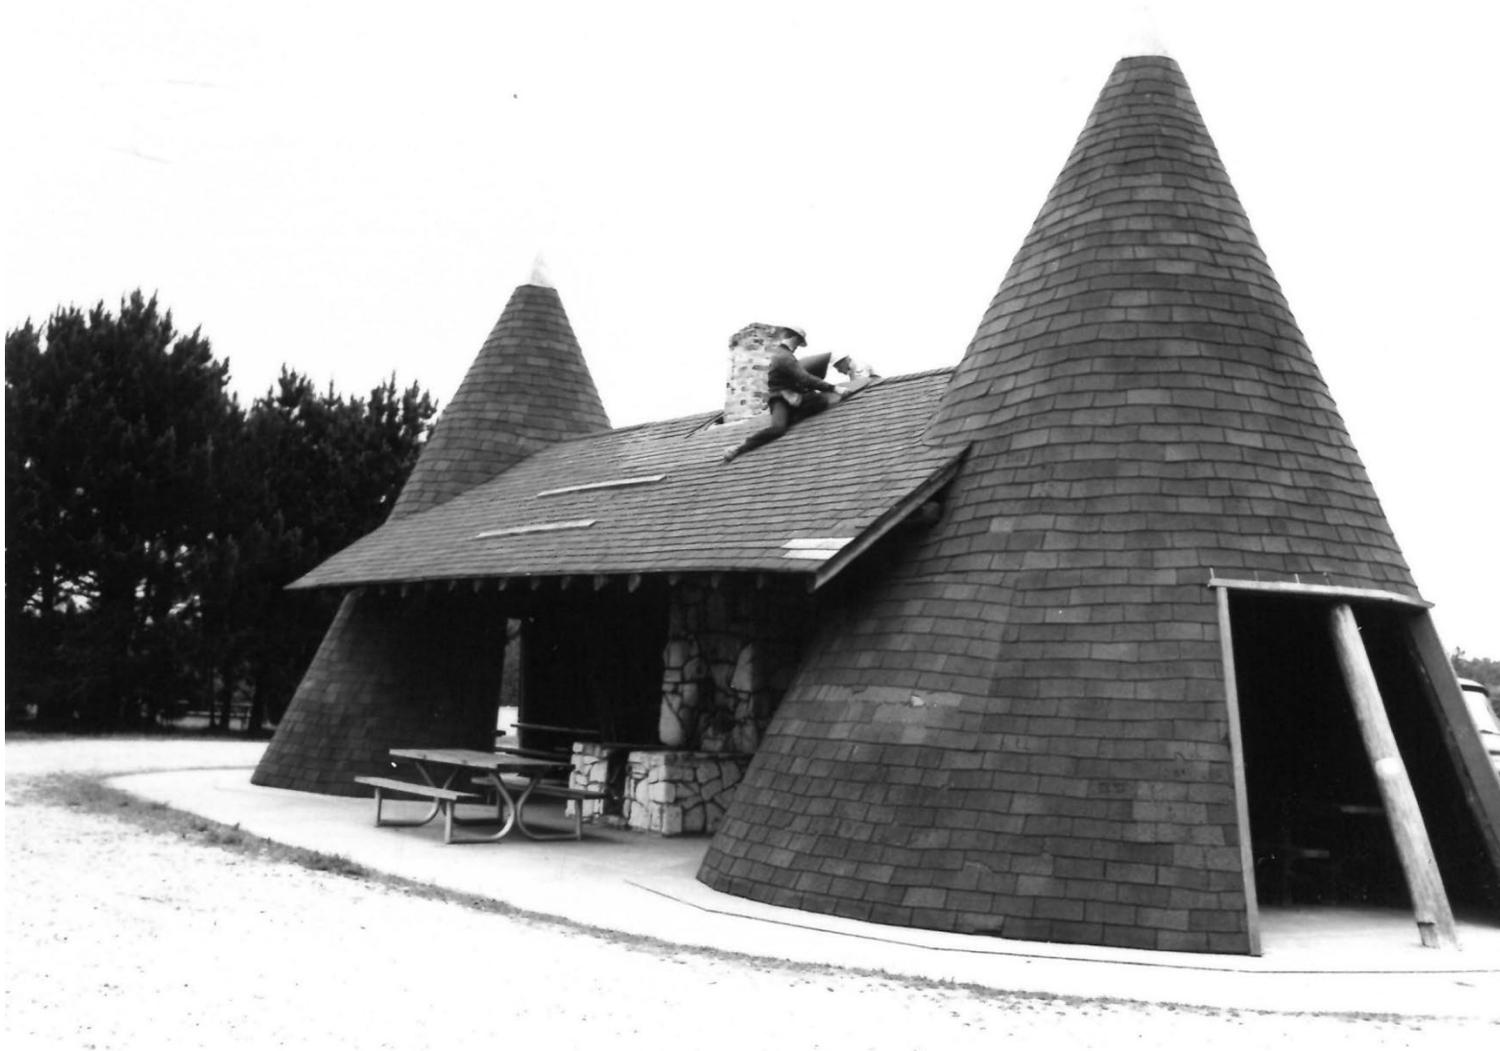
Photo 4: The Show Pool Shelter in the 1960s. The shelter appears to have lost its window openings.

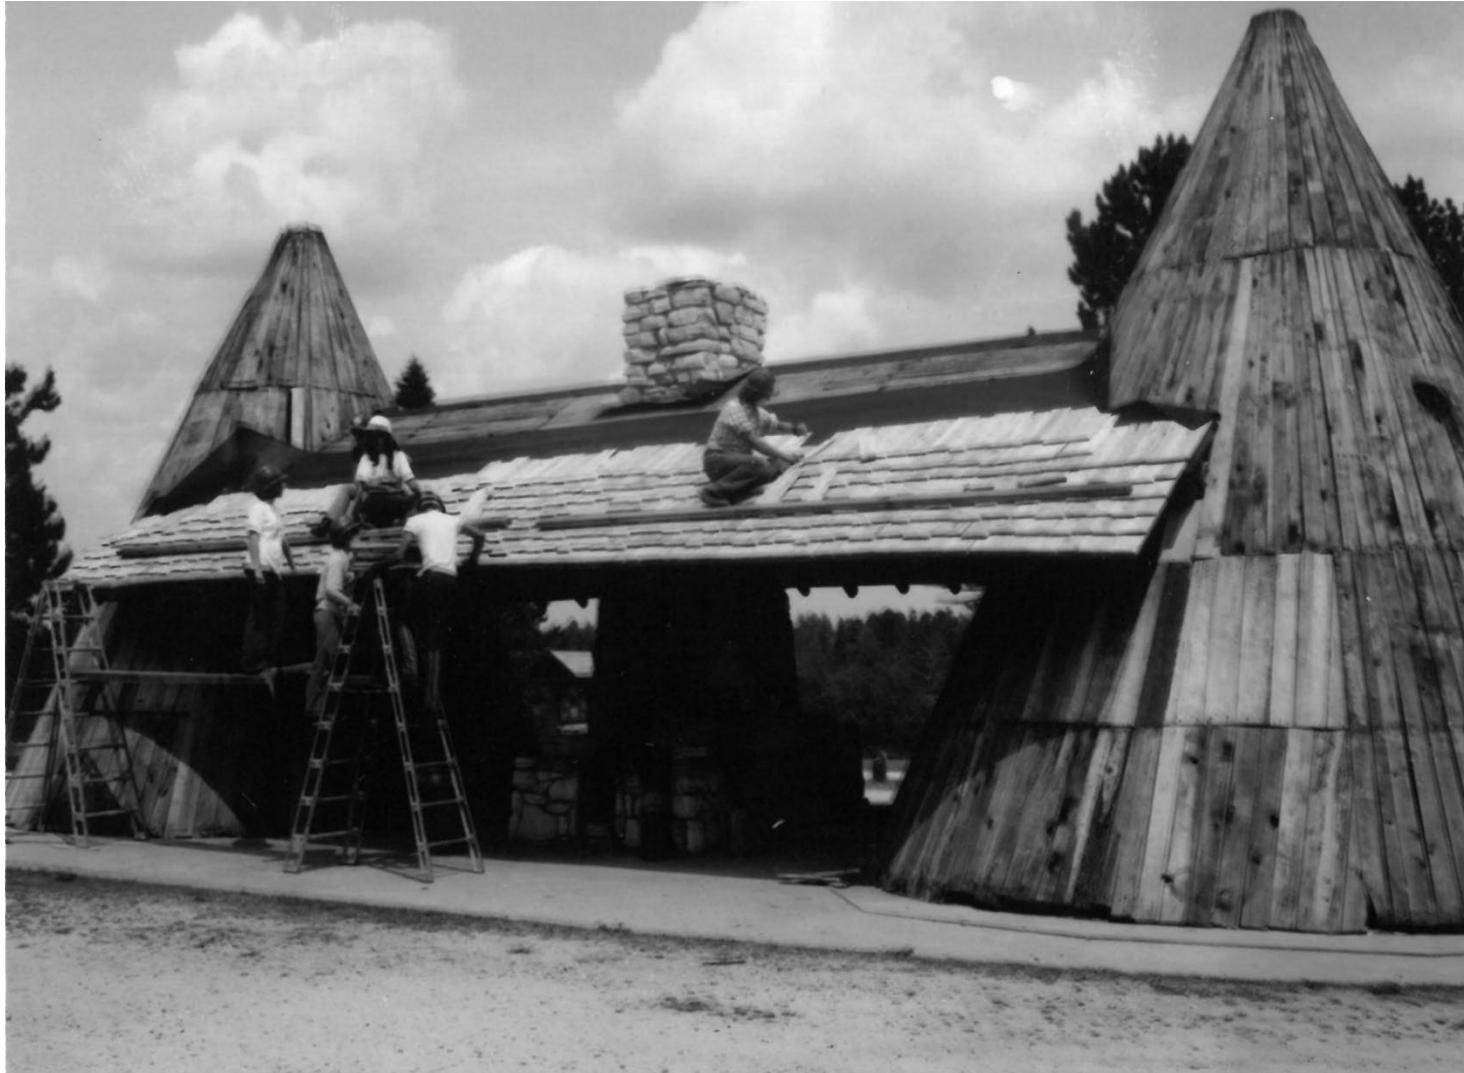
Photo 5: The Show Pool Shelter in 1974 when it was being covered with cedar shakes for the first time.

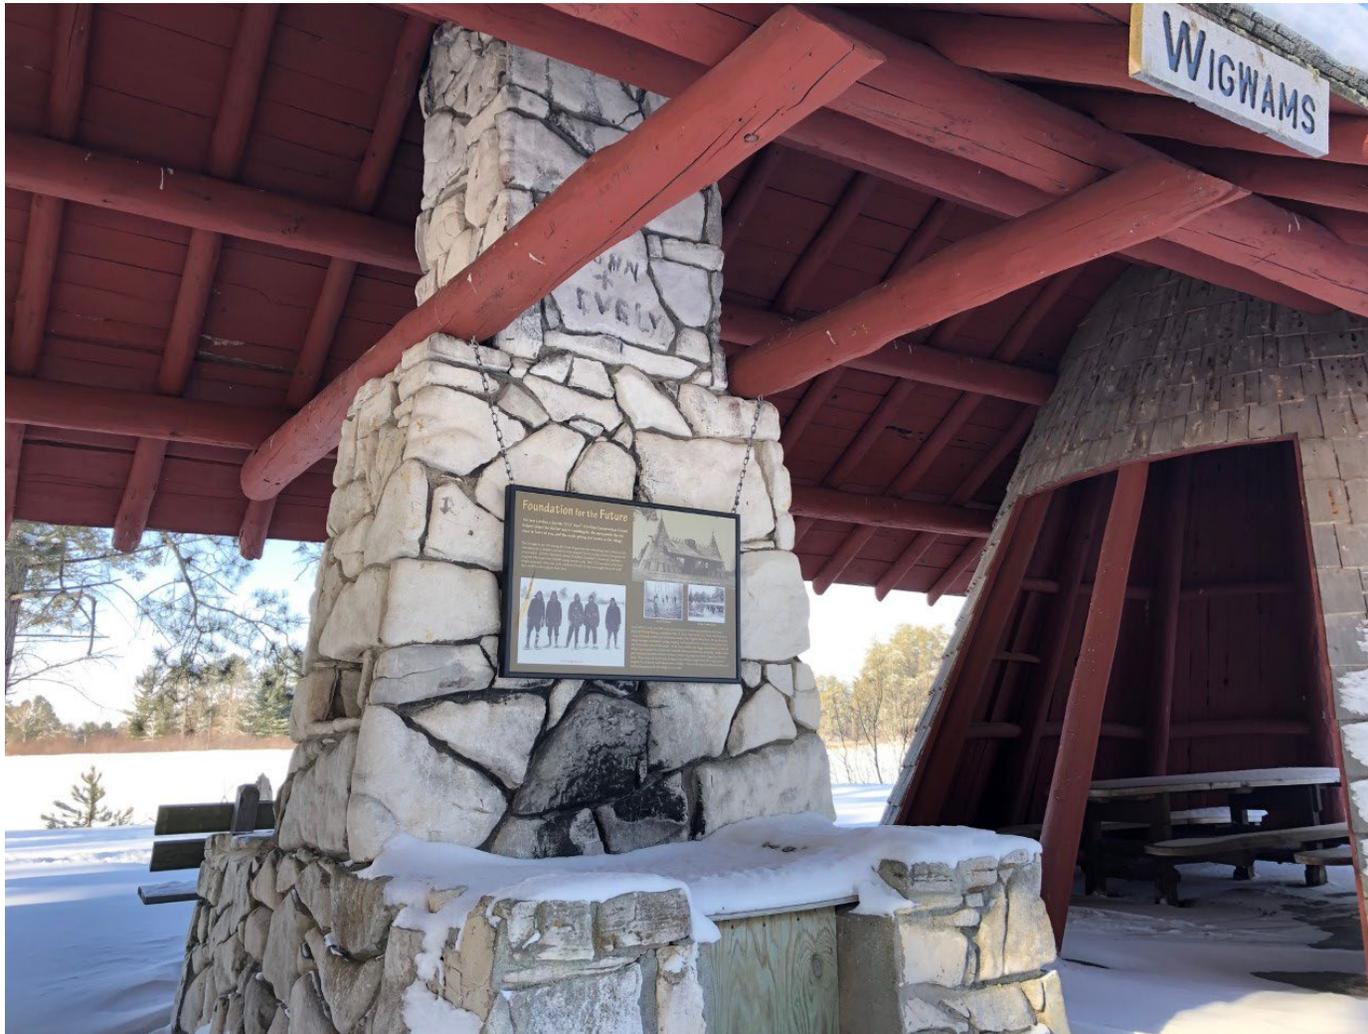
Photo 8 of stone fireplace in 2022.

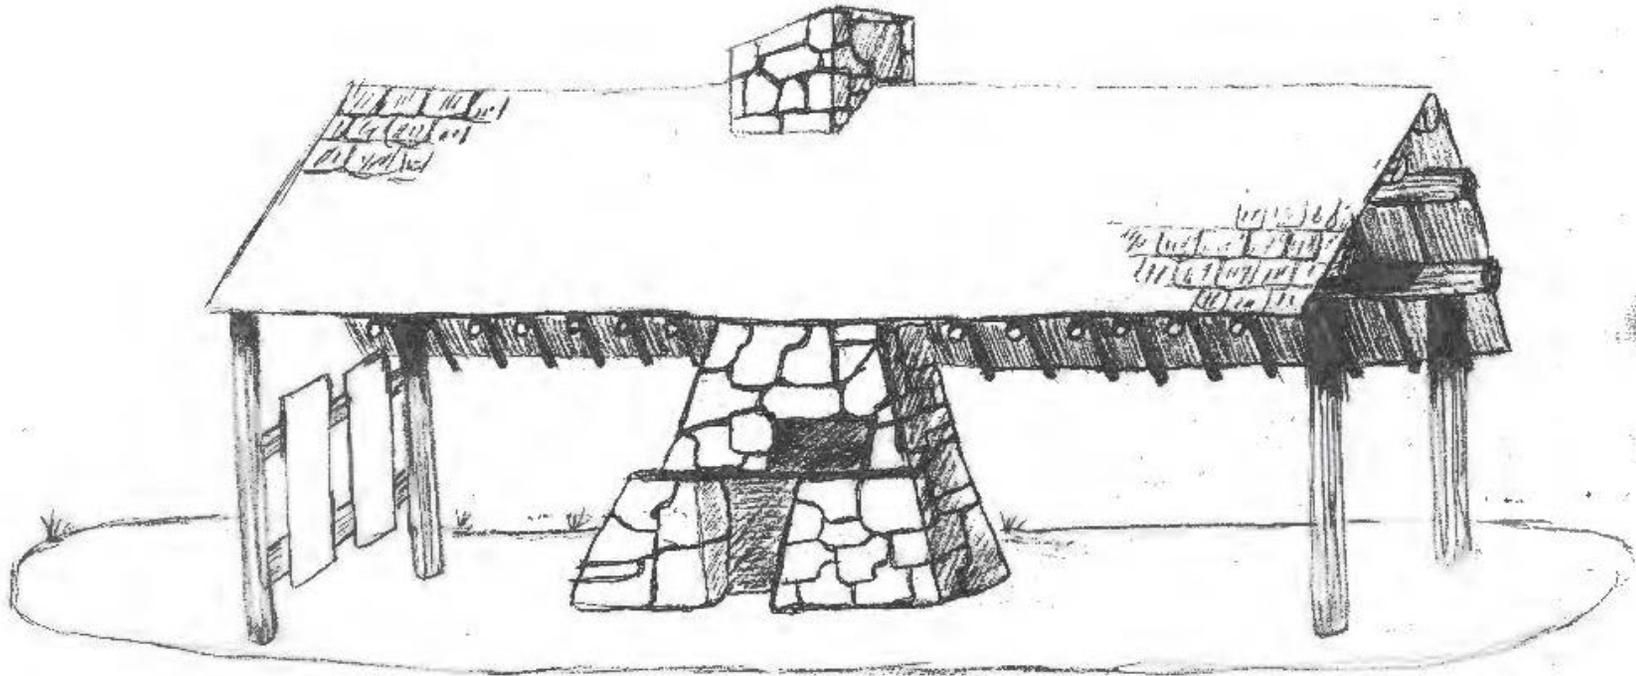
Concept Drawing 1 for Alternative B – With vertical posts, a wind break and interpretive panels.

Under this preferred alternative, the Service proposes to remove the conical roof tops and walls of the Show Pool Shelter while retaining the central portion of the structure with the stone fireplace and existing roof. The roof would be extended to replace the conical roof portion. Cedar shakes would be replaced on the existing

roof, rotten log timbers in the frame or other features would be replaced with like materials, maintenance and repair of the existing concrete floor foundation, and cleaning and repairing the stone fireplace.

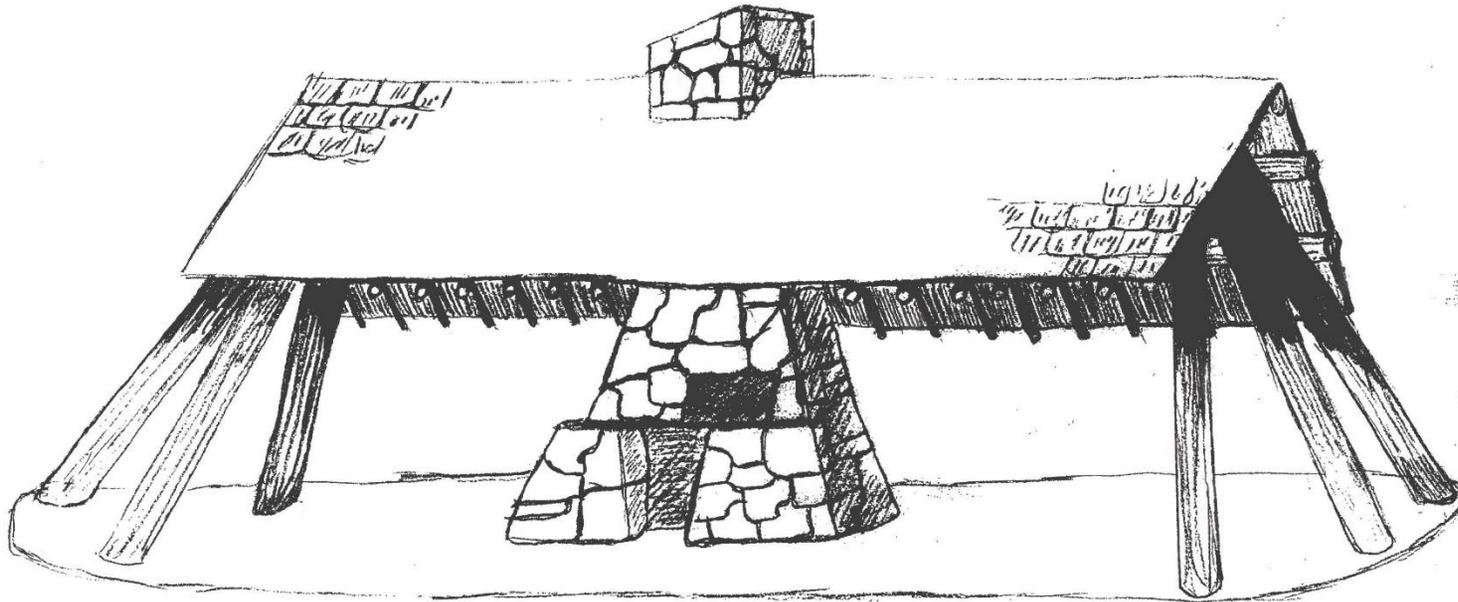
Concept Drawing 2 for Alternative B – Keeping some angled support timbers.

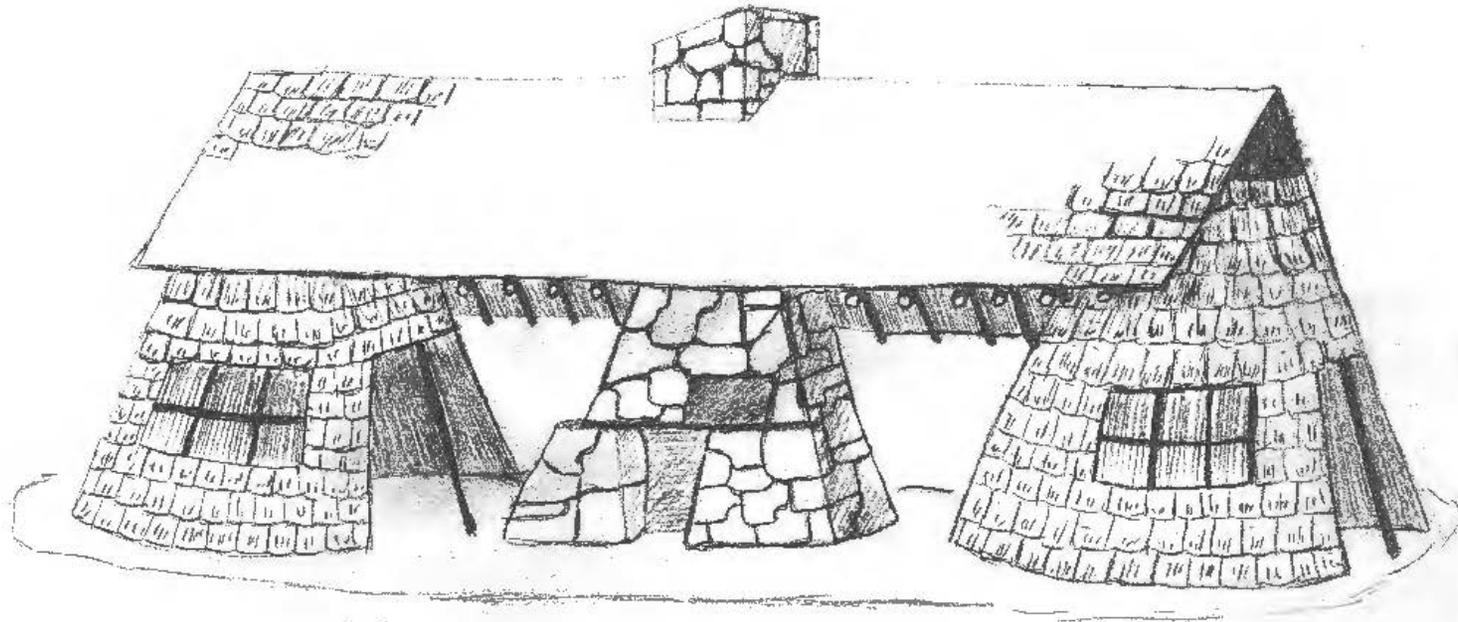
Concept Drawing for Alternative C – Retain conical base but remove cone tops and open up front and back windows.

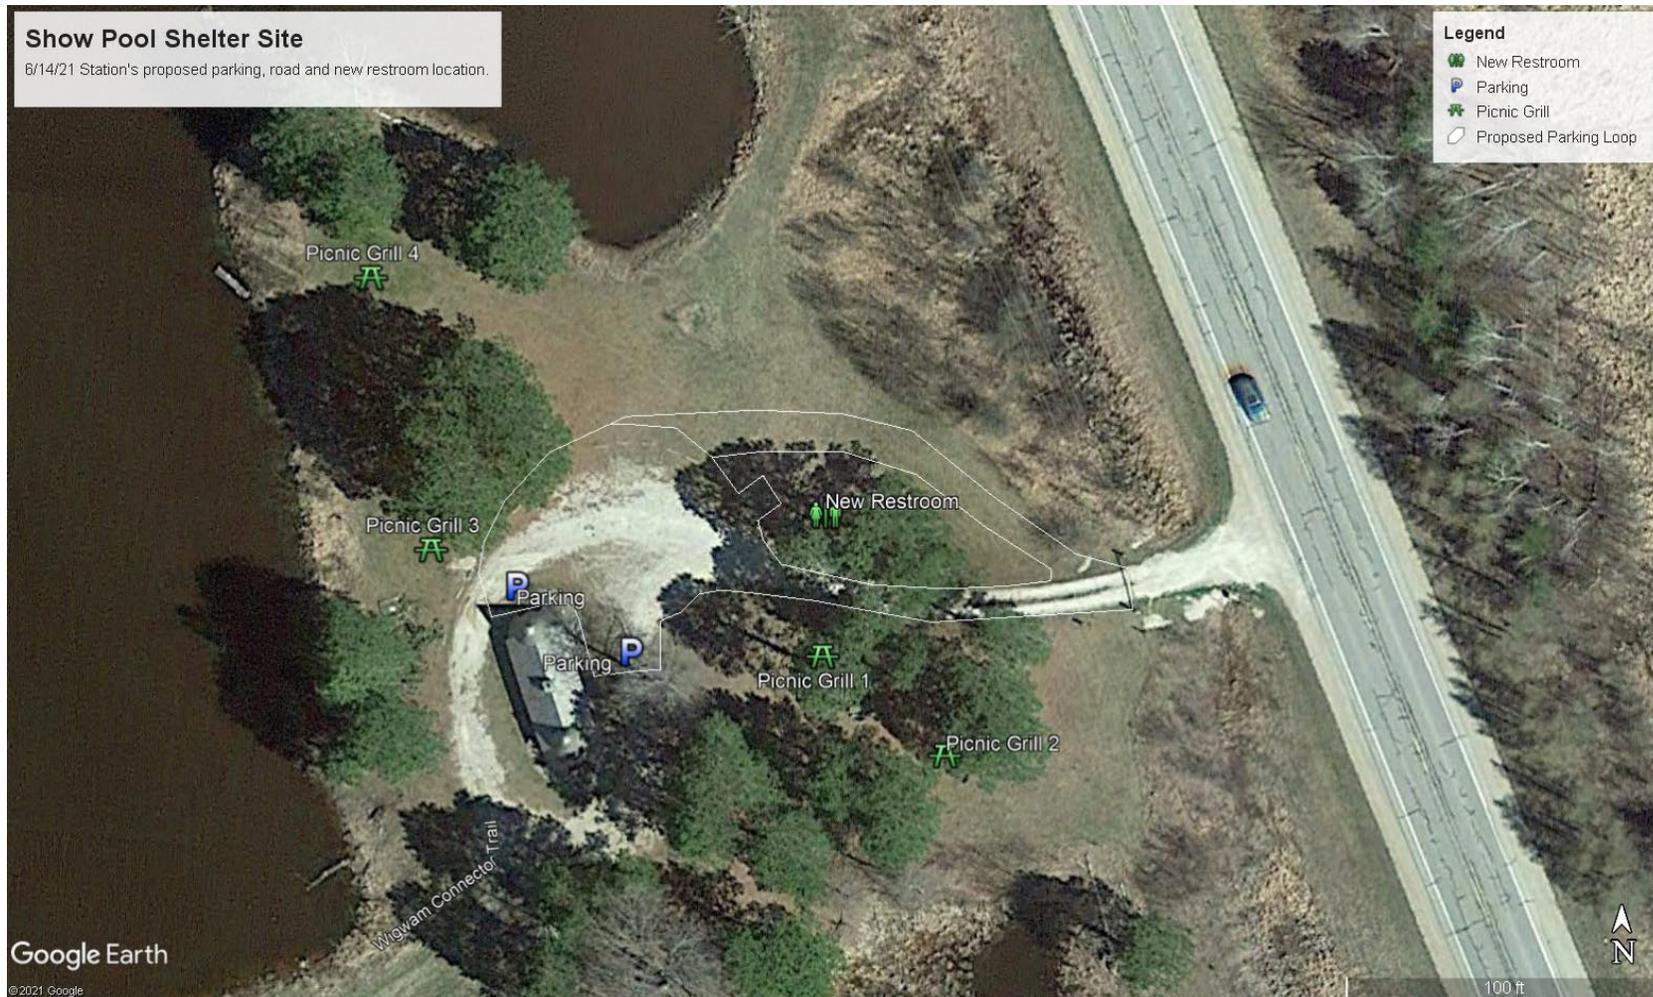
Figure 5. Proposed site changes to parking, road, and outhouse in the surrounding environment of the historic picnic shelter.

- In addition to addressing the shelter, the Show Pool Access Area will see improvements. A new wheelchair accessible outhouse has been purchased and is expected to be installed during the summer of 2022. This will replace the current outhouse which will be removed and the vault filled. The parking area will be renovated and expanded slightly. The driveway will be truncated ending at the parking lot and the portion that wraps around the west side of the Show Pool Shelter will be removed to prevent cars from driving round the structure and disturbing or blocking the view of the pools. An accessible parking space will be added to the site as well as wheelchair accessible picnic tables and grills. Lastly, The North Show Pool dike was breached in April of 2018 and is planned to be repaired in the summer or fall of 2022. Repairs to the breach will enable this pool to retain water for wetland and inland lake habitats once again.
