Evaluation of a Resistance Board Weir in the White Salmon River For Capture of Lower Columbia River Fall Chinook Salmon (*Oncorhynchus tshawytscha*) for Transport during the Year of Condit Dam Removal

U.S. FISH AND WILDLIFE SERVICE
COLUMBIA RIVER FISHERIES PROGRAM OFFICE
VANCOUVER, WASHINGTON

A Conservation Measure in Preparation for Condit Dam Removal

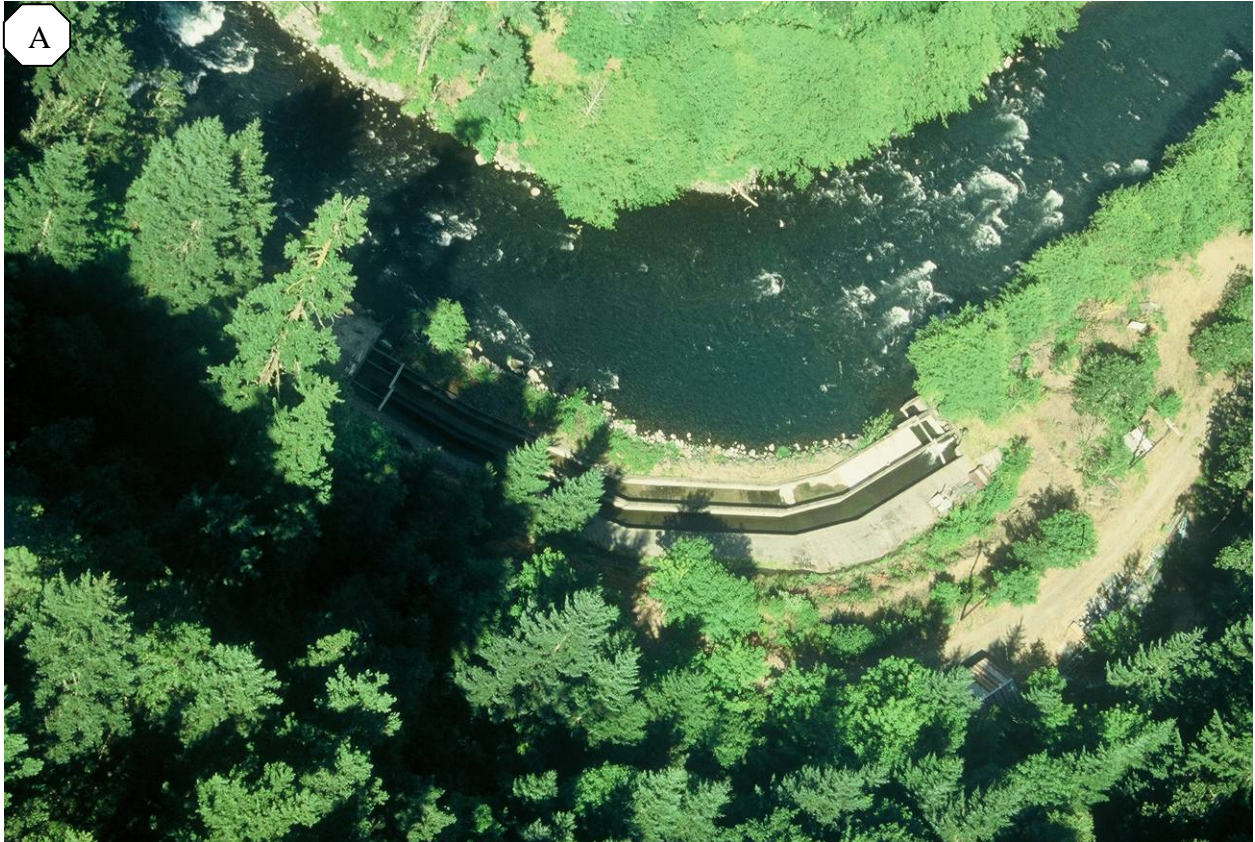
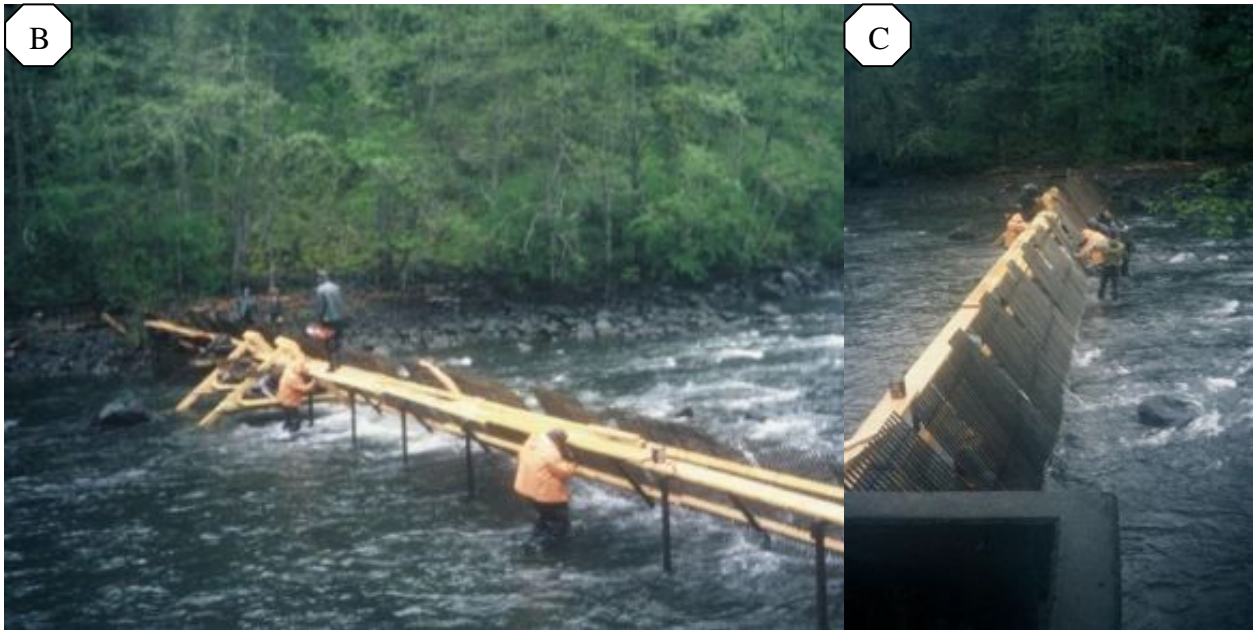
Figure 1. (A) Aerial photograph of White Salmon Ponds, a historical brood stock collection facility operated by Spring Creek National Fish Hatchery located at river mile 1.4 on the White Salmon River. (B, C) Pictures of Spring Creek NFH staff constructing the historical picket weir that would block upstream migration of Lower Columbia River Fall Chinook salmon adults for redirection in the White Salmon Ponds. Returning adults were trapped and collected to supply the annual production of Spring Creek NFH production through the late 1970's, and intermittently thereafter. Adult collections have not occurred at the site since the early 1990's. Photos courtesy of PacifiCorp.

The White Salmon Ponds were constructed in the early 1950's on the White Salmon River at river mile 1.4 and consists of two adjacent 12 x 220 x 5 ft raceway ponds (Figure 1A). The facility was built as a brood stock collection site for Spring Creek NFH and used annually up until the early 1970's and sporadically thereafter to either collect adult LCR fall Chinook salmon or acclimate juvenile salmon prior to release into the White Salmon River. The ponds were last used for juvenile releases in 2002 because the water intake does not meet NOAA Fisheries criteria for incidental take of listed salmonids. Monthly discharge in the White Salmon River during September averages 670 cubic feet per second (cfs). Approximately 3.3 cfs can be diverted through the water intake for operation of the ponds (Northwest Environmental Services 2007) and to attract returning LCR fall Chinook to enter the ladder. In 2008, the ponds were operated without the traditional adult picket weir in place, in an attempt to lure and volitionally capture LCR fall Chinook salmon in the ponds. This method was met with little success (Engle and Skalicky 2009).

Traditionally, capture of adult LCR fall Chinook salmon occurred by installing a 120 ft picket weir across the river near the entrance to the White Salmon Ponds (Figure 1B and 1C). Returning adults would encounter the weir and navigate into the ponds through a number of ladder steps in the river-side pond and eventually into a holding area in the hill-side pond. The original picket weir used for these operations is in disrepair. An Alaskan Resistance Board Weir (Stewart 2002) was constructed and installed by Washington Department of Fish and Wildlife (WDFW) and the WSWG to direct LCR fall Chinook salmon into the ponds.

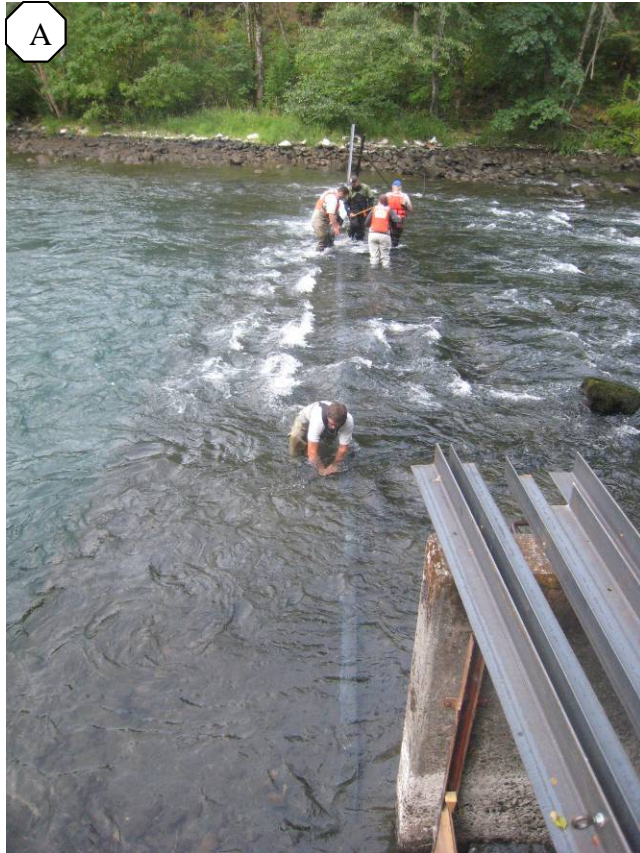
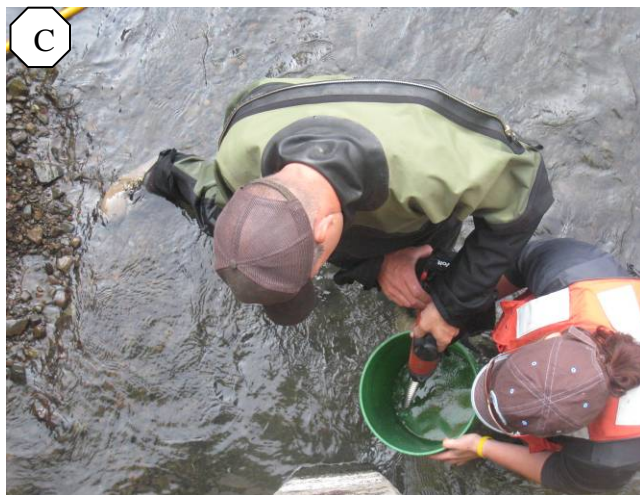
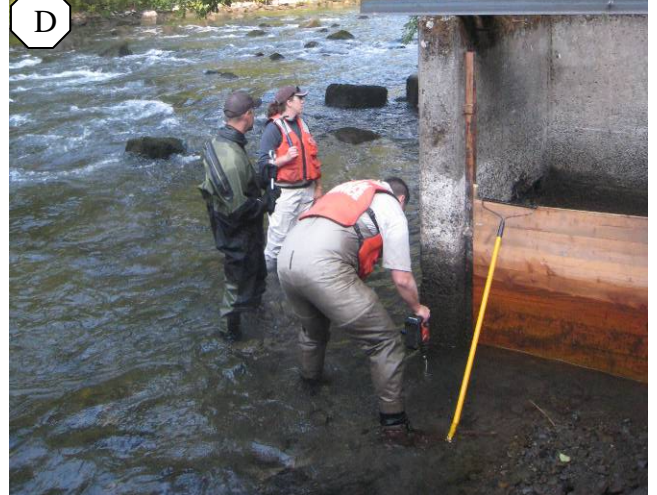
Figure 2. Pictures of White Salmon Working Group members installing the 4 inch angle iron and drilling into the concrete sill at the White Salmon Ponds at river mile 1.4. (A) Angle iron was installed to shield the cable that holds the resistance board weir in place and extended the entire wetted width of the White Salmon River on the existing concrete sill. (B) Angle iron was placed immediately behind the submerged pieces of the historical White Salmon Weir. (C, D) U.S. Fish and Wildlife Service personnel drilling in concrete for installation of eyebolts to hold the submerged cabling.

On August 18th WDFW and the representatives from the WSWG installed 8 foot sections of 4 inch profile angle iron (Figure 2A), 2 eyebolts at each side of the river (Figure 2C and 2D), and a 3/8 inch steel cable across the 120 feet wetted width of the river. Water depth at the riffle directly upstream of the ponds was approximately 3 feet and flows were reduced from 671 to 265 cfs over a 45 minute period and maintained at that level for 3 hours, then increased to 377 cfs for another 2.5 hours. The angle iron, eyebolts and cable were placed along an existing concrete sill that traverses the White Salmon River adjacent to the ponds (Figure 2B). Angle iron pieces 8 feet in length with an attached eyelet in the middle and two 3/8 inch holes drilled approximately 1.5 feet from either end were attached to the concrete sill in succession across the wetted width of the river. At each point of attachment on the sill a bracket with an eyelet was also attached so that each eyelet was approximately 4 feet apart. The 3/8 inch holes were used as anchor sites in the existing concrete sill and a cordless rotary hammer drill equipped with a 42 inch long, 3/8 inch diameter bit were used for drilling holes. Eyebolts installed at both ends of the wetted width and in-line with the angle iron were 12 inches long and 1 inch in diameter. The 3/8 inch steel cable was run through the angle iron eyelets, anchored at each end of the river to the eyebolts, tightened with an adjustable turnbuckle and fastened with cable clamps.

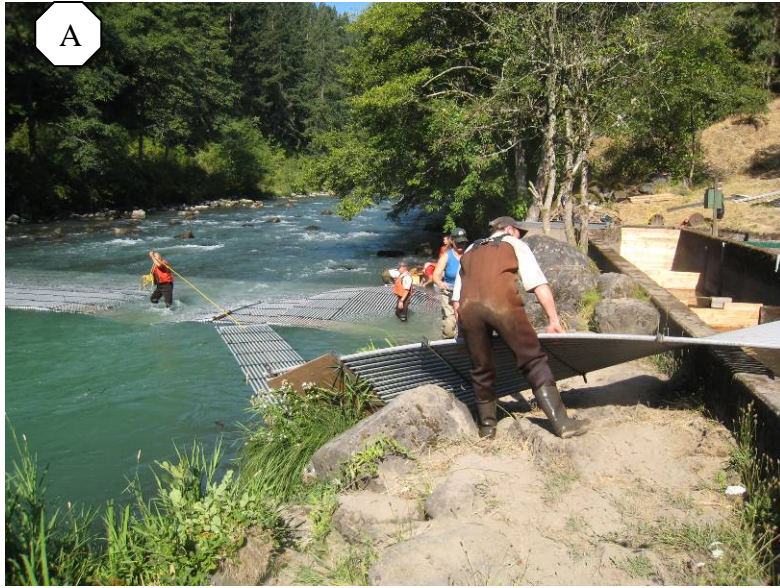
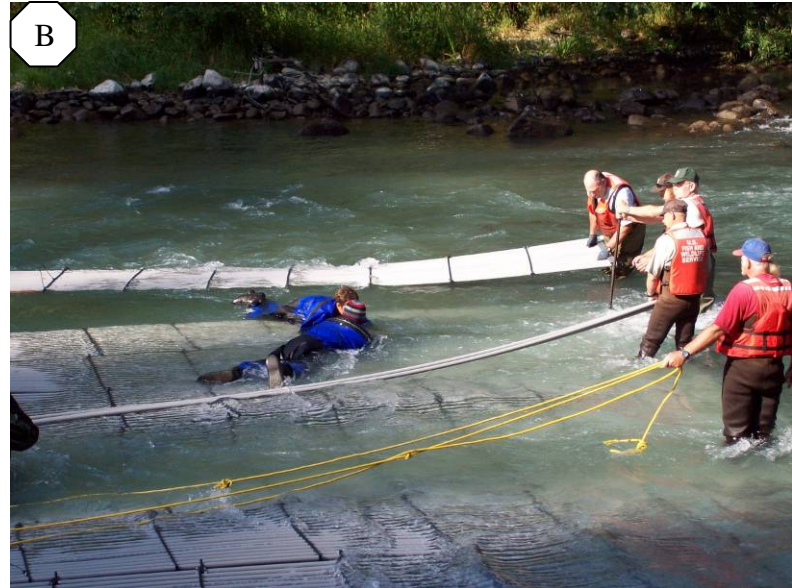
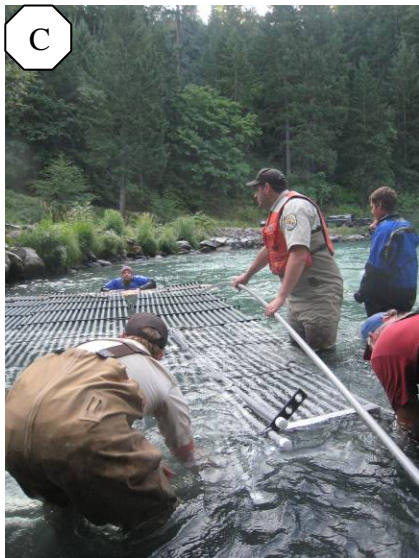
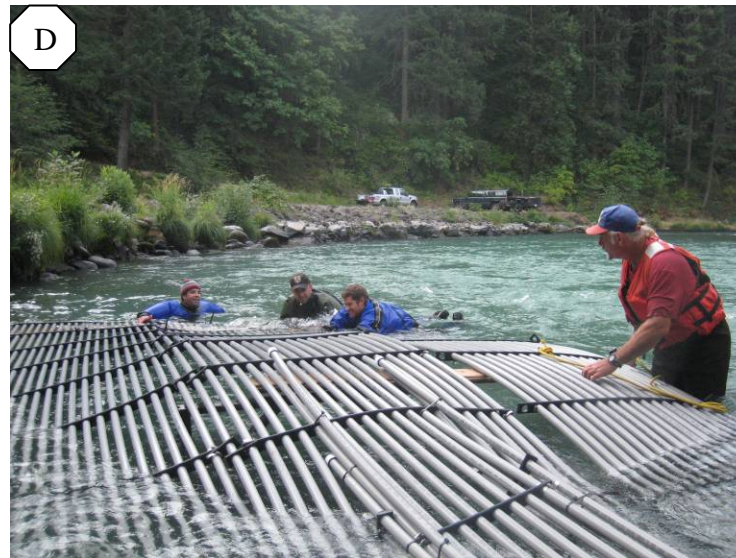
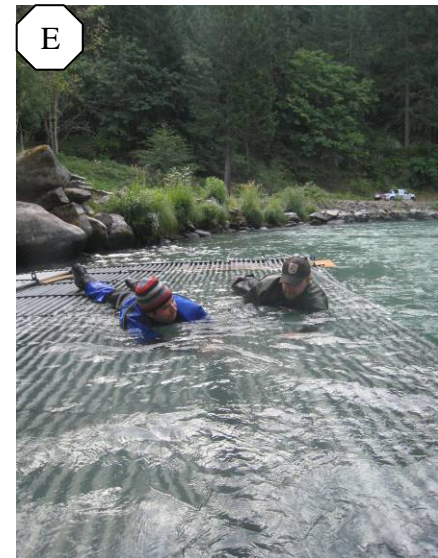
Figure 3. Installation of resistance board weir panels adjacent to the White Salmon Ponds at river mile 1.4 on August 20th, 2009. Prefabricated panels were floated in the river (A) pulled by rope into position for attachment (B) and a connecting pipe (C) was threaded between two panels by personnel positioned at the end of the weir (D) and connected throughout the length of the panel (E). On August 20th, the installation of panels required 14 people and was completed in approximately 3.5 hours and included installation of a video passage system.

During the second flow request on August 20th, the weir panels were affixed to the cable and connected across the wetted width of the river using methods similar to Stewart (2002). Water depth at the riffle site upstream of the ponds was approximately 4 feet and flows were reduced from 627 cfs to 409 cfs over a 45 minute period and sustained that level for 3 hours. After installation, several panels near the thalweg of the river were weighted down to allow fish passage prior to sampling that began on August 25th, 2009. Figure 3 outlines some of the construction and installation of the White Salmon River Resistance Board Weir.

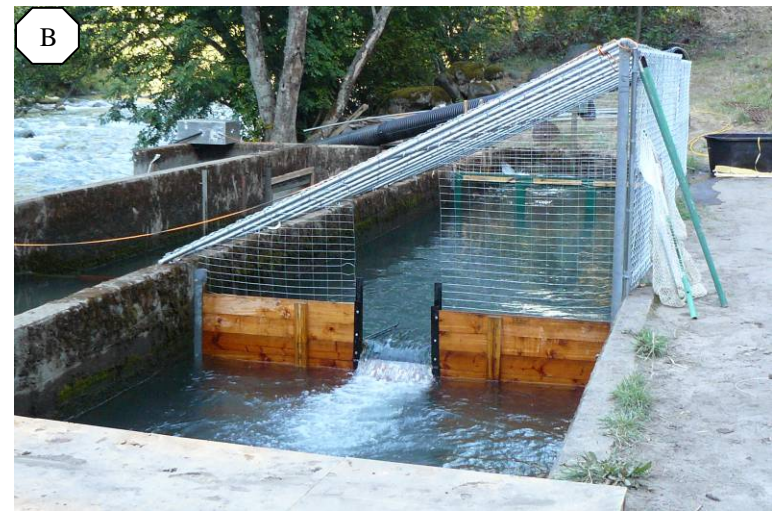
Figure 4. Fish entry and holding points within the White Salmon Ponds during 2009. (A) Navigation path of fish within the White Salmon Ponds during weir operation and collections. This differed from 2008 when entrance into the ponds was at the downstream end of the ponds. (B) Secure holding pen constructed by Spring Creek NFH staff within the upper end of the outer pond. (C) Entrance to the White Salmon Ponds adjacent to the resistance board weir (ponds not in operation). The ladder step shown was added during mid-September 2009 after initial collections did not include LCR fall Chinook salmon. This additional step likely increased access to the ponds for LCR fall Chinook and increased capture efficiency for the remainder of the operation.

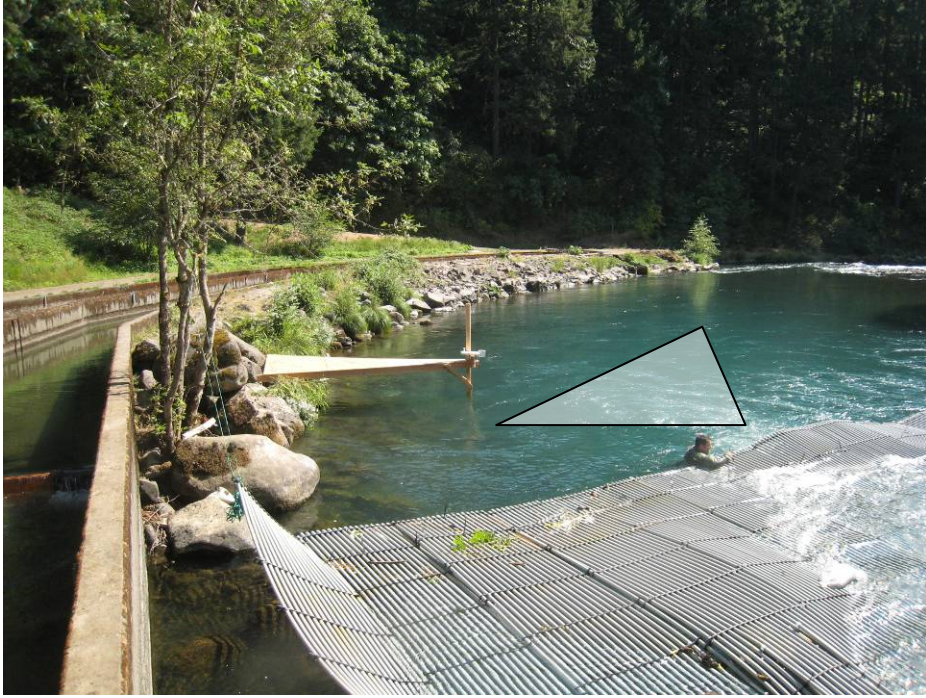
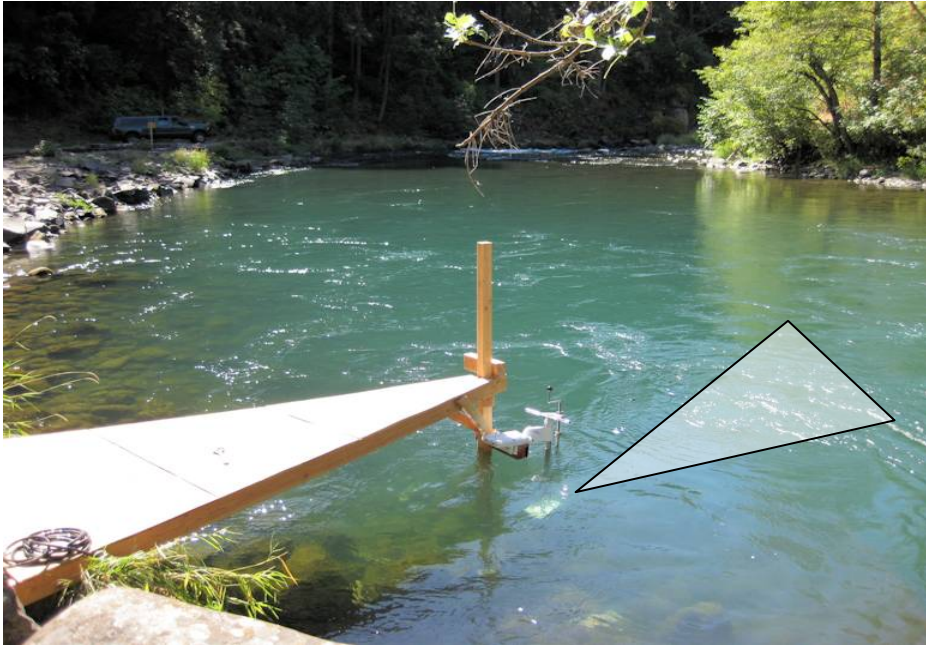
Figure 7. Scaffolding fabricated below the White Salmon River weir with the deployment bracket and DIDSON camera attached. The shaded triangle depicts the area being imaged by the DIDSON camera. The scaffolding was located approximately 18 feet downstream of the weir.

In early September 2009, we fabricated a 9 foot wood scaffolding for mounting an adjustable DIDSON deployment bracket (Figure 7) which the DIDSON camera is mounted to. The bracket can be adjusted for depth, rotational angle and vertical pitch. The bracket and camera were approximately 9 feet from shore and 18 feet downstream of the weir with a camera depth of approximately 5 feet. We used a standard unibody DIDSON which can operate in either high (1.8MHz) or low frequency (1.1MHz) modes. We used the 1.8MHz mode to generate the highest quality images and to accommodate the shorter range of our targets. Operating at this mode the camera can effectively image out approximately 45 feet but we chose to image out 21 feet which is 30 feet from the opposite shore. At this point, the riverbed rises becoming relatively shallow and the number of salmonids present past 30 feet was minimal in our test recordings and field observations. The scaffolding was required to place the camera in the best possible location for imaging fish with respect to the channel configuration below the weir. The cameras beams must be unobstructed and image the portion of channel that most of the fish are using.

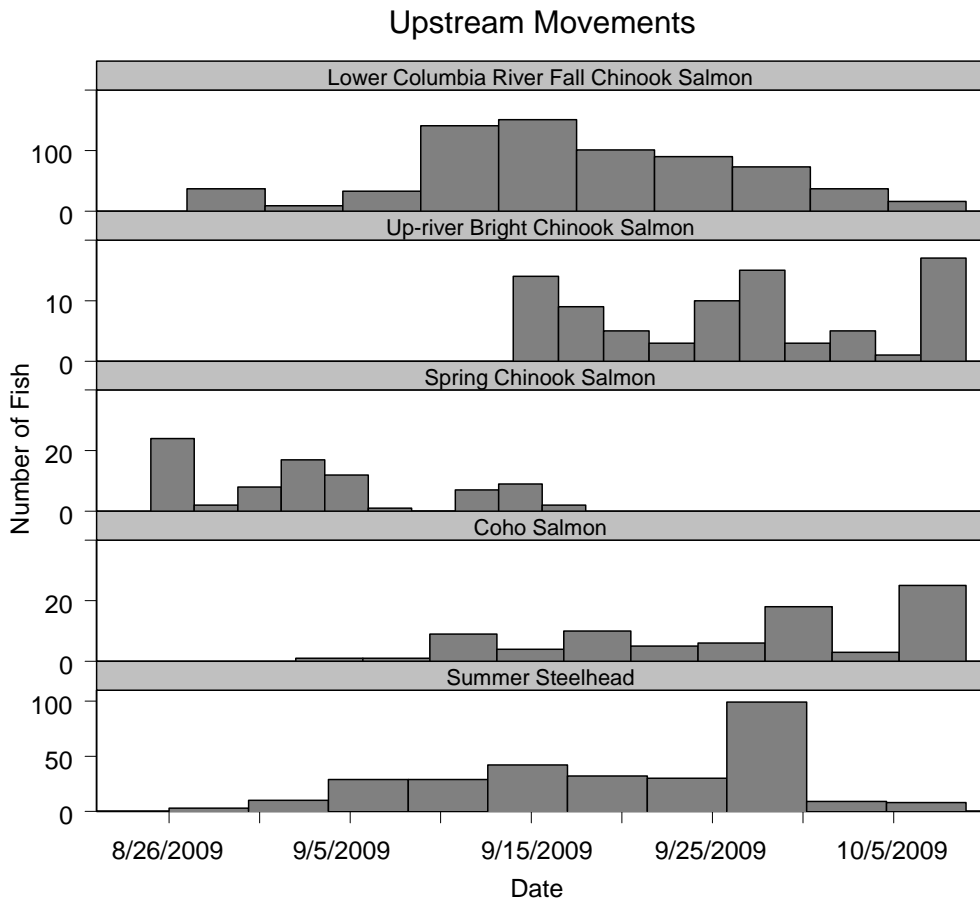
Figure 8. Upstream migration of adult salmonids by date at the White Salmon River weir (RM 1.4) during 2009. A fish was considered an upstream migrant if it was observed traveling upstream through the video passage system or was captured in the collection ponds. Dates of Operation for the video passage system are provided in Table 1.

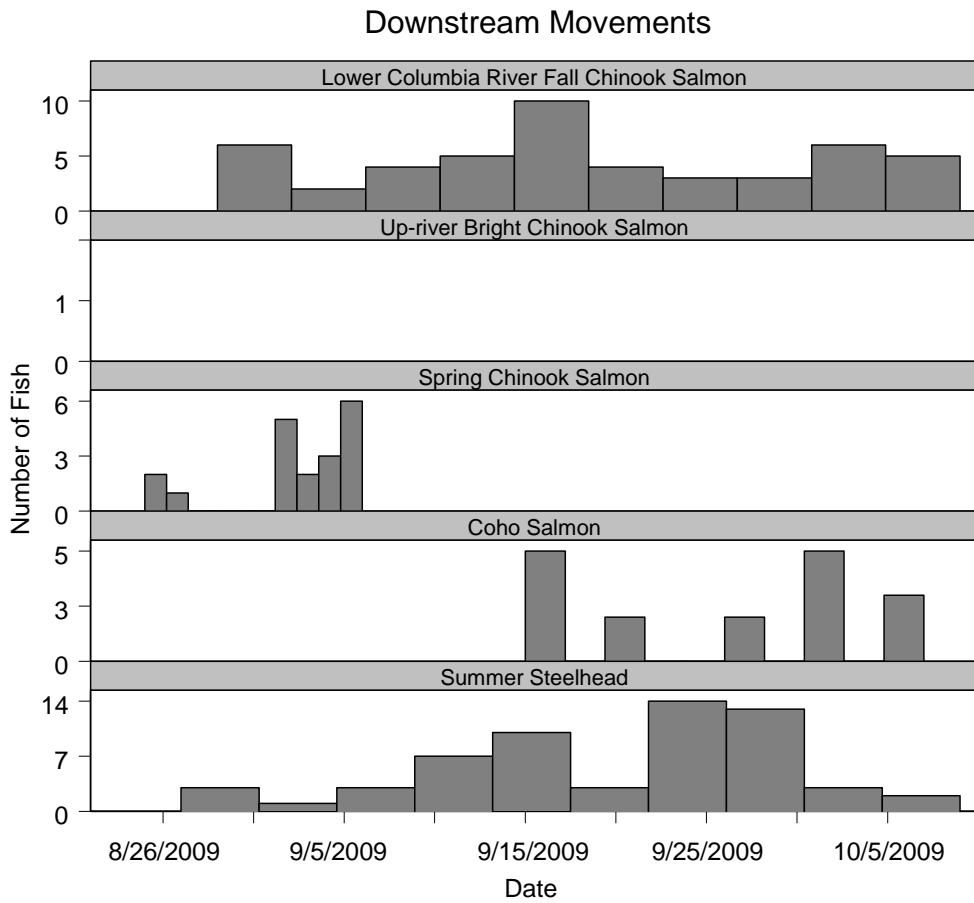
Figure 9. Downstream migration of adult salmonids by date through the video passage system in the White Salmon River weir (RM 1.4) during 2009. Dates of Operation for the video passage system are provided in Table 1.

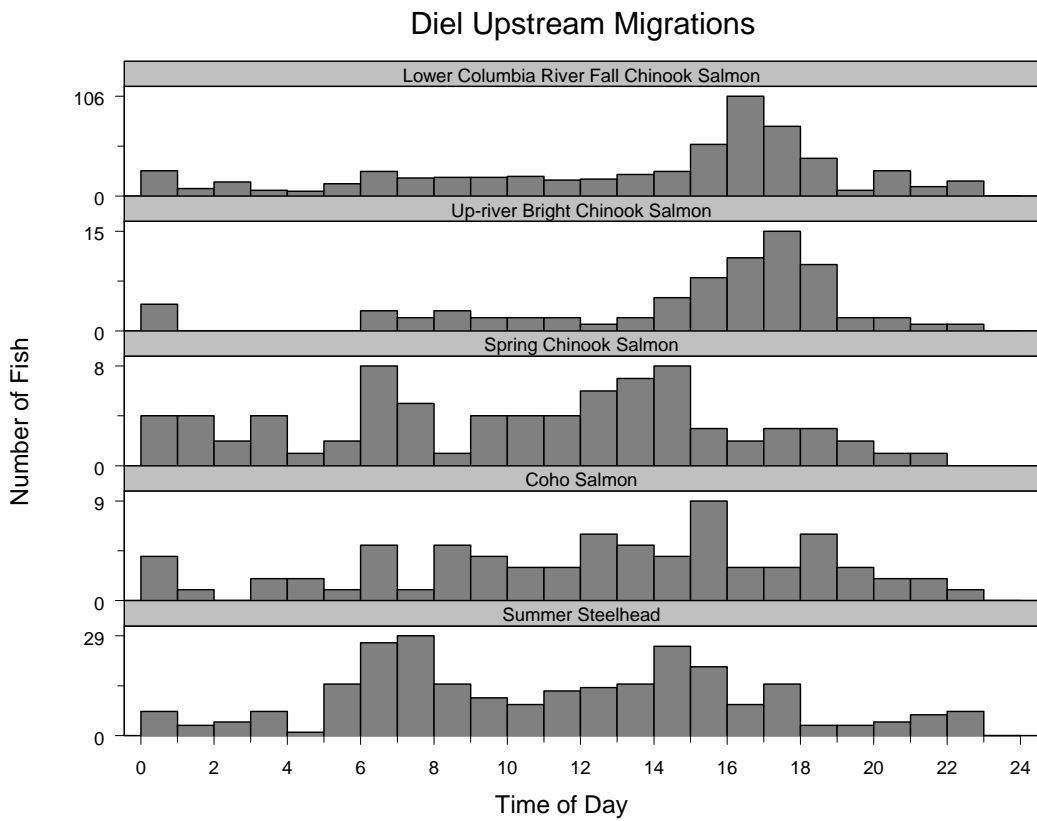
Figure 10. Diel upstream migration of adult salmonids through the video passage system in the White Salmon River weir (RM 1.4) during 2009. Dates of Operation for the video passage system are provided in Table 1.

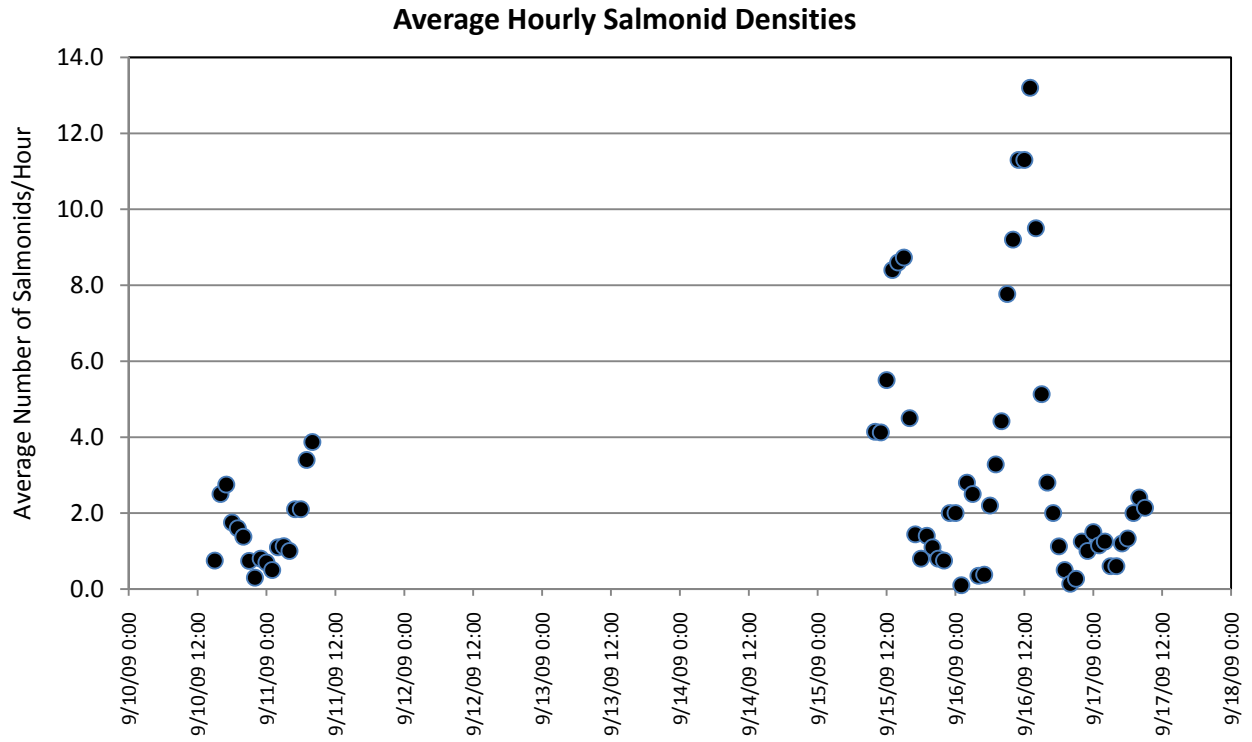
Figure 12. Average hourly salmonid densities for the 66 hours of data acoustic data collected.

We collected a total 66 hours (33 daylight, 33 nighttime) of acoustic video on September 10th, 11th, 15th 16th and 17th (Table 6). Daylight and nighttime was differentiated according to the official daylight hours for White Salmon, WA. A discernable diel pattern of fish densities occurred throughout the monitoring period. Average hourly salmonid densities during the day were 4.1 times higher than densities at night. The highest density observed during the day was 13.2 salmonids/hour and occurred at 1300 hours. Conversely, the highest hourly density at night was 2.8 salmonids/hour (Figure 12). The overall pattern is best depicted in a 24 hour time series collected on September 16th (Figure 13).

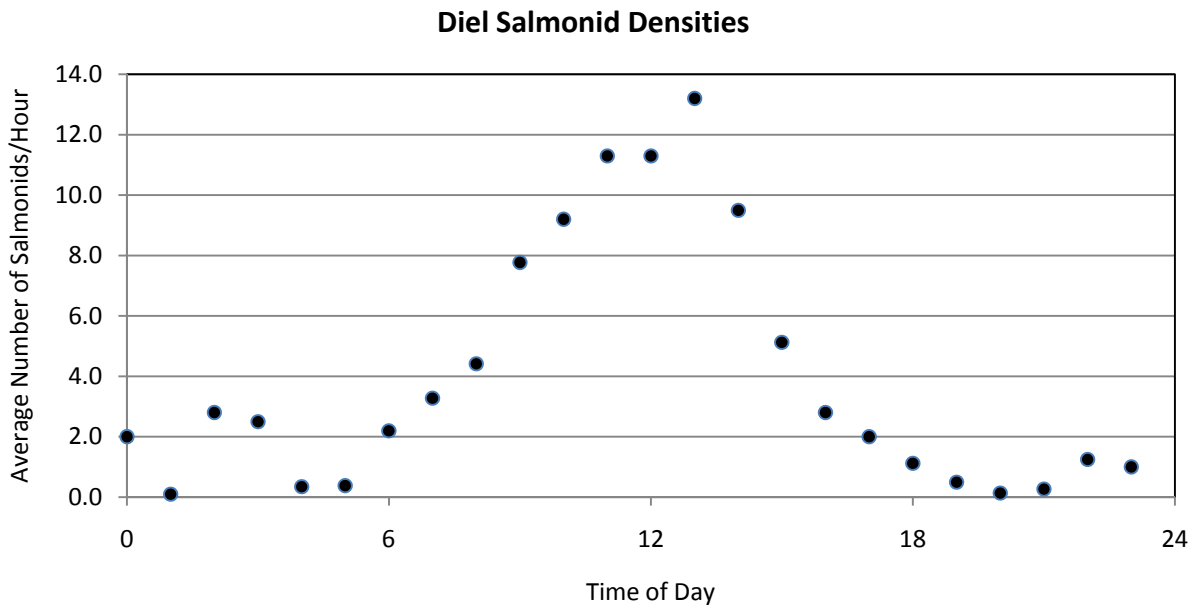
Figure 13. Average hourly salmonid densities for a 24 hour time series on September 16th 2009.
