# Clear Creek Dam Fish Passage Assessment

## FINAL REPORT

Thomas, J.A. and P. Monk. 2016. Final Report for the Clear Creek Dam Fish Passage Assessment. United States Fish and Wildlife Service, Mid-Columbia River Fishery Resource Office, Yakima Sub-Office. Yakima, WA.

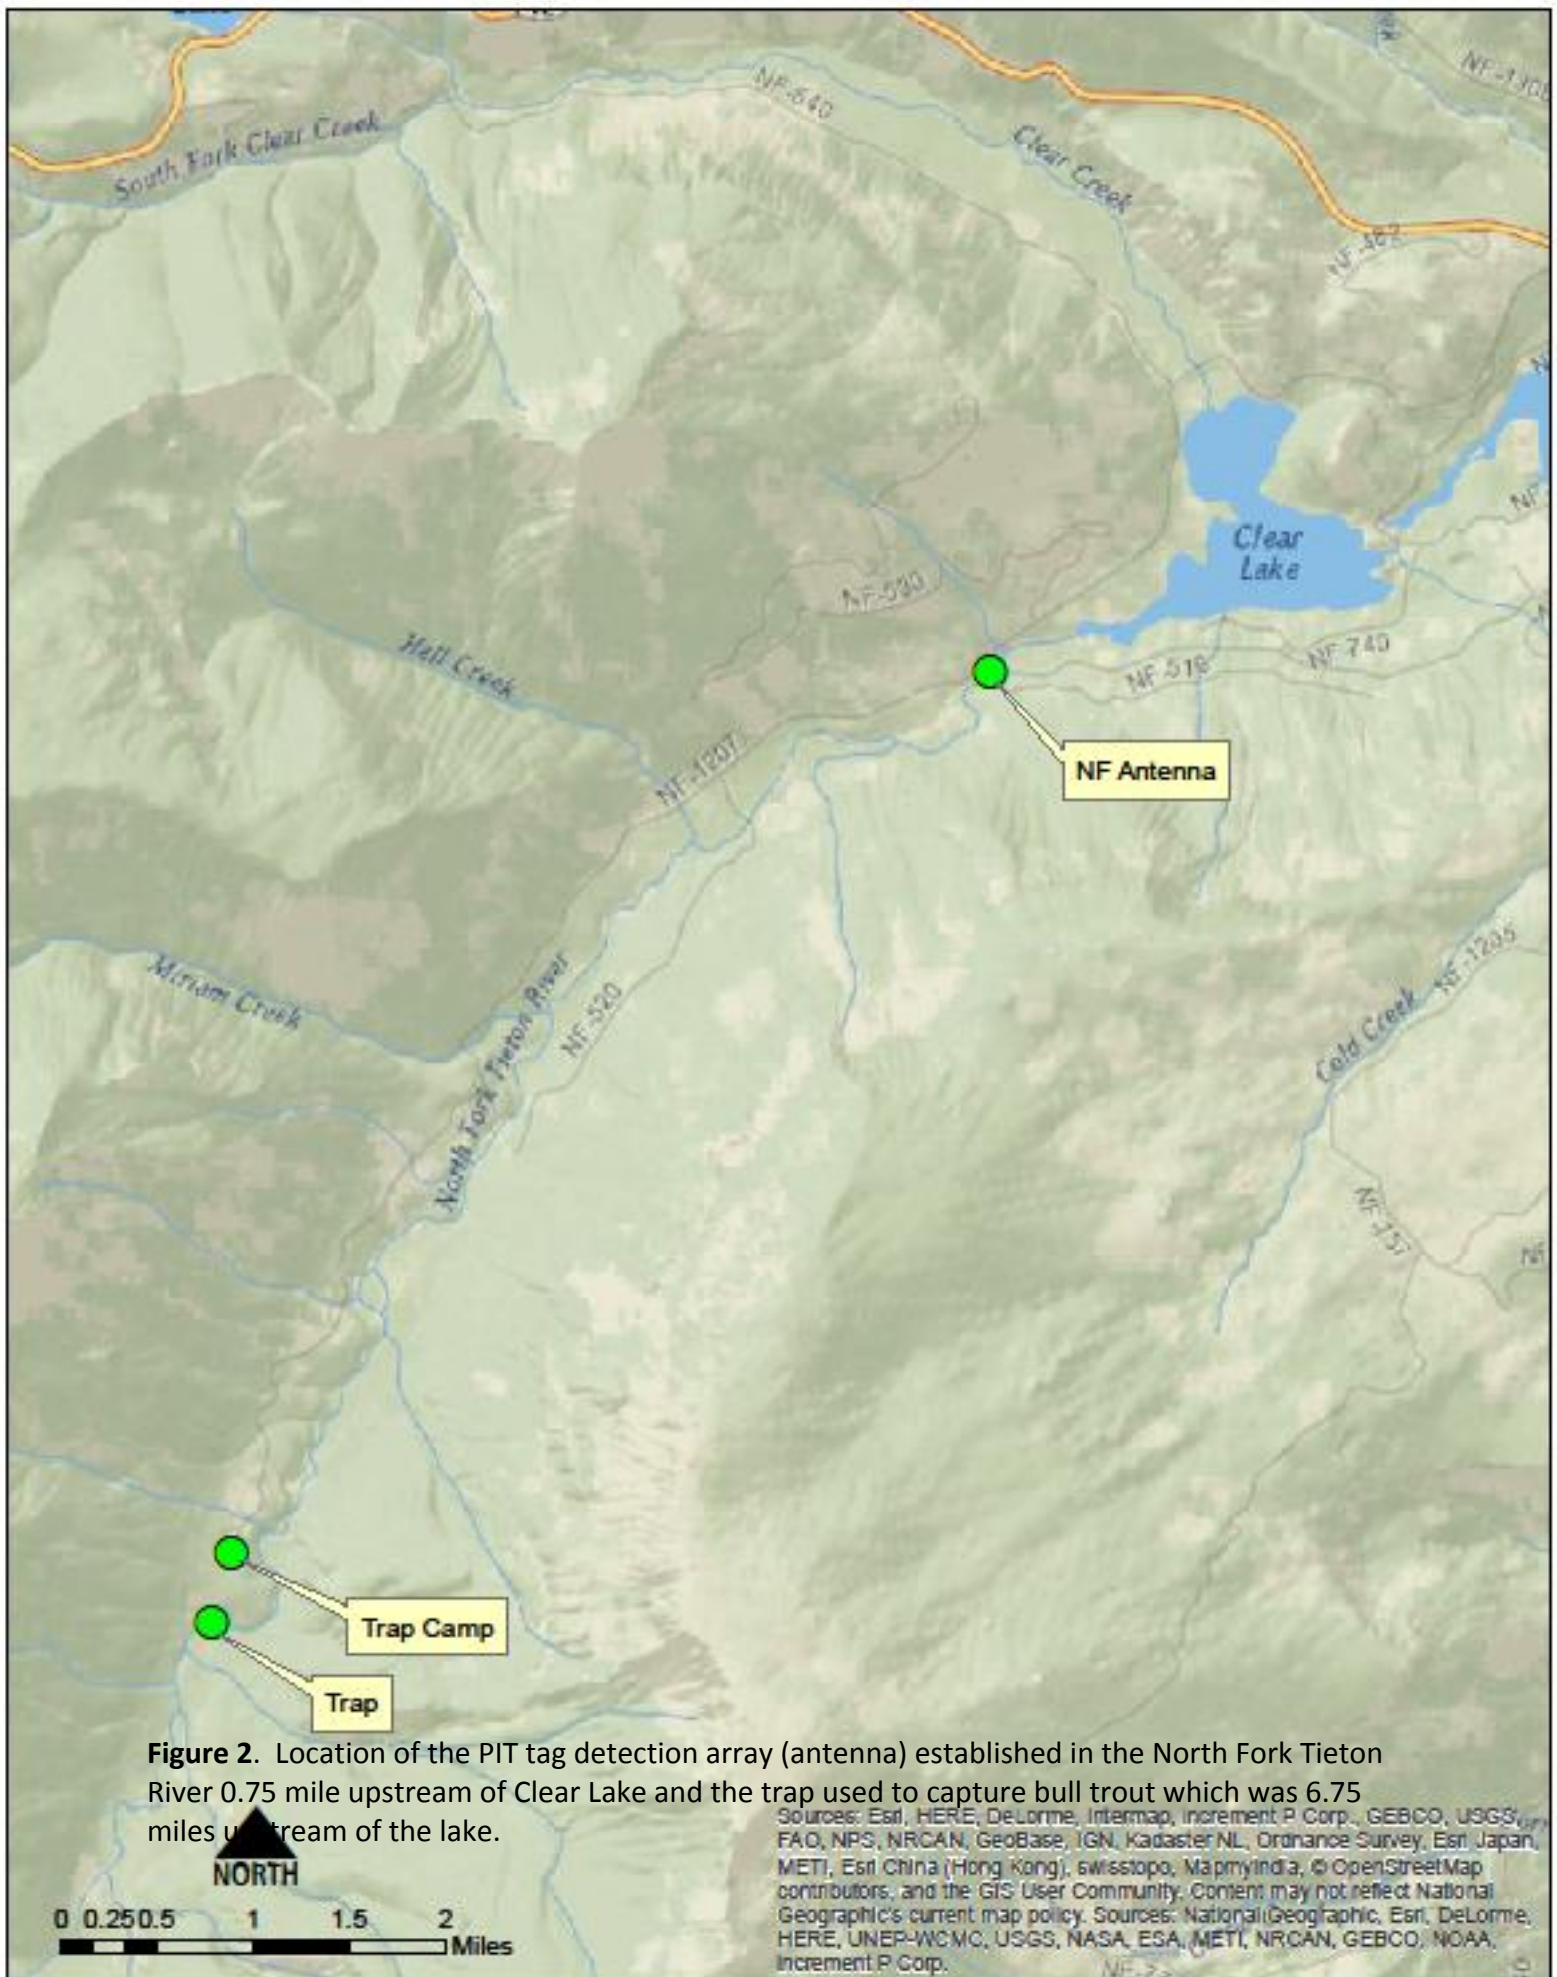
**Figure 2.** Location of the PIT tag detection array (antenna) established in the North Fork Teton River 0.75 mile upstream of Clear Lake and the trap used to capture bull trout which was 6.75 miles upstream of the lake.

**Figure 2.** Location of the PIT tag detection array (antenna) established in the North Fork Tieton River 0.8 mile upstream of Clear Lake and the trap used to capture bull trout which was 6.75 miles upstream of the lake. .... 9

Access to the site was as good as one can expect along the upper NF Tieton River. The NF Tieton road (FS 1207) runs adjacent to the river for about six miles ending at a turnaround at Scatter Creek on the wilderness boundary. However, for almost all of this distance the road is rarely close to the river and thick forest separates the two. Direct access to the river is not any easier adjacent to the turnaround but a cleared trail enters the wilderness there and essentially ends at the trap site. While it was still necessary to pack the trap components to the trap site, doing so on an established trail was considerably easier than bushwhacking to an alternative site along the road. There was also a spacious primitive campsite at the turnaround which served as the base camp for the crew manning the trap.

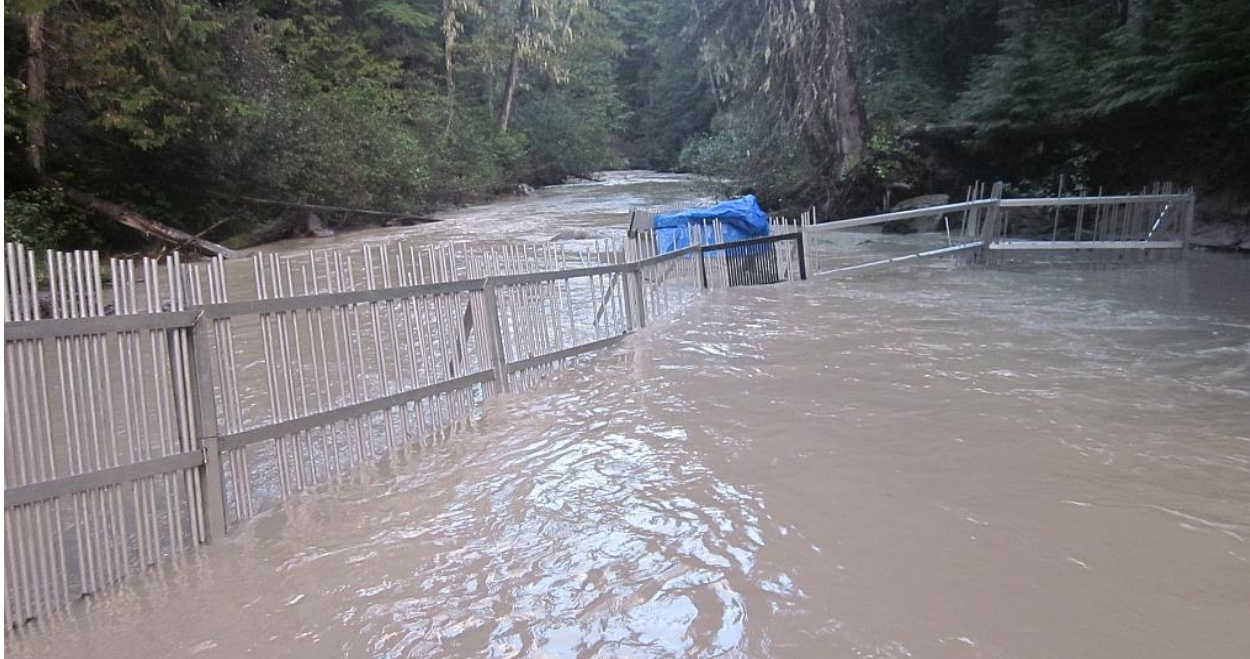
**Figure 3.** NF Tieton River fish trap after the high flow event on September 22, 2013. The photo was taken the next day after the river had receded.

**Figure 3.** NF Tieton River fish trap after the high flow event on September 22, 2013. The photo was taken the next day after the river had receded..... 21

The second high flow event began the afternoon of September 27. The river rose gradually until the early morning hours of September 29 when, fed by over a day of heavy rainfall, the stage began to rise rapidly. Efforts to save the trap in the pre-dawn hours were halted because of dangerous conditions and a few hours later the trap disintegrated and washed downriver (Figure 4). All of the weir and trap box components were recovered from as much as 200 yards downstream a few days later after the stage had receded.

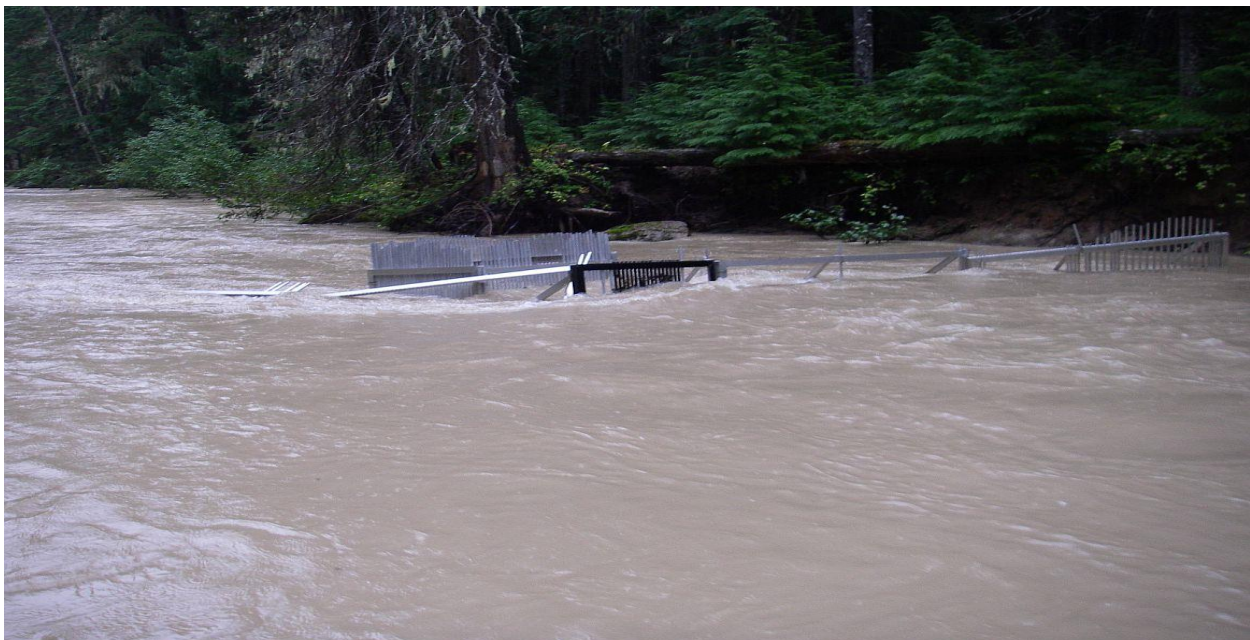
**Figure 4.** NF Tieton River fish trap during the high flow event which occurred at the end of September, 2013. This photo was taken the morning of September 29.

**Figure 4.** NF Tieton River fish trap during the high flow event which occurred at the end of September, 2013. This photo was taken the morning of September 29. .... 21

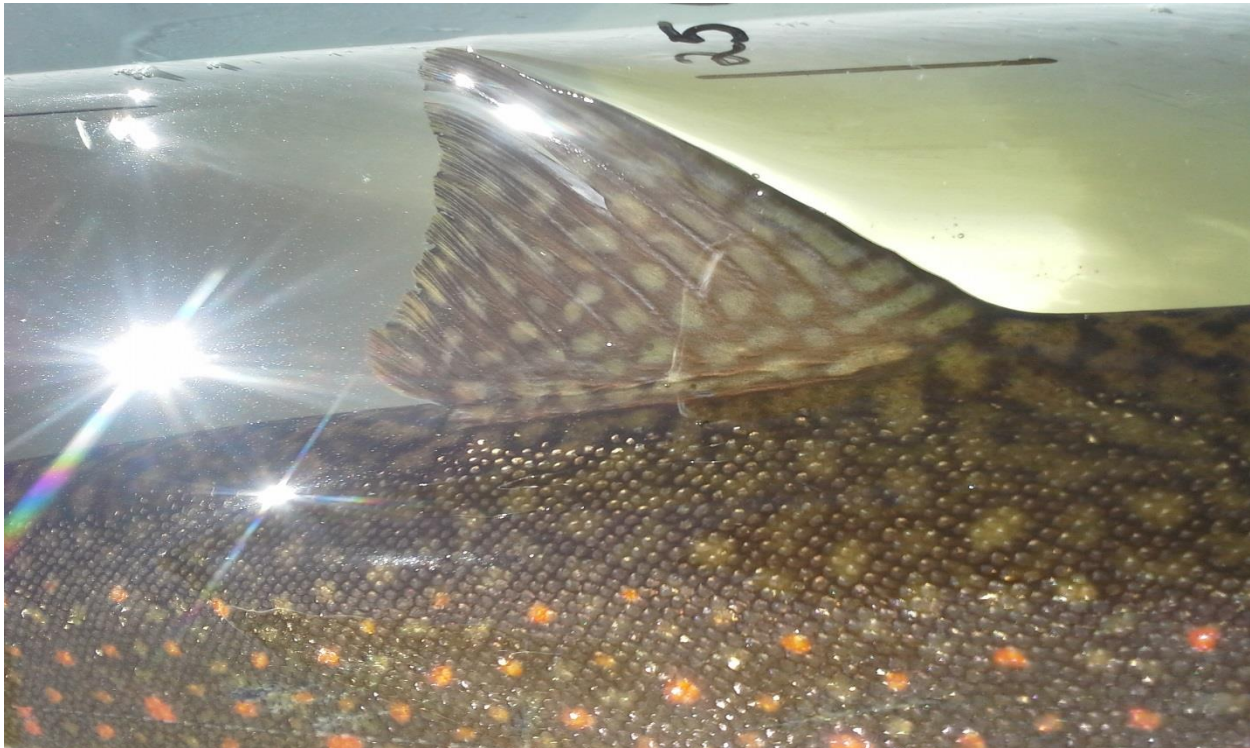
**Figure 5.** Dorsal fin of an adult Bull Trout suspected of being a hybrid (Bull Trout x Brook Trout) which was caught below Clear Creek Dam on July 2, 2015. Note the spots on the fin. The dorsal fin of a genetically pure Bull Trout would be clear. Genetic analysis revealed that this fish was a hybrid. Another with similar markings was not.

**Figure 5.** Dorsal fin of an adult Bull Trout suspected of being a hybrid (Bull Trout x brook trout) which was caught below Clear Creek Dam on July 2, 2015. Note the spots on the fin. The dorsal ..... 25

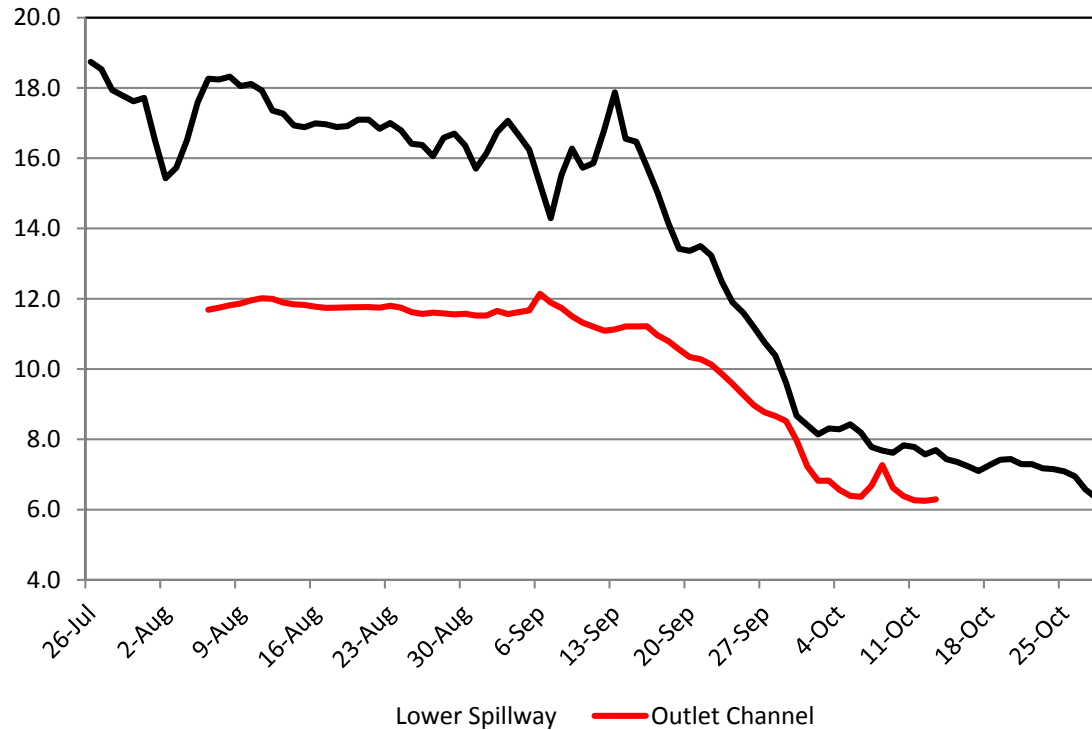
**Figure 6.** Average daily water temperatures (°C) from late-July through the end of October, 2013 in the spillway and outlet channels of Clear Creek Dam on the lower NF Tieton River

**Figure 6.** Average daily water temperatures (°C) from late-July through the end of October, 2013 in the spillway and outlet channels of Clear Creek Dam on the lower NF Tieton River ..... 28

Water temperatures at the top of the spillway (i.e. the upper ladder) and the bottom tracked closely and will not be differentiated here. On July 25 the mean daily water temperature in the spillway channel exceeded 18°C. The mean remained above 15°C, the temperature believed to limit Bull Trout distribution (Allan 1980; Brown 1992; Fraley and Shepard 1989; Goetz 1991), until September 17 before beginning a steady decline (Figure 6). Temperature data for the outlet channel were more limited because high releases from the dam had washed the data logger closer to the stream bank and it was left in the dry after October 13. However, by that time average water temperatures in both the outlet and spillway channels were fairly similar and below 8°C. This was not the case through August and most of September when temperatures were much cooler in the outlet channel. The logger in the NF Tieton River only collected data for 19 days. It ran out of storage space on August 19 because it had mistakenly been set to record data every minute. The data that were collected showed average daily water temperatures ranging from 10-11.5°C.

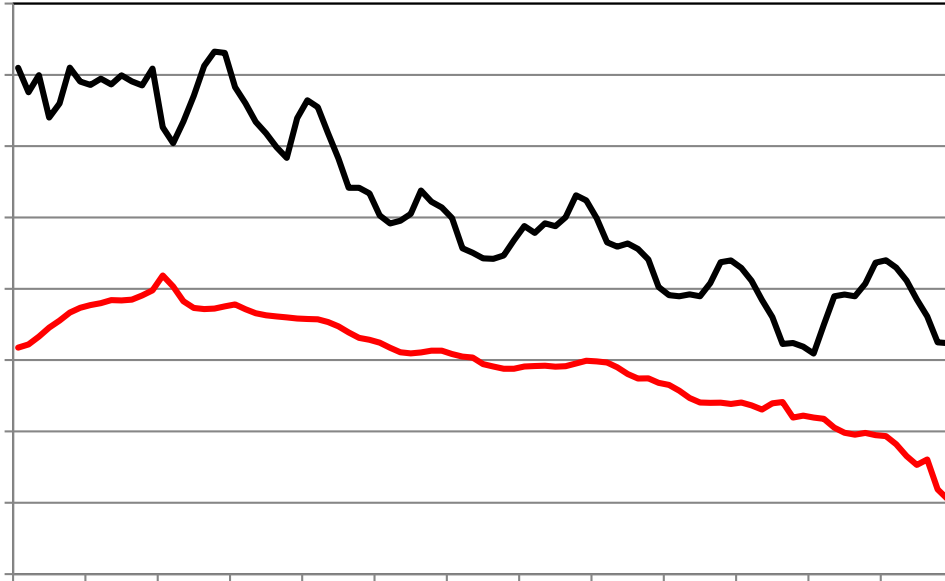
**Figure 7.** Average daily water temperatures (°C) from August 1 through the end of October, 2014 in the spillway and outlet channels of Clear Creek Dam on the lower NF Tieton River

Between July 30 and October 28 average daily water temperatures in the NF Tieton River ranged from 4.7-11.9°C with the highest temperatures ( $\geq 11^\circ\text{C}$ ) generally occurring the middle

two weeks of August. After September 1 average daily temperatures were below 10°C for all but one day.

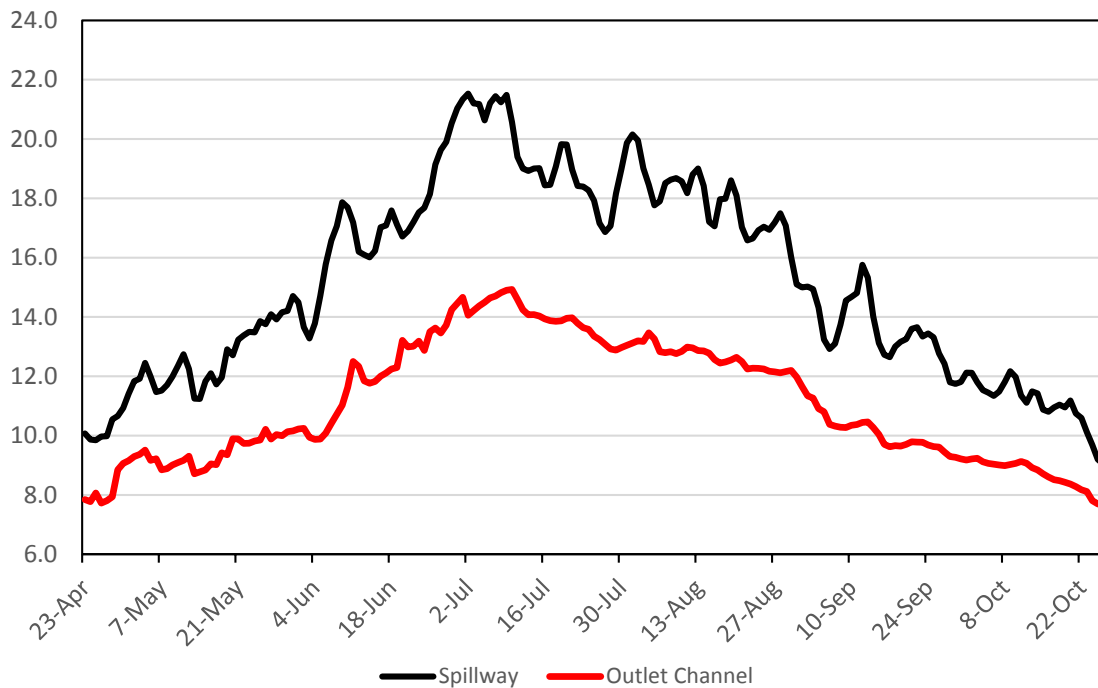
**Figure 8.** Average daily water temperatures (°C) from April 23 through the end of October, 2015 in the spillway and outlet channels of Clear Creek Dam on the lower NF Tieton River

In 2015, the mean daily water temperature in the spillway channel first exceeded 15°C on June 6 where it remained until August 31. This temperature was also exceeded for two days in mid-September and not until September 14 did the mean drop below 15°C for good. During this period mean daily water temperatures in the spillway channel exceeded 20°C for 12 consecutive days in late-June and early July, topping out at 21.5°C on both July 2 and July 9. In contrast, the mean daily water temperature in the spillway never exceeded 15°C (Figure 8). From June 6 through September 14 temperatures in the outlet channel were 5.1°C cooler on average, the difference ranging from 2.4°C late in the period to 7.5°C in early July. The lowest mean daily temperature reached in the spillway, 9°C on October 27, was present in the outlet channel for 33 days including almost the entire month of October.

Mean daily water temperatures in the NF Tieton River ranged from 4.9 - 13.7°C. The high end of this range was about 2°C higher than the two previous years owing to the fact that 2015 was extraordinarily warm, a near historic drought year with significantly diminished stream flows. The average monthly water temperatures (°C) in the river for the months of May, June, July, August, September and October were 7.8, 10.3, 12.5, 11.8, 8.9 and 7.5, respectively.

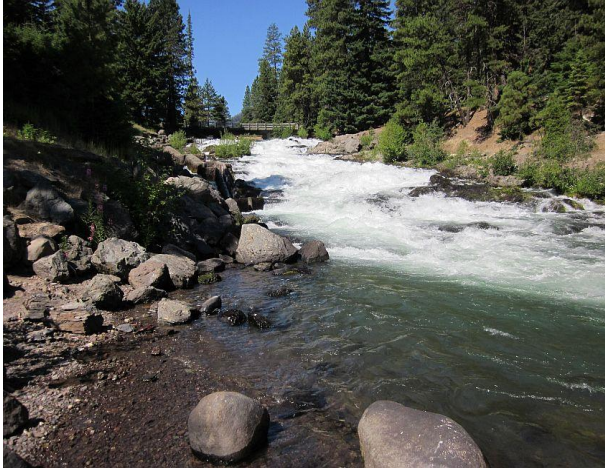
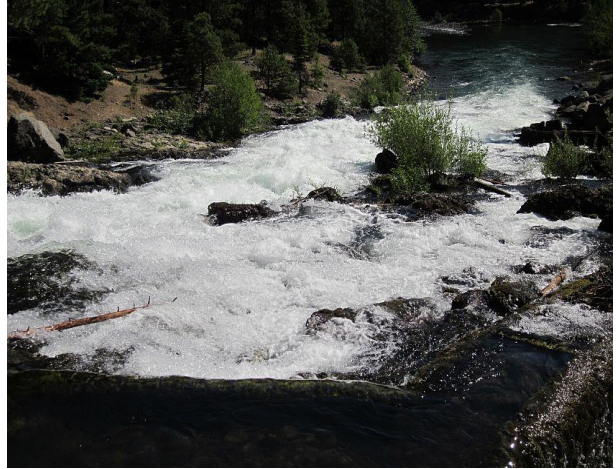
Lower spillway channel at Clear Lake elevation of 3011.8 feet

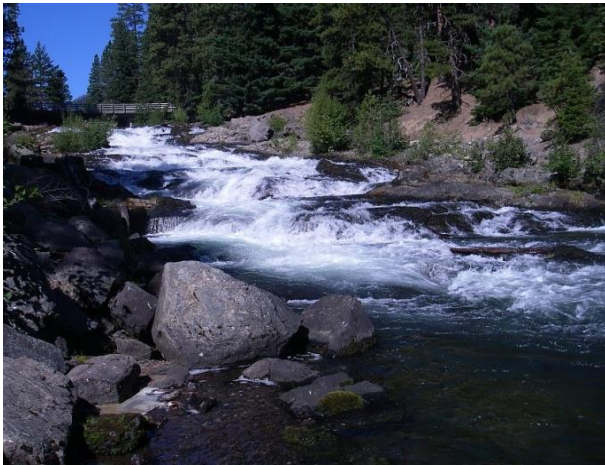
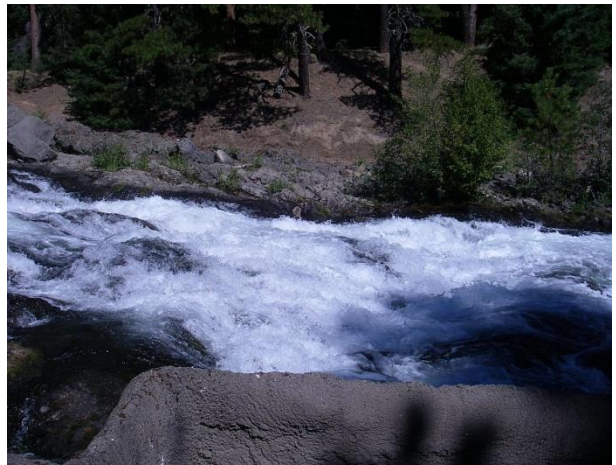
Lower spillway channel at Clear Lake elevation of 3011.6 feet

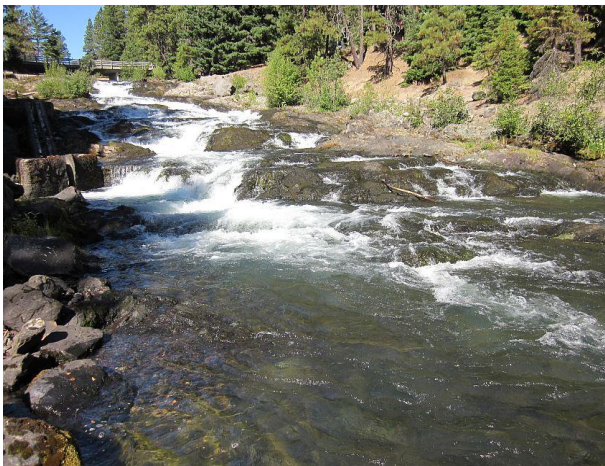
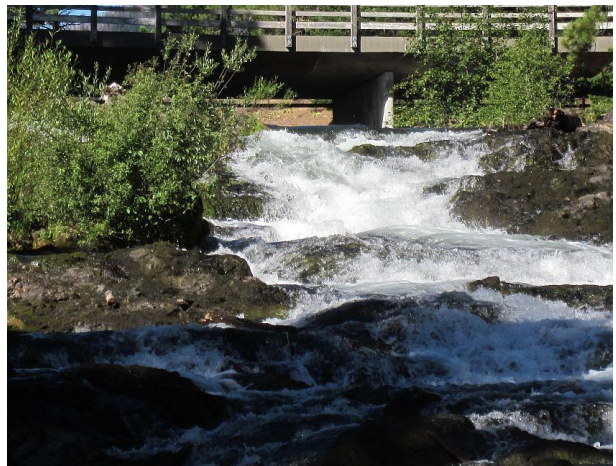
Lower spillway channel at Clear Lake elevation of 3011.4 feet

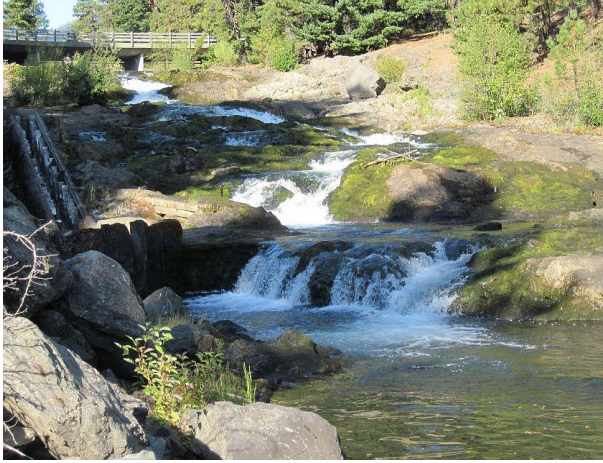
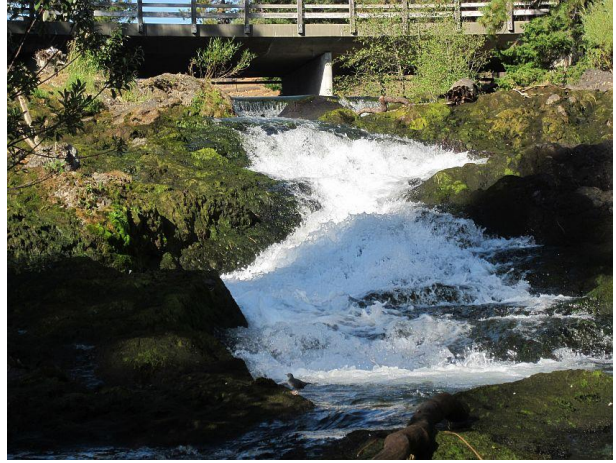
Lower spillway channel at Clear Lake elevation of 3011.0 feet (spillway weir crest elevation)

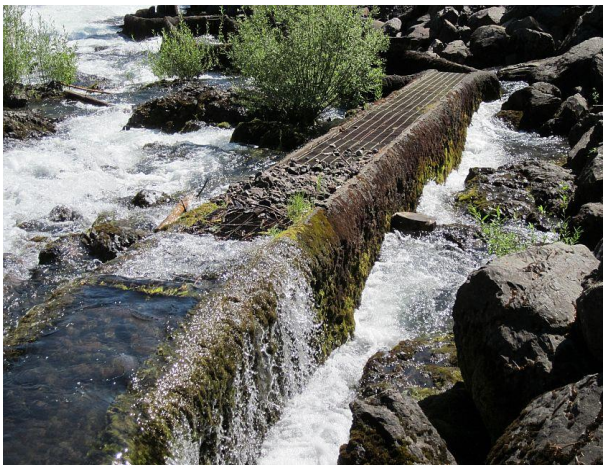
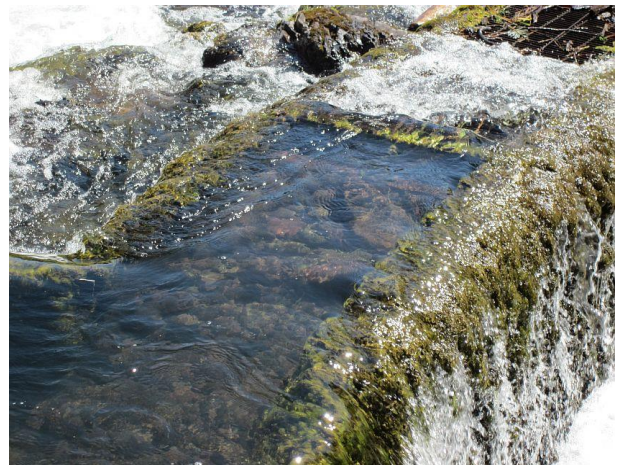
Upstream terminus of the Denil ladder completely clogged with cobble and gravel

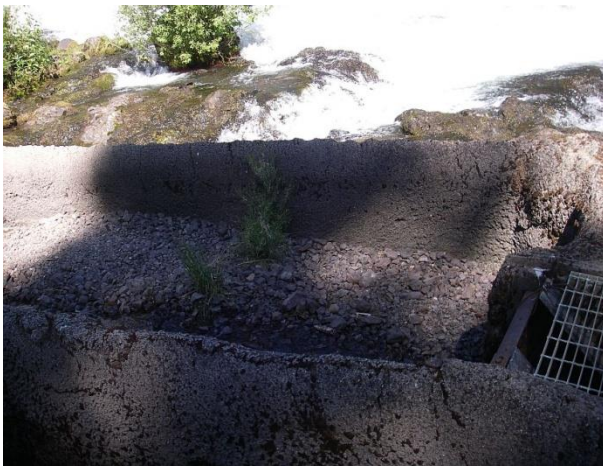
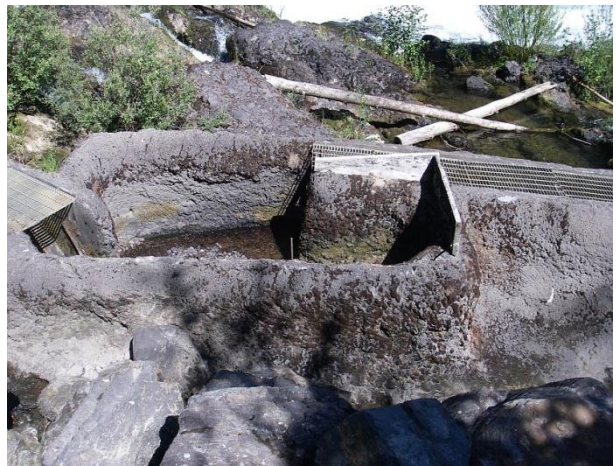
Totally dewatered downstream sections of the Denil ladder

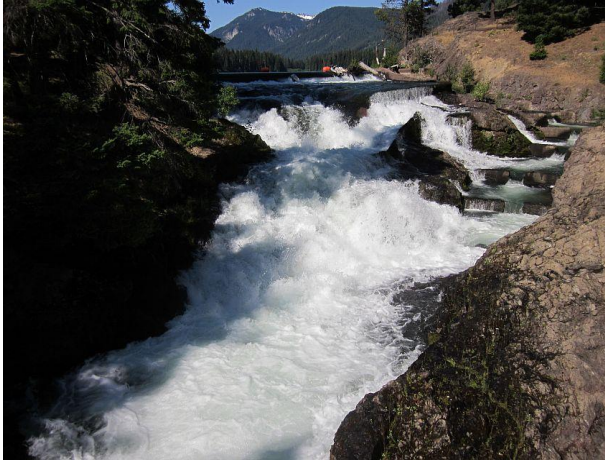
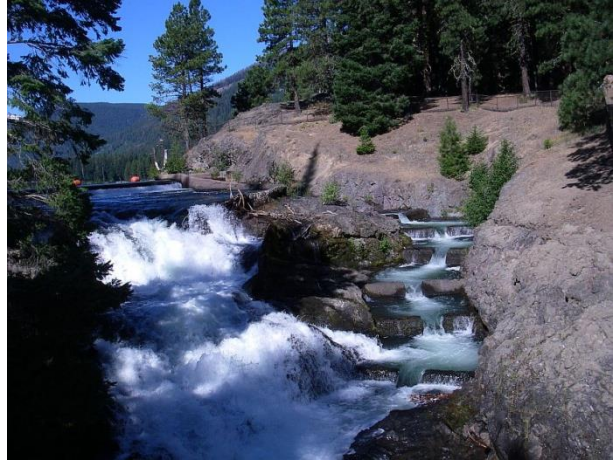
Upper spillway channel at lake elevation 3012.2 feet (left) and 3011.6 feet (right)

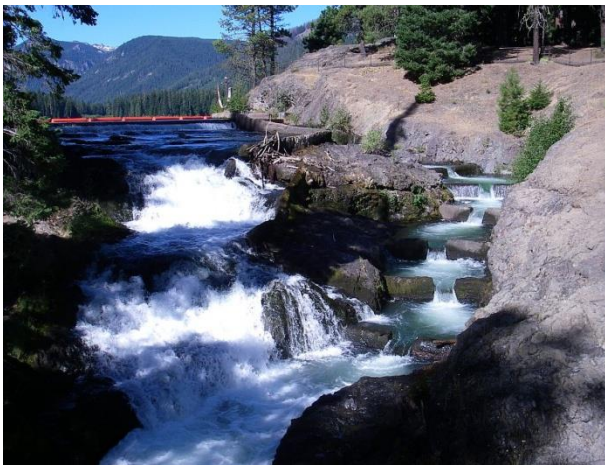
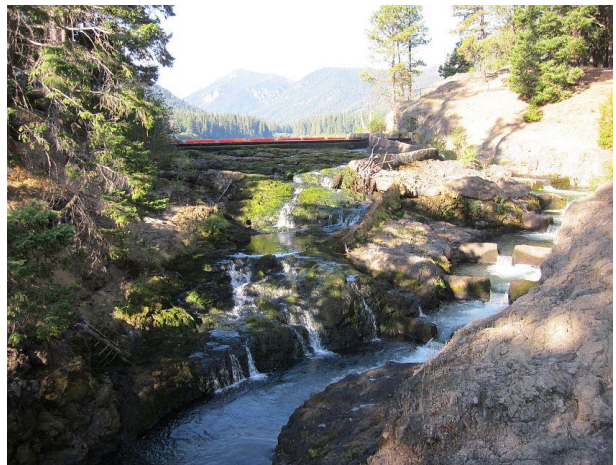
Upper spillway channel at lake elevation 3011.4 feet (left) and 3011.0 feet (right)

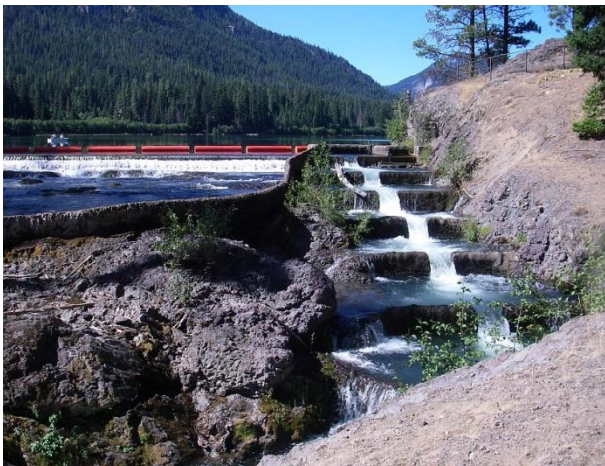
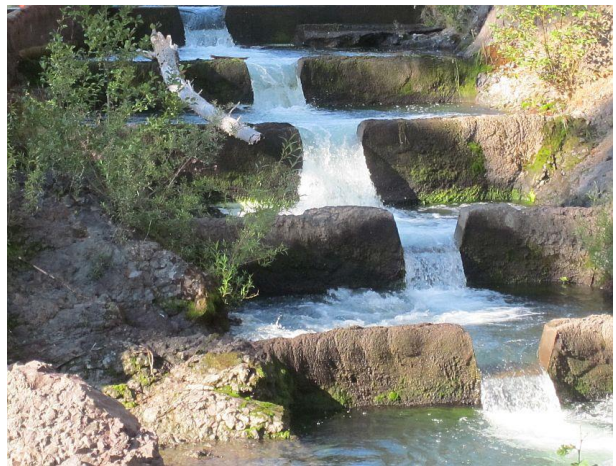
Pool-and-weir fish ladder in upper spillway channel

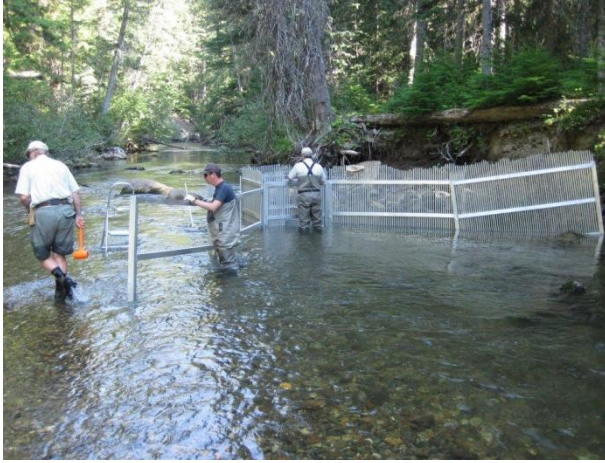
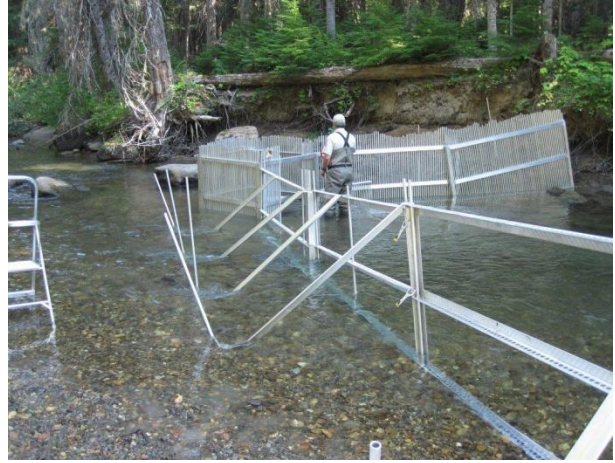
Weir and trap installation on the North Fork Tieton River (September 17, 2012)

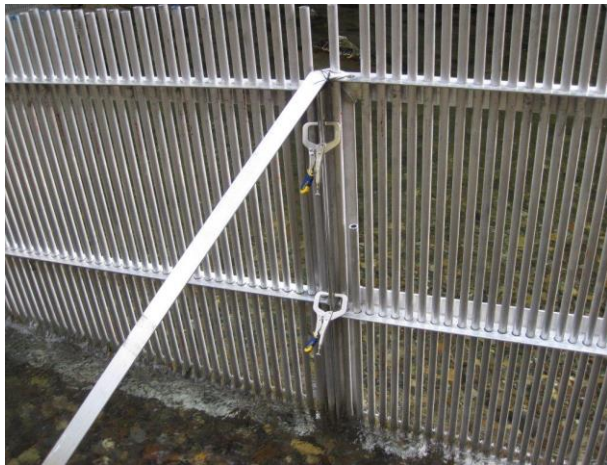
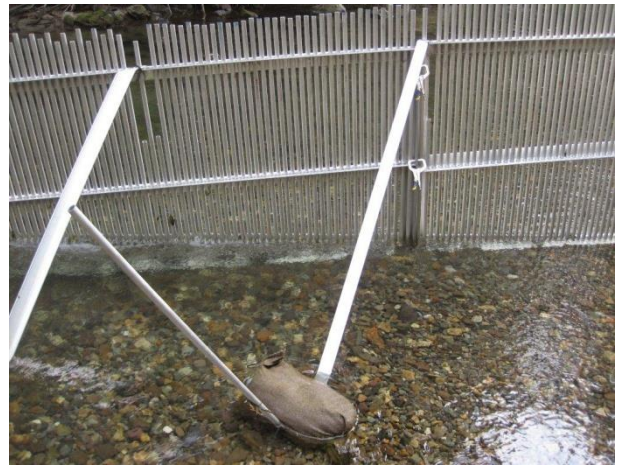
Weir and trap installation on the North Fork Tieton River (September 17, 2012)

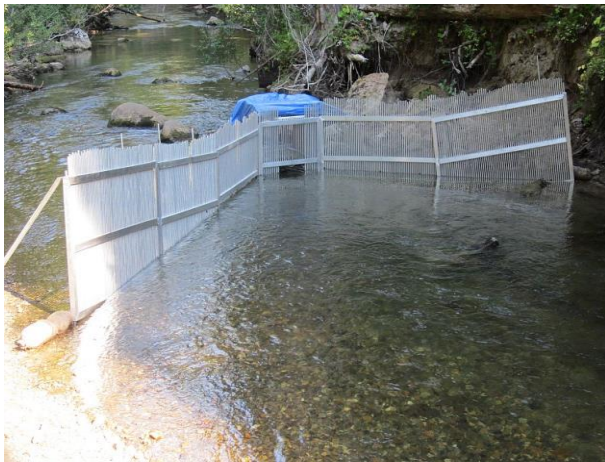
Completed picket-weir and box trap

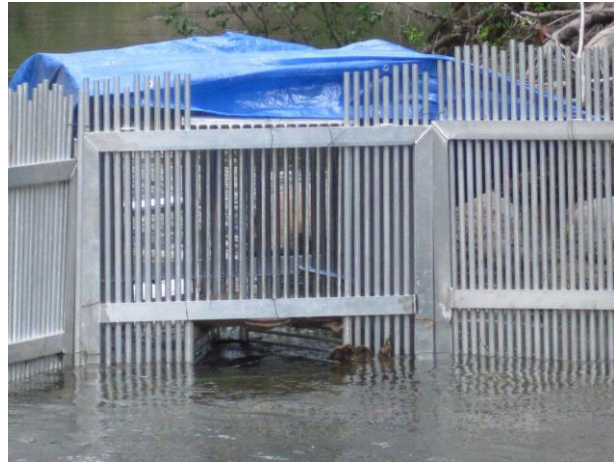
The capture box

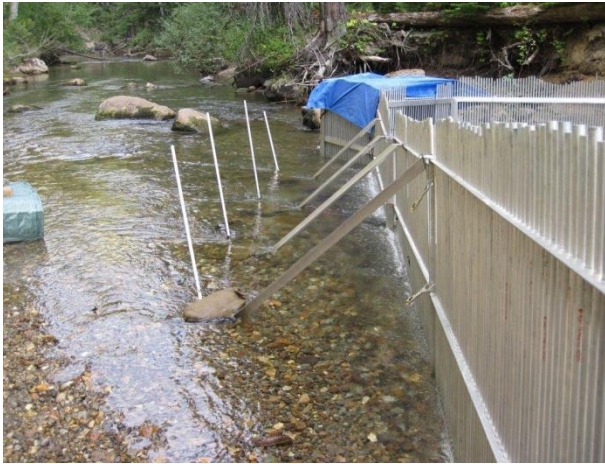
Downstream side of trap

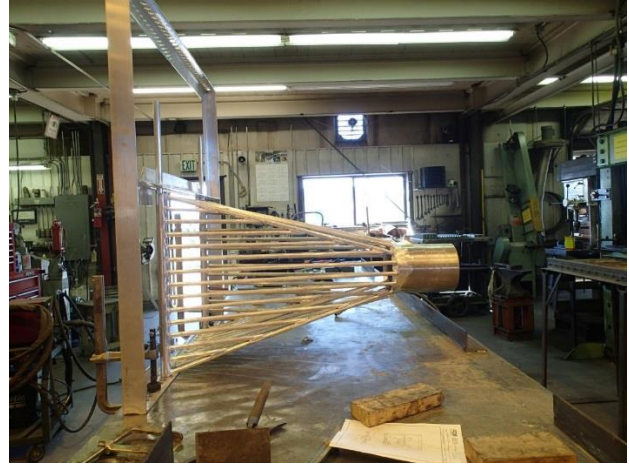
Modification to the trap entrance in 2013

Having noted the escape of two Bull Trout from the capture box during the first year the trap was deployed (2012) and avoidance behavior (trap shyness) displayed by a few Bull Trout approaching the trap entrance, the trap was modified for use in 2013. The original trap box was directly connected to adjacent weir panels. The entrance to the trap was flat and perpendicular to the current with two wings extending into the trap where fish would pass through a vertical opening 4-5 inches wide. It was thought that trapped fish would be disinclined to go back through this opening but that turned out to be false on at least a couple of occasions. The entrance was modified so that a caged cone extended about three feet back from the entrance. This cone led to a 10-inch diameter opening to which a four-foot section of PVC pipe was attached. This pipe extended about two feet into the trap and was approximately six inches above the stream bed inside it. A burlap sleeve was then affixed to the end of the pipe to further dissuade captured fish from finding the opening. The entrance to the trap was painted flat black to minimize avoidance behavior (all modifications were done WDFW's Region 3 screen shop). Also, in response to higher streamflows observed after the first year of the study,

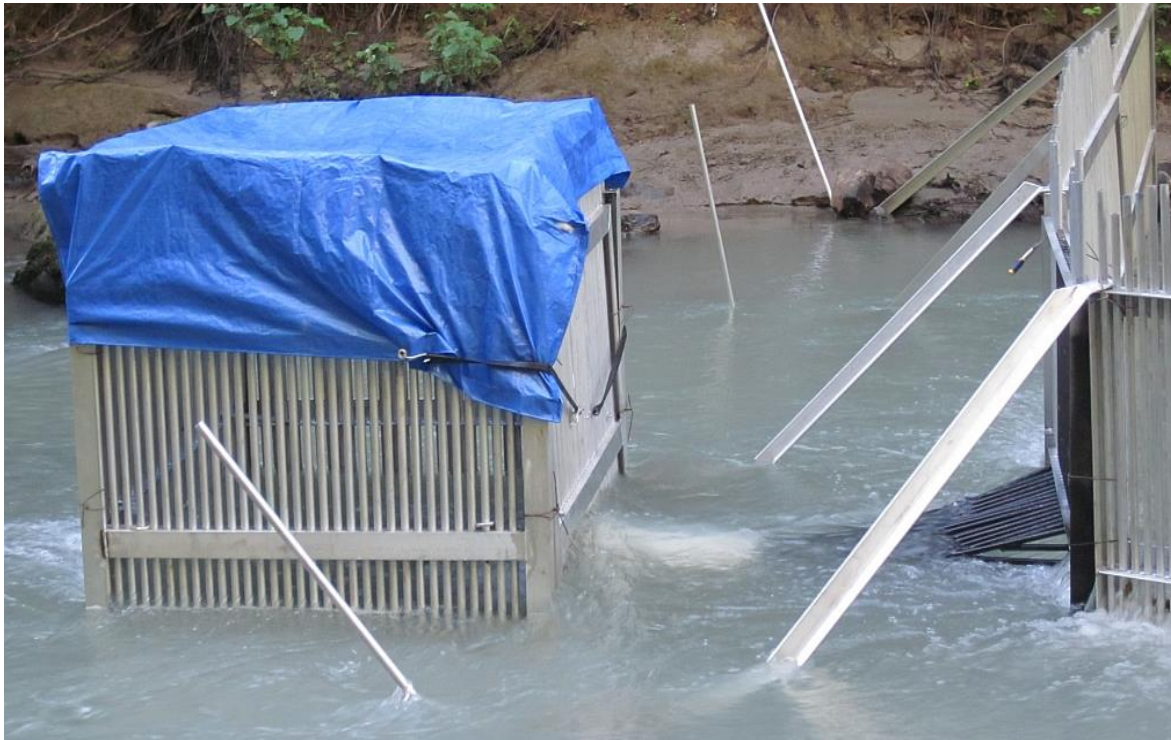
The modified configuration of the trap used in 2013. Note the modified entrance leading to the PVC pipe extending into the trap. The trap itself sits about five feet from the entrance.

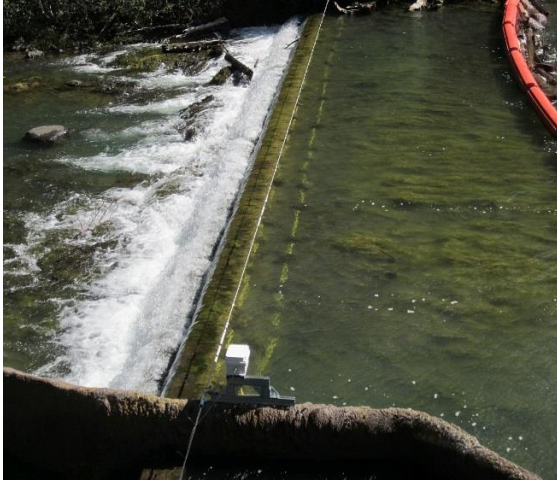
Upper spillway PIT tag detection antenna

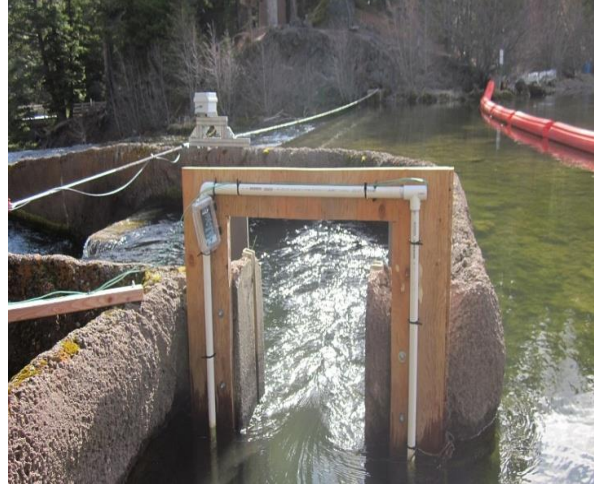
Upper ladder PIT tag detection antenna

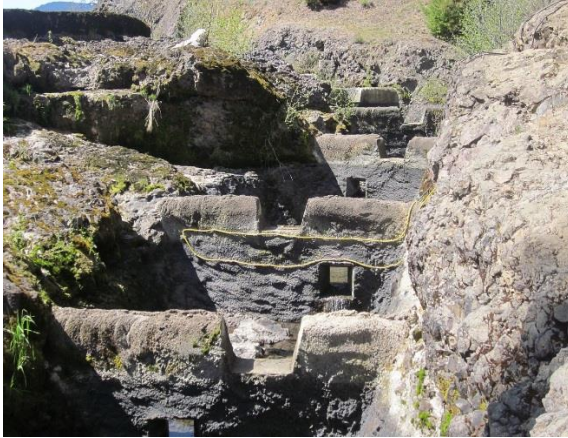
Lower ladder PIT tag detection antenna

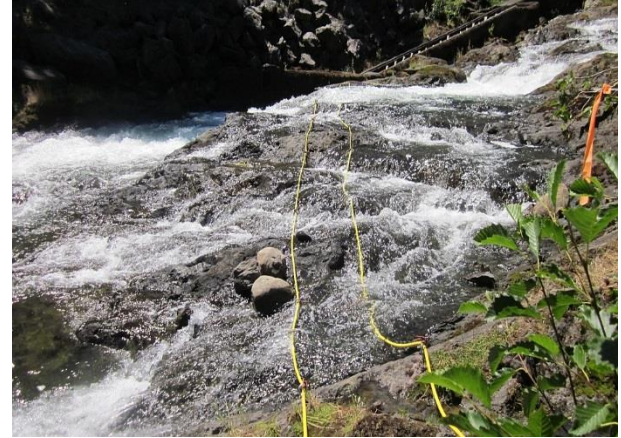
Lower spillway PIT tag detection antenna

The lower spillway antenna utilized a flat-plate, or pass-over, design and was first installed on July 9, 2013. The antenna was constructed using a continuous length of General Cable Carol Super-VU Tron Supreme power cable (12 gage with 4 strands) strung across the channel and doubled back. After the lake level was lowered and the ladder was boarded up the antenna was attached to the dewatered bedrock channel using stainless steel anchor bolts with eye nuts attached. The antenna wire was run through the eyes and secured with zip ties for stability. This antenna measured 54 feet long by about 2 feet wide. It operated on 12 volt DC current supplied by two deep-cycle batteries recharged by two solar panels installed at the site.

This PIT tag interrogation site presented many challenges. The antenna had to endure extreme hydraulic stress and there were numerous problems encountered. The antenna wire broke in late-September 2013 which we believed was the result of friction where it contacted the eye nuts. A new antenna was installed late-April, 2014. Fourteen new stainless steel anchor bolts with eye nuts were installed in the bedrock to augment those installed previously. A 3/8-inch diameter non-stretch marine rope was strung through the eyelets, looped back on the right bank, and stretched tightly with turnbuckles installed on the left bank. Rather than stringing the antenna wire through the eyelets the wire was affixed to the rope using over 100 heavy duty cable ties. Unfortunately, about two weeks later the antenna was broken again. It was subsequently discovered that an animal, probably a beaver, had gnawed through both the rope and the wire. A new design was developed that would not only be durable enough to withstand extreme hydraulic conditions but gnawing animals as well. After waiting out the spring runoff, the antenna was reinstalled on July 9, stringing the rope and antenna wire through semi-flexible 1.5-inch HDPE pipe that was custom cut and fit between the anchors. The successful reinstallation lasted until late October when the antenna broke again under the force of high flows. Utilizing the same "beaver resistant" design employed previously, the antenna was once again reconstructed on April 21, 2015 and operated without incident until it was decommissioned for the season on October 27. A few days later the antenna was destroyed again by extreme flows. After losing four antennas in just over two years it is very doubtful that this PIT tag interrogation site will be utilized in any future monitoring activities.

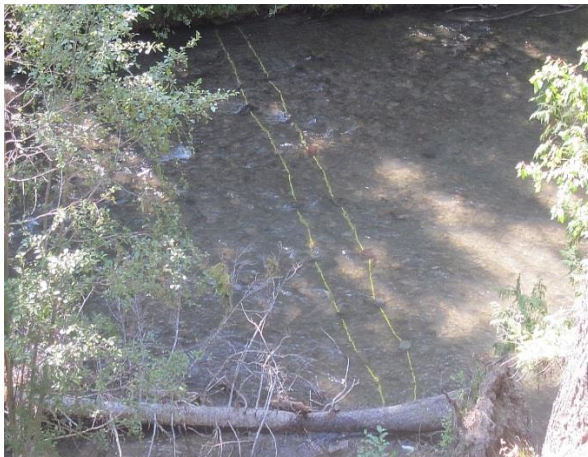
NF Tieton River PIT tag detection antenna

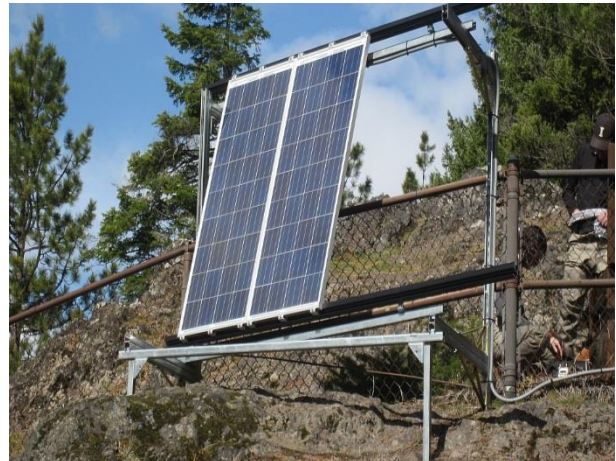
Solar panels at upper spillway/ladder site

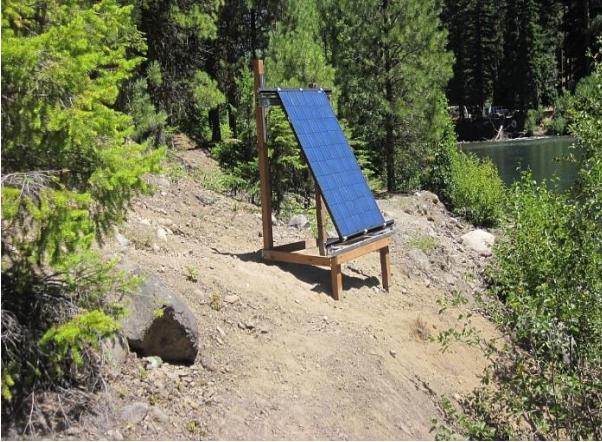
Solar panels at lower spillway site

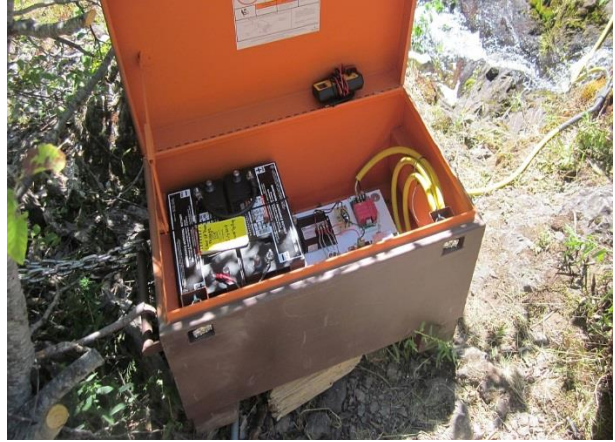
Batteries and readers kept inside locked job boxes

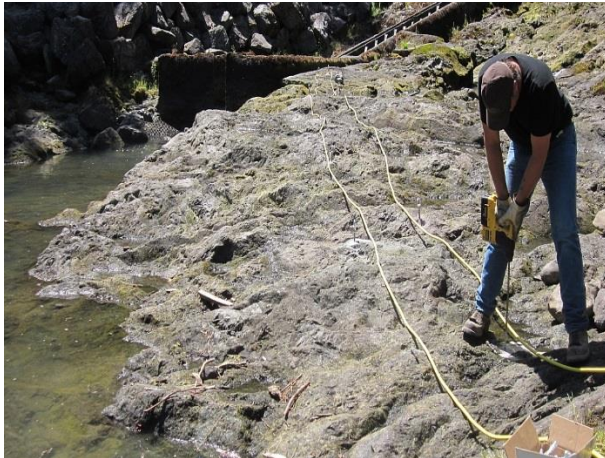
Drilling into bedrock on the lower spillway site

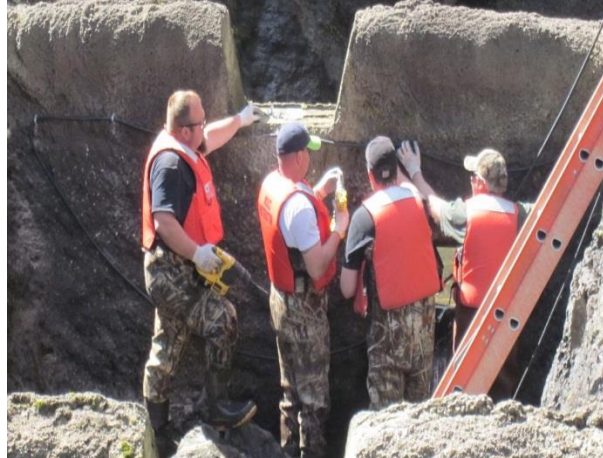
Installing the lower ladder antenna in 2014

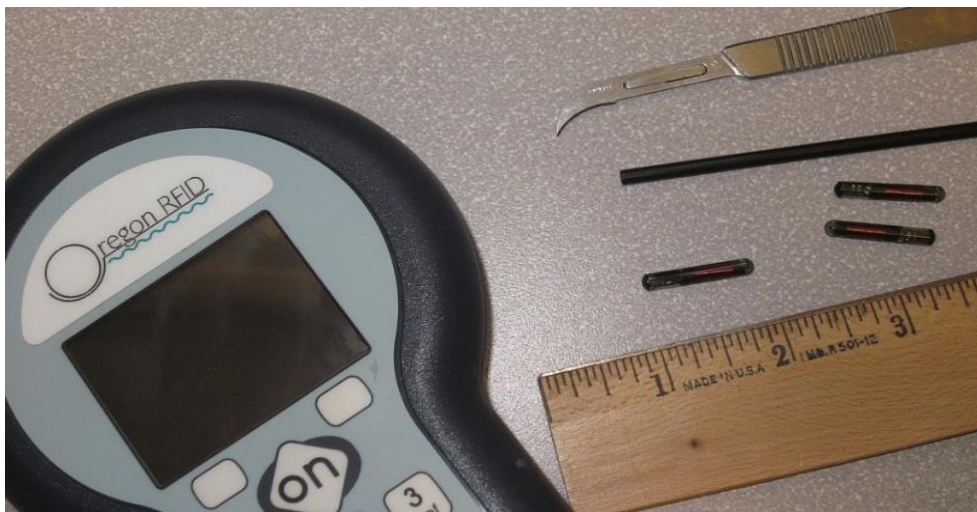
HDX PIT tags, scalpel, insertion straw and Oregon RFID® portable tag reader

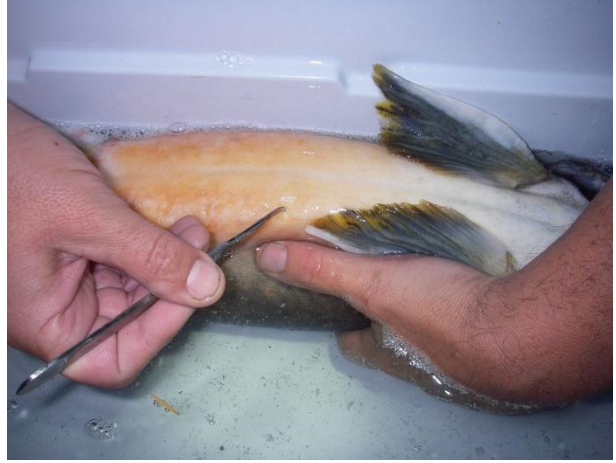
Making the incision to insert the HDX PIT tag
