# Clear Creek Dam Fish Passage Assessment

## FINAL REPORT

Thomas, J.A. and P. Monk. 2016. Final Report for the Clear Creek Dam Fish Passage Assessment. United States Fish and Wildlife Service, Mid-Columbia River Fishery Resource Office, Yakima Sub-Office. Yakima, WA.

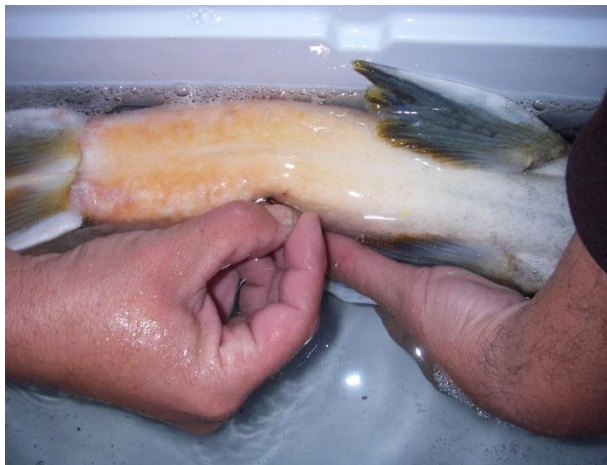
Inserting the HDX PIT tag

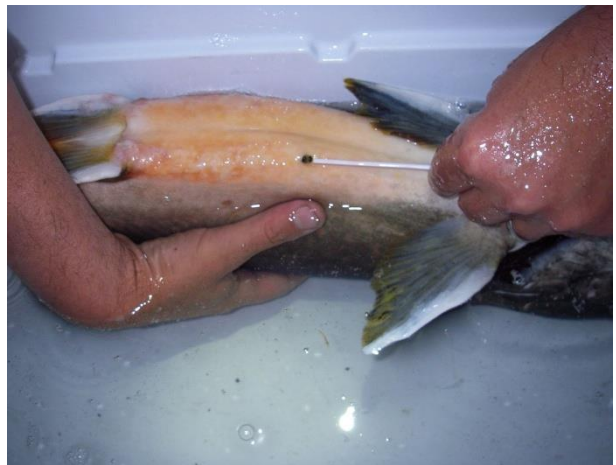
Pushing the tag in between muscle and skin

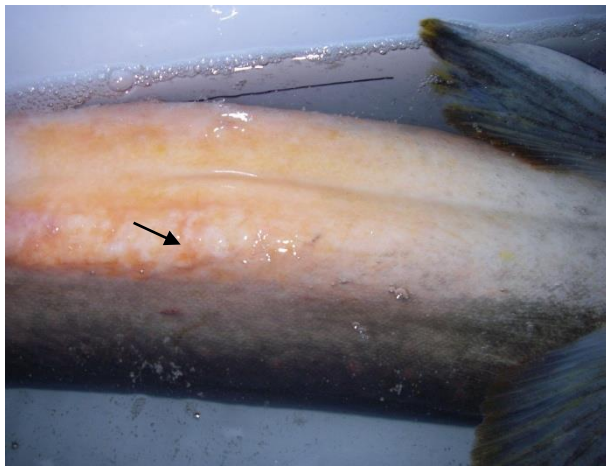
Finished. Arrow points to inserted PIT tag
