# **Clear Creek Dam Fish Passage Assessment**

## **First Annual Progress Report**

**U.S. Fish and Wildlife Service  
Mid-Columbia Fishery Resource Office  
Yakima Sub-Office**

**April 10, 2013**

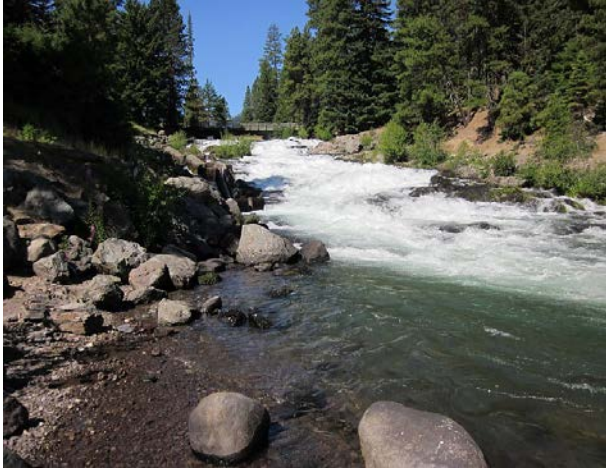
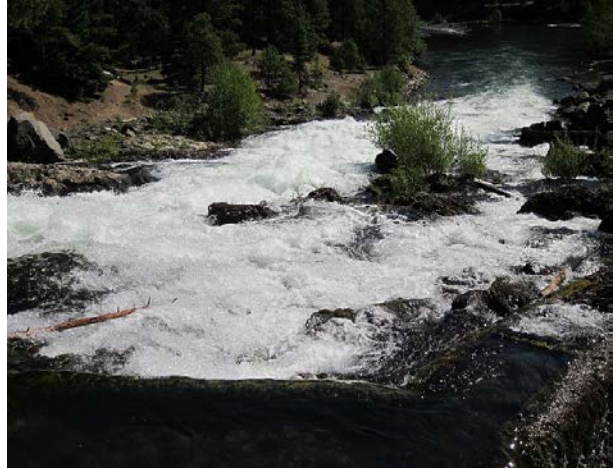
Lower spillway channel at Clear Lake elevation of 3012.8 feet

Without the benefit of serviceable ladders passage up the spillway channel for migrating fish is difficult at best. This channel, blasted out of bedrock, is approximately 140 meters long with two high gradient segments. The lower segment is approximately 70 meters long with an average gradient of 20-25 percent (all gradients are estimates); the upper segment is shorter (40 meters) but steeper with an average gradient of about 35 percent. In between these two segments is a low gradient section (< 5%) approximately 30 meters long which extends from the exit of the denil ladder to just below the entrance to the first pool of the upper ladder. The extent to which it is possible for bull trout to swim up the lower section of the spillway channel is unknown. Hydraulic conditions vary drastically depending on the volume of discharge coming down the spillway, consequently so does one's judgment as to whether fish could successfully swim up the channel. It is strongly suspected that fish cannot ascend the channel at high flows. In July, 2011 two bull trout were observed repeatedly trying without success. Photographs of hydraulic conditions in the spillway channel over a range of flows are presented in Appendix A.

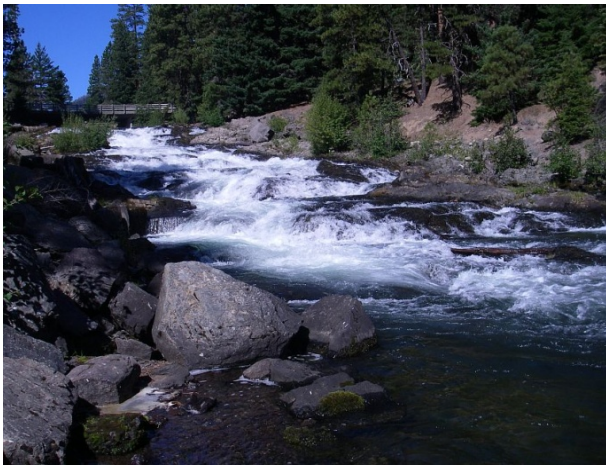
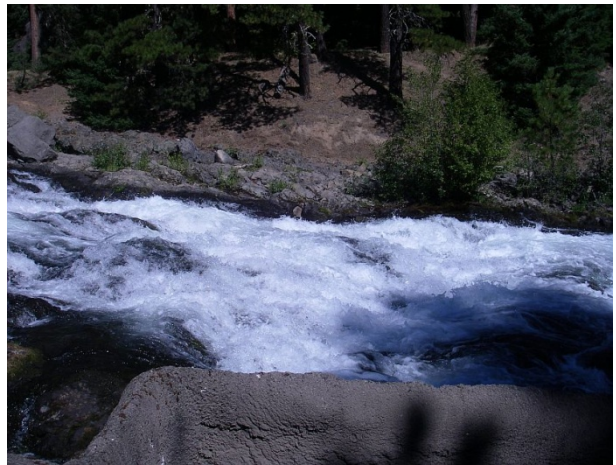
Lower spillway channel at Clear Lake elevation of 3011.6 feet

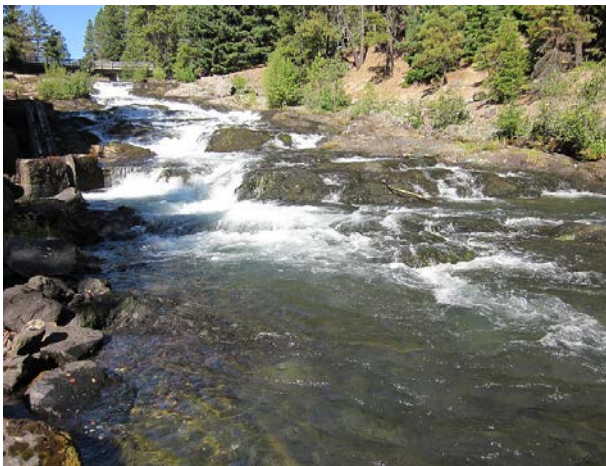
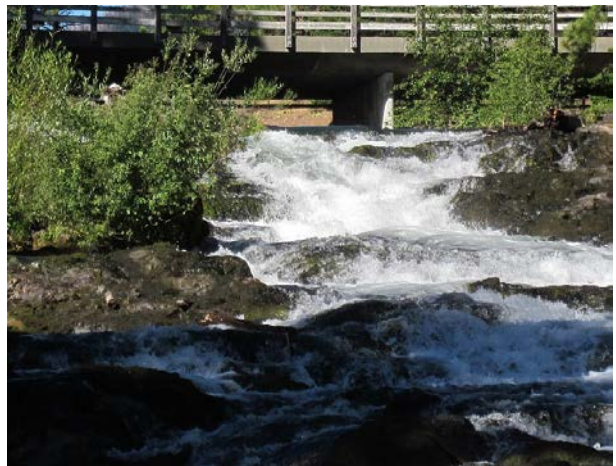
Lower spillway channel at Clear Lake elevation of 3011.4 feet

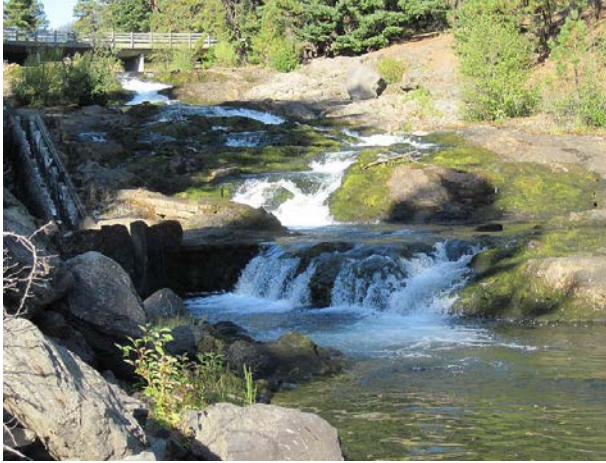
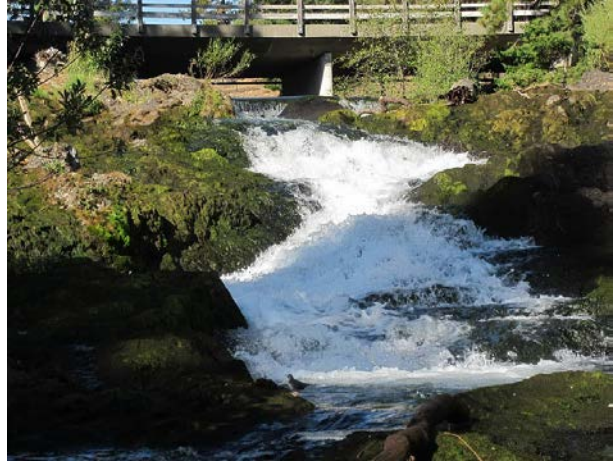
Lower spillway channel at Clear Lake elevation of 3011.0 feet

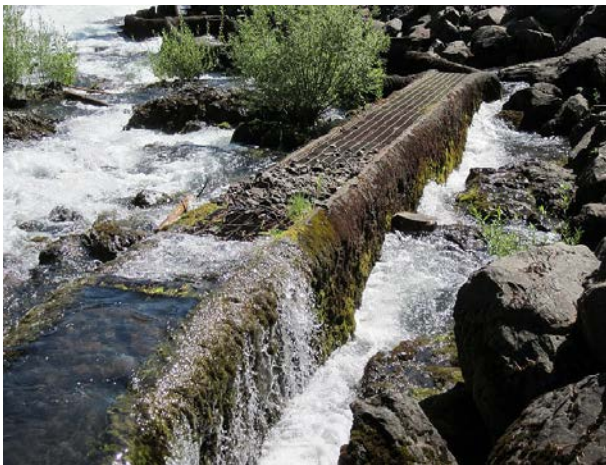
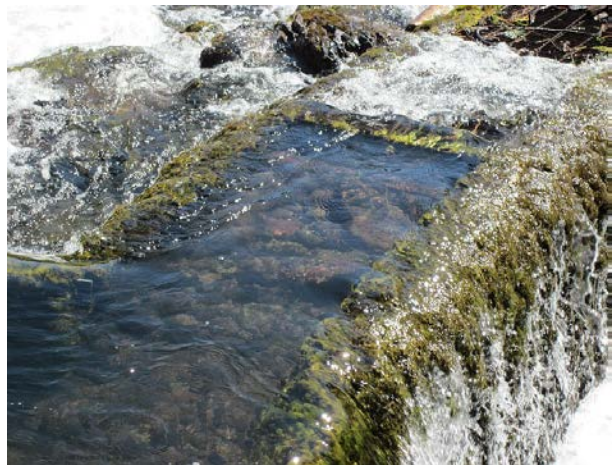
Upstream terminus of the Denil ladder completely clogged with bed load

Clear Creek and Tieton dams were constructed without fish passage facilities. Consequently, upon their completion anadromous salmonids were excluded from habitat upstream and resident fish populations above the dams were isolated. While Tieton Dam remains impassable, two fish ladders were constructed in the bedrock spillway channel of Clear Creek Dam in 1992. The lower "ladder" is actually a series of four denil ladders interspaced with resting pools located on the right bank of the spillway. The slopes of the four ladder sections range from 12.5 to 45 percent. The upper ladder is a pool-and-weir design constructed on the left side of the spillway channel. It contains 11 weirs with a two-foot hydraulic drop from weir to weir. The pool-and-weir ladder appears to be functional but this is not the case with the denil ladder. It is considered too steep and does not meet accepted criteria (USBR 2004) so it may have never passed fish with much success. It most certainly does not at present as it has not been maintained in years, is completely clogged with gravel, and is otherwise in disrepair. Photographs of both ladders are presented in Appendix A.

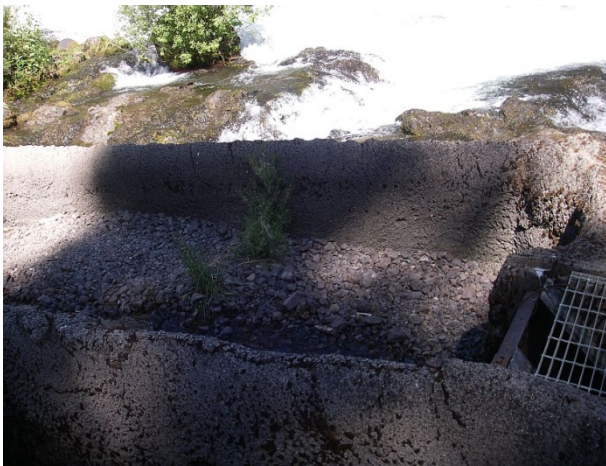
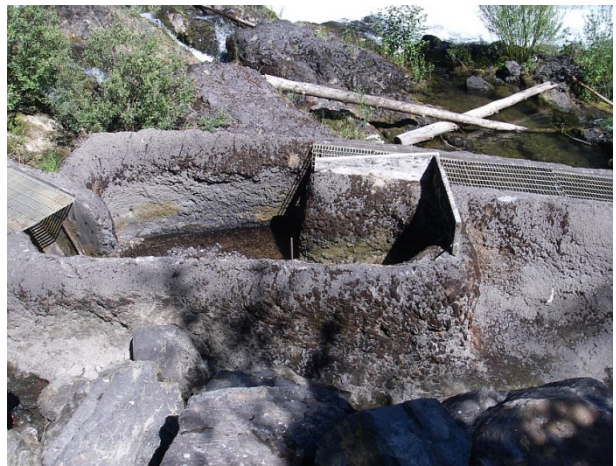
Totally dewatered downstream sections of the Denil ladder

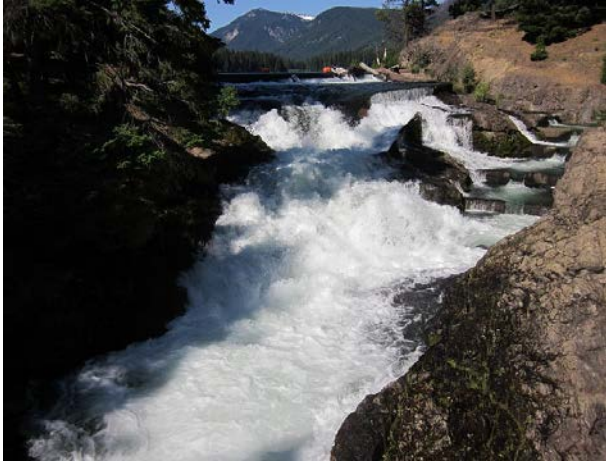
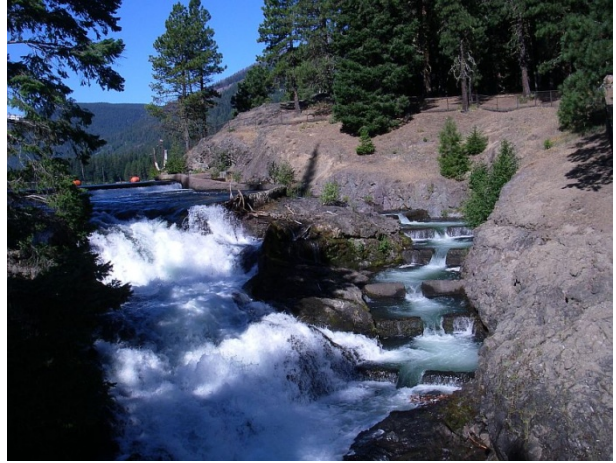
Upper spillway channel at lake elevation 3012.2 feet (left) and 3011.6 feet (right)

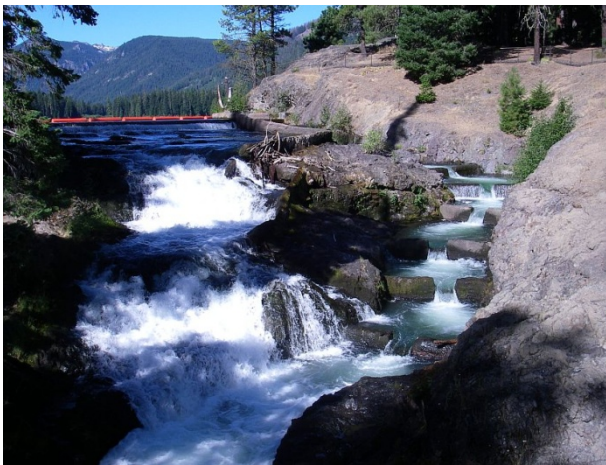
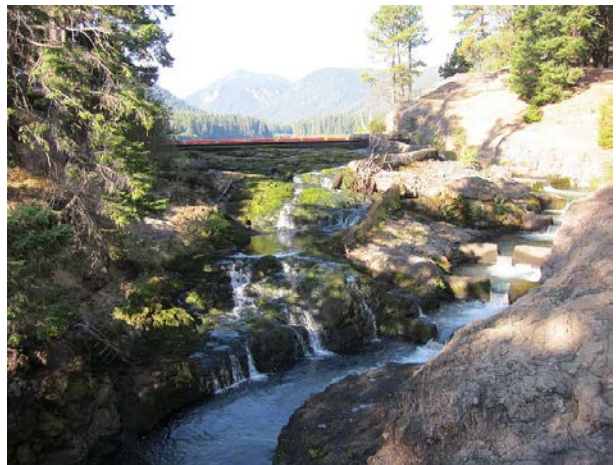
Upper spillway channel at lake elevation 3011.4 feet (left) and 3011.0 feet (right)

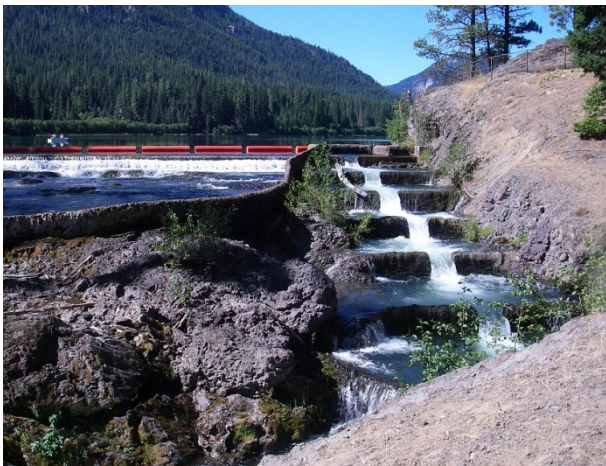
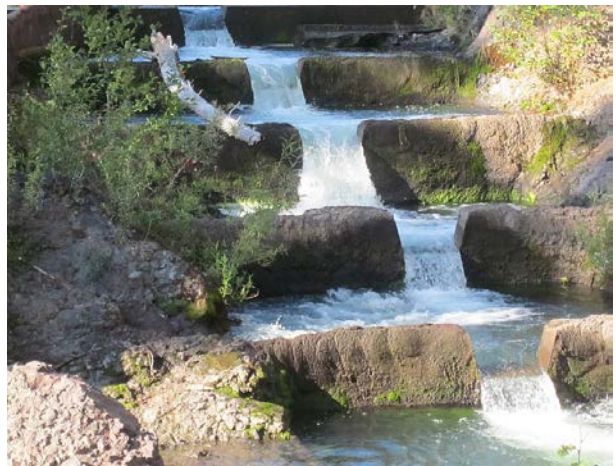
Pool-and-weir fish ladder in upper spillway channel

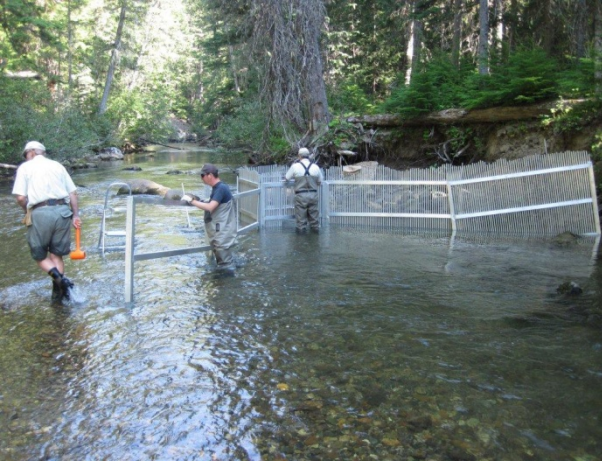
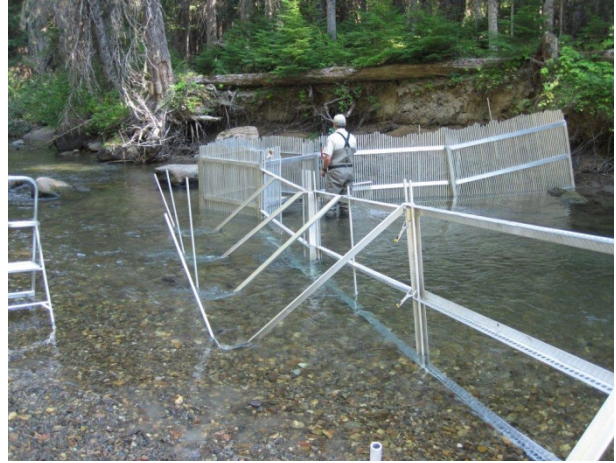
Weir and trap installation on the North Fork Tieton River (September 17, 2012)

Three eight-foot weir panels were coupled together and extended from the left bank downstream at about a 40 degree angle where they connected with the capture box; two panels were used on the right bank angled somewhat less. The capture box was situated in the thalweg of the channel, a location where the stream bed was relatively flat. With the braces, numerous sandbags strategically placed, and all pickets driven into the stream bed to the extent possible, the weir and the trap box were impressively solid. To prevent potential avian predation a tarp was draped over the top of the box and secured, burlap was wired to the top of the funnel opening to prevent captured fish from jumping out, and half-inch wide zip ties were affixed to the back of the vertical opening to dissuade captured fish from swimming back out. Photographs of the trap under construction and completed are presented in Appendix B.

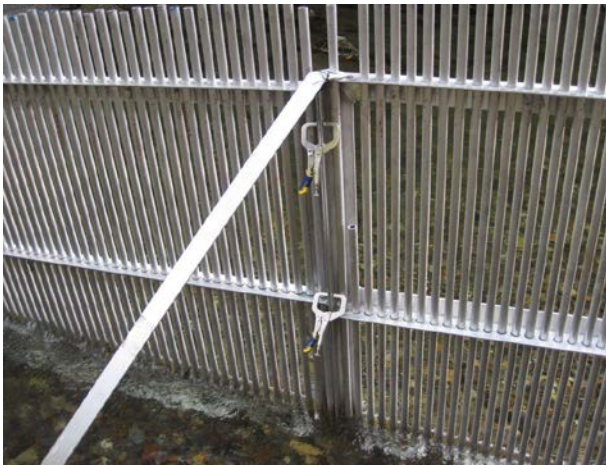
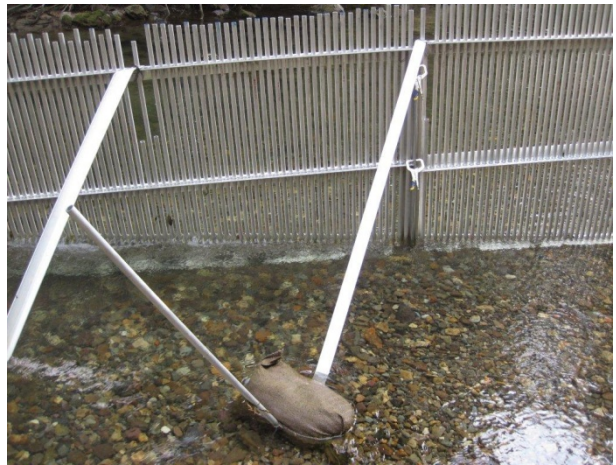
Weir and trap installation on the North Fork Tieton River (September 17, 2012)

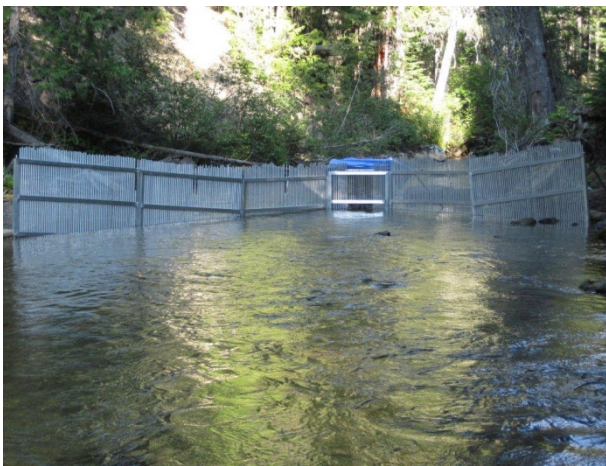
Completed picket-weir and box trap

The trap was constructed by WDFW's Region 3 screen shop. The component parts of the picket-weirs and the capture box were made out of aluminum which was both durable and lightweight. The weir panel frames were eight-feet long by four-feet tall; approximately seventy spiked pickets (60" x 0.75") slipped through holes drilled in each frame and were pounded into the stream bed (spacing between pickets was about 0.6"). Adjacent panels were coupled together and all panels were braced from downstream. The dimensions of the capture box were 4 x 4 x 4 feet. It was assembled from four panels, used the same type of pickets as the weirs, and had a funnel opening. There was no aluminum top or bottom to the capture box.

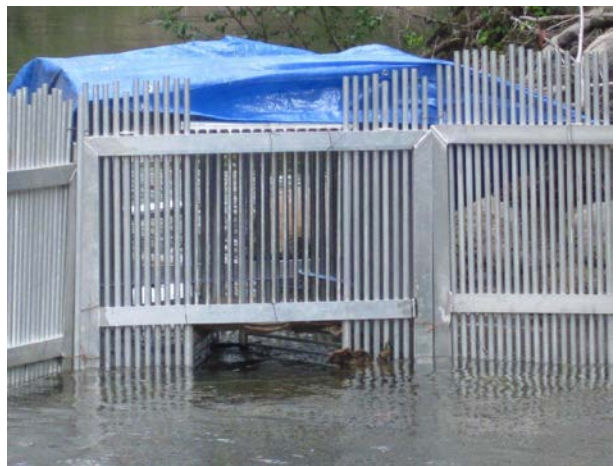
The capture box

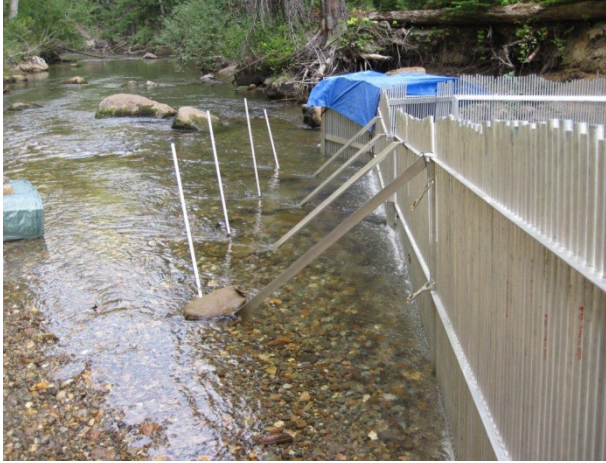
Downstream side of trap

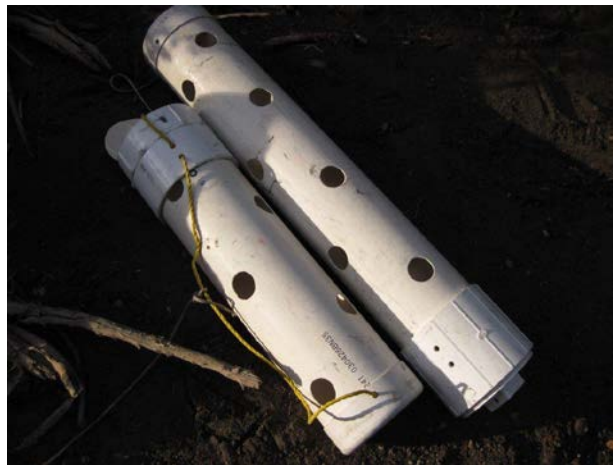
PVC recovery tubes

After completing the tag implantation an Oregon RFID® portable reader was used to scan the tag number and fish were placed in 6-inch diameter PVC flow-thru recovery tubes. These were secured in the channel where a light current existed with the head of the fish oriented upstream. They were held and monitored until able to swim away freely. Photographs related to the tagging operation are presented in Appendix B.

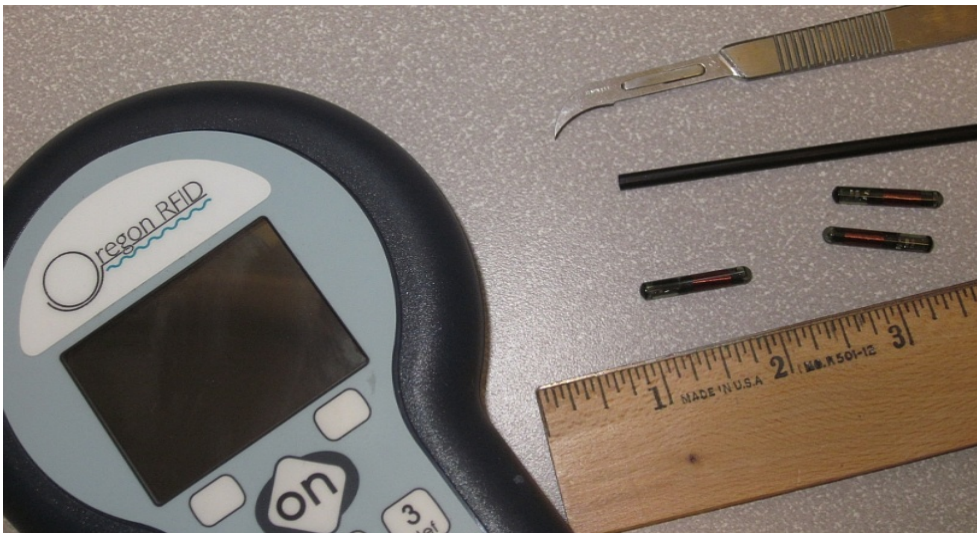
HDX PIT tags, scalpel, insertion straw and Oregon RFID® portable tag reader

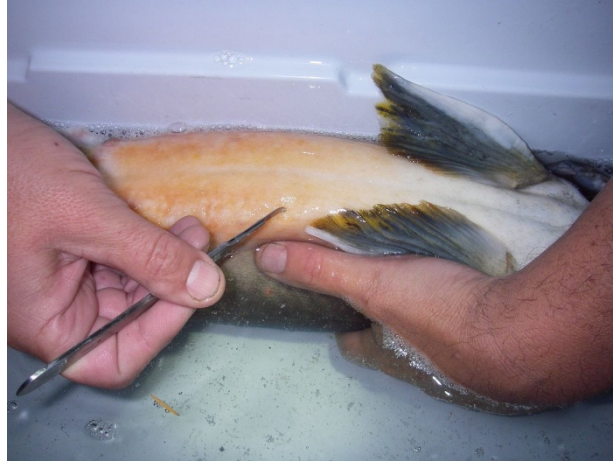
Making the incision to insert the HDX PIT tag

The fish were measured, sexed, and a small tissue sample was taken from the anal fin which was preserved in 70% isopropyl alcohol for genetic analysis. A scalpel was used to make a one-half inch vertical incision just posterior and ventral to the pectoral musculature near the end of the pectoral fin. This incision penetrated only the epidermal layer under which a half-duplex PIT (HDX PIT) tag was horizontally inserted. We used 23 mm x 3.65 mm tags (manufactured by Texas Instruments, Inc.) operating on the 134.2 kHz radio frequency identification standard for animal tagging. The tag was gently pushed in between muscle and skin towards the tail of the fish until barely visible, at which point a cocktail straw was used to implant it about one inch further. This surgical procedure was fairly simple and did not require any sutures.

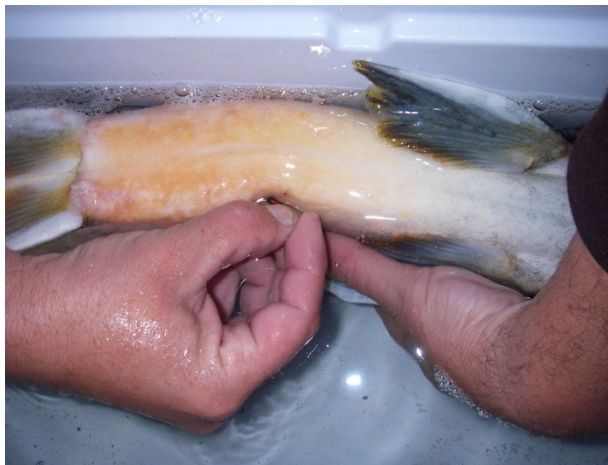
Inserting the HDX PIT tag

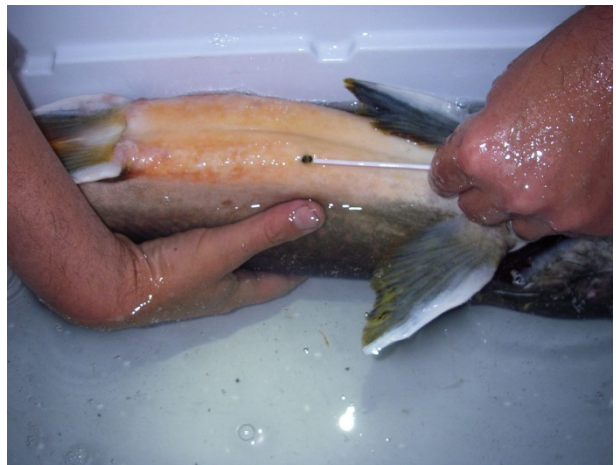
Pushing the tag in between muscle and skin

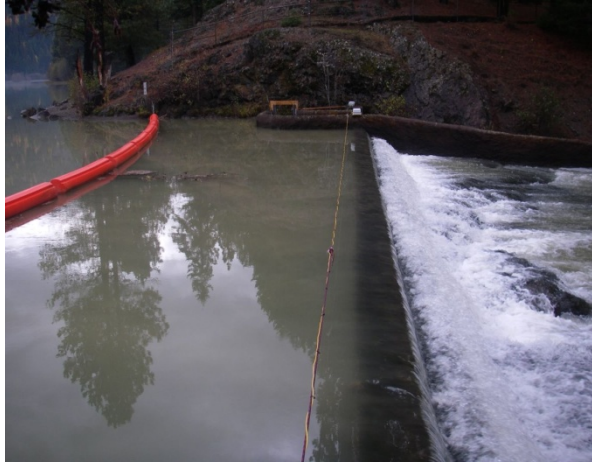
Antenna spanning the spillway weir

A HDX PIT tag interrogation site was constructed at the top of the spillway of Clear Creek Dam during early September, 2012 and was functioning prior to trapping and tagging adult bull trout. HDX PIT tag readers and data loggers, manufactured by Texas Instruments, were procured from Oregon RFID®. A large, single loop antenna was constructed spanning the entire width of the spillway weir, approximately 27 m (85 ft) in length. The antenna was constructed out of 1/0 gage welding cable for the bottom of the loop and 8 gage THHN wire for the top. The top loop was affixed to 1.5 cm climbing rope which was stretched tight. The antenna operated on 18 volt DC current supplied by rechargeable deep-cycle batteries and was installed in a swim-through configuration (Zydlewski et al. 2006) to detect fish migrating over the weir. The detection range of the spillway antenna was approximately 0.3 m (1 ft) upstream and downstream throughout the entire loop.

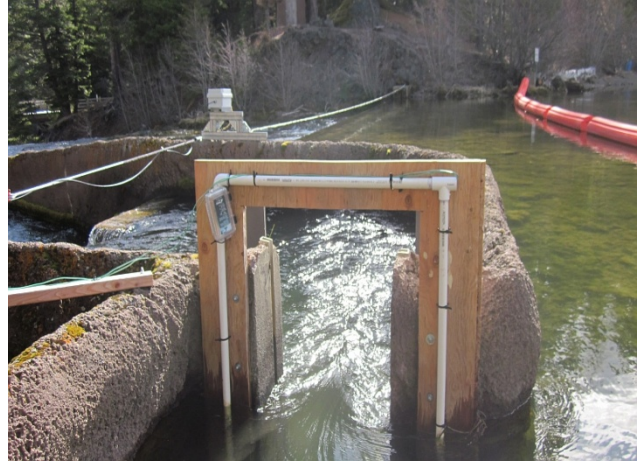
Antenna at exit of pool-and-weir fish ladder

A second antenna was installed in a swim-through configuration on the upstream exit of the pool-and-weir fish ladder. This antenna was approximately 1 m x 1.5 m (3 ft x 5 ft) in size, constructed from 3 wraps of 12 gage THHN wire housed in a PVC pipe frame and mounted to the wall of the fish ladder. Operating on a 12 volt DC current, also supplied by rechargeable deep-cycle batteries, the detection range of the ladder antenna was approximately 1.0 m (3 ft) upstream and downstream of the antenna. Antennae performance was evaluated periodically during the study using test tags and by using timer tags set to send a tag code every 31 minutes. Data was downloaded manually with a laptop computer and subsequently stored on Reclamation's Upper-Columbia Area Office network. Photographs of the spillway and ladder antennae are provided in Appendix C.

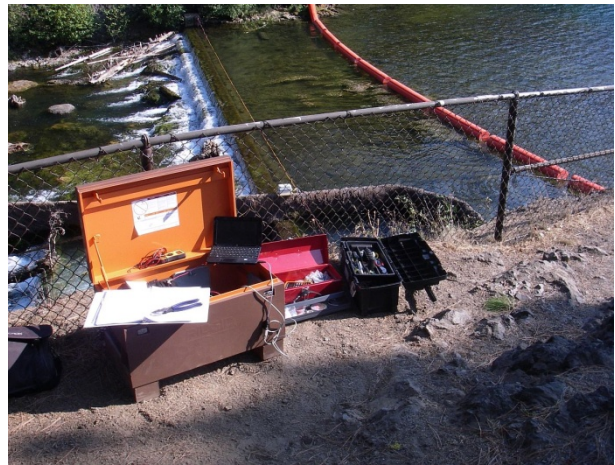
Steel job box holding batteries and tag readers

drawdown between batteries was somewhat erratic. This was due in part to a few that were defective. These were quickly identified and replaced but still the rate at which the power supply would deplete was hard to predict. The power system required consistent attention and short-term outages were not uncommon. Batteries were generally exchanged at least weekly with numerous exchanges occurring even more frequently.

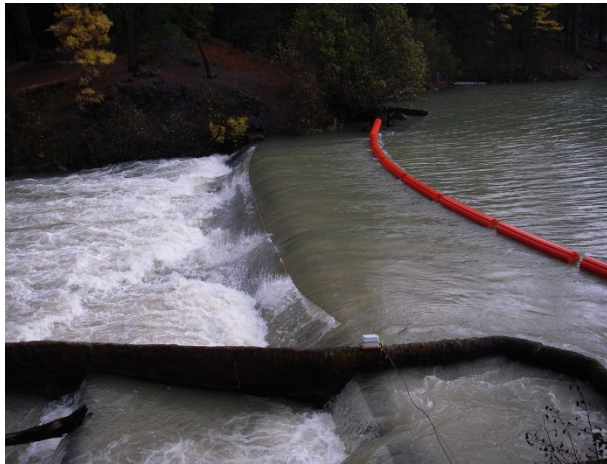
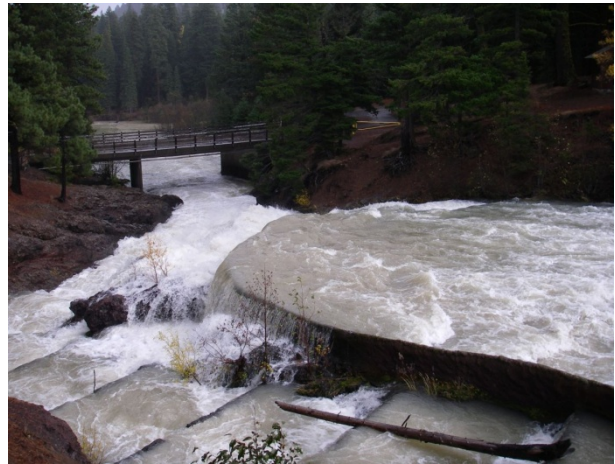
October high flow event which submerged and stretched the spillway antenna (photo on left)

Another factor which caused power interruptions affecting detection capability was significant short-term variation in hydrologic conditions. Because of its small size Clear Lake is subject to rapid increases in lake elevation, and thus spillway flow, during storm events. With the top loop of the spillway antenna stretched a bit less than two feet above the spillway weir, the antenna is vulnerable to submersion under these circumstances. Two such events occurred in October, 2012. One occurred mid-month and resulted in breakage of the antenna and the other (two weeks later) submerged it and stretched the rope to which it was attached. Both resulted in the loss of detection capability for over two days before repairs could be made. The ladder antenna was not affected in either case.
