Clear Creek Dam Fish Passage Assessment

Second Annual Progress Report

**U.S. Fish and Wildlife Service
Mid-Columbia Fishery Resource Office
Yakima Sub-Office**

**U.S. Bureau of Reclamation
Columbia-Cascades Area Office**

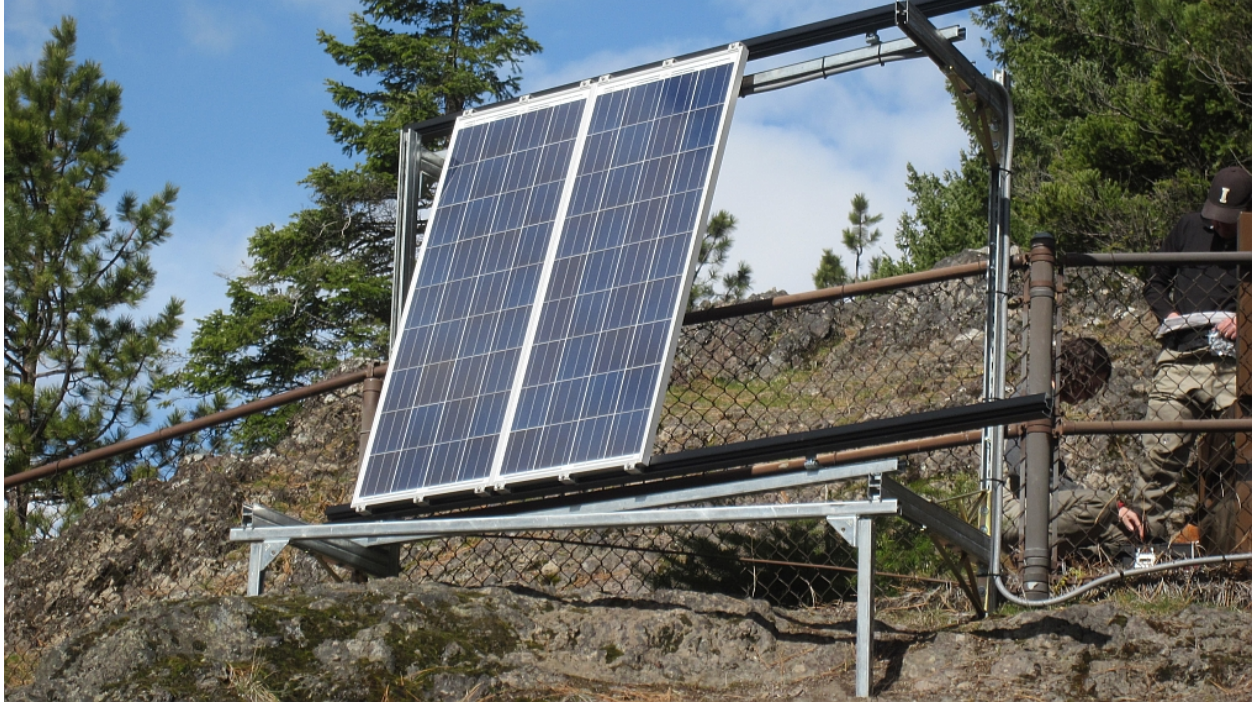
Figure 1. Solar panels installed to power the upper spillway and ladder antennae

As was described in the first annual report, two antennae were operating at the end of 2012. These were located at the top of the spillway channel (spanning the channel directly above the concrete weir on the spillway crest) and at the exit/entry portal of the pool-and-weir ladder. Both operated until the third week of December when weather conditions precluded access to the site and the batteries froze. Solar panels were installed at the site in March, 2013 (Figure 1) to charge the batteries which power these antennae and eliminate the need to exchange batteries. At the same time a new high-tension nylon rope with less stretch than the previous one was installed spanning the spillway weir and a turnbuckle was included at the right side anchor. This provided much greater tightening capability to prevent the loss of the antenna to high flows. Elevated mounting platforms for the tuning boxes for both the spillway and ladder antennae were also constructed to eliminate the possibility of submergence.

After thinking this through, we believe what most likely occurred was that the new solar charging system for the upper spillway and ladder site created “noise” or interference with the PIT tag interrogation equipment which for some reason only affected the much larger spillway antenna. We briefly considered the possibility that natural solar “noise” was the source of the problem but this hypothesis was discarded. Solar noise can cause interference with RFID

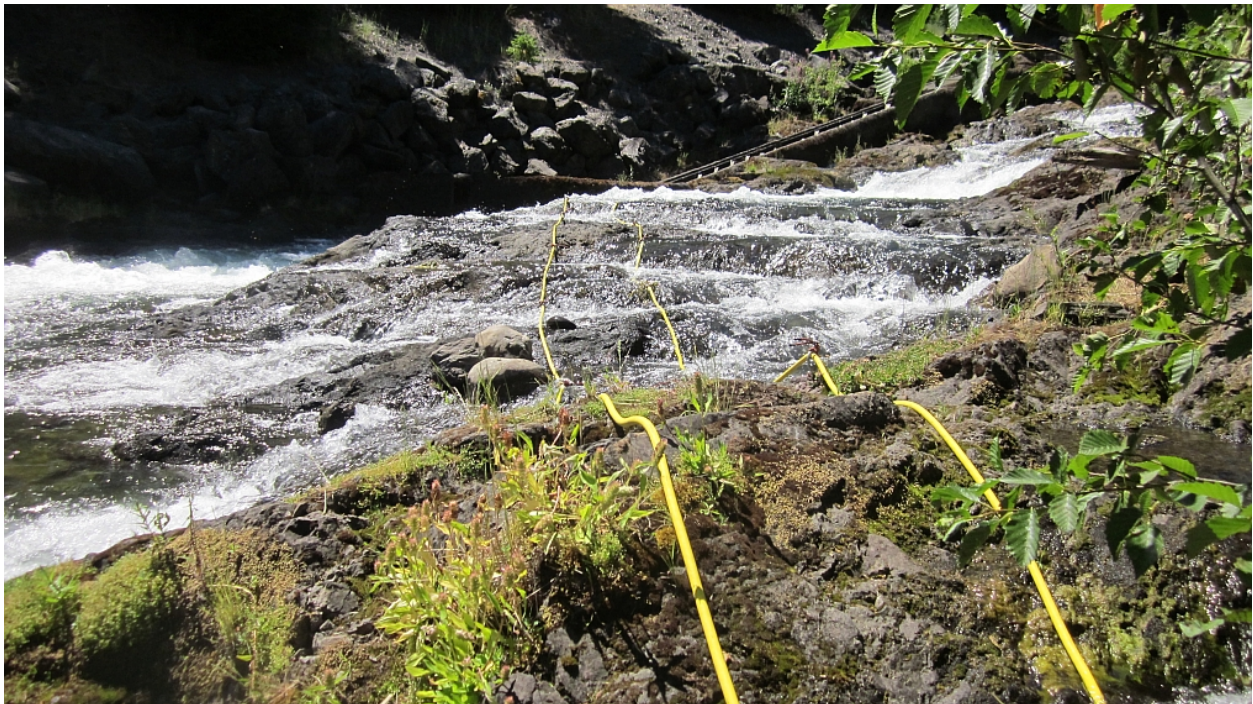
Figure 2. Antenna installed at the lower terminus of the spillway channel on July 9, 2013

A new antenna was installed spanning the spillway channel just above its lower terminus on July 9, 2013 (Figure 2). PIT tag detections at this lower spillway site will provide confirmation that any bull trout detected at the top of the spillway channel actually left Clear Lake. They will also provide data to determine when tagged fish attempted to ascend the channel and the success they had in doing so.

The NF Tieton and lower spillway antennae were constructed from General Cable Carol Super-VU Tron Supreme power cable, 12 gage with 4 strands. The North Fork antenna consisted of a single coil attached to the stream bed using rebar anchors in a flat-plate or pass over configuration. This antenna measured 20 meters (66 feet) long by about 1 meter (3 feet) wide. After dewatering the channel the lower spillway antenna was attached to the bedrock spillway using stainless steel anchor bolts with eye nuts attached. The antenna wire was run through the eyes and tied off for stability (Figure 4). This antenna was also in a flat-plate configuration measuring 16.3 meters (54 feet) long by about 0.6 meters (2 feet) wide. Both antennae operated on 12 volt DC current supplied by rechargeable deep-cycle batteries. Solar panels were mounted to recharge the batteries at the lower spillway site (Figure 5); The North Fork site lacked the necessary exposure for a solar configuration, thus the two six-volt batteries which powered the antenna were exchanged weekly. Antenna performance was evaluated periodically using test tags and through the use of timer tags, once installed, set to send a tag code to the reader every 31 minutes. Data was downloaded manually with a laptop computer and subsequently stored on Reclamation's Upper-Columbia Area Office network.

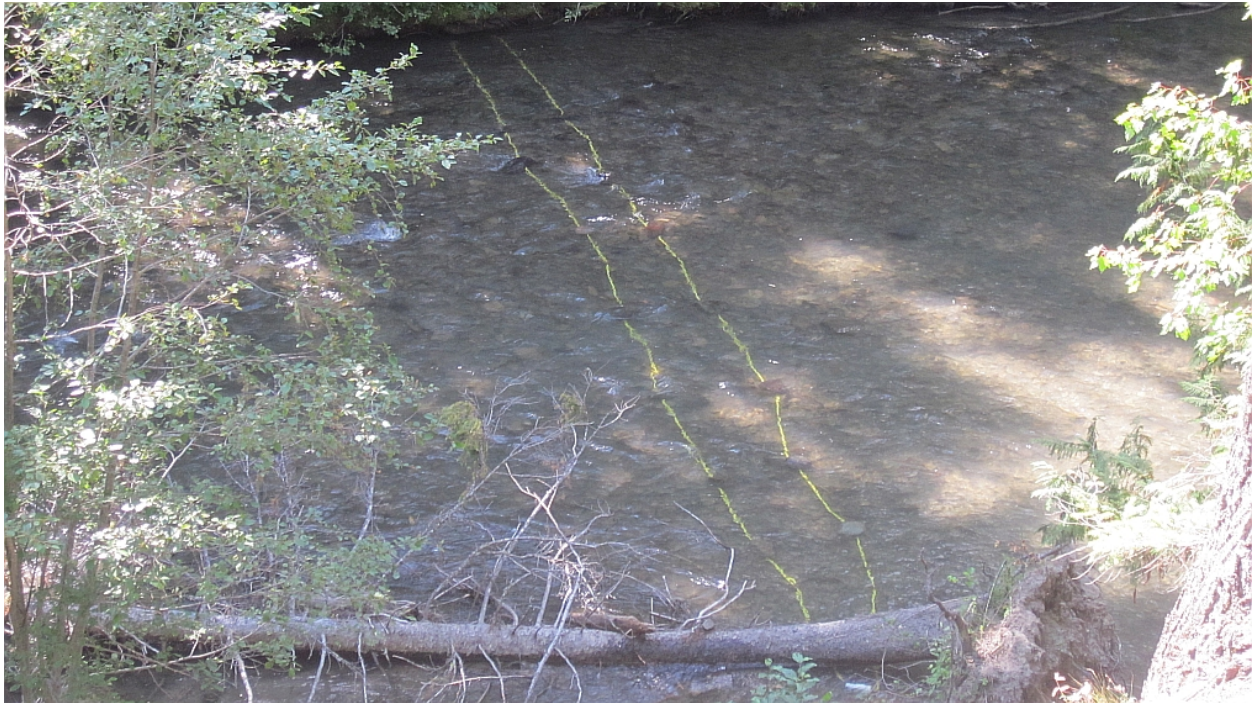
Figure 3. Antenna installed in the North Fork Tieton River on August 1, 2013

A new antenna was also installed in the NF Tieton River on August 1 (Figure 3). This channel-spanning antenna was located 0.75 mile upstream of Clear Lake. Detections at this site will reveal pre- and post-spawn migration timing (and residence time in the river), provide some

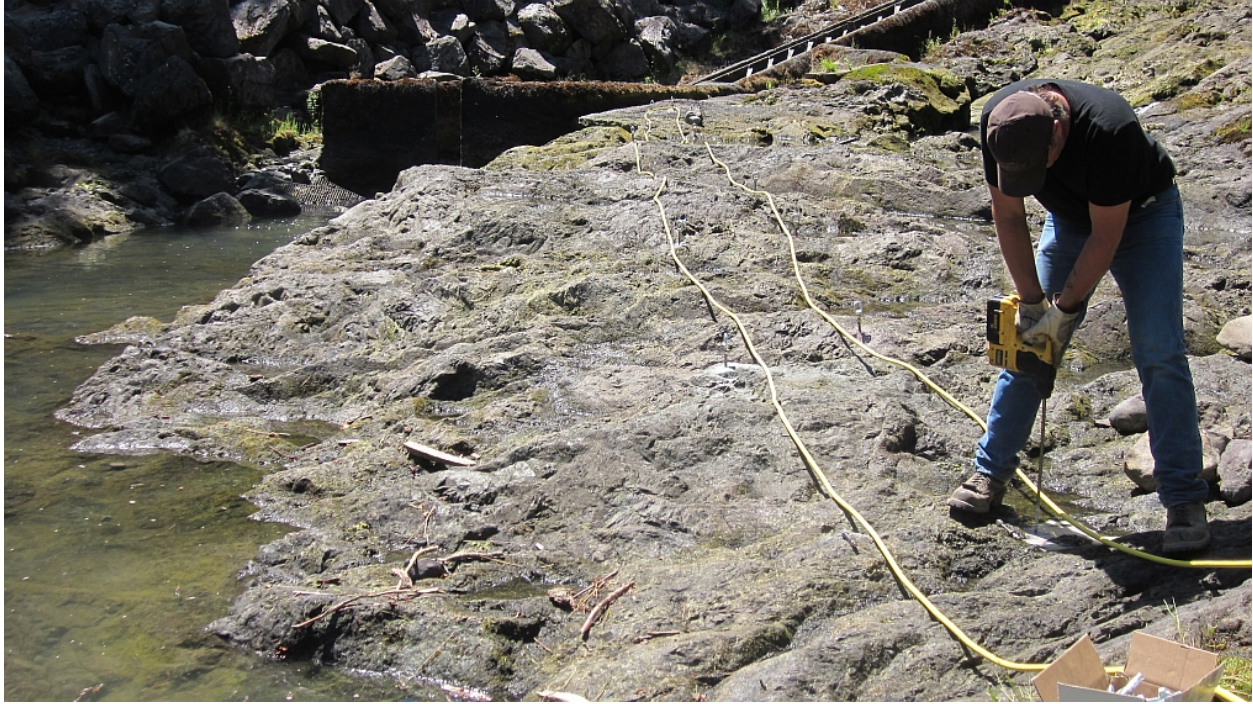
Figure 4. Installation of the lower spillway antenna on July 9, 2013

This antenna was constructed in a challenging location. It became operational the morning of July 9 with a read-range of 16-18 inches on either side of (and above) the antenna wires. The antenna operated for 12 consecutive days until about noon on July 21 at which time the reader stopped. The problem was diagnosed as a faulty voltage controller which took four days to correct. Detection capability was restored on the morning of July 25. Through August 14 (20 days) we believe the antenna was operating continuously but it was initially installed without a timer tag so this was difficult to judge. The problems we had previously encountered with the voltage controller introduced some doubt as to the antennas continuous detection capability. However, it was checked with a timer tag on three occasions during the period and successfully read the tags during each. On August 14 we disconnected the voltage controller so that the solar panel charged the batteries directly, exchanged the 24-volt panel (which was overcharging the batteries) for a 12-volt panel, and installed a timer tag. With these modifications, no further problems were encountered for a period of 24 days until the reader mysteriously quit reading

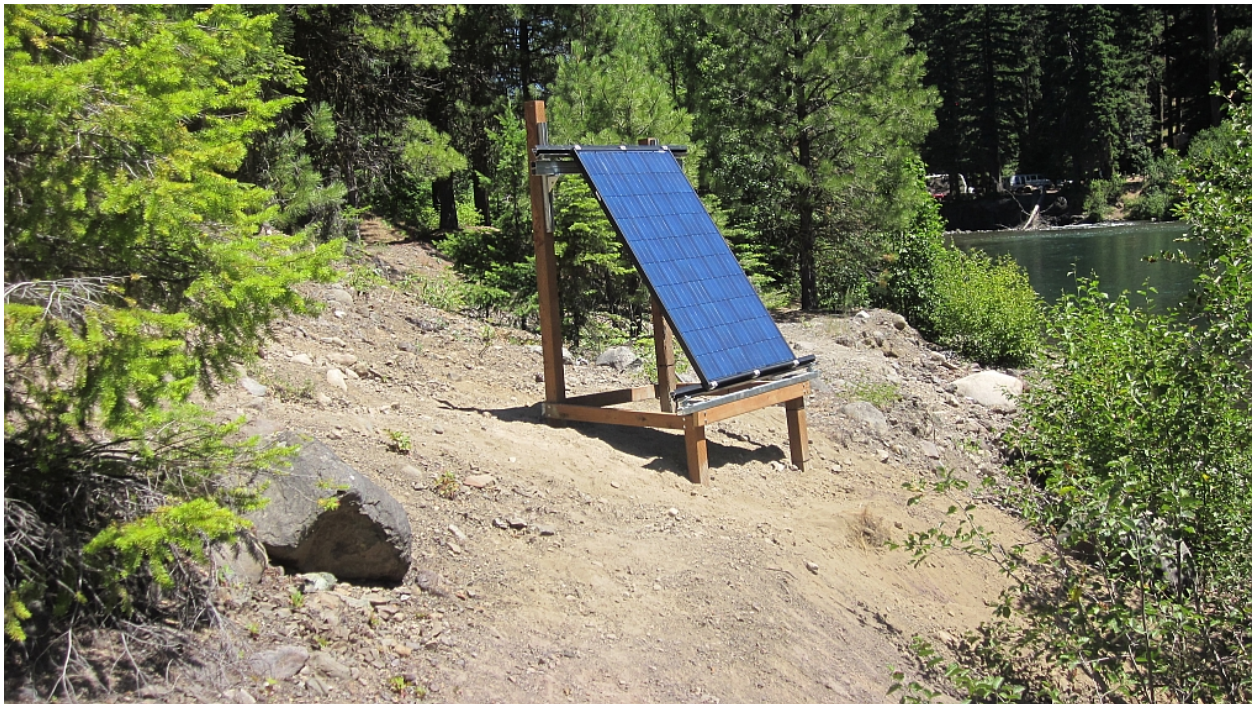
Figure 5. Solar panels installed to power the lower spillway antenna

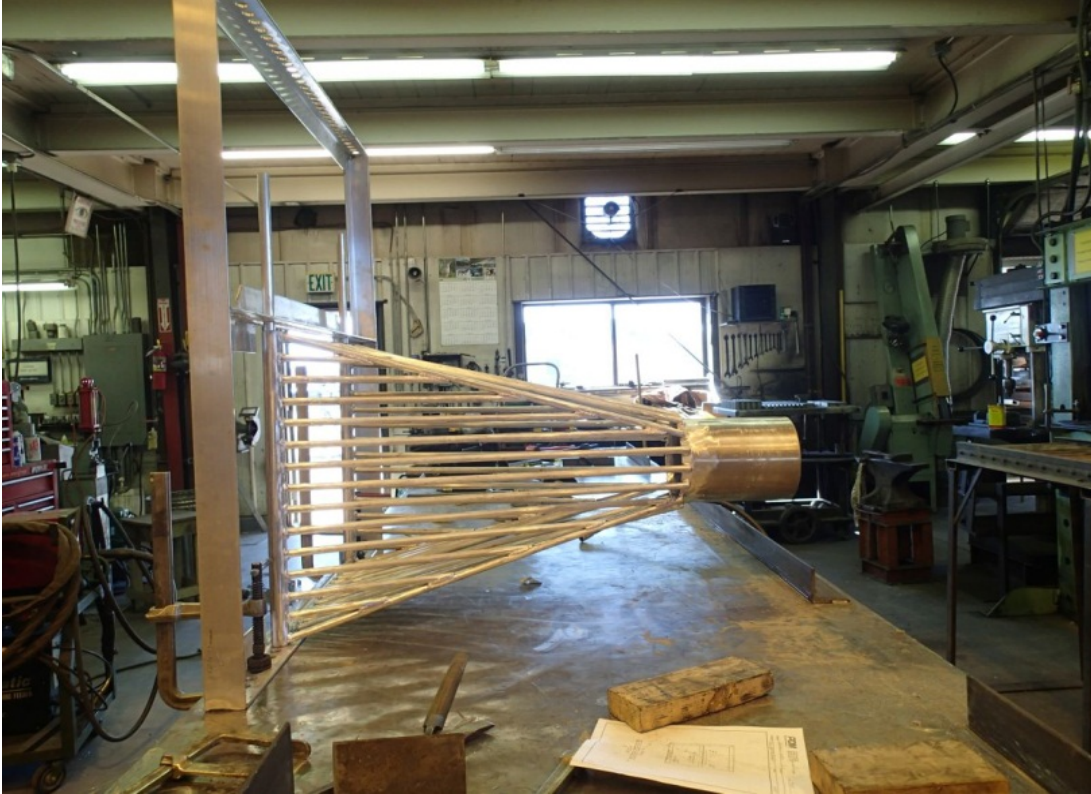
Figure 7. Modification to the entrance of the 2013 trap in WDFW's screen shop

The same picket-weir box trap that was used in 2012 was again utilized in 2013 but with some significant modifications. Having noted the escape of two bull trout from the capture box in 2012 and avoidance behavior (trap shyness) displayed by a few bull trout approaching the trap entrance, these modifications were deemed necessary. Figure 6 shows the trap configuration used in 2012. The trap box was directly connected to adjacent weir panels. The entrance to the trap (not pictured) was flat and perpendicular to the current with two wings extending into the trap where fish would pass through a vertical opening 4-5 inches wide. It was thought that trapped fish would be disinclined to go back through this opening but that turned out not to be the case on at least a couple of occasions. The entrance was modified so that a caged cone extended about three feet back from the entrance (Figure 7). This cone led to a 10-inch diameter opening to which a four-foot section of PVC pipe was attached. This pipe extended about two feet into the trap and was approximately six inches above the stream bed inside it. A burlap sleeve was then affixed to the end of the pipe to further dissuade captured fish from finding the opening. Finally, the entrance to the trap was painted flat black to minimize avoidance behavior. Figure 8 shows the trap entrance and the position of the trap relative to it. All modifications were done WDFW's Region 3 screen shop.

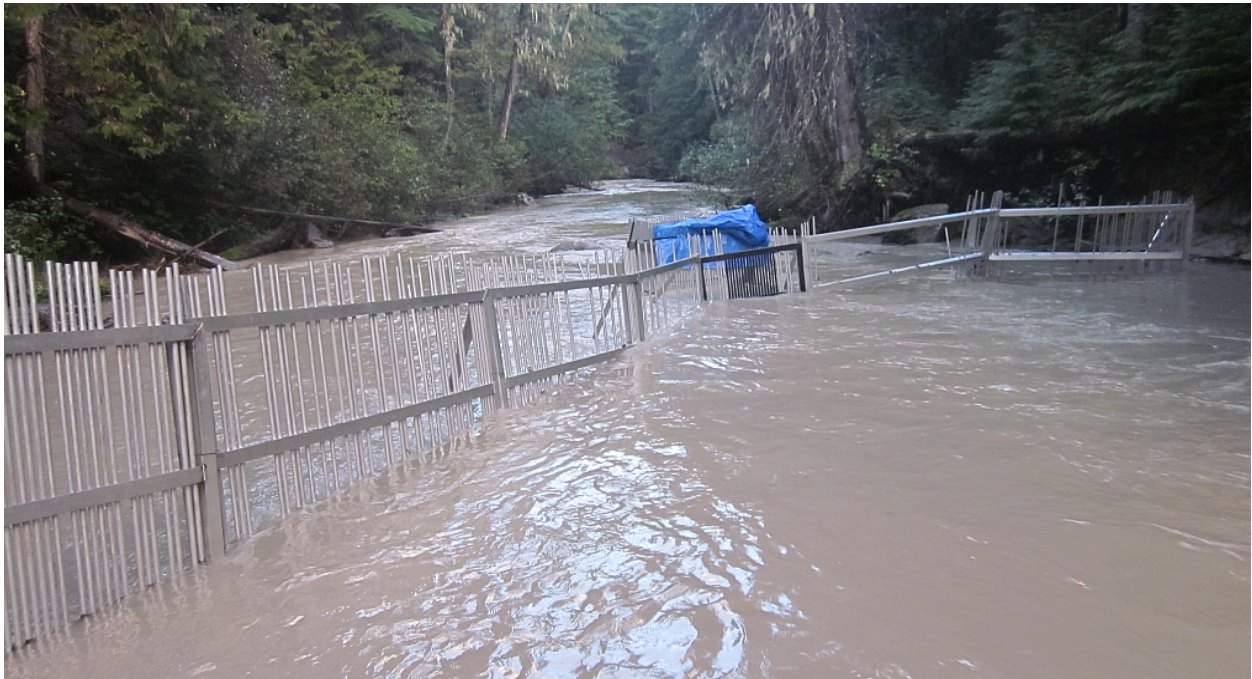
Figure 9. North Fork Tieton River fish trap after the high flow event on September 22, 2013 had partially collapsed the two weir panels on the right bank and weir pickets had been pulled to relieve pressure on the panels. The photo was taken the next day after the river had receded.

The trapping operation progressed without complications except for two notable exceptions. The first was the high flow event on September 22 when the river rose approximately 1.5 feet and partially collapsed the two eight-foot weir panels on the right bank (Figure 9). At 6:30 PM the crew worked quickly pulling pickets from the weir panels to reduce pressure on them. The structure incurred no further damage. At around 11:00 PM, after river stage had dropped about 12 inches, the partially collapsed panels were righted to the greatest extent possible and pickets were replaced in alternating holes in the weir panels. The trap was fishing again but with the possibility that fish could pass through the three-inch gap between alternating pickets. With intermittent rain still occurring throughout the day on September 23, all of the pickets were not replaced until the following morning. The panels on the right bank were also realigned

and reinforced at that time. Surprisingly, two bull trout were captured in the trap over the course of this event but it is reasonable to assume that some escaped capture in the 36-plus hours the weir panels did not completely block the river.

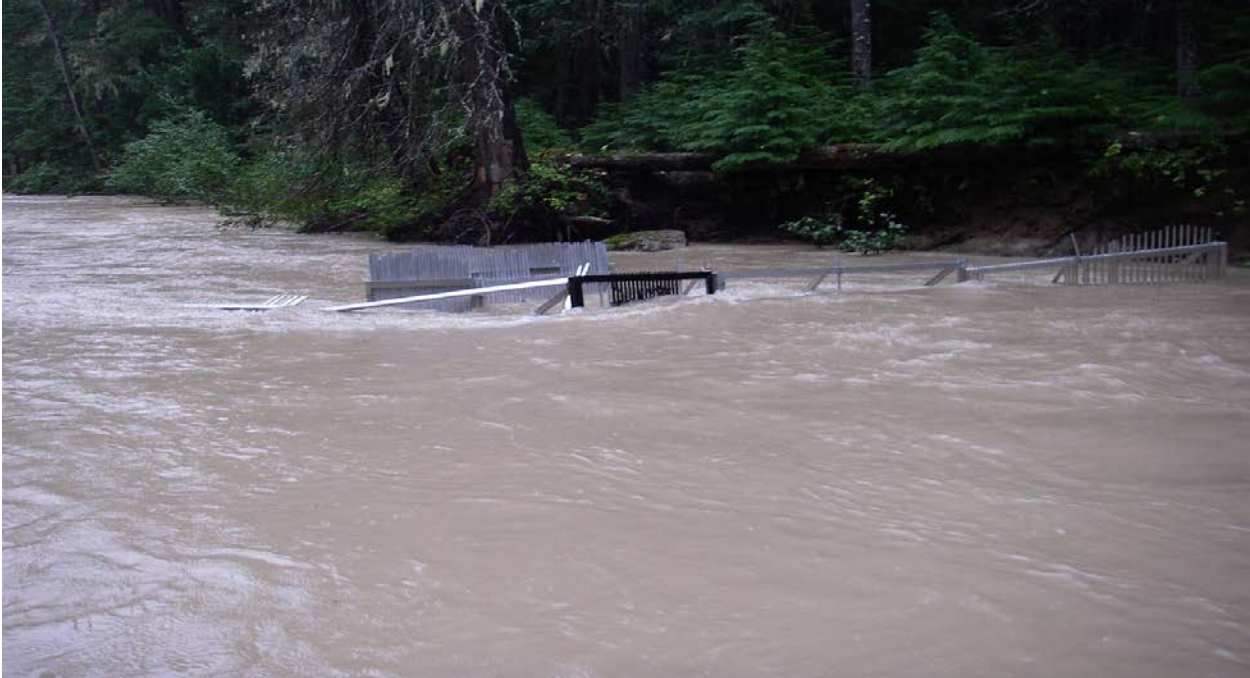
Figure 10. North Fork Tieton River fish trap during the high flow event which occurred at the end of September, 2013. This photo was taken the morning of September 29th. The left weir panels have already washed downstream. The remaining panels and the box were gone soon after. The river continued to rise.

The second high flow event began the afternoon of September 27 with a steadily rising river that seemed to level off by late night. However, heavy rains occurred the next day and by very early in the morning of September 29 the river was rising rapidly. Efforts to save the trap in the pre-dawn hours were halted because of dangerous conditions. A few hours later the trap began to disintegrate and washed downriver (Figure 10). Our trapping operation had come to a quick and decisive end. (Note: all of the weir and trap box components were recovered a few days later when the river had receded. Some had washed as much as 200 meters downstream).
