DRAFT
ENVIRONMENTAL ASSESSMENT
Moorman Mountain Boardwalk Trail

Mountain Longleaf National Wildlife Refuge
Fort McClellan, Calhoun County, Alabama
U.S. Fish and Wildlife Service
March 2006

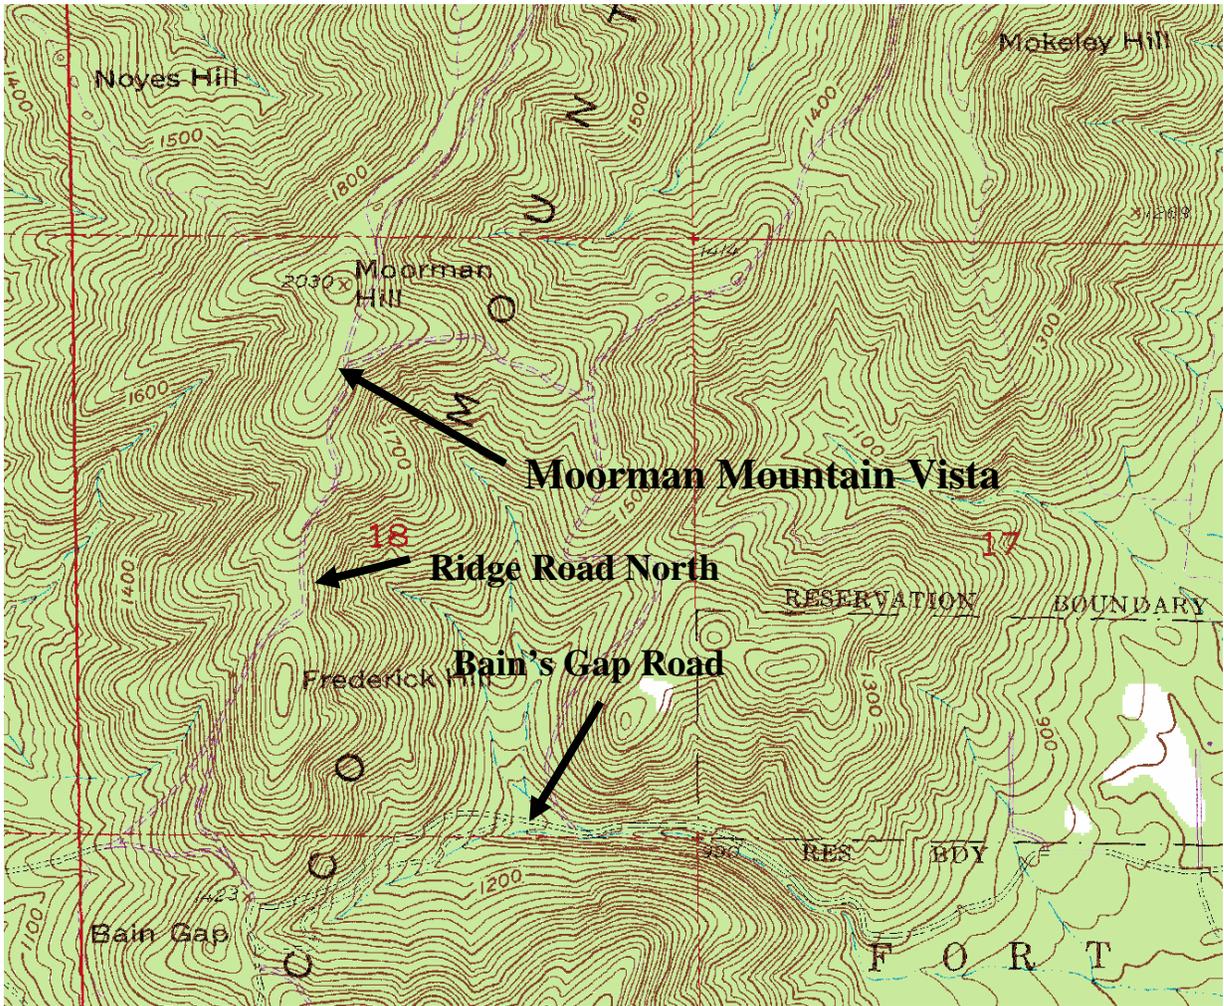
Figure 3
Moorman Mountain Topography

The vista is located along a small rock outcrop just east of Ridge Road North (Figure 3). During army ownership, the vista point served as a rendezvous for graduating training classes to celebrate and paint their unit’s insignia on the rock outcroppings. Since closure of the fort in 1998, the rocks have weathered and most paint has disappeared into history.

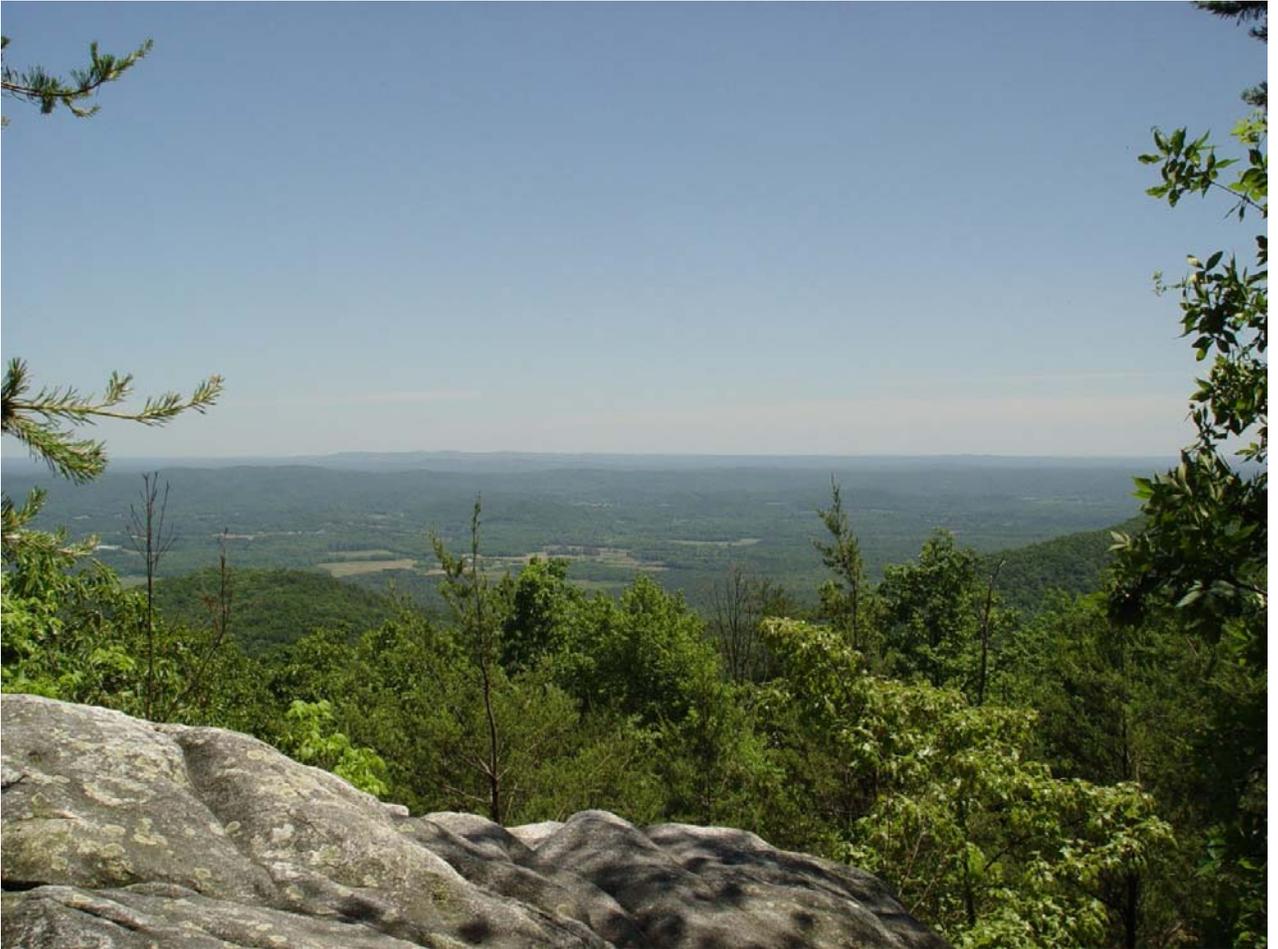
Figure 4

Moorman Mountain Vista View

across the Choccolocco Valley into the nearby Talladega Mountains attract increasing numbers of visitors (Figure 4). The side road behind the vista was graveled in 2004 to provide better parking for visitors. Signage has also been erected along refuge roads directing visitors to the vista point. Additionally, the refuge web site and brochures provide map directions to the vista and photographs of the view.
