San Juan River
Historical Ecology Assessment
Funded by the U.S. Bureau of Reclamation

San Juan Recovery Implementation Program
Biology Committee Meeting
February 20, 2015

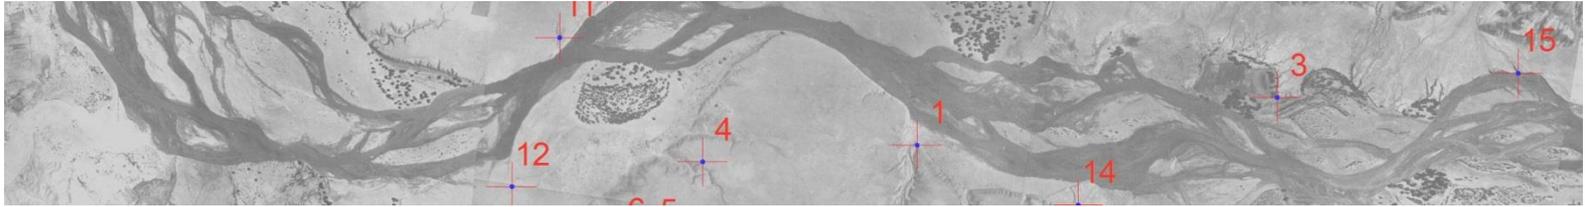
Methods – Image Georeferencing

- georeferenced to 2011 NAIP imagery
- manual control points placed at features visible in both images
 - higher density near river
- spline transformation used to align imagery
- protocol for images with high distortion

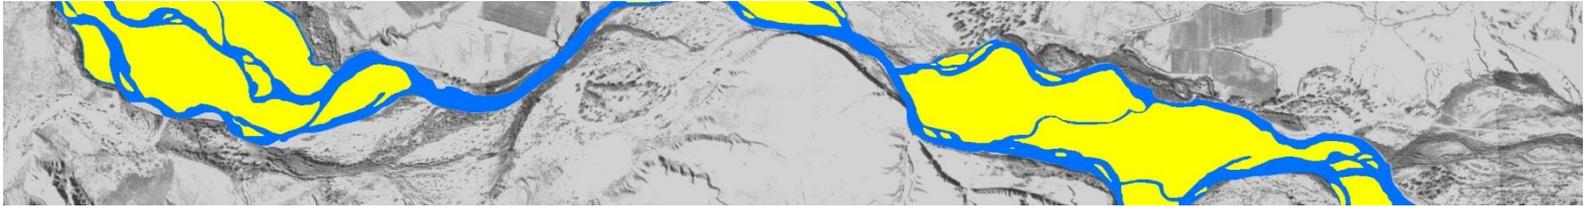
Methods - Digitization

Interpretation and digitization protocol

- 1:5,000
- Left bank, right bank, and islands
- Digitized by 1st analyst and then reviewed by a 2nd analyst
- Protocols for poor image quality
- Repeat digitization 2.02 m average horizontal error
 - largest error on sand-bars
 - in sample reach ≈ 0.02 acres per acre (2%)*

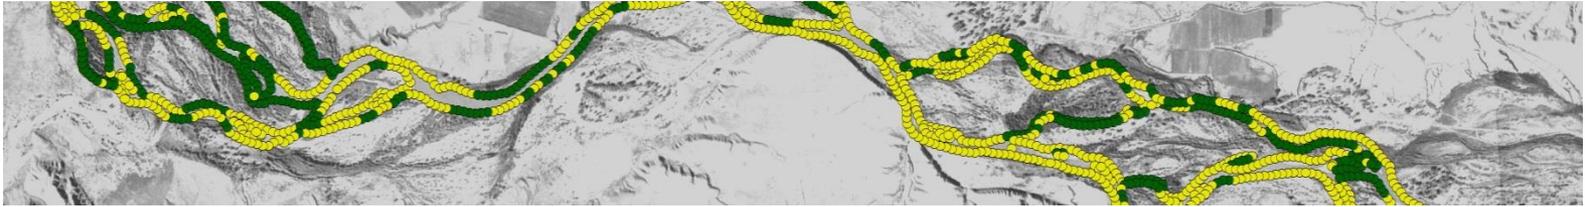
Methods – Vegetation Sampling

Bank Armoring Estimation

- Transect offset 2m from digitized river edge
- Sample points placed at 37.4 m intervals (≈ 43 samples/bank/VM)
- Presence or absence of vegetation recorded at each point (1:5,000)
- Cover estimates for individual banks in each RM are reported with $\approx 90\%$ confidence that values are within 10% of actual cover
- Sample size for most islands is too low to report vegetation cover
- When multiple river miles are combined the sample size becomes much larger

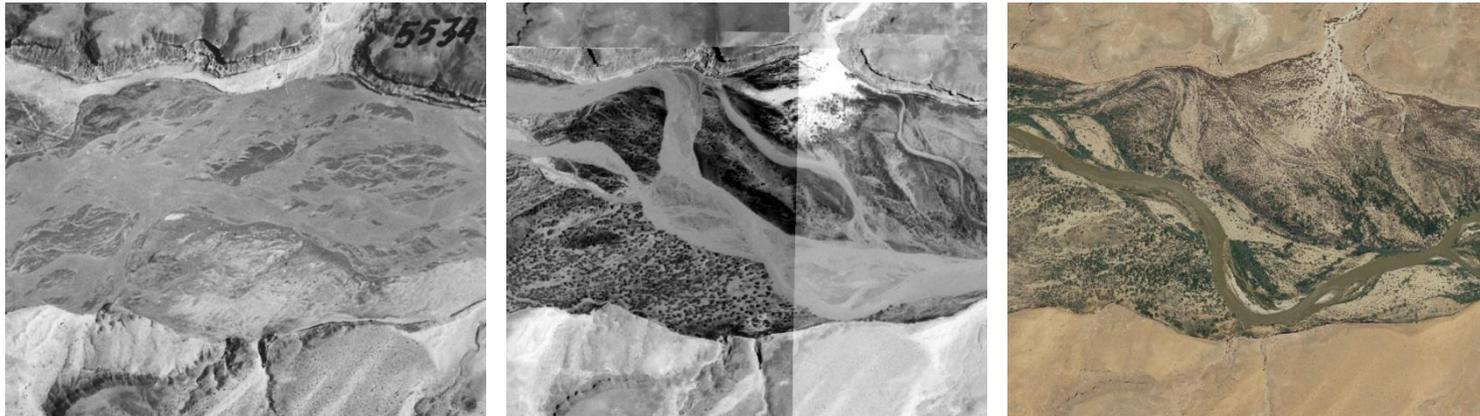
Ex. 1 [VM 151] (large area in 1930's, high decrease to 2010's)

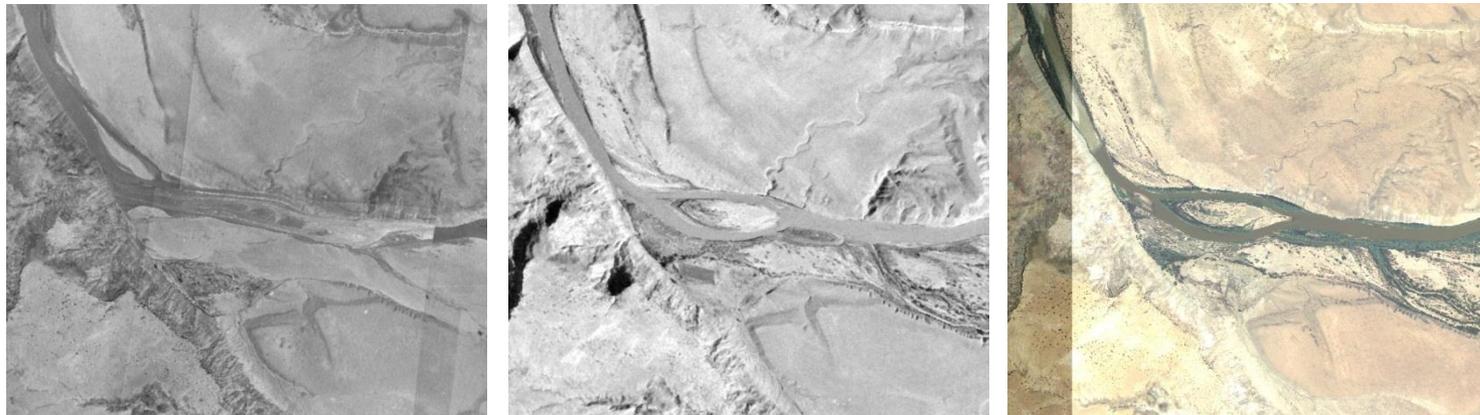
Ex. 2 [VM193](relatively small area in 1930's, still a 50% decrease)

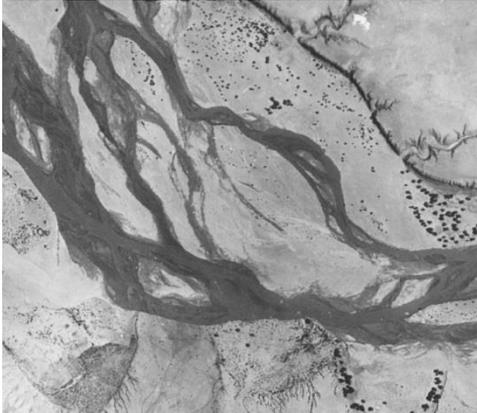
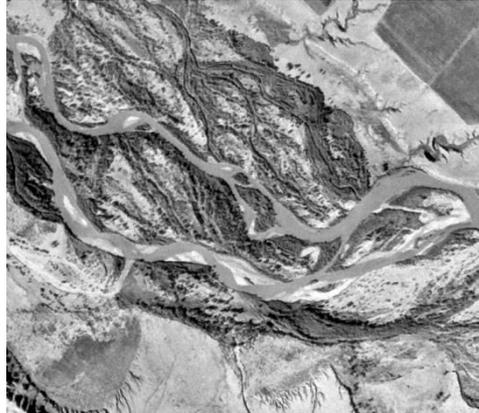
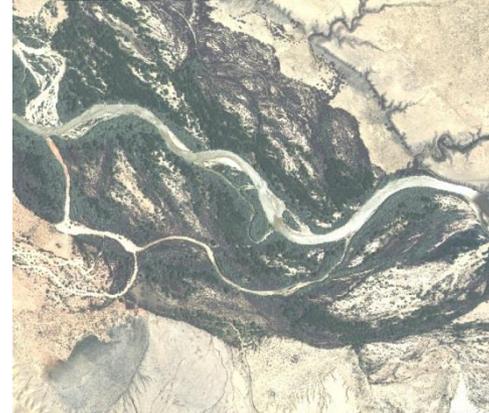
Ex. 1 [RM 204/205] Island Area stays the same
