FINAL REPORT

**Evaluation of the Need for Fish Passage
at the Arizona Public Service
and Fruitland Irrigation Diversion Structures**

October 2005

Melissa Stamp and Michael Golden,
BIO-WEST, Inc.,
and R. Craig Addley,
Watershed Systems Group, Inc.

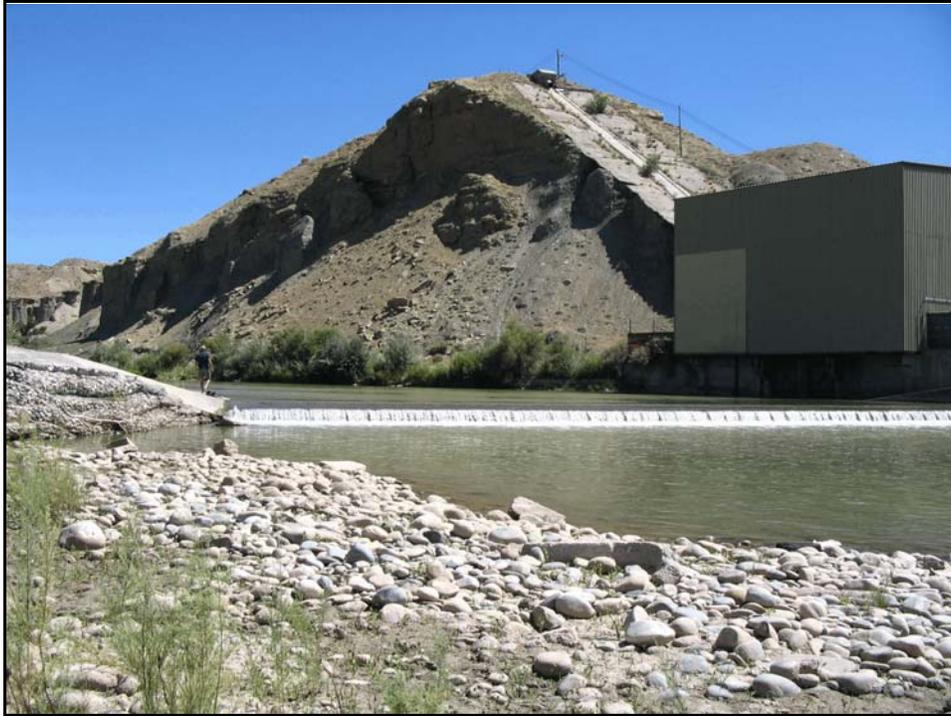
Figure 3.1a. Photos of APS Weir. Top: Upstream view of concrete weir. Bottom: Upstream view of weir with pumphouse and sluiceway visible on the right side of the photo.

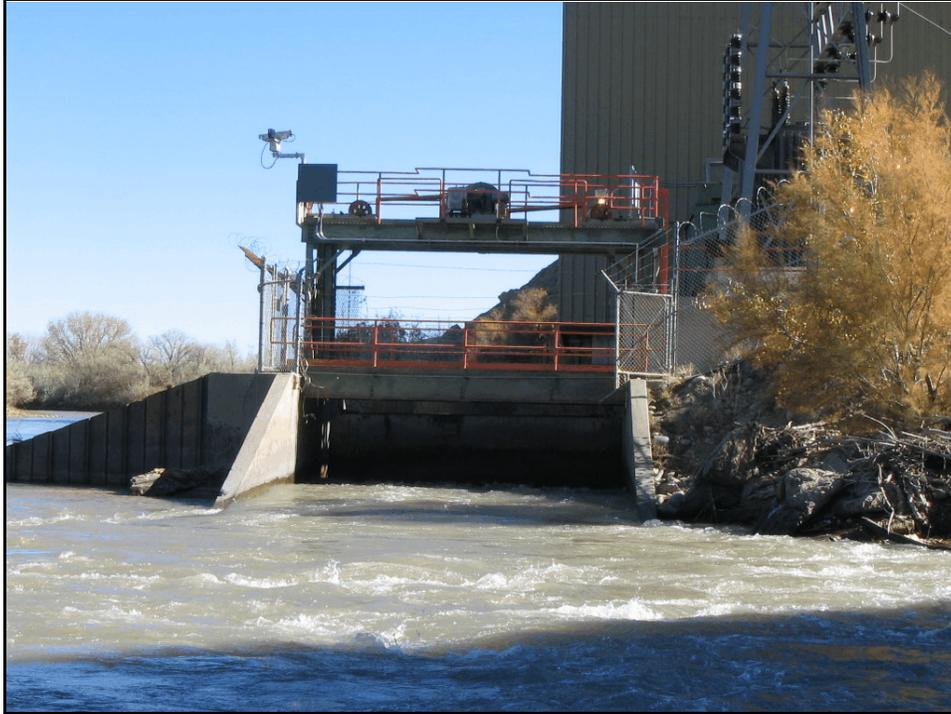
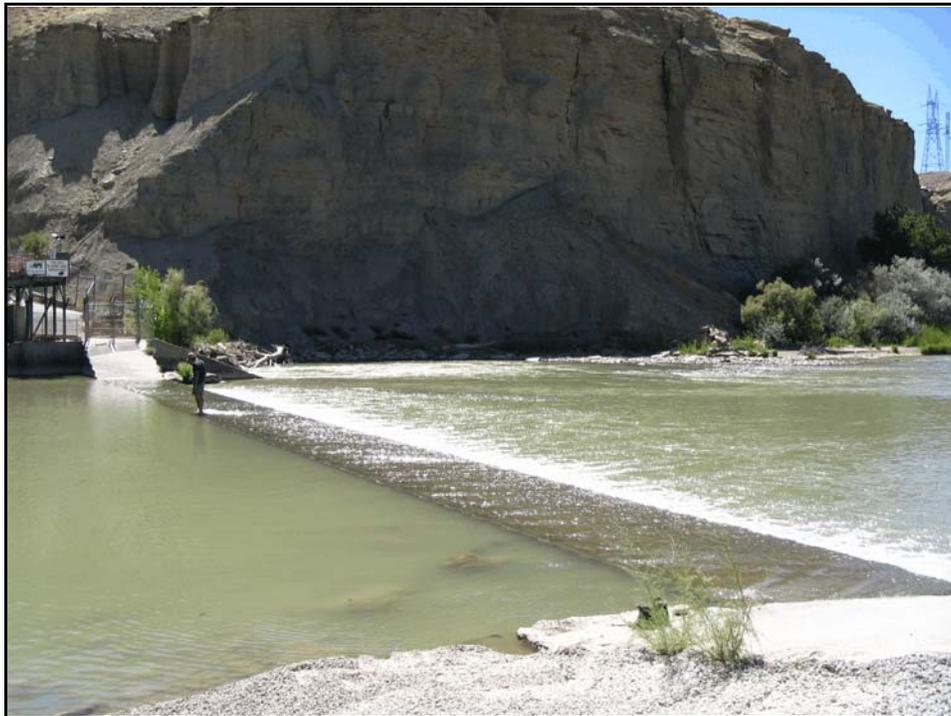
Figure 3.1b. Photos of APS Weir. Top: Upstream close-up view of sluiceway gate. Bottom: View across concrete weir from river right to river left.

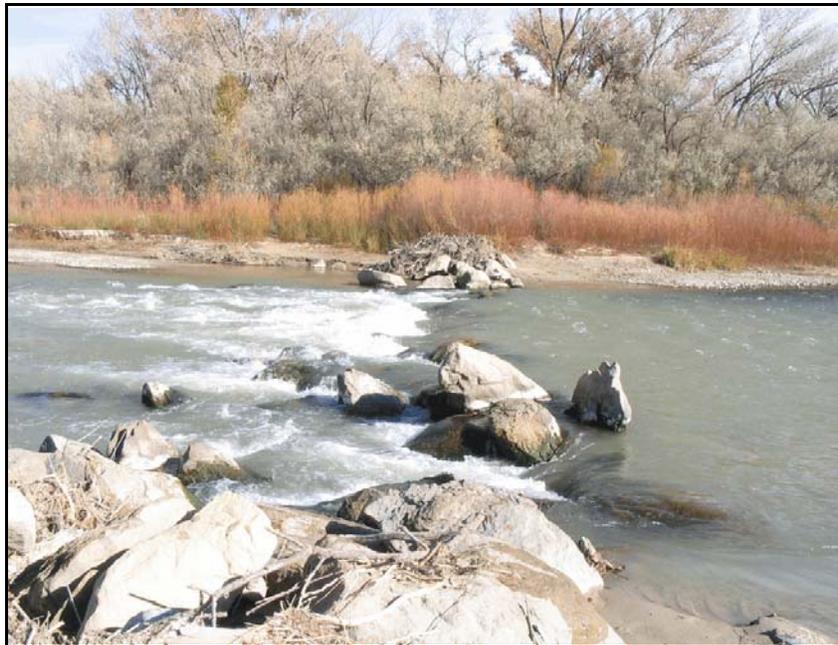
Figure 3.3a. Photos of Fruitland Diversion. Top: View of rock dam looking towards river left. Bottom: View of rock dam looking towards river right.

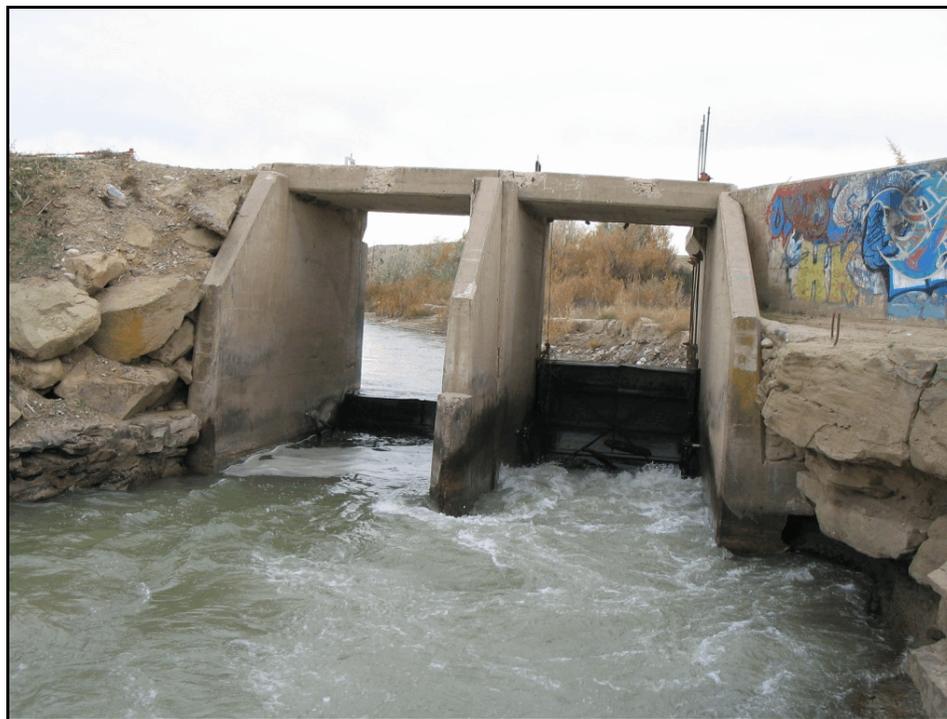
Figure 3.3b. Photos of Fruitland Diversion. Top: Downstream view of sluiceway gates and canal headgates. Bottom: Upstream close-up view of sluiceway gates.

The second component of the Fruitland diversion is a sluiceway facility located between the island and the left bank of the river (Figure 2.2 and 3.3b). The sluiceway consists of two 10-foot wide steel radial headgates that open from the bottom. At the time of our topographic survey, which occurred after the end of the irrigation season, the right sluiceway gate was in the closed position and left sluiceway gate was open. This gate arrangement is typical of conditions during

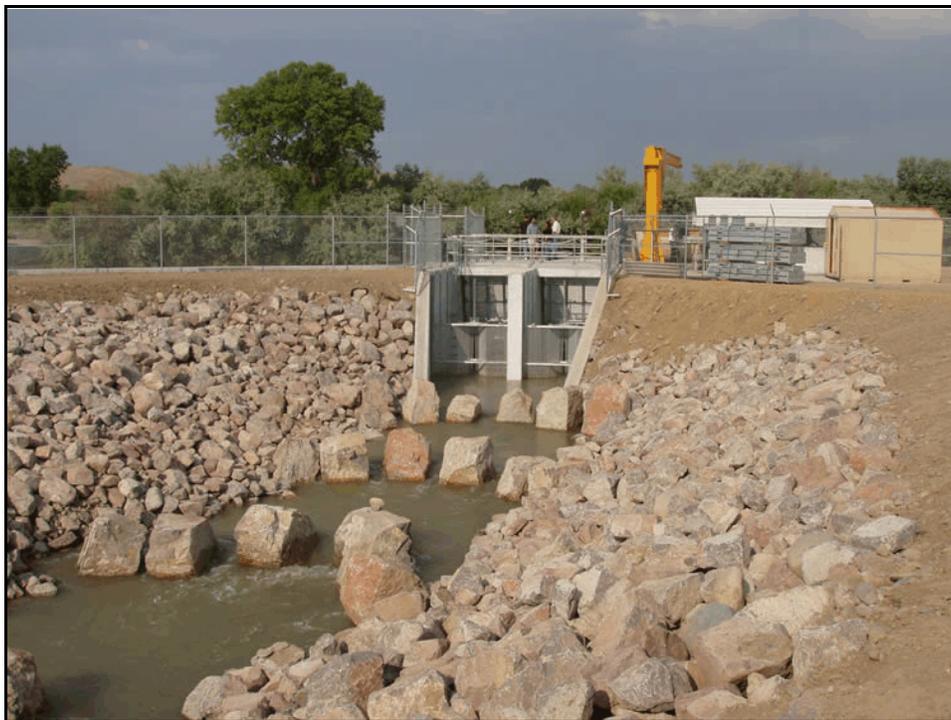
Figure 3.4. Photo of fish passage facility at PNM weir. Photo by William Miller, Miller Ecological Consultants; photo obtained from San Juan Recovery Program web site at <http://www.fws.gov/southwest/sjrip/>.

The PNM fish passage facility consists of an artificial “side channel” with boulder (rip-rap) bed material that leads to a gate area where fish are collected and sorted (Figure 3.4). Native fishes are returned to the river above the diversion structure. The fishway is about 350 feet long. Although detailed information on the flow velocities and depths within the PNM fishway was not readily available, the weir was designed to meet some general criteria used by the Bureau of Reclamation (BOR) when designing fishways for native sucker species. Velocities are kept below a maximum of 1.2 m/s (4 ft/s); vertical drops are avoided or kept to a height of 0.12 m (0.4 ft) or less; and water depths are kept to a minimum of 0.9 m (3 ft) to provide cover and reduce predation risk (B. Mefford 2005, pers. comm.). The successful use of the PNM facility by both adult Colorado pikeminnow and razorback sucker provides evidence that these fish are capable of sustained swimming speeds of up to 1.2 m/s, at least in channels where boulders provide velocity refuge zones.

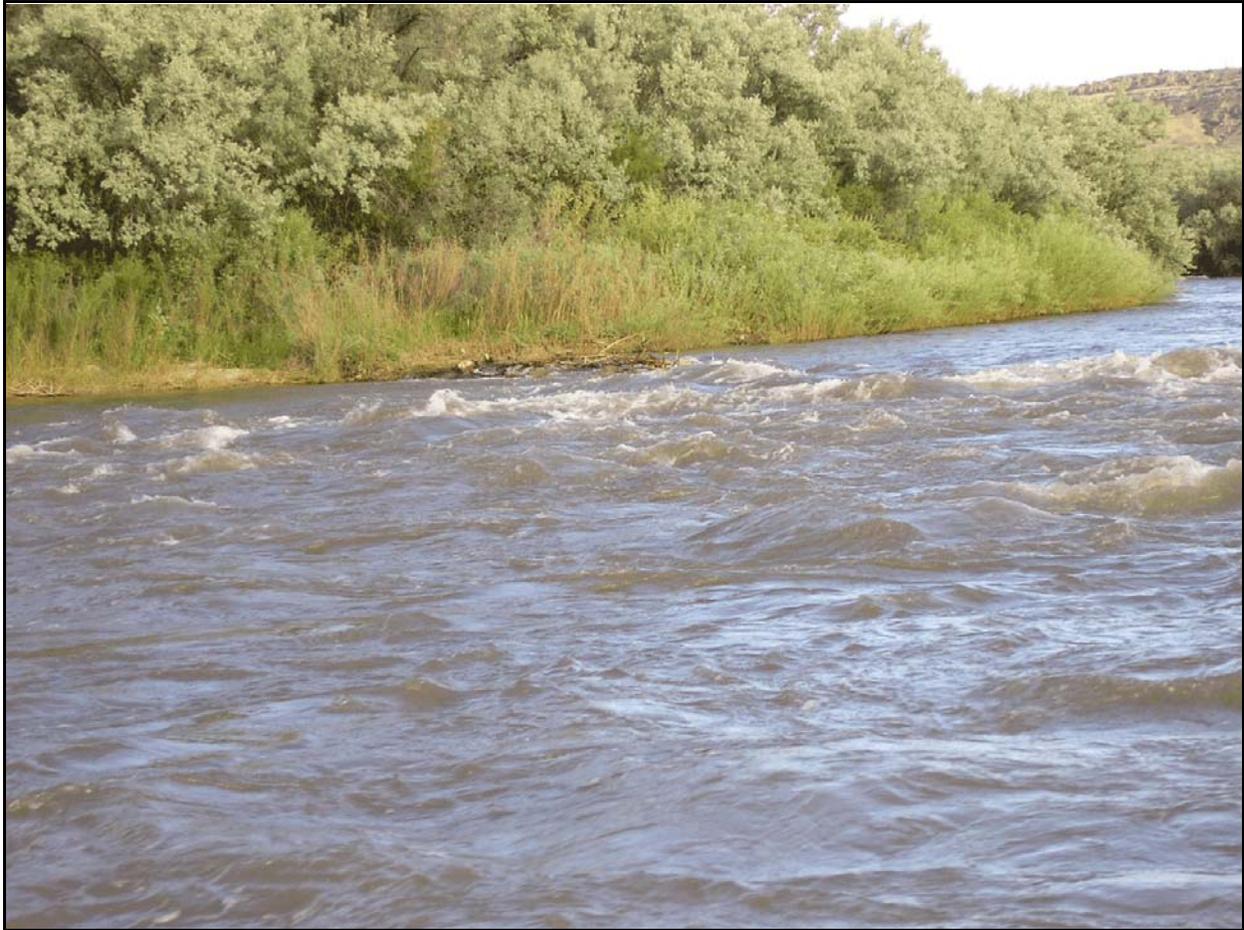
Figure 4.6. Photo showing upstream view of the right side of the Fruitland diversion rock dam at 7,500 cfs.

Model results for the 5,000 cfs flow level are similar to the results for the 3,000 cfs flow level for the less restrictive depth/velocity criteria (Figures 4.4b and 4.4c). However, at 5,000 cfs, short gaps in suitable nodes appear when the most restrictive criteria are used (Figure 4.4c). For the 8,000 cfs and 10,000 cfs model runs, very few nodes meet the restrictive criteria, particularly within the upstream portion of the rock dam (Figure 4.4c). At these high discharge levels, flow velocities are high throughout the main river channel, and exceed 1 m/s in the main channel areas above and below the rock dam (Figure 4.5). However, even at these high flow levels, narrow continuous suitable paths are available along the far right side of the dam when the less restrictive depth/velocity criteria are used (Figure 4.4c). Observations of the rock dam during the high-flow (7,500 cfs) survey in June 2005 confirm that conditions along the far right side of the dam appear to meet the less restrictive passage criteria. In this area, a large eddy develops immediately below the rock dam, and velocities just above the rock dam are slowed by inundated vegetation (Figure 4.6).

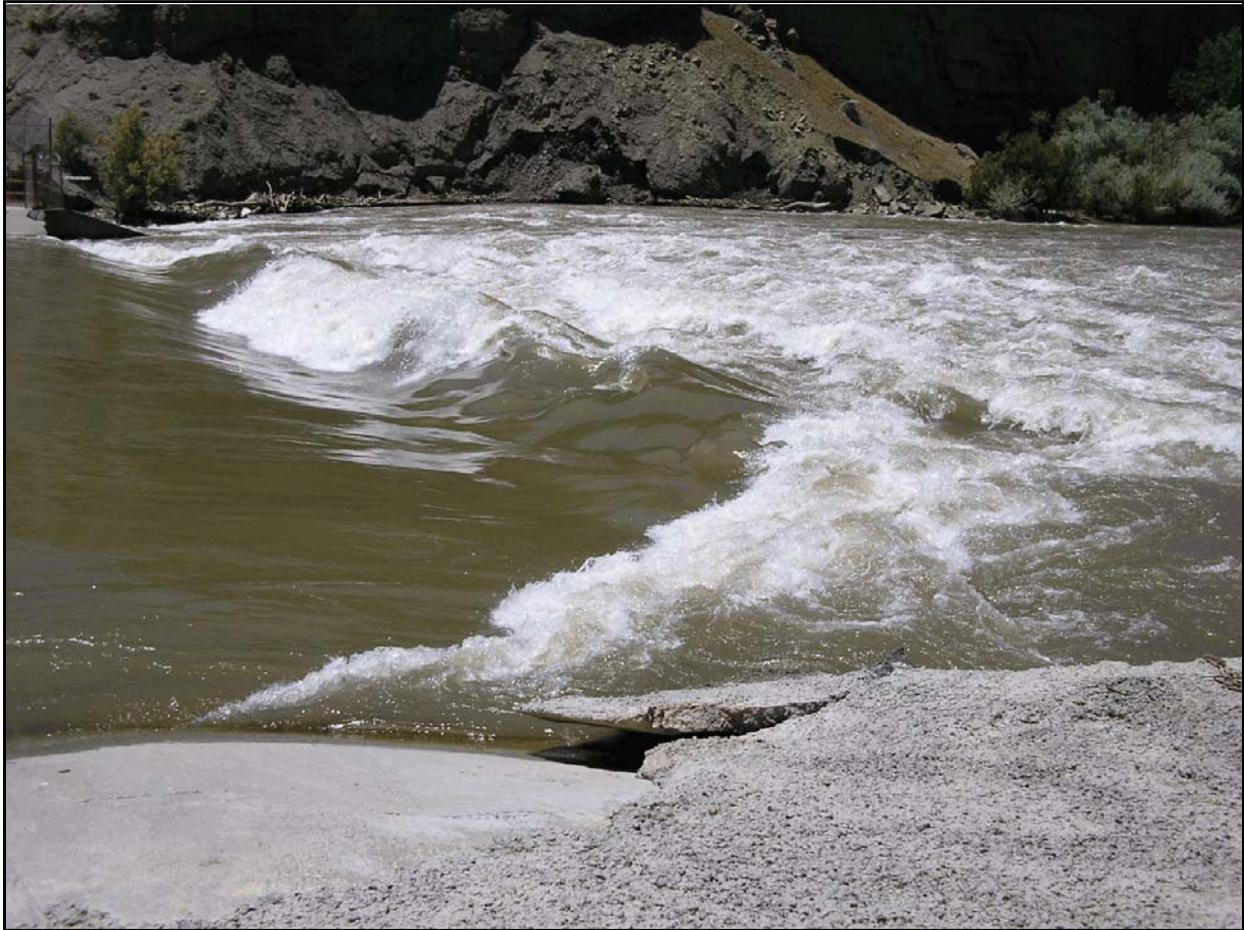
Figure 4.10. Photo of the APS diversion at 7,000 cfs. Photo taken from the right bank looking across the weir to the sluiceway. Note the strong hydraulic jump across middle portion of weir and the more moderate hydraulics towards the right edge of water.
