ROOSEVELT HABITAT CONSERVATION PLAN

ANNUAL REPORT

2011

Salt River Project
Environmental Services Department
Siting and Studies
PAB 352
P.O. Box 52025
Phoenix, Arizona 85072-2025

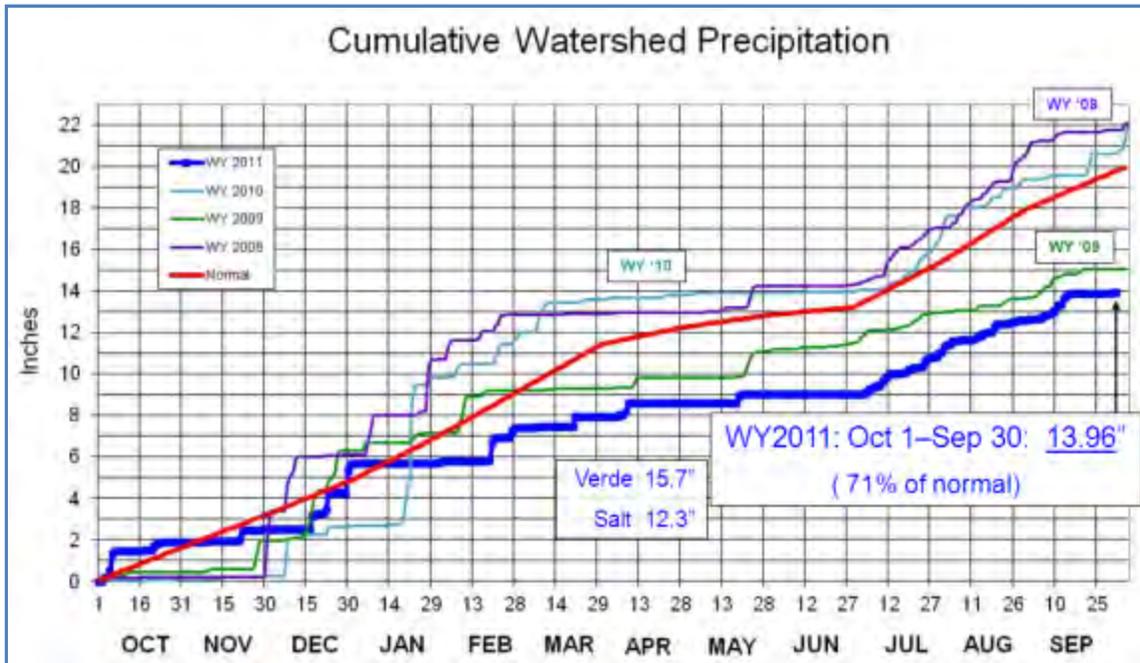
Figure 1. Cumulative watershed precipitation, October 1, 2010 through September 30, 2011.

For the water year, October 1, 2010, through September 30, 2011, the Salt/Verde watershed average precipitation accumulation was 13.96” or 71% of normal with the Salt side receiving 12.3” or 62% of normal versus the Verde’s 15.7” or 79% of normal. (See figure 1.)

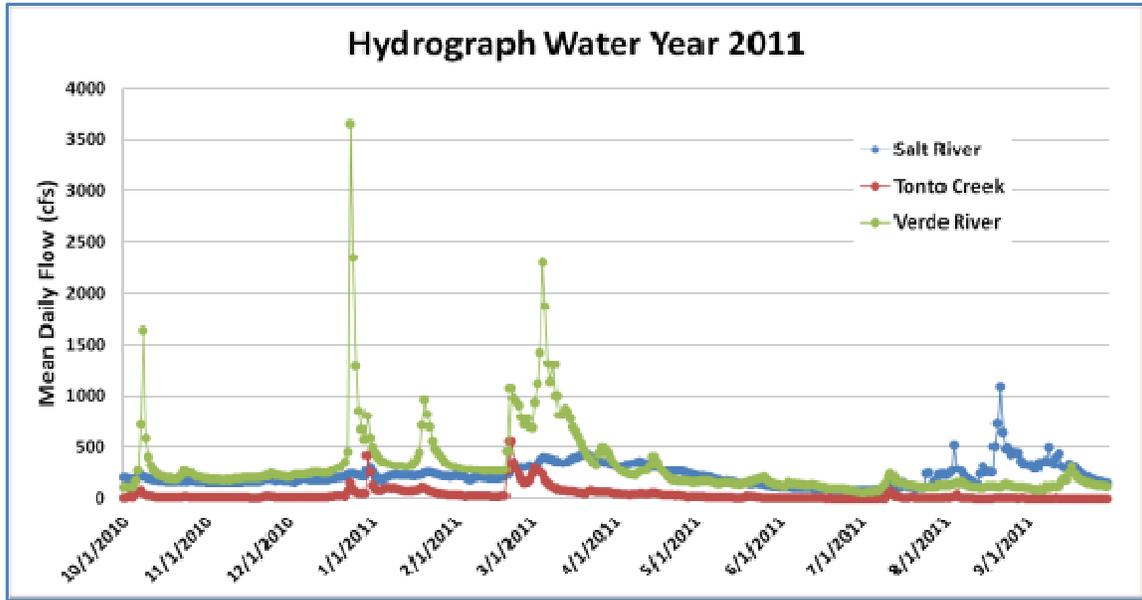
Figure 2. Hydrograph for Salt River, Tonto Creek and Verde River, Water Year 2011.

Reservoir Status: The reservoir system was 88% of capacity heading into water year 2011 due to above median runoff from the 2010 winter season and near normal precipitation from the 2010 monsoon season. The winter season began favorably with December precipitation being 186% of normal. However, the wet December was an anomaly given the moderate La Niña (below normal sea surface temperatures over the equatorial Pacific). Total runoff this winter (January-May) was approximately 222,000 acre-feet which is 42% of median and ranked as the 22nd driest winter on record. Total runoff from the monsoon (July-September) produced about 72,000 acre feet. (See figure 2.) Total storage decreased from 88% of capacity to 68% capacity during water year 2011.

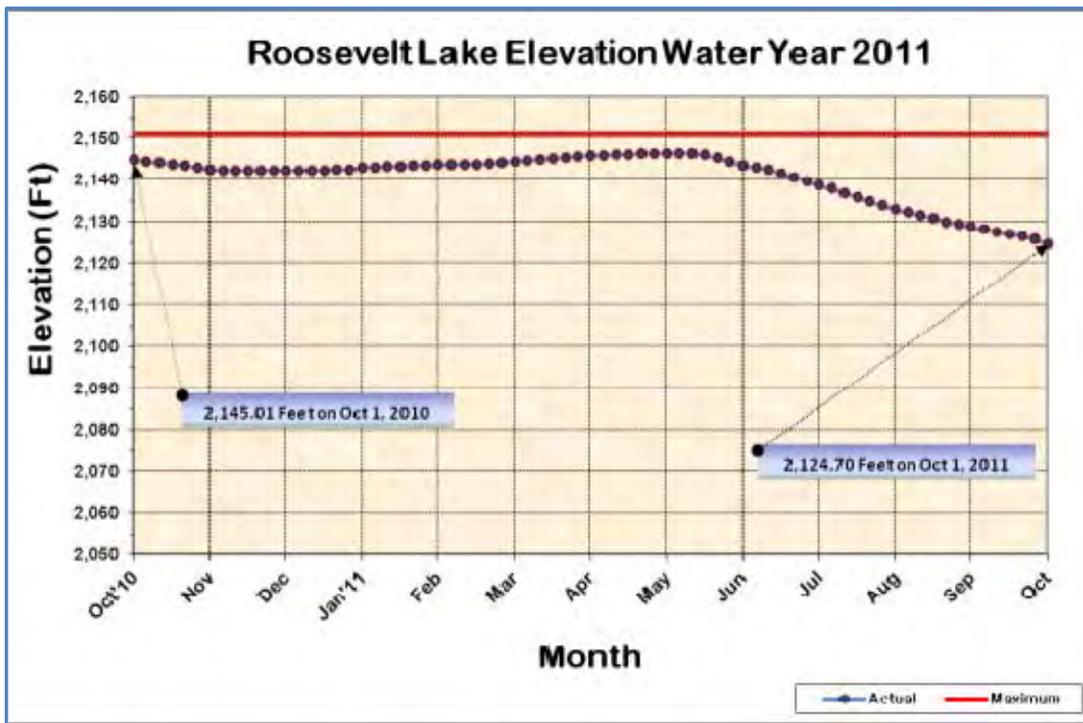
Figure 3. Roosevelt Lake elevations, Water Year 2011.

Roosevelt Operations: Roosevelt operations were most influenced by the lack of winter runoff. Even with La Niña conditions in place, there was potential for Roosevelt Dam to fill and force water releases over Granite Reef Diversion Dam due to the abundant runoff from the previous year. However, the winter of 2012 produced only 77,000 acre feet of runoff into Roosevelt Lake. The elevation at Roosevelt Dam varied little through the winter with the water order

on the Verde system and meager inflows through the winter season. On May 4th the water order transitioned back to the Salt system and reservoir levels began to decline. (See figure 3.) The transition took place later in the season than normal this year due to a maintenance outage at Roosevelt Dam in late April 2011 that delayed the transition to the Salt system this spring. The water order switched back to the Verde system on November 21, 2011.

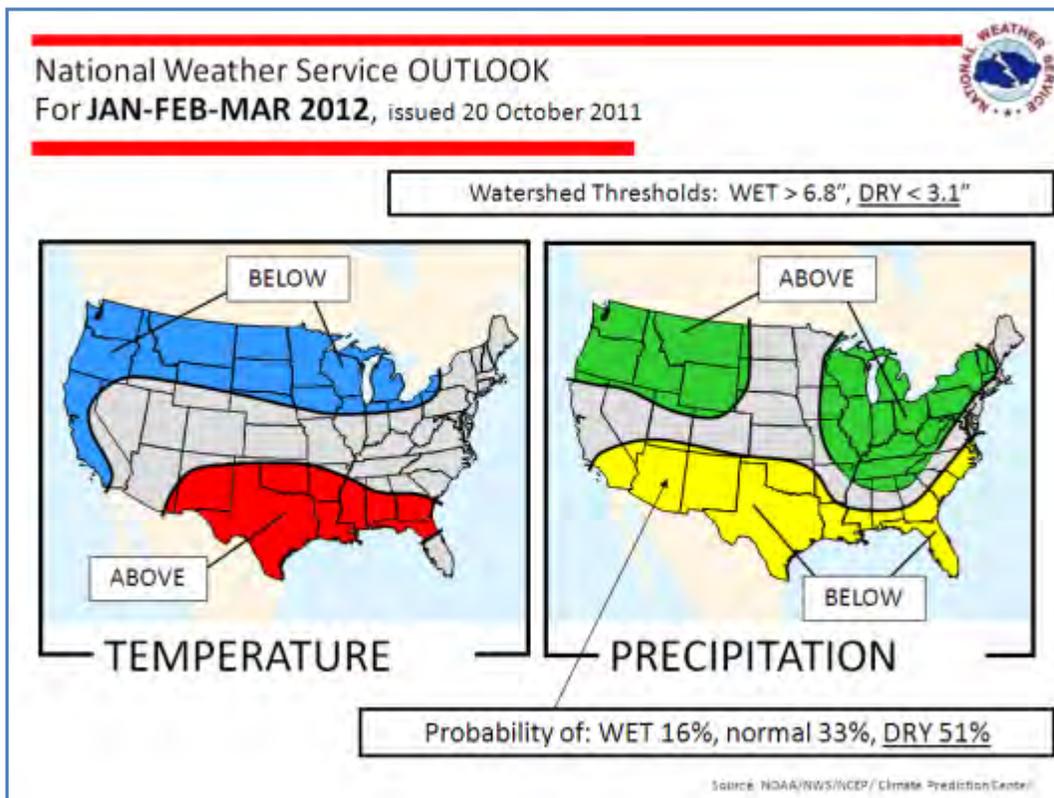
Figure 4. Temperature and precipitation outlooks for January through March 2012.

Weather Outlook: Currently, La Niña conditions are again present and expected to continue. The Climate Prediction Center is predicting La Niña conditions to continue into the winter. If so, another dry winter appears imminent in Arizona's near future (figure 4). Preliminary reservoir storage projections indicate the total system would be at about 55% of capacity if the forecast for another dry winter is correct.

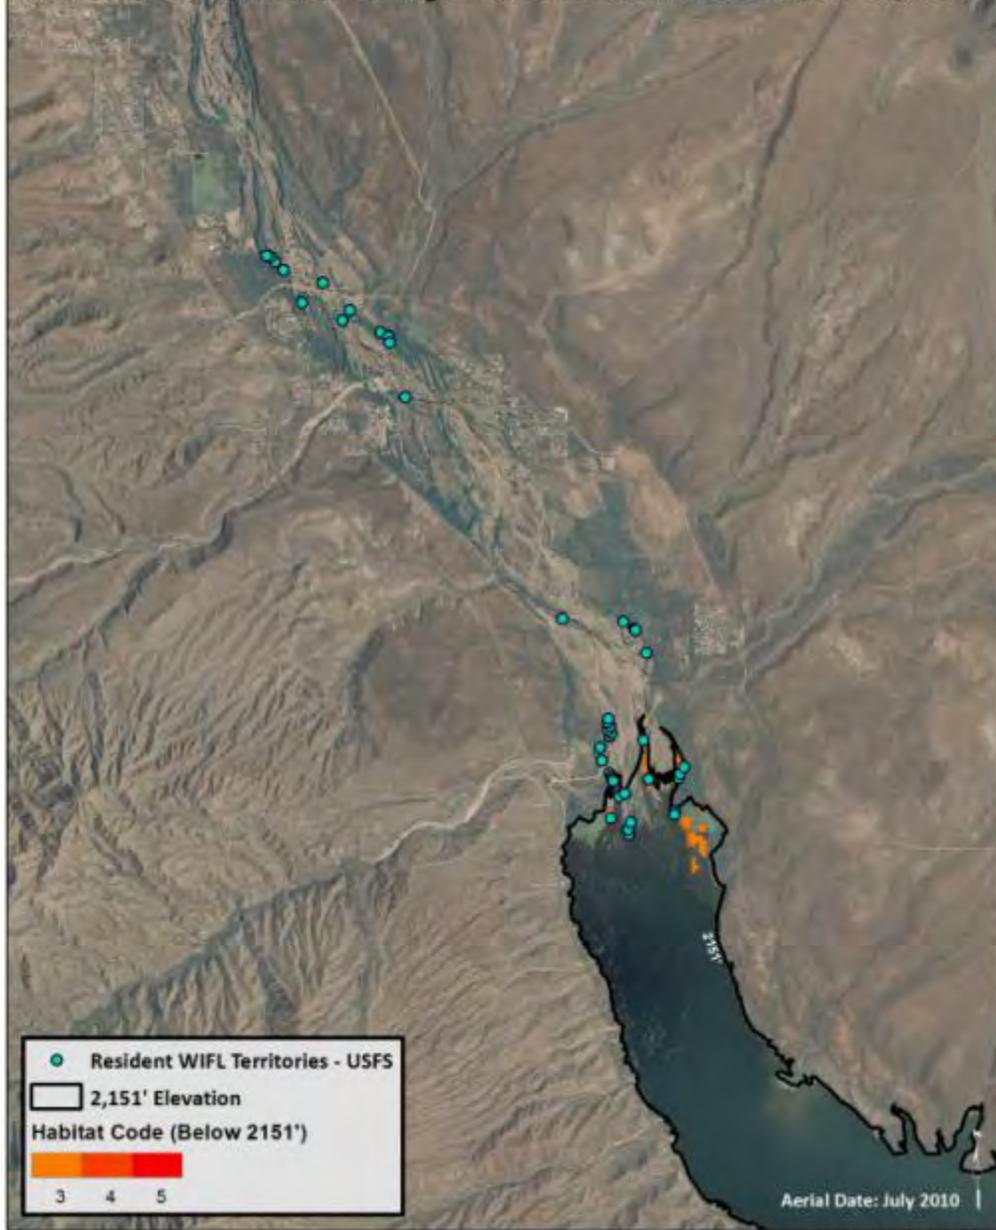
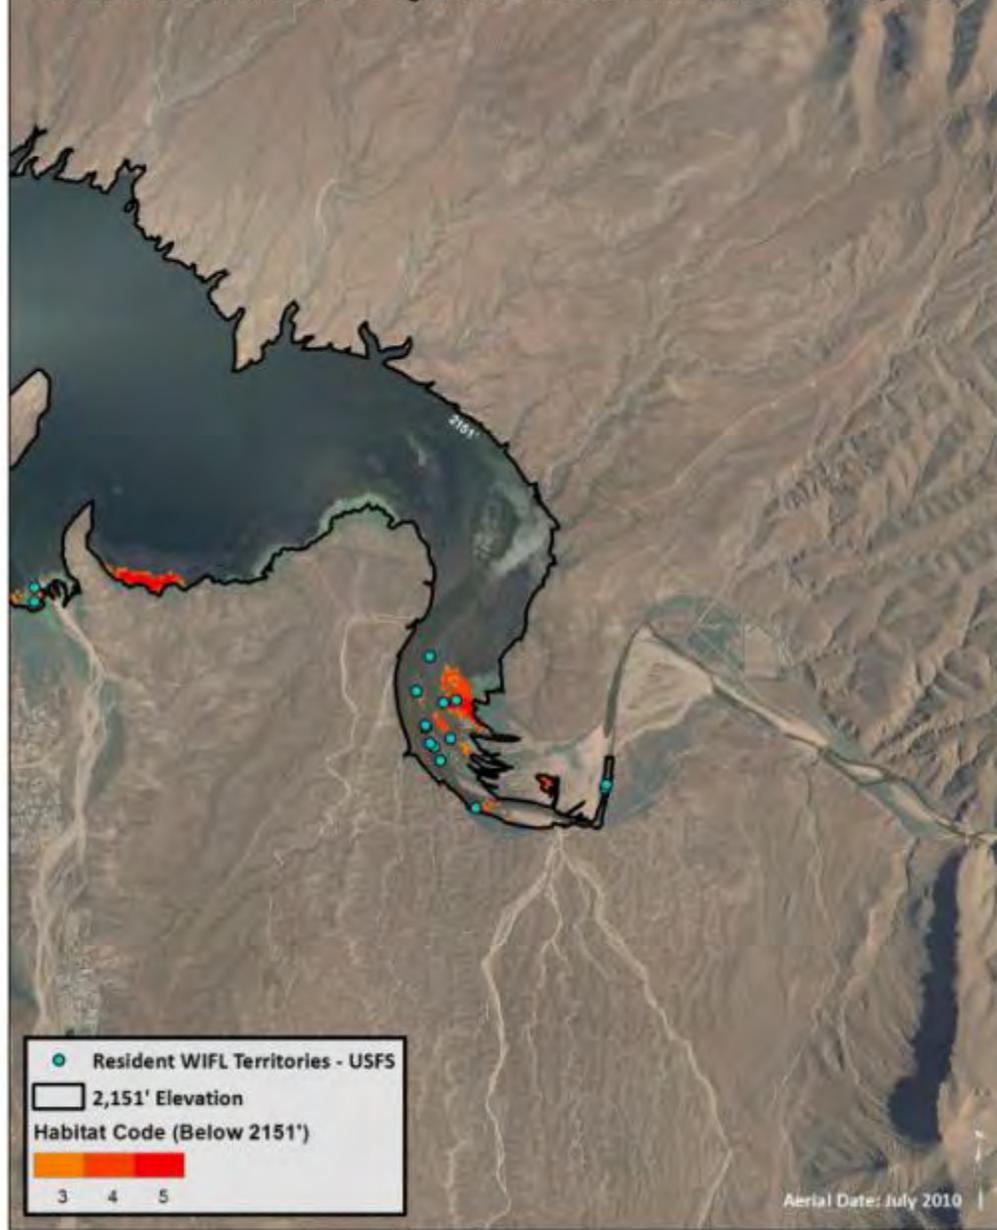
Tonto Creek Arm Willow Flycatcher Habitat Model Results, 2011

Figure 6. Salt River and Tonto Creek arms of Roosevelt Lake showing 2011 flycatcher habitat model results and flycatcher territory locations as provided by Tonto Basin Ranger District, Tonto National Forest. Satellite image was taken on June 22, 2011 at lake elevation 2140.33' (87% full). The aerial photo was taken in July 2010 when the lake was 95% full.

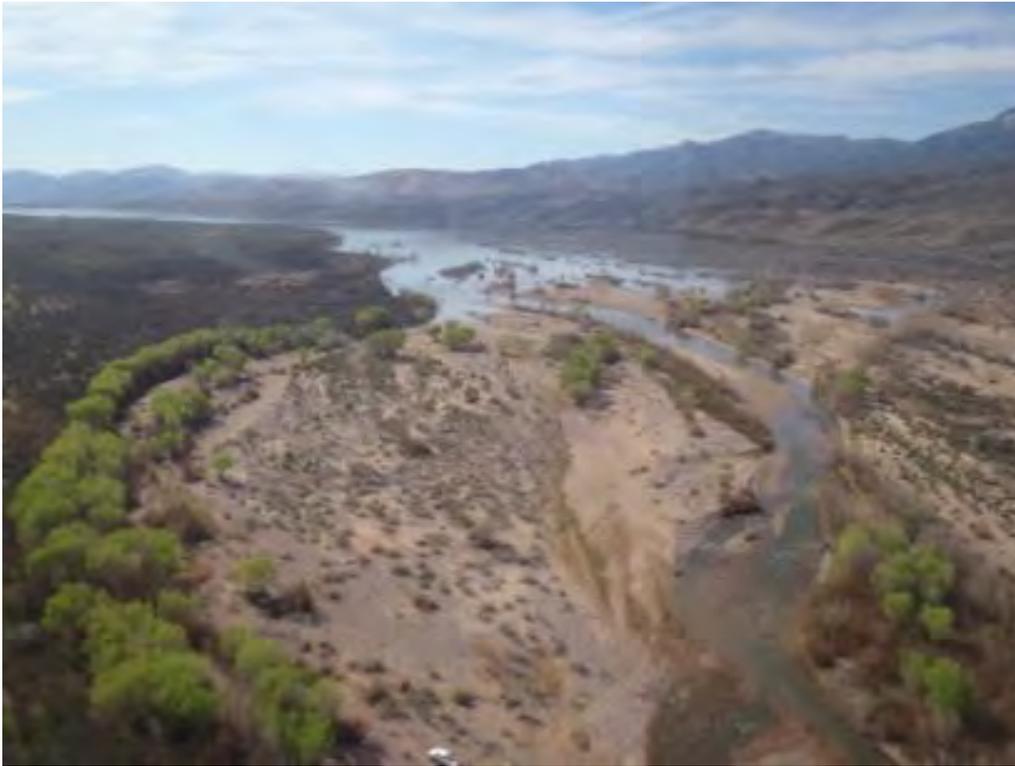
Figure 7. Tonto Creek arm of Roosevelt Lake looking downstream from A-Cross Road. March 14, 2011. Photo by R. Valencia.

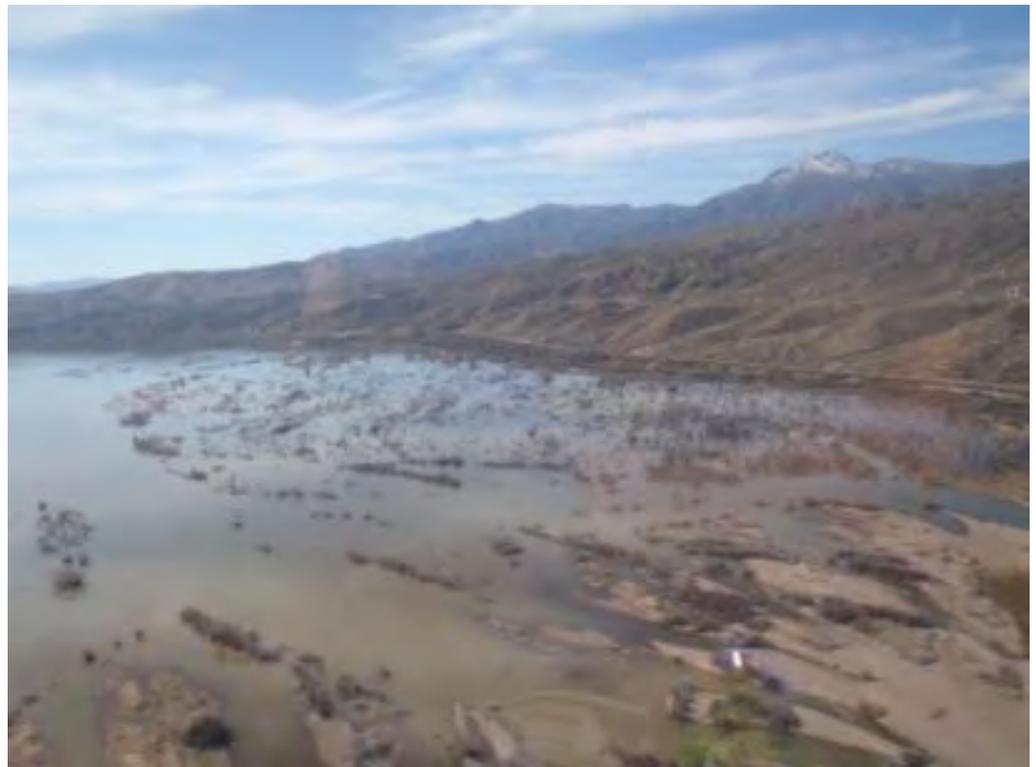
Figure 8. Inundated vegetation at Tonto Creek inlet to Roosevelt Lake. March 14, 2011. Photo by R. Valencia.

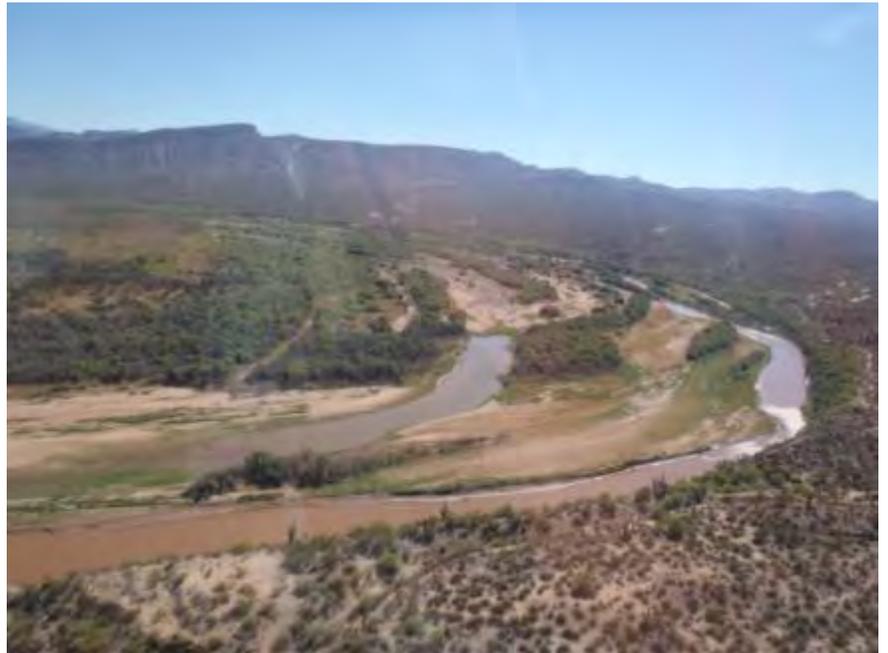
Figure 9. Occupied flycatcher habitat at the Salt River inlet (Cottonwood Acres) looking upstream. Photograph taken October 17, 2011 at lake elevation 2122.79' (67% full).

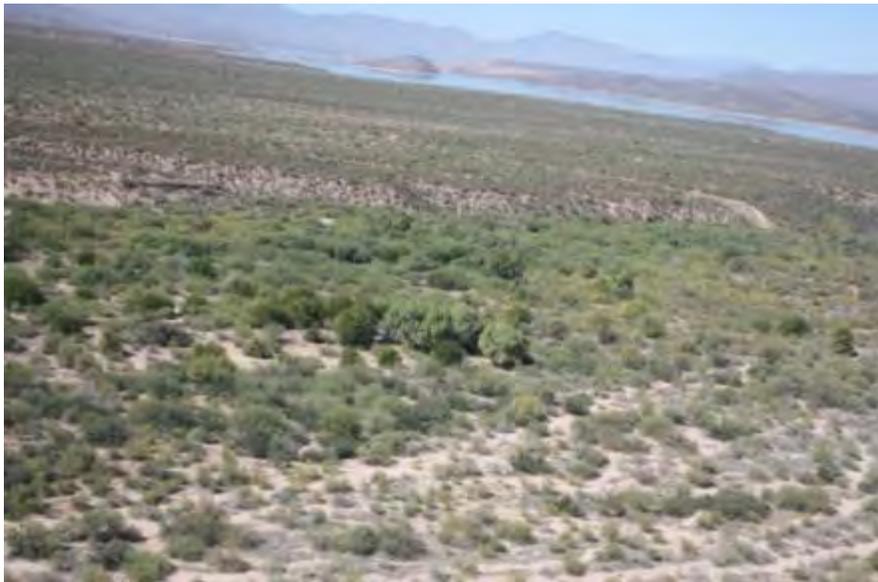
Figure 10. Habitat at the mouth of Pinto Creek. October 17, 2011.

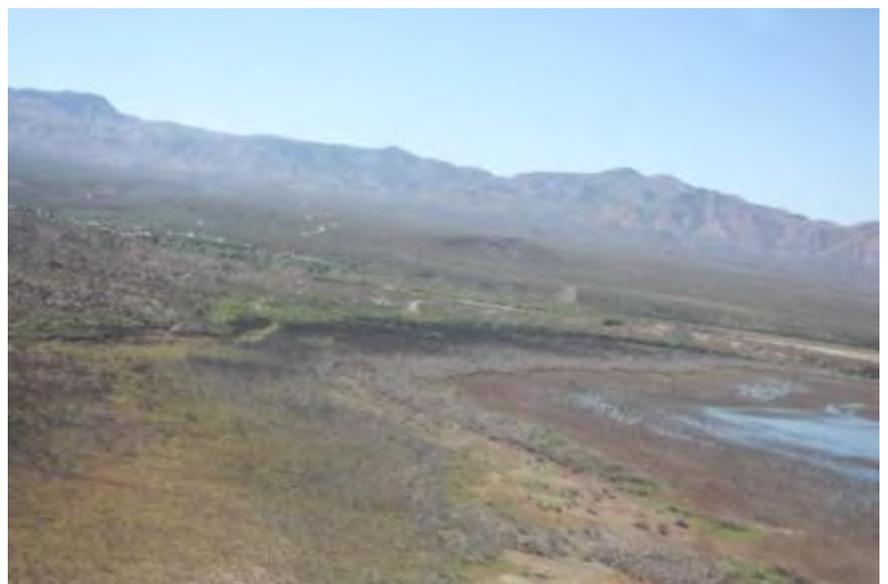
Figure 11. Exposed lake bottom upstream from the confluence of Pinto Creek. October 17, 2011.

There is an ongoing problem near Pinto Creek and the Roosevelt Mound. Its proximity to Roosevelt Estates and Resort makes it more accessible to motorized vehicles and therefore difficult to patrol. ATV and UTV riders are the primary violators. Often, signs are removed, broken off, or run over.

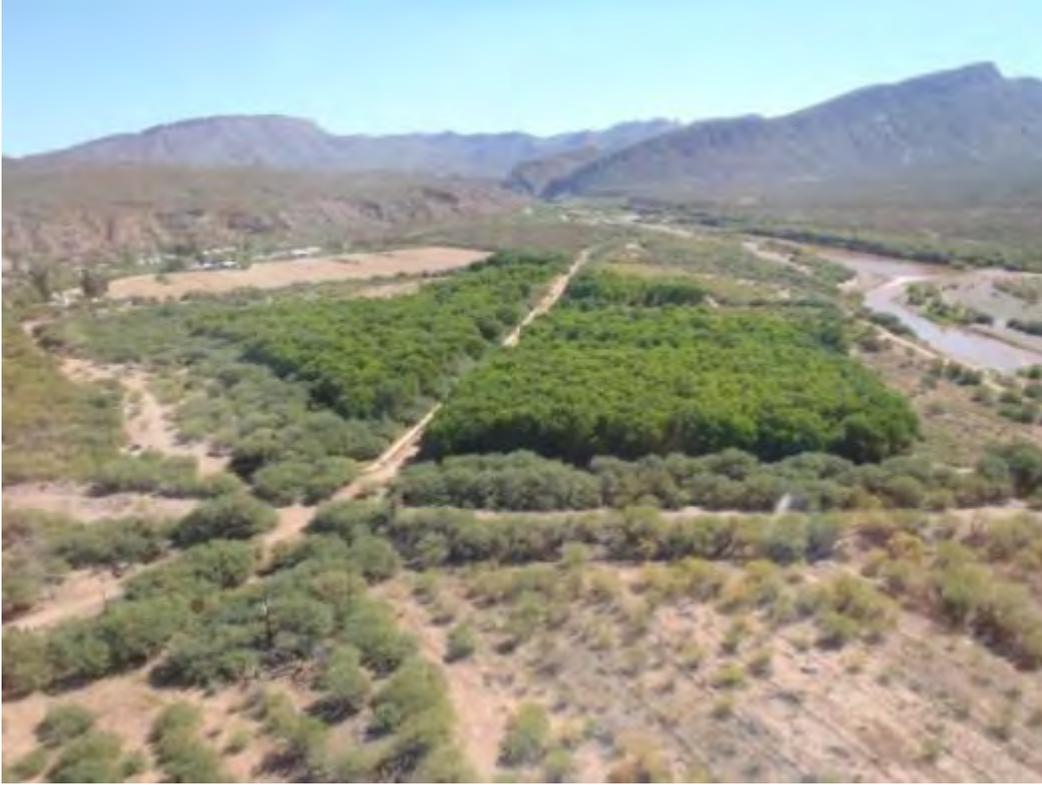
Figure 12. Rockhouse Project, looking southeast (upstream). Photo taken October 17, 2011. Photo by C. Paradzick.

Operations and Maintenance. SRP continued to contract with Tim Wheeler (Maratimo Construction) to conduct irrigation and site maintenance. Irrigation intervals varied depending on rain events, soil moisture levels and temperature, but were performed according to the following general schedule. Regular flood irrigation of the site began at the end of April and continued every 10 to 18 days through the end of September, after which irrigation intervals were reduced to monthly.

Operations and Maintenance. SRP will continue with the same general irrigation schedule. General monitoring of tree growth and health will continue. Regular maintenance of the irrigation system will be conducted. We will remove vegetation, both mechanically and chemically, from the ditch areas, as necessary.

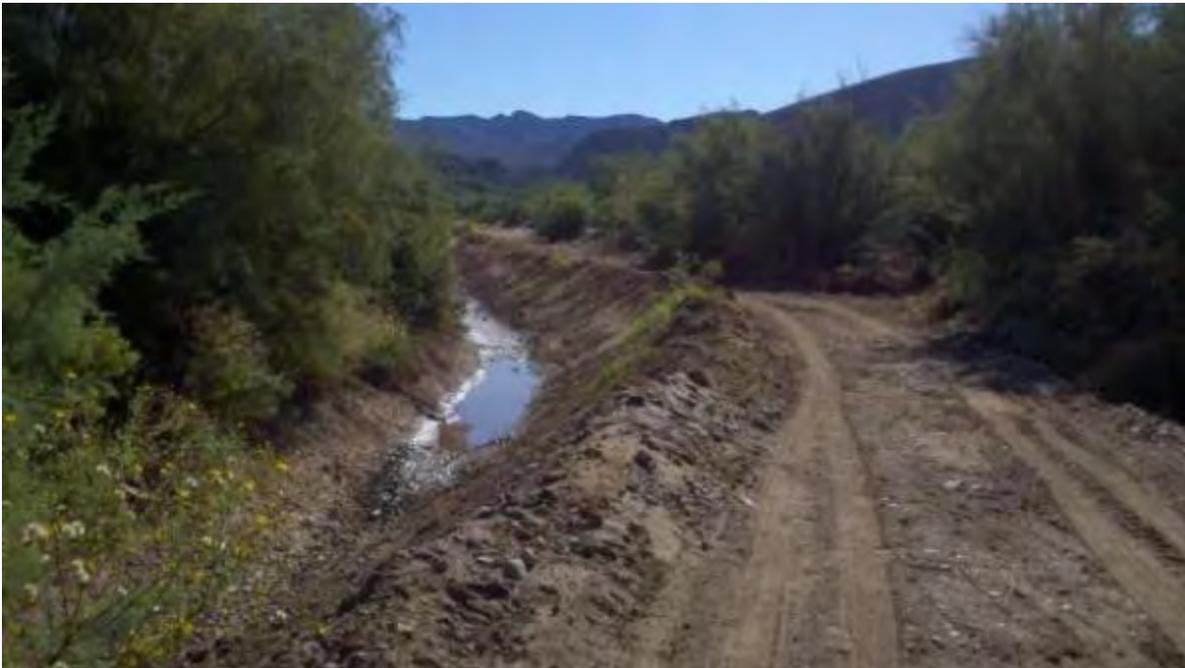
Figure 13. Completed ditch maintenance work, September 2011. Photo by M. Wicke.

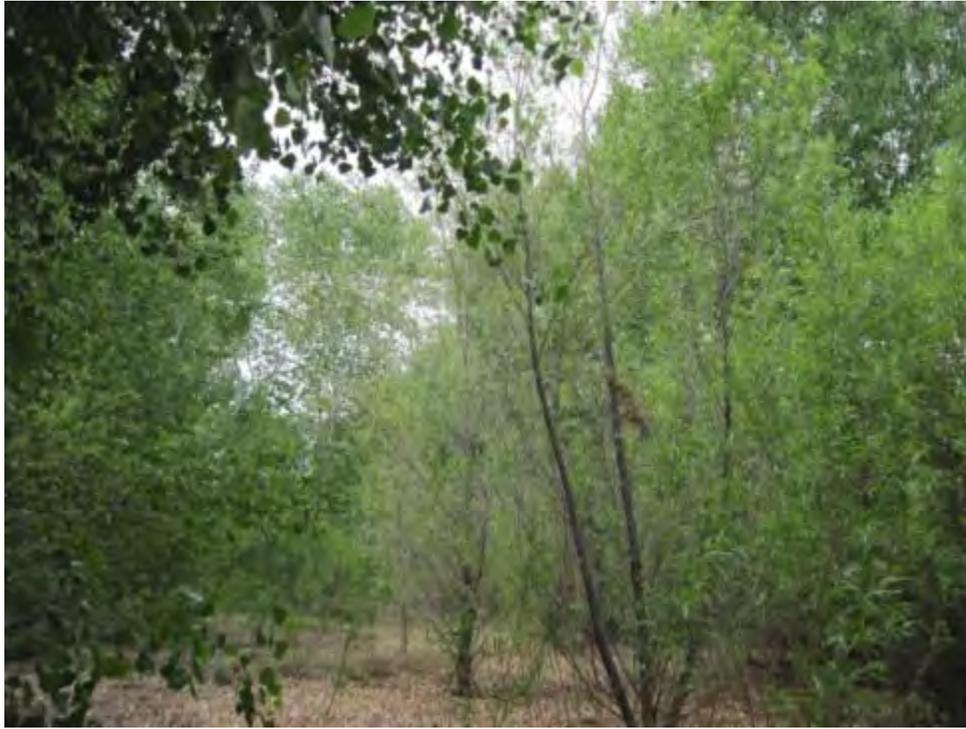
Figure 14. Interior of planting at the Rockhouse site. Photo taken May 2011 by R. Valencia.

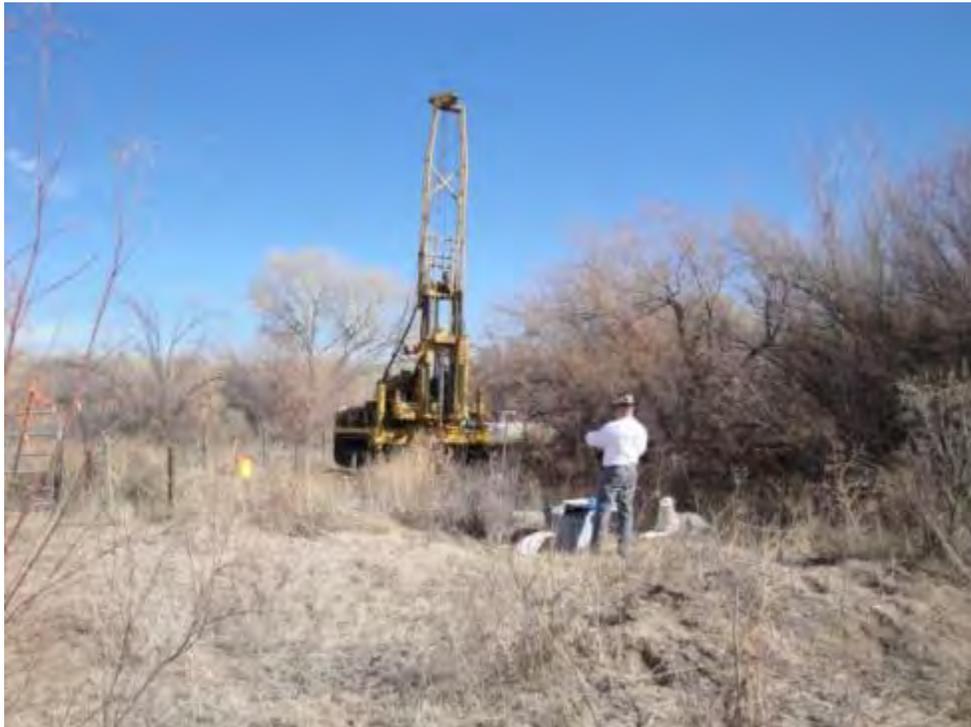
Figure 16: Drill rig installing piezometer in the river bottom at Adobe Preserve. Photo by Dan Wolgast.

Depth to water measurements are taken monthly and recorded in a spreadsheet format at SRP. Instream flow measurements are taken in the San Pedro River at the Adobe Preserve on the same schedule. Presence of surface water is noted at all other mitigation properties. SRP will be working with TNC in the coming year to merge our data sets and share data collected along the lower river.

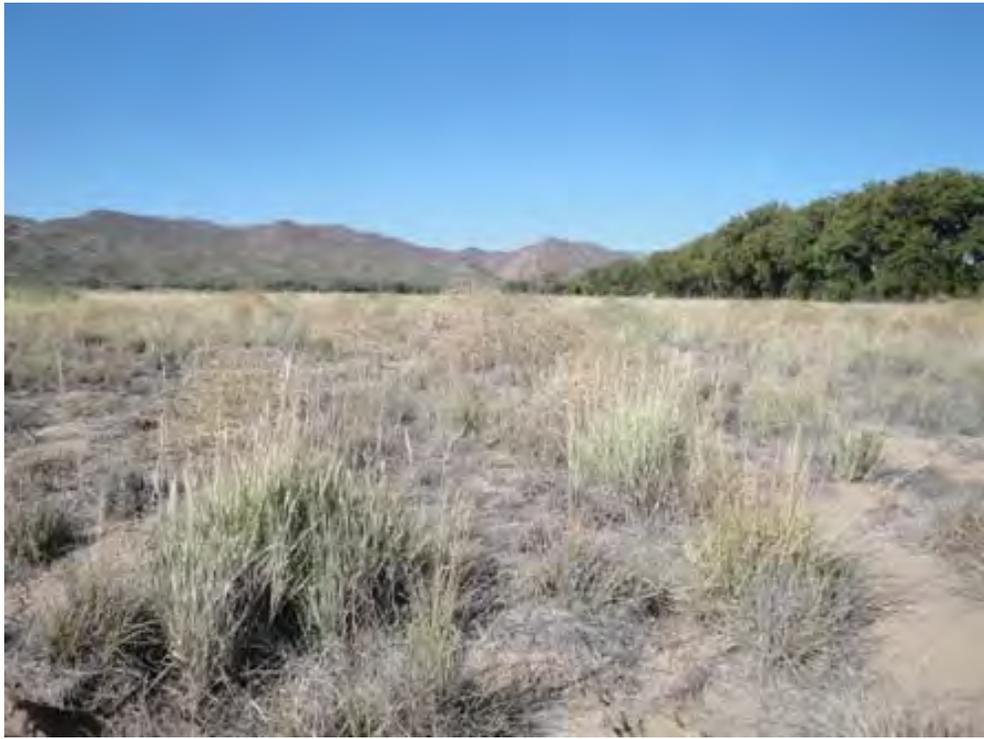
Figure 18: South field looking west, showing healthy tufts of *Hilaria jamesii* and *Sporobolus airoides*.

Invasive Weed Control. . Weed management in the native grass fields requires a constant effort. Control efforts are focused mainly on Russian thistle (*Salsola* spp.), but include nettleleaf goosefoot (*Chenopodium murale*), careless weed (*Amaranthus palmeri*), and crownbeard (*Verbesina encelioides*). Whole fields or portions of fields were mowed three times this year. In mid-June, the entire south field, the northern-most portion of the east field, and portions of the west field with the densest growth of Russian thistle ("tumbleweed") were mowed to six inches. This included any native grasses and saltbush. This effectively eliminated most of the nettleleaf goosefoot in the south field, but the tumbleweed came right back, requiring a second mowing in mid-August. This time, only patches of weeds were mowed; specifically, the same dense portions of the west field, the east, south and west edges of the south field, and the south third of the east field, including the five-acre piece seeded in 2010. The final mowing was in mid-October, to coincide with the end of the Russian thistle growth trajectory.

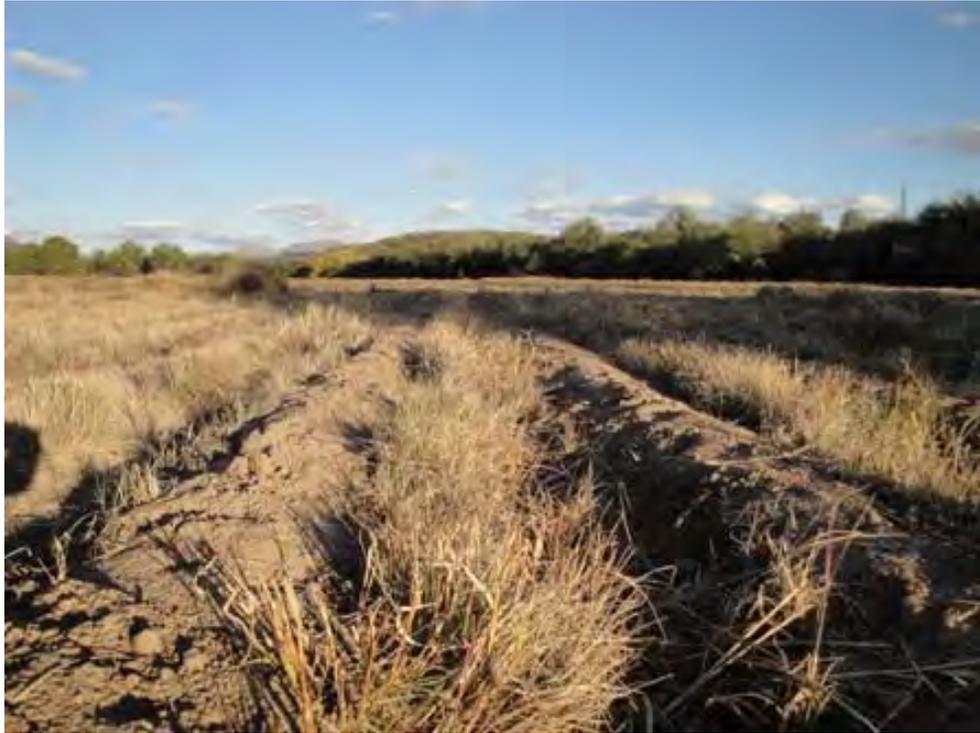
Figure 19: 5-acre field, looking east. Grasses visible here are Botriochloa, Leptochloa and Aristida spp.

Seeding. The last portion of Black Farm to be planted, a triangular piece of about five acres in the southeast corner of the property, was prepared and seeded in September 2010. Initially, London rocket (*Sisymbrium irio*), Indian wheat (*Plantago minor*) and Green sprangletop (*Leptochloa dubia*) made a strong showing. The London rocket seemed to form a thick, protective cover for the young grasses in the south-half of the field. With the onset of warm weather in early summer 2011, the London rocket died off, while tumbleweed came in thick in the north-half of the field. Despite this heavy growth of weeds, the planted grasses are doing very well, especially in the areas with thick London rocket.

After a year in the ground, many of the species in the original mix have germinated and are now identifiable. These include Sideoats grama (*Bouteloua curtipendula*), Green sprangletop, Plains bristlegrass (*Setaria macrostachya*), Purple threeawn (*Aristida purpurea*), Cane beardgrass (*Botriochloa barbinodis*), and Galleta (*Hilaria jamesii*).

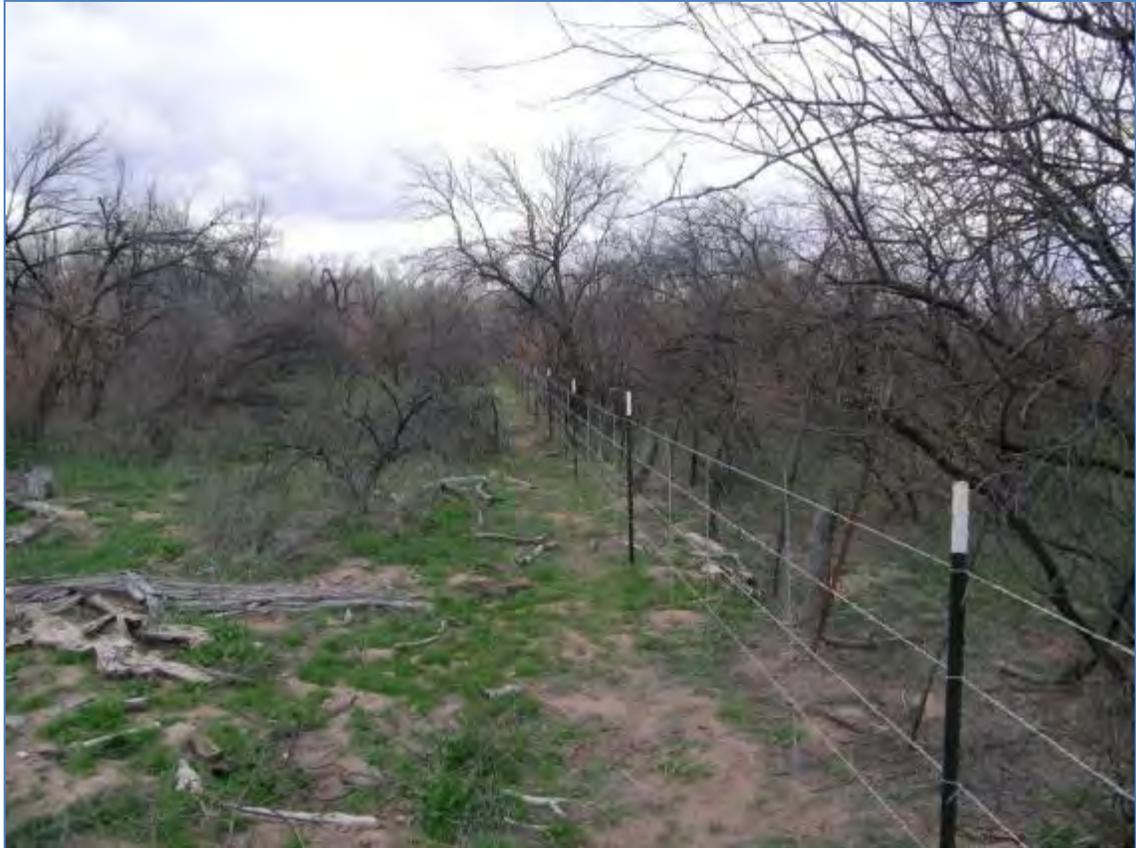
Figure 21: Newly constructed fencing at Stillinger Preserve. Photo by Ben Grantham, N&B Fence.

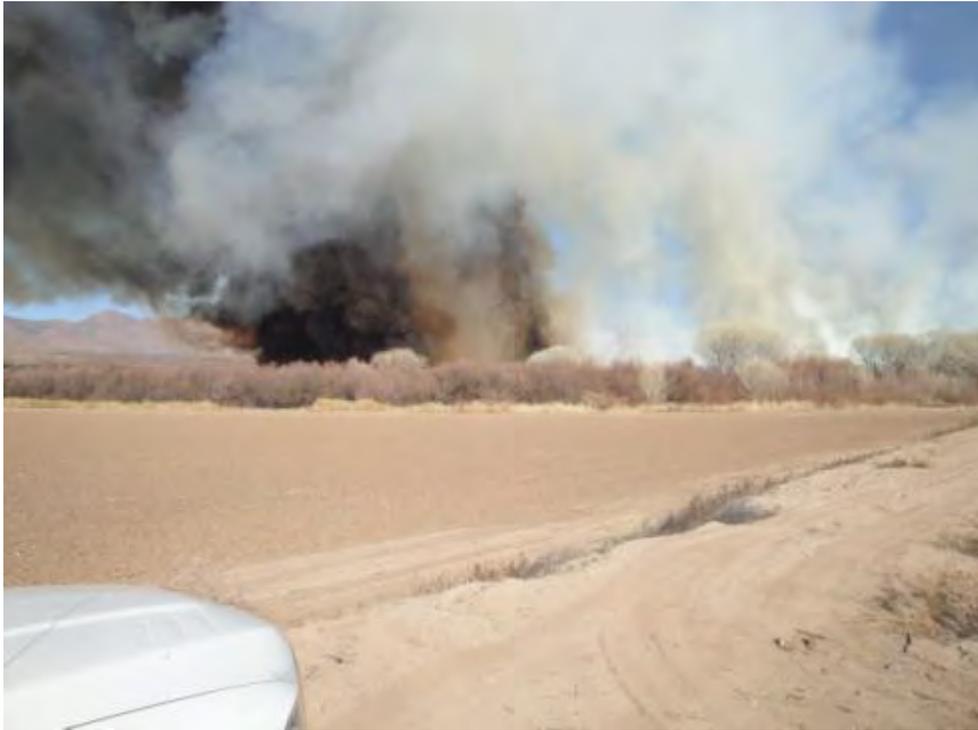
Figure 22. The River Fire looking north. February 11, 2011. Photo by D. Wolgast.

By Monday afternoon, the BLM FMO contacted Valencia to inform her that wind speeds had increased and the fire was flaring up again, moving in the direction of BLM lands. By Tuesday, the fire burned an additional 40 acres on BLM and SRP lands, bringing the total area burned on SRP mitigation lands to 58 acres: 46 acres on Roosevelt HCP land; 12 acres on Horseshoe-Bartlett HCP land. (See figure 20.)

On Tuesday, February 15, Valencia, Chuck Paradzick (SRP) and Wolgast visited the site and met with Scott Cooke, the BLM Safford District Field Manager to get a status on fire fighting efforts. At the time, both BLM and U.S. Forest Service crews were on site putting out a few hot spots. The fire was extinguished by the end of that day. It was determined that the fire was human caused, likely from farm workers burning weeds along irrigation drains.

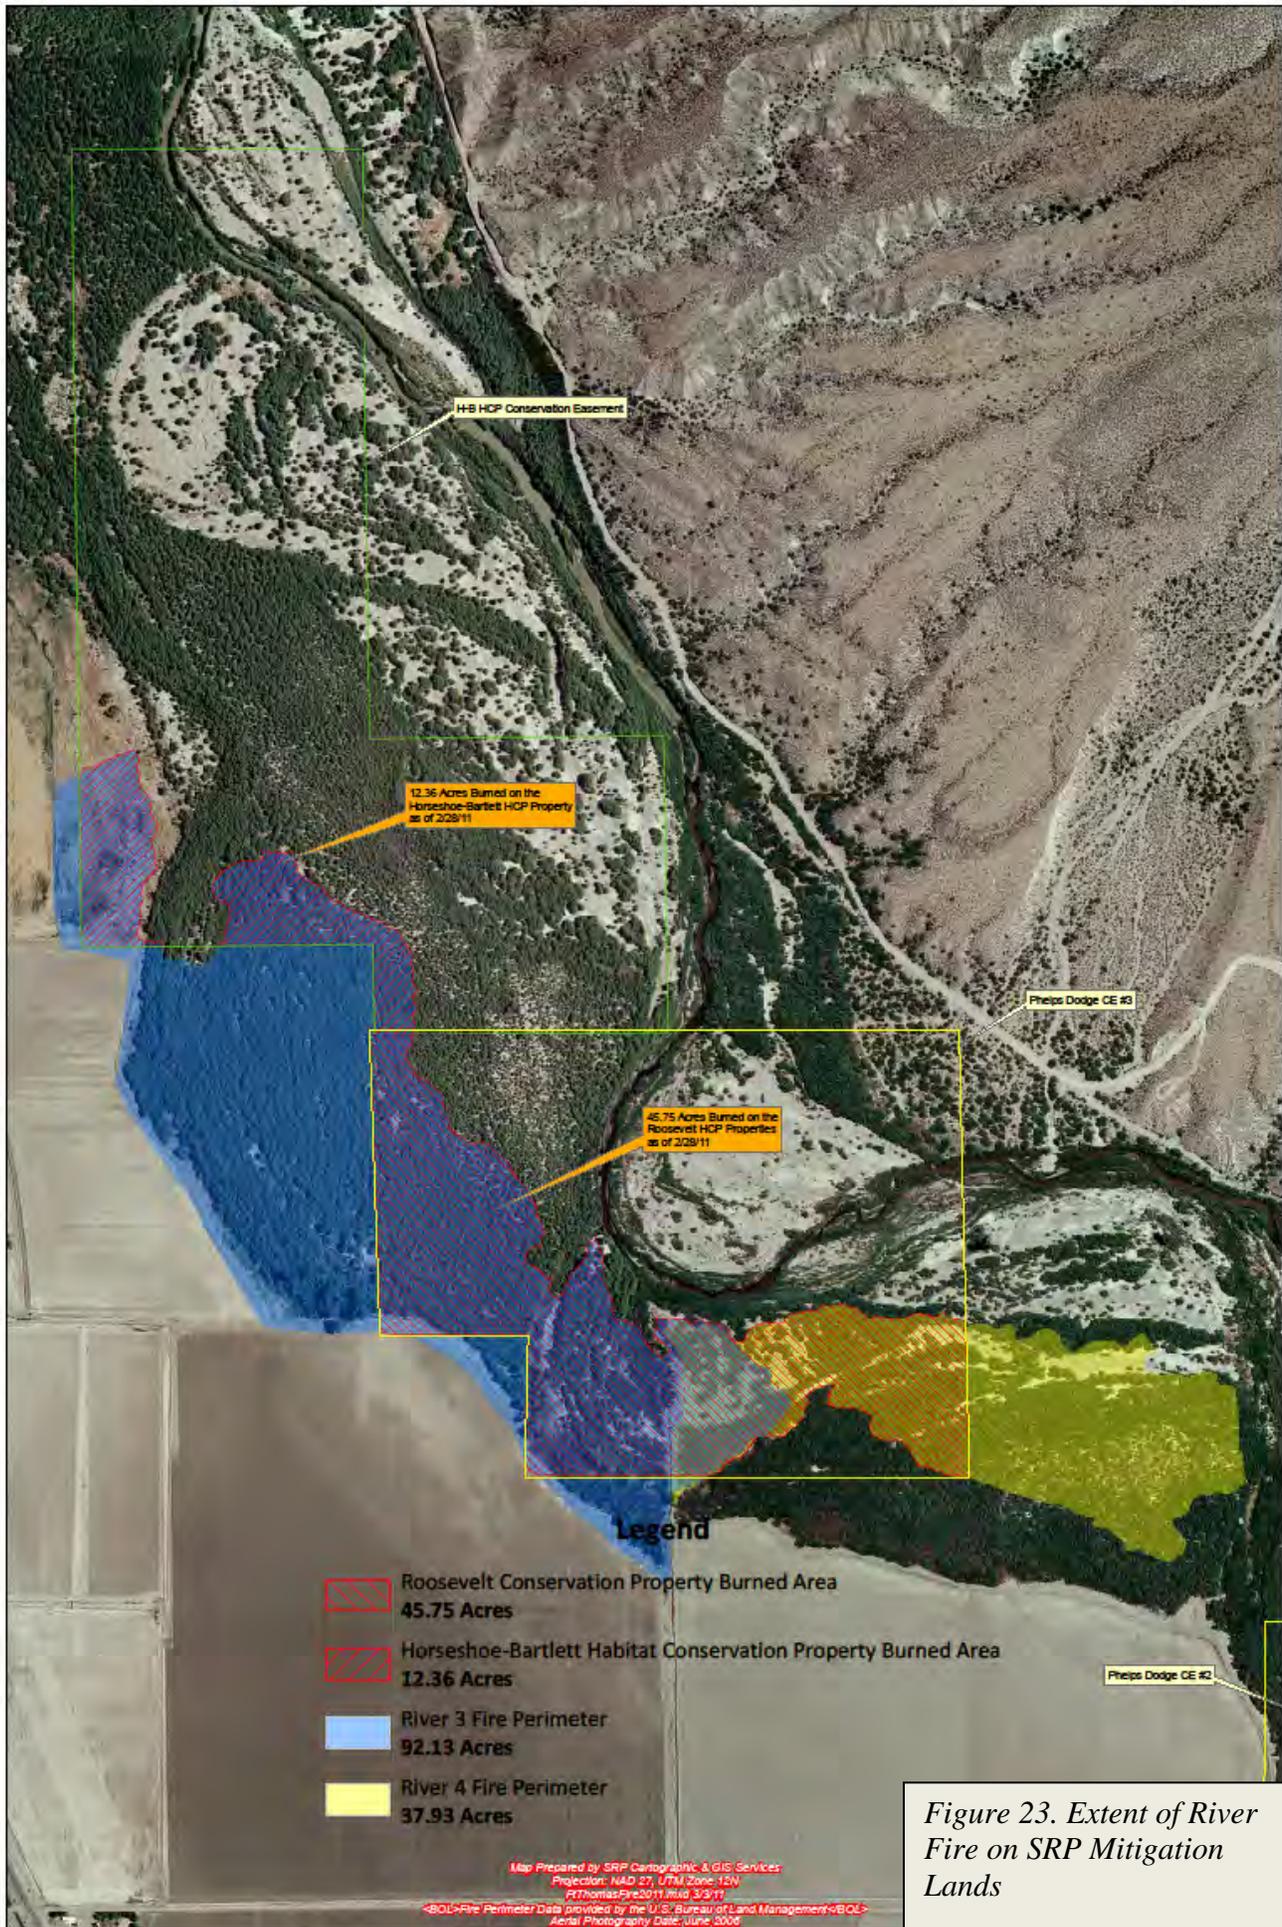
River 3 and 4 Fires- Roosevelt and Horseshoe-Bartlett HCP Properties, 2011

Figure 23. Extent of River Fire on SRP Mitigation Lands

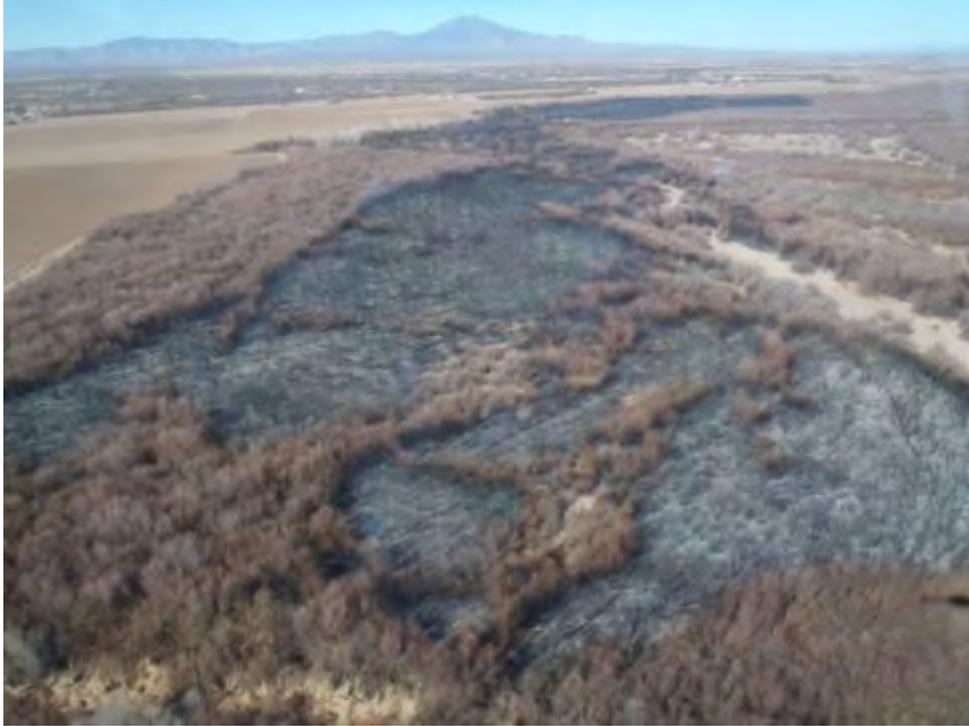
*Figure 24. Aerial view of the River Fire looking downstream. February 15, 2011.
Photo by C. Paradzick.*

SRP is utilizing the areas burned by the 2011 fire to conduct a small-scale experiment to see if we can successfully introduce native plant species onto these sites before they turn into a tamarisk-kochia monoculture. We intend to test several restoration approaches, with various planting techniques and species. As a quick test, we seeded a mix of native grasses in a few areas where we were able to take advantage of irrigation run-off to see if grasses would establish before kochia returned. We also planted 21 one-gallon alkali sacaton grasses in the same area. We had excellent survival of potted grasses and have observed germination of seeded grasses in areas that retained moisture, but kochia still returned and is shading out the native grass.

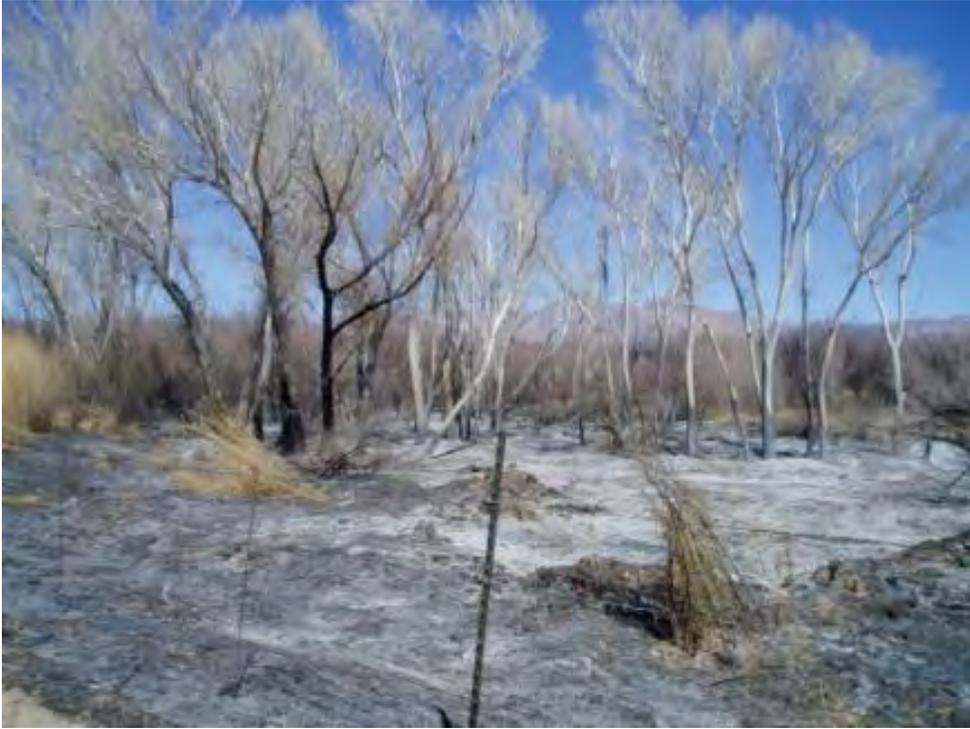
*Figure 25.
Stand of burned
Fremont
cottonwoods at
Fort Thomas
Preserve.
February 15,
2011. Photo by
R. Valencia.*

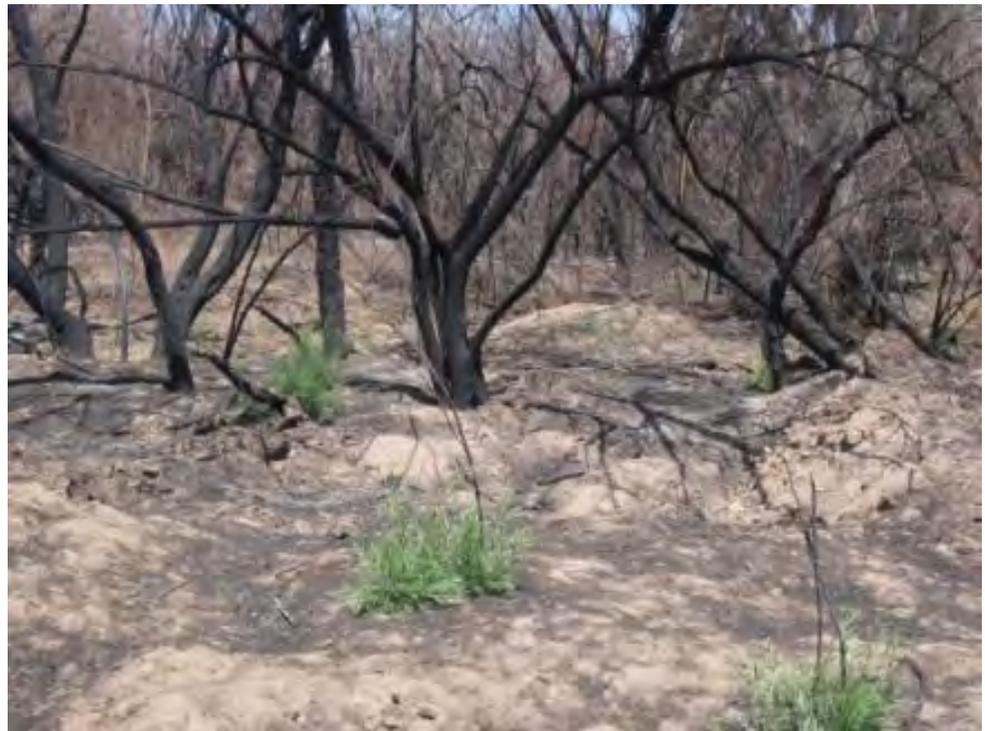
*Figure 26. Coyote
willow (Salix
exigua) resprouting
after the fire.
April 14, 2011.
Photo by R.
Valencia.*
