Chapter 11 BILL WILLIAMS RIVER WATERSHED

Bill Williams River Watershed

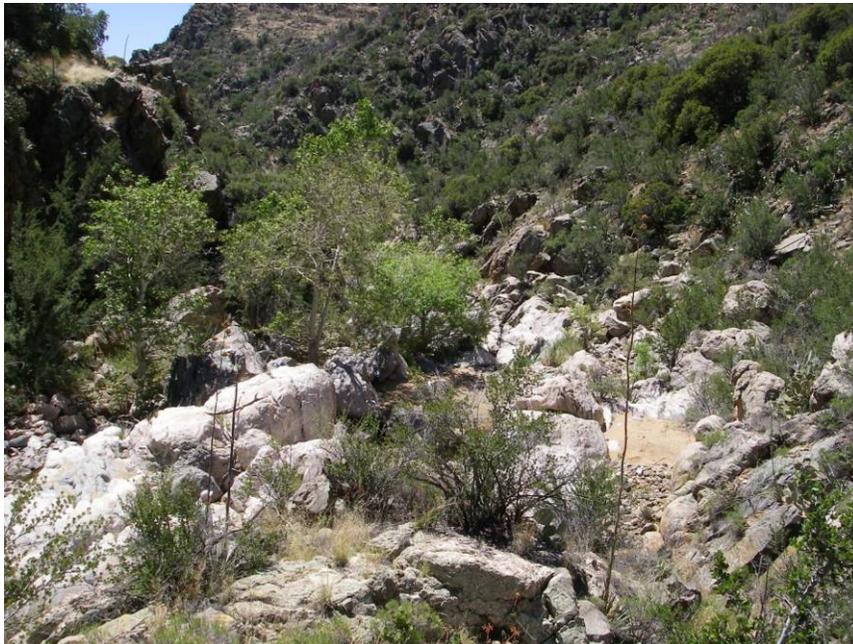
Figure 8. Loco Creek below Blue Tank.

Loco Creek is a high gradient, bedrock dominated stream that does not provide adequate aquatic habitats for most fishes to persist (Figure 8 and Figure 9). Fish movement through Loco Creek would be during spring runoff events and flash floods that create increased sediment loads, high turbidity, rapid currents, altered habitat conditions, increased stress levels of organisms in transport, altered fish behavior and mortality, all of which limit the ability of survival during transport. There is approximately ½ mile of rugged ephemeral wash above Bass Tank, but no ponds/tanks that can harbor fish. No fish have ever been sighted by the fisheries biologist in 10 years of observation and it is the biologist's opinion that Loco Creek does not provide adequate aquatic habitat to support fish. (A. Clark pers. comm.)

Loco Creek is a high gradient, bedrock dominated stream that does not provide adequate aquatic habitats for most fishes to persist. Fish movement through Loco Creek would be during periodic spring runoff events and flash floods that create increased sediment loads, high turbidity, rapid currents, altered habitat conditions, increased stress levels of organisms in transport, altered fish behavior and mortality, all of which limits the ability of survival during transport. Upstream movement by fish is very limited in this stream and consists of 4 miles of mostly rugged and unsuitable habitat up to Bass Tank. Large waterfalls are not known from Loco Creek but extensive areas of sharp elevation change in narrow and slot rocky canyons. Figure 8 and Figure 9 provide representative photos of the habitats.

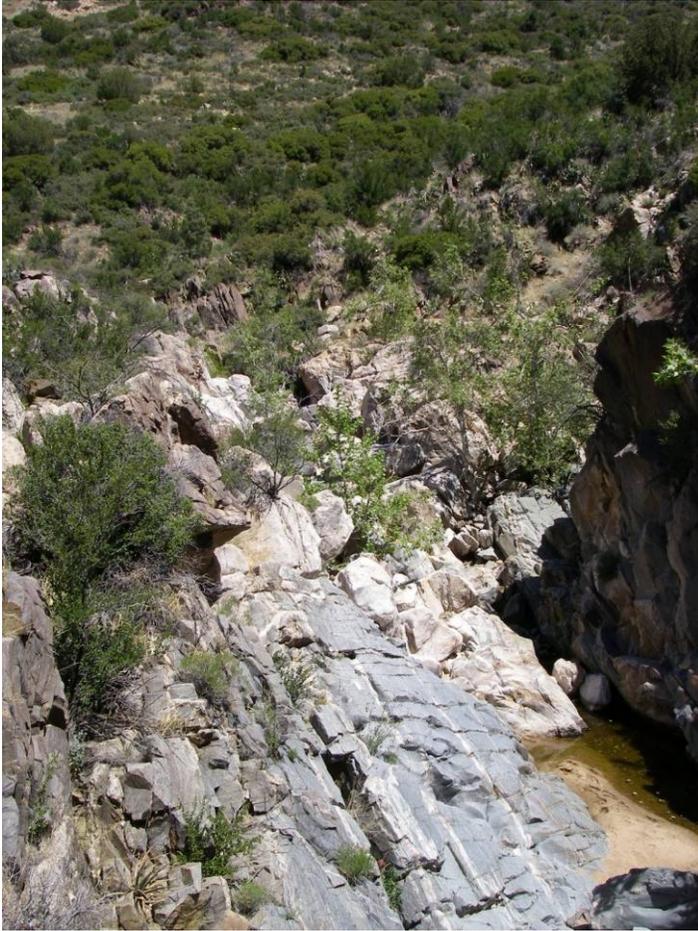
Figure 9. Loco Creek below Boundary Spring.

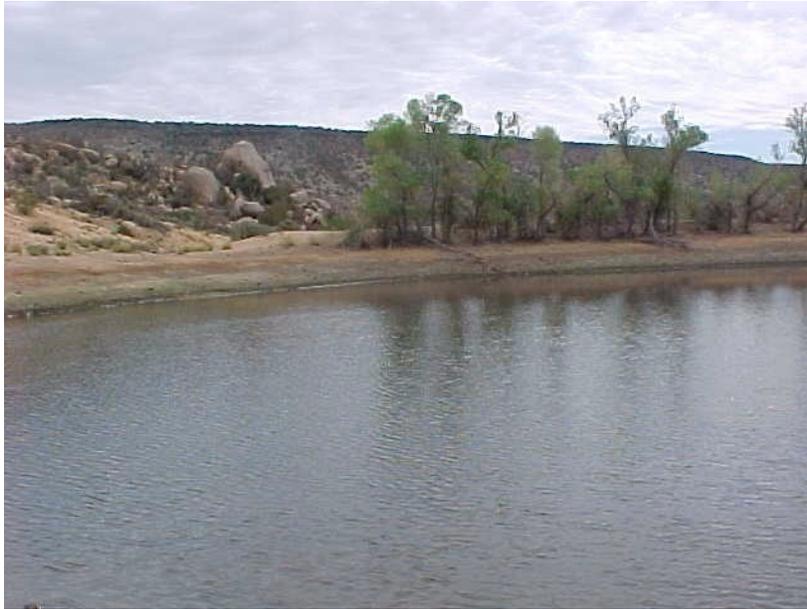
Figure 11. Berm dam at Blue Tank. Water spills to the left of the Cottonwood trees.

Blue Tank is a 3.5 acre earthen livestock tank maintained by precipitation on State Trust Land leased by the Yolo Ranch (Figure 10 and Figure 12). It sits at approximately 4,695 feet elevation in a small ephemeral tributary of Loco Creek, a tributary to Sycamore Creek that feeds into the Santa Maria River. According to Arizona Department of Water Rights records (Reservoir Application No. 3R-2596), Blue Water Dam was constructed in 1967. The spillway is evident in aerial imagery and a photo of the earthen berm dam is below (Figure 11).

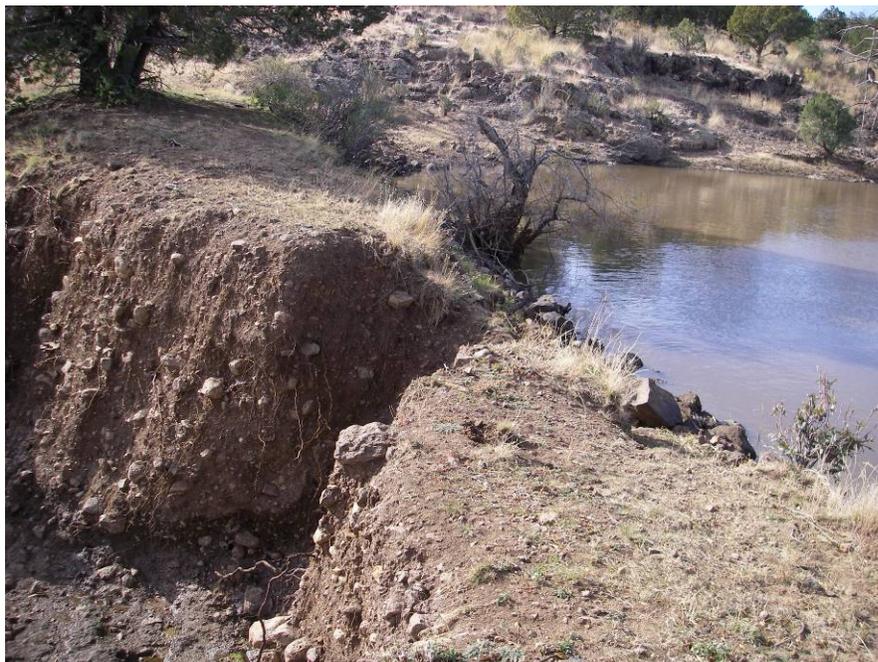
Figure 33. Breach at Stubb's Dam, October 2007.

Stubb's Tank sits in a large open juniper lined flat near the top of a small tributary to Stubb's Wash. The dam at Stubb's began to erode significantly on its western edge starting in September 2004. High flows in the summer of 2007 created a large wash out as a result of very heavy rainfall and corresponding runoff in the area (Figure 33 and Figure 34). The dam remained functional but capacity of the tank was reduced. The Yolo ranch repaired the dam in the summer of 2008. The tank, prior to 2005, had not been known to spill. It has a small contributing watershed and is a comparatively large tank. Water leaving Stubb's Tank would flow down an unnamed wash one mile until meeting Stubb's Wash. Stubb's Wash is also ephemeral and drains 0.6 miles where it meets Connell Gulch forming Boulder Creek. Boulder Creek has numerous/extensive pockets of water that persist during dry times and is considered interrupted perennial for 23 miles before draining into Burro Creek. Burro Creek is intermittent/ephemeral for 19 miles until it reaches a perennial segment for 7 miles before reaching the Big Sandy River.

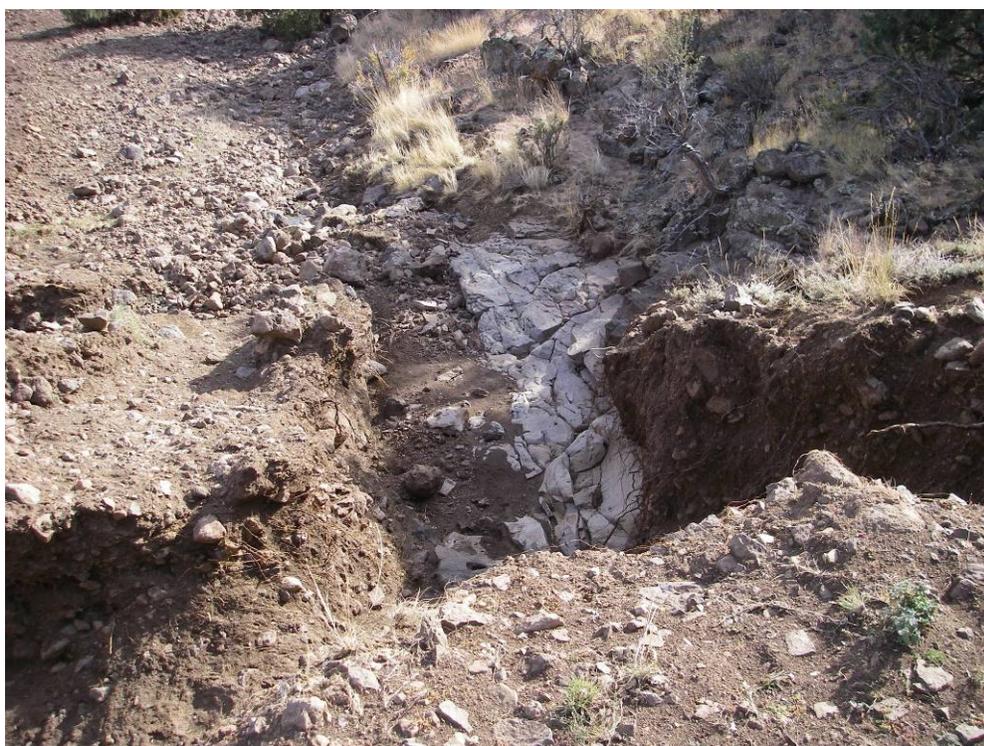
Figure 34. Stubb's Dam breach looking downstream, October 2007.

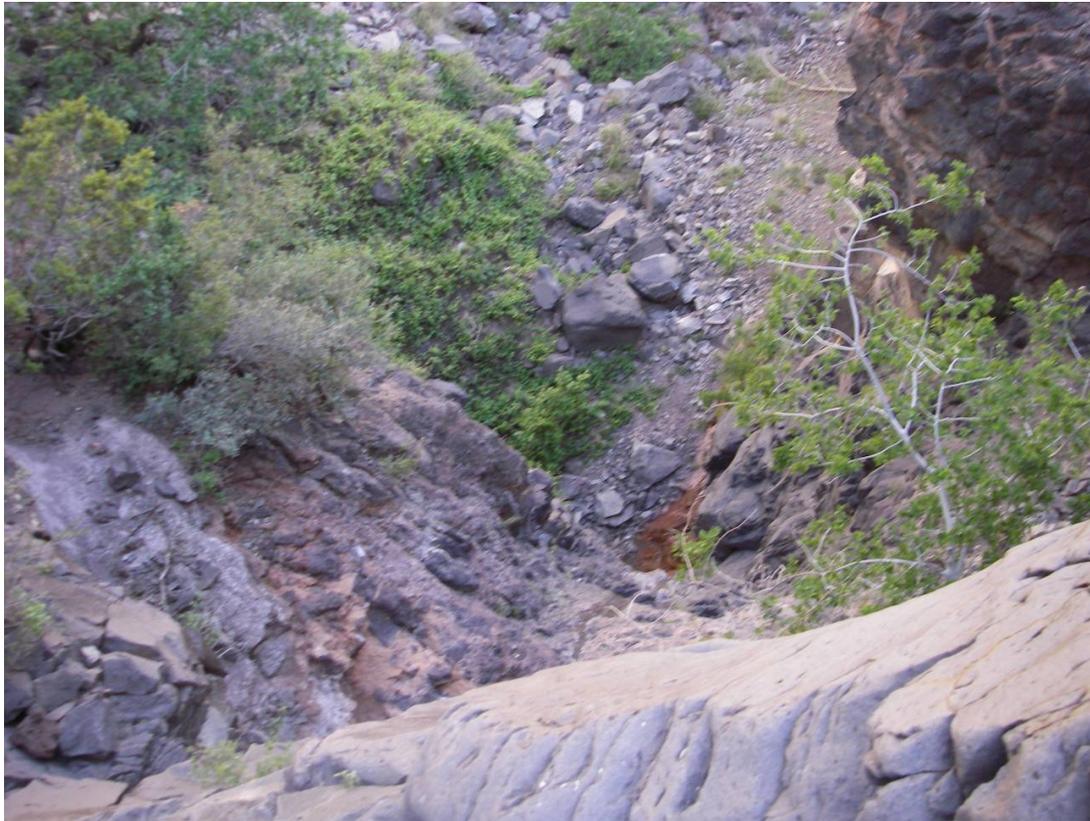
Figure 40. Vertical Drop on Pine Creek UTM 12S 310728E 3858237N, June 2008.
