San Juan River Habitat Monitoring: 2017

Annual Report

**San Juan River Biological Committee
United States Fish and Wildlife Service**

**Ecosystems Research Institute
Vincent Lamarra and Daniel Lamarra
435.554.7106
1023 West 800 North
Suite 108
Logan, Utah 84321**

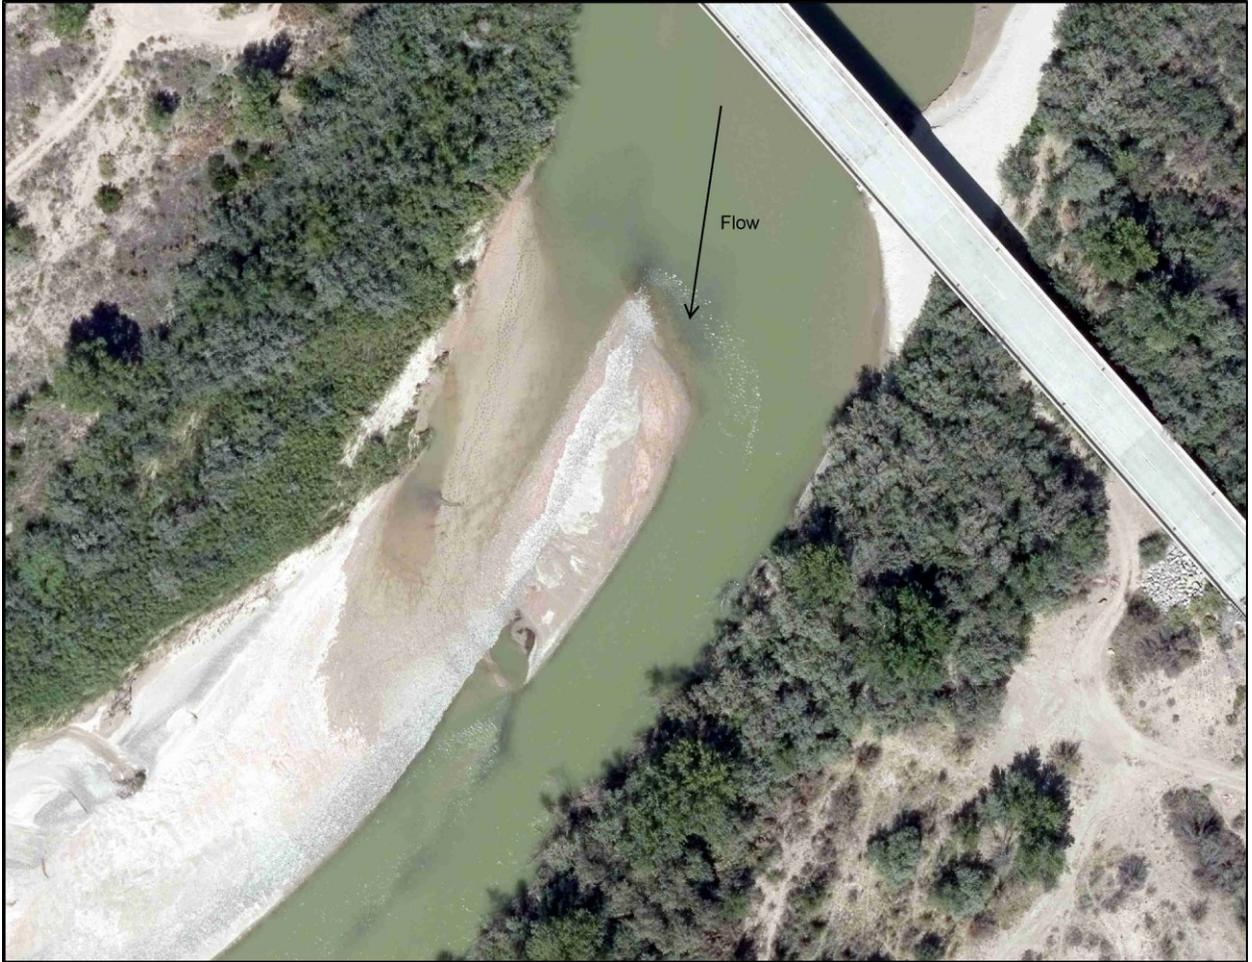
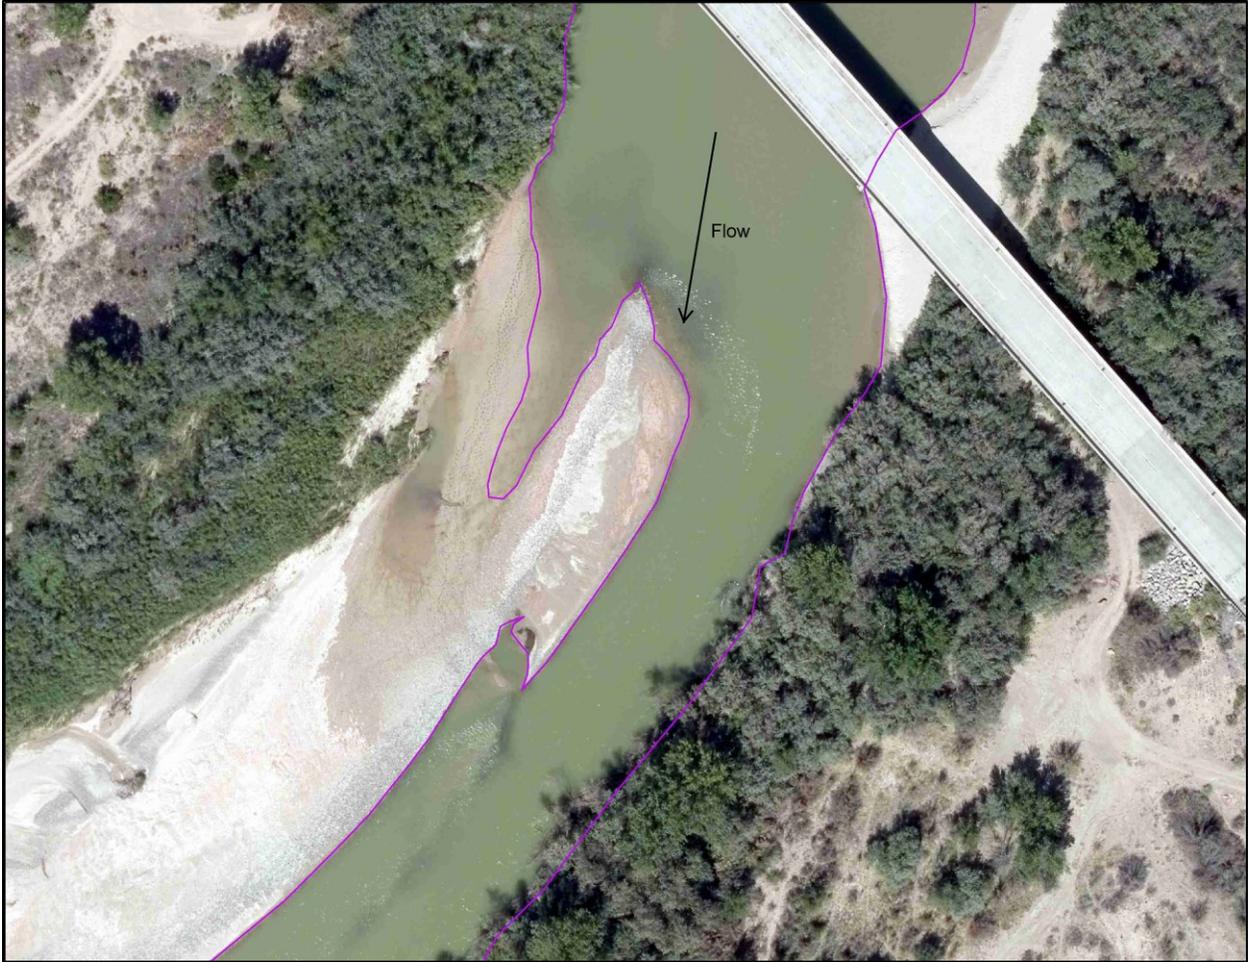
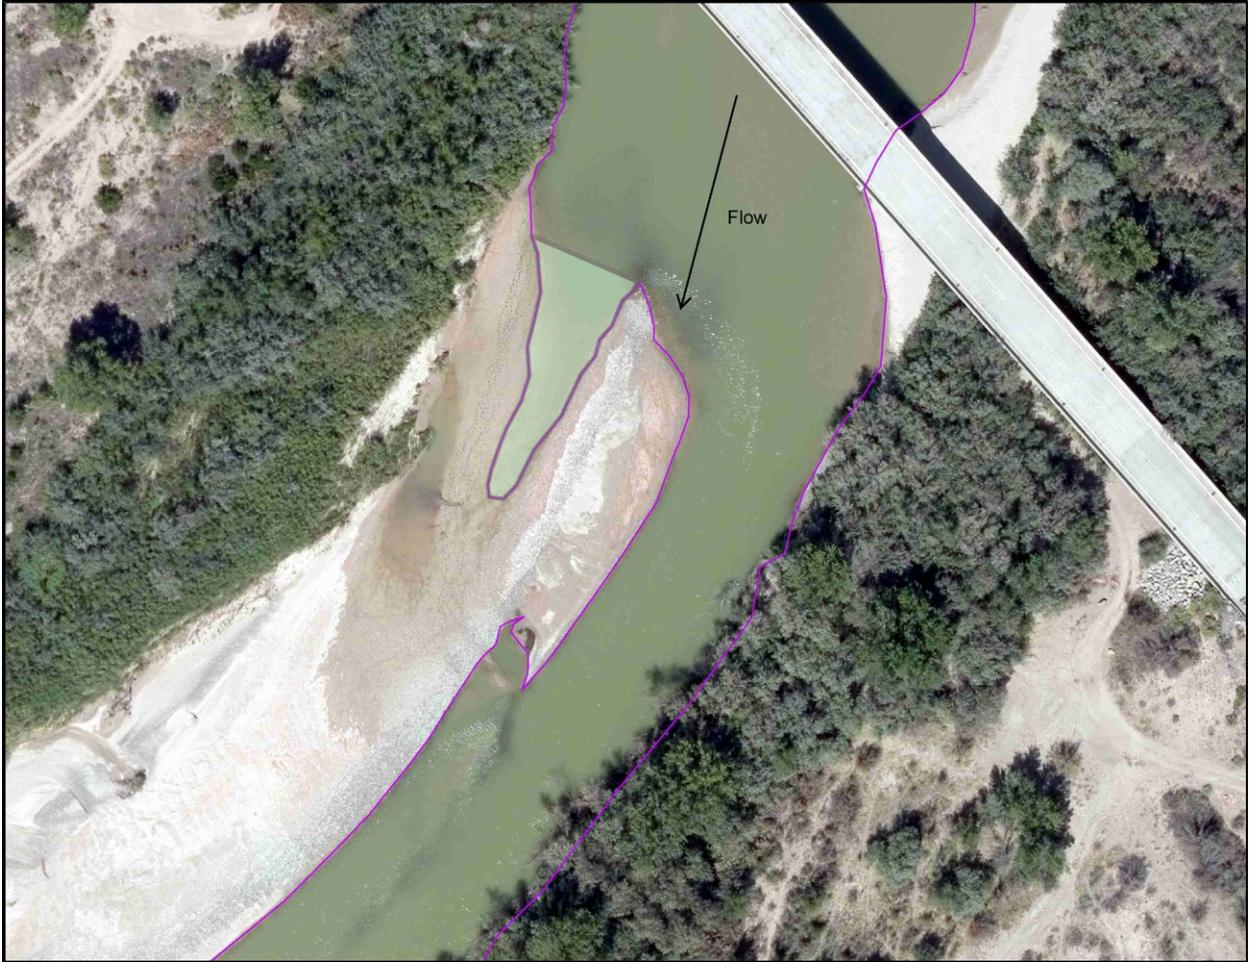
Picture 1: River Mile 75, Raw Image.

Picture 2: River Mile 75, Wetted Edge Defined.

Picture 3: River Mile 75, Embayment Boundary Defined.

The figures provided below illustrate the process of defining, delineating, and identifying the boundary of backwaters and embayments. These figures represent a variety of types of backwaters and embayments along with their orientation to flow. The process of delineation is outlined in a series of three photographs according to the order in which low velocity habitat is identified and defined. The first photograph is simply the raw image we receive from contractors. The second photograph shows where the wetted edge of the river is defined. The third and last image is a combination of the first two photos with the boundary of the low velocity habitat defined. The low velocity habitat vector polygon is traced onto the vector line of wetted area insuring consistency between the wetted area edge, and the low velocity polygon.

Embayments can be defined as an open shoreline depression similar to a backwater, with little flow change. The mouths of embayments typically are wide and oriented up stream. The majority of embayments form at the beginning of a point bar, or at the head end of island complexes. Examples of embayments at river miles 75,141 and 150 can be found in figures below.

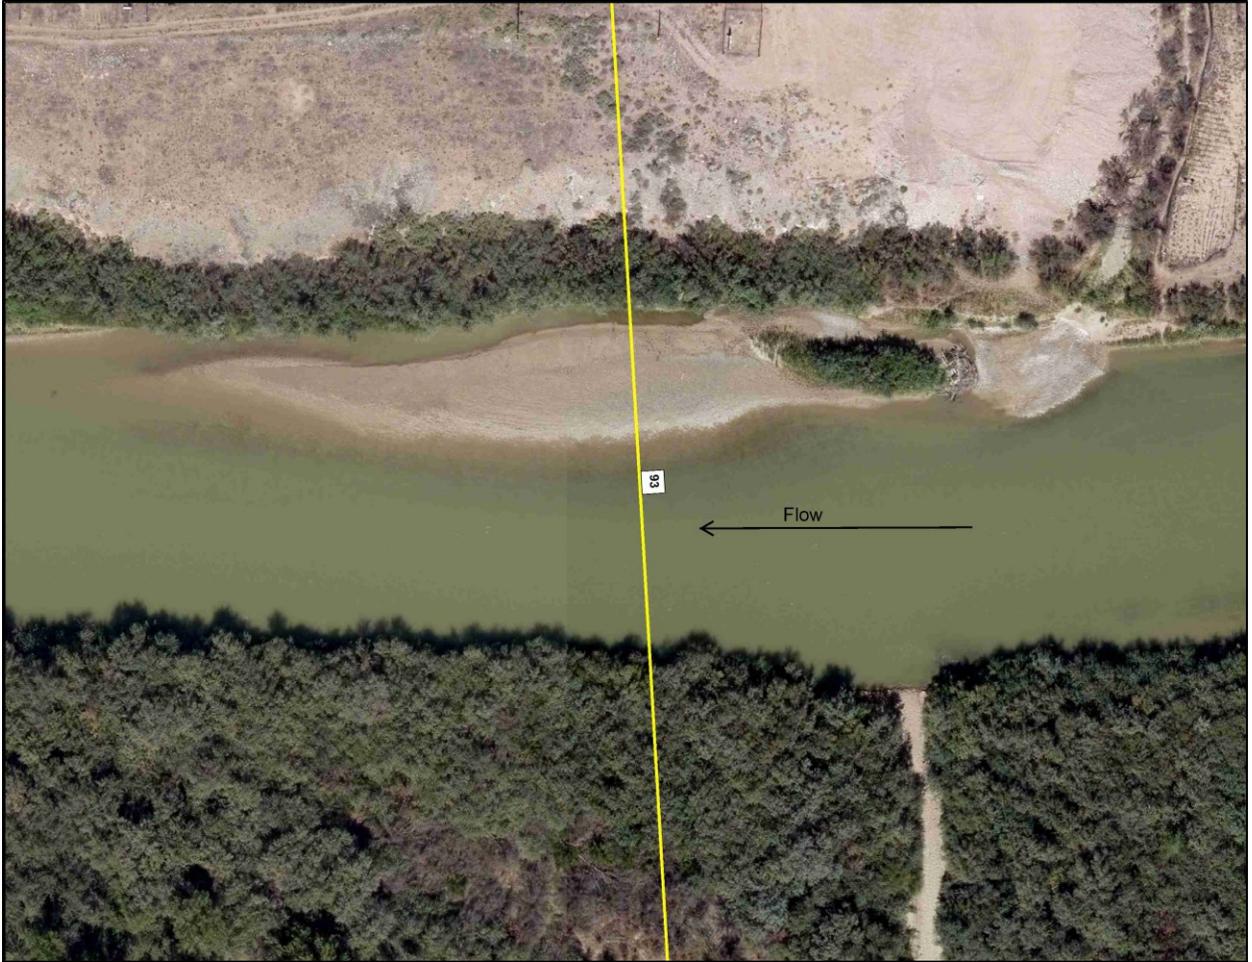
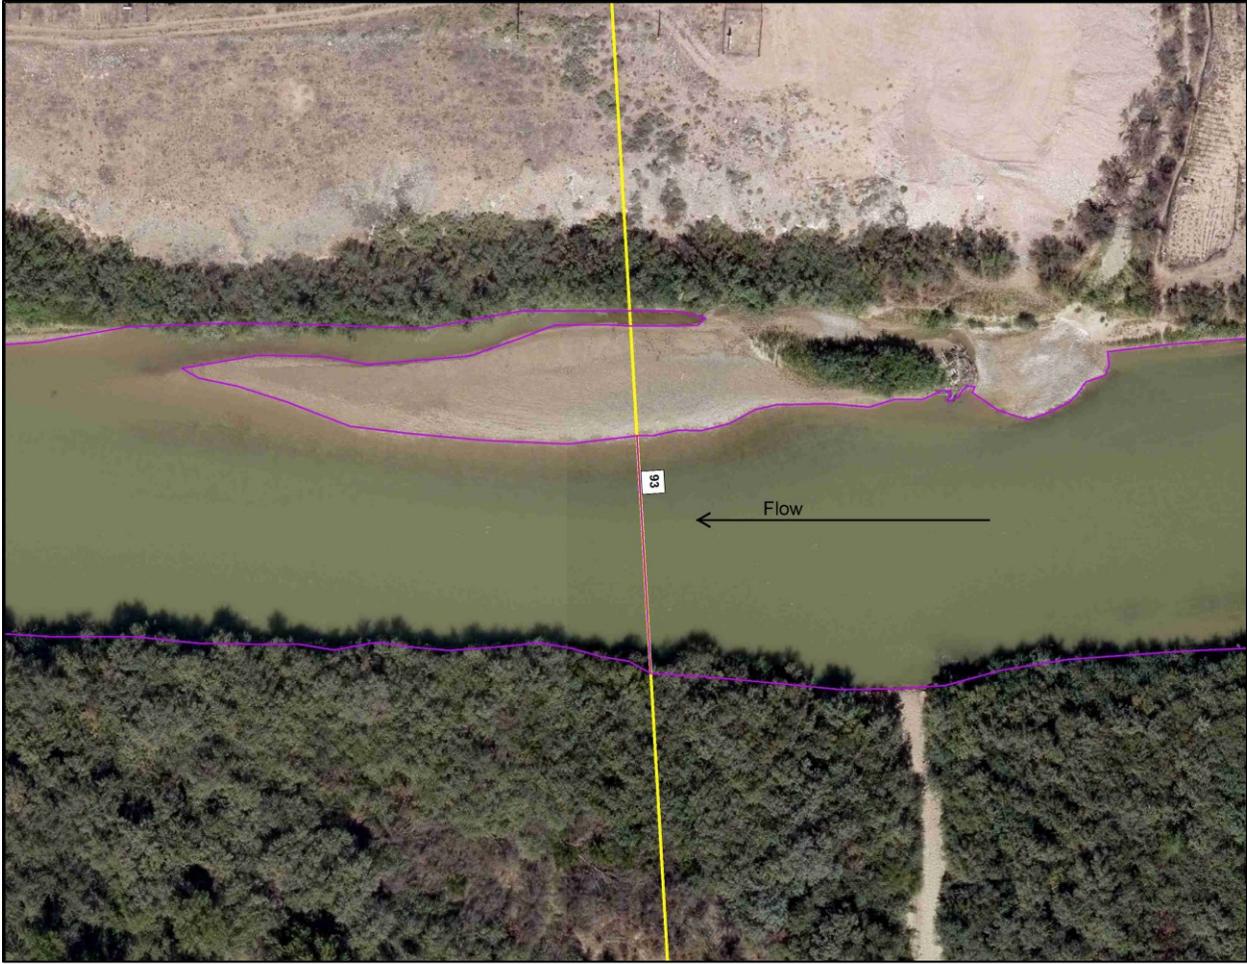
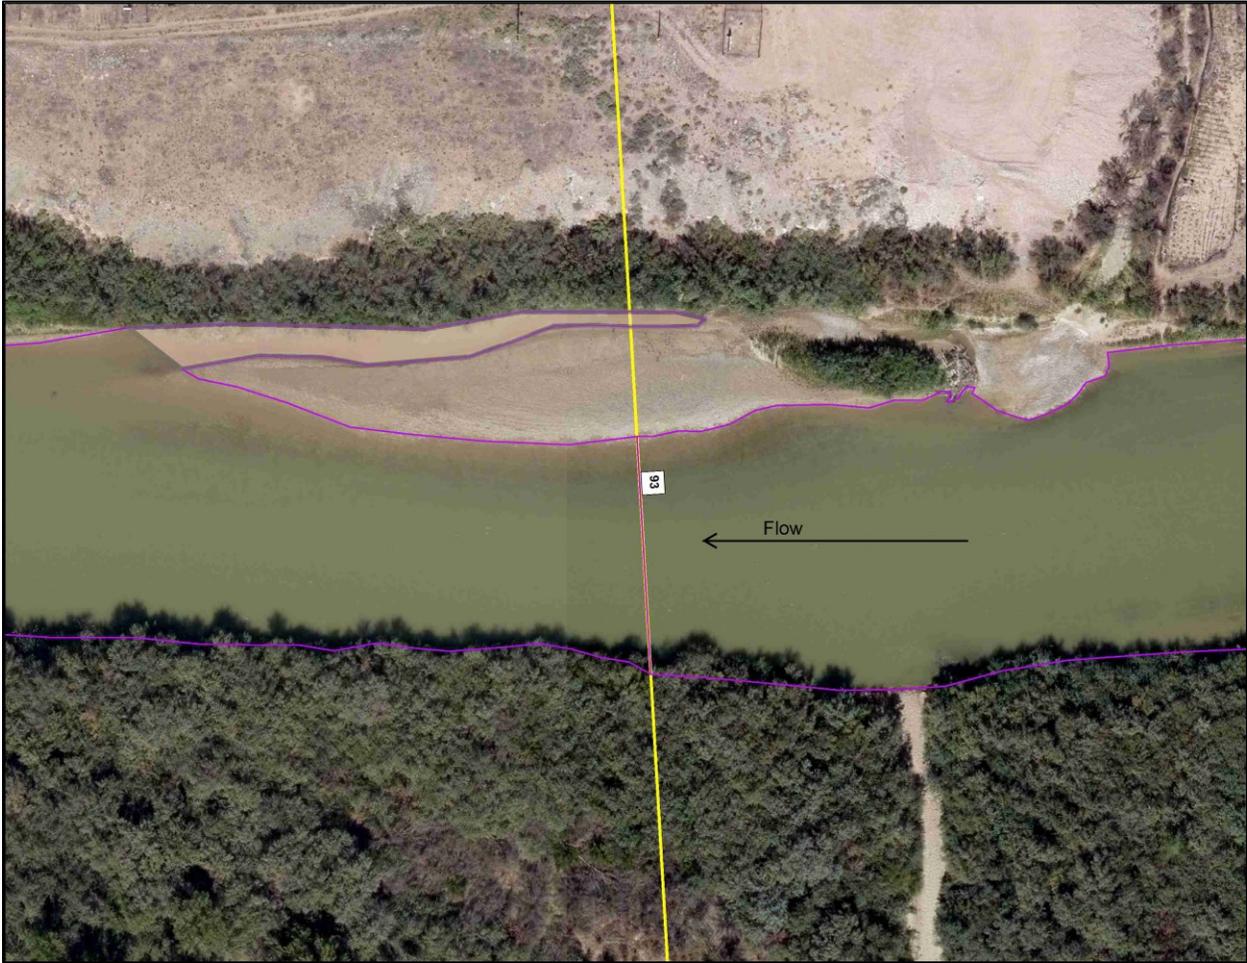
Picture 4: River Mile 93, Raw Image.

Picture 5: River Mile 93, Wetted Area Defined.

Picture 6: River Mile 93, Bank Backwater Boundary Defined.

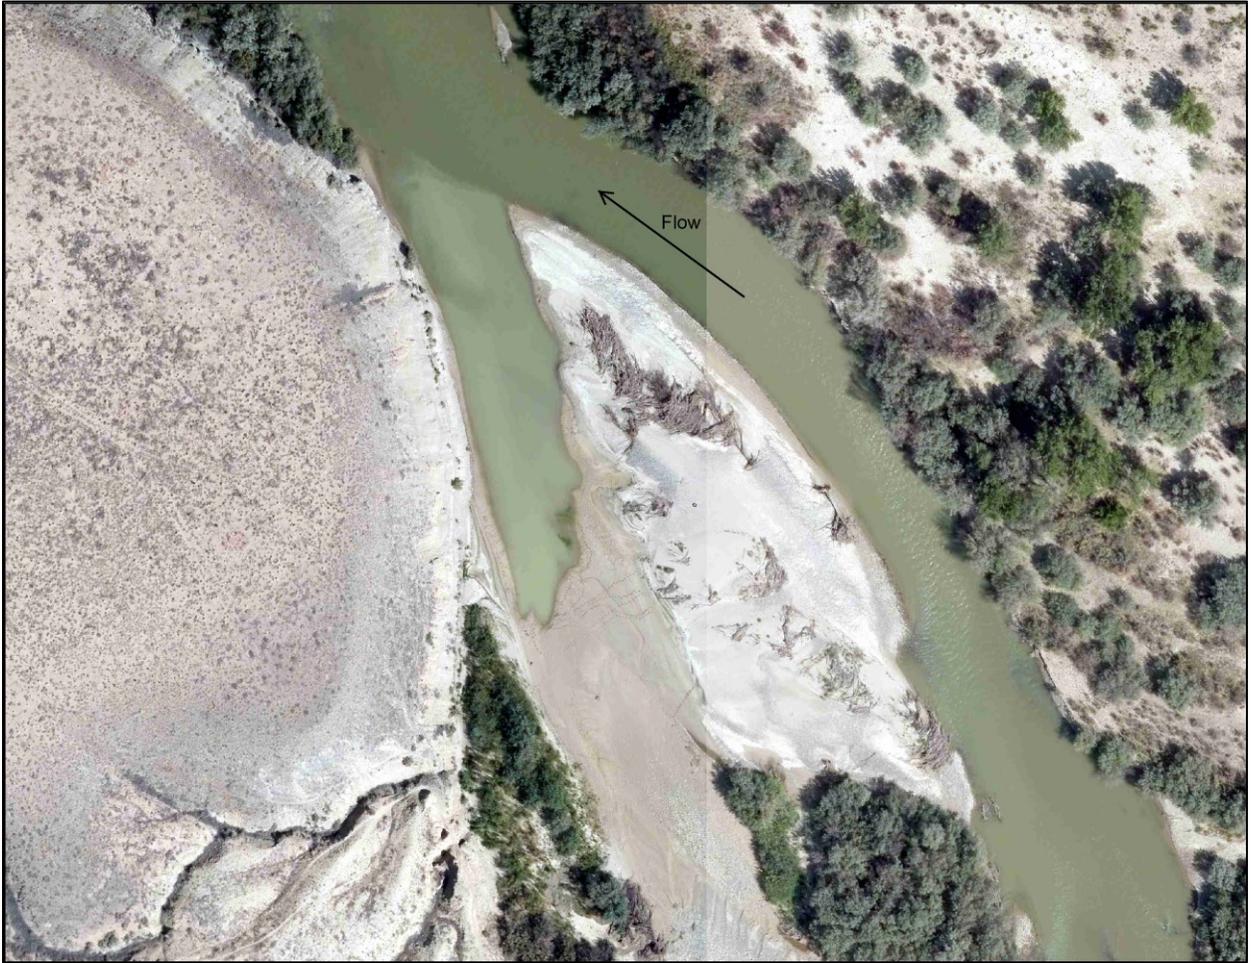
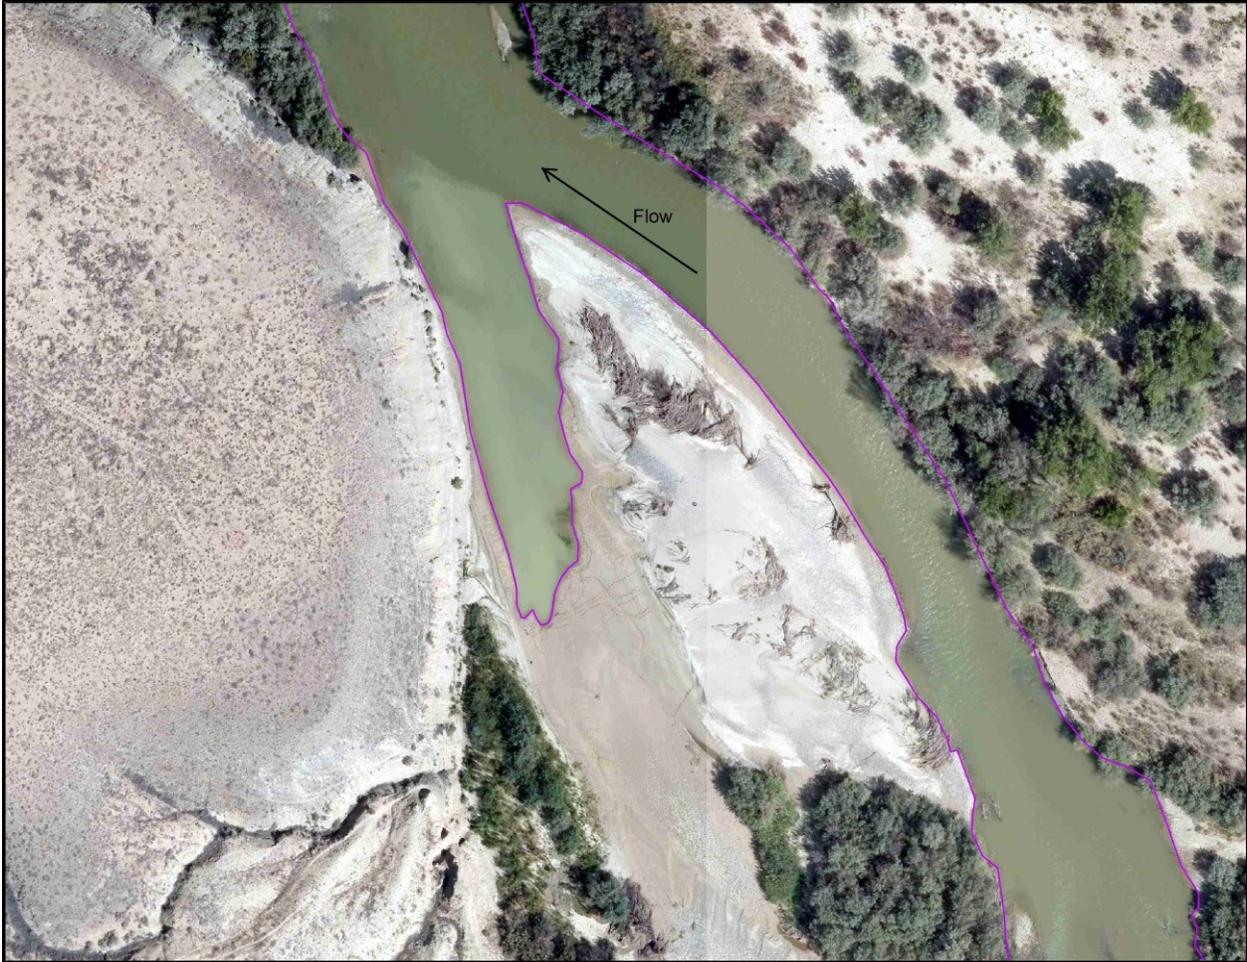
Picture 7: River Mile 134 Raw Image.

Picture 8: River Mile 134, Wetted Area Defined.

Picture 9: River Mile 134, Secondary Channel Backwater Boundary Defined.

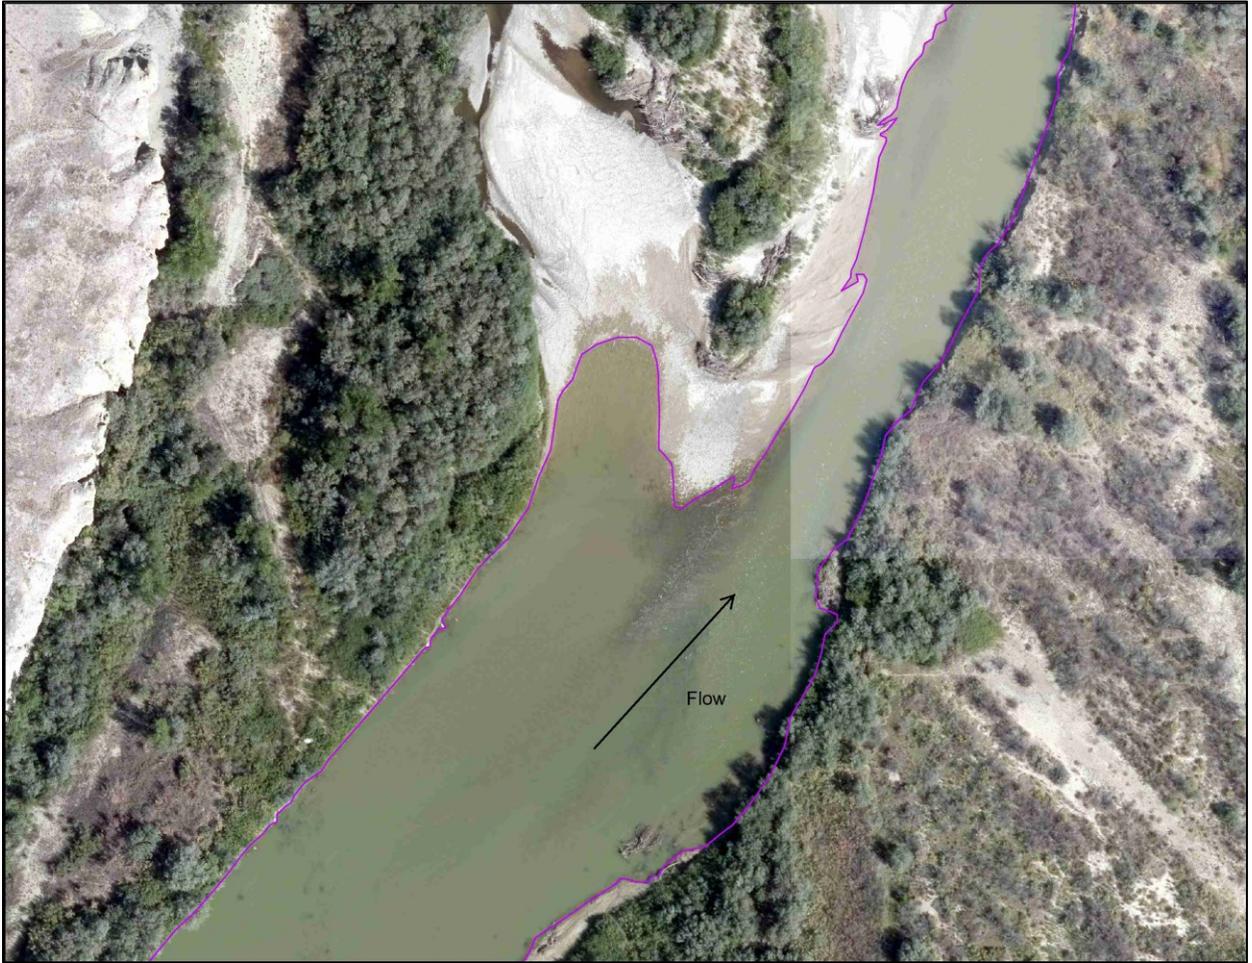
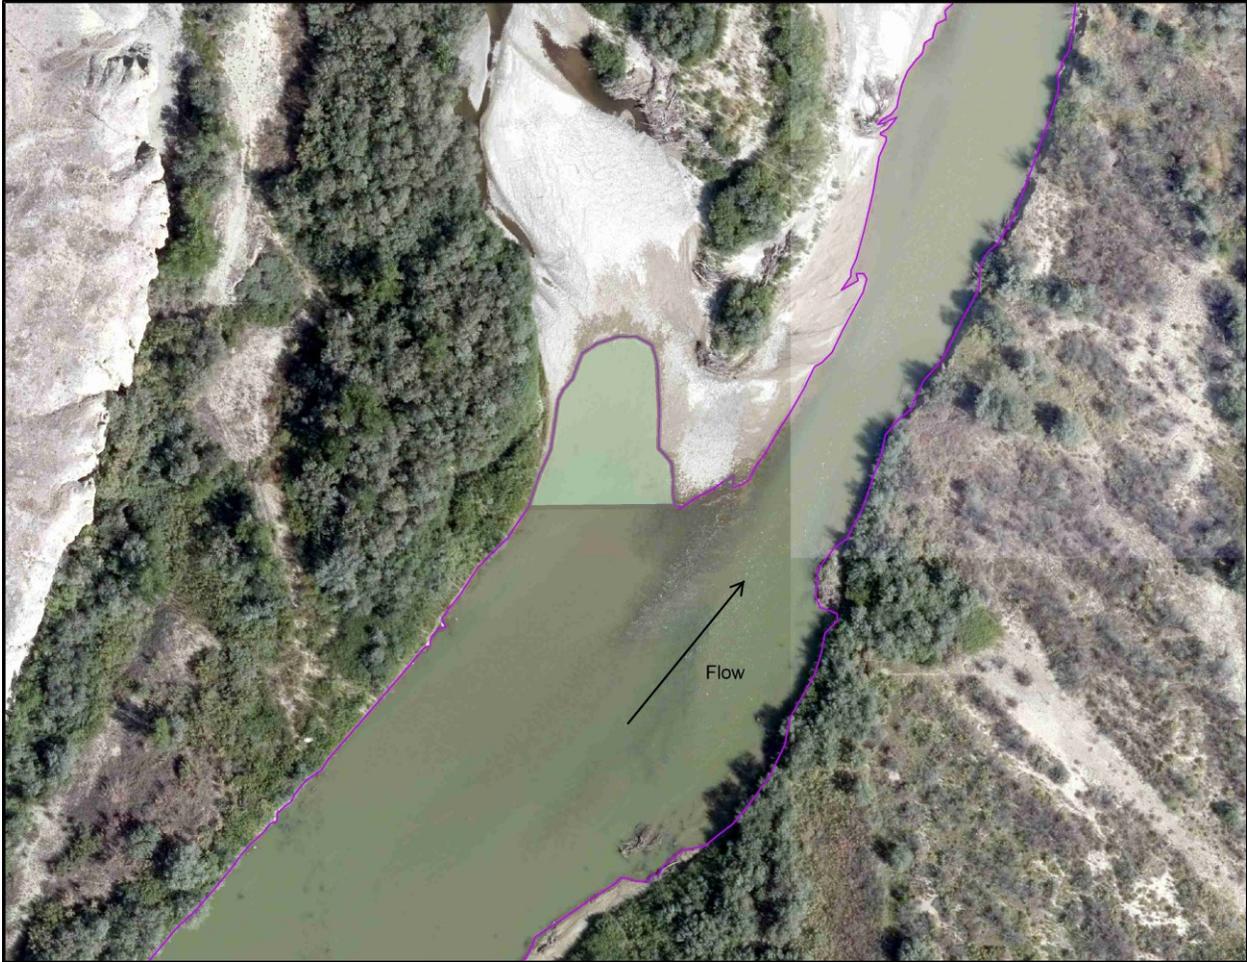
Picture 10: River Mile 141, Raw Image.

Picture 11: River Mile 141, Wetted Area Defined.

Picture 12: River Mile 141, Embayment Area Boundary Defined.

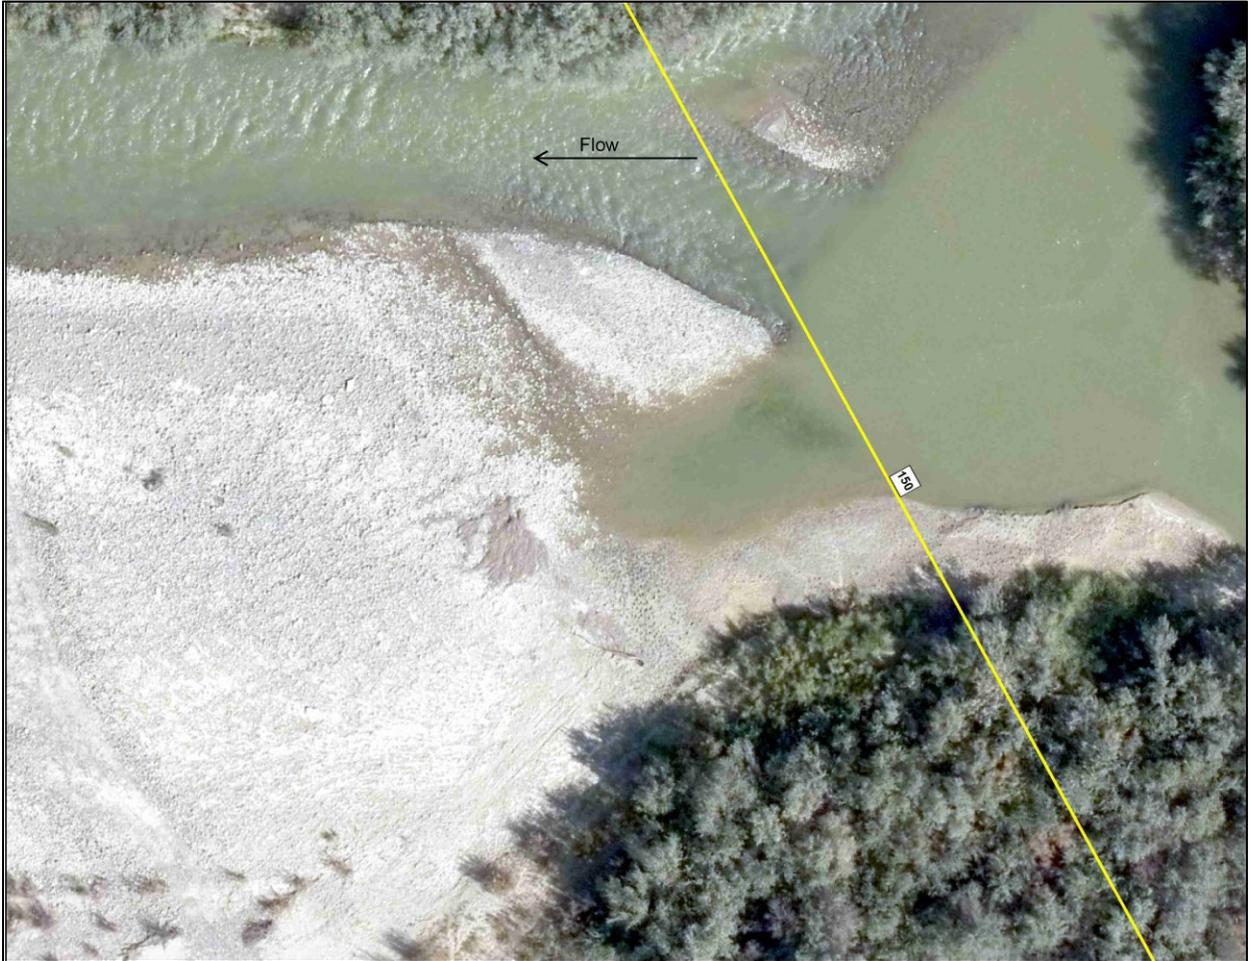
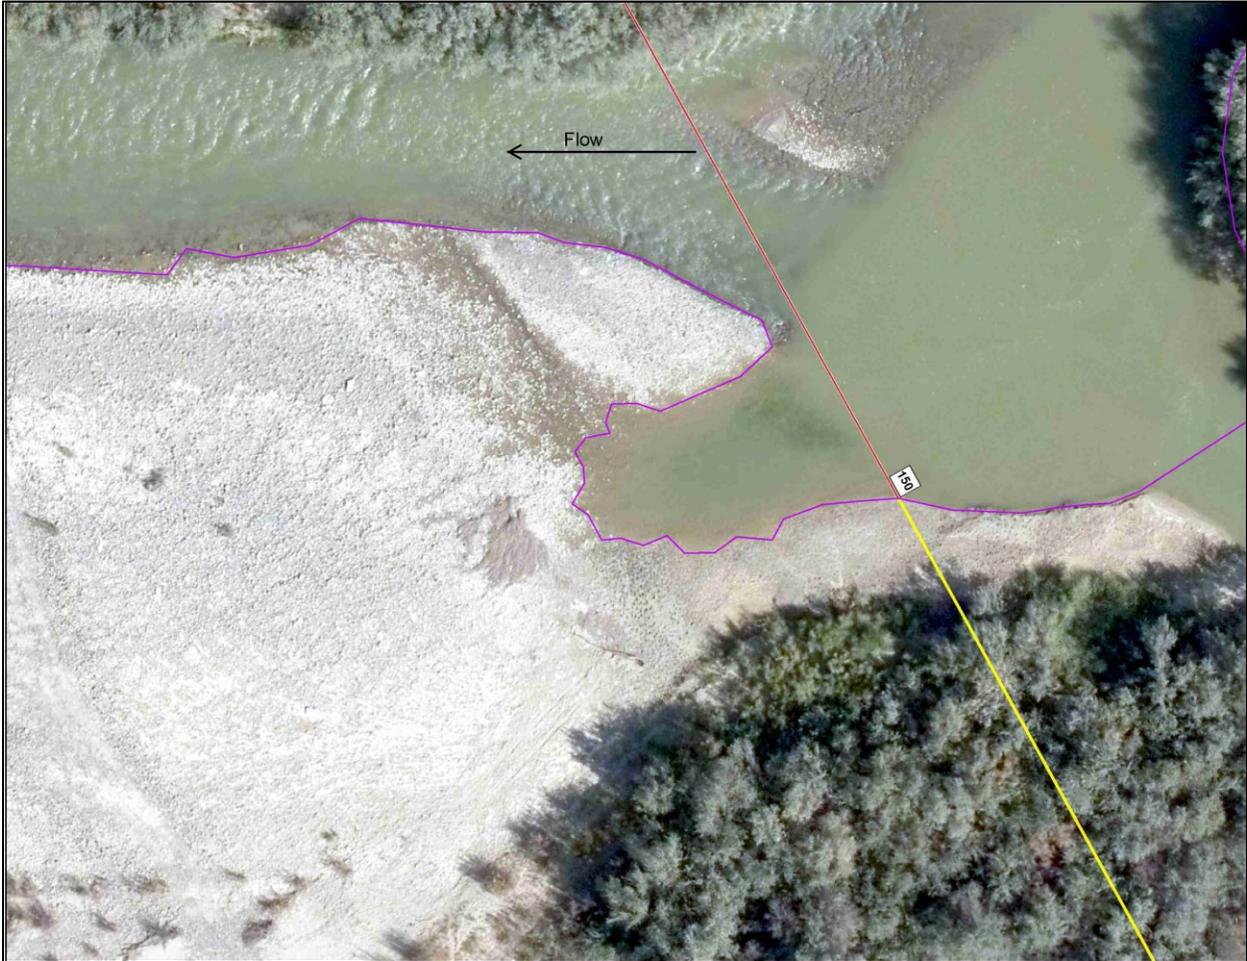
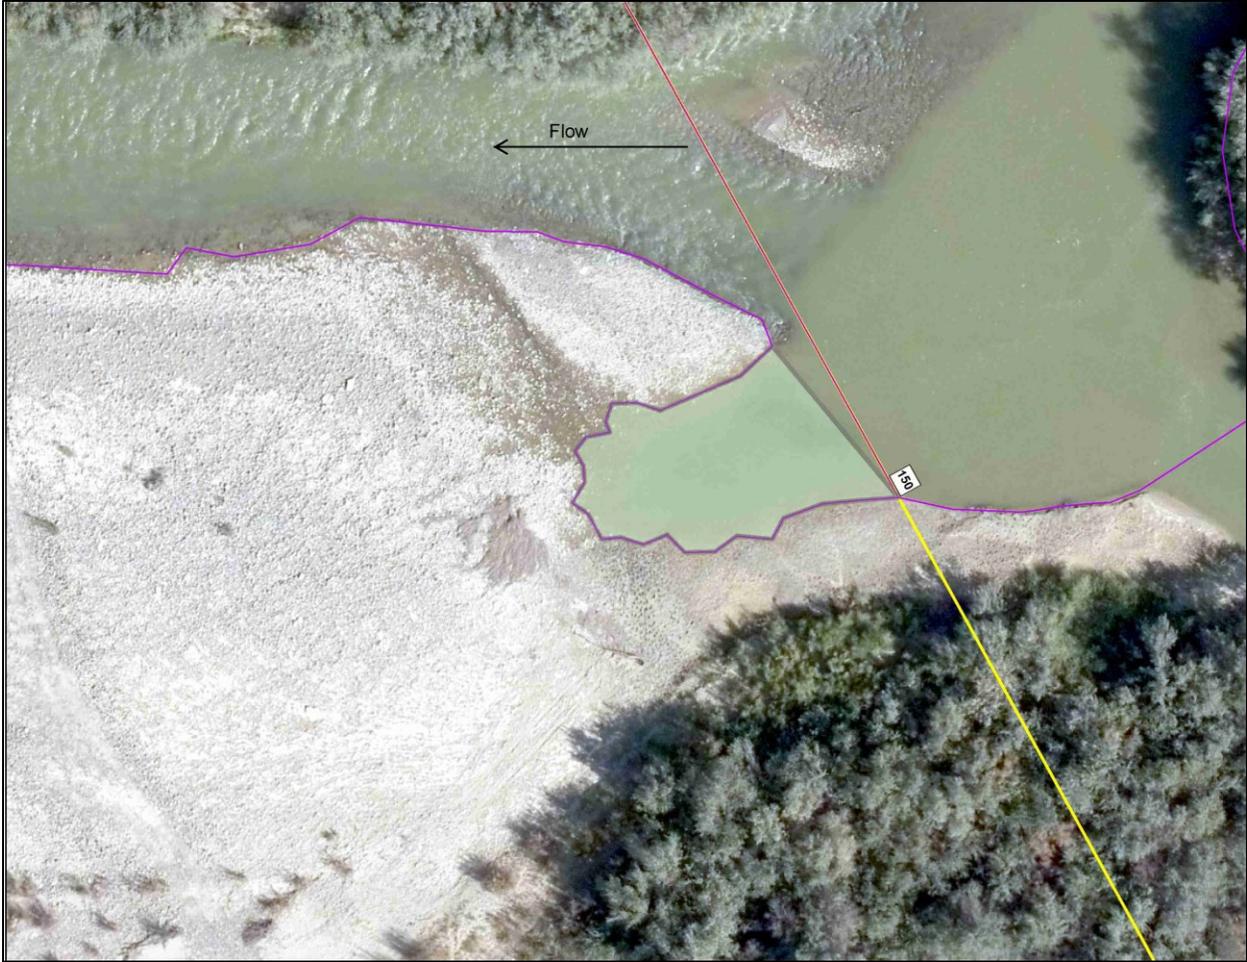
Picture 13: River Mile 150 Raw Image.

Picture 14: River Mile 150, Wetted Area Defined.

Picture 15: River Mile 150, Embayment Area Boundary Defined.

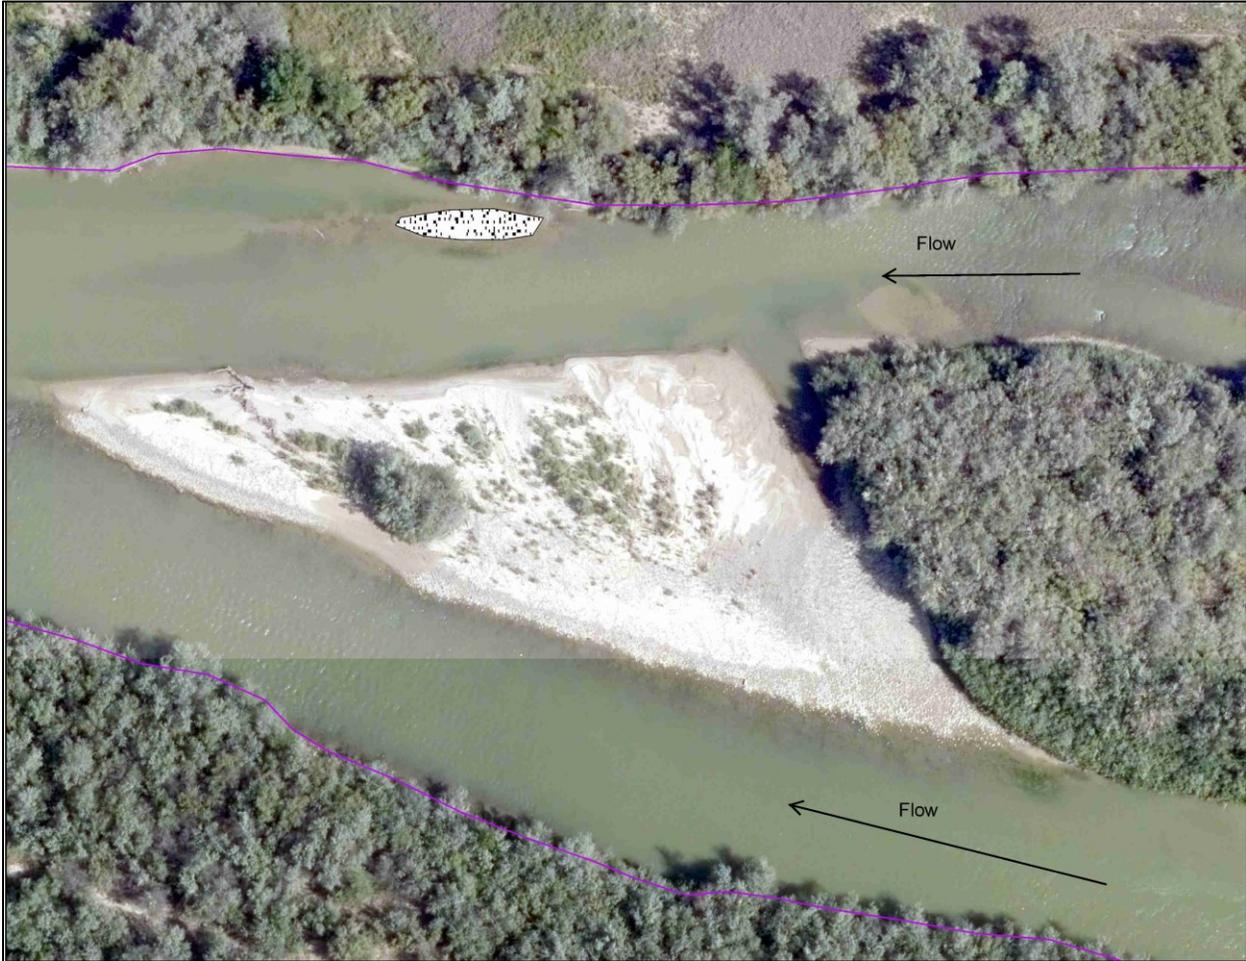
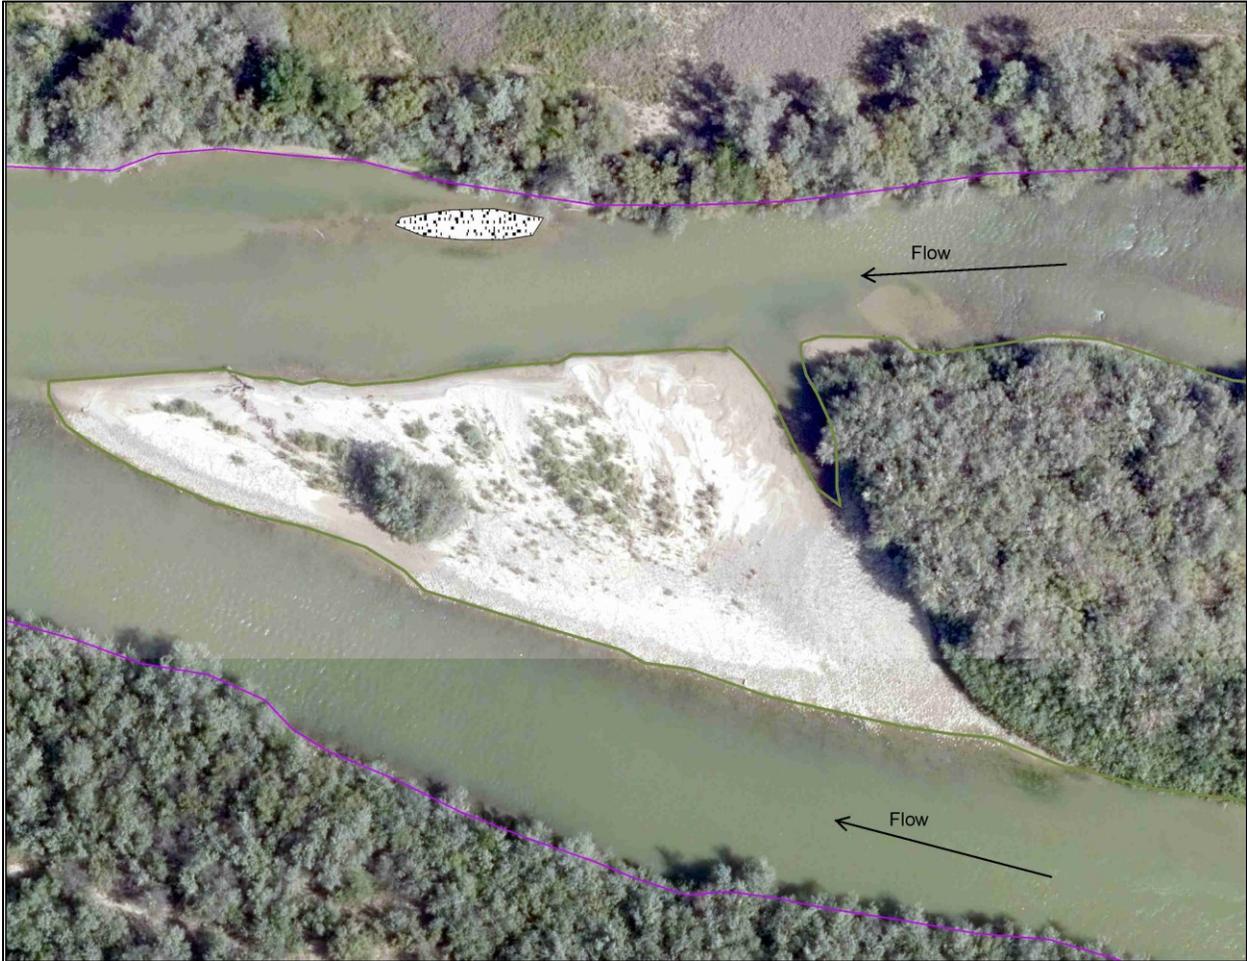
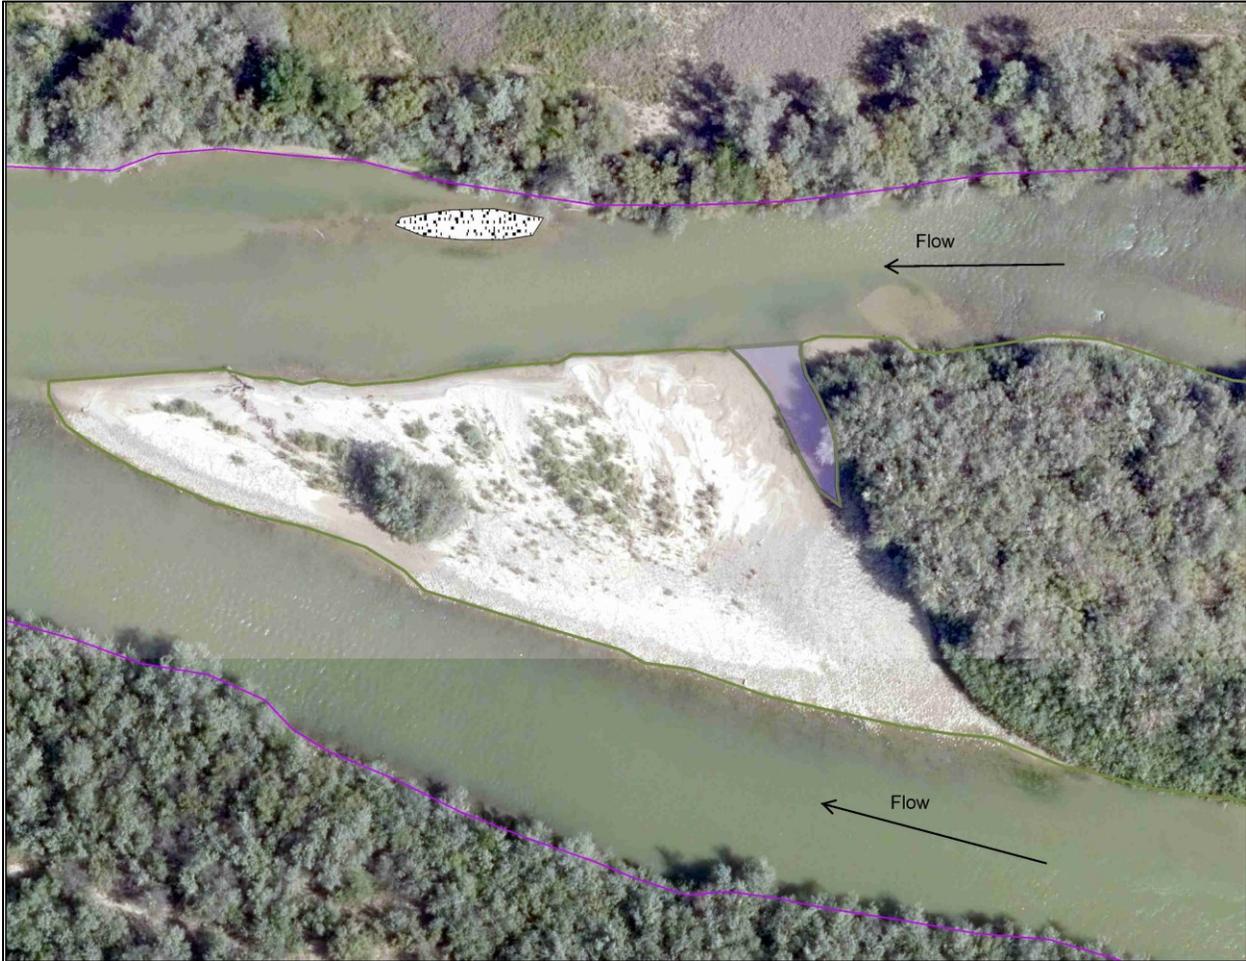
Picture 16: River Mile 155, Raw Image.

Picture 17: River Mile 155, Island Area Defined.

Picture 18: River Mile 155, Island Backwater Area Boundary Defined.
