San Juan River Habitat Monitoring: 2017

Annual Report

**San Juan River Biological Committee
United States Fish and Wildlife Service**

**Ecosystems Research Institute
Vincent Lamarra and Daniel Lamarra
435.554.7106
1023 West 800 North
Suite 108
Logan, Utah 84321**

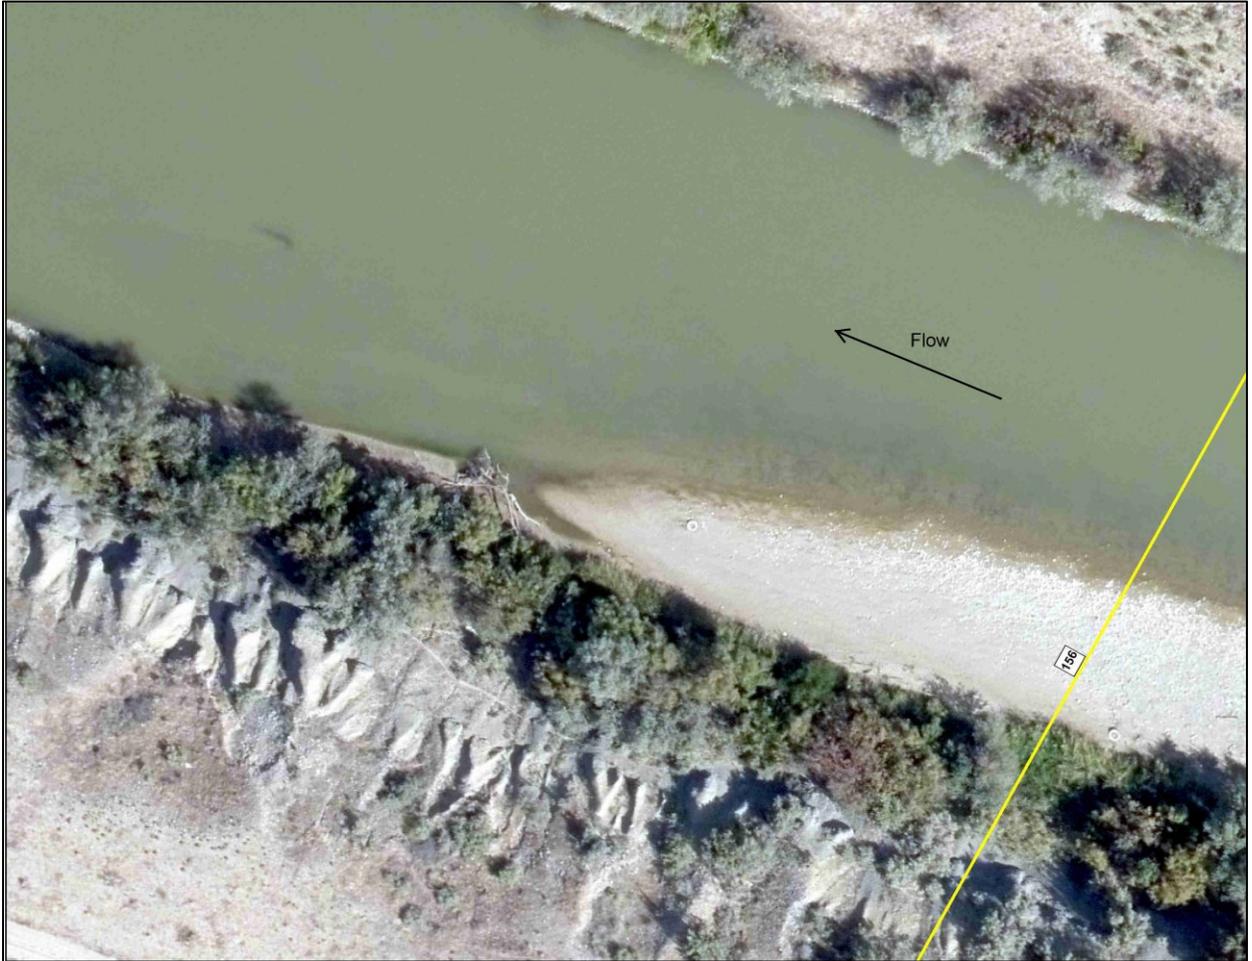
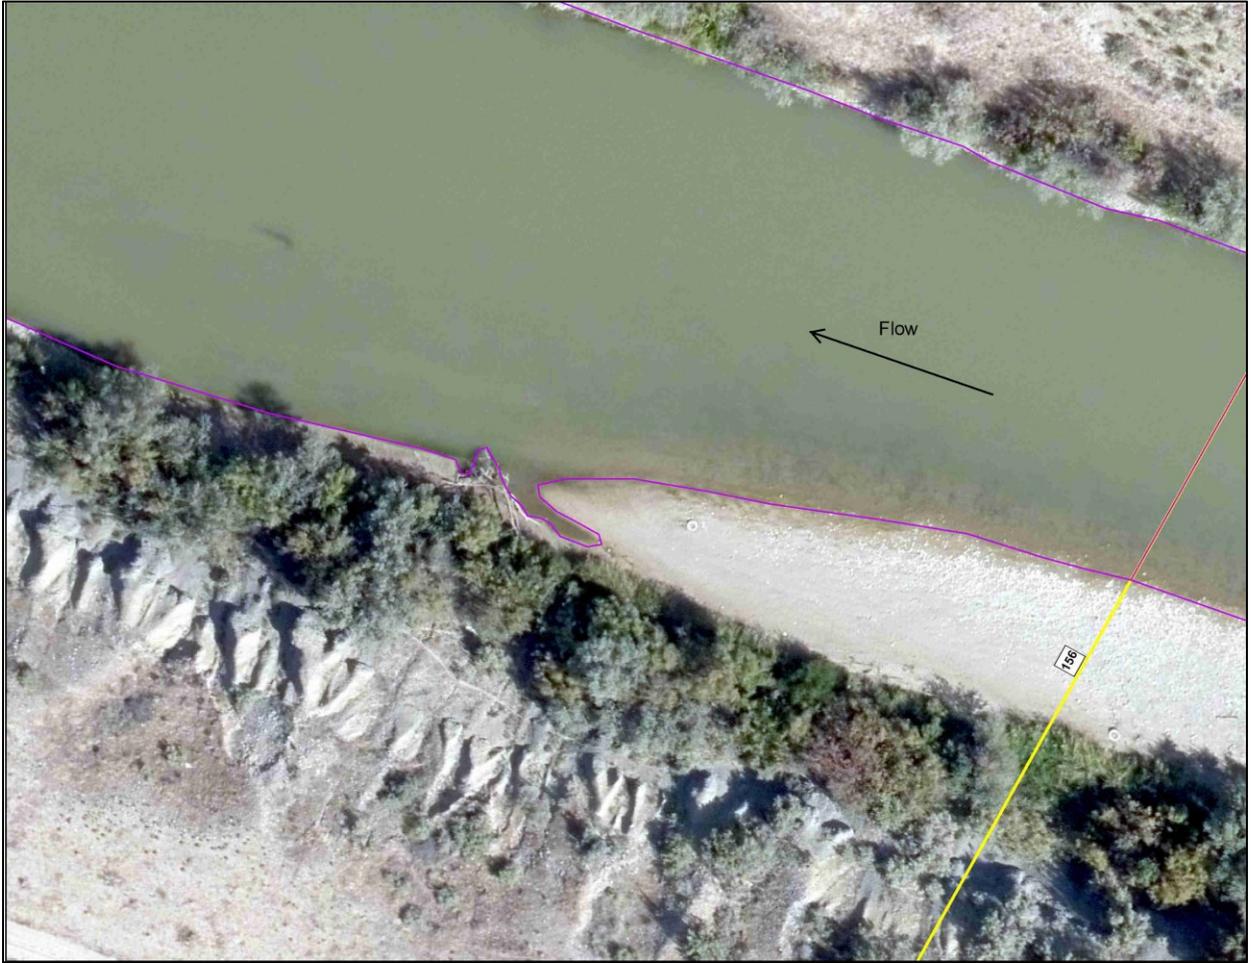
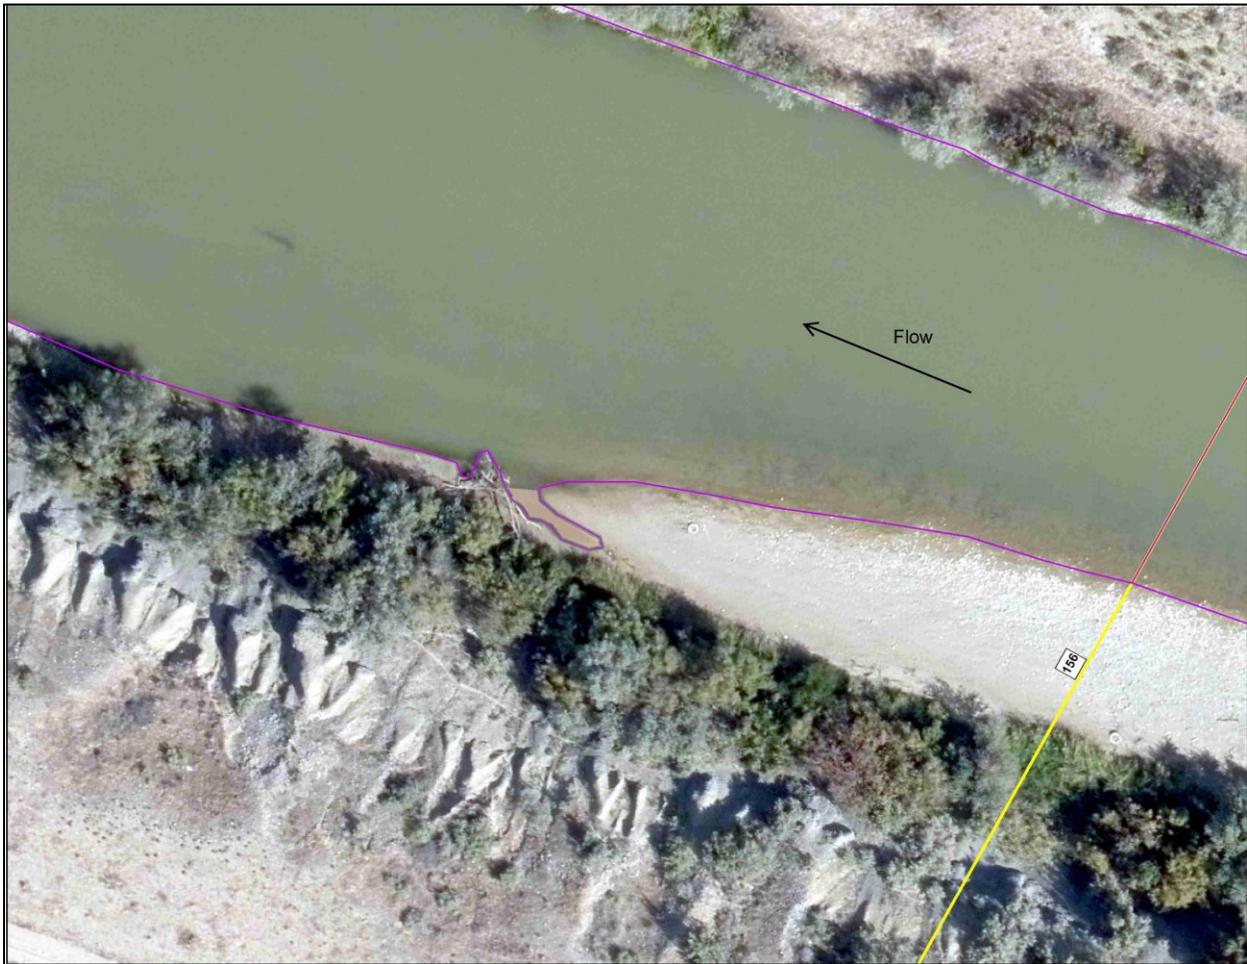
Picture 19: River Mile 156, Raw Image.

Picture 20: River Mile 156, Wetted Area Defined.

Picture 21: River Mile 156, Bank Backwater Boundary Defined.

The figures provided below illustrate the process of defining, delineating, and identifying the boundary of backwaters and embayments. These figures represent a variety of types of backwaters and embayments along with their orientation to flow. The process of delineation is outlined in a series of three photographs according to the order in which low velocity habitat is identified and defined. The first photograph is simply the raw image we receive from contractors. The second photograph shows where the wetted edge of the river is defined. The third and last image is a combination of the first two photos with the boundary of the low velocity habitat defined. The low velocity habitat vector polygon is traced onto the vector line of wetted area insuring consistency between the wetted area edge, and the low velocity polygon.
