San Juan River Historical Ecology Assessment

Changes in Channel Characteristics and Riparian Vegetation

September 2015

Prepared by Steven Bassett
The Nature Conservancy in New Mexico
212 East Marcy Street, Suite 200
Santa Fe, NM 87501

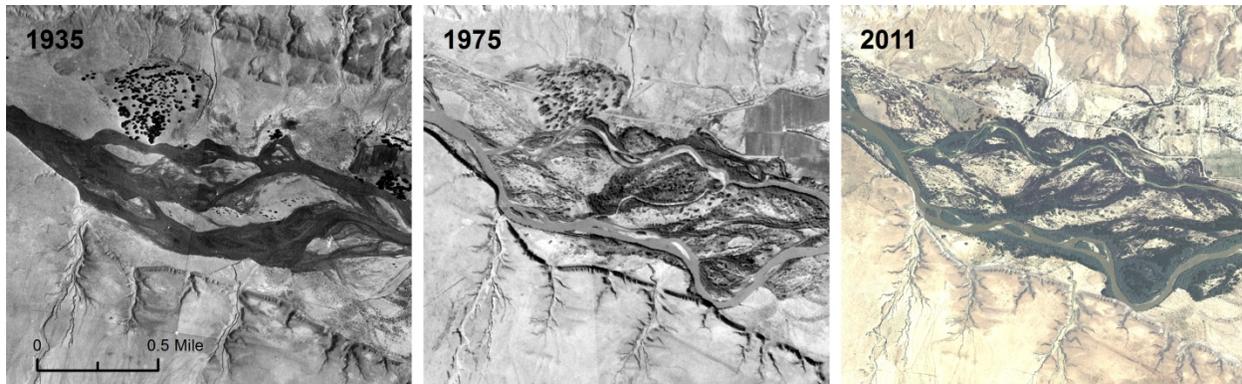
Figure 2. Sample imagery from each time period used in analysis. Valley miles 203 and 204 are shown.

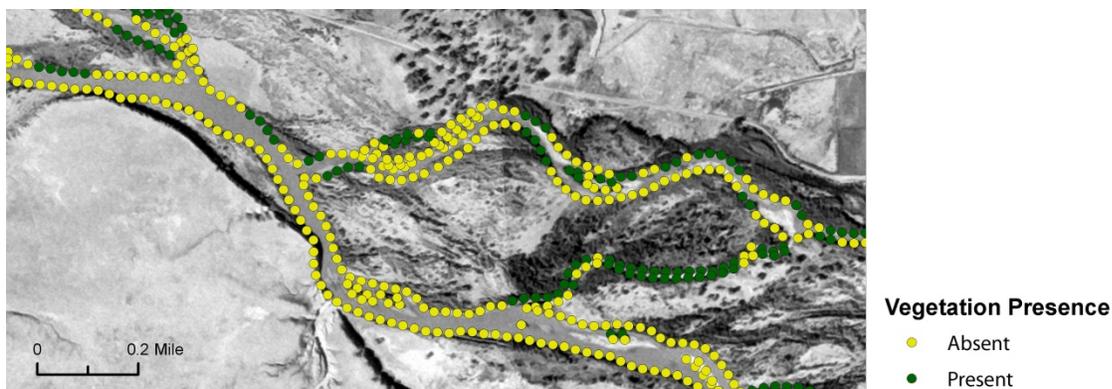
Figure 3. An example reach including valley mile 203 with vegetation sampling points color coded by vegetation presence.

Bank armoring by vegetation is considered to be a significant control on erosion and bank avulsion (Cadot et al. 2010). To quantify the vegetation located on the banks of the river, continuous transects were placed parallel to the digitized active channel on both banks and islands. Sample points were placed at 37.4 meter intervals along the transects throughout the entire study reach (Figure 3). This point density was selected to provide a minimum of 150 sample points per valley mile. Presence or absence of vegetation was recorded for each sample point at a scale of 1:5,000. This protocol was repeated for each series of aerial photos.

The sample point technique overestimates true canopy cover due to gaps in vegetation smaller than the photo resolution and shadows cast by the canopy (Frescino & Moisen 2012). The cover estimates derived from my analysis should not be considered analogous to true canopy cover but do serve as an index to changes in vegetation cover over time.

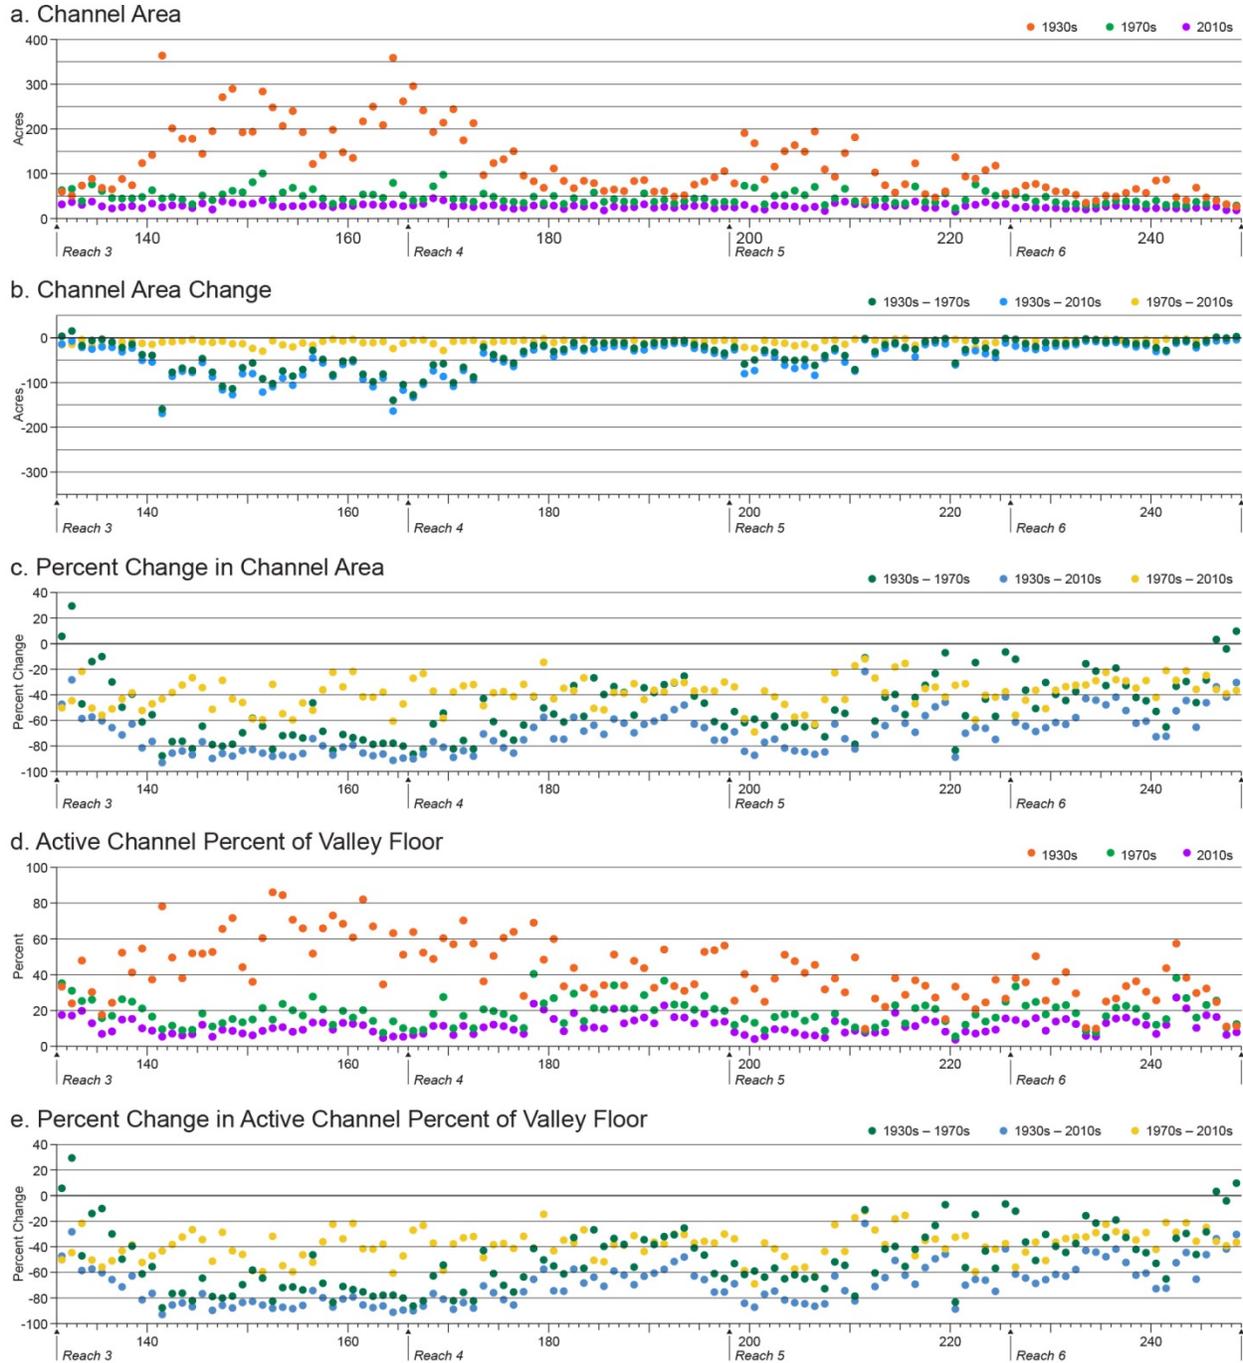
Figure 6. Planform channel characteristics summarized for each valley mile.

Reach-level summaries conceal the high variation along the river. No two valley miles are alike. Despite similarities between each reach's river miles, there are many river miles that do not follow the patterns seen in other parts of the reach (Figure 6).

Channel area, when expressed as a percent of valley floor illustrates how the channel area has changed over time relative to maximum possible river area (Figure 6d). The percent of valley floor occupied by the river channel is a measure of channel confinement by the valley walls. Channel confinement by valley walls was high in the 1930s throughout reaches 3 and 4 but confinement by valley walls has since decreased as channel area decreased. Valley miles 135, 136, 233, and 234 have a consistently low level of confinement but this is likely the result of incorrect delineation of the valley walls. The decreasing amount of confinement by valley walls suggests that the river is being confined by other mechanisms.
