**San Juan River Basin  
Recovery Implementation Program**

**HYDROLOGY/GEOMORPHOLOGY/HABITAT  
2001-2002  
ANNUAL REPORT**

**prepared by  
Ron Bliesner  
Keller-Bliesner Engineering  
78 East Center  
Logan, UT 84321  
(435) 753-5651**

**May 16, 2003**

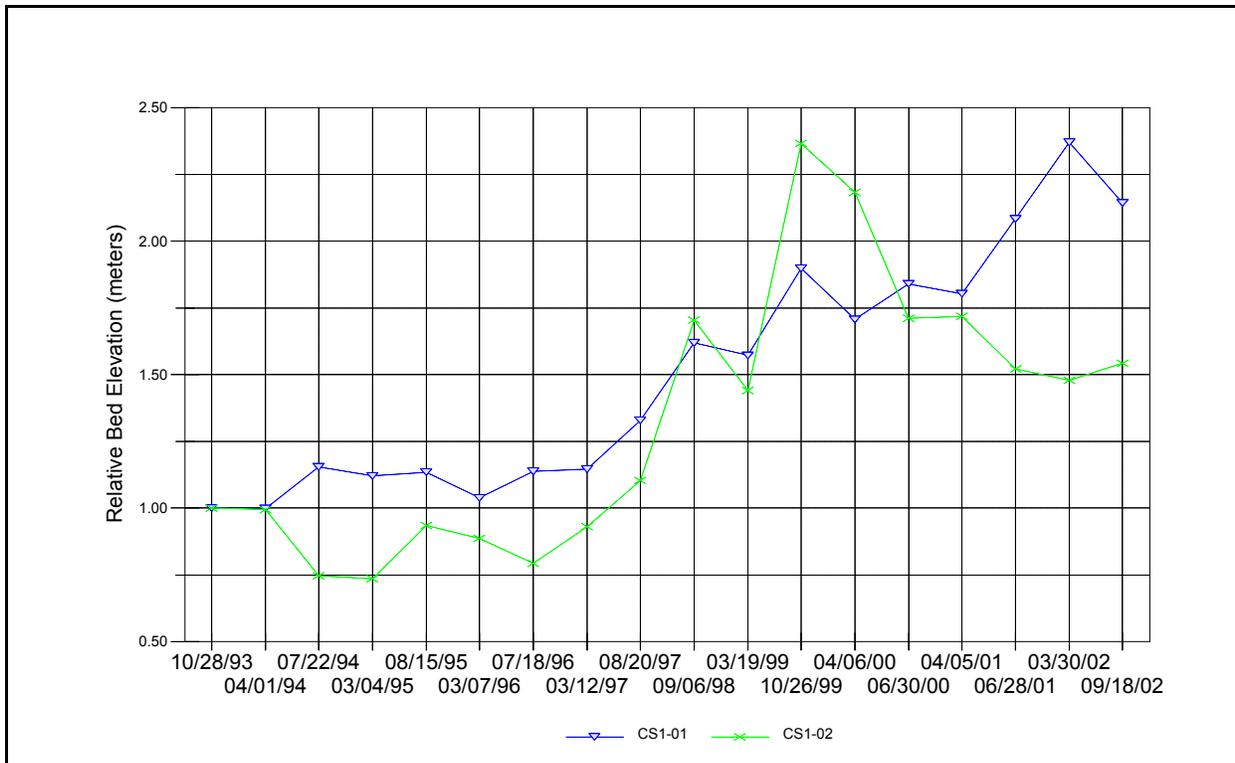
**Figure 3.6. Average Relative Bed Elevation for Reach 1 Transects, 1993-2002**

CS1-01 and CS1-02 started to behave differently during the 2000 runoff season. CS1-01 continued to aggrade through the March 2002 survey with some scour since. CS1-02 continued to degrade through March 2002 and shown some deposition since that time. Both transects are most likely in a recovery phase after being subject to the backwater effects of Lake Powell.

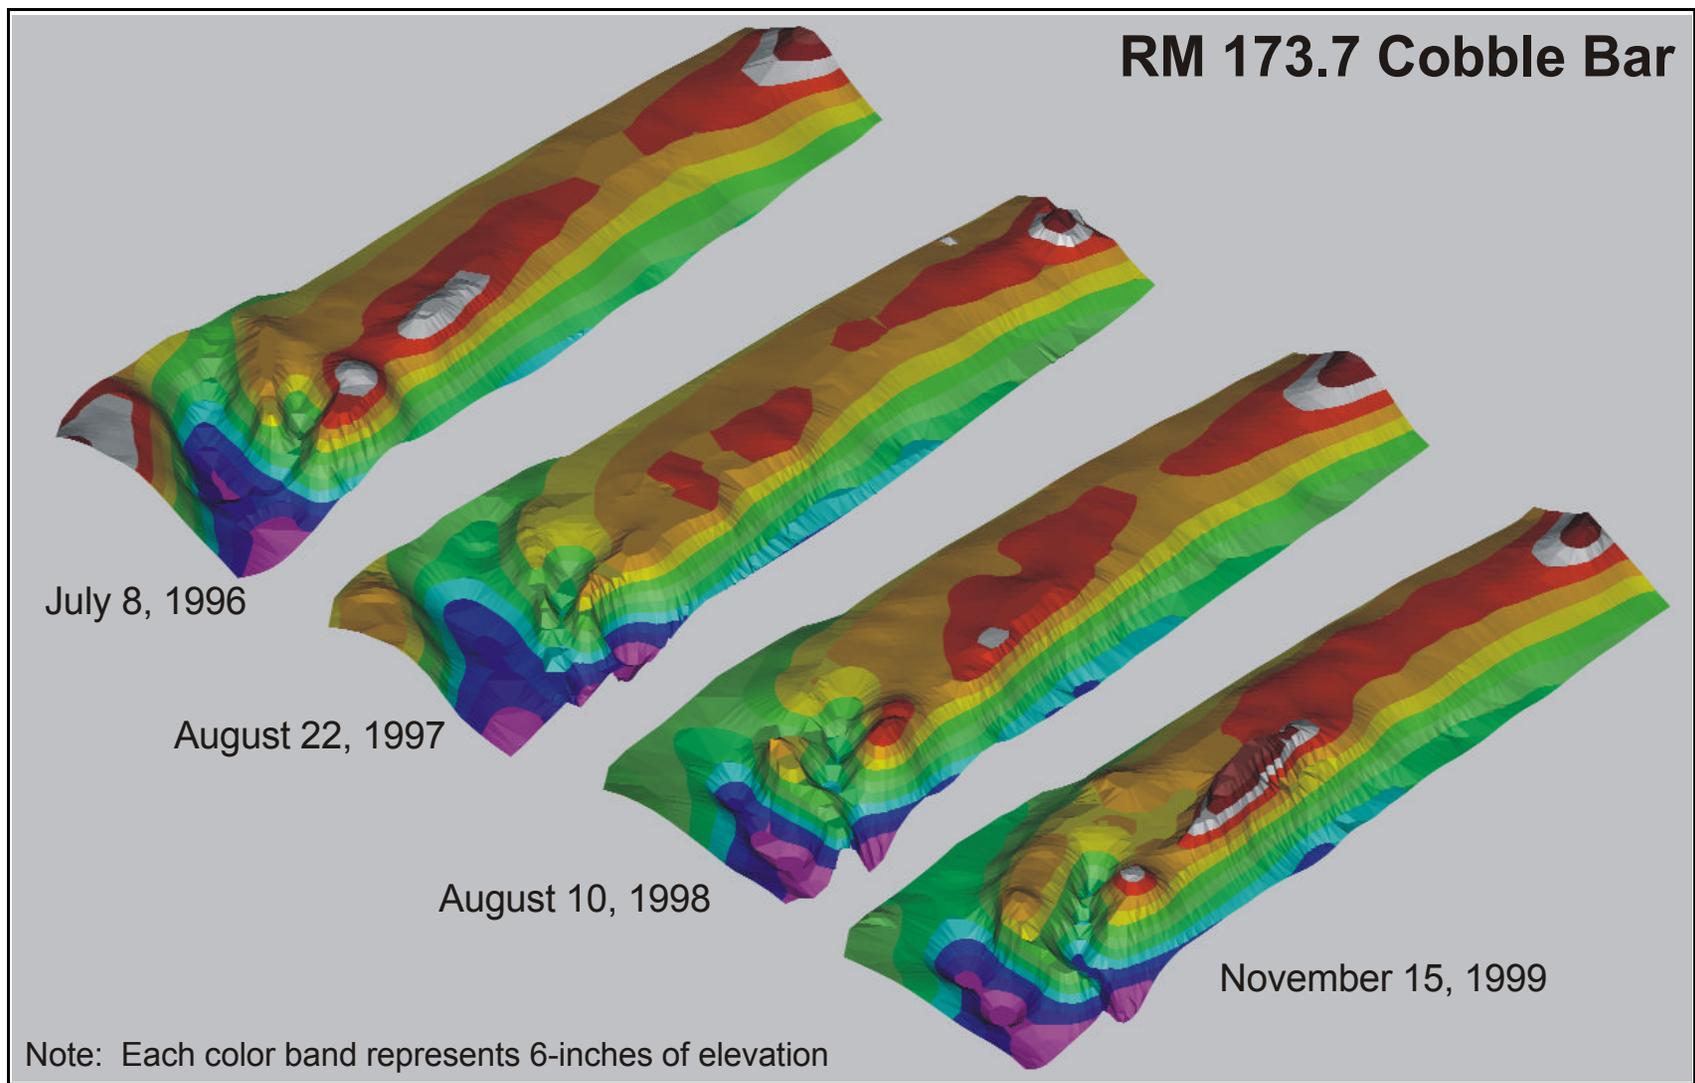
**Figure 3.9. Topography of Cobble Bar at RM 173.7, 1993-1999**

Topographic surveys were completed for the cobble bars at RM 173.7, 168.4, 132 (M-6) and 131 (M-4). The rendered images for the latest survey as well as images for the previous surveys are shown in Figures 3.9 to 3.16. Each color band represents 15-cm (6-inches) of elevation change. Table 3.3 summarizes the elevation changes for the four bars.

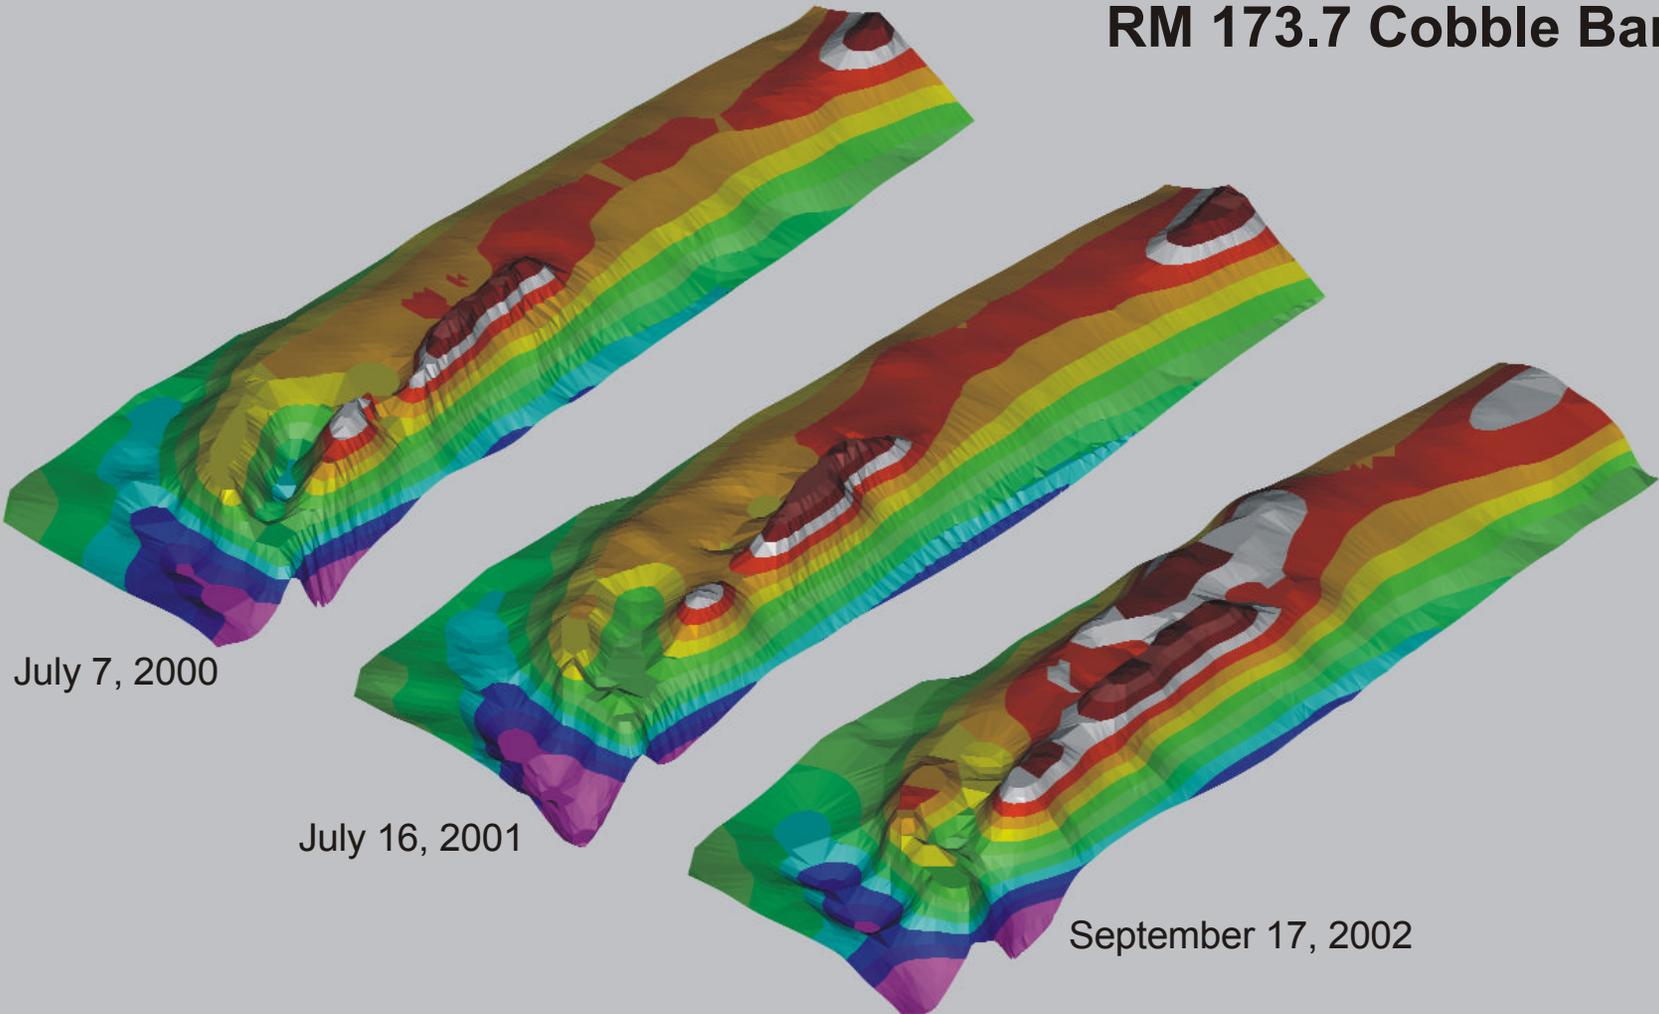
Note: Each color band represents 6-inches of elevation

**Figure 3.10. Topography of Cobble Bar at RM 173.7, 1999-2002**

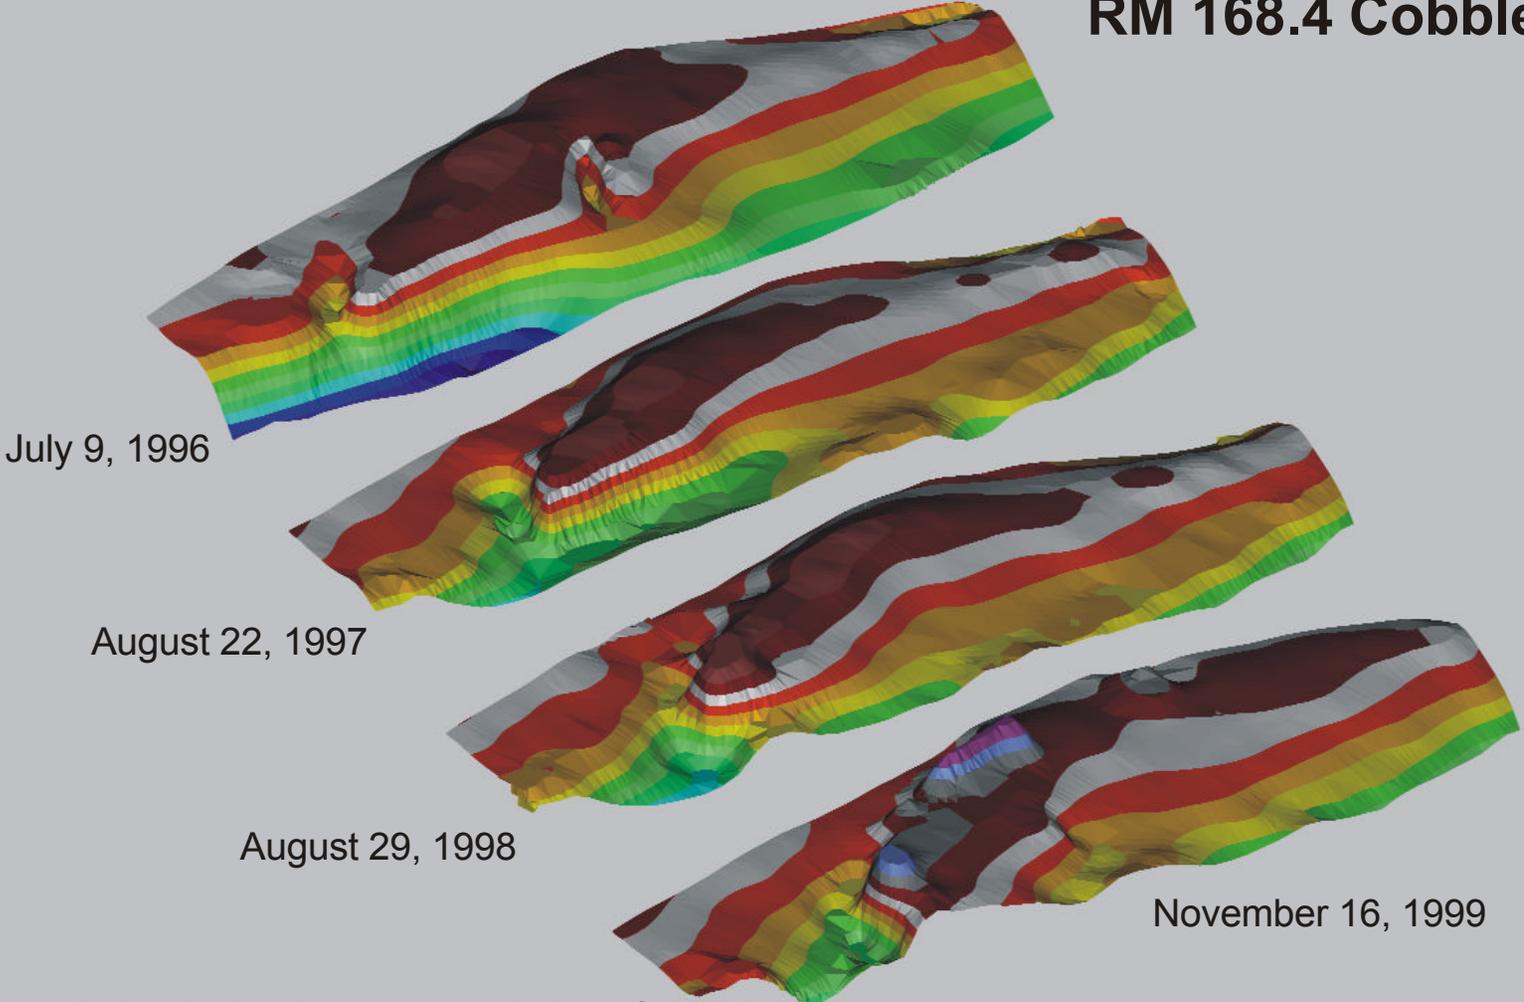
Note: Each color band represents 6-inches of elevation

**Figure 3.11. Topography of Cobble Bar at RM 168.4, 1993-1999**

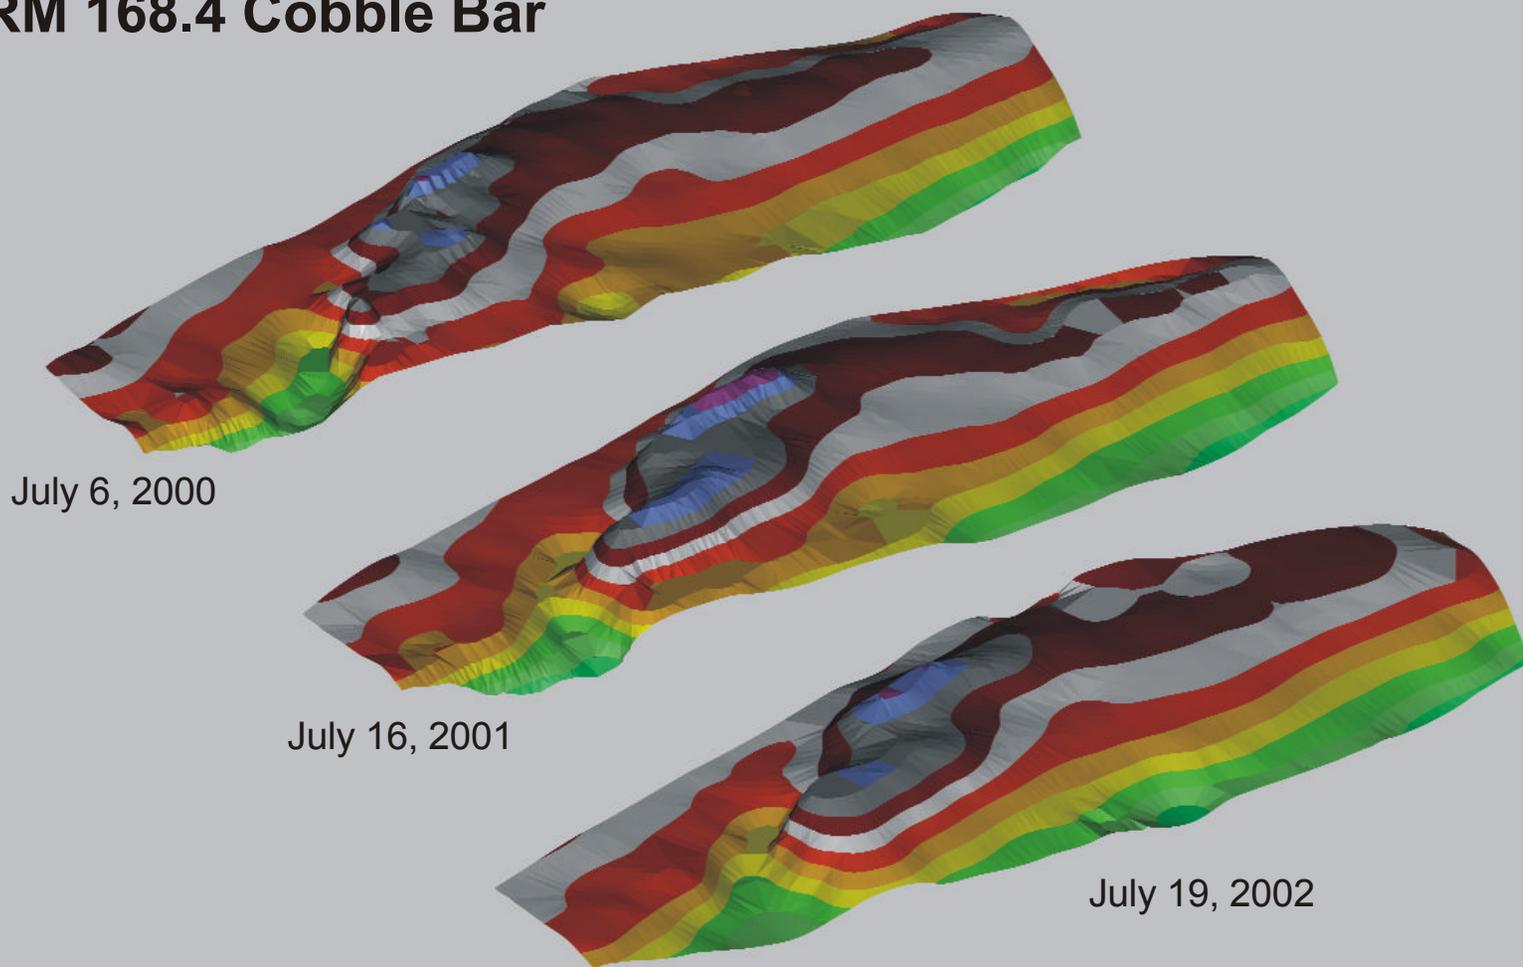
Note: Each color band represents 6-inches of elevation

**Figure 3.12. Topography of Cobble Bar at RM 168.4, 1999-2002**

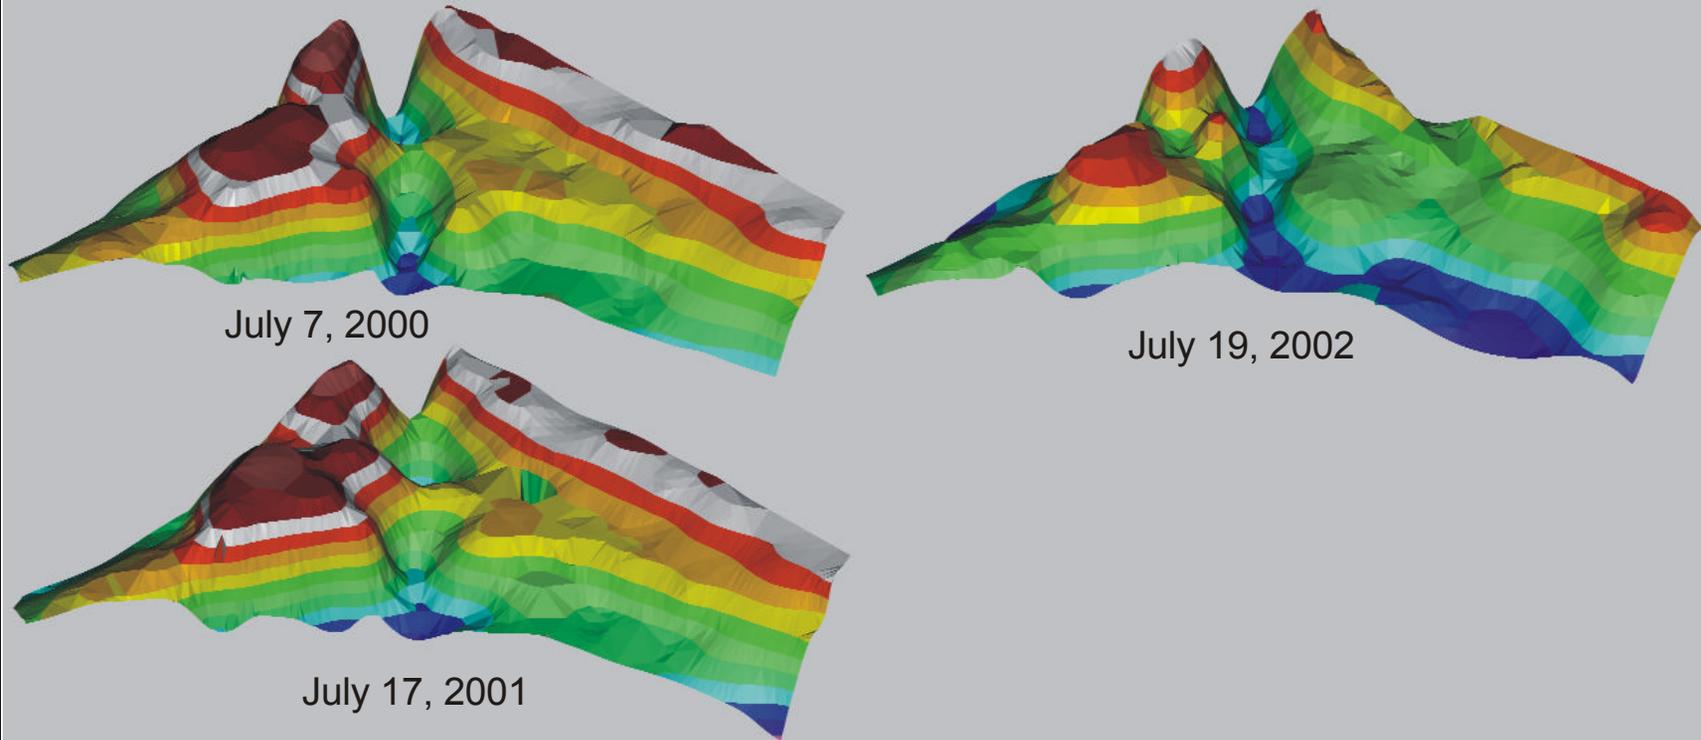
Note: Each color band represents 6-inches of elevation

**Figure 3.14. Topography of Cobble Bar at RM 132, 1999-2002**

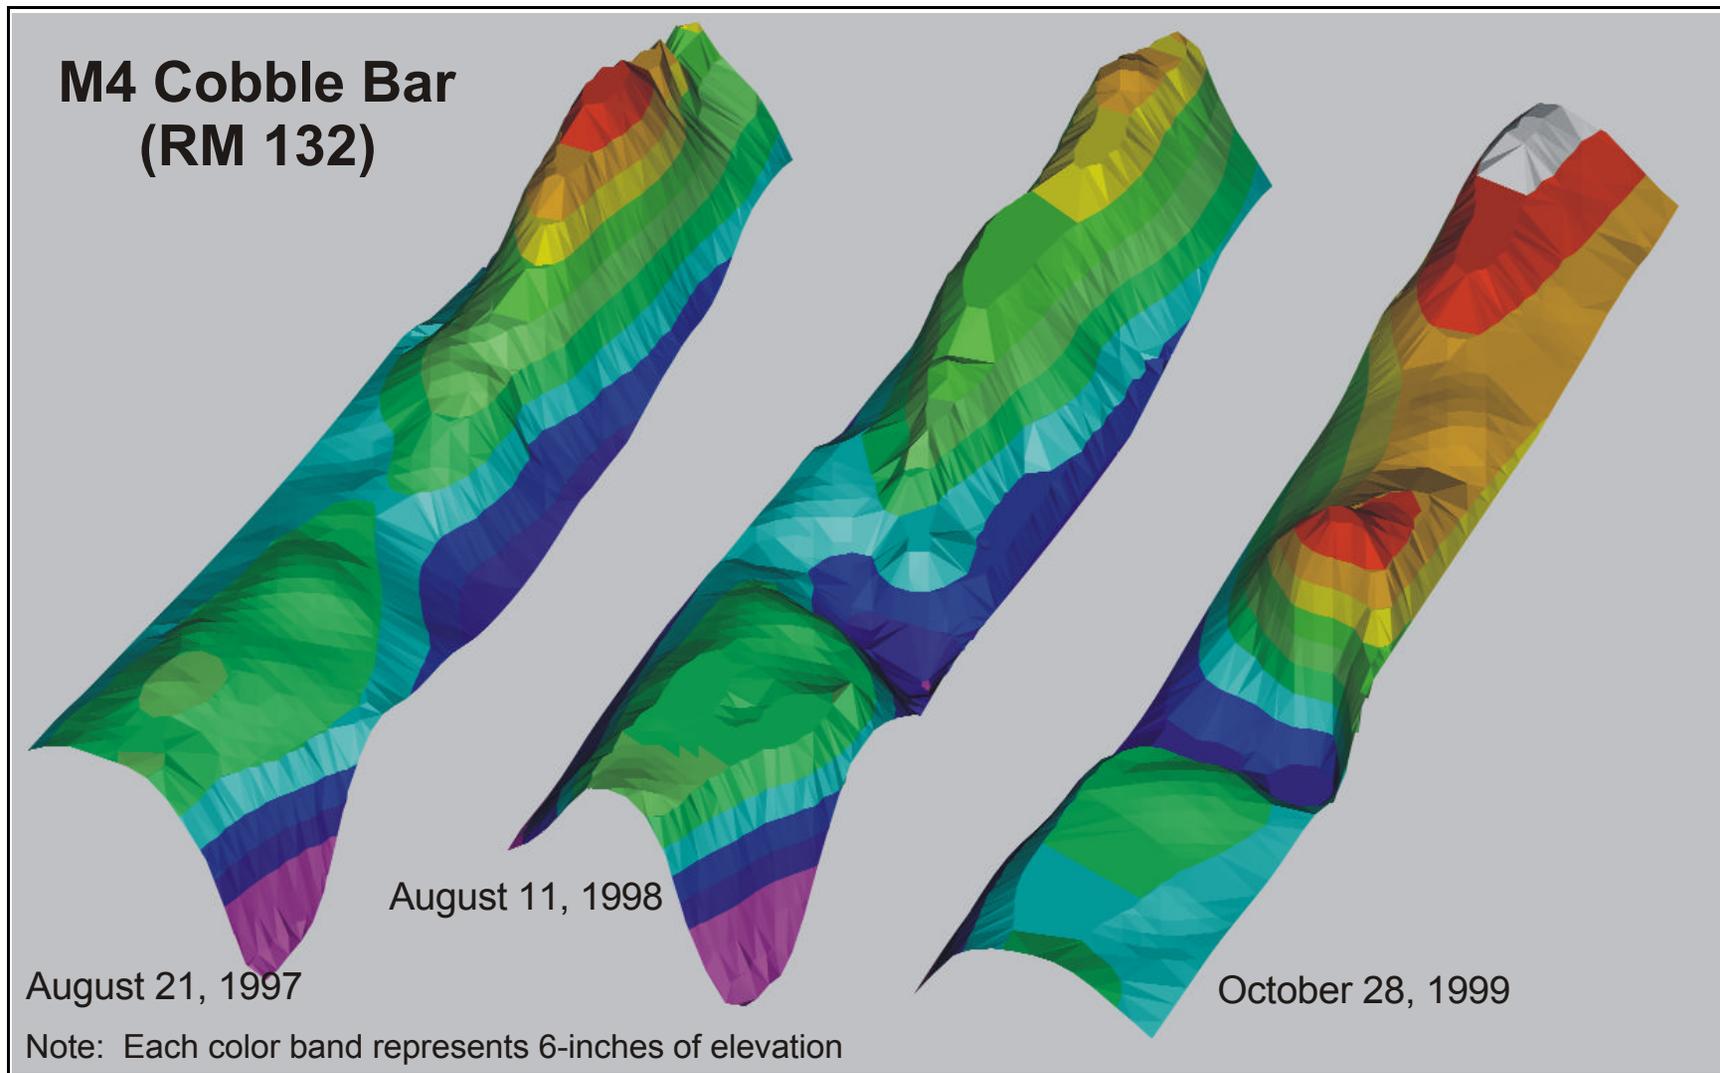
**Figure 3.15. Topography of Cobble Bar at RM 131, 1998-1999**

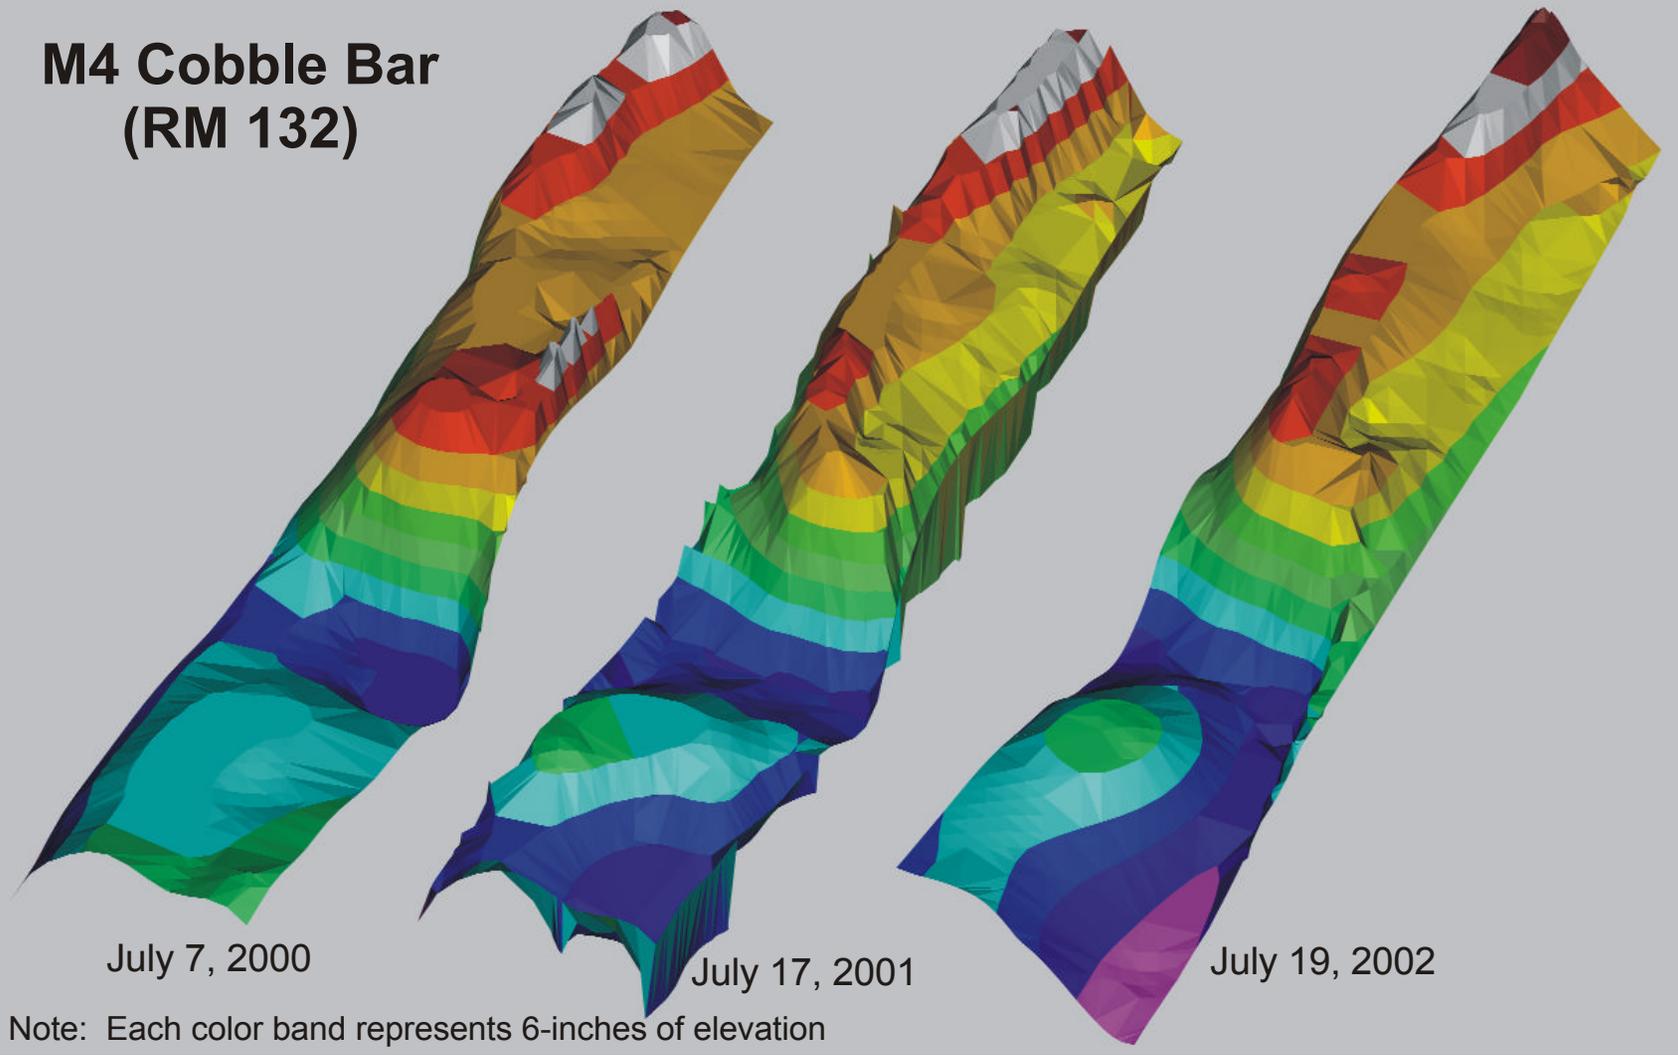
**Figure 3.16. Topography of Cobble Bar at RM 131, 1999-2002**

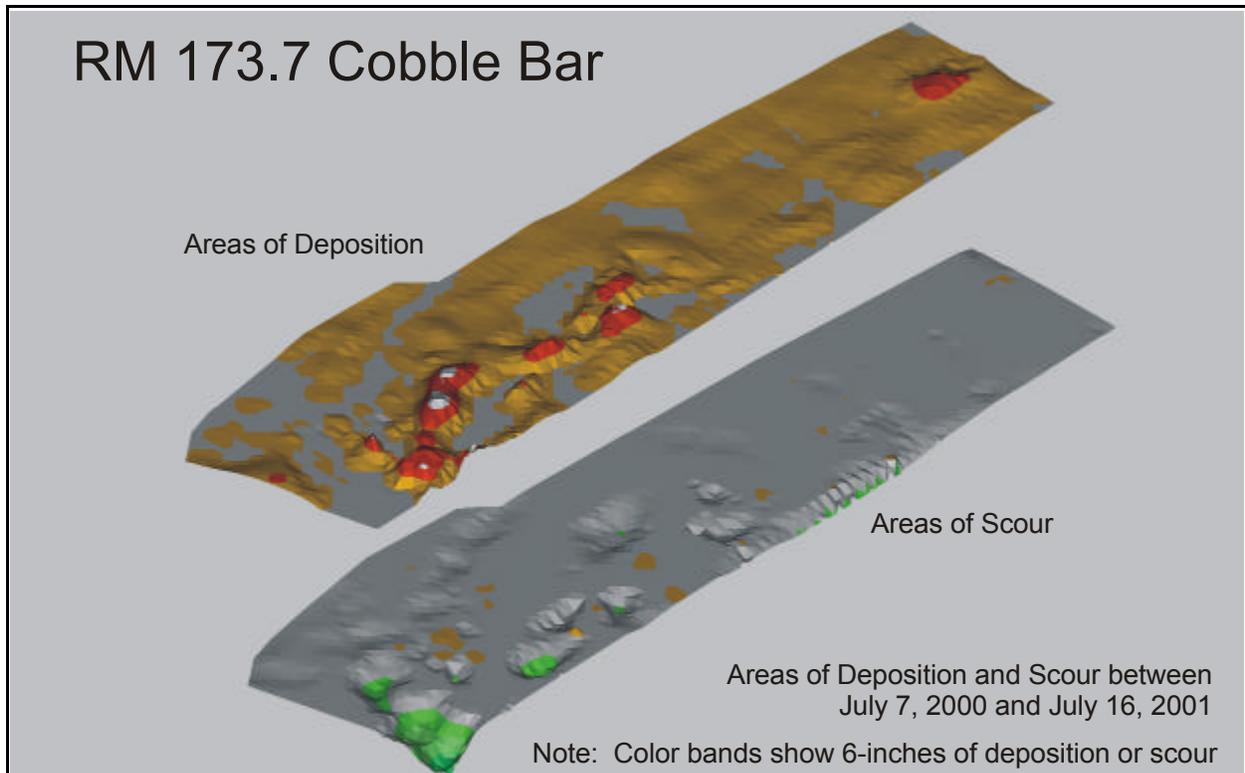
**Figure 3.17. Areas of Scour and Deposition Pre- to Post-runoff 2001 for the RM 173.7 Cobble Bar**

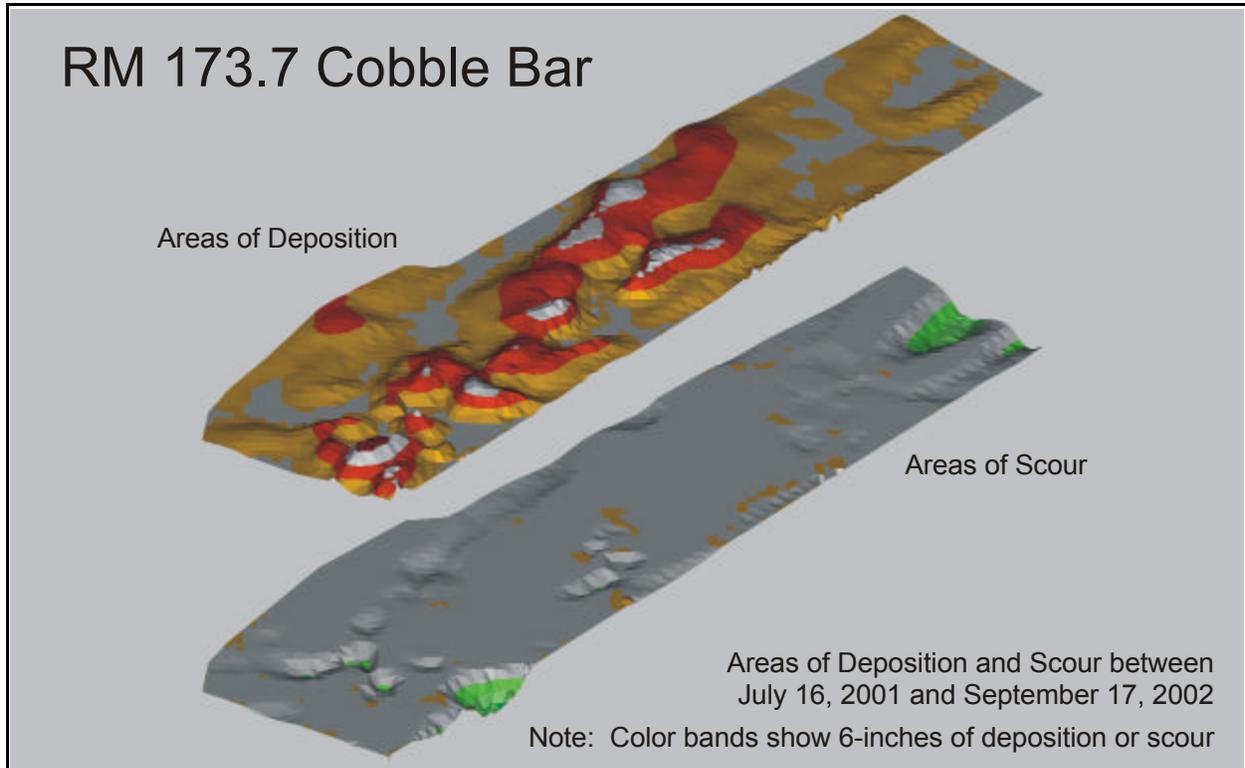
**Figure 3.18. Areas of Scour and Deposition Pre- to Post-runoff 2002 for the RM 173.7 Cobble Bar**

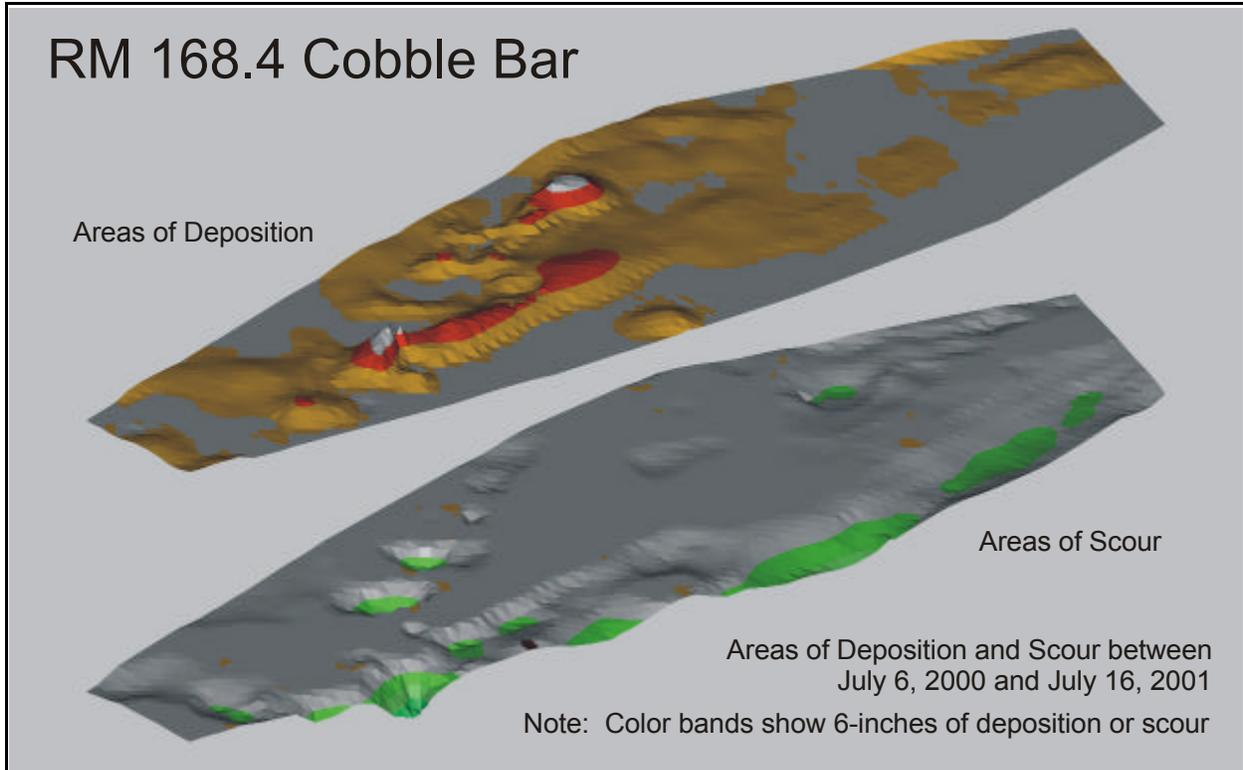
**Figure 3.19. Areas of Scour and Deposition Pre- to Post-runoff 2001 for the RM 168.4 Cobble Bar**

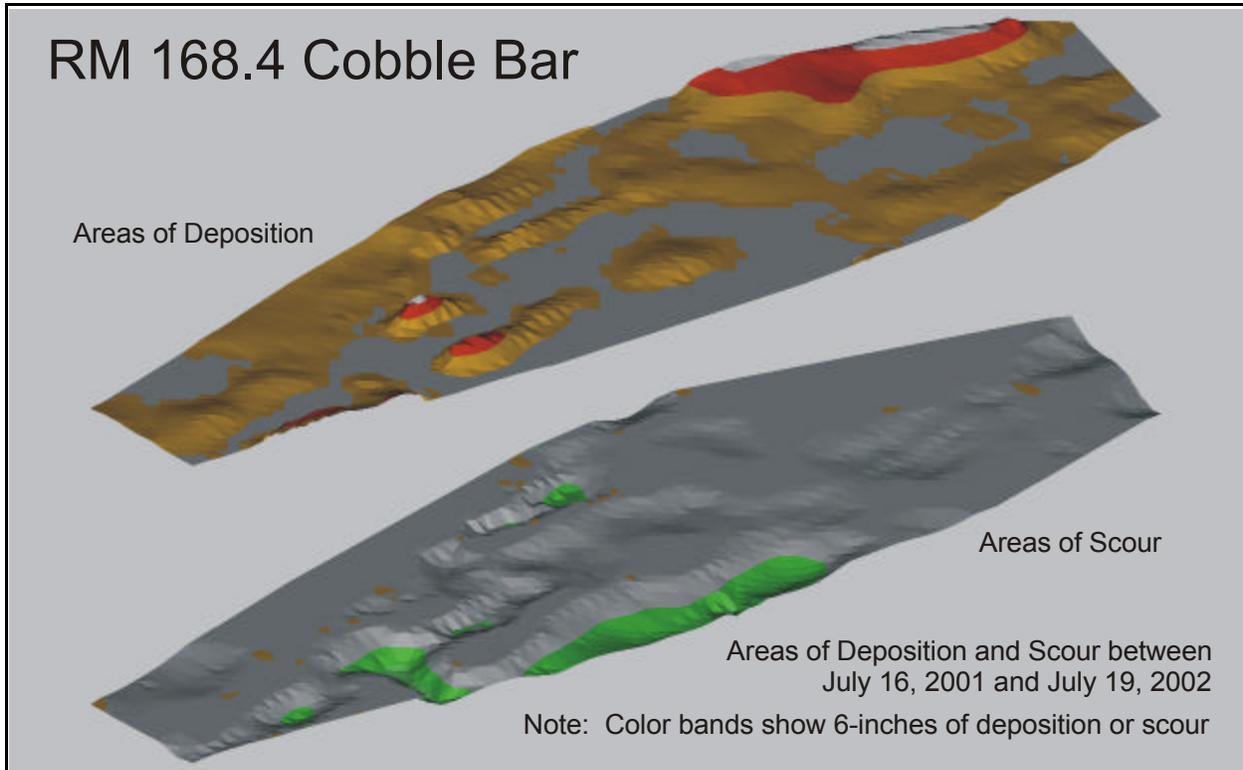
**Figure 3.20. Areas of Scour and Deposition Pre- to Post-runoff 2002 for the RM 168.4 Cobble Bar**

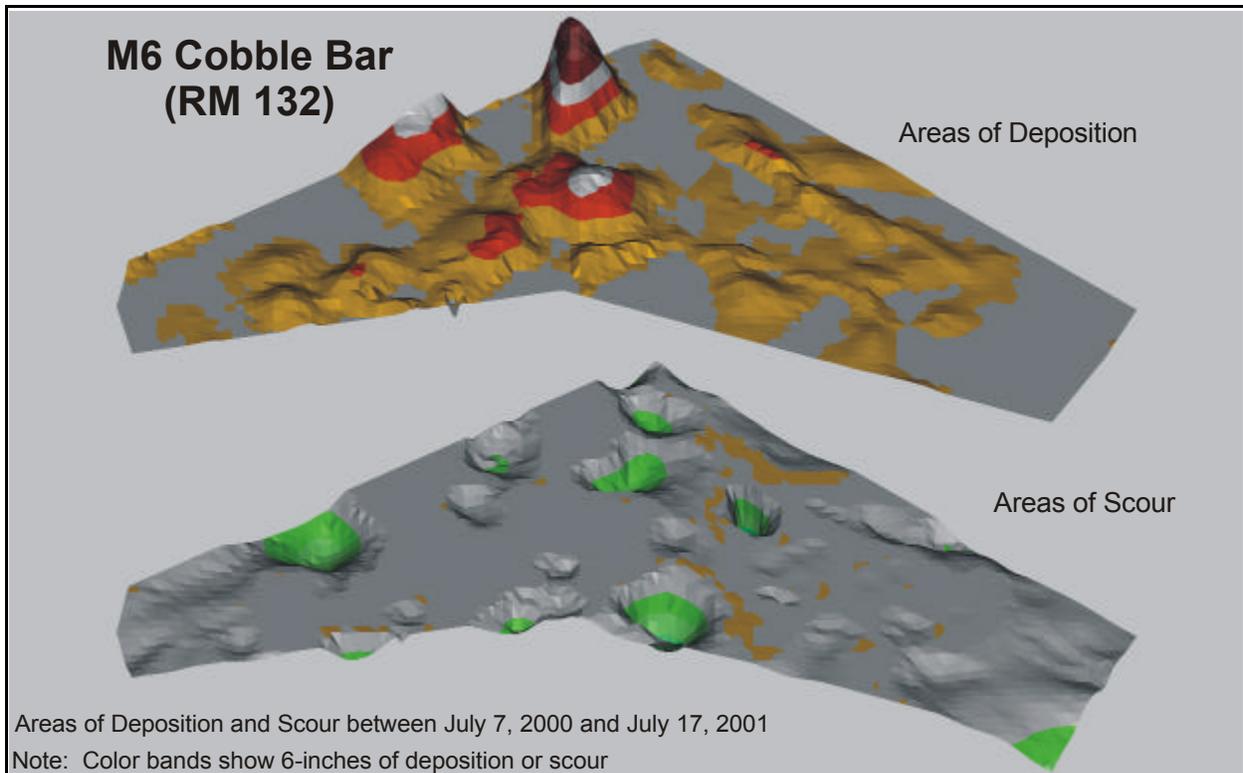
**Figure 3.21. Areas of Scour and Deposition Pre- to Post-runoff 2001 for the RM 132 Cobble Bar**

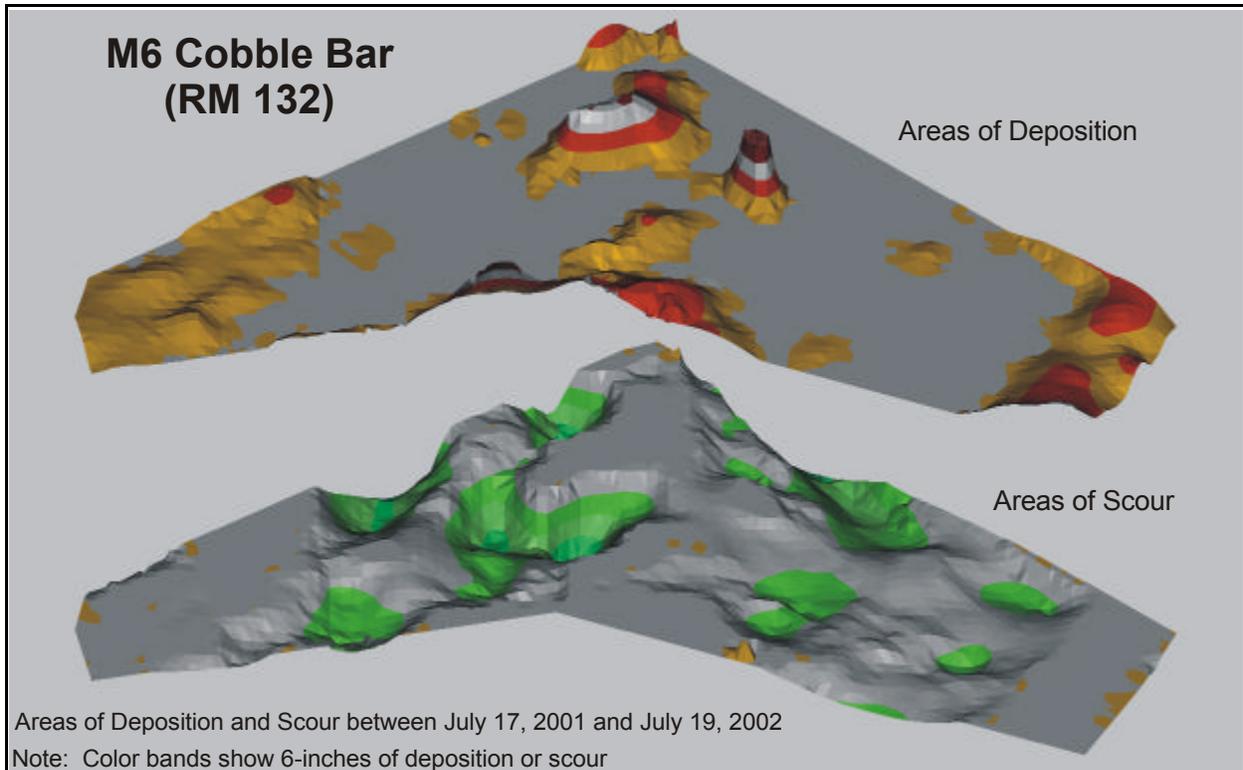
**Figure 3.22. Areas of Scour and Deposition Pre-to Post-runoff 2002 for the RM 132 Cobble Bar**

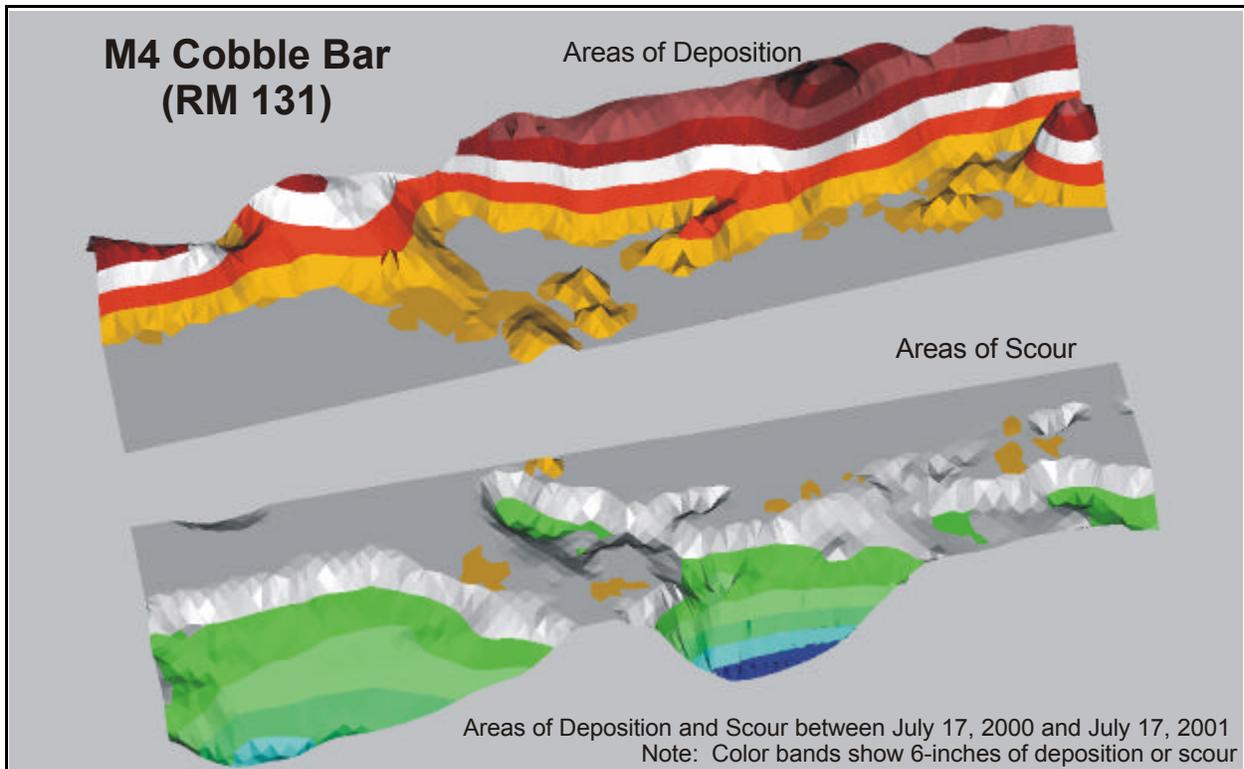
**Figure 3.23. Areas of Scour and Deposition Pre- to Post-runoff 2001 for the RM 131 Cobble Bar**

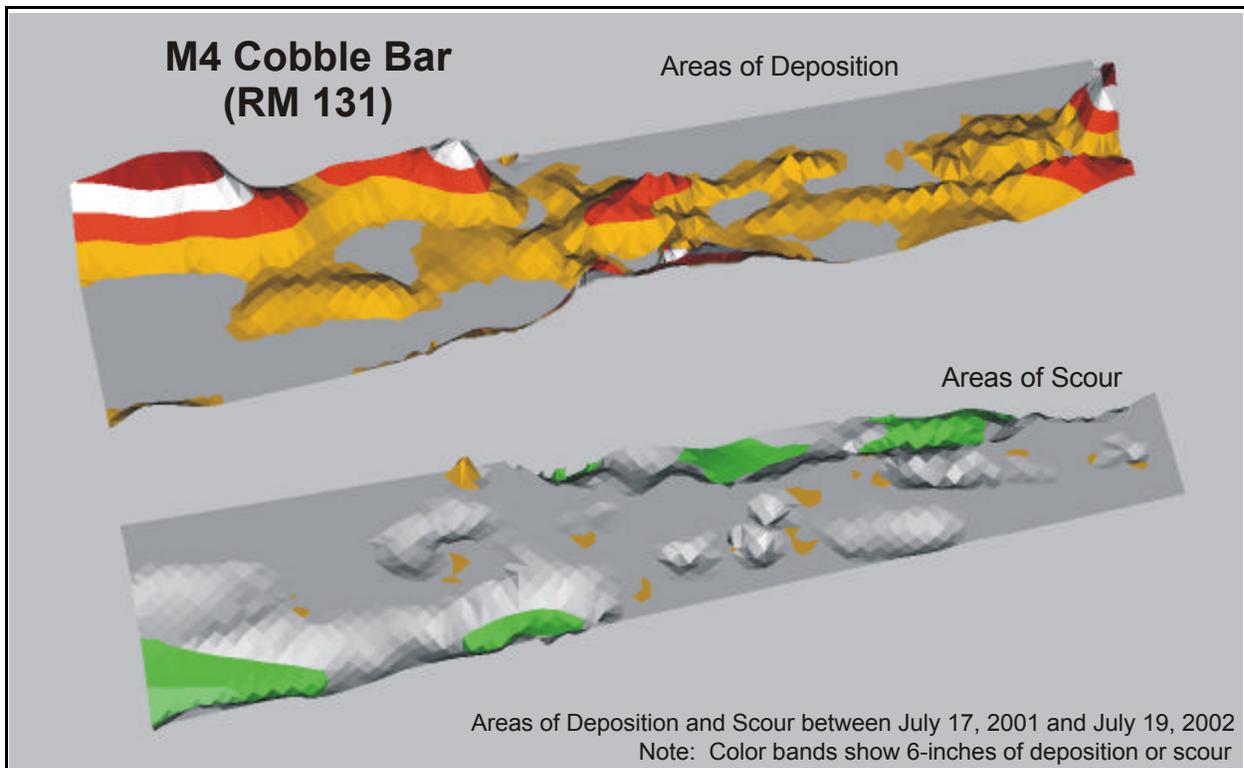
**Figure 3.24. Areas of Scour and Deposition Pre- to Post-runoff 2002 for the RM 131 Cobble Bar**

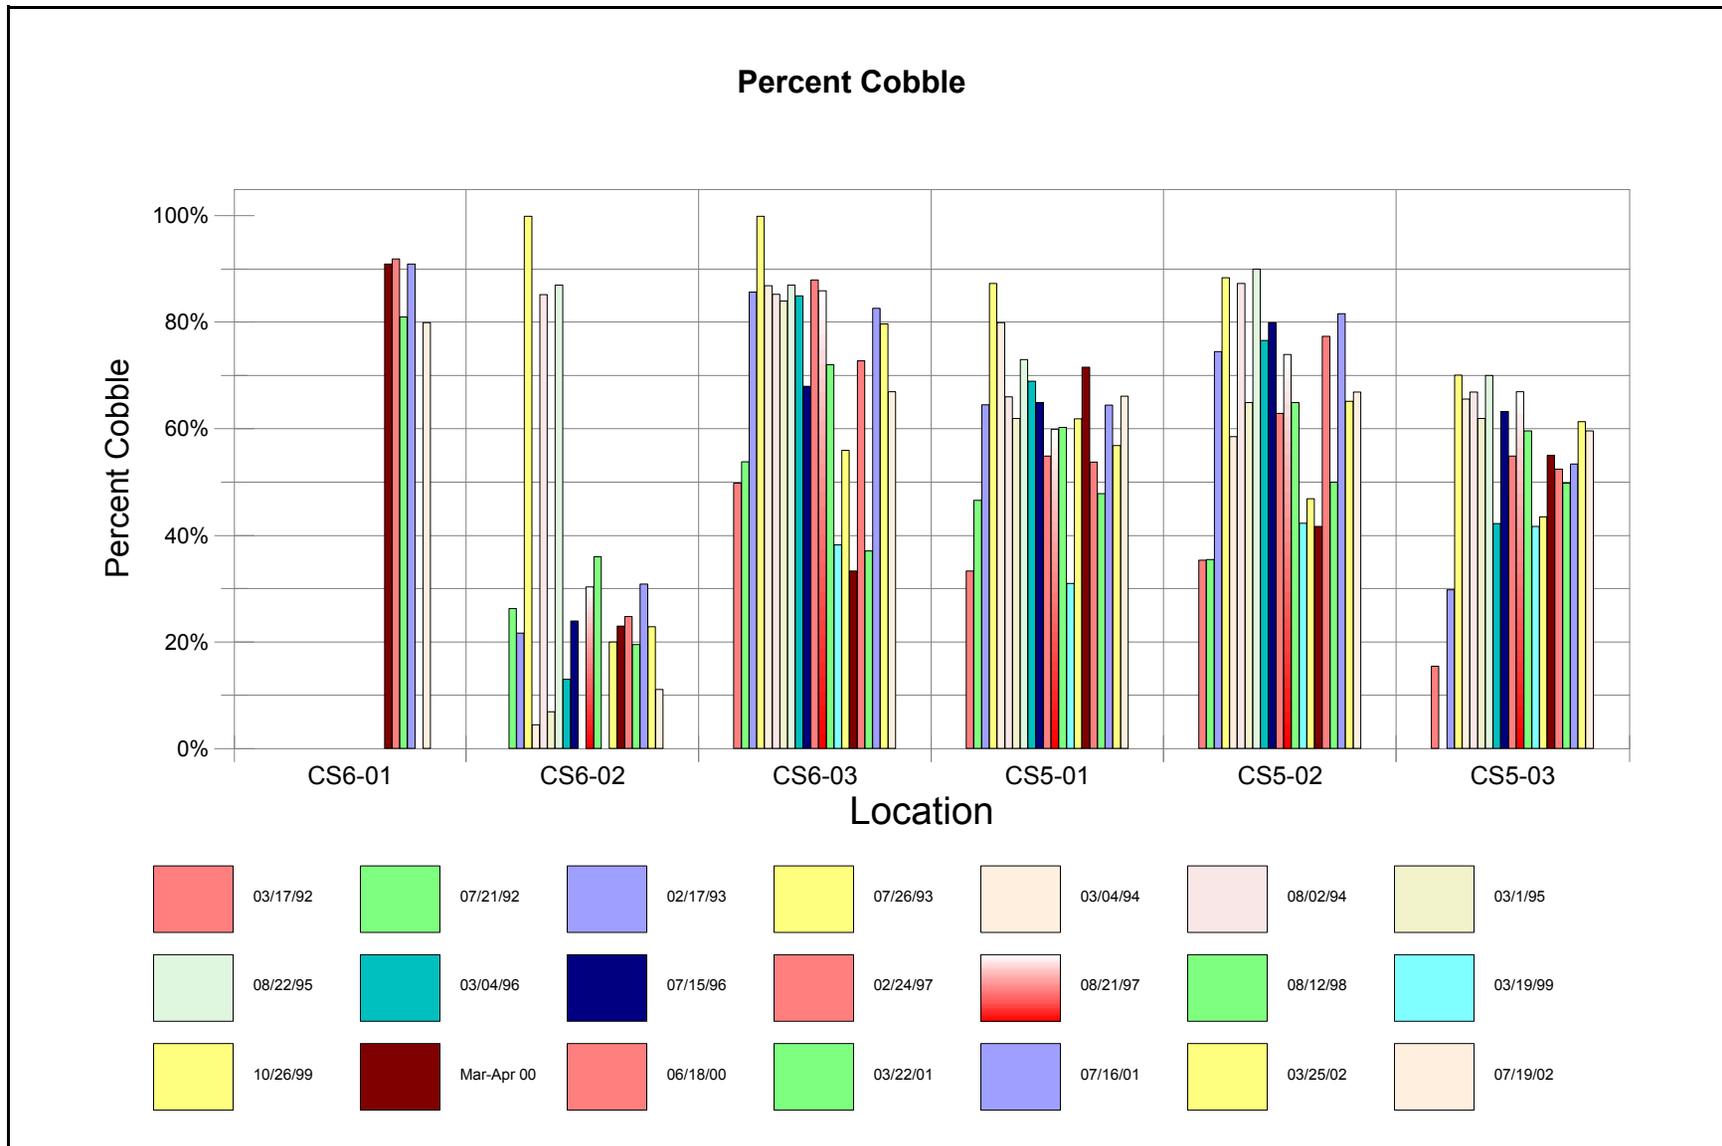
**Figure 3.27. Cobble Percentage at CS6-01 to CS5-03, 1992-2002**
