**San Juan River Basin  
Recovery Implementation Program**

**HYDROLOGY/GEOMORPHOLOGY/HABITAT  
2001-2002  
ANNUAL REPORT**

**prepared by  
Ron Bliesner  
Keller-Bliesner Engineering  
78 East Center  
Logan, UT 84321  
(435) 753-5651**

**May 16, 2003**

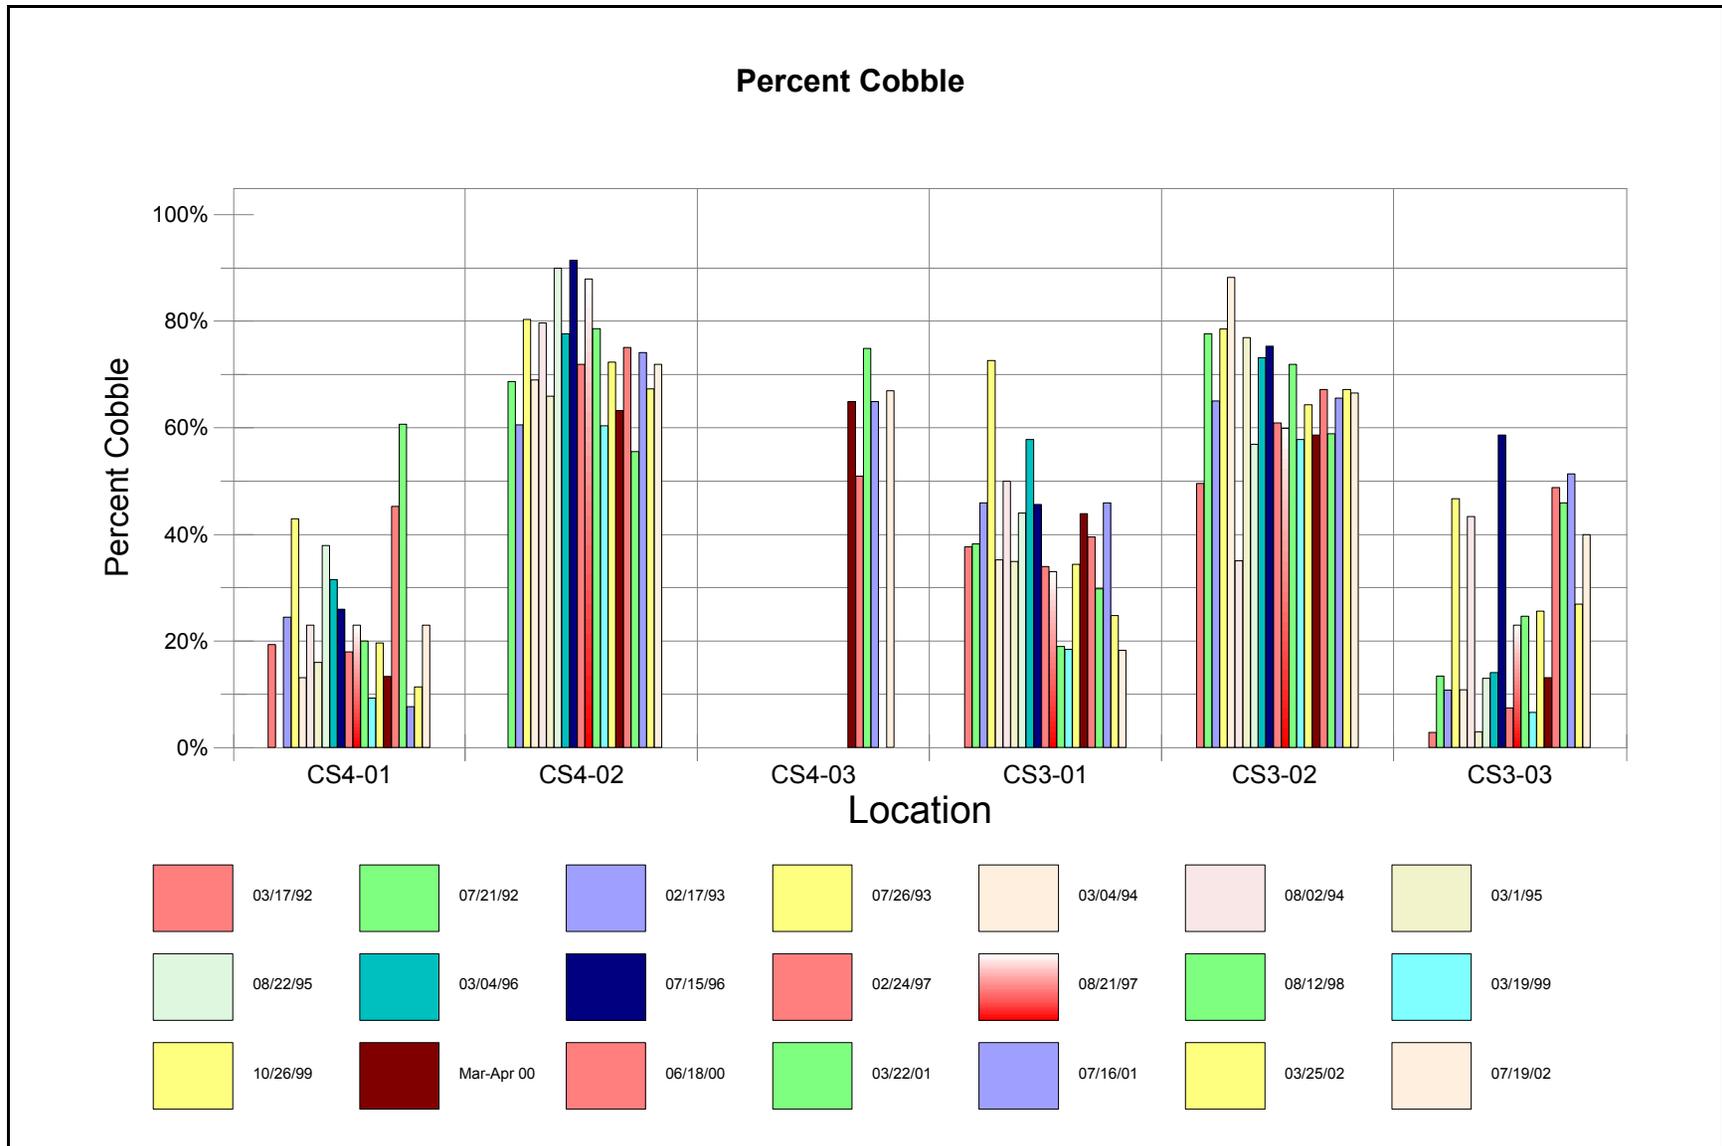
**Figure 3.28. Cobble Percentage at CS4-01 to CS3-03, 1992-2002**

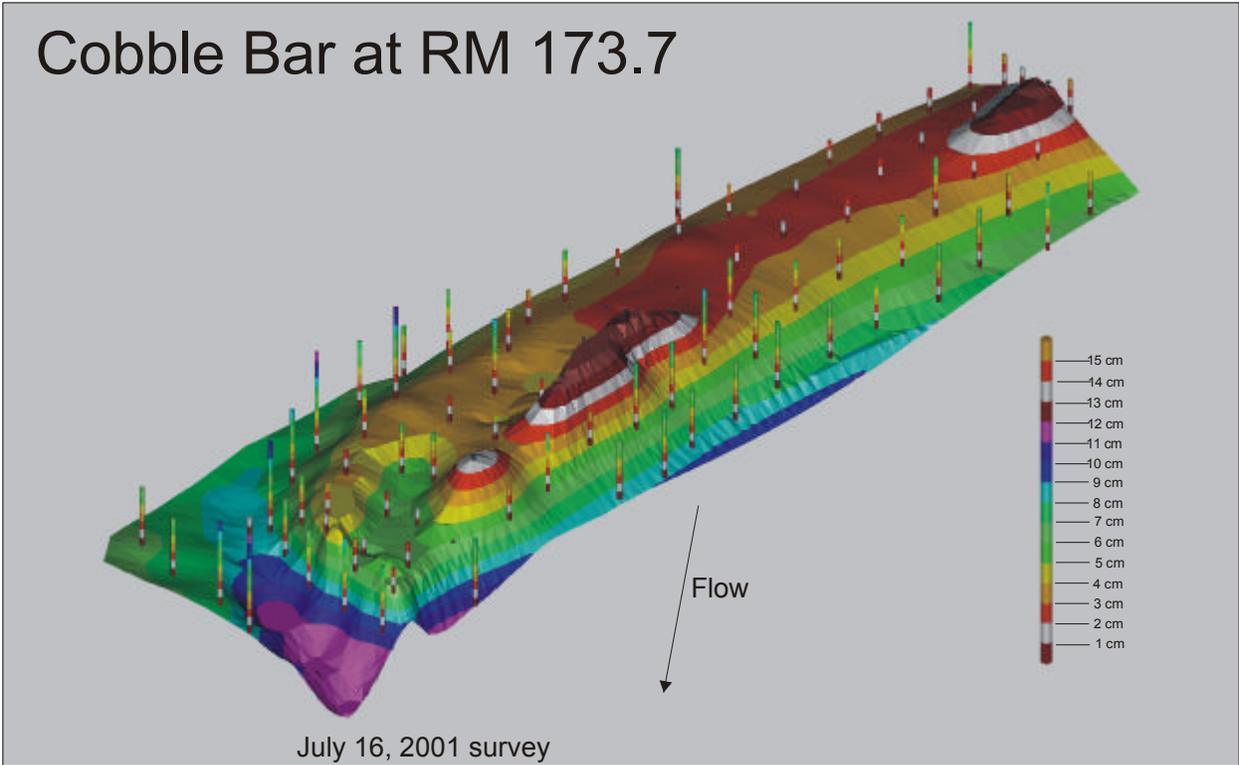
**Figure 3.29. July 16, 2001 Survey with Embeddeness Markers**

Depth of open interstitial space was also measured at each cobble bar. Figures 3.29 through 3.36 show three-dimensional plots of the four cobble bars at river mile 173.7, 168.4, 132 (M-6) and 131 (M-4) for the post-runoff 2001 and 2002 surveys. The “posts” seen on the surface of each image represent the depth of open interstitial space as measured at that point. Each color band on the posts indicate 1-cm of embeddedness or open interstitial space. The higher posts represent areas with greater open interstitial space.

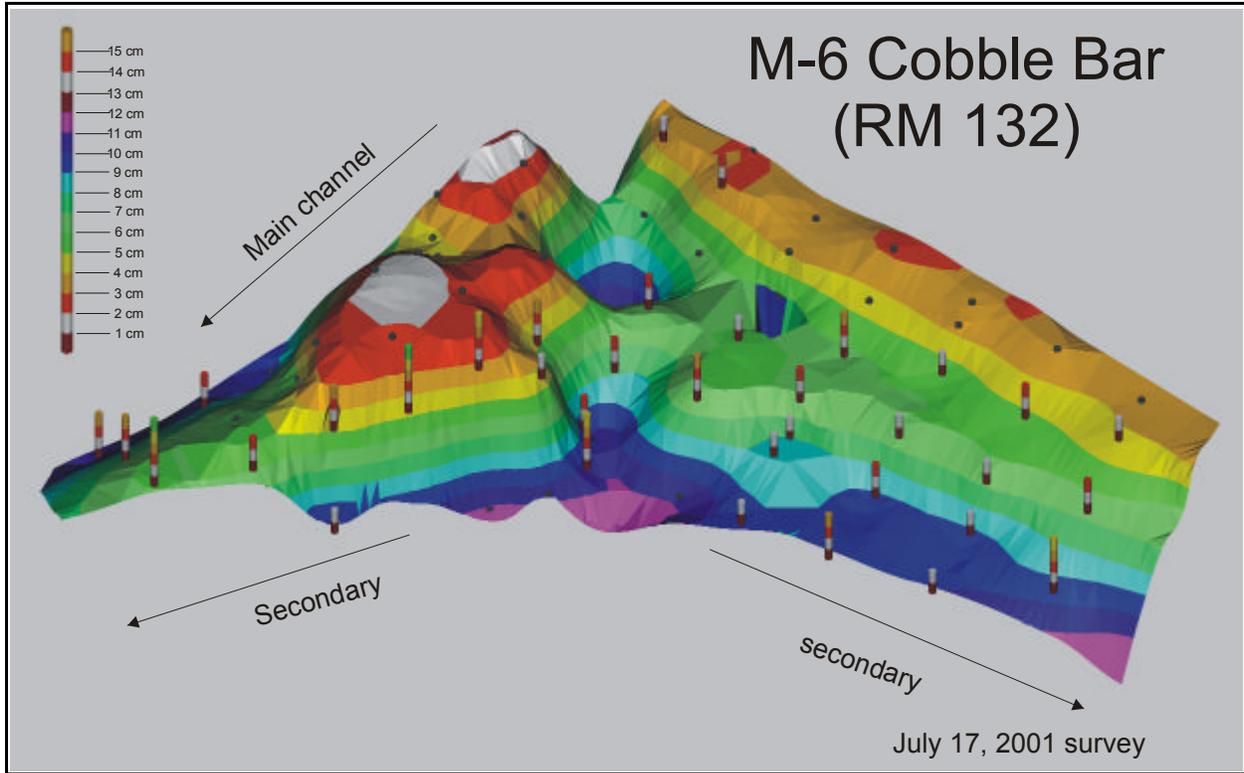
**Figure 3.33. July 17, 2001 Survey with Embeddedness Markers**

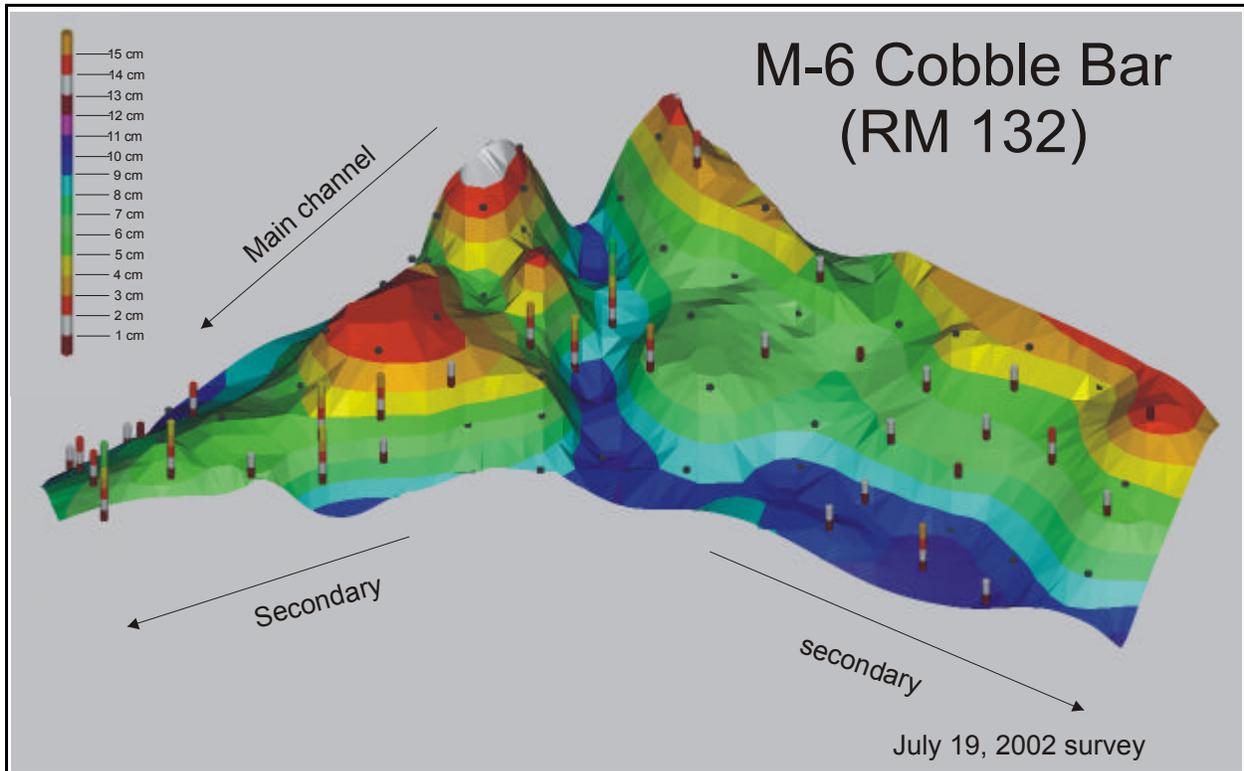
**Figure 3.34. July 19, 2002 Survey with Embeddedness Markers**

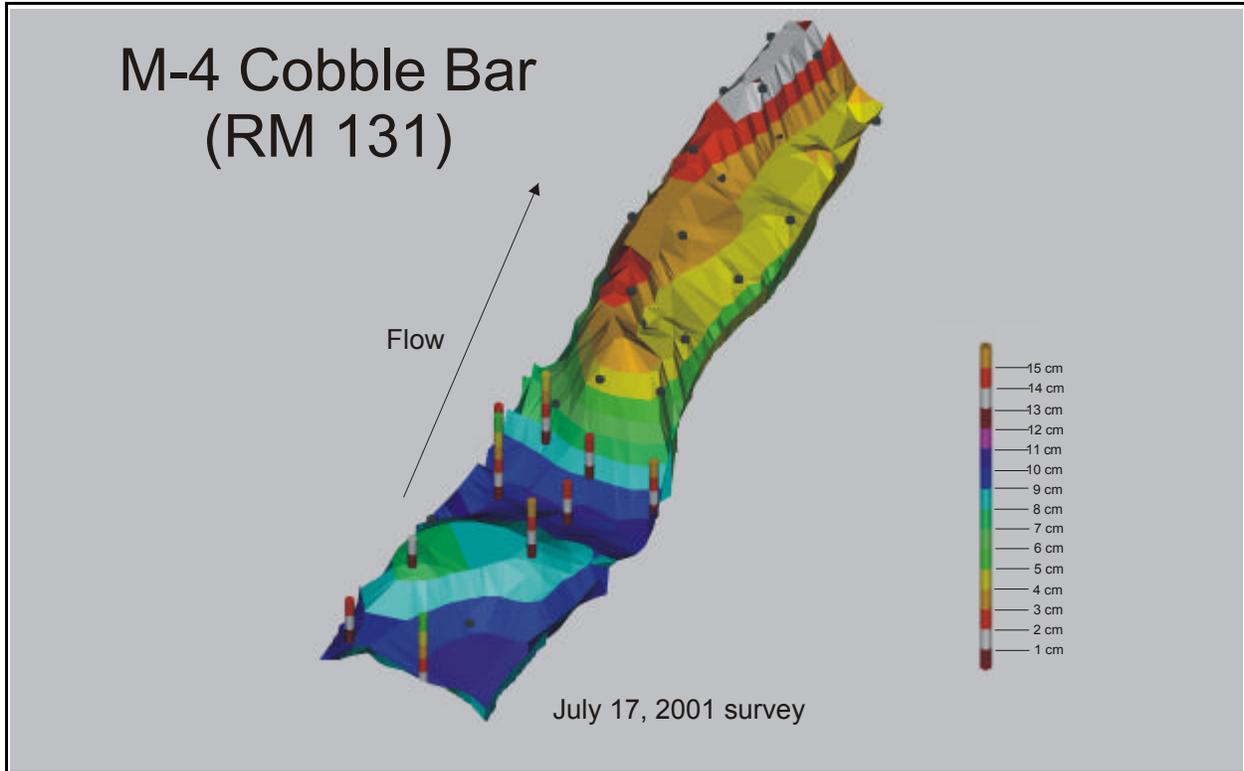
**Figure 3.35. July 17, 2001 Survey with Embeddedness Markers**

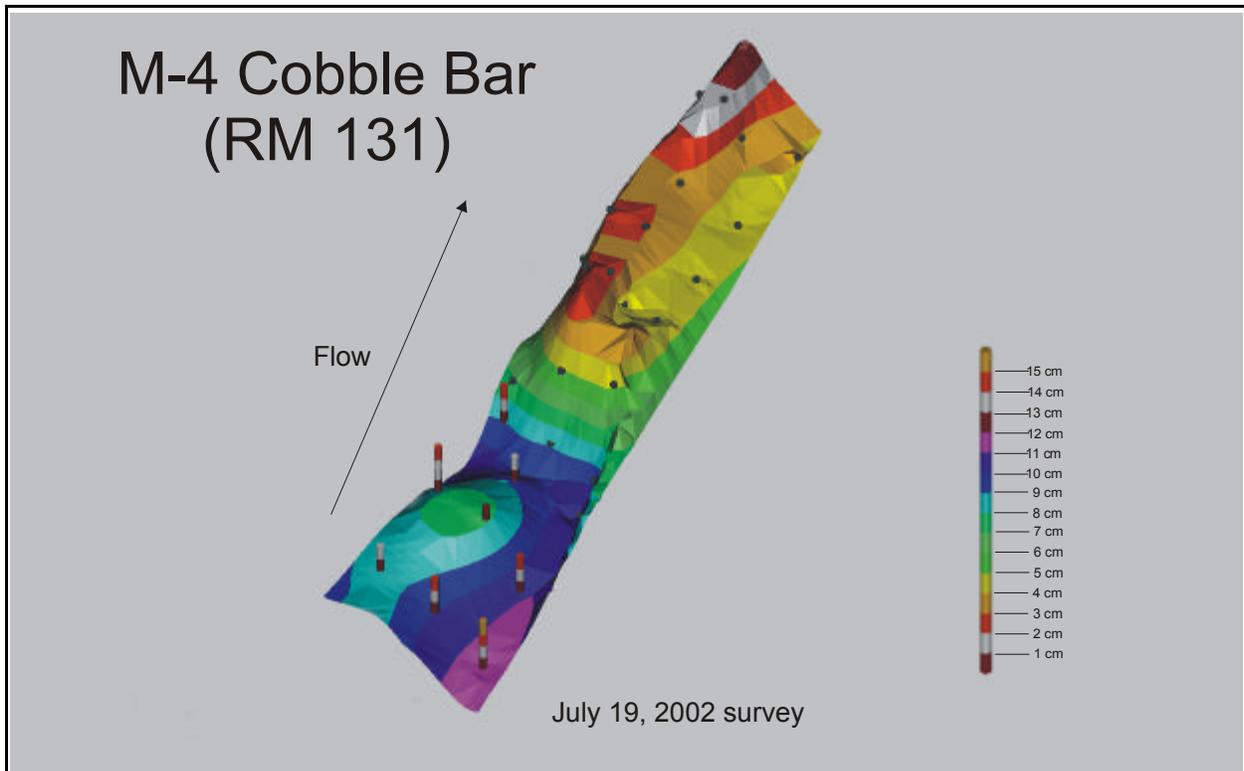
**Figure 3.36. July 19, 2002 Survey with Embeddedness Markers**

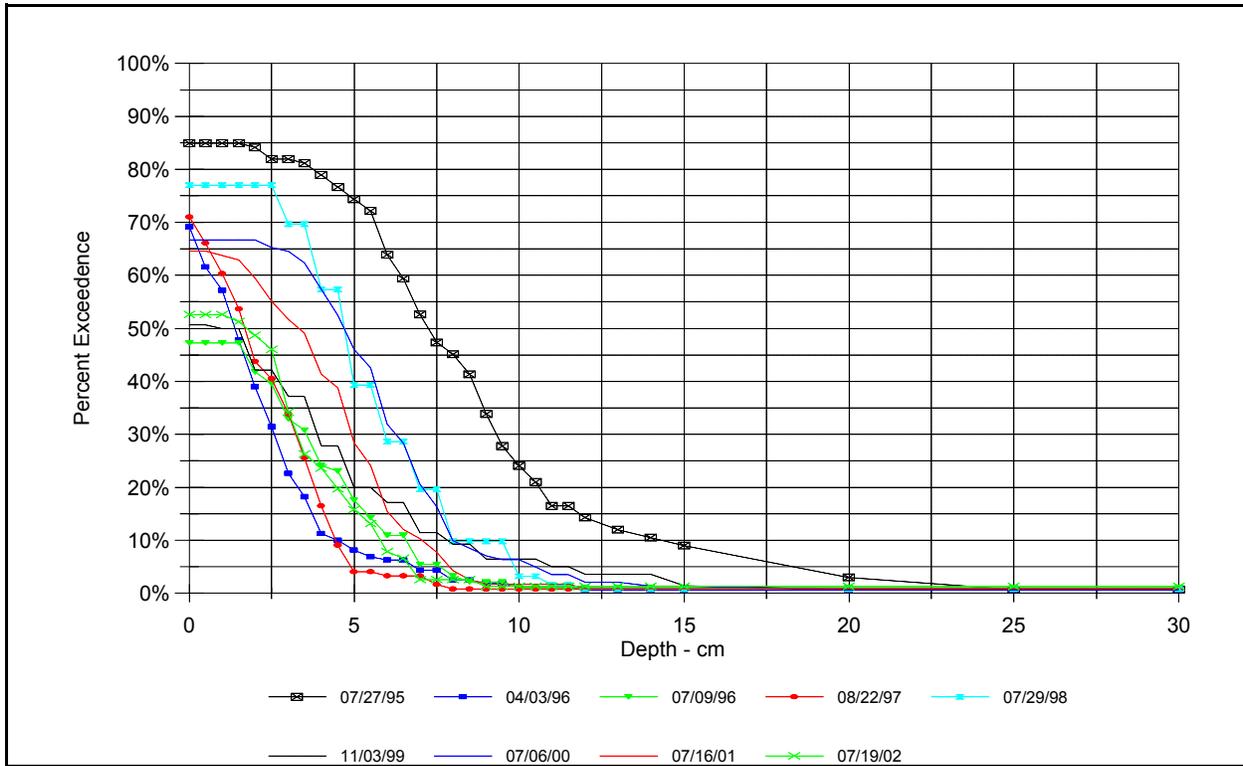
**Figure 3.39. Frequency Distribution of Depth of Open Interstitial Space for Cobble Bar 168.4 Expressed in cm**

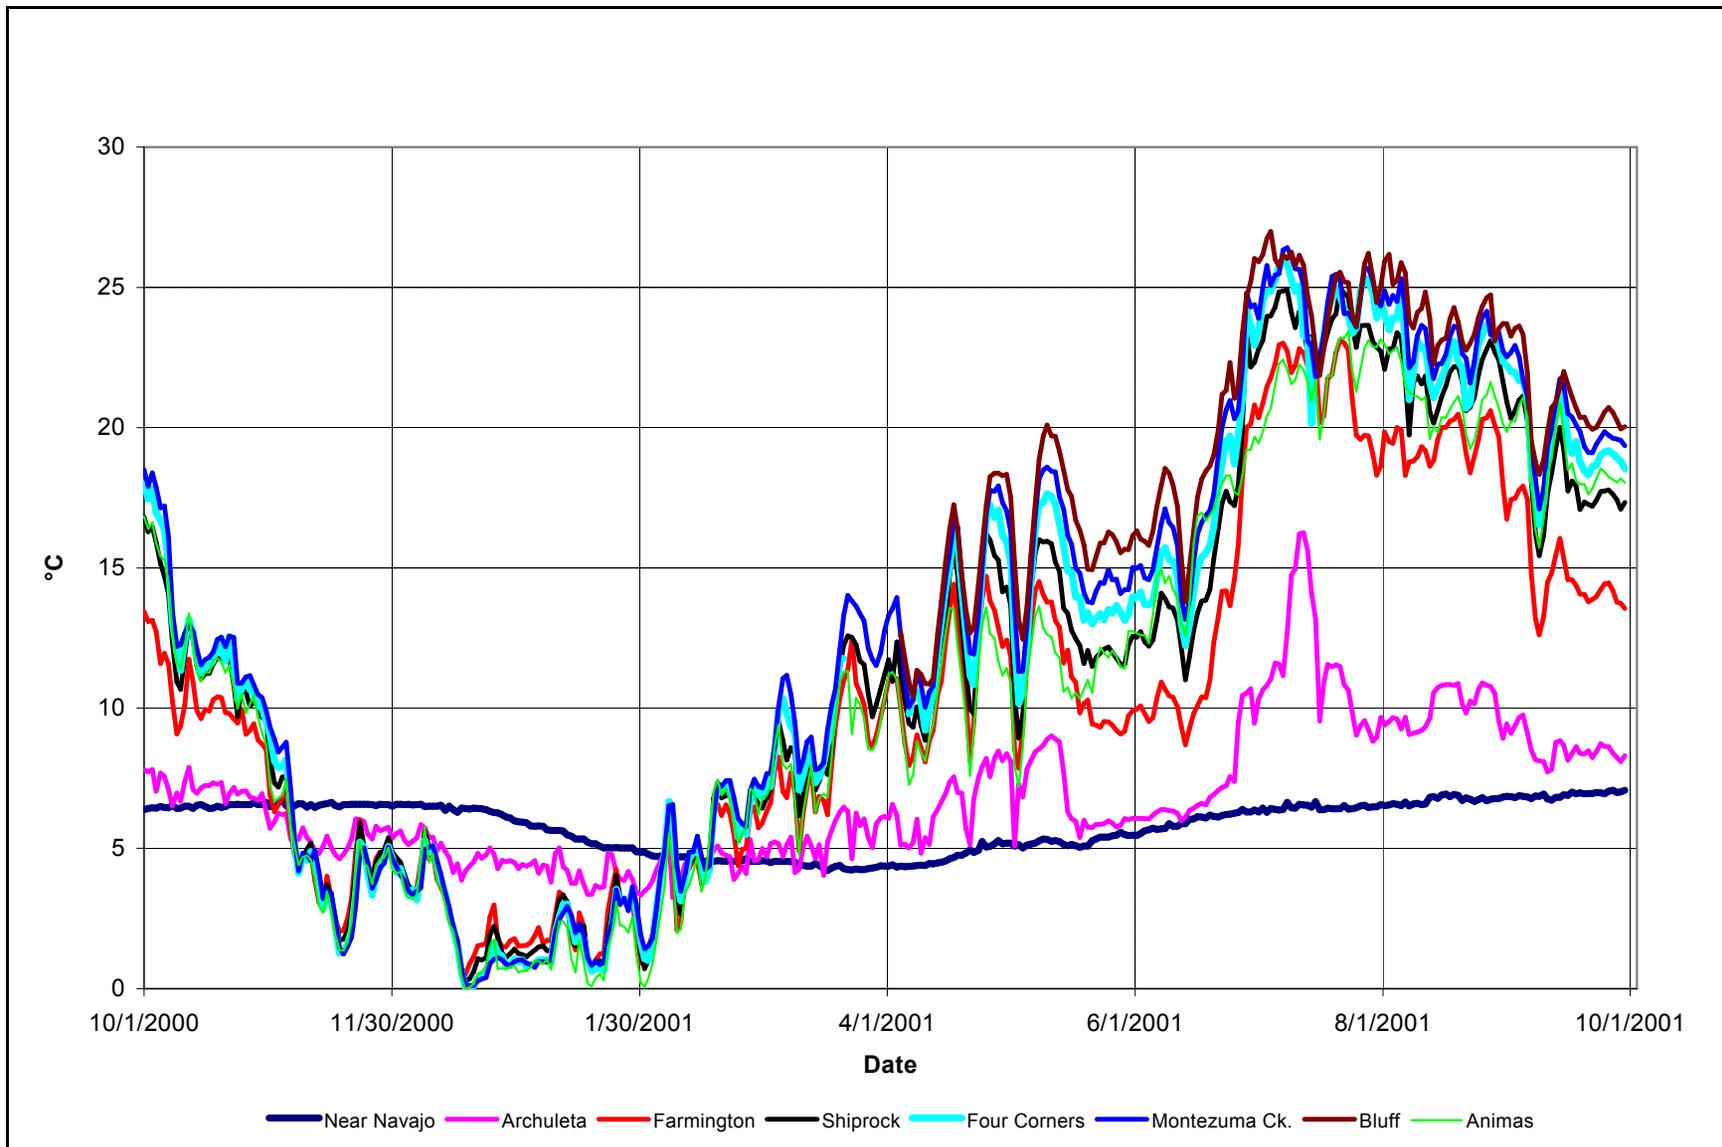
**Figure 4.1. San Juan Basin Average Water Temperature Data, 2001**

The plot of the 2001 and 2002 StowAway temperature data is shown in Figure 4.1 and 4.2. Maximum, minimum and average plots are shown for Archuleta and Montezuma Creek in Figures 4.3 to 4.6. The new equipment is operating fairly well and is providing a more consistent and reliable record. An exception to this is that the StowAway at Farmington which stopped recording in November 2001. It was tested and restarted in March 2002 with no obvious problems. However, it still was not properly recording temperature and was finally replaced in October 2002.

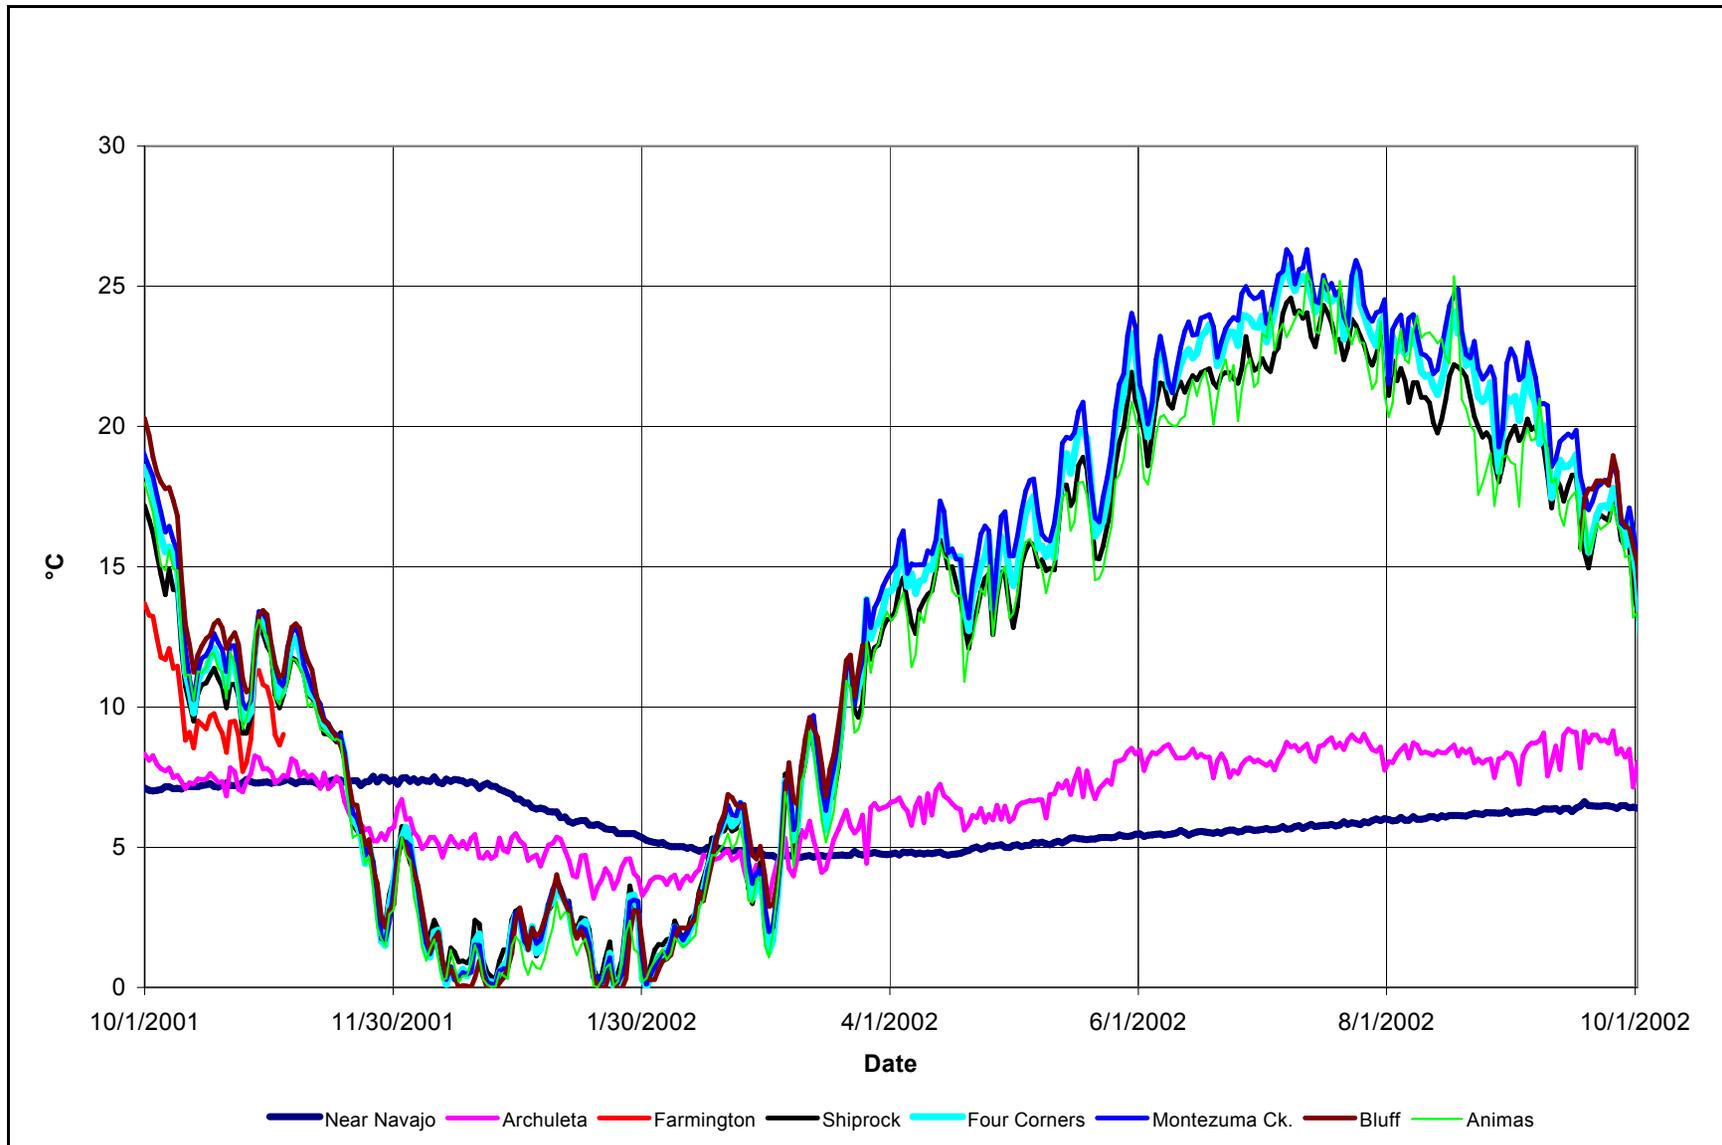
**Figure 4.2. San Juan Basin Average Water Temperature Data, 2002**

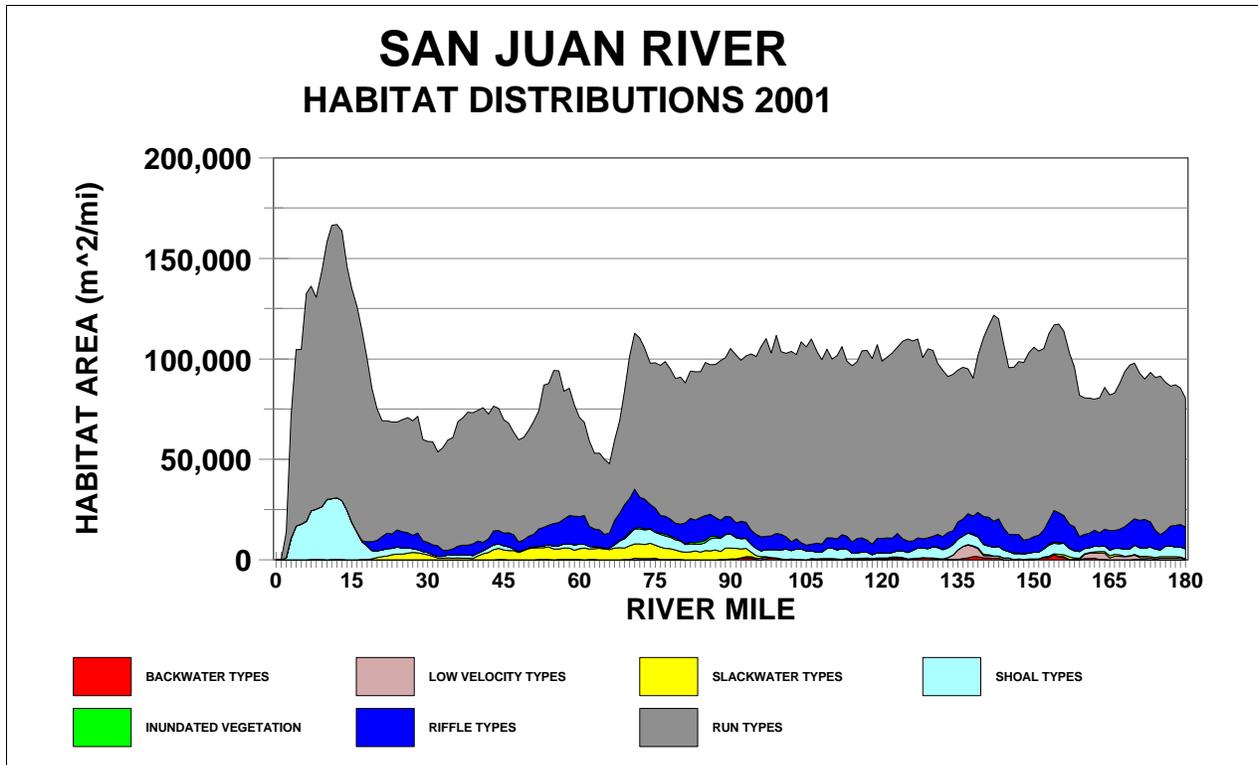
Figure 5.3. Spatial Distribution of Major Habitat Types in the San Juan River during 2001

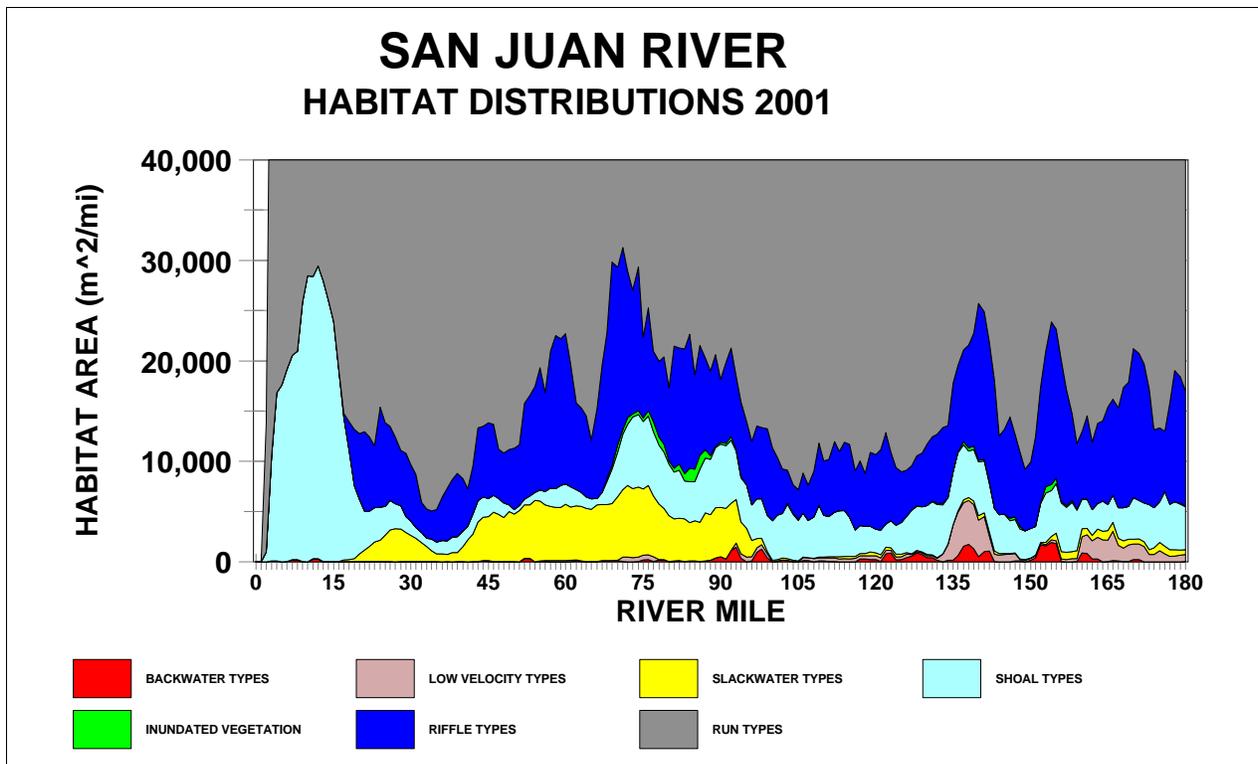
Figure 5.4. Detailed Spatial Distribution of the Major Habitat Types in the San Juan River during 2001

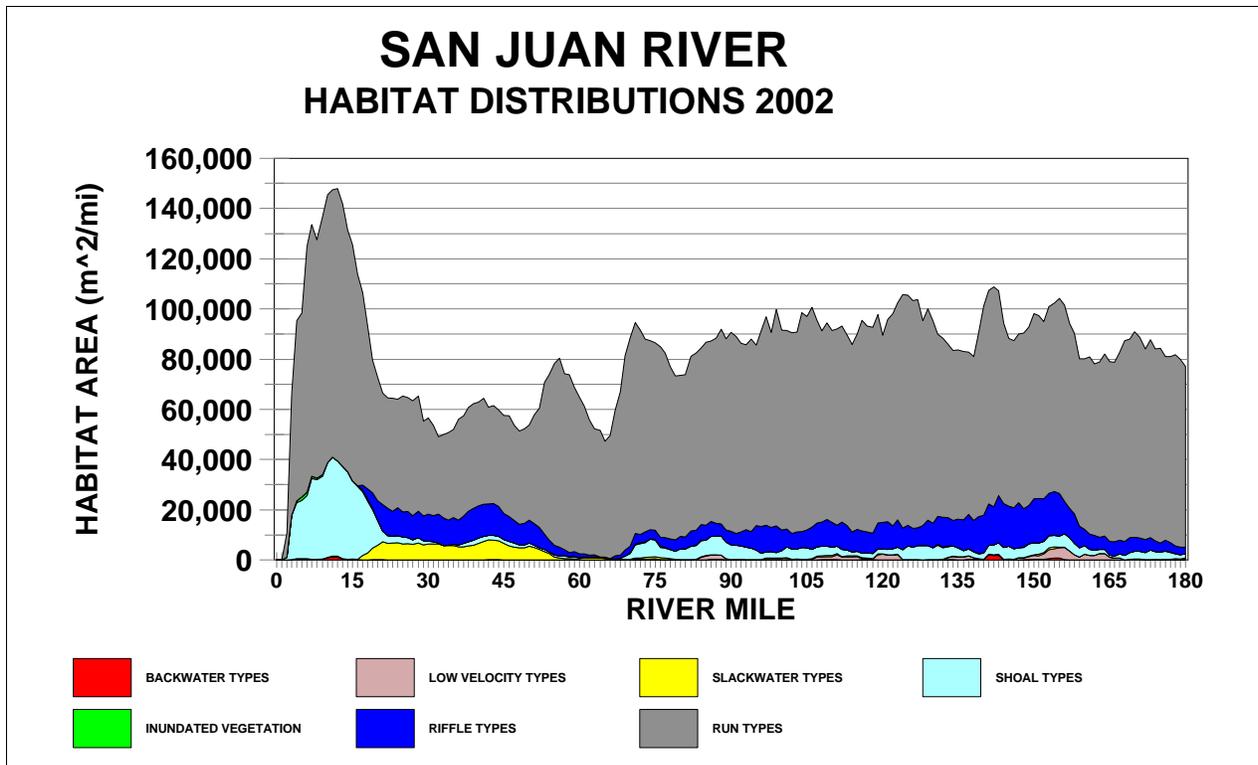
Figure 5.5. Spatial Distribution of the Major Habitat Types in the San Juan River during 2002

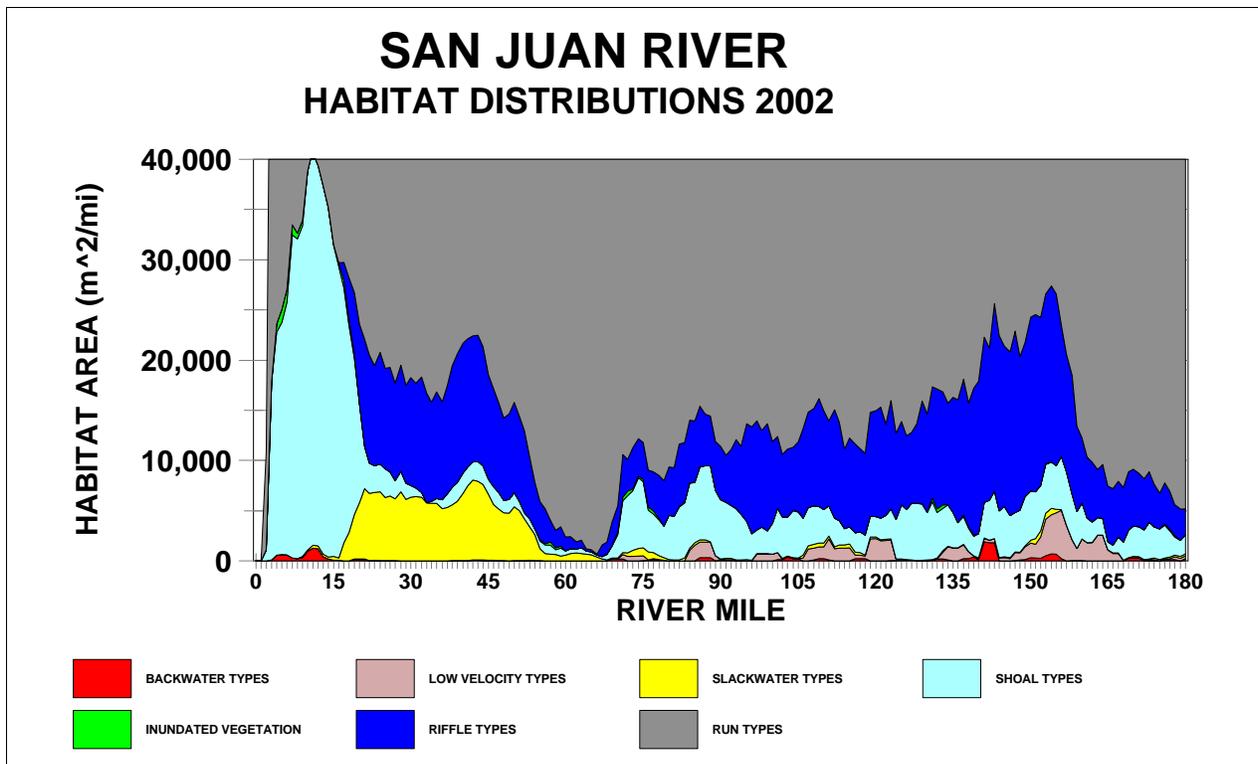
Figure 5.6. Detailed Spatial Distribution of the Major Habitats in the San Juan River during 2002

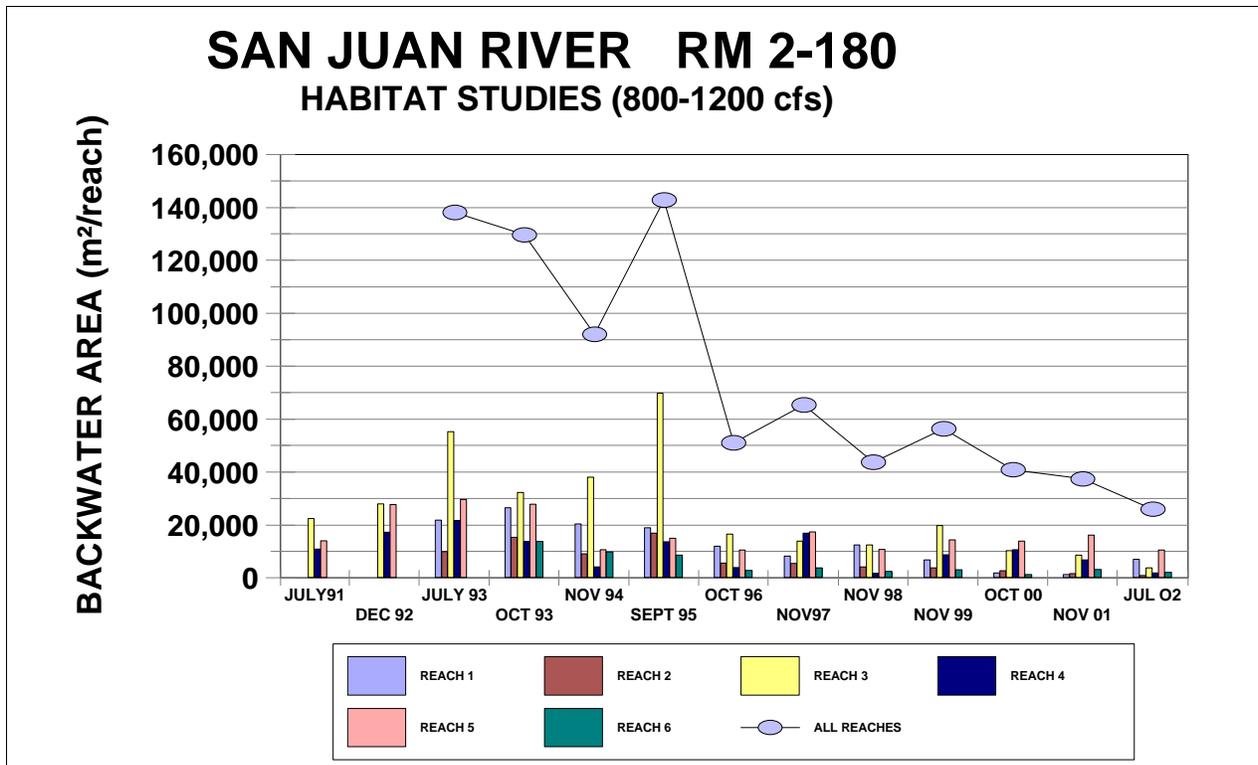
Figure 5.7. Surface Area of Backwater Habitats in the San Juan River between RM 2 and RM 180

Backwater habitats represent an important component of the life cycle of many of the native species found in the San Juan River. Because of this fact, the temporal trend in the magnitude of surface area of this habitat type is used as a monitoring indicator to assess influences of flows on habitat quantity. As noted in previous investigations (Bliesner and Lamarra 1998), the magnitude of backwater habitats are influenced by their location in the river, flow magnitude, and summer storm events. A summary of the total surface areas for 2001 (37,473 m<sup>2</sup>) and 2002 (25,993 m<sup>2</sup>) compared to previous years are shown in Figure 5.7 for both surface area and the number of backwaters. The data indicated that after reaching a maximum surface area of 143,000 m<sup>2</sup> (373 backwaters) between RM 2 and RM 180, there has been a decrease to 25,993 m<sup>2</sup> (53 backwaters) in the summer of 2002. The loss of almost 120,000 m<sup>2</sup>, or 320 backwaters, primarily occurred in Reaches 3, 4, and 5.

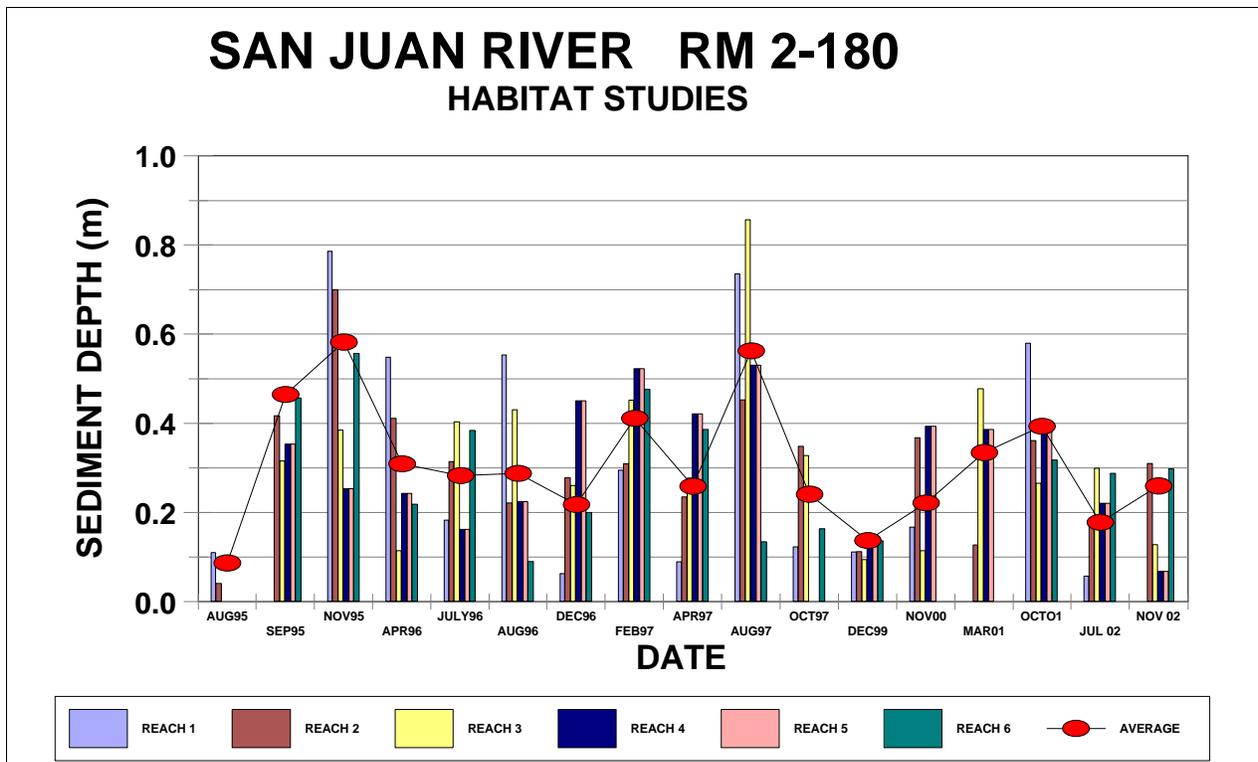
Figure 5.8. Depth of Sediments in Backwaters in the San Juan River between RM 2 and RM 180

The depths of backwaters is an important attribute relative to use by native endangered species. In the San Juan River system, backwater depths are effected by sediment laden summer storms. Bed sediment depths in backwaters have been periodically measured since August 1995. A good example of the influence of storms can be seen during August, September and November 1995. In 2001 and 2002, sediment depth in backwaters were documented four times. These depths are shown in Figure 5.8 compared to the historical monitoring data. Sediment depths were typically lower in the spring before summer storms. On average sediment depths riverwide increased from 0.33 meters to 0.39 meters in 2001 and from 0.18 meters to 0.26 meters in 2002 (Figure 5.8). Deepest backwater sediment depths were found in Reach 1 (0.50 meters) in 2001 and in Reach 2 (0.58 meters) in 2002.
