Chincoteague NWR: Recreational Beach Structured Decision Making Process, Locating the Best Site for a Recreational Beach and Parking Lot

Chincoteague National Wildlife Refuge: Locating the Best Site for a Recreational Beach and Parking Lot

Summary Report

November 2011

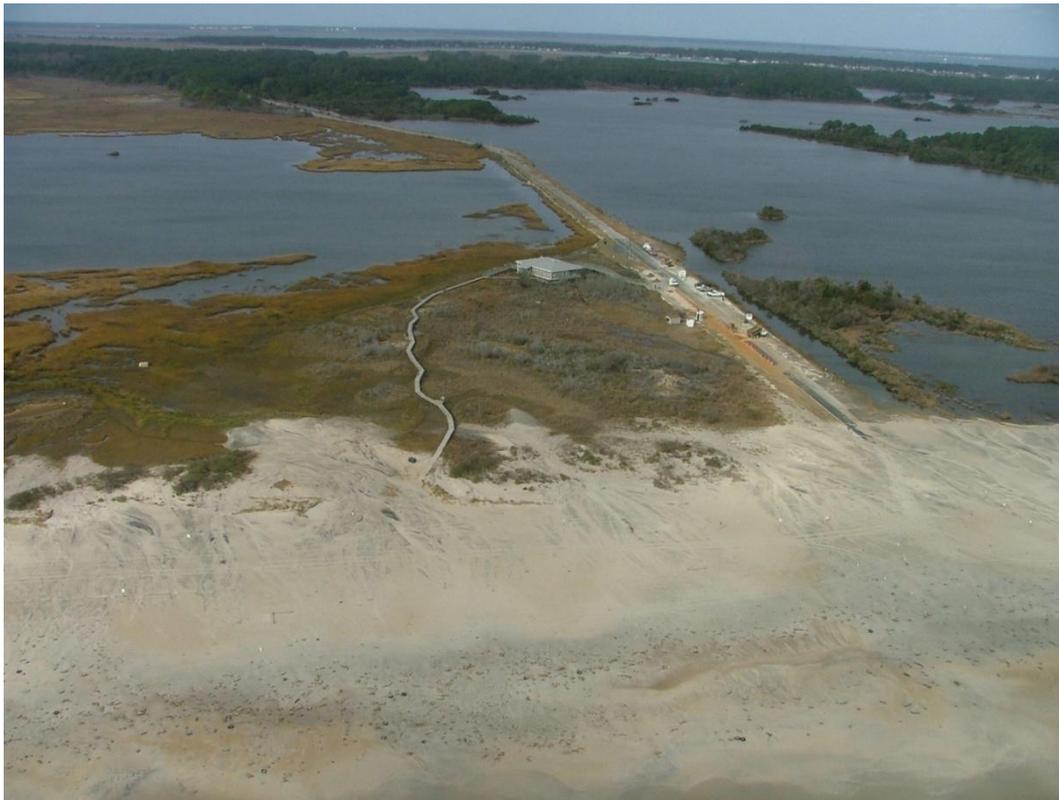
Overwash at the terminus of Beach road due to the December 2009 Nor'easter (Nor'Ida).

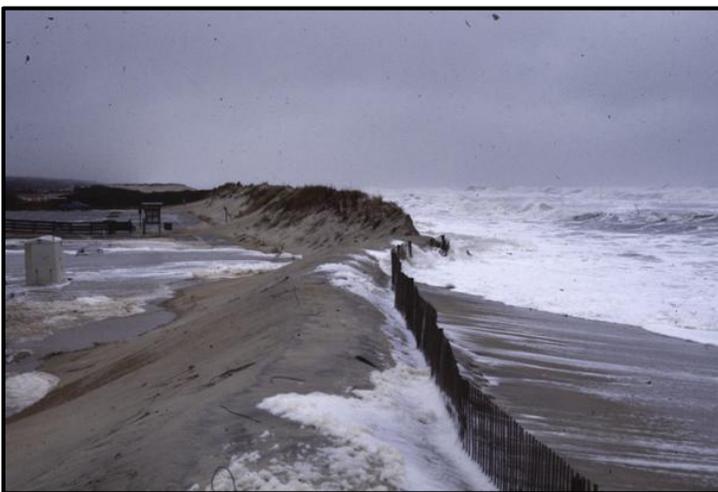
Storm damage to the Tom's Cove Visitor Center and parking lot #1 (December 1992).

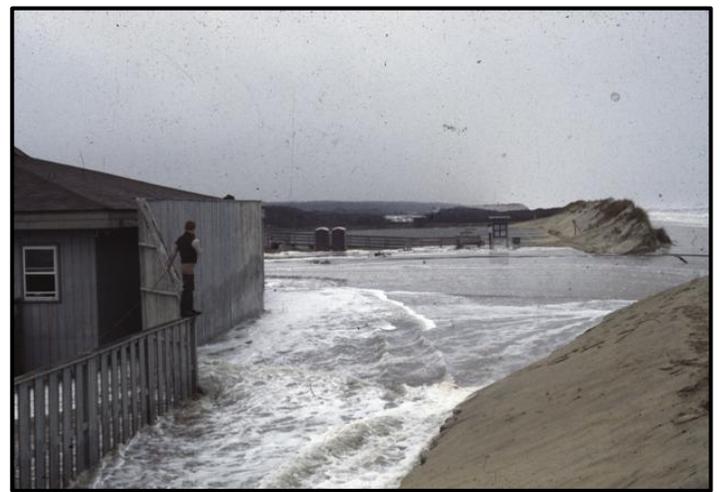
1991 Photo of parking lot and recreational beach.

As a result of severe storms, the beach front has narrowed and the shoreline is moving westward. The 1991 photo shows the parking area and visitor center that was located behind the artificial dunes. Storm activity removed the dunes, parking lots and buildings. The second photo (2003) shows the deposition of sand that is building the island in its westward movement. Using artificial dunes in an attempt to 'protect' the beach front only temporarily prevents the natural barrier beach process from occurring. The red lines in the photos delineate the 2008 road to the parking lots.

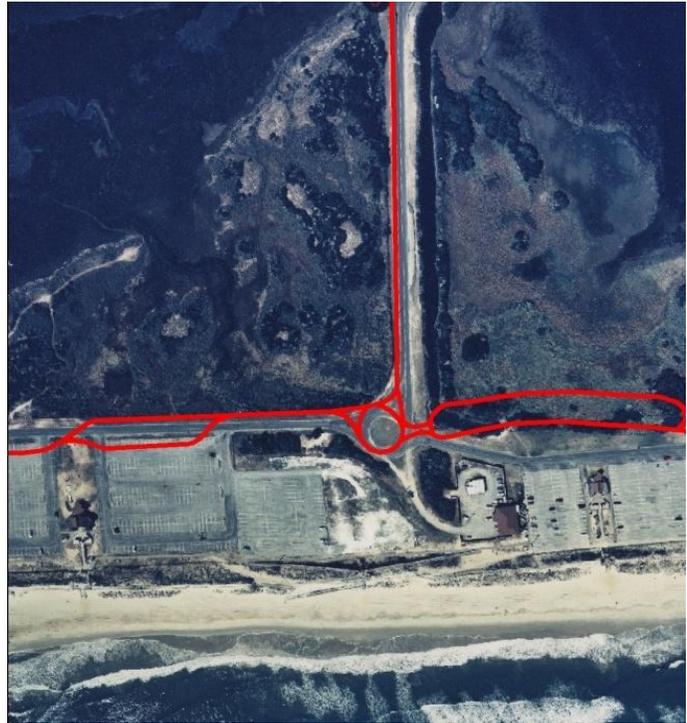
2003 Photo of parking lot and recreational beach.

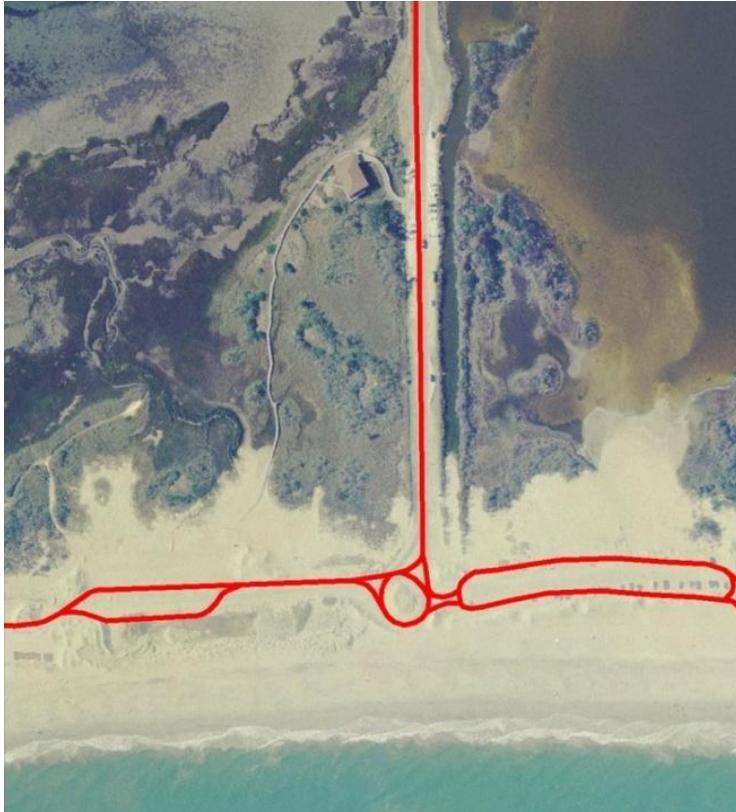
The westward movement of the beach can be seen in the photo below. This is an aerial photo taken in 2009. The far left side of the photo shows the road to the recreational beach and the remainder of the photo shows the stretch of beach to the north. The colored lines represent the location of the shoreline over the past 68 years, beginning with the blue line in 1942 to last year (the black line).

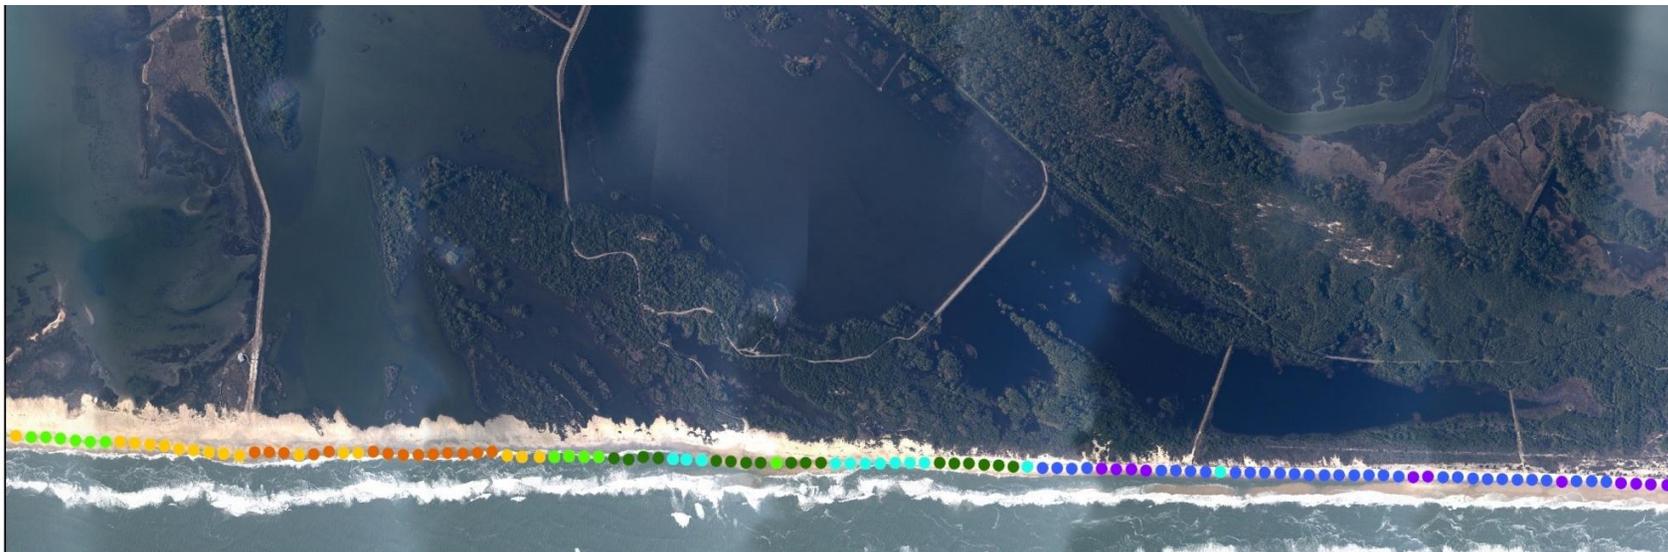
The shoreline is in a constant state of flux. Through time, some areas of the beach experience higher rates of change than other more stable areas of beach. The National Park Service’s Assateague Island National Seashore (ASIS) has been recording the rate of shoreline change (linear regression rate) of the high-water shoreline twice a year from 1997 to 2008. The rate of change is measured in meters (3.28 feet) per year. The majority of the beach has been experiencing a negative rate of change (loss of beach).

Shoreline Change Rate		
1997-2008	●	-2.9 - -2.5
m/yr (LRR)	●	-2.4 - -2.0
●	●	-10.1 - -7.0
●	●	-6.9 - -5.0
●	●	-4.9 - -4.0
●	●	-3.9 - -3.0
	●	-1.9 - -1.5
	●	-1.4 - -1.0
	●	-0.9 - 0.0
	●	0.1 - 10.0

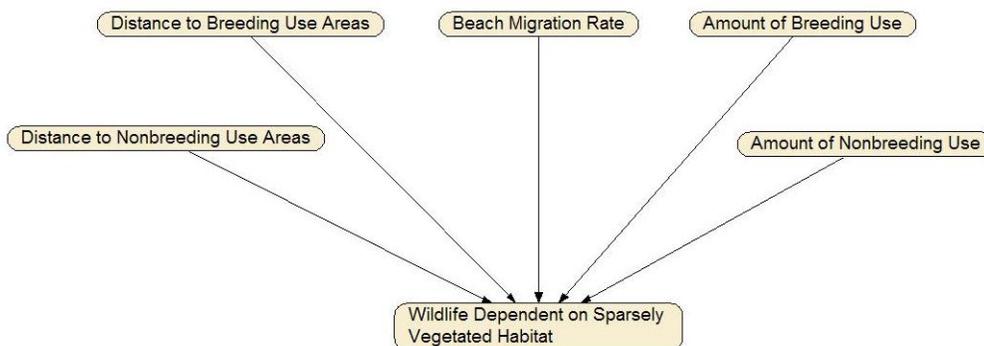
Influence diagram depicting elements that affect wildlife dependent on sparsely vegetated habitat.

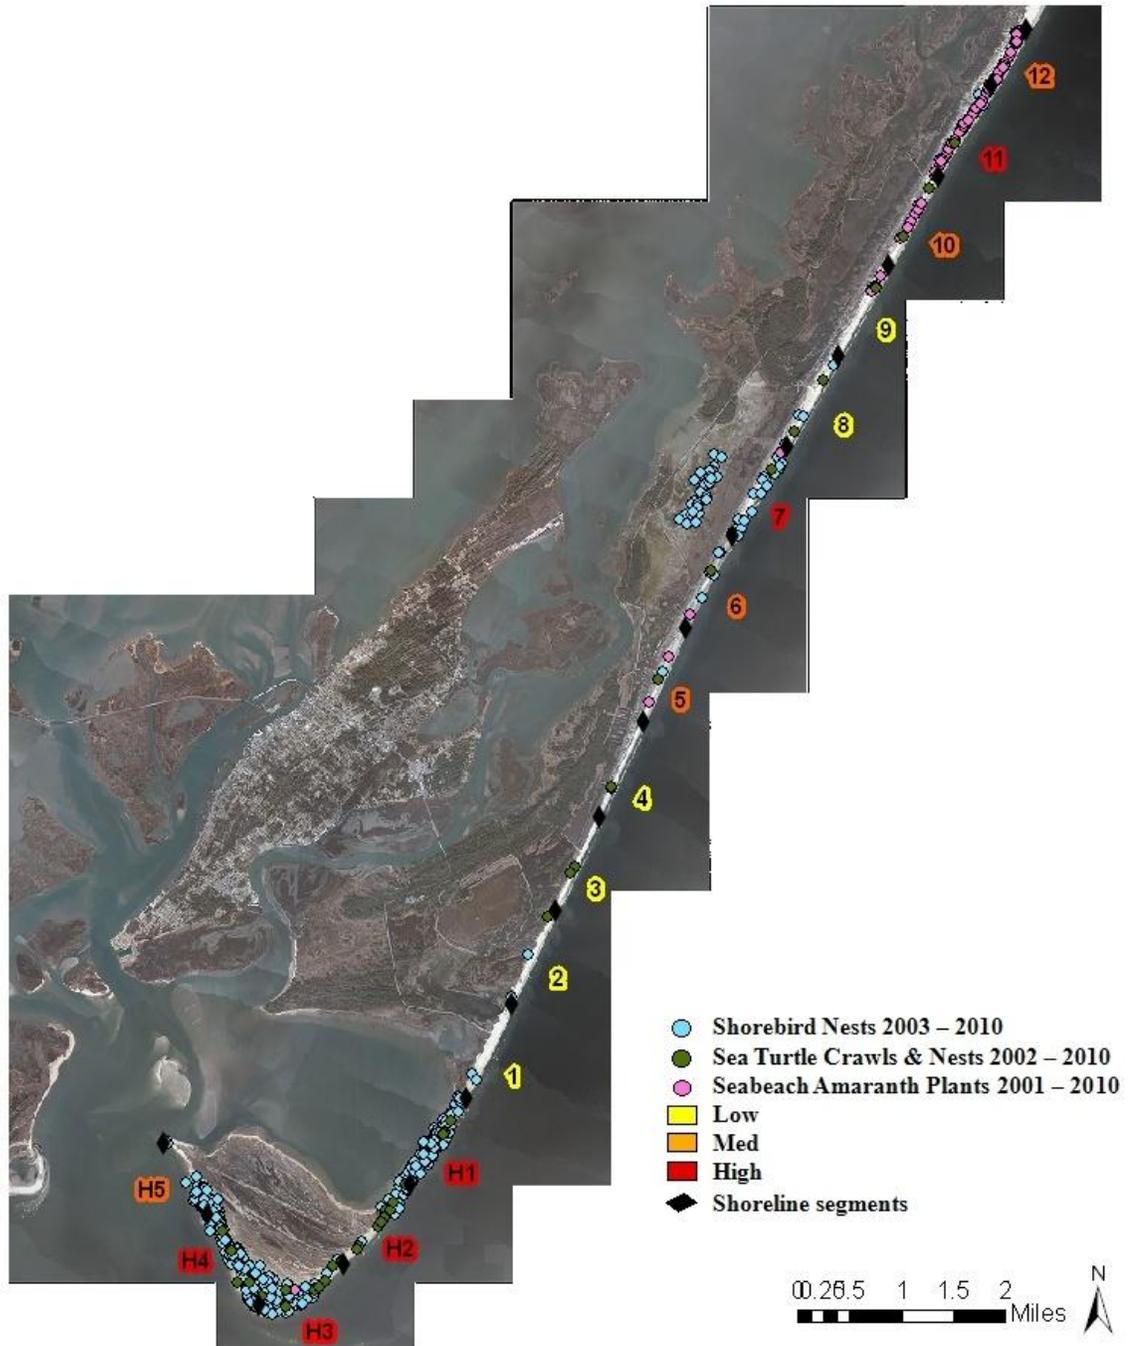
Generalized locations for nesting shorebirds, sea turtles and sea beach amaranth plants, (blue, green and purple dots) along with the level of averaged breeding use (red, orange and yellow numbers) for beach segments.

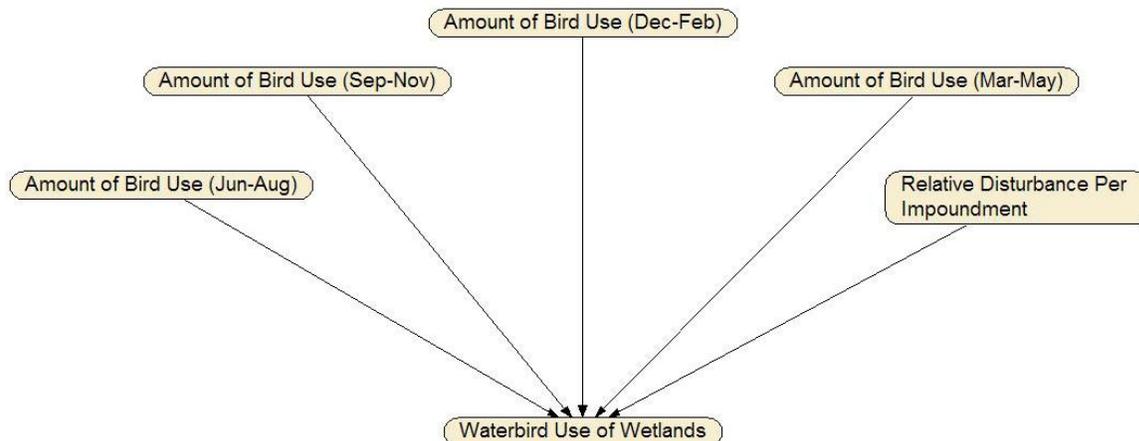
Influence diagram for elements that affect waterbird use of refuge wetlands.

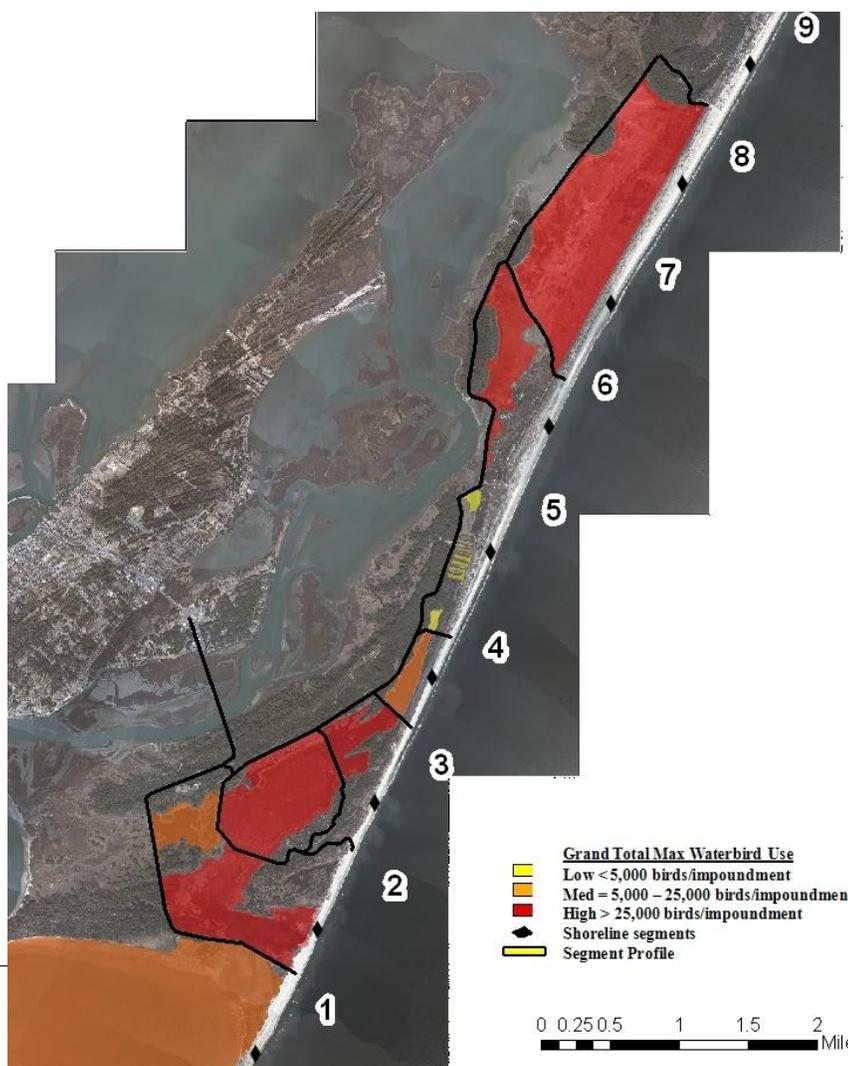
The refuge analyzed waterbird data from 2005 to 2009. From this data, they developed the following table and map of maximum waterbird use for each wetland. Each wetland (Tom’s Cove and 10 impoundments) received a relative rank according to the level of use: <5,000 birds/impoundment = low; medium = 5,000 – 25,000; and high = > 25,000. The map shows the rank for each wetland (yellow = low, orange = medium, red = high). The rank was then converted into a score for the matrix. Wetlands with a high level of use were given a 1, medium a 2, and low a 3. Recall that we are scoring for the least impact to wildlife, therefore wetlands with low use get a higher score.

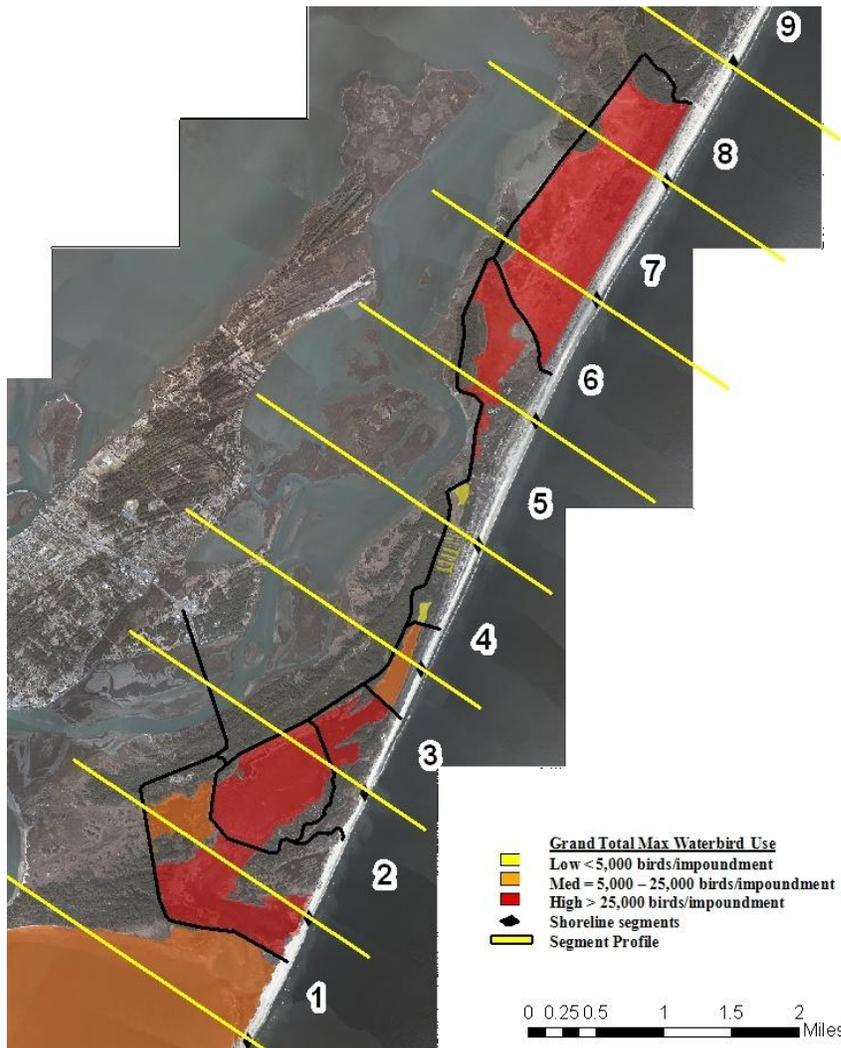
For the purposes of this analysis, the refuge has been split into beach segments. Each of the segments contains one or two wetlands. Beach segments 1 – 8 (the other segments have been removed from the analysis based on earlier criteria) received a score which was the average score of the two wetlands within that segment, or just the score if only one wetland was in the segment. These are listed in the table (and entered into the matrix) followed by the map of beach segments and wetlands within each segment.

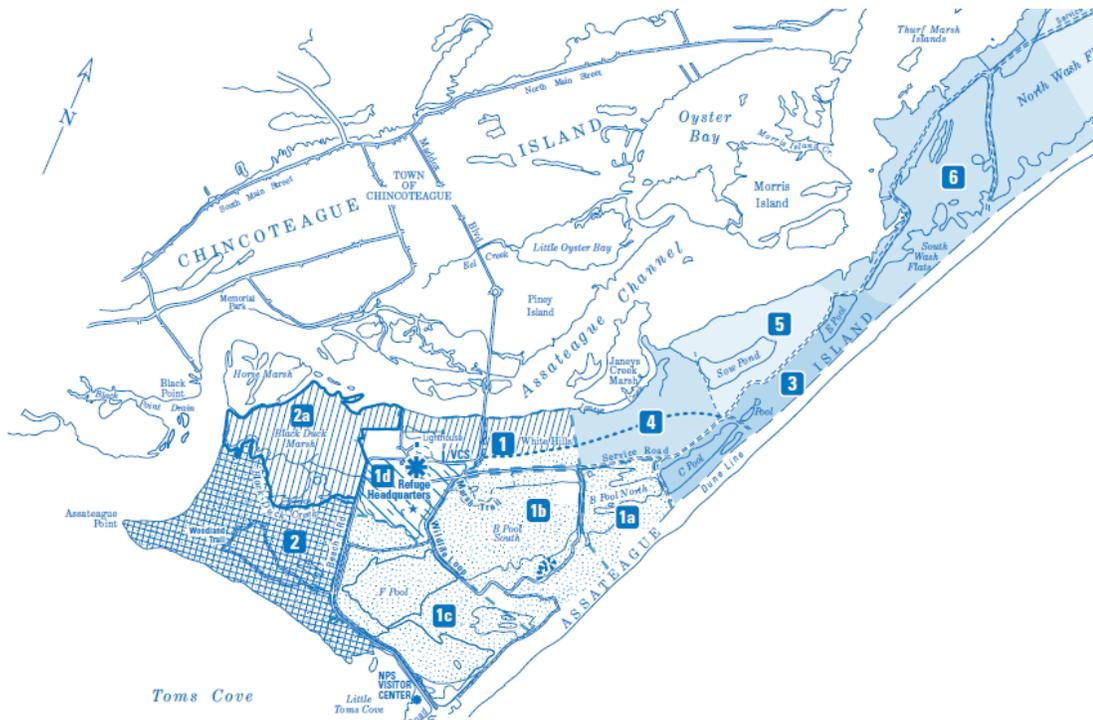
The Refuge has many hunt areas that provide a variety of opportunities to hunters. An access road bisecting a hunt unit would have a negative impact to that unit due to restrictions that are required to keep non-hunting visitors safe.

For beach segments 1-8, a one was given to the Hunt Zone that would be bisected by an access route to that beach segment. The ones were summed and each beach segment received a rank of low (matrix score of 3) if the sum was zero; medium rank if 1-5, and a high rank (matrix score of 1, least desirable) if greater than 5.
