3.3 BIOLOGICAL RESOURCES

This section describes the biological resources present from a regional context and at the site-specific level for the Otay River Estuary Restoration Project (proposed action). Descriptions are provided of the vegetation communities, plants, wildlife (e.g., birds, mammals, reptiles, and terrestrial and marine invertebrates), fish, and listed and sensitive species supported within the San Diego Bay National Wildlife Refuge (NWR). The information presented in this section of the environmental impact study (EIS) is based on surveys conducted between February 2011 and July 2011 for the Otay River Floodplain Site and in March 2013 for the Pond 15 Site. An additional survey was conducted in May 2014 to review existing conditions within project features. Focused surveys were conducted in spring and summer 2011 for coastal California gnatcatcher (*Polioptila californica californica*), burrowing owl (*Athene cunicularia*), least Bell's vireo (*Vireo bellii pusillus*), Belding's Savannah sparrow (*Passerculus sandwichensis beldingi*), northern harrier (*Circus cyaneus*), light-footed Ridgway's rail (*Rallus obsoletus levipes*), and rare plants (Biological Resources

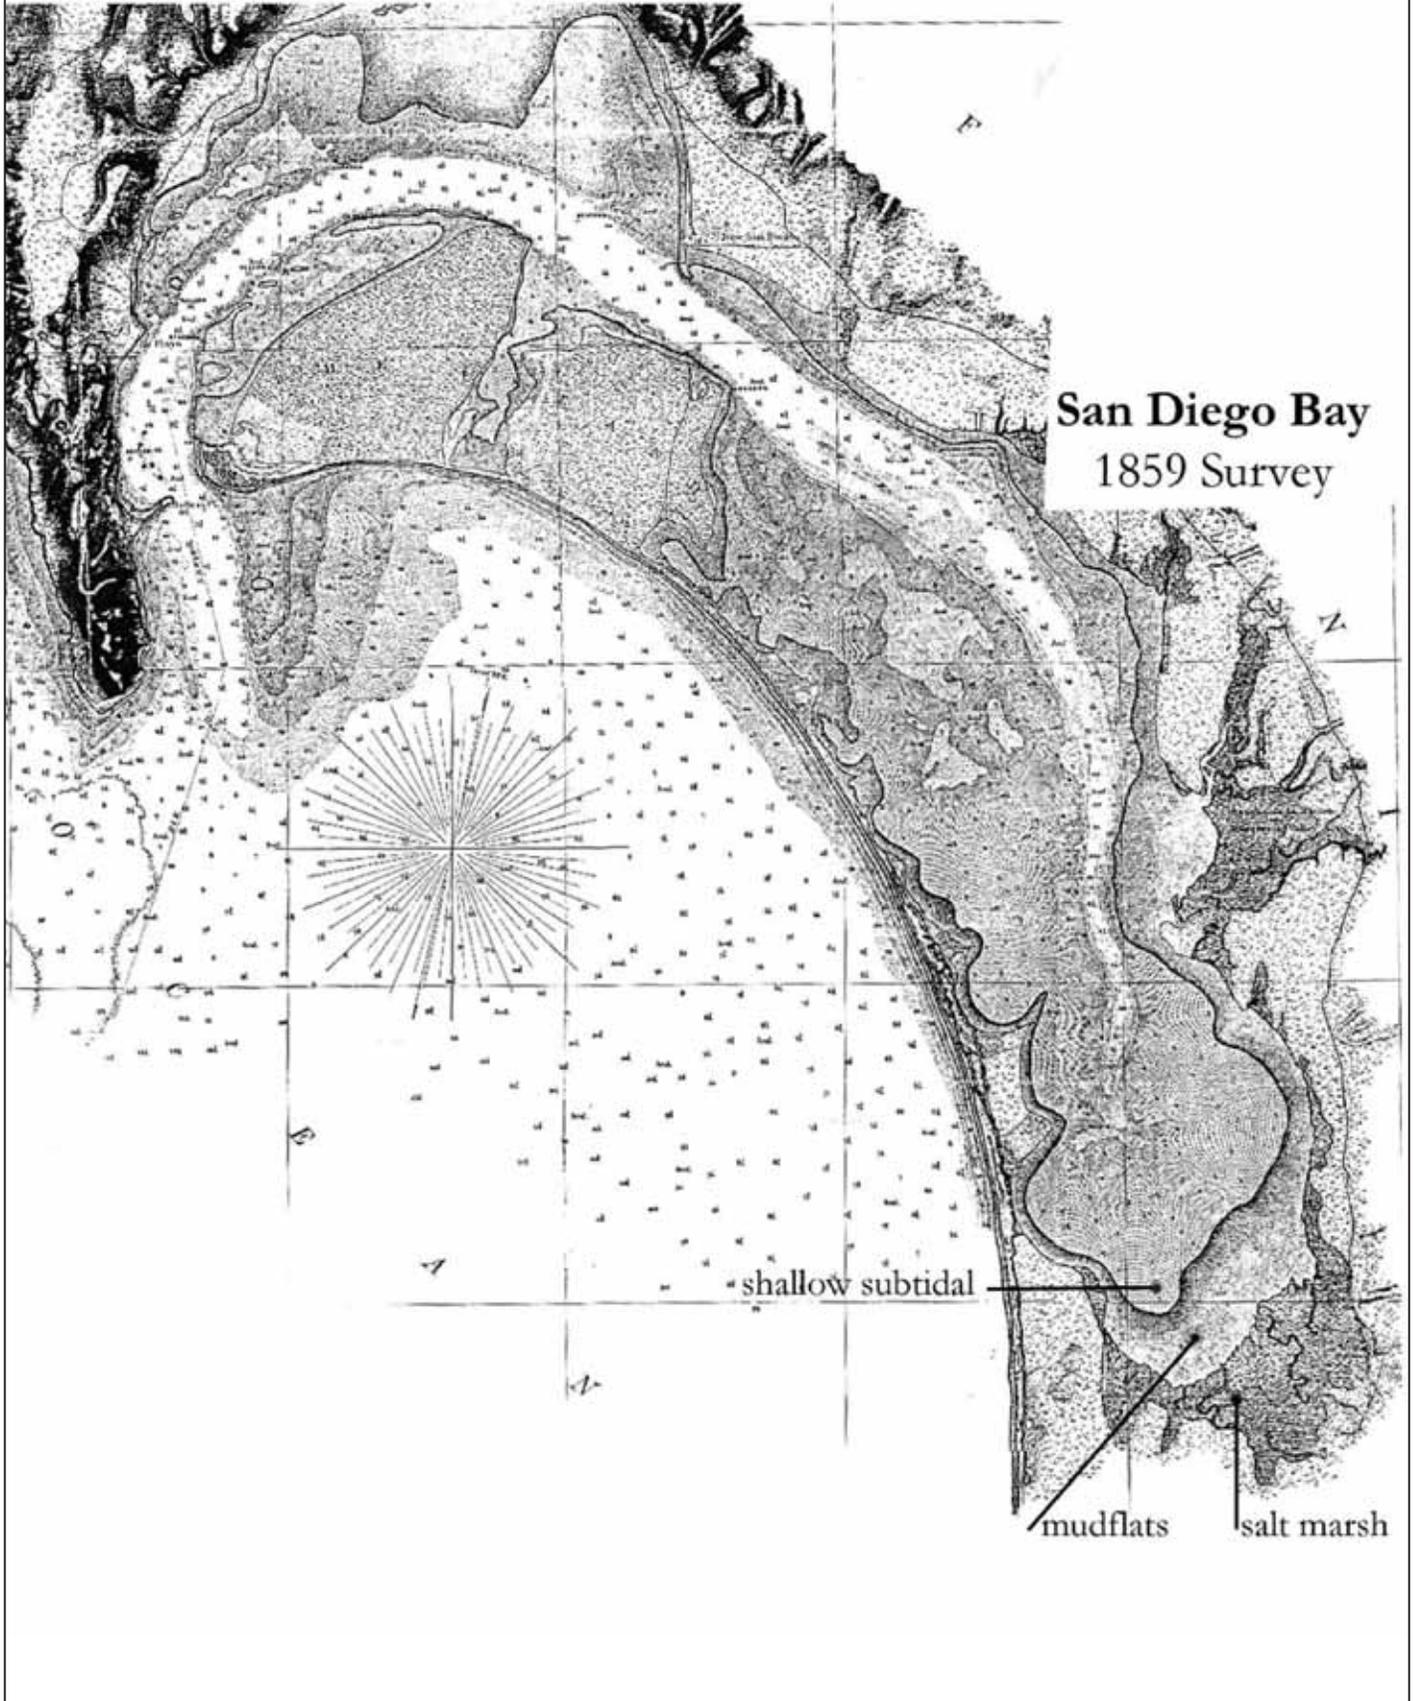
**FIGURE 3.3-1
Historical Condition of San Diego Bay (1859)**

shallow subtidal

mudflats

salt marsh

Prior to the 1900s and human disturbance, survey mapping indicated that the region consisted of coastal salt marsh, intertidal mudflats, and shallow subtidal habitats, as illustrated in Figure 3.3-1, Historical Condition of San Diego Bay (1859) (USFWS 2006a). San Diego Bay was a fertile, shallow, flat-bottomed bay surrounded by extensive mudflats and salt marshes. A narrow channel was present from the mouth of the San Diego Bay to the southern end of Sweetwater Marsh (USFWS 2006a).

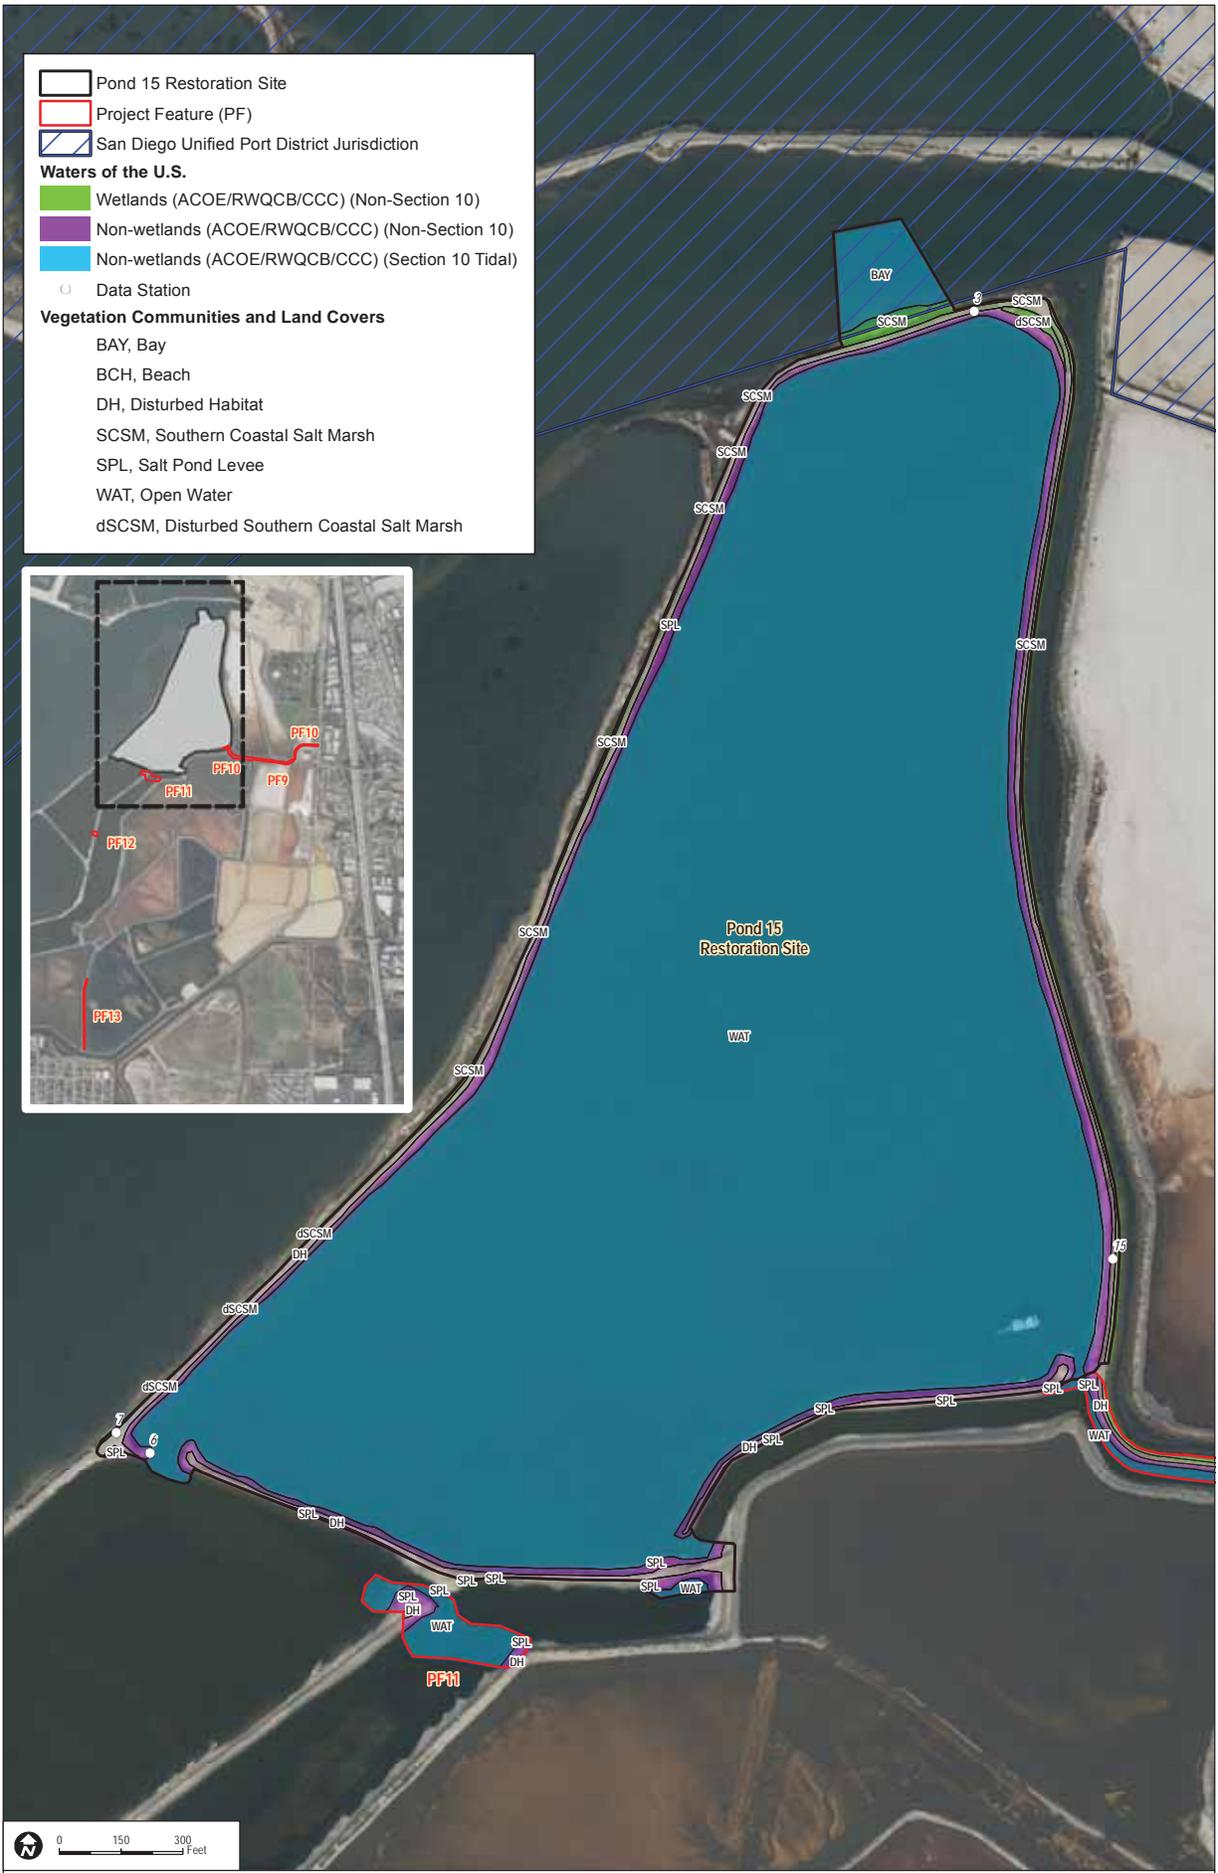
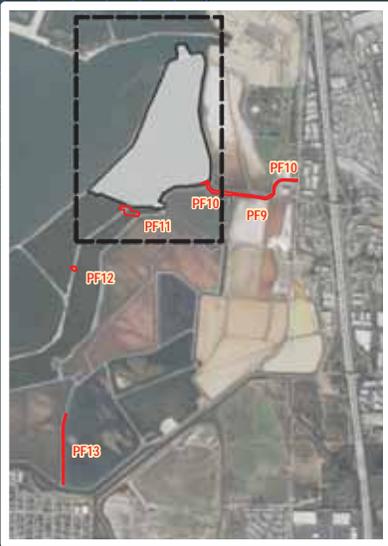
FIGURE 3.3-7
Pond 15 Restoration Site and Project Features Jurisdictional Delineation

BAY, Bay
 BCH, Beach
 DH, Disturbed Habitat
 SCSM, Southern Coastal Salt Marsh
 SPL, Salt Pond Levee
 WAT, Open Water
 dSCSM, Disturbed Southern Coastal Salt Marsh

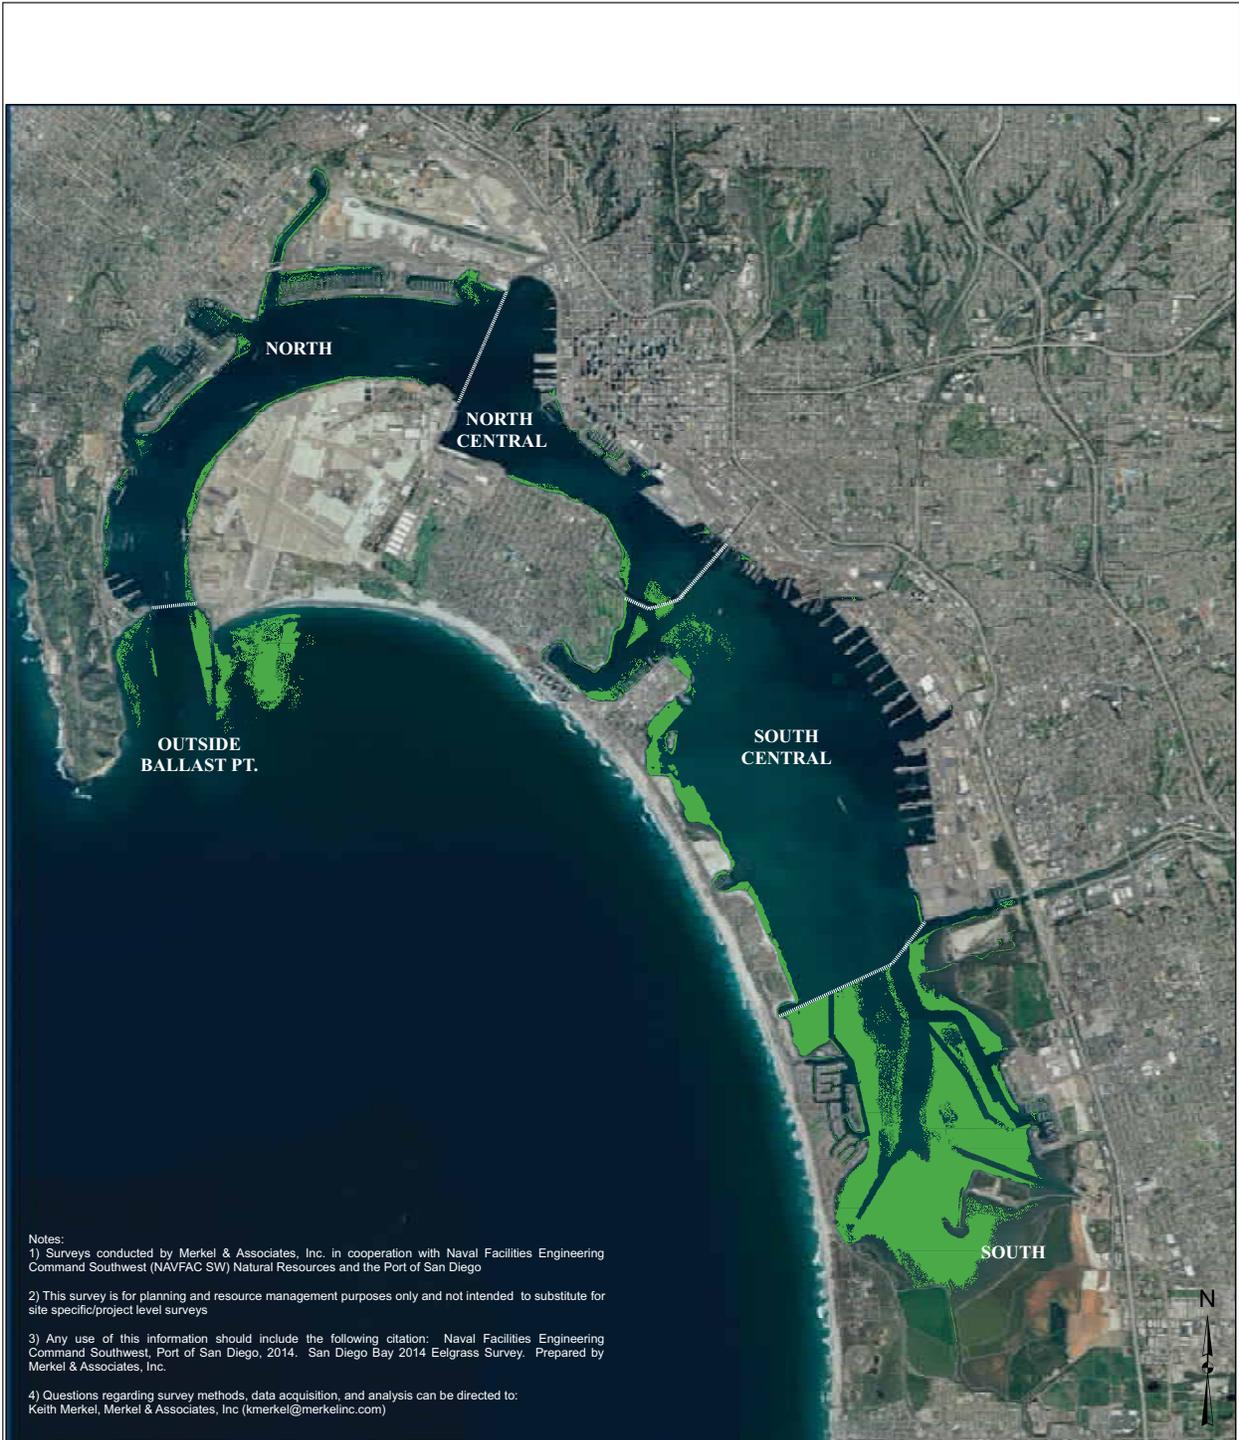
FIGURE 3.3-8
San Diego Bay 2014 Eelgrass Survey

SAN DIEGO BAY

2014 EELGRASS SURVEY

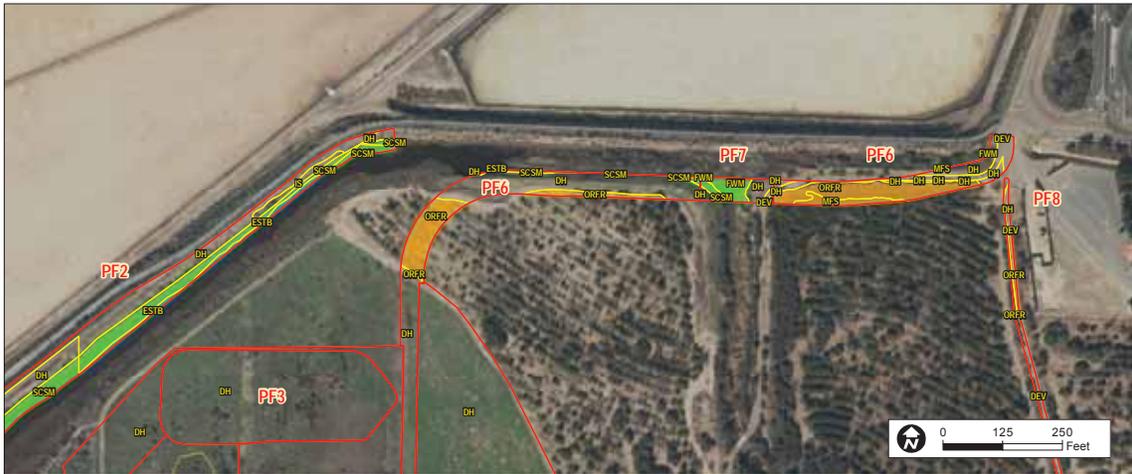
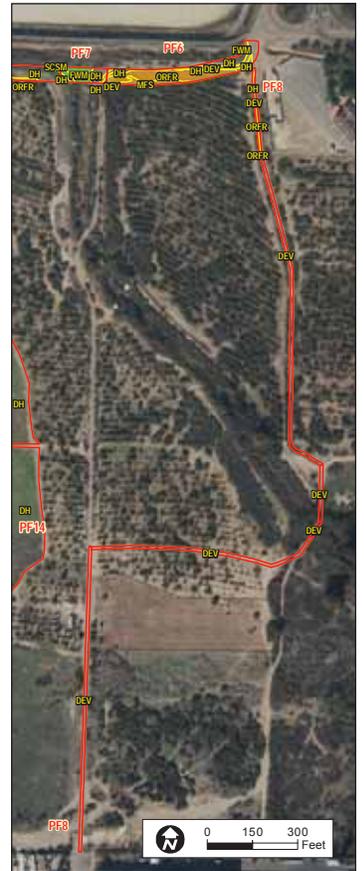
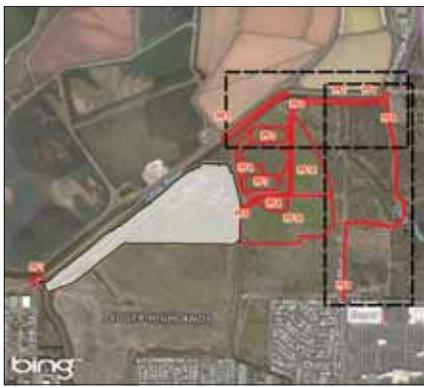
Otay River Floodplain Restoration Site		Vegetation Communities and Land Covers
	Project Feature (PF)		ESTB, Brackishwater
	Waters of the U.S.		FWM, Coastal and Valley Freshwater Marsh
	Wetlands, ACOE/RWQCB/CCC, Non-Section 10		IS, Isocoma Scrub
	Non-wetlands, ACOE/RWQCB/CCC, Section 10 Tidal		MFS, Mule Fat Scrub
	Non-wetlands, CCC only		ORFR, Otay River Floodplain Restoration
			SCSM, Southern Coastal Salt Marsh
			DH, Disturbed Habitat
			DEV, Developed Land
			CAM, Cismontane Alkali Marsh

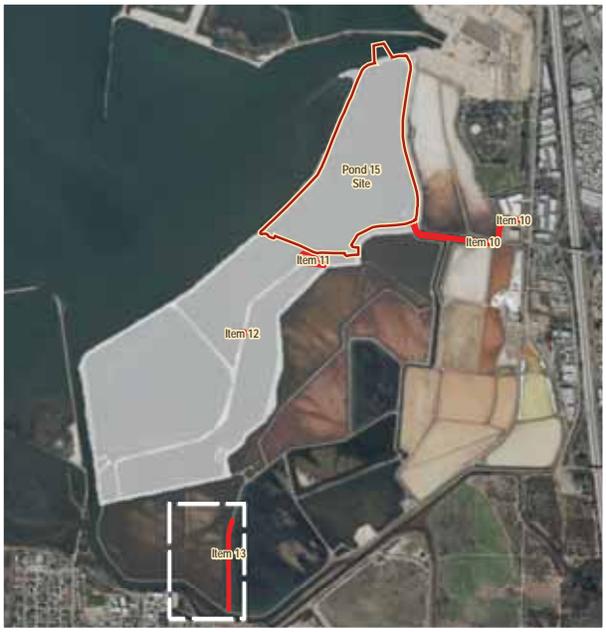
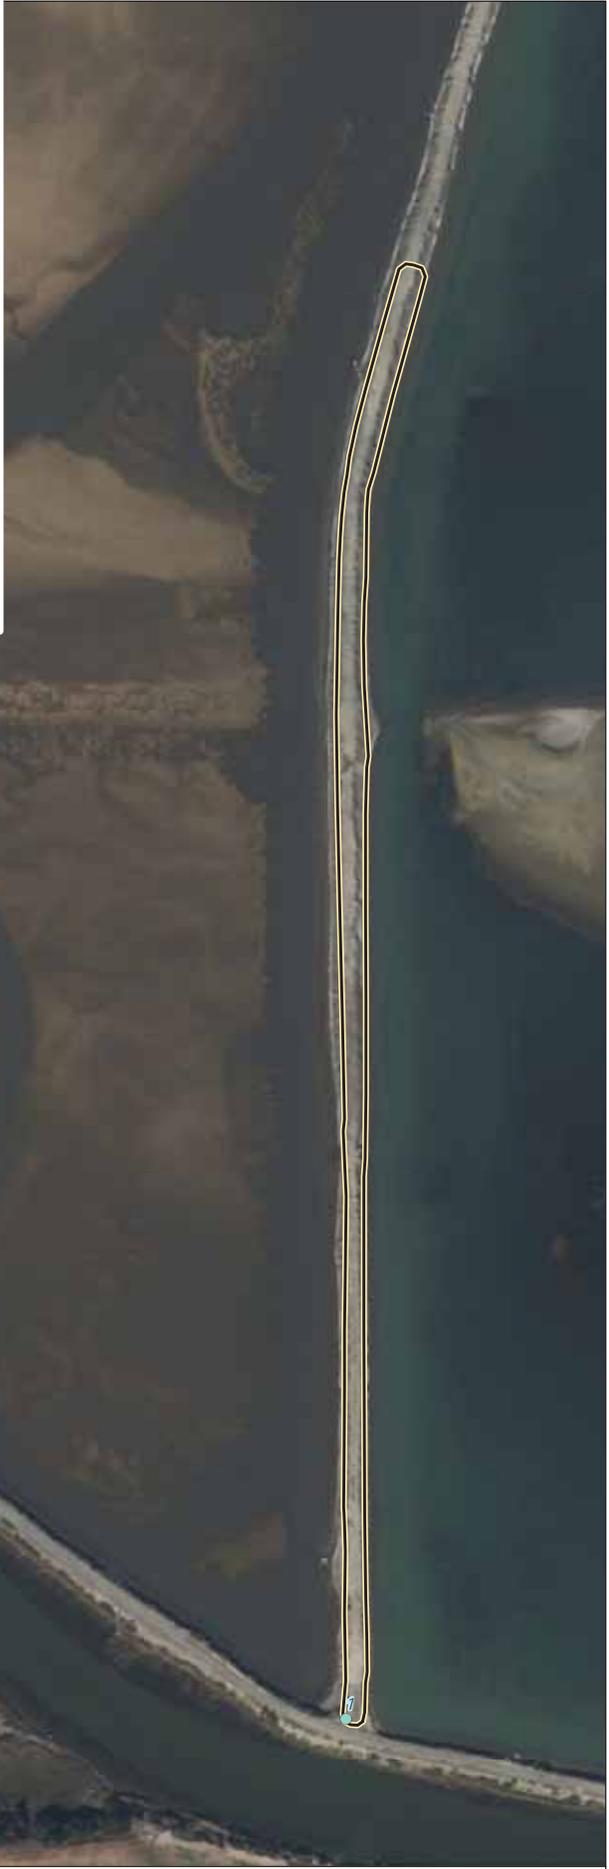
Project Site
Special-Status Plant Species (# = plant population)

Special-status plant species that were observed or have potential to occur on site are presented in Table 3.3-7. Special-status plants with low or no potential to occur, based on the location and conditions, are shown in Table 3.3-8. Results of surveys are provided in Section 3.3.3.1 and are shown on Figure 3.3-11, Otay River Floodplain Restoration Site Special-Status Plant Species, Figure 3.3-12, Pond 15 Restoration Site Special-Status Plant Species, and Figure 3.3-13, Ponds 22 and 23 Special-Status Plant Species.
