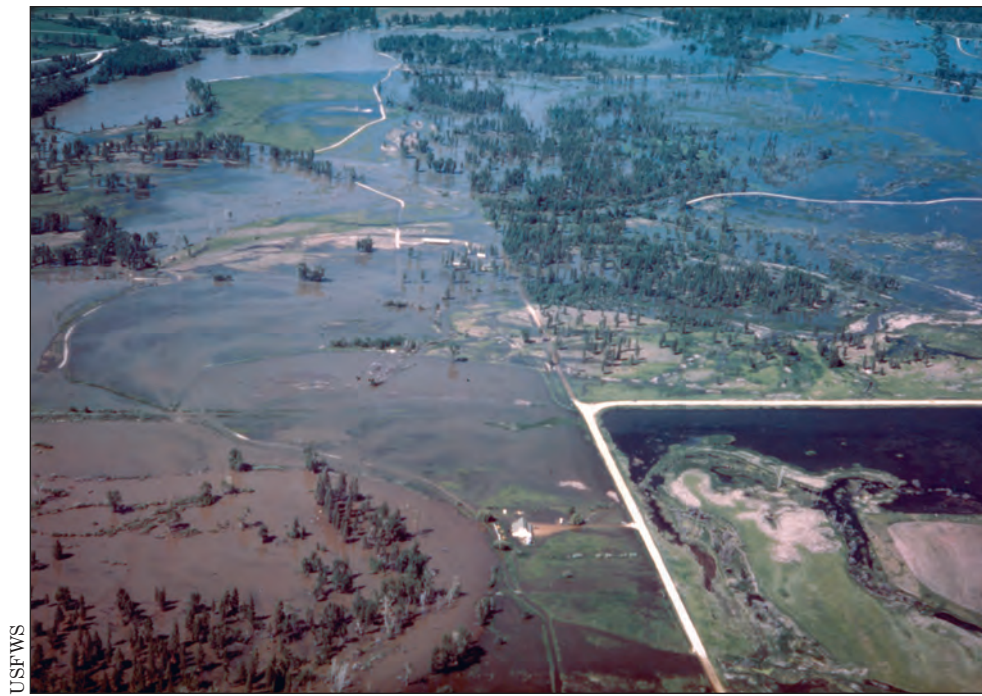
Figure 8. Flooding of the Bitterroot River on Lee Metcalf National Wildlife Refuge, Montana, in 1974.

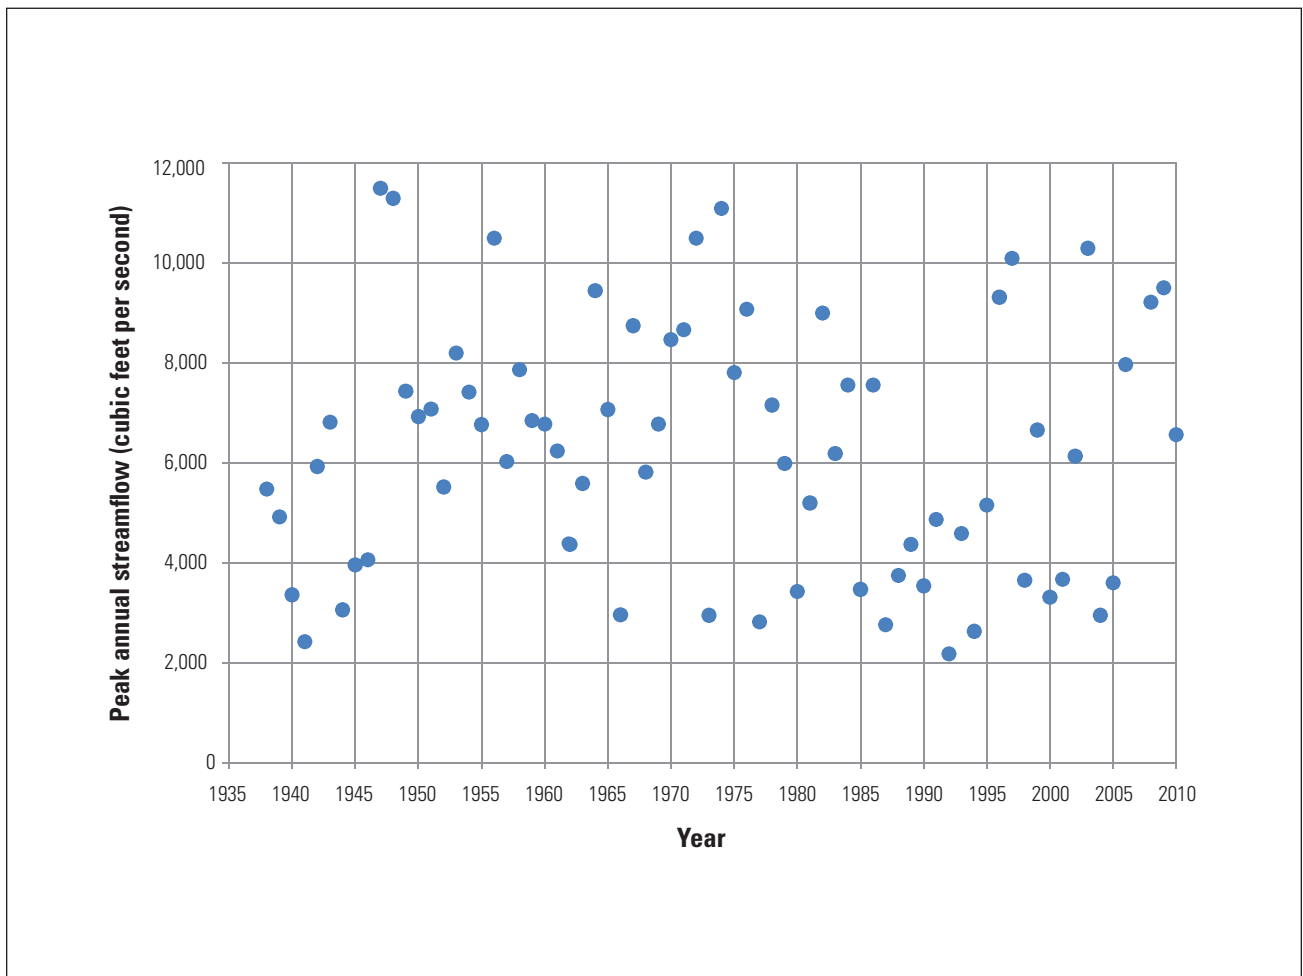
Figure 9. Bitterroot River streamflow near Darby, Montana (USGS 2011).
