History of Dune Management in the NPS Assigned Area of Chincoteague National Wildlife Refuge
November 2014 Updated April 2016
Prepared by the National Park Service, Assateague Island National Seashore

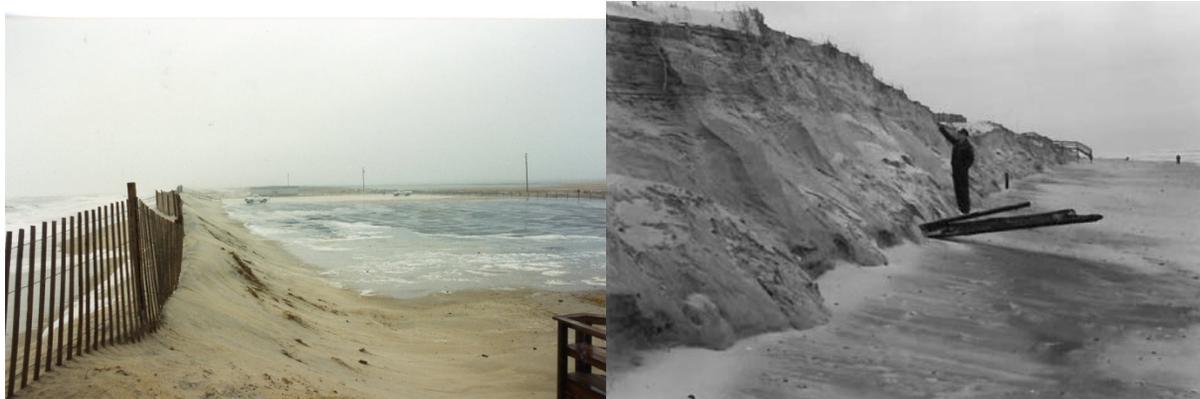
1994 storm showing artificial dune, sand fence, and water encroaching from both sides; Eroded artificial dunes at recreational beach after another 90s storm

NPS had also learned that the artificial dunes could narrow the existing beach. During the 1990s it was not uncommon for high tides to push beachgoers up on the dunes, with waves reaching the toe of the dune. In the case of the dune built at Cape Hatteras, three decades of interference with overwash greatly altered the shape of the beaches on the Outer Banks compared to beaches on islands further south, where there was no artificial dune. On those islands, beaches are 125 to 200 yards wide. Beaches backed by the dune, by contrast, were 30 yards wide or less, and in many places there was hardly any beach at all (Dean, 1999). At Assateague State Park, beach widths between the dune toe and the high tide line ranged from 6 m to 25 m between 1998 and 2005. Just north of Assateague State Park, on Assateague Island National Seashore, there are no maintained dunes, and the dry beach ranges from 150 m to 250 m in width.

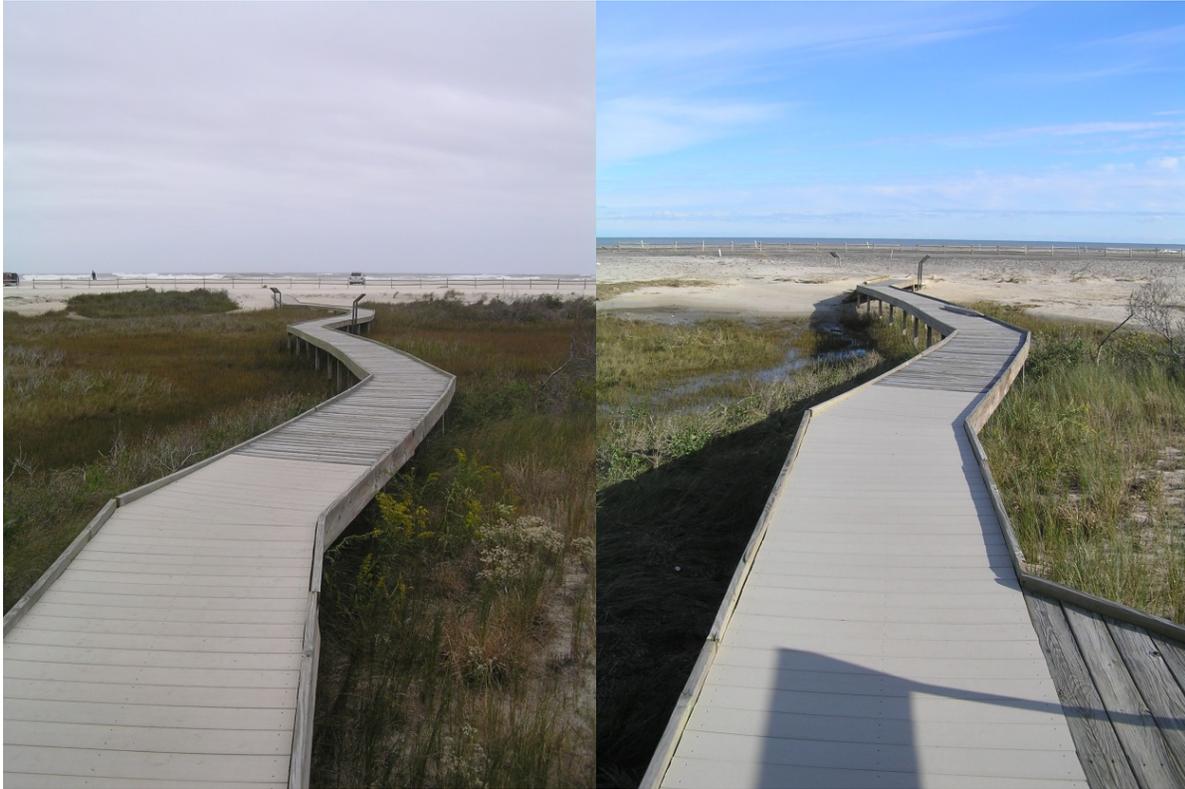
Before and After Photographs from Hurricane Sandy. This boardwalk runs from the park visitor center to the Tom's cove side of the island. You can see the overwash-placed sand that increases island elevation and replenishes the marsh.
