Draft Environmental Assessment
Kīlauea Point National Wildlife Refuge Trail Stabilization

October 2015

U.S. Fish and Wildlife Service
Kaua'i National Wildlife Refuge Complex
P.O. Box 1128
Kīlauea, HI 96754

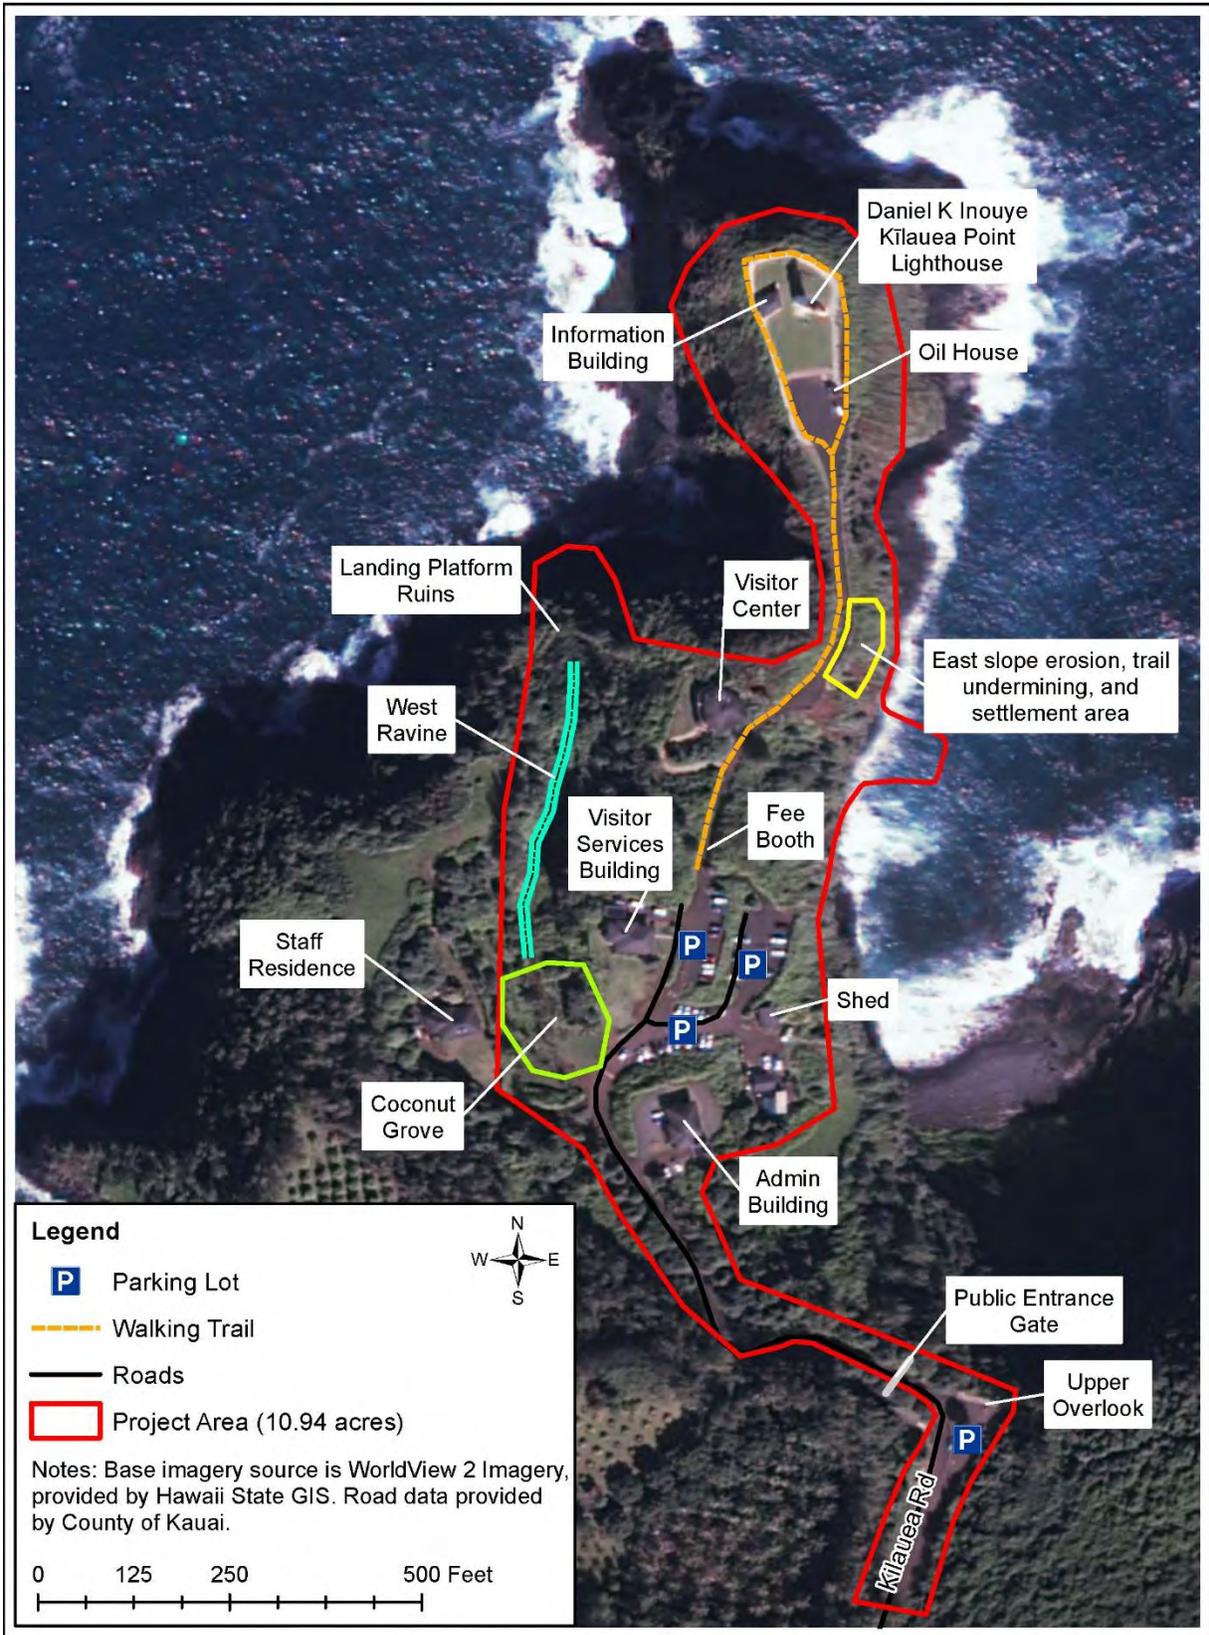
Figure 1-2. Existing Site Plan

The Trail Stabilization project area covers approximately 11 acres and consists of the extents depicted in the Existing Site Plan (Figure 1-2).

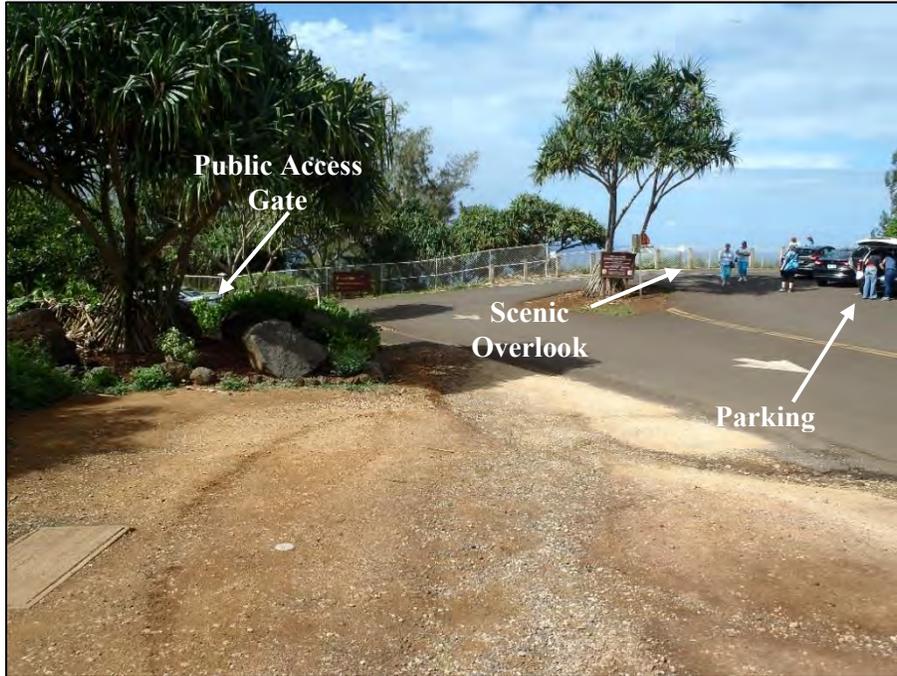
Figure 1-3. Upper Scenic Overlook
(General view looking north at the upper scenic overlook)

The project area is located in a developed section of the Refuge. The southern portion of the project area consists of an upper scenic overlook and public entrance access road with an access gate (Figures 1-3 through 1-6). A parking area for visitors adjoins the overlook to the southeast. A graveled area in the County road right-of-way of Kīlauea Road (south of the overlook), is used by visitors as overflow parking (Figure 1-5).

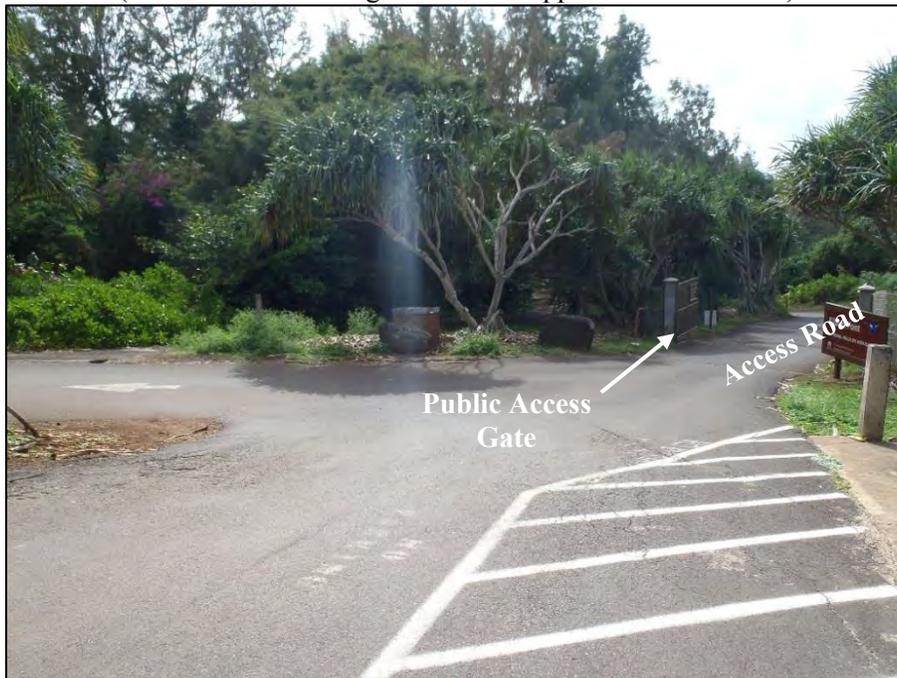
Figure 1-4. Public Access
(Upper scenic overlook looking west at the public access road and gate)

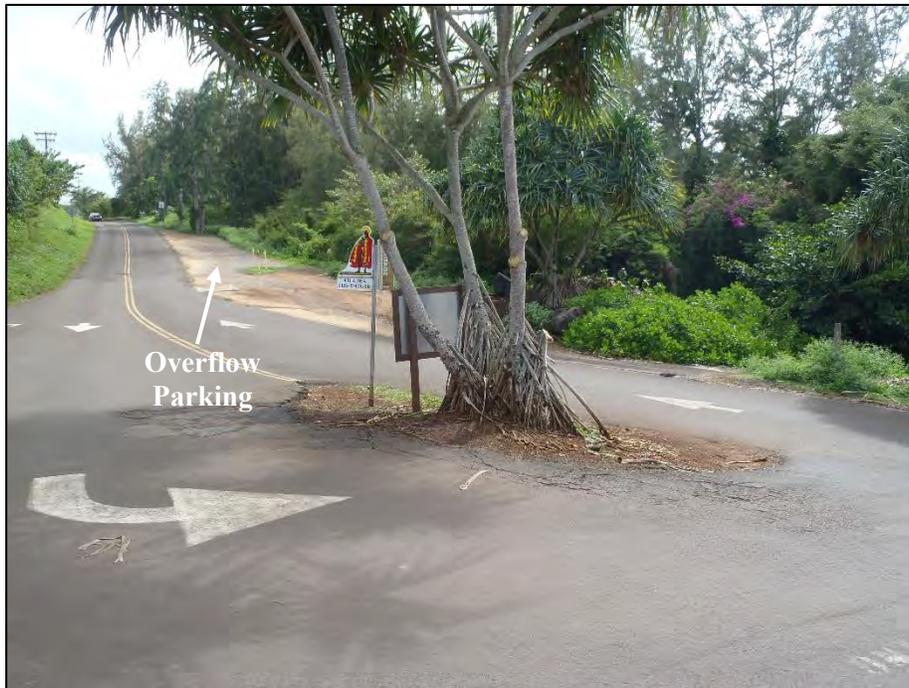
Figure 1-5. Overflow Access

(Looking south at Kīlauea Road leading up to the upper outlook and the overflow parking)

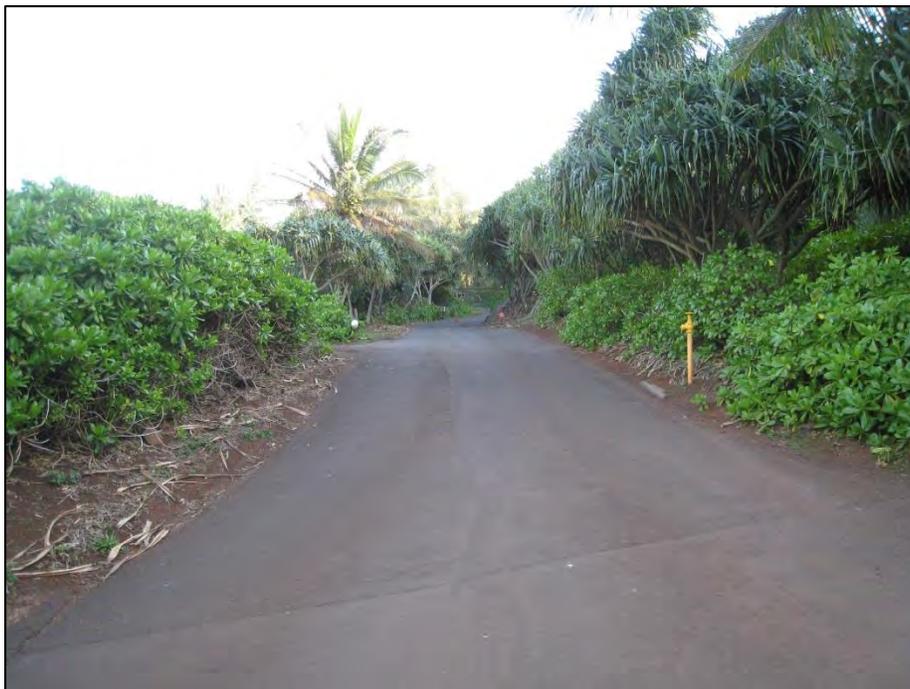
Figure 1-6. Public Access Road

(General view looking southeast along the public access road)

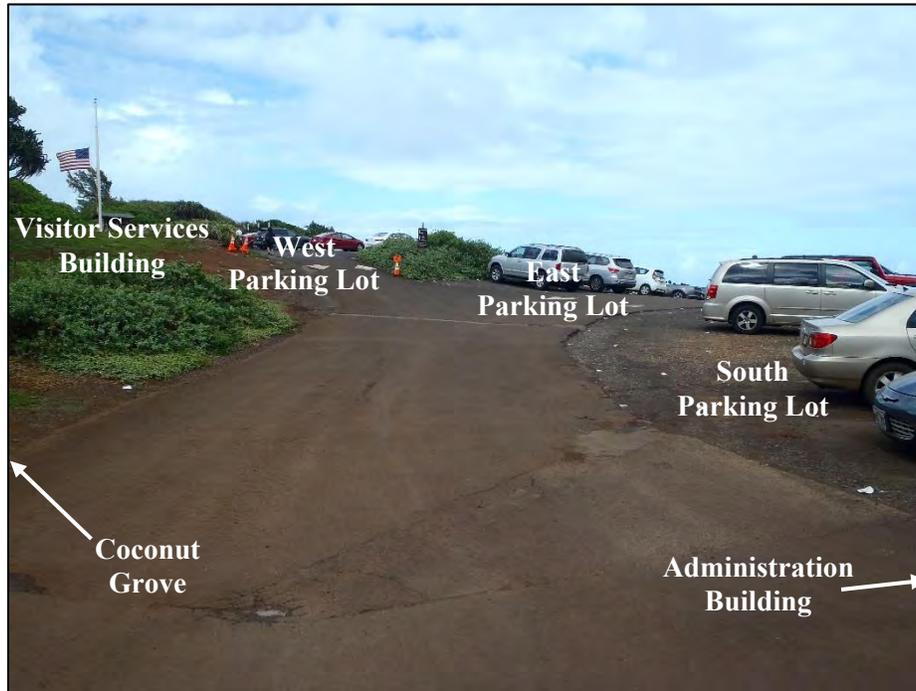
Figure 1-7. Central Project Area Parking
(General view looking north across the parking areas)

The access road opens up to the coconut grove and parking areas surrounded by multiple buildings and structures in the central portion of the project area (Figure 1-7). There are three parking lots in this area (west, east, and south parking lots). The west parking lot adjoins the visitor services building, the east parking lot is located downslope to the east of the west parking lot, and the south parking lot is located downslope to the south of both (Figures 1-8 through 1-10). Buildings around the parking area consist of the visitor services building (Figure 1-11), administration building (Figure 1-12), maintenance sheds, and a fee booth (Figure 1-13). The coconut grove area consists of a mowed grassy area and coconut trees (Figure 1-14). Downstream of the coconut grove is a small ravine (west ravine) with a channel at the base that is normally dry and only conveys water during precipitation events (Figure 1-15).

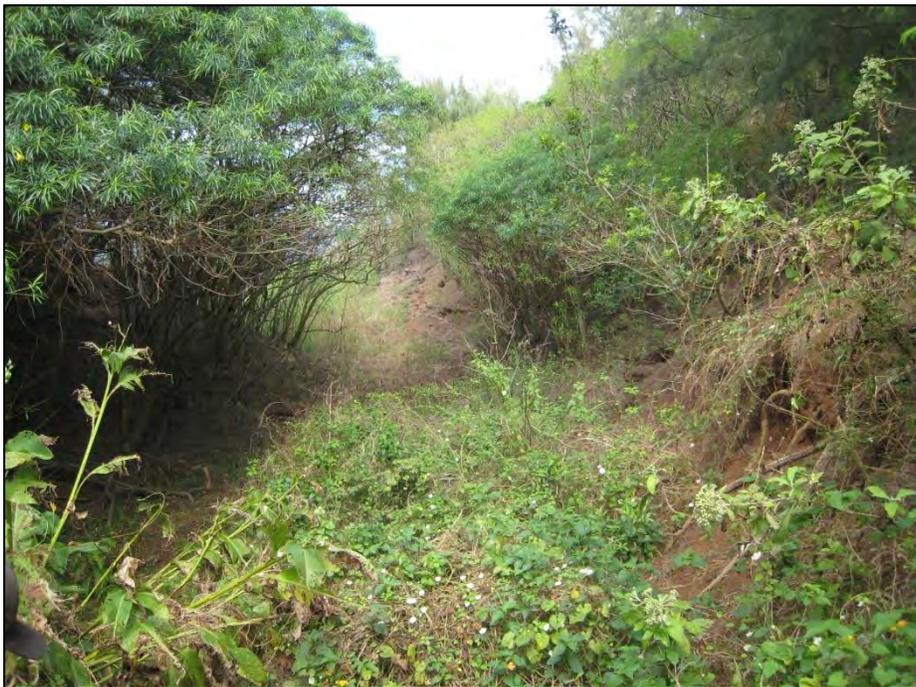
Figure 1-15. West Ravine
(Standing at the base of the ravine looking north along the dry channel)

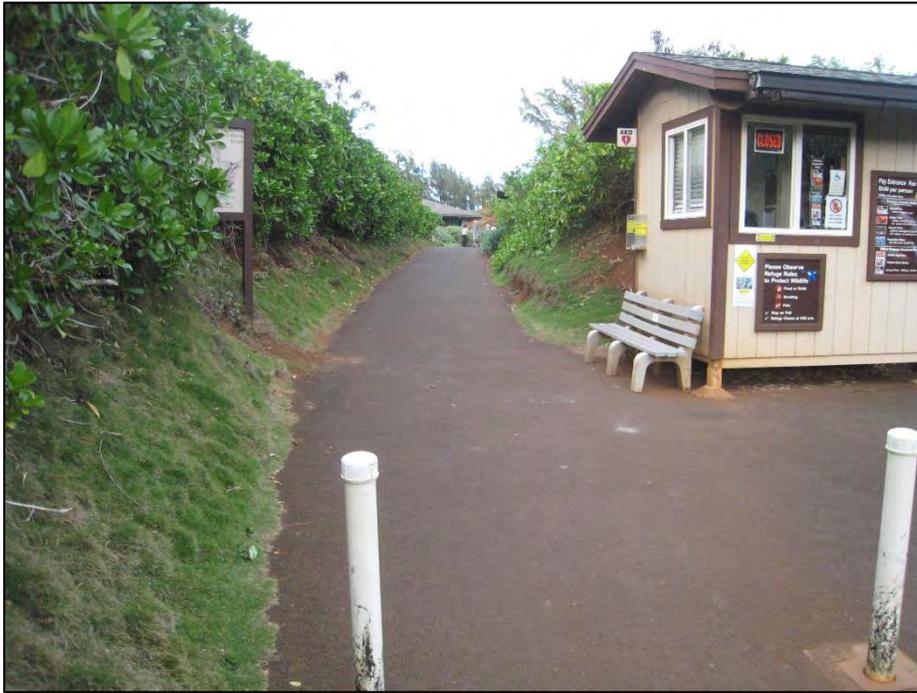
Figure 1-16. Walking Trail Alignment (Southern Portion)
(Looking north from the fee booth along the southern portion of the walking trail alignment)

The northern portion of the project area consists of the walking trail alignment which extends from the fee booth north to the lighthouse (Figures 1-16 through 1-18). There are multiple structures adjoining the

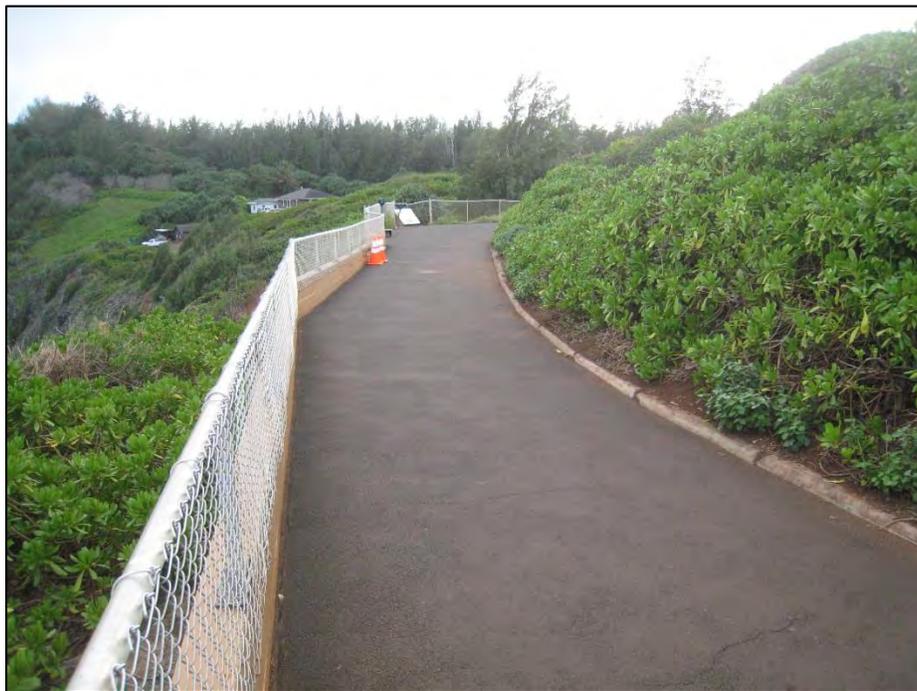
Figure 1-17. Walking Trail Alignment (Central Portion)
(Looking south along the central portion of the walking trail alignment)

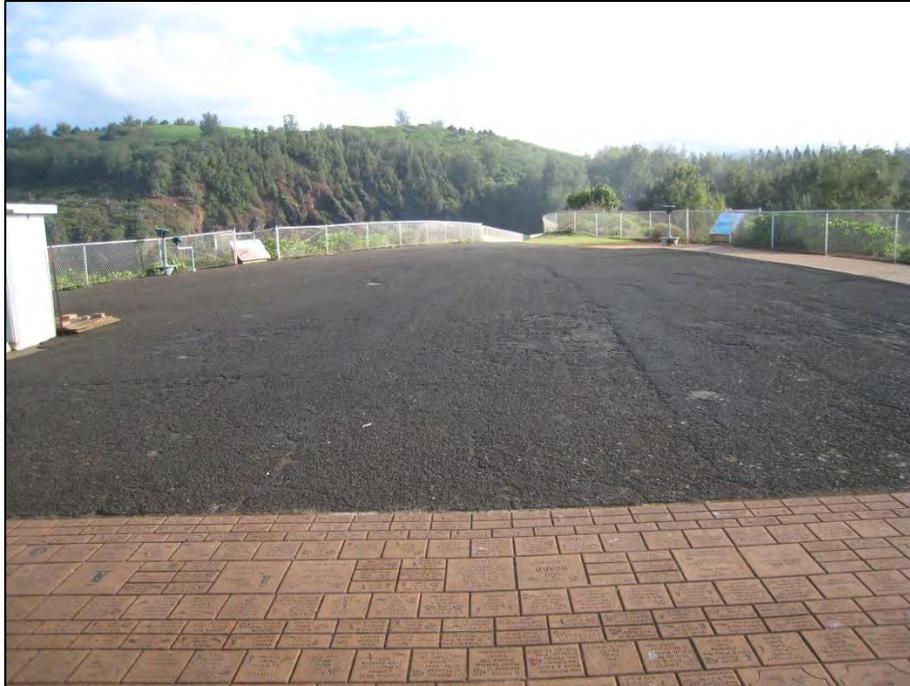
Figure 1-18. Walking Trail Alignment (North Portion)
(Looking south at the walking trail alignment from the north edge of the walking trail)

The walking trail consists of an asphalt path that is approximately 700 feet long. A concrete retaining wall supports the east side of the walking trail for about 260 feet. Shotcrete, a cement-like substance, has been placed downslope from the retaining wall to help prevent erosion and undermining of the wall in various sections. Undermining and settlement of the walking trail along with water and sediment deposition on the trail has raised slope erosion, trail instability, O&M issues, and public safety concerns. Damage to the walking trail has been documented with most of the damage occurring from undermining and settlement along an approximate 100-foot length of the trail (Figure 1-21). Damage to the walking trail, retaining wall and Shotcrete include:

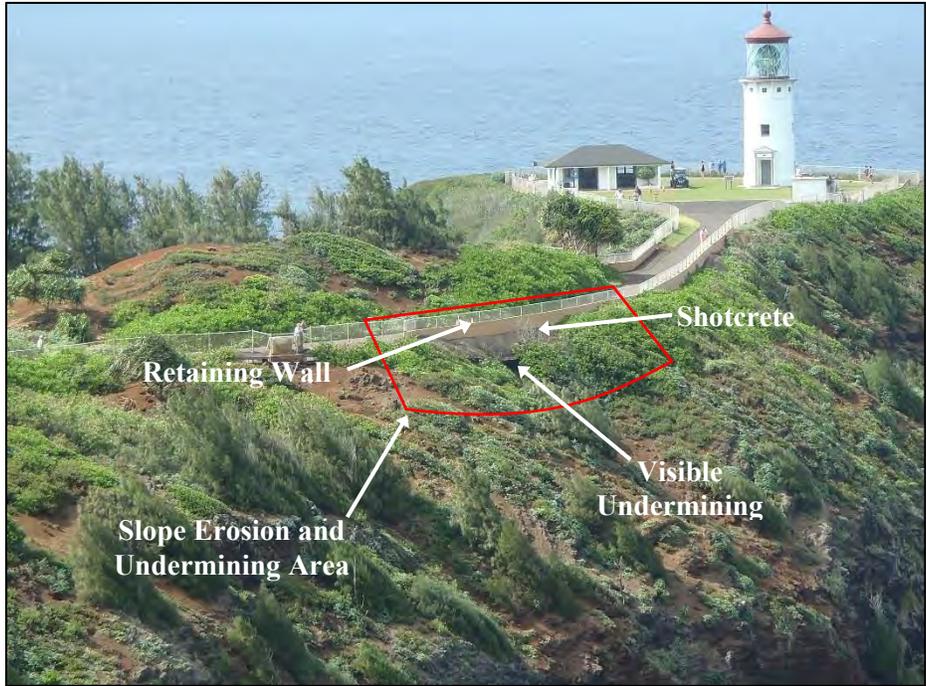
Figure 1-21. Walking Trail Slope Erosion and Undermining Area
(Looking north from the upper scenic overlook at the middle and northern portion of the walking trail alignment)

- Severe cracking of the existing concrete retaining wall (Figure 1-22);
- Transverse and longitudinal cracking of the asphalt walking trail (Figures 1-22 and 1-23);
- Cracking of the Shotcrete (Figure 1-24);
- Shotcrete moving downslope and pulling away from the retaining wall (Figure 1-24); and
- Severe undermining along the base of the Shotcrete (Figure 1-21 and 1-25).

The 1- to 4-inch thick paved walking trail and 2- to 3-inch base course material currently rest on native clayey silt. Slope erosion and settlement of the walking trail has occurred along a relatively isolated length of the trail (less than 100-foot length). In a 2014 geotechnical investigation the following preliminary conclusions were made for the direct causes for the slope degradation and structural wall damage (GHD 2014):

- Naturally high wind and rain surface erosion. (Note that this is the general nature of the site and whatever wall repair solution is selected, the design will need to accommodate future erosion of soil down the slope.)
- Native site soil is reddish clay and is susceptible to erosion.
- The downhill slope is excessively steep and is exposed to potential erosion action.
- In storm events, wind driven rain may be striking the wall & shotcrete and causing scour at the base.
- It appears that water may be entering the soil profile behind the wall and potentially removing away fines particles causing potential voids.
- The path of water into the soil profile has not been confirmed and may be a combination of surface water running down the path and/or subgrade water migration through the utility trenches.
- It appears the problem may be accelerating.

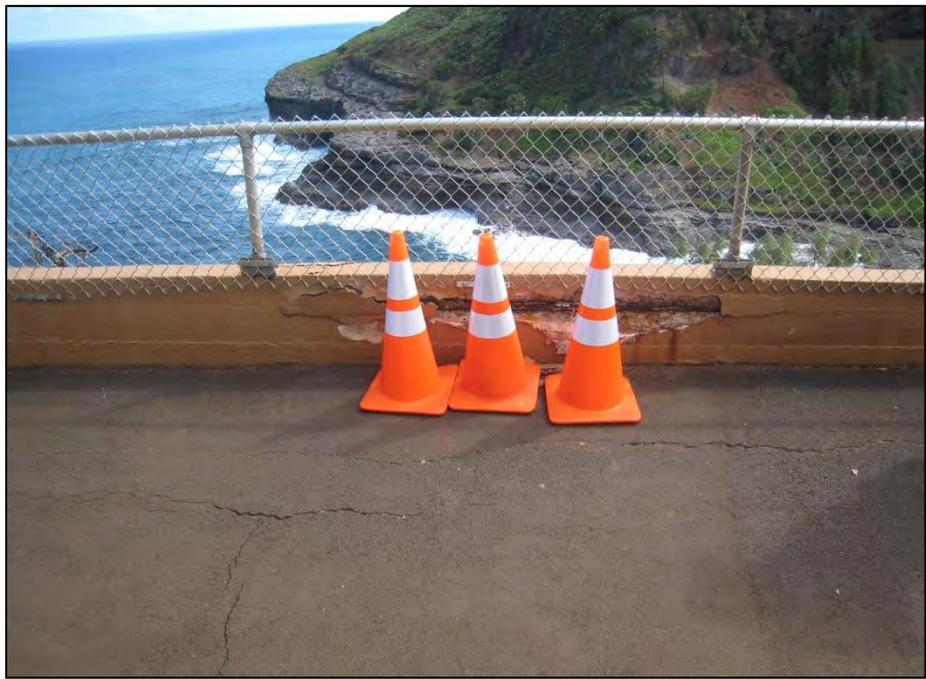
Figure 1-22. Retaining Wall and Walking Trail Cracking
(Cracking of concrete retaining wall and longitudinal and transverse cracking of asphalt walking trail)

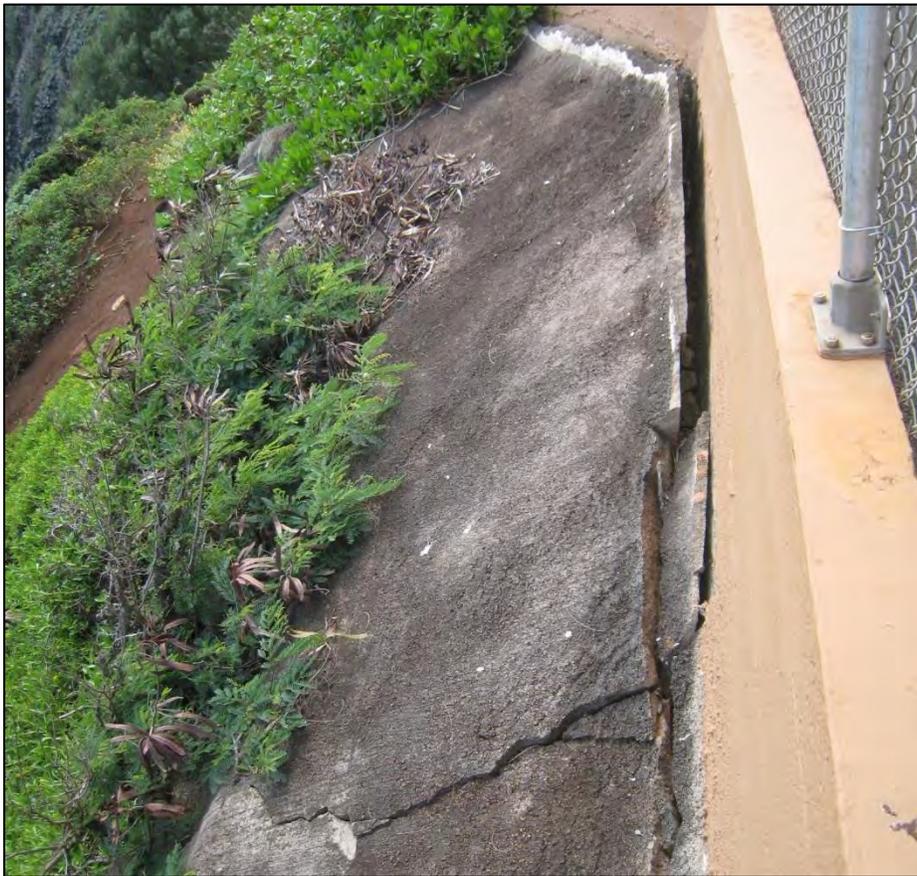
Figure 1-24. Shotcrete Damage
(Cracking and pulling away of Shotcrete from the concrete retaining wall)

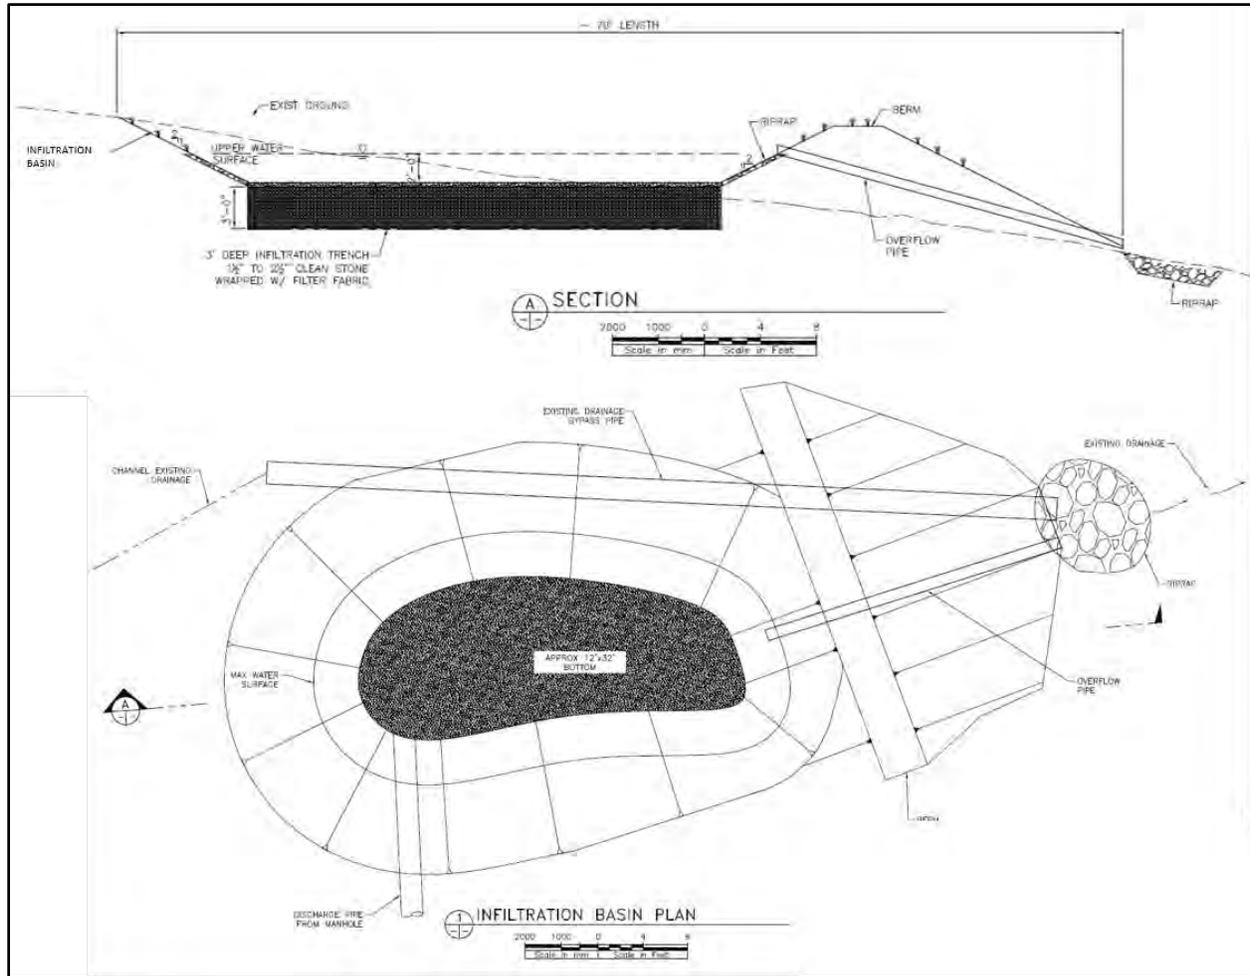
Figure 3-5. West Ravine Discharge Stormwater Infiltrations System Plan and Section

The west ravine discharge would consist of extending the conveyance pipe underground from the visitor center south along the walking trail alignment 250 feet to the visitor service building driveway and then generally west approximately 180 feet to the west ravine. The pipe would discharge into an infiltration system constructed in the bottom of the ravine (See Figure 3-4 below). Existing natural flows would continue to flow within the existing ravine channel without impedance of flow, but would require a bypass pipe in the area of the infiltration system. The infiltration system would consist of an infiltration basin and infiltration trench designed similar to the East Slope Discharge Alternative, but would be approximately 40% larger. The size of basin for this alternative would capture collected flows for a 1.4-inch storm event. Overflow water from storm events over the 1.4-inch design storm, would discharge from the infiltration system downstream and combine with the existing drainage flow. The channel would be lined with riprap at the discharge point of the bypass pipe and basin overflow, and flows would continue downstream in the existing ravine approximately 300 feet to the ocean. See Figure 3-5 below for a plan and section of the stormwater infiltration system.

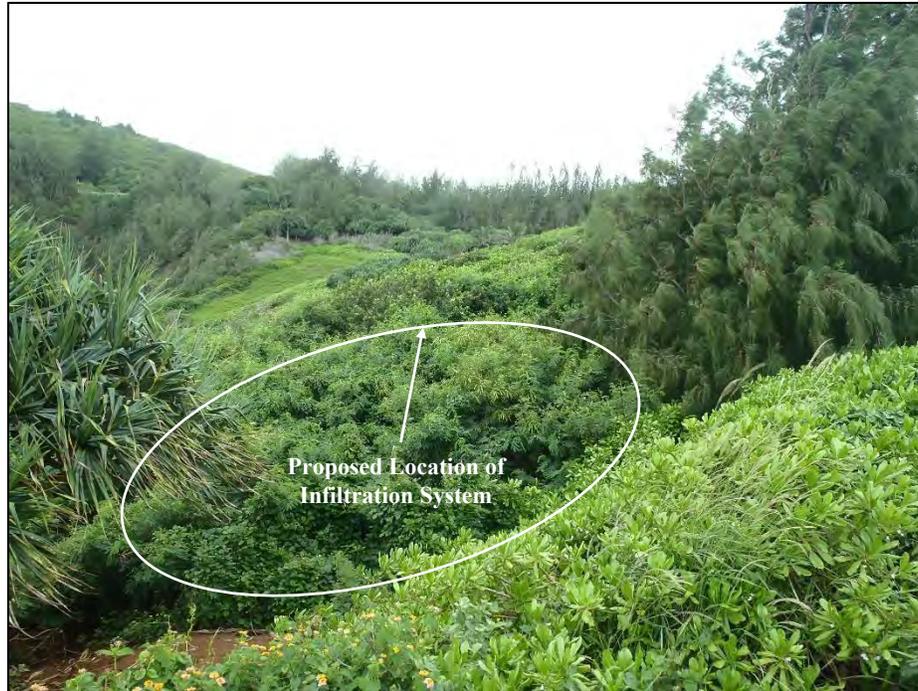
Figure 5-5. Viewshed of the East Slope from the Walking Trail

Long-term and short-term adverse impacts are anticipated for this alternative. Minor short-term impacts are anticipated during construction, as the upper overlook includes a view of the construction disturbance area. See Figure 5-4 below for a view of the project area from the upper scenic overlook. This alternative includes construction an approximate 40-foot by 55-foot infiltration system on the east slope that would potentially be visible from the upper scenic overlook and from a section of the walking trail (Figure 5-4 and 5-5). To help conceal the infiltration system, native vegetation would be planted around the perimeter which is anticipated to take several years to become established. The infiltration system is not anticipated to be visible at the upper scenic overlook, but may be visible from the walking trail after vegetation becomes established. Based on the visibility from the upper overlook this alternative would have a negligible long-term adverse impact and from the walking trail would have a minor long-term adverse impact to visual resources.
