**2013 ANNUAL REPORT
CERCLA NON-TIME CRITICAL
REMOVAL ACTION**

**MIDWAY ATOLL NATIONAL WILDLIFE REFUGE
MIDWAY ISLAND
Contract No. F11PC00327**

28 February 2014

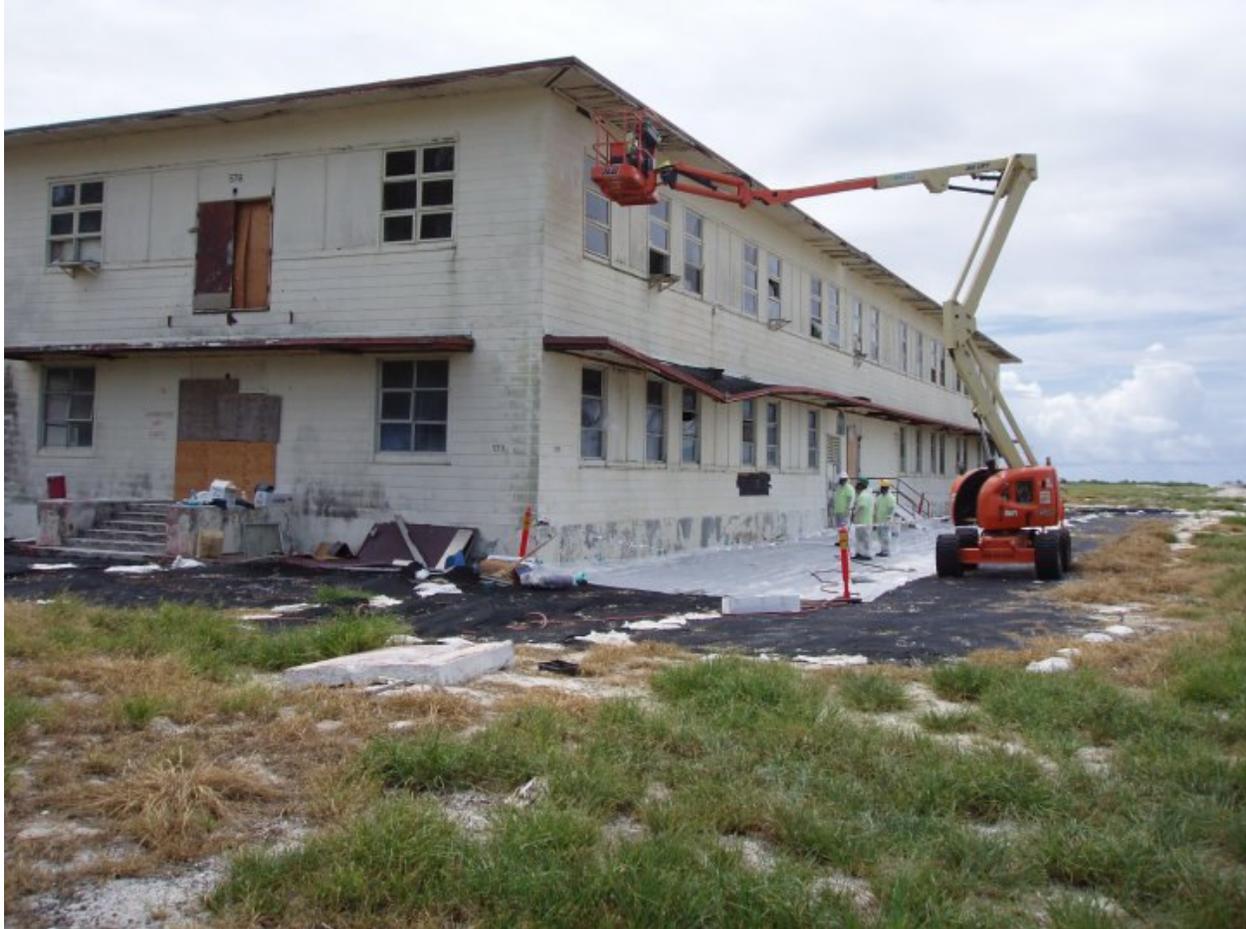
Photo 01: Iniki begins removing ACM transite siding from Bldg 579.

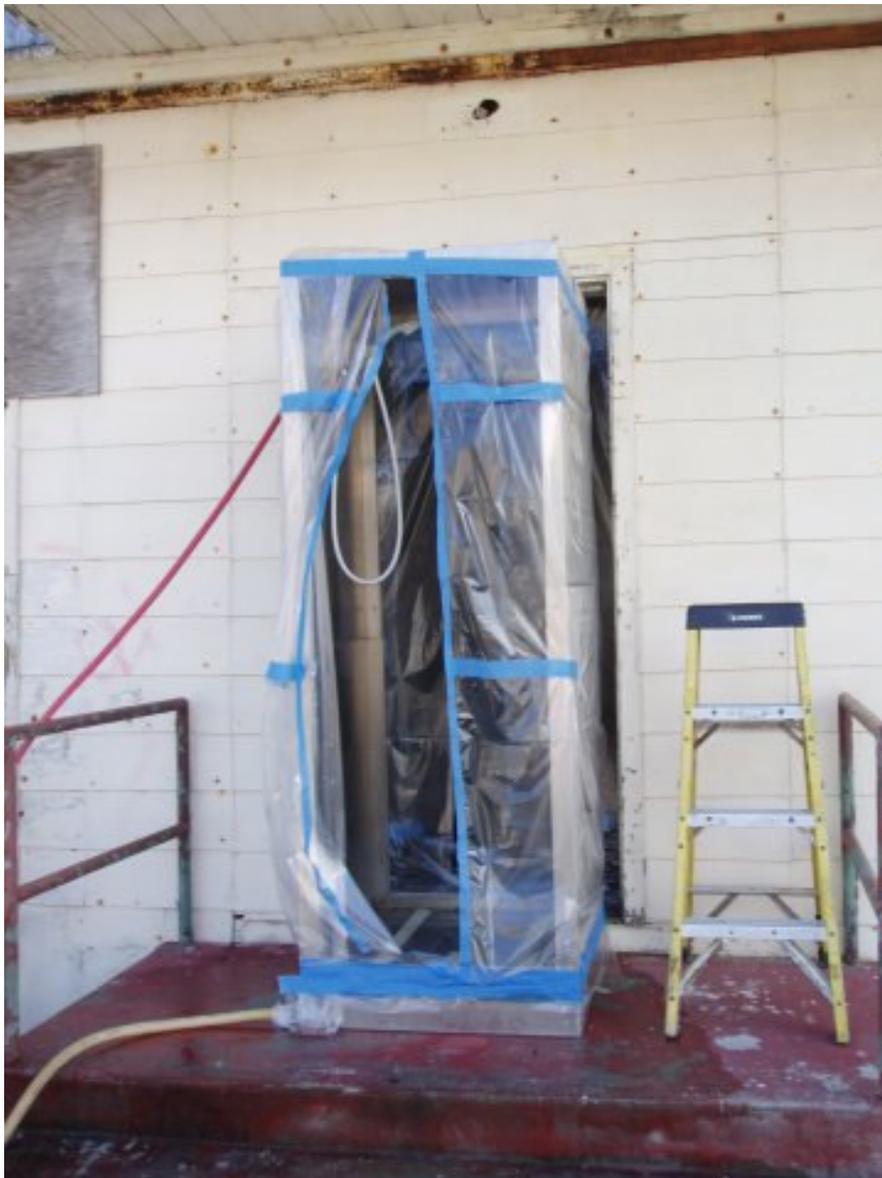
Photo 01: DBSI wet access to stairwell abatement in Bldg 578.

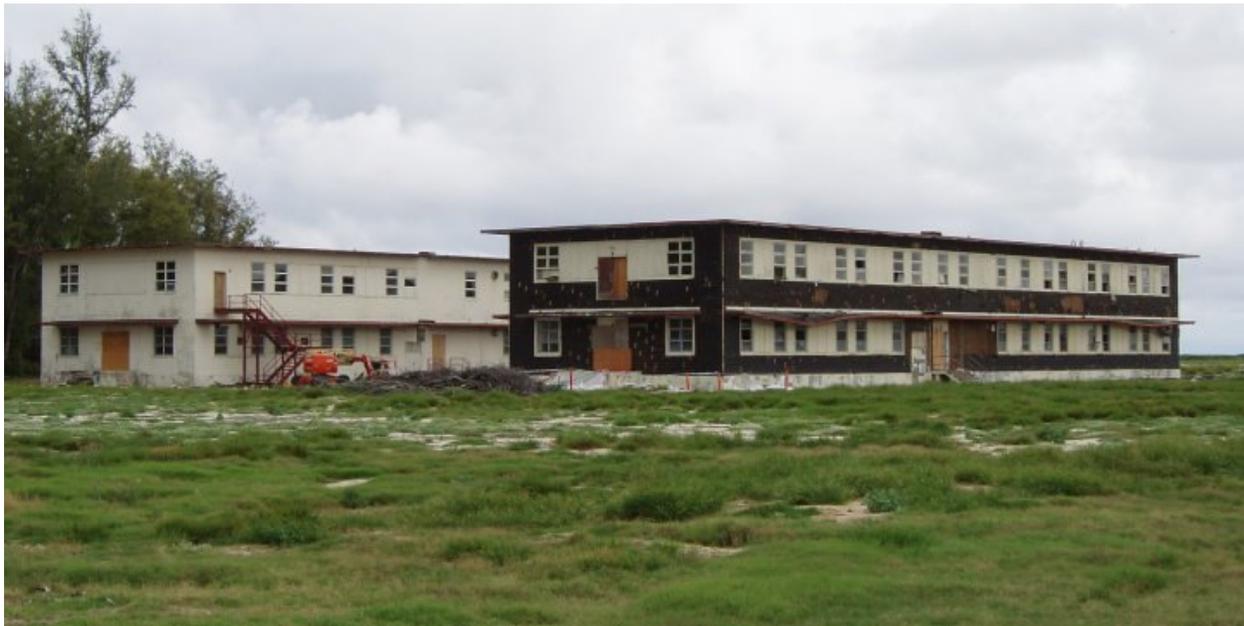
Photo 02: End of Day. Bldg 579 (right) exterior ACM siding fully removed.

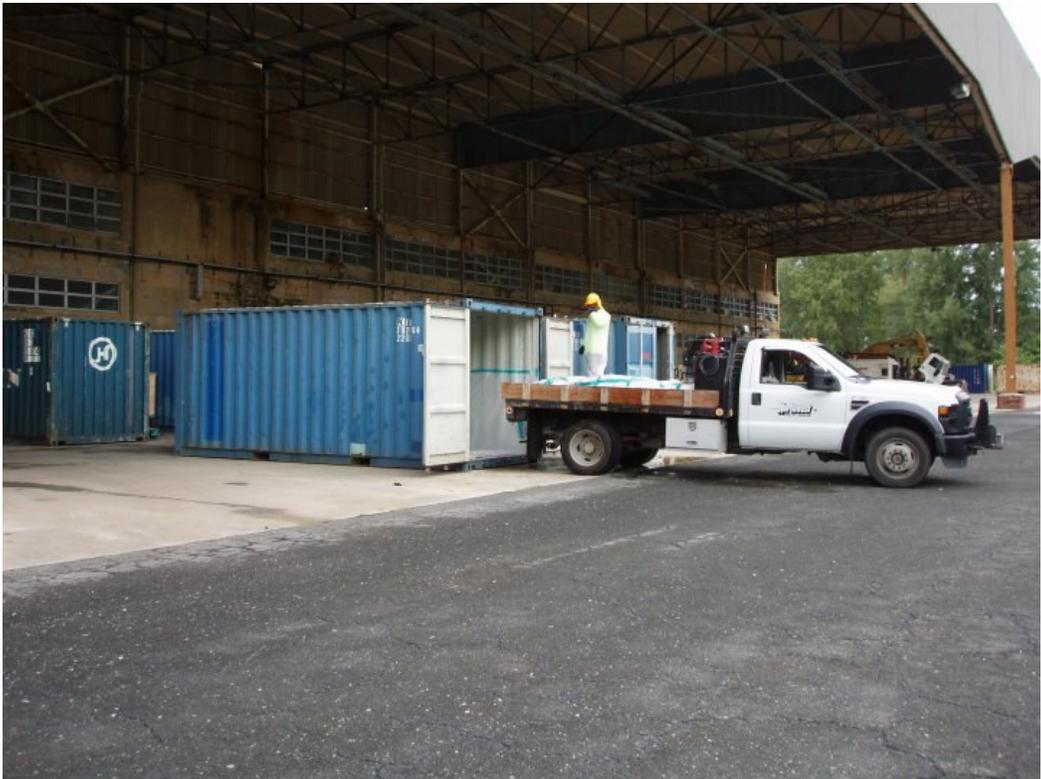
Photo 02: Shipping container that the bagged ACM material from Bldg 579 is placed into.

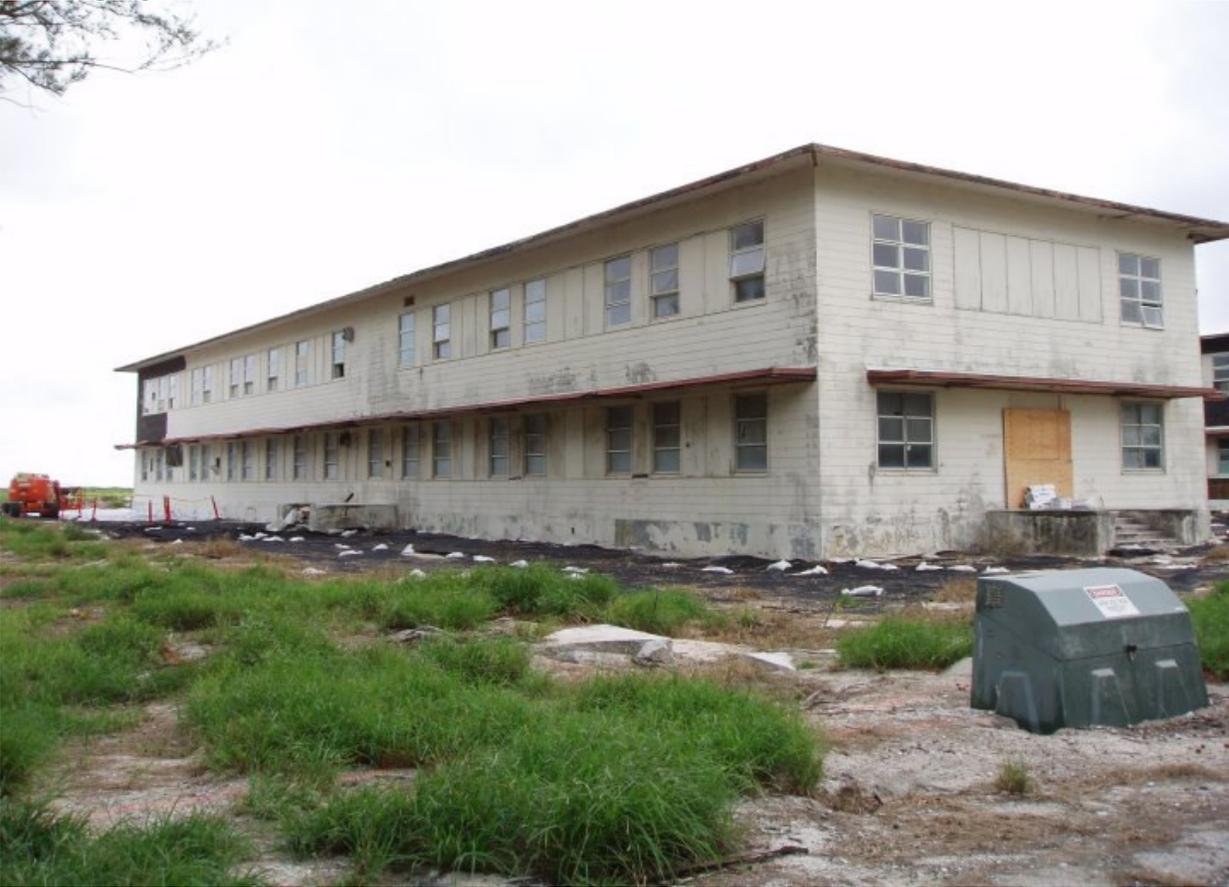
Photo 01: Bldg 578 long East wall and short North sections remaining for ACM siding removal next week.

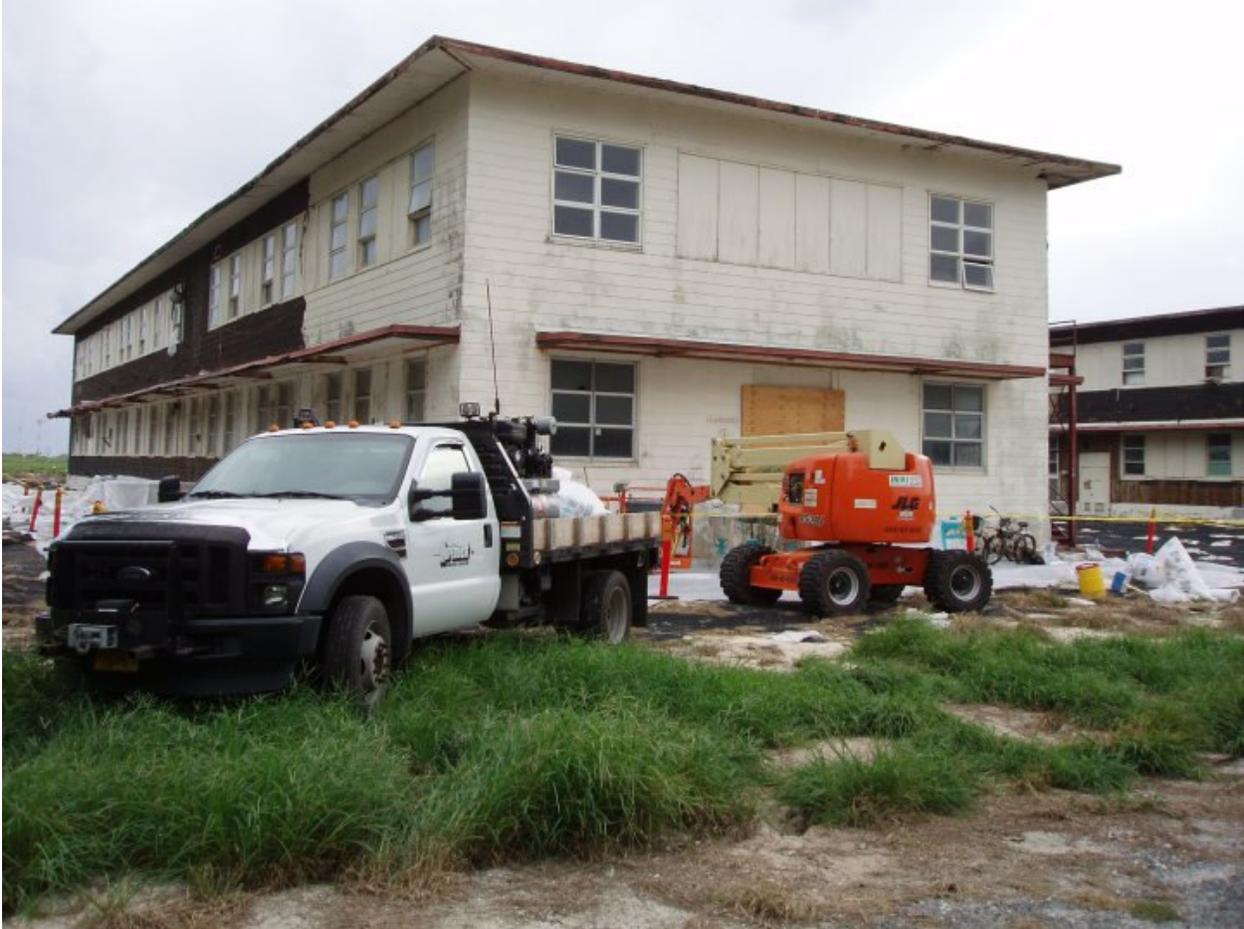
Photo 01: Bldg 578 showing remainder of ACM siding to remove near end of work day.

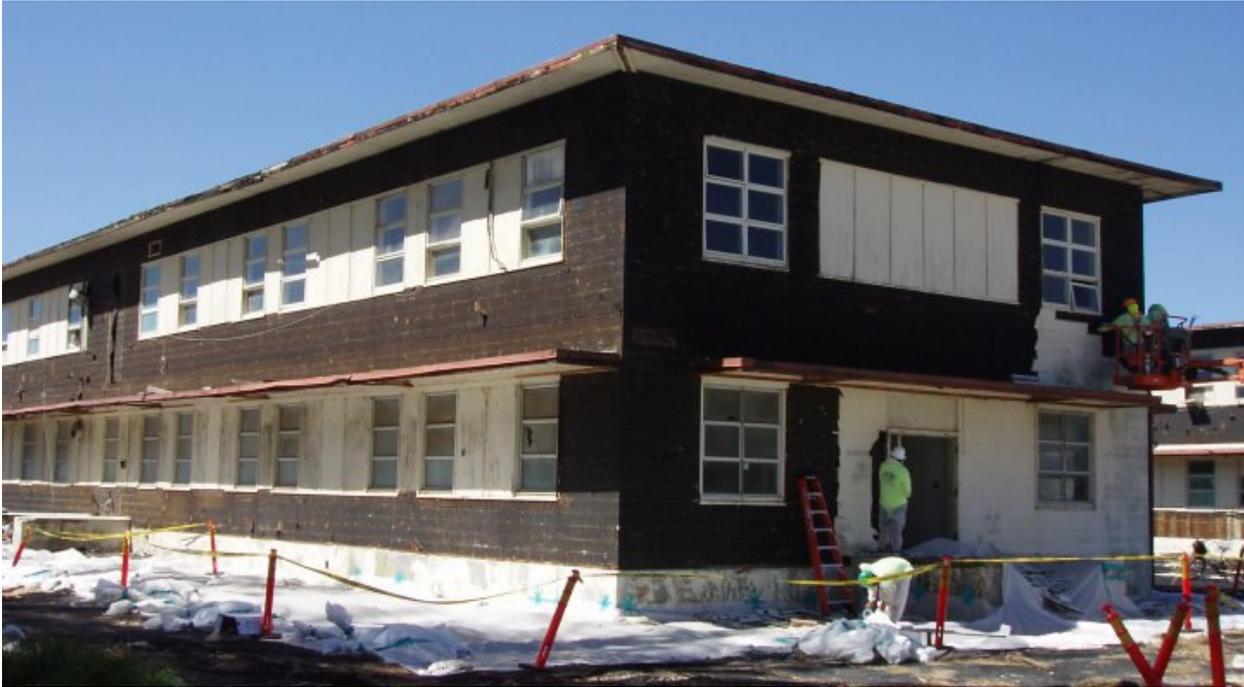
Photo 02: Bldg 578 ACM siding removal nearing completion.

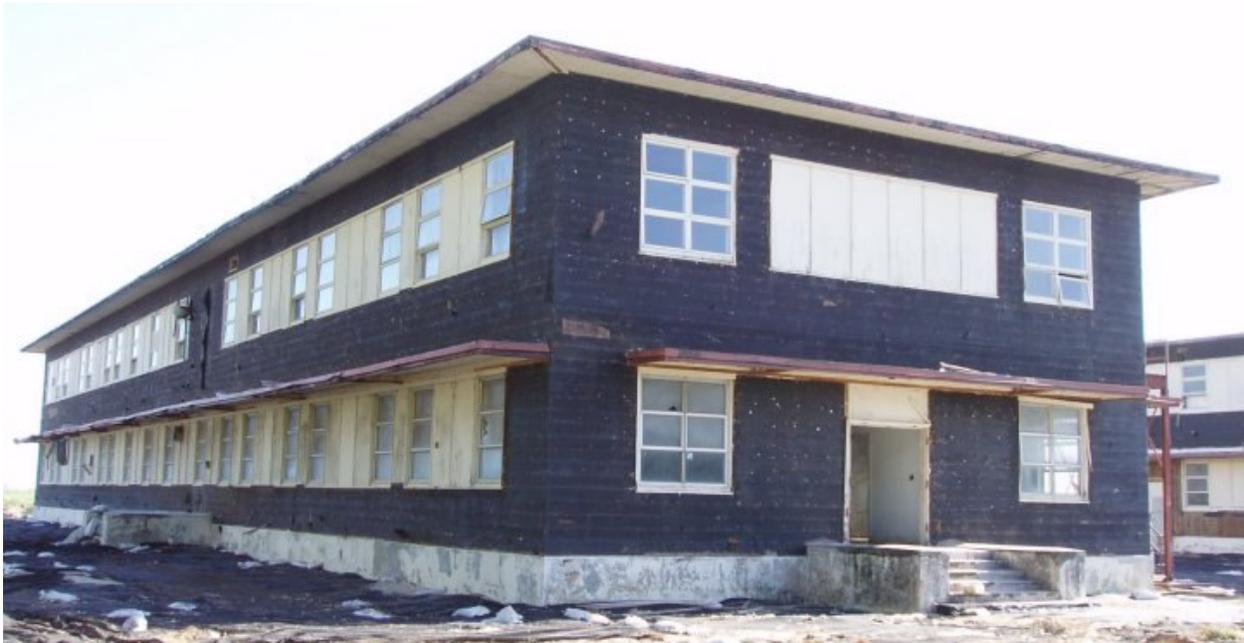
Photo 03: Bldg 578 transite siding fully removed and work area clean of associated materials.

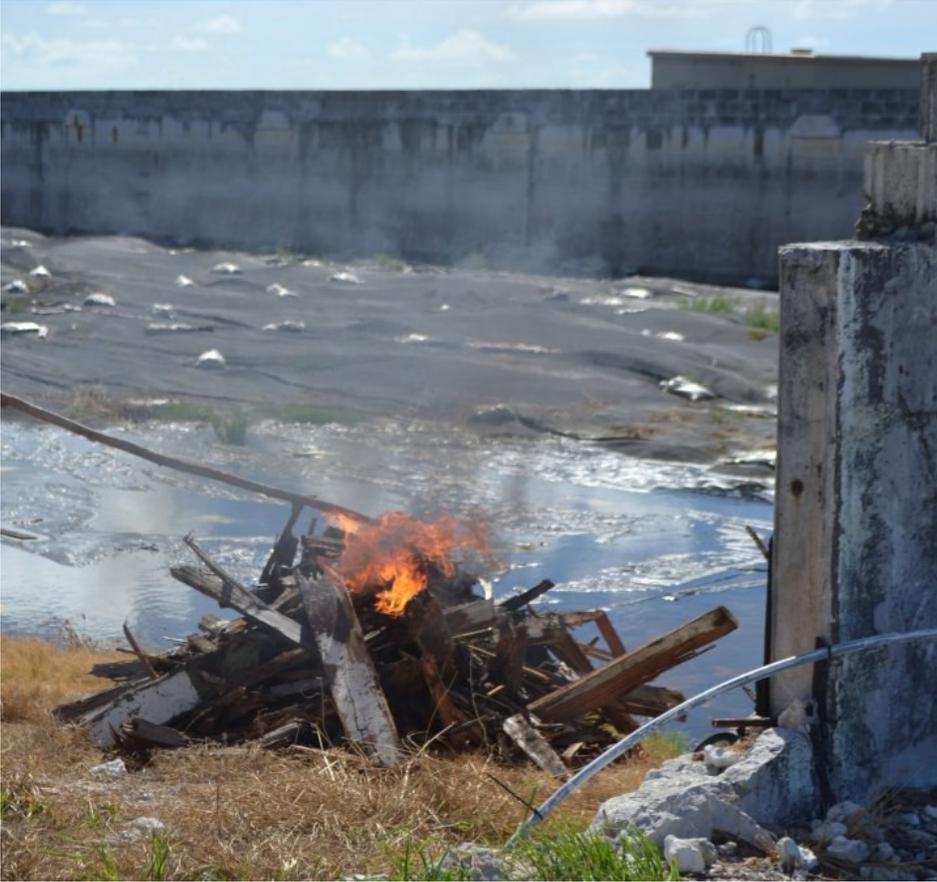
Photo 03: R2 Test Burn wood pile.

NWDE proceeds with setting up a small test pile on the south part of the entry ramp. This location is out of the water and away from the sun shade cloth in the cell. The pile is smaller than the prior attempted test burn as recommended by the Fire Department, approximately 48" diameter x 30" tall.

0950 – Air sampling pumps are started. The test wood pile is ignited using a small amount of diesel fuel. Fire watch will be continuous until conditions warrant otherwise.

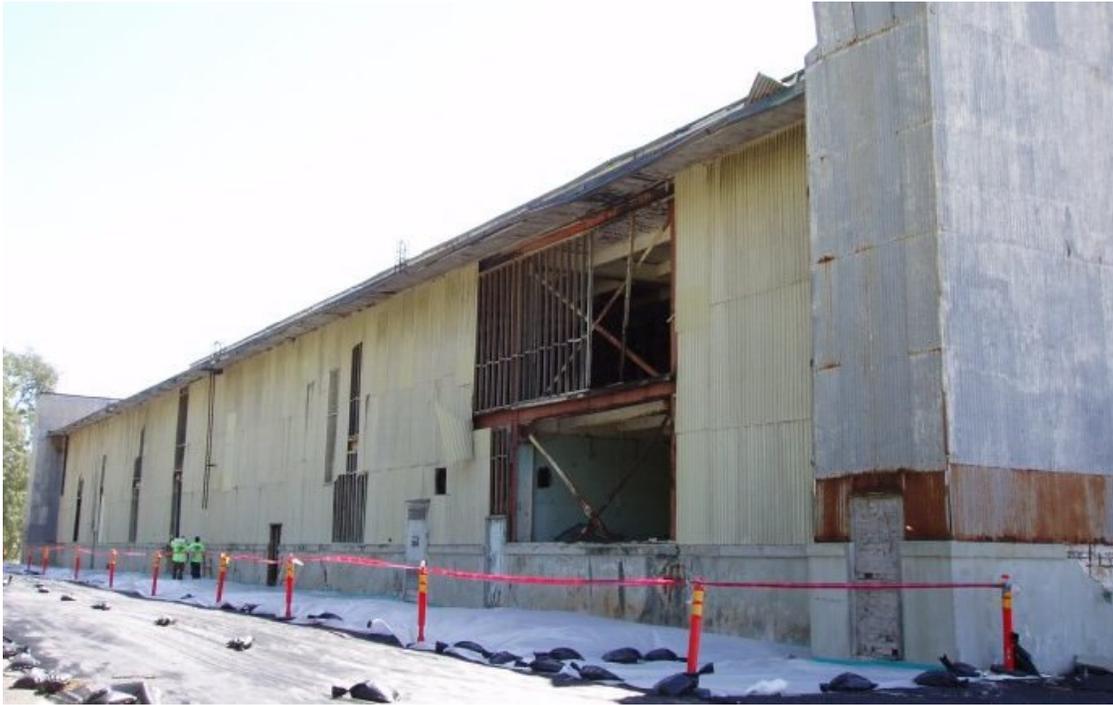
Photo 02: Sea Plane Hanger, prepping for paint.

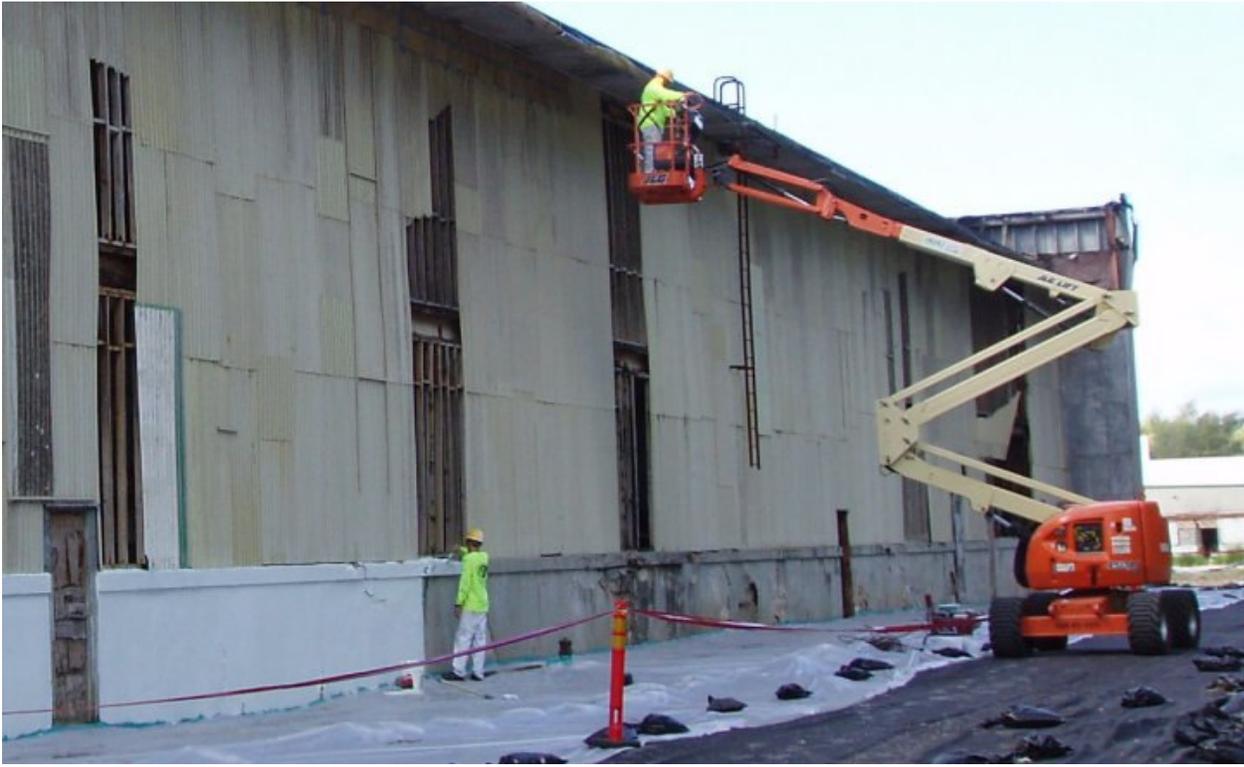
Photo 03: Sea Plane Hanger foundation and eaves being painted with Lead Stop.

0940 – Iniki's E. Esposito and N. Wond mask and paint the Sea Plane Hanger foundation and exterior eaves with Lead Stop paint. Application is with both roller and spray gun equipment. G. Lewis assists with tasks between this site and the Midway Bowl site.

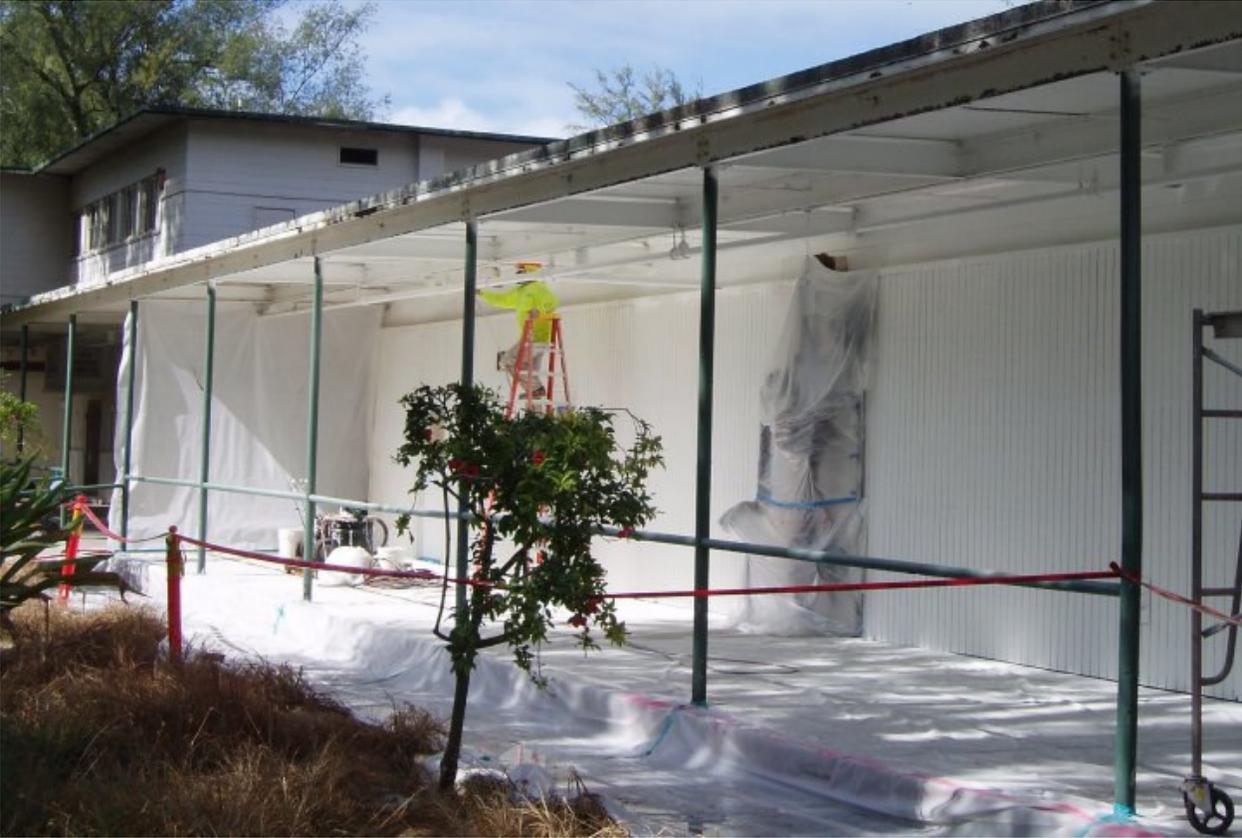
Photo 02: Midway Bowl Bldg 259 covered walkway with Lead Stop paint applied.

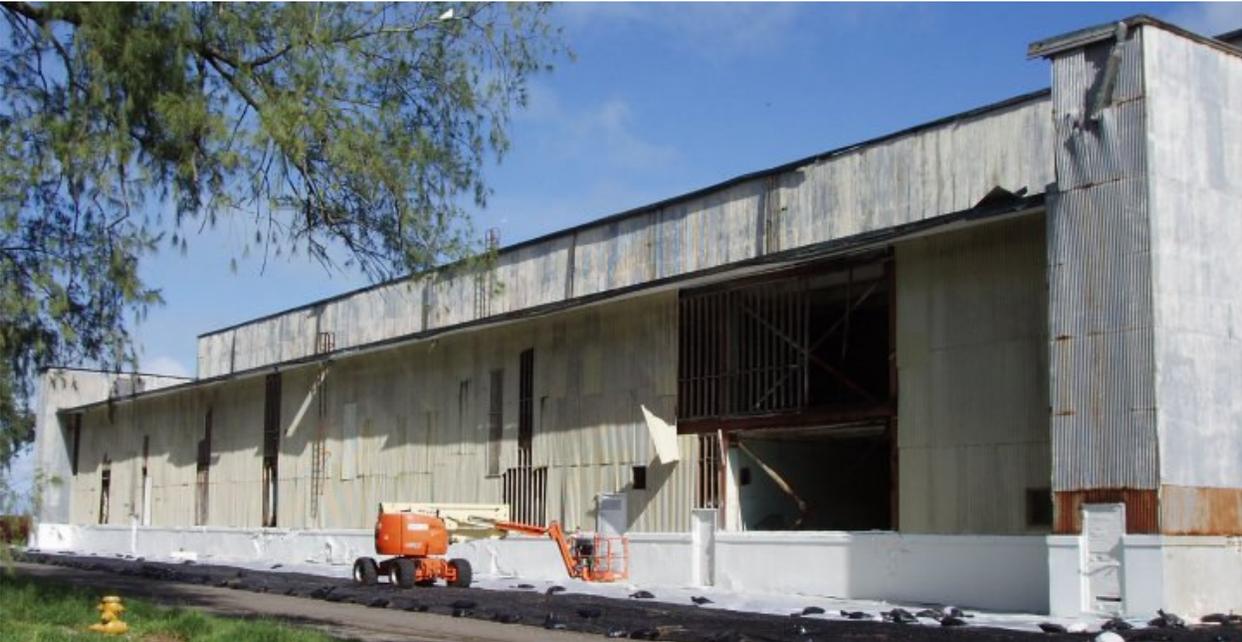
Photo 03: Sea Plane Hanger with Lead Stop paint applied.

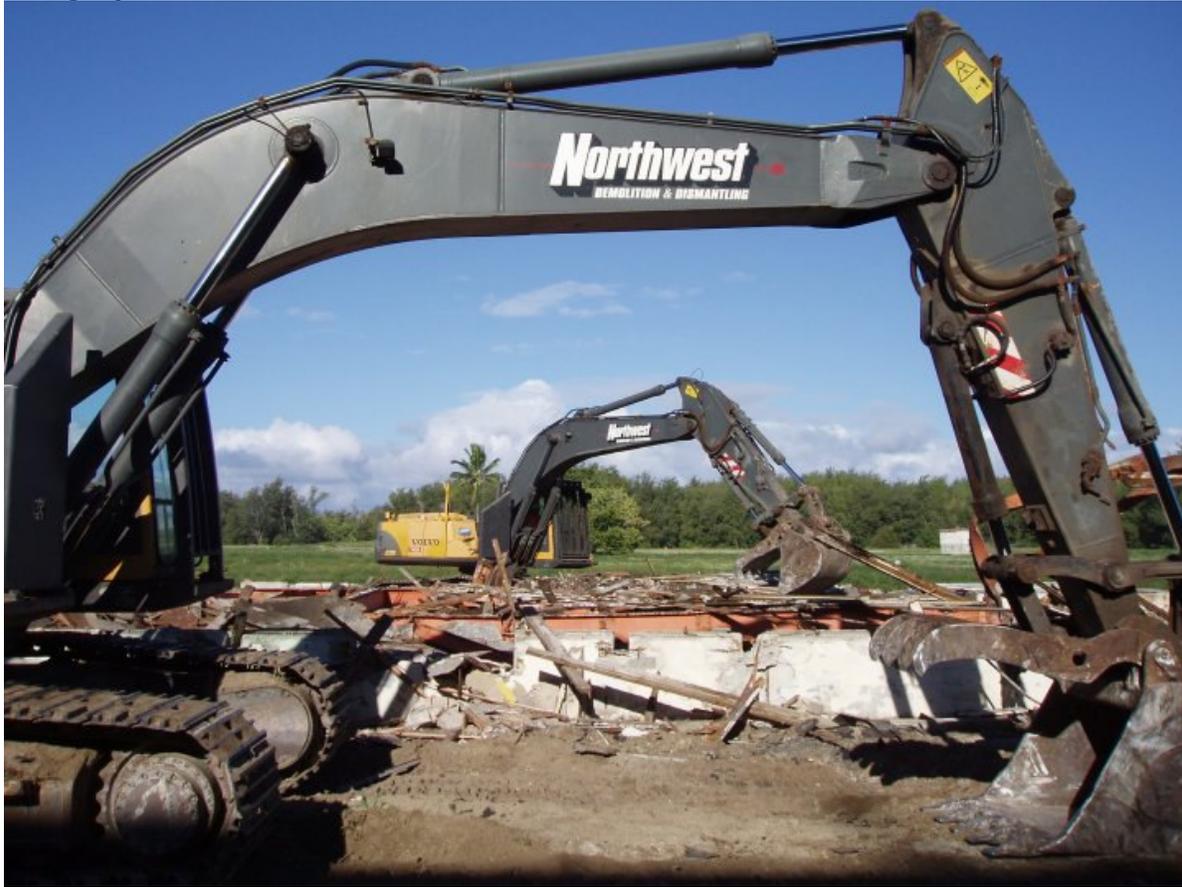
Photo 01: View facing West of Bldg 579, Northern end. Wood removed and steel floor beams exposed.

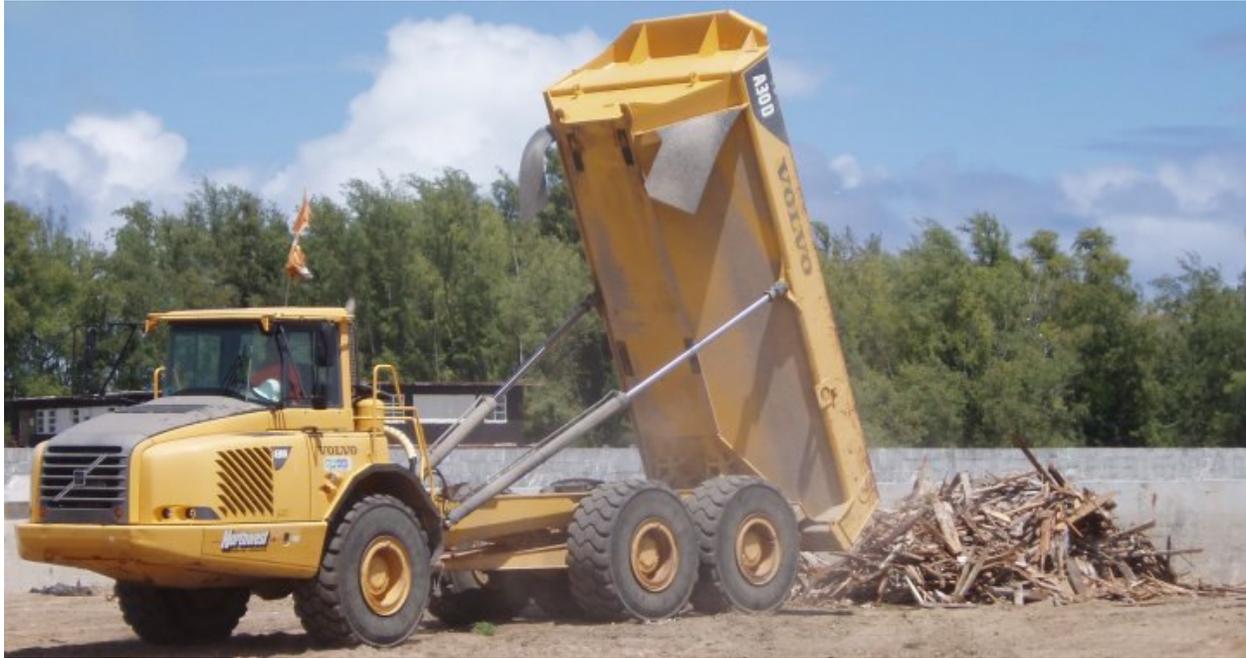
Photo 03: R2, Cell 2. Maectite treated wood debris from Bldg 579.

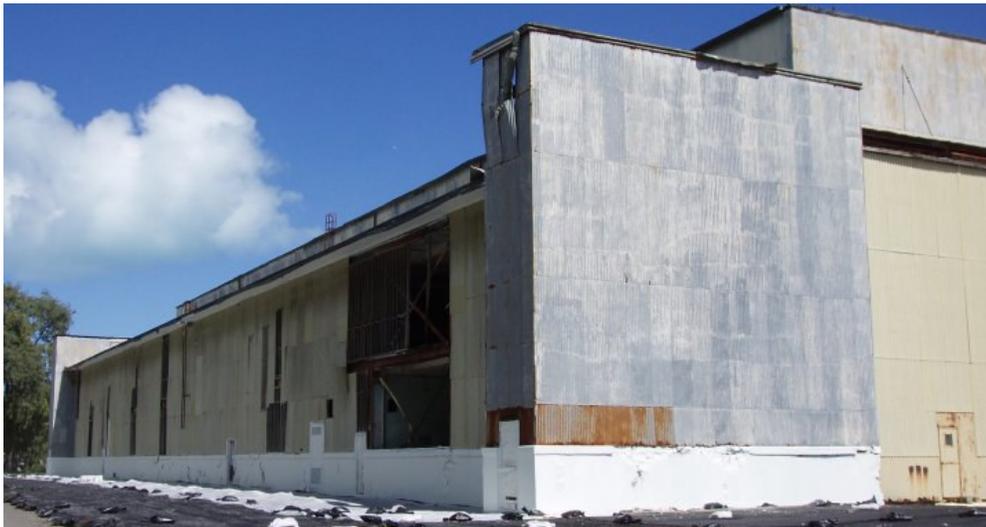
Photo 03: Sea Plane Hanger, short foundation walls painted with Lead Stop.

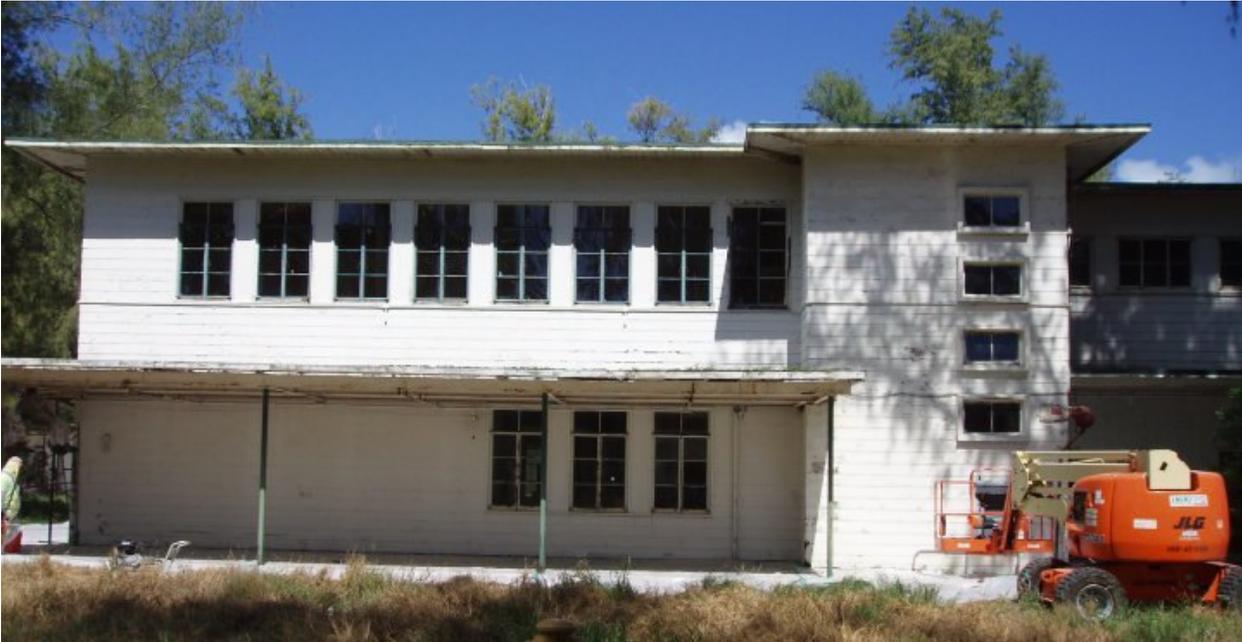
Photo 04: Eastern section of Bldg 259, lead scrape and Maectite prep.

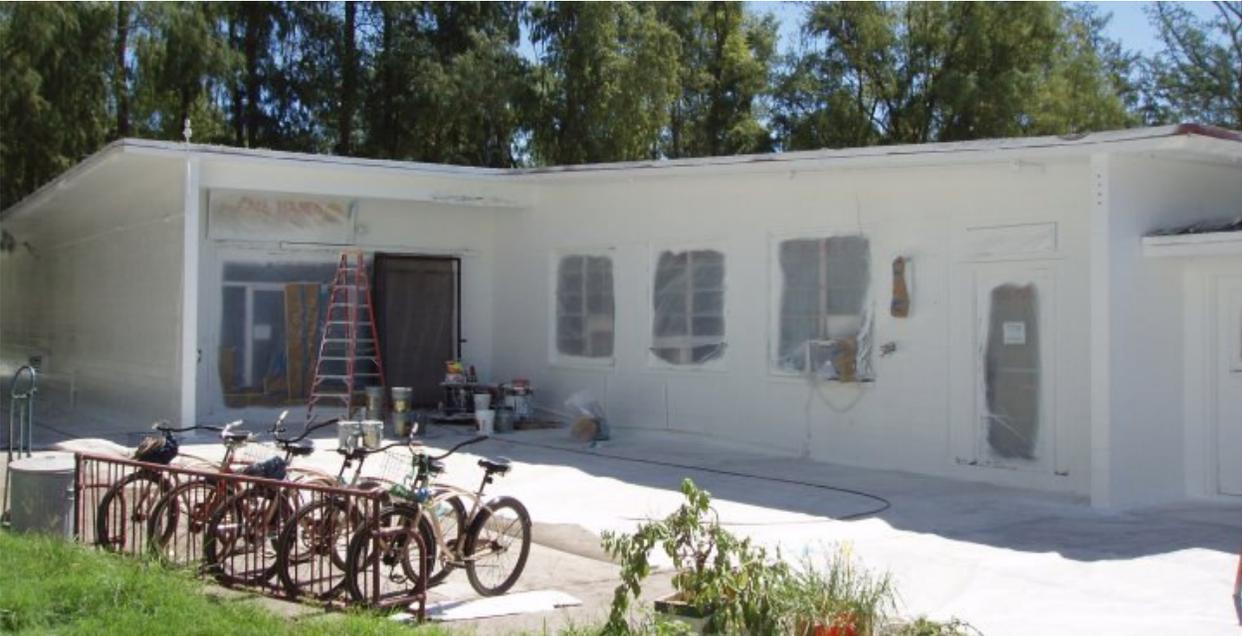
Photo 05: Bldg 2404 All Hands Club entry with Lead Stop paint.

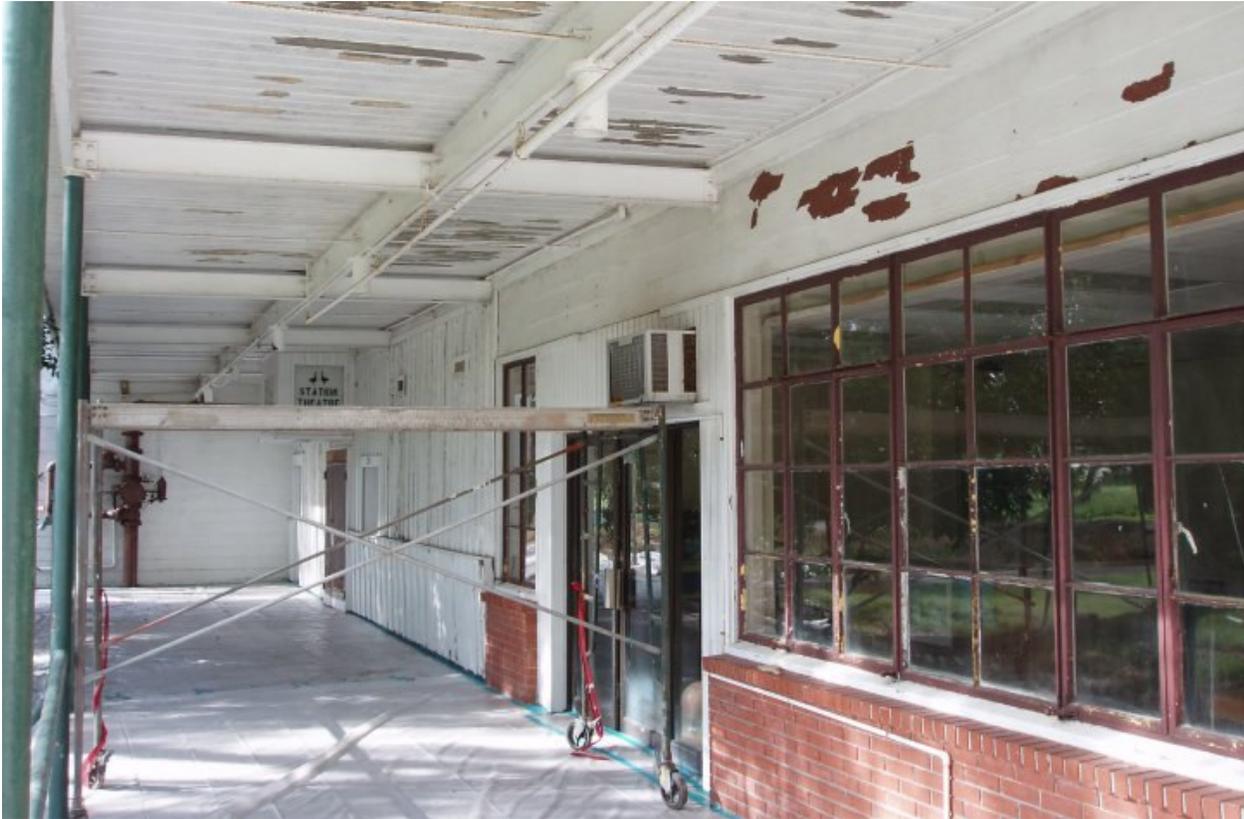
Photo 01: Bldg 259 theater entrance covered walkway. Lead scrape complete on LBP surfaces.

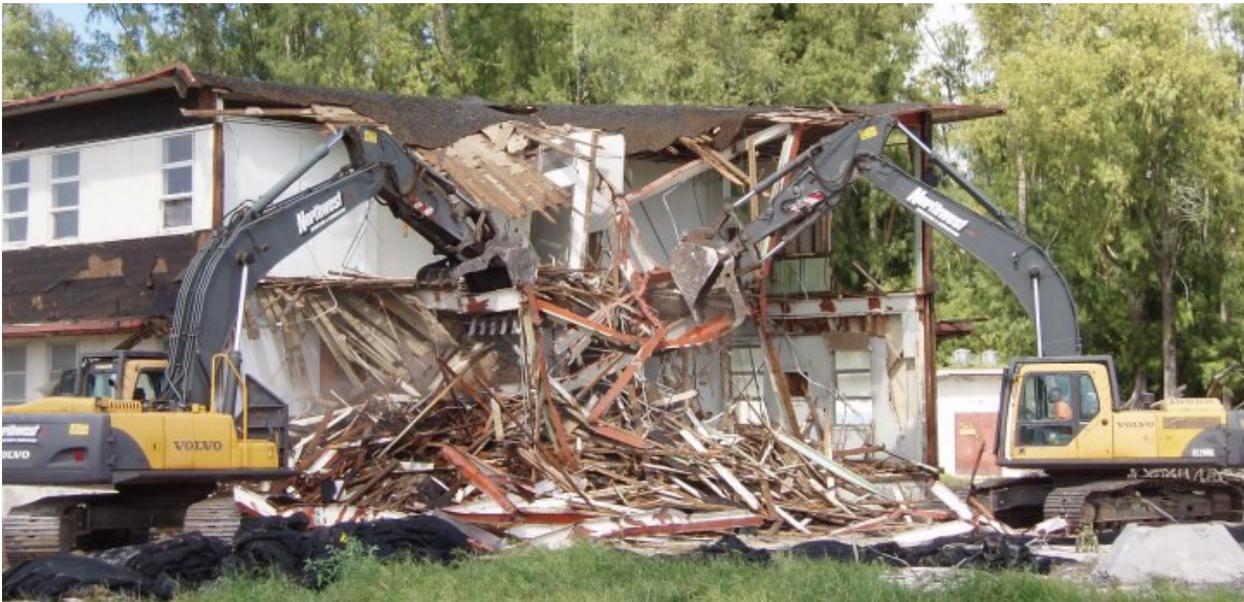
Photo 04: View Northeast- The south end of Bldg 578 being dismantled.

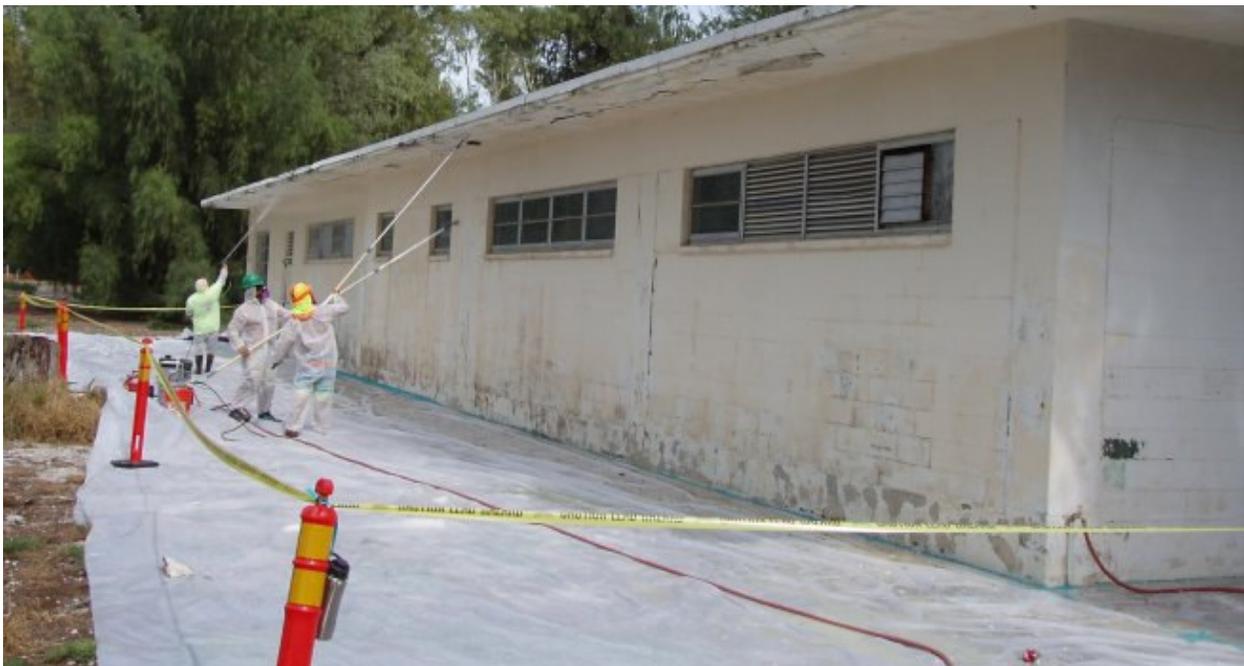
Photo 03: View Northeast- Bldg 2403 lead scrape tasks.

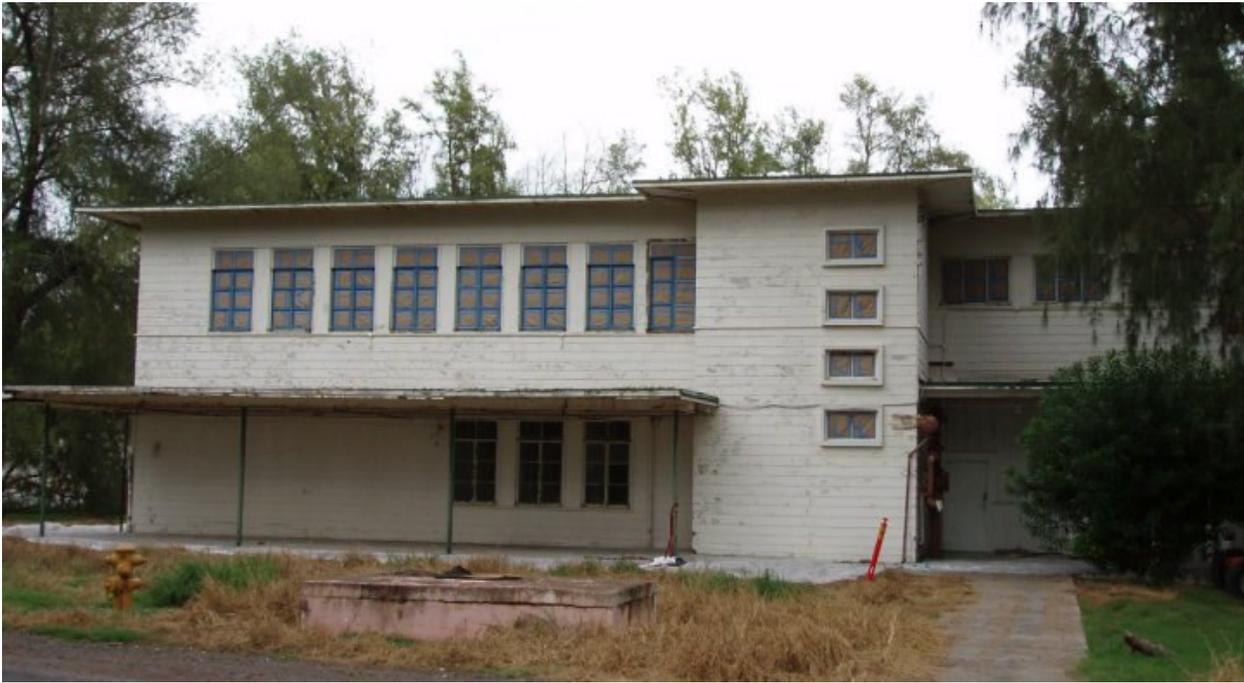
Photo 04: View Northeast- Bldg 259, northwest section. Mask and tape for paint.

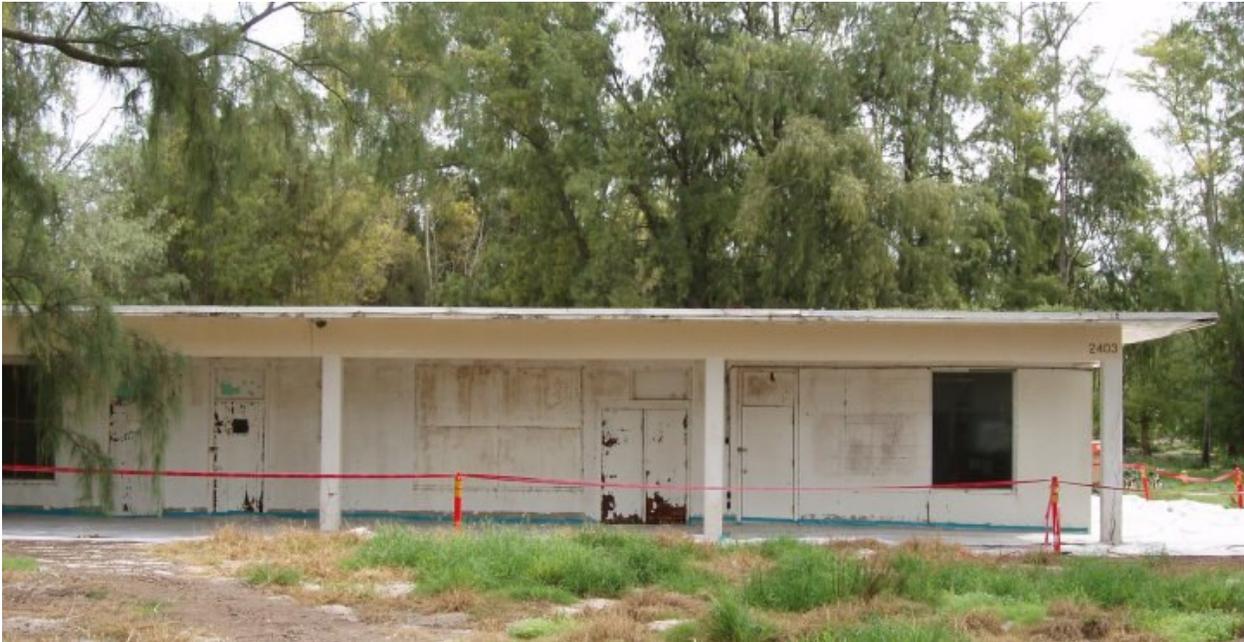
Photo 05: View Northeast- Bldg 2403, southeast section. Lead scrape task.

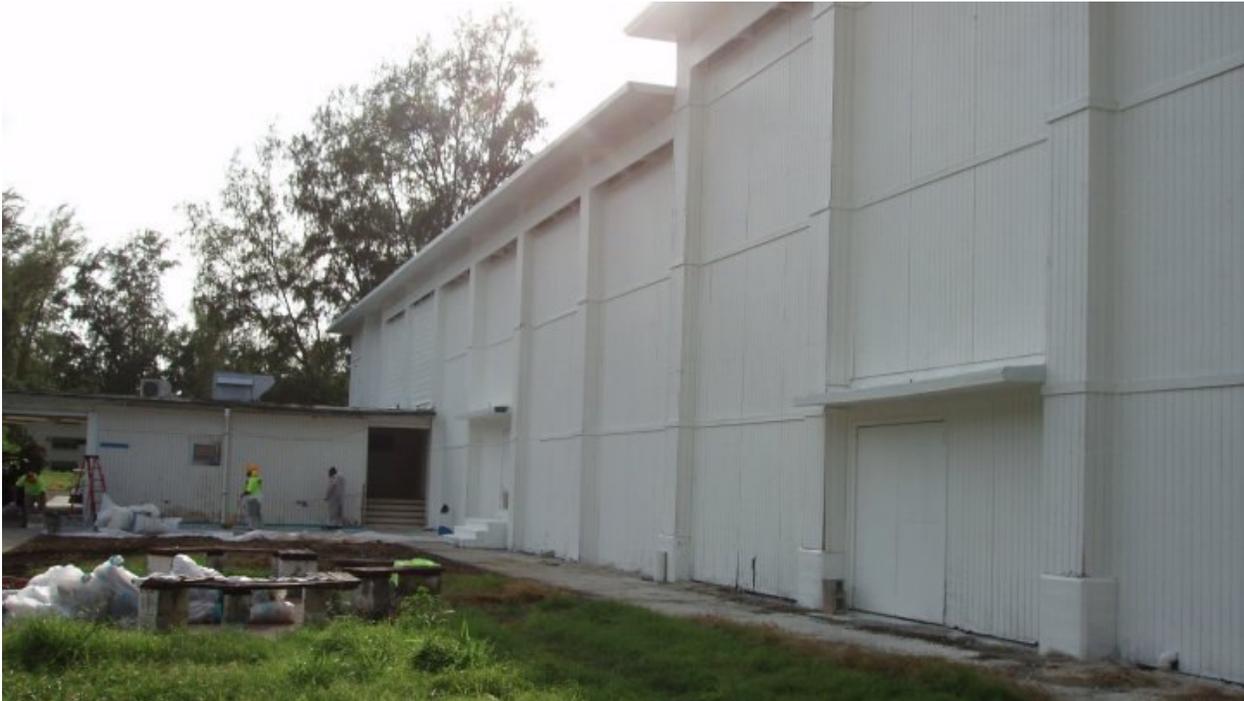
Photo 04: View West- Bldg 259 courtyard Lead Stop paint on theater wall.

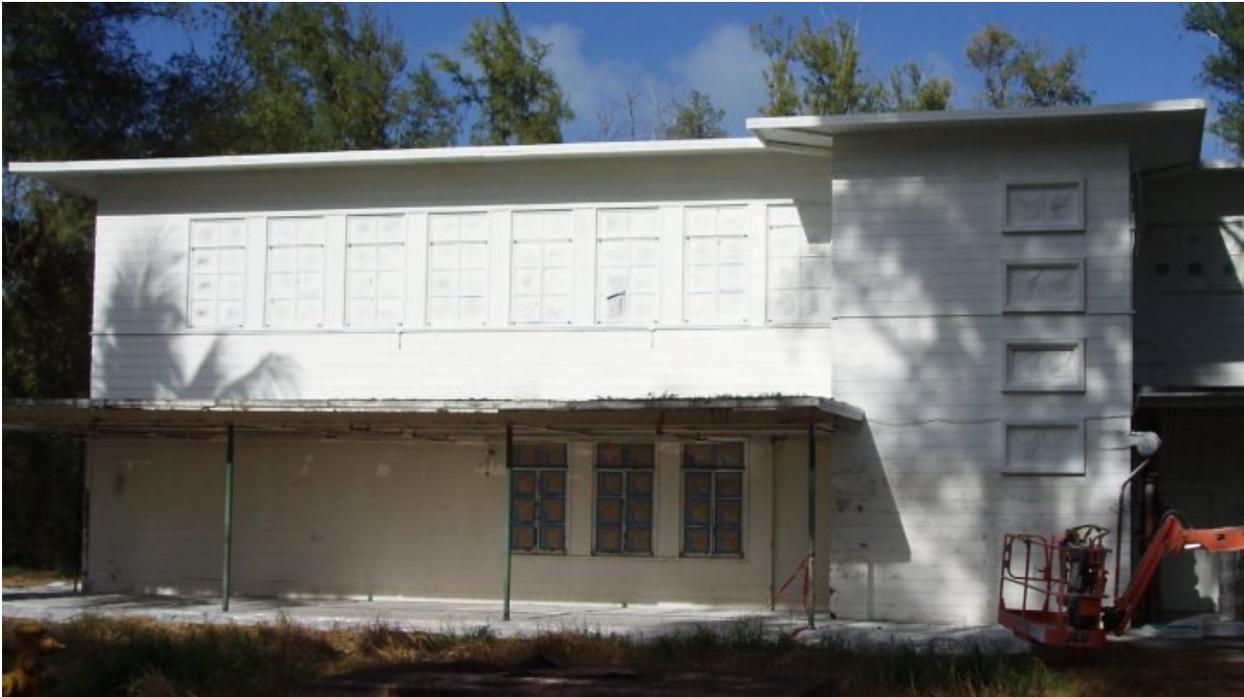
Photo 05: View Northeast- Bldg 259 theater wall with Lead Stop paint applied.
