**2013 ANNUAL REPORT
CERCLA NON-TIME CRITICAL
REMOVAL ACTION**

**MIDWAY ATOLL NATIONAL WILDLIFE REFUGE
MIDWAY ISLAND
Contract No. F11PC00327**

28 February 2014

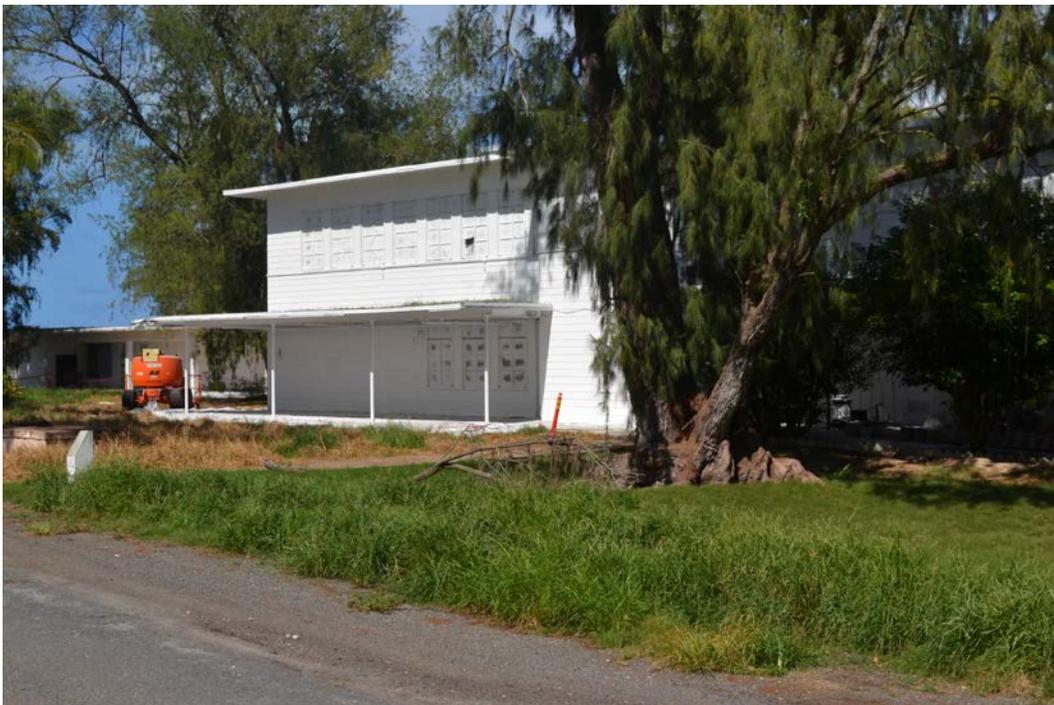
Photo 04: View NW corner of Bldg 259 – Applying Lead Stop.

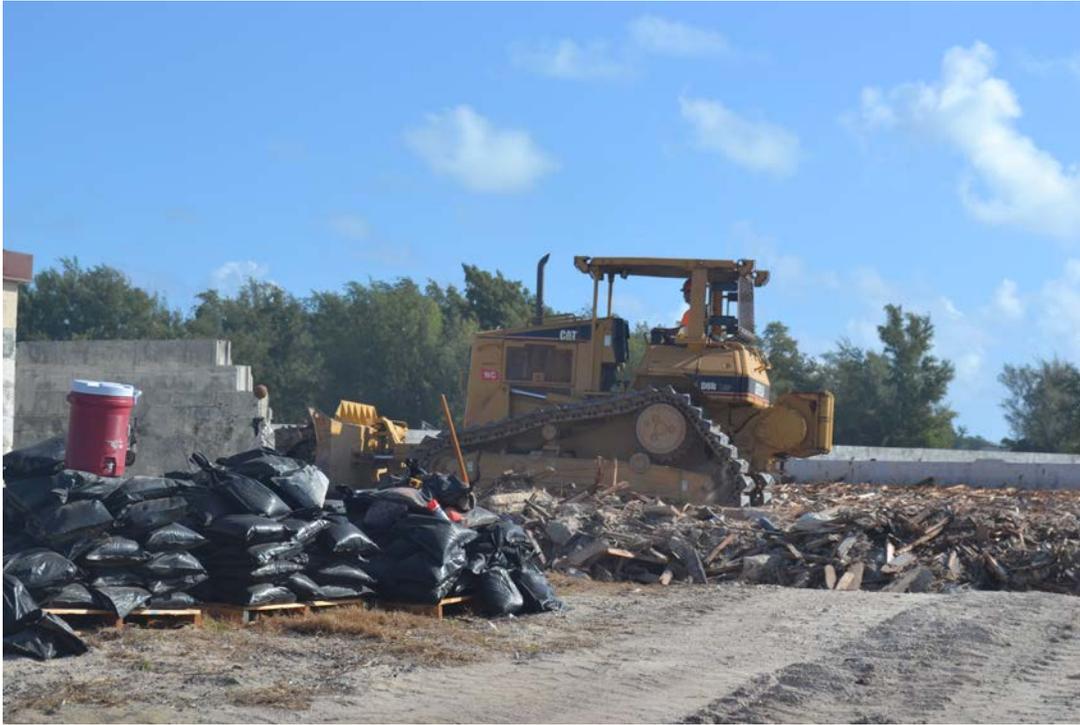
Photo 05: View east side of R2 Unit – Compacting demolition debris from Bldgs 578 / 579 in active cell.

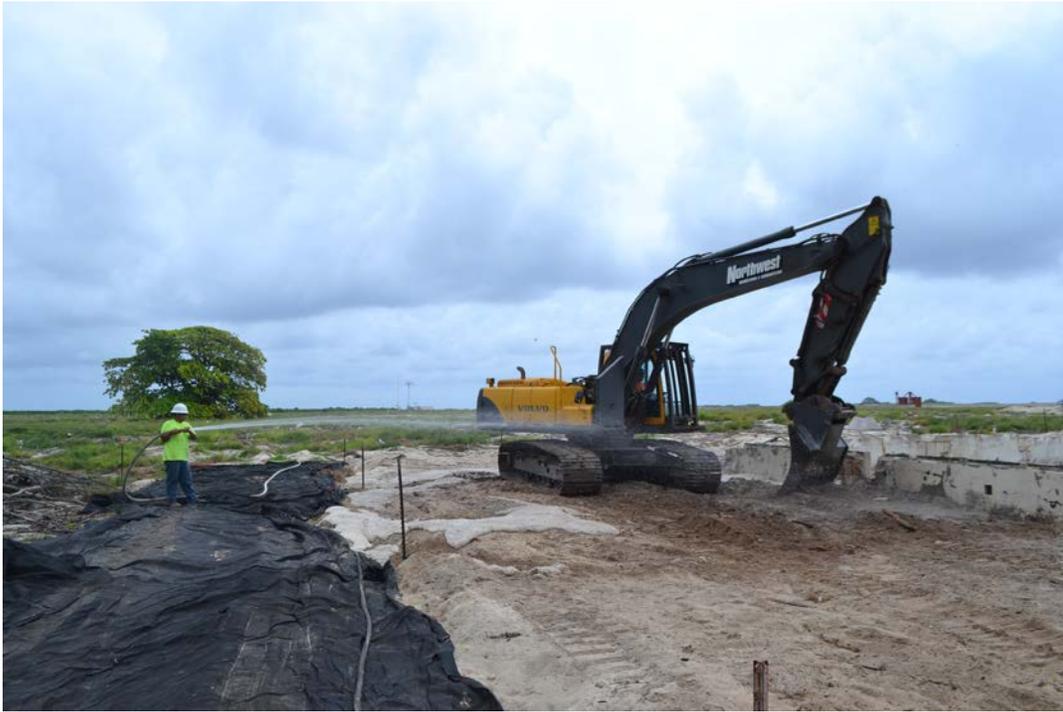
Photo 03: View east side of Bldg 578 – Mixing to uniformity with continuous wetting.

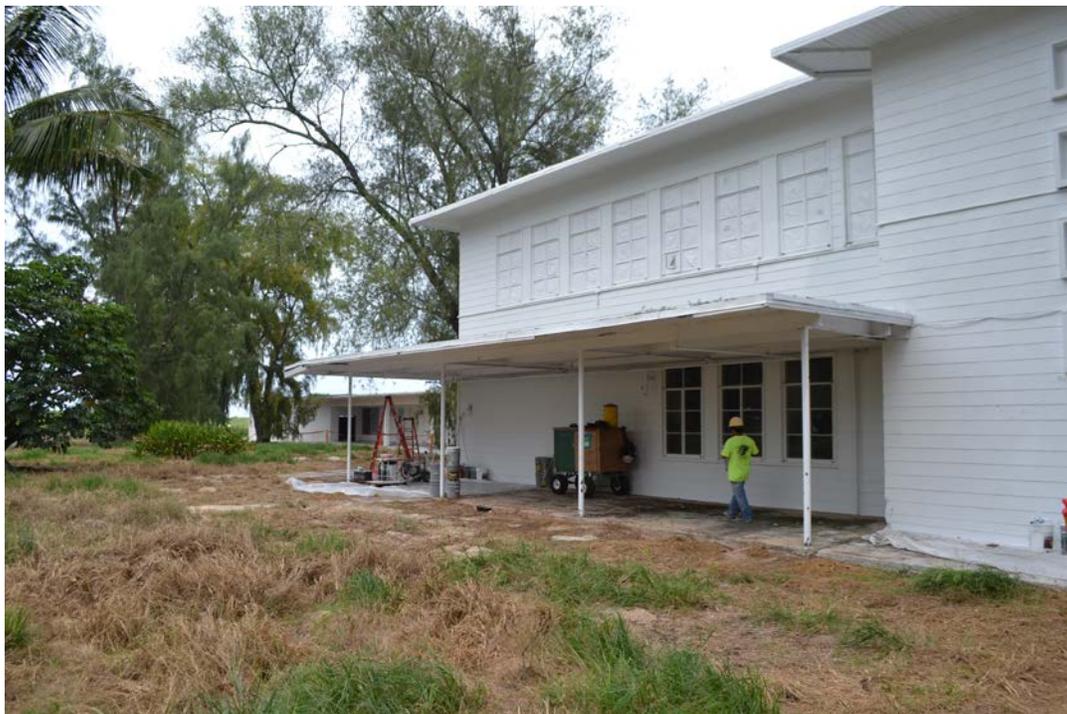
Photo 04: View NW corner of Bldg 259 – Cleaning up after completion of top coat.

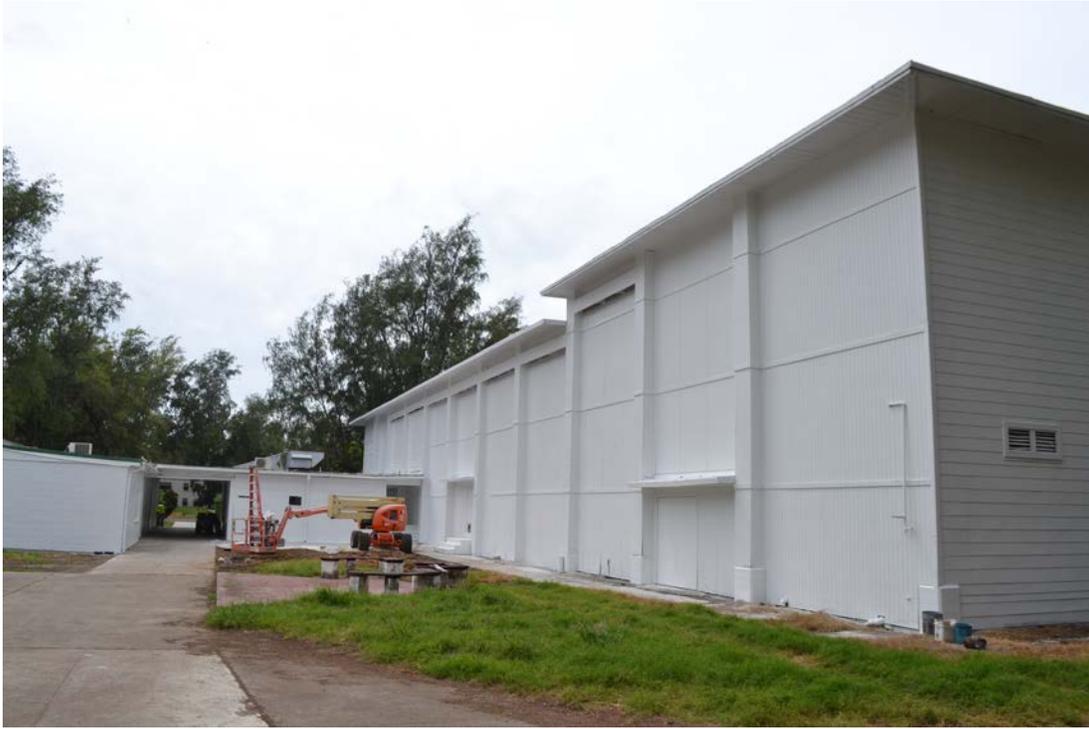
Photo 05: View back side of theatre Bldg 259 – Top coat complete.

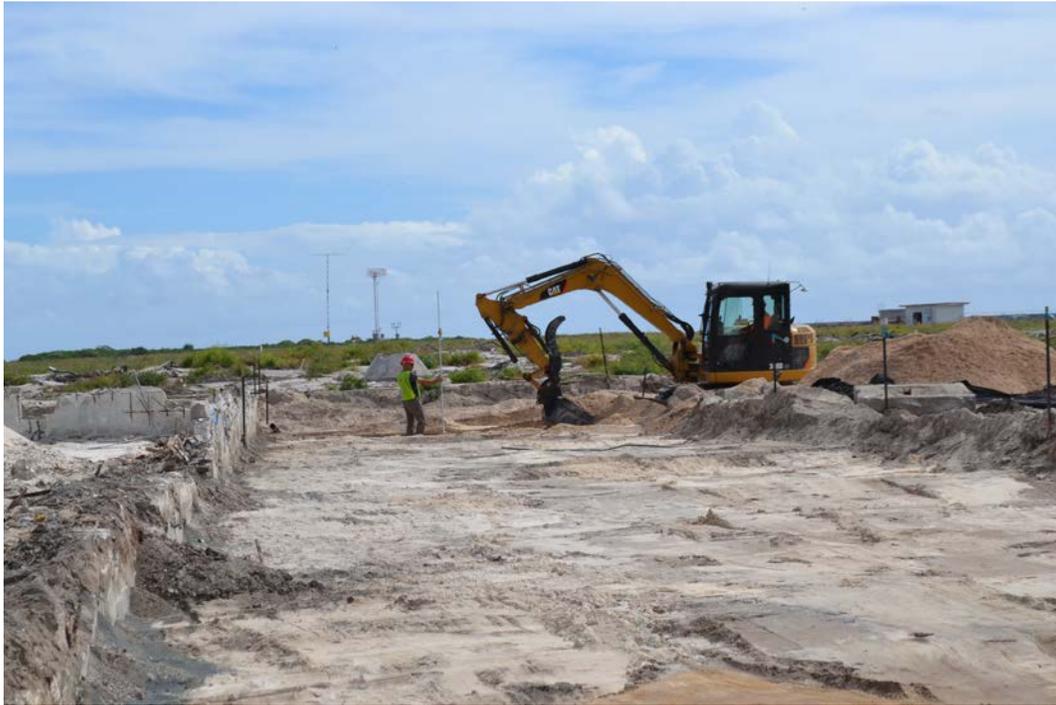
Photo 03: View west side of Bldg 578 – Excavating treated sand along south side of Bldgs 578 / 579.

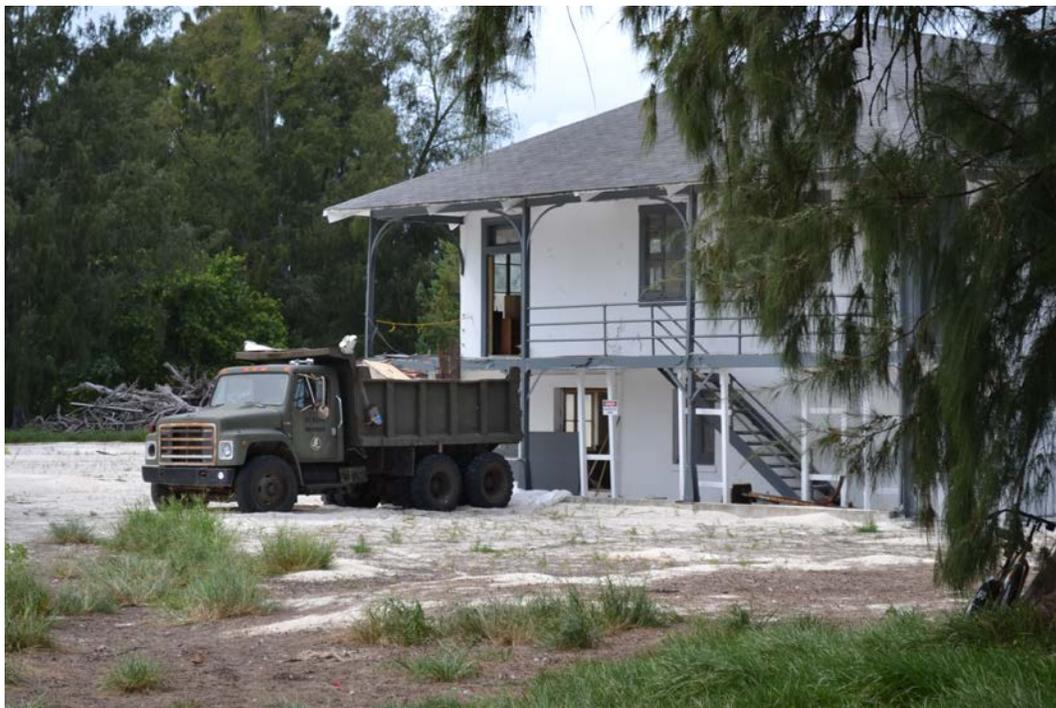
Photo 04: View of Bldg 643 – Cleaning debris out prior to abatement.

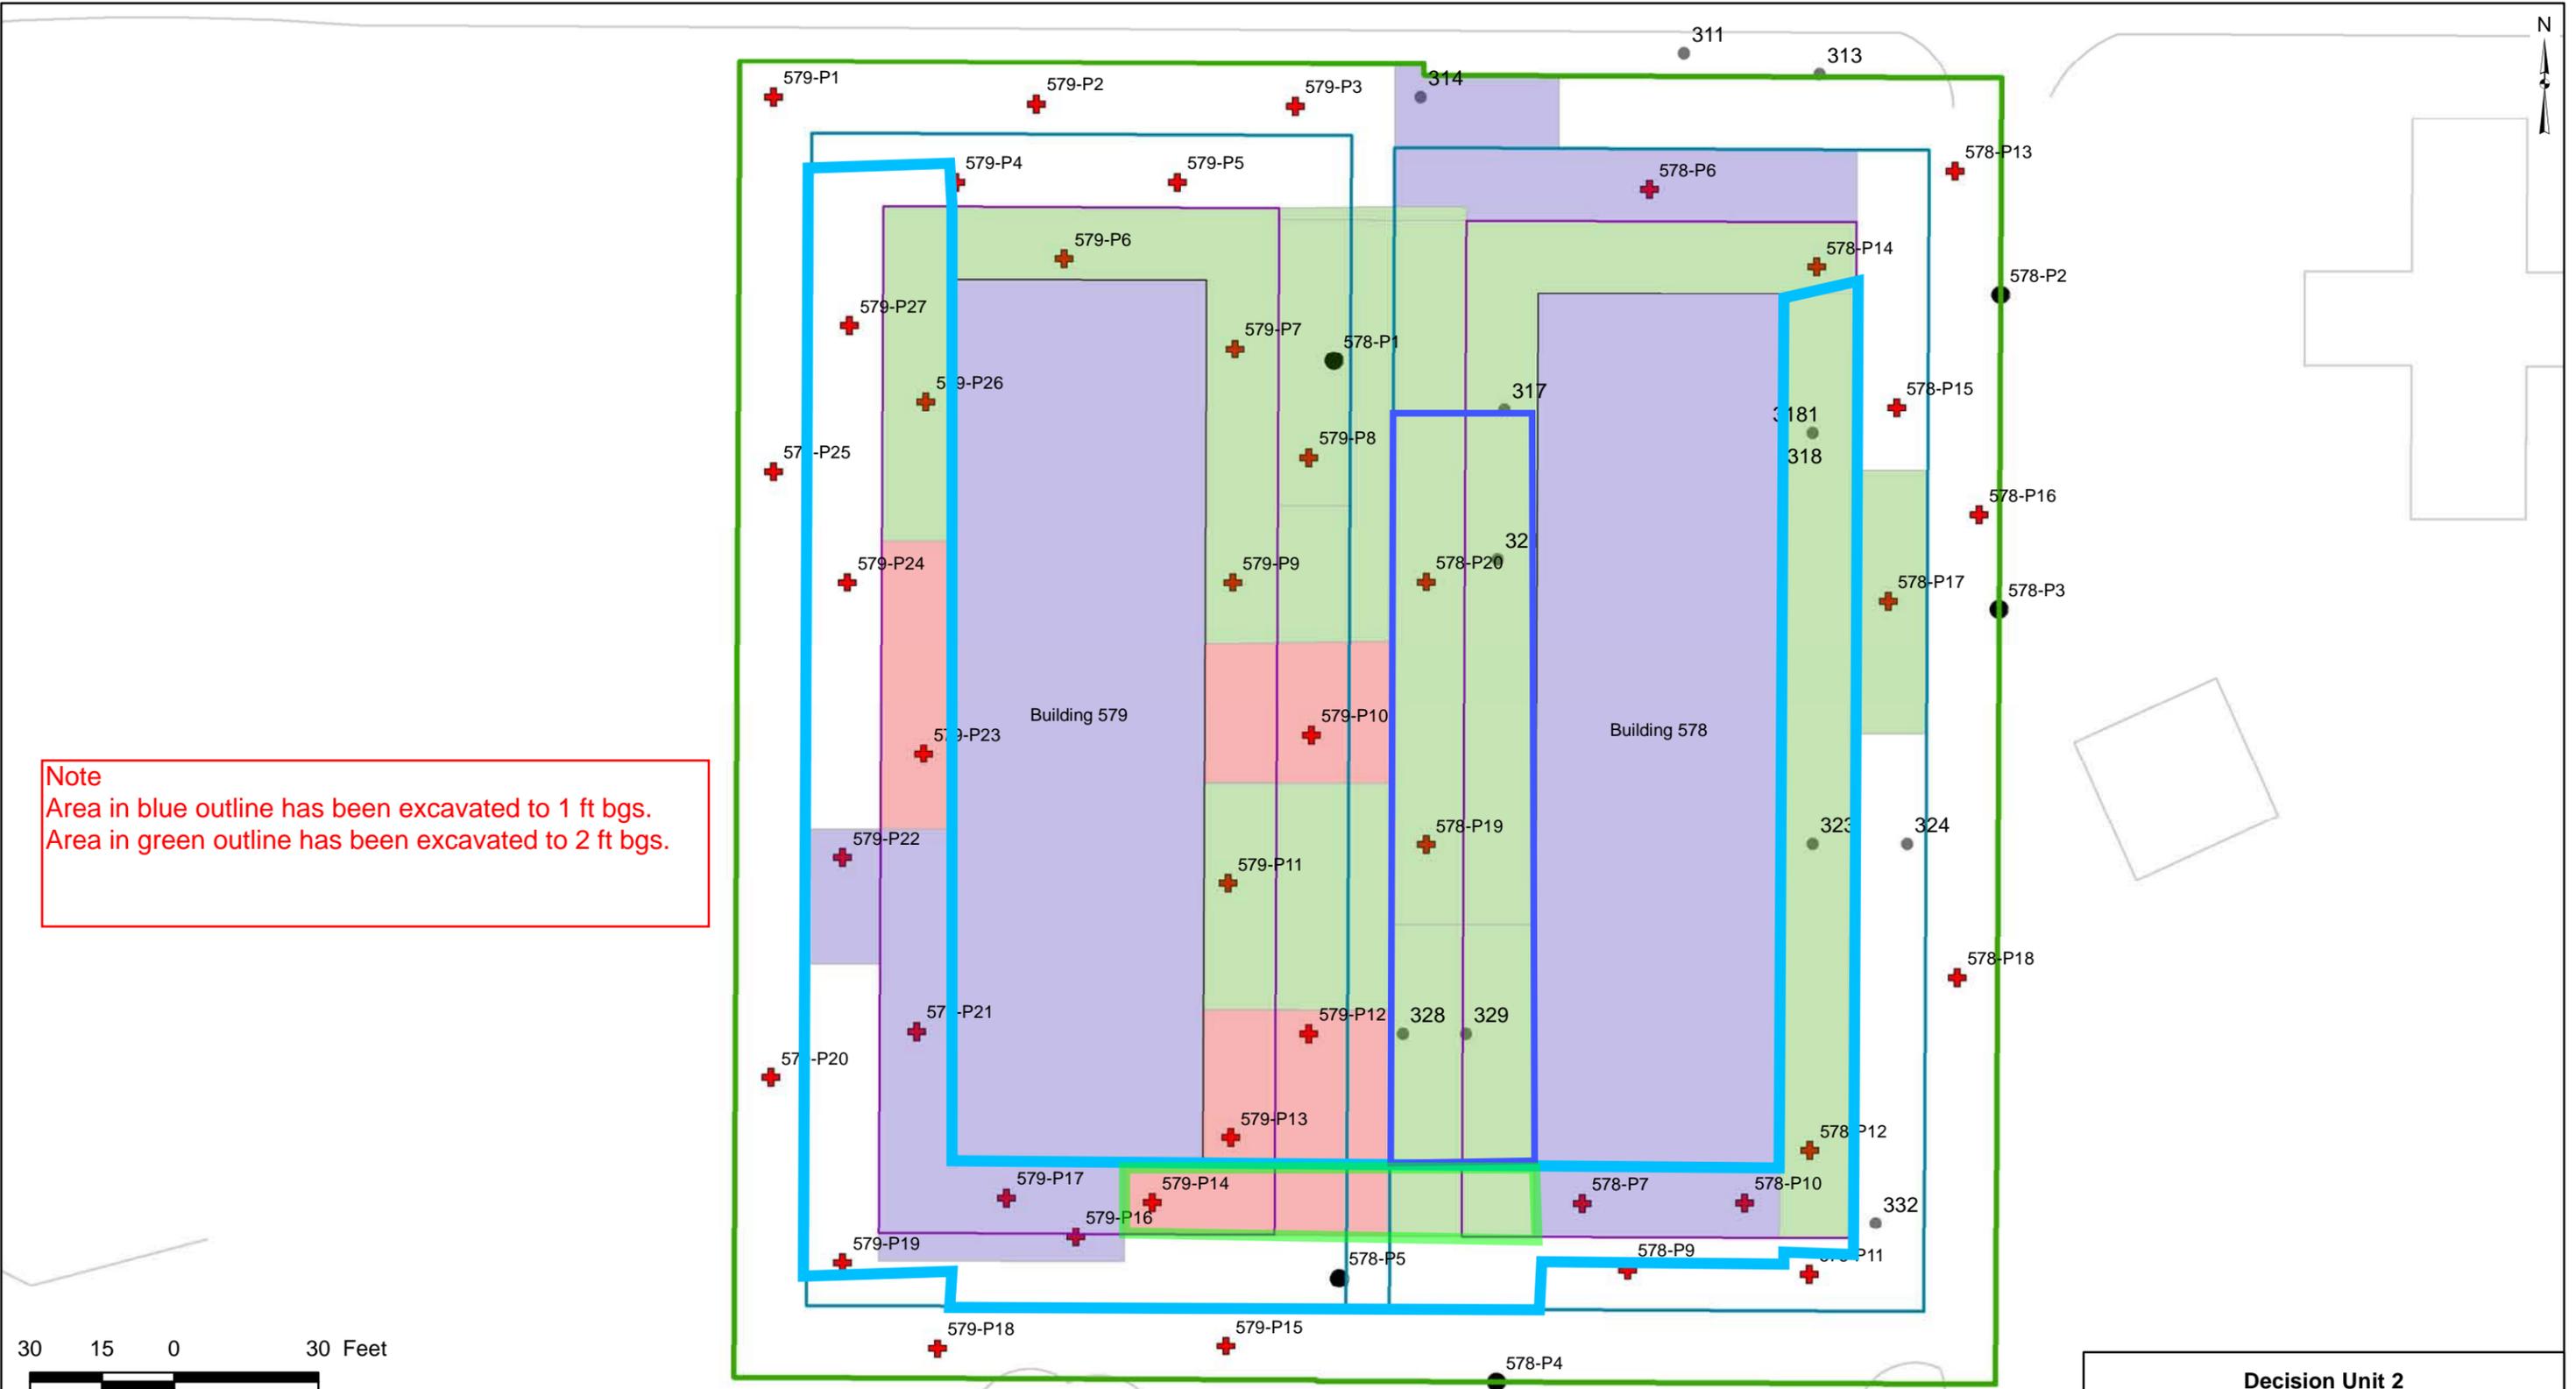
Note
 Area in blue outline has been excavated to 1 ft bgs.
 Area in green outline has been excavated to 2 ft bgs.

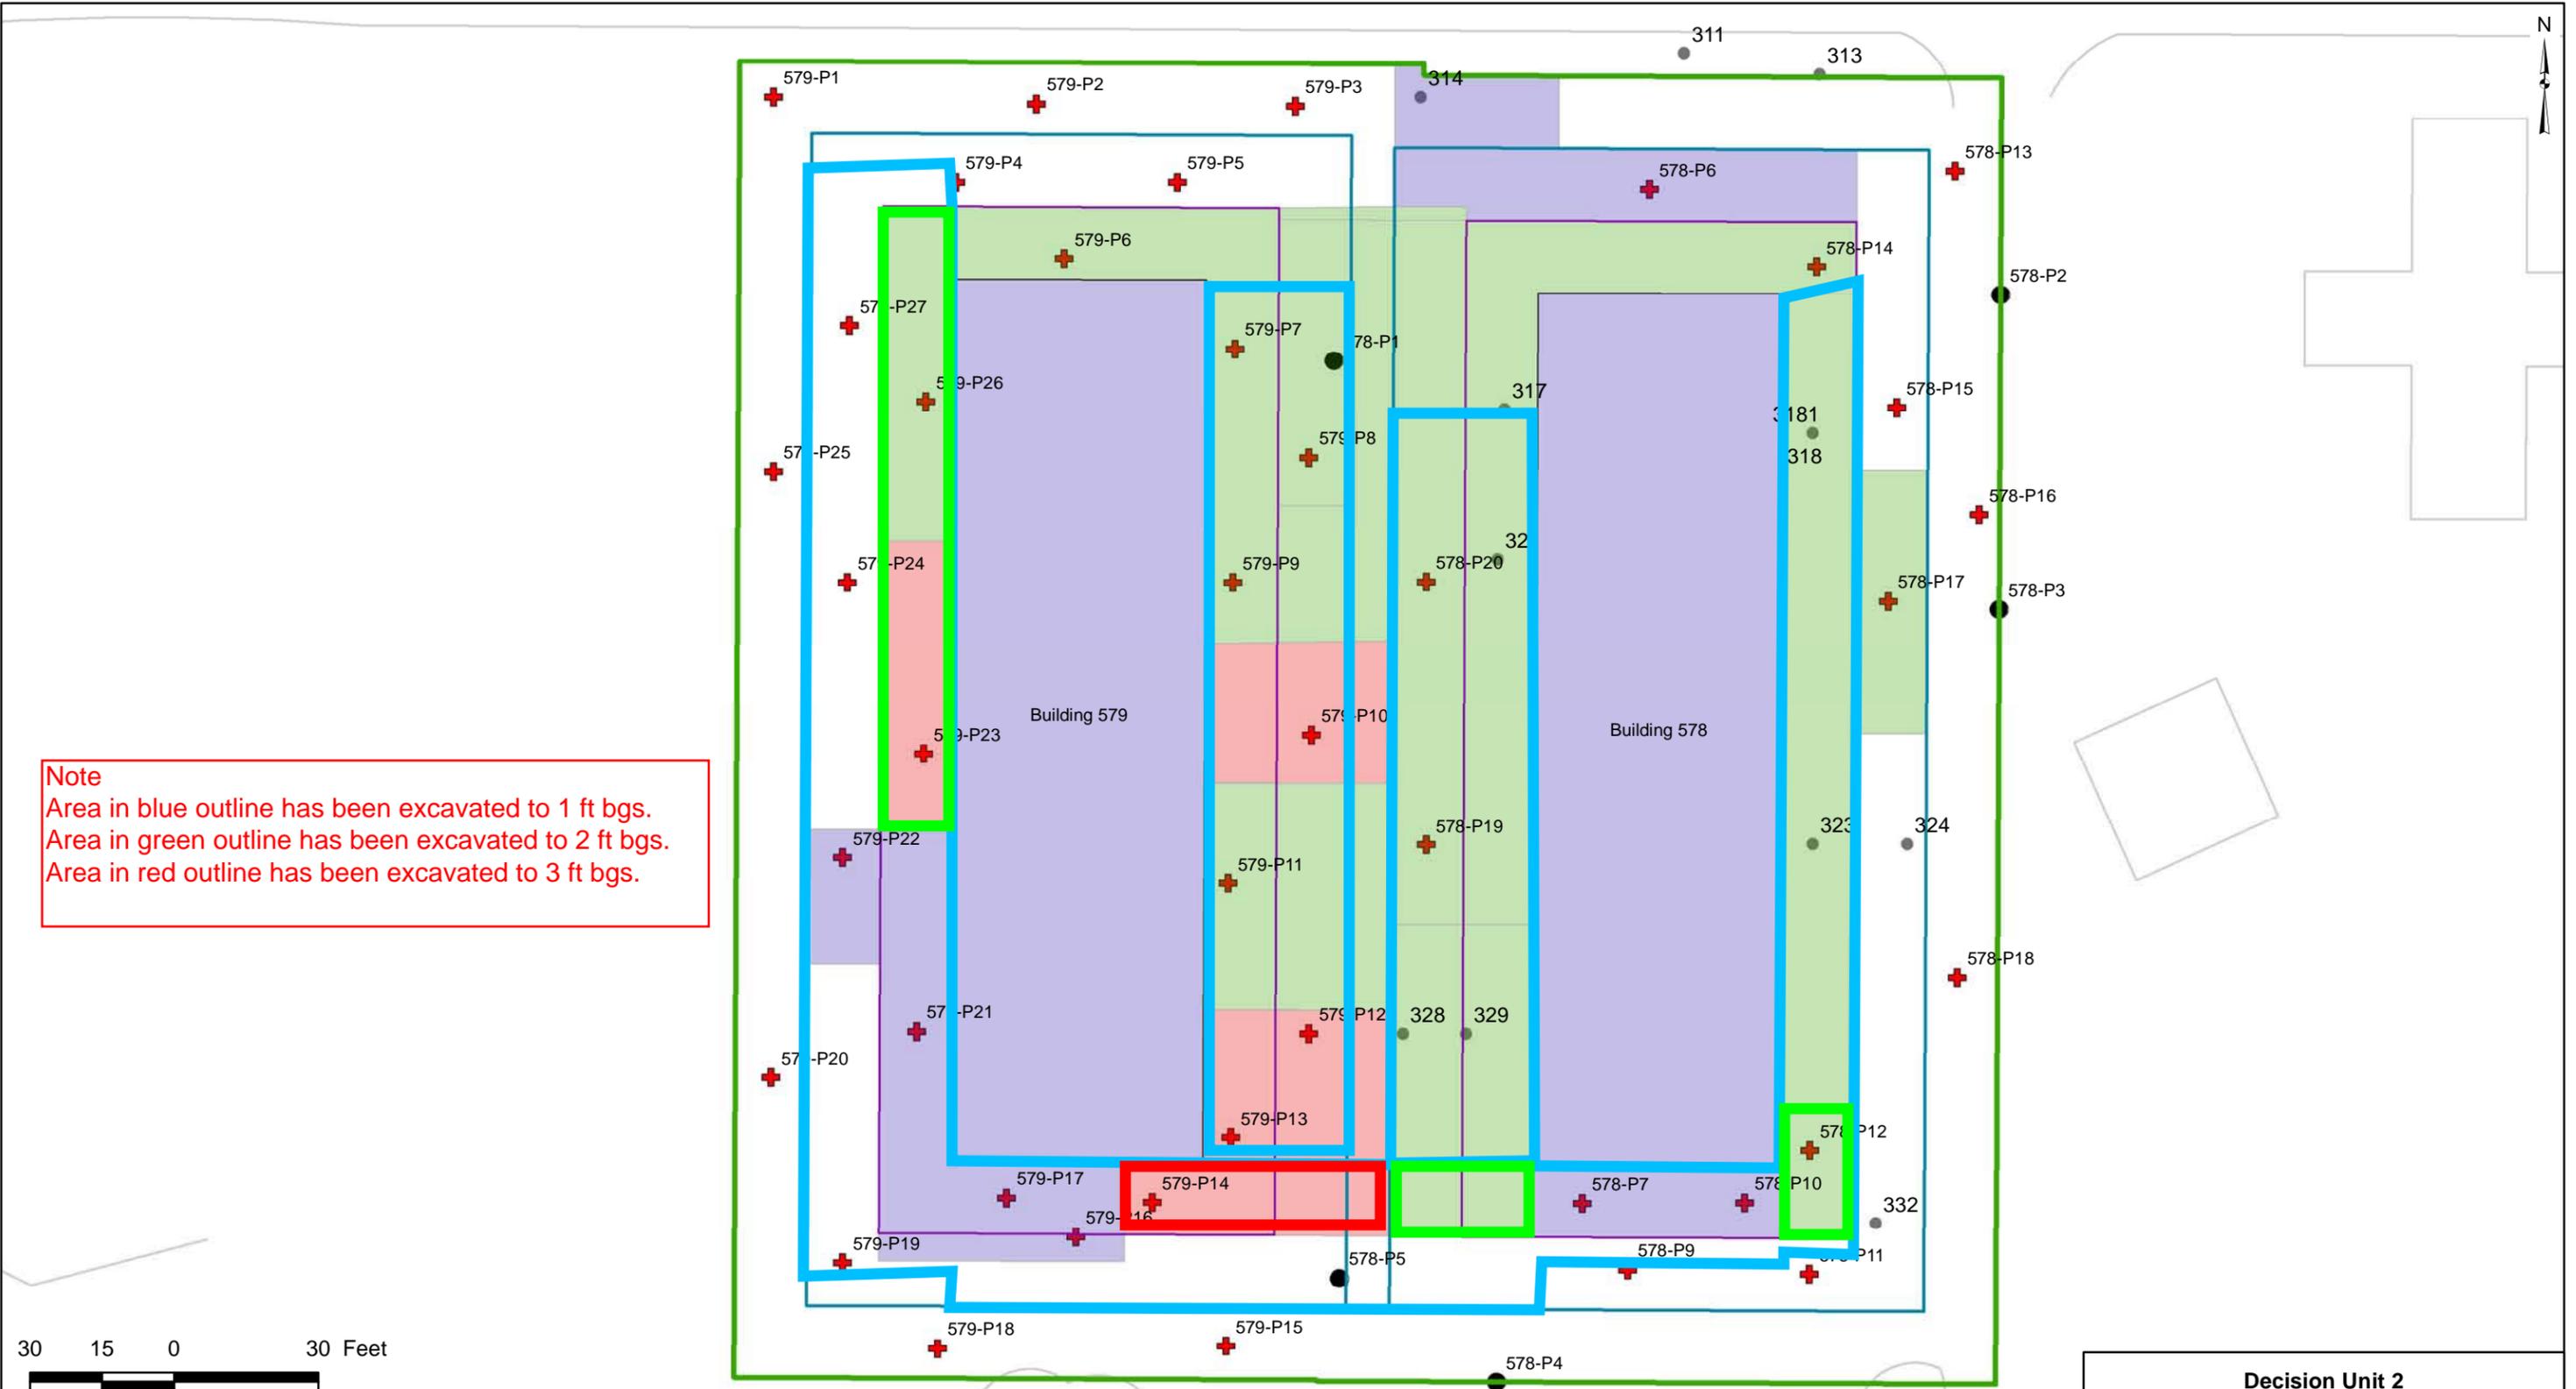
Note
 Area in blue outline has been excavated to 1 ft bgs.
 Area in green outline has been excavated to 2 ft bgs.
 Area in red outline has been excavated to 3 ft bgs.

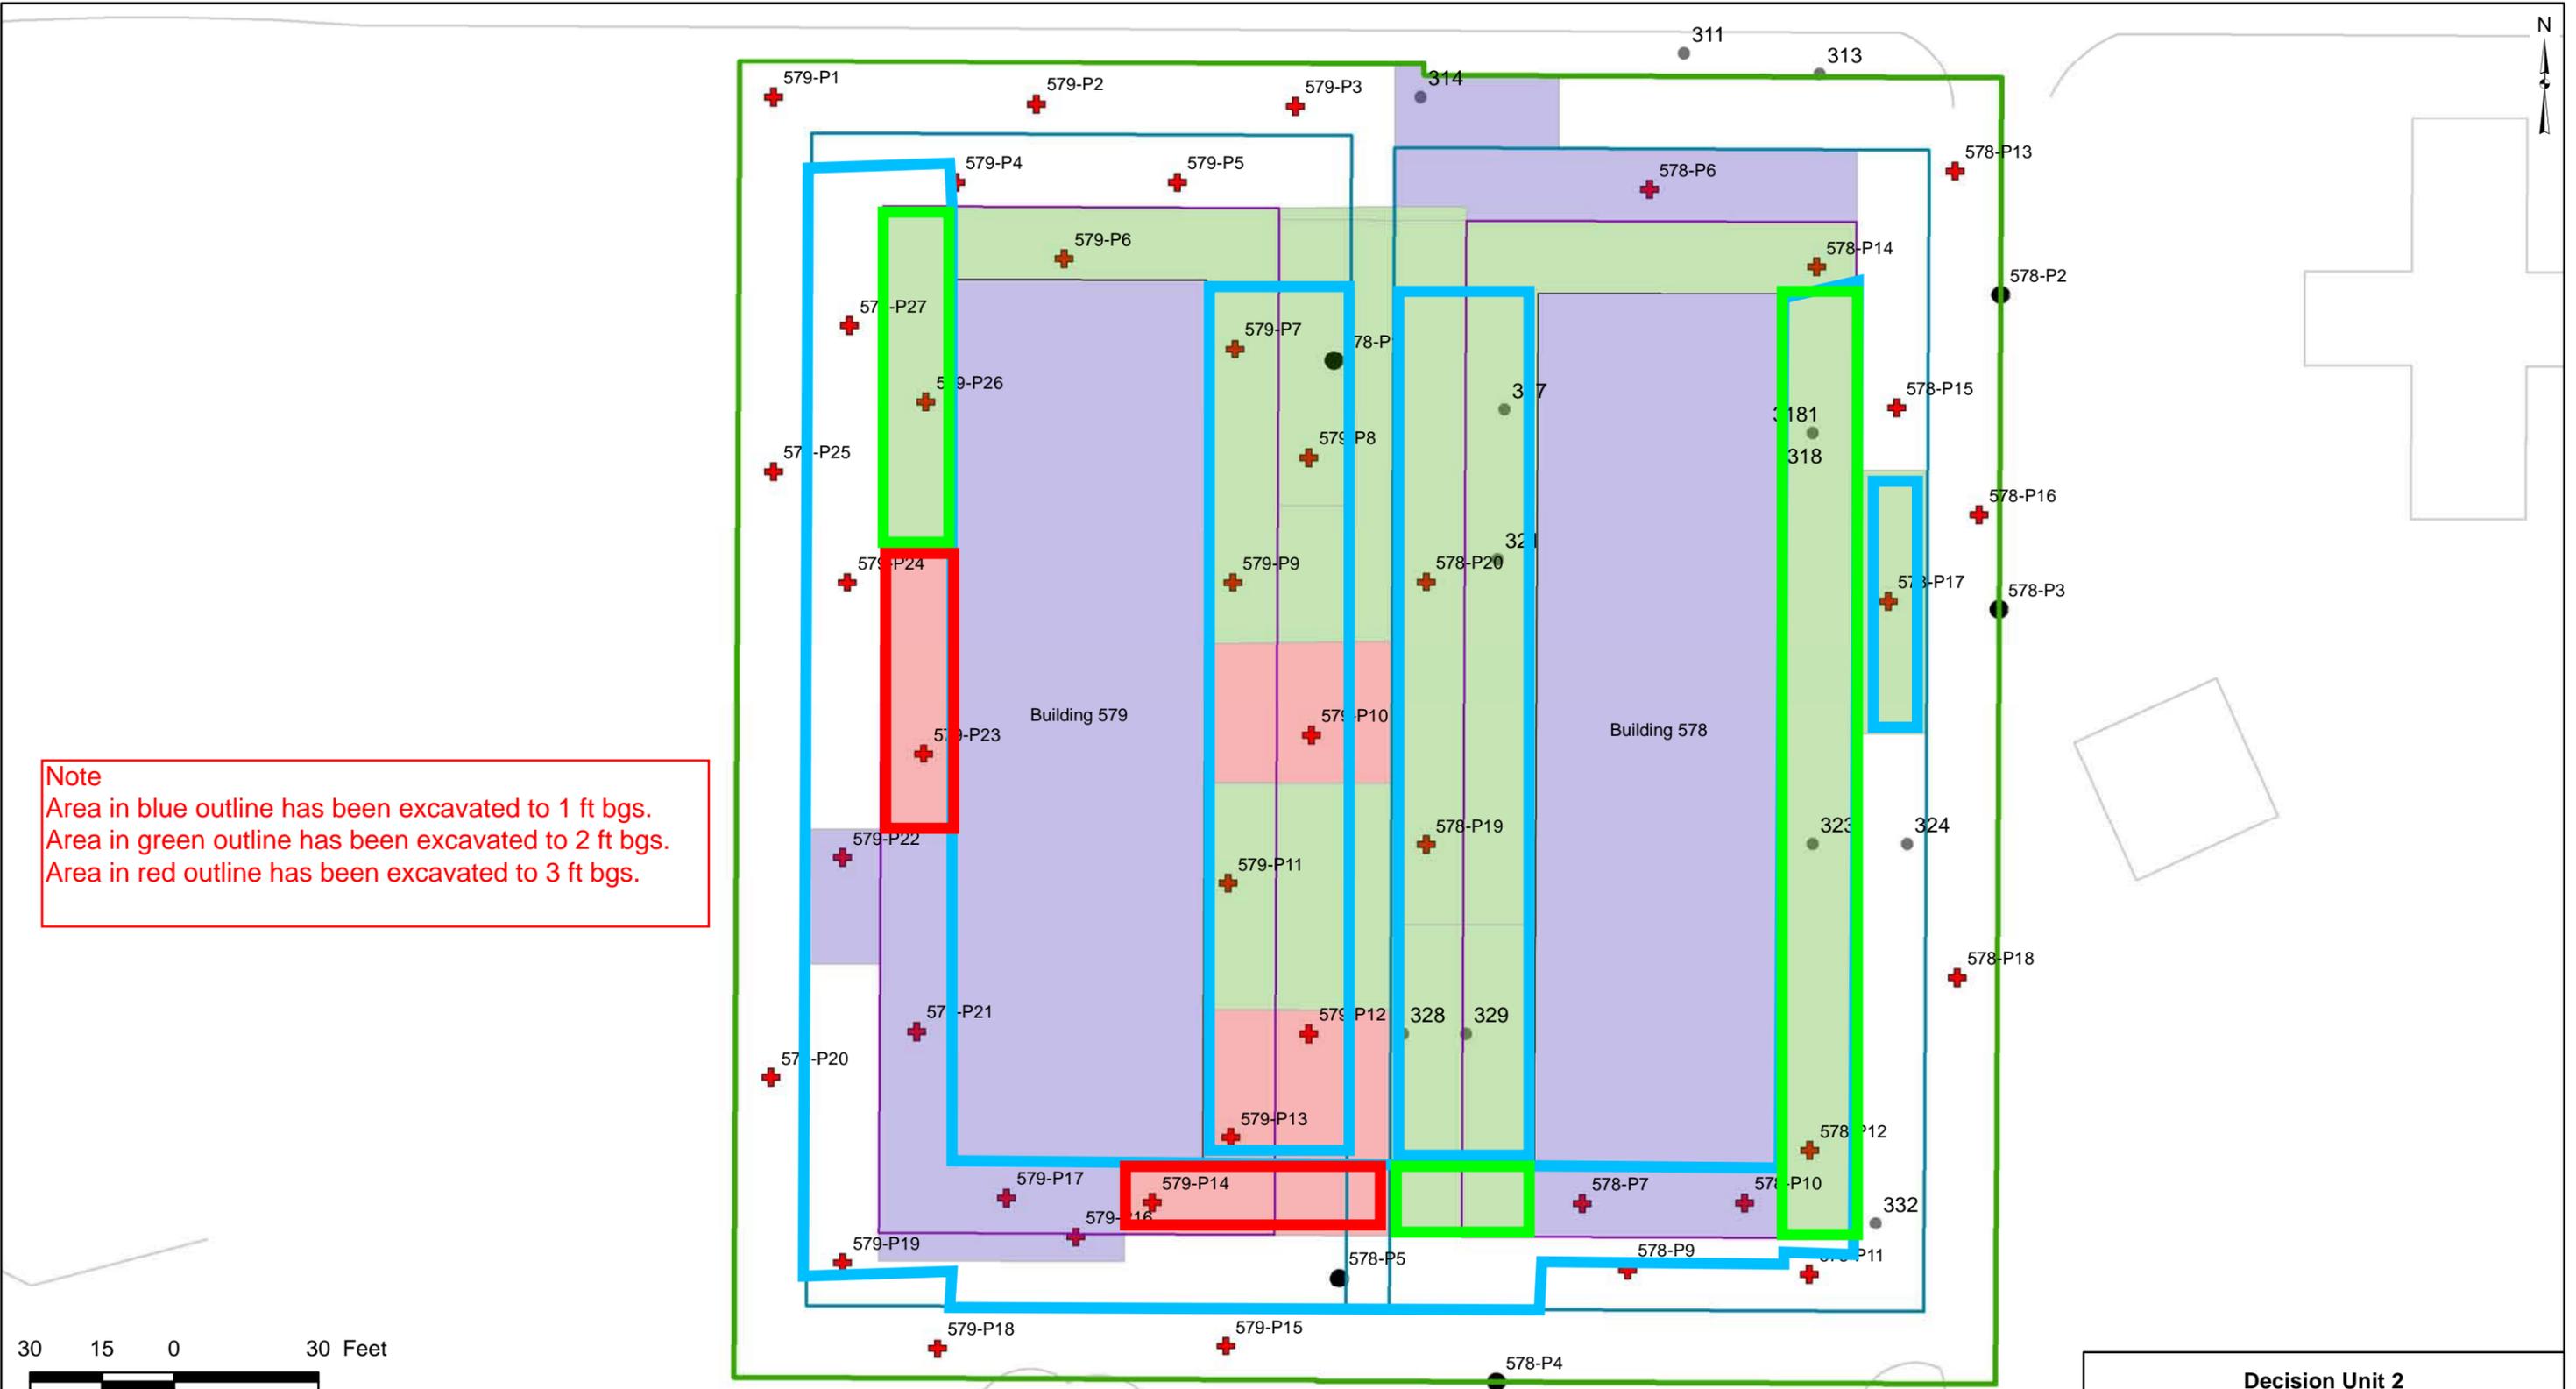
Note
 Area in blue outline has been excavated to 1 ft bgs.
 Area in green outline has been excavated to 2 ft bgs.
 Area in red outline has been excavated to 3 ft bgs.

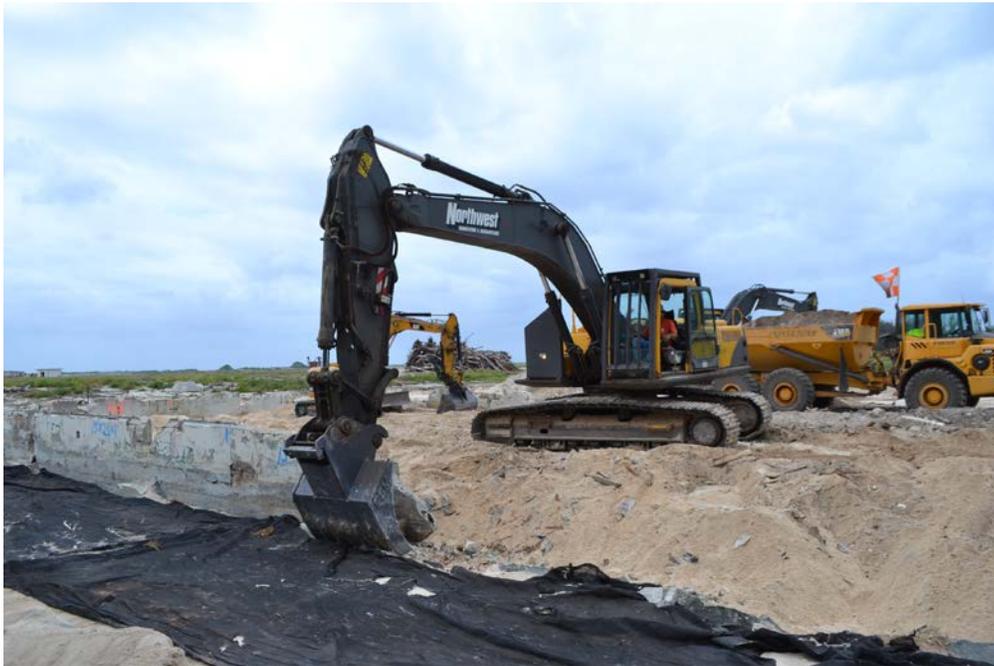
Photo 02: View of east side of Bldg 578 – Demolishing concrete foundation wall.

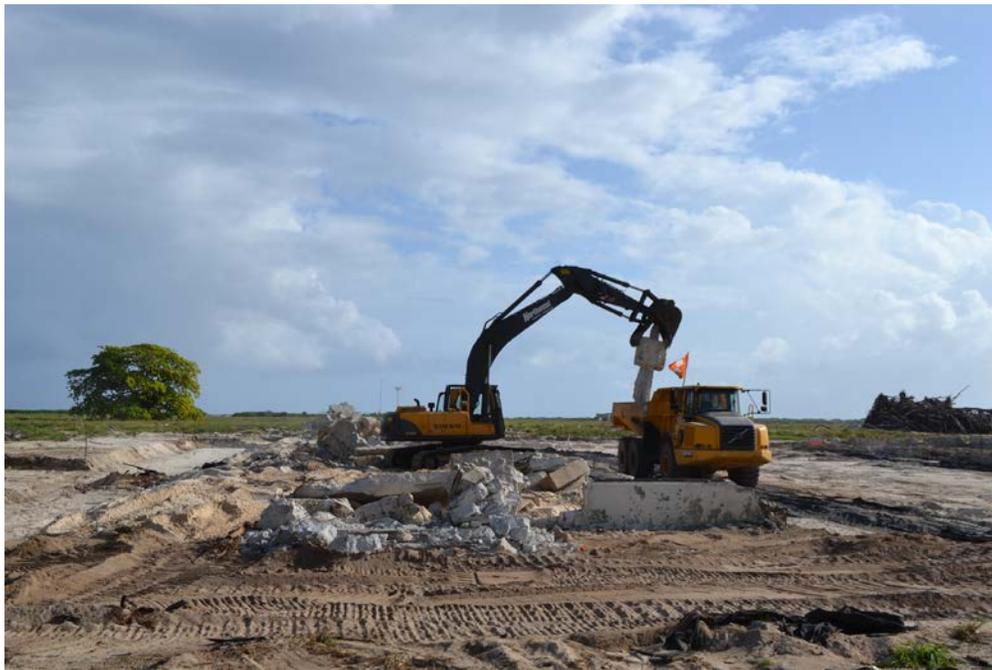
Photo 03: View of north side of Bldg 578 – Loading out concrete.

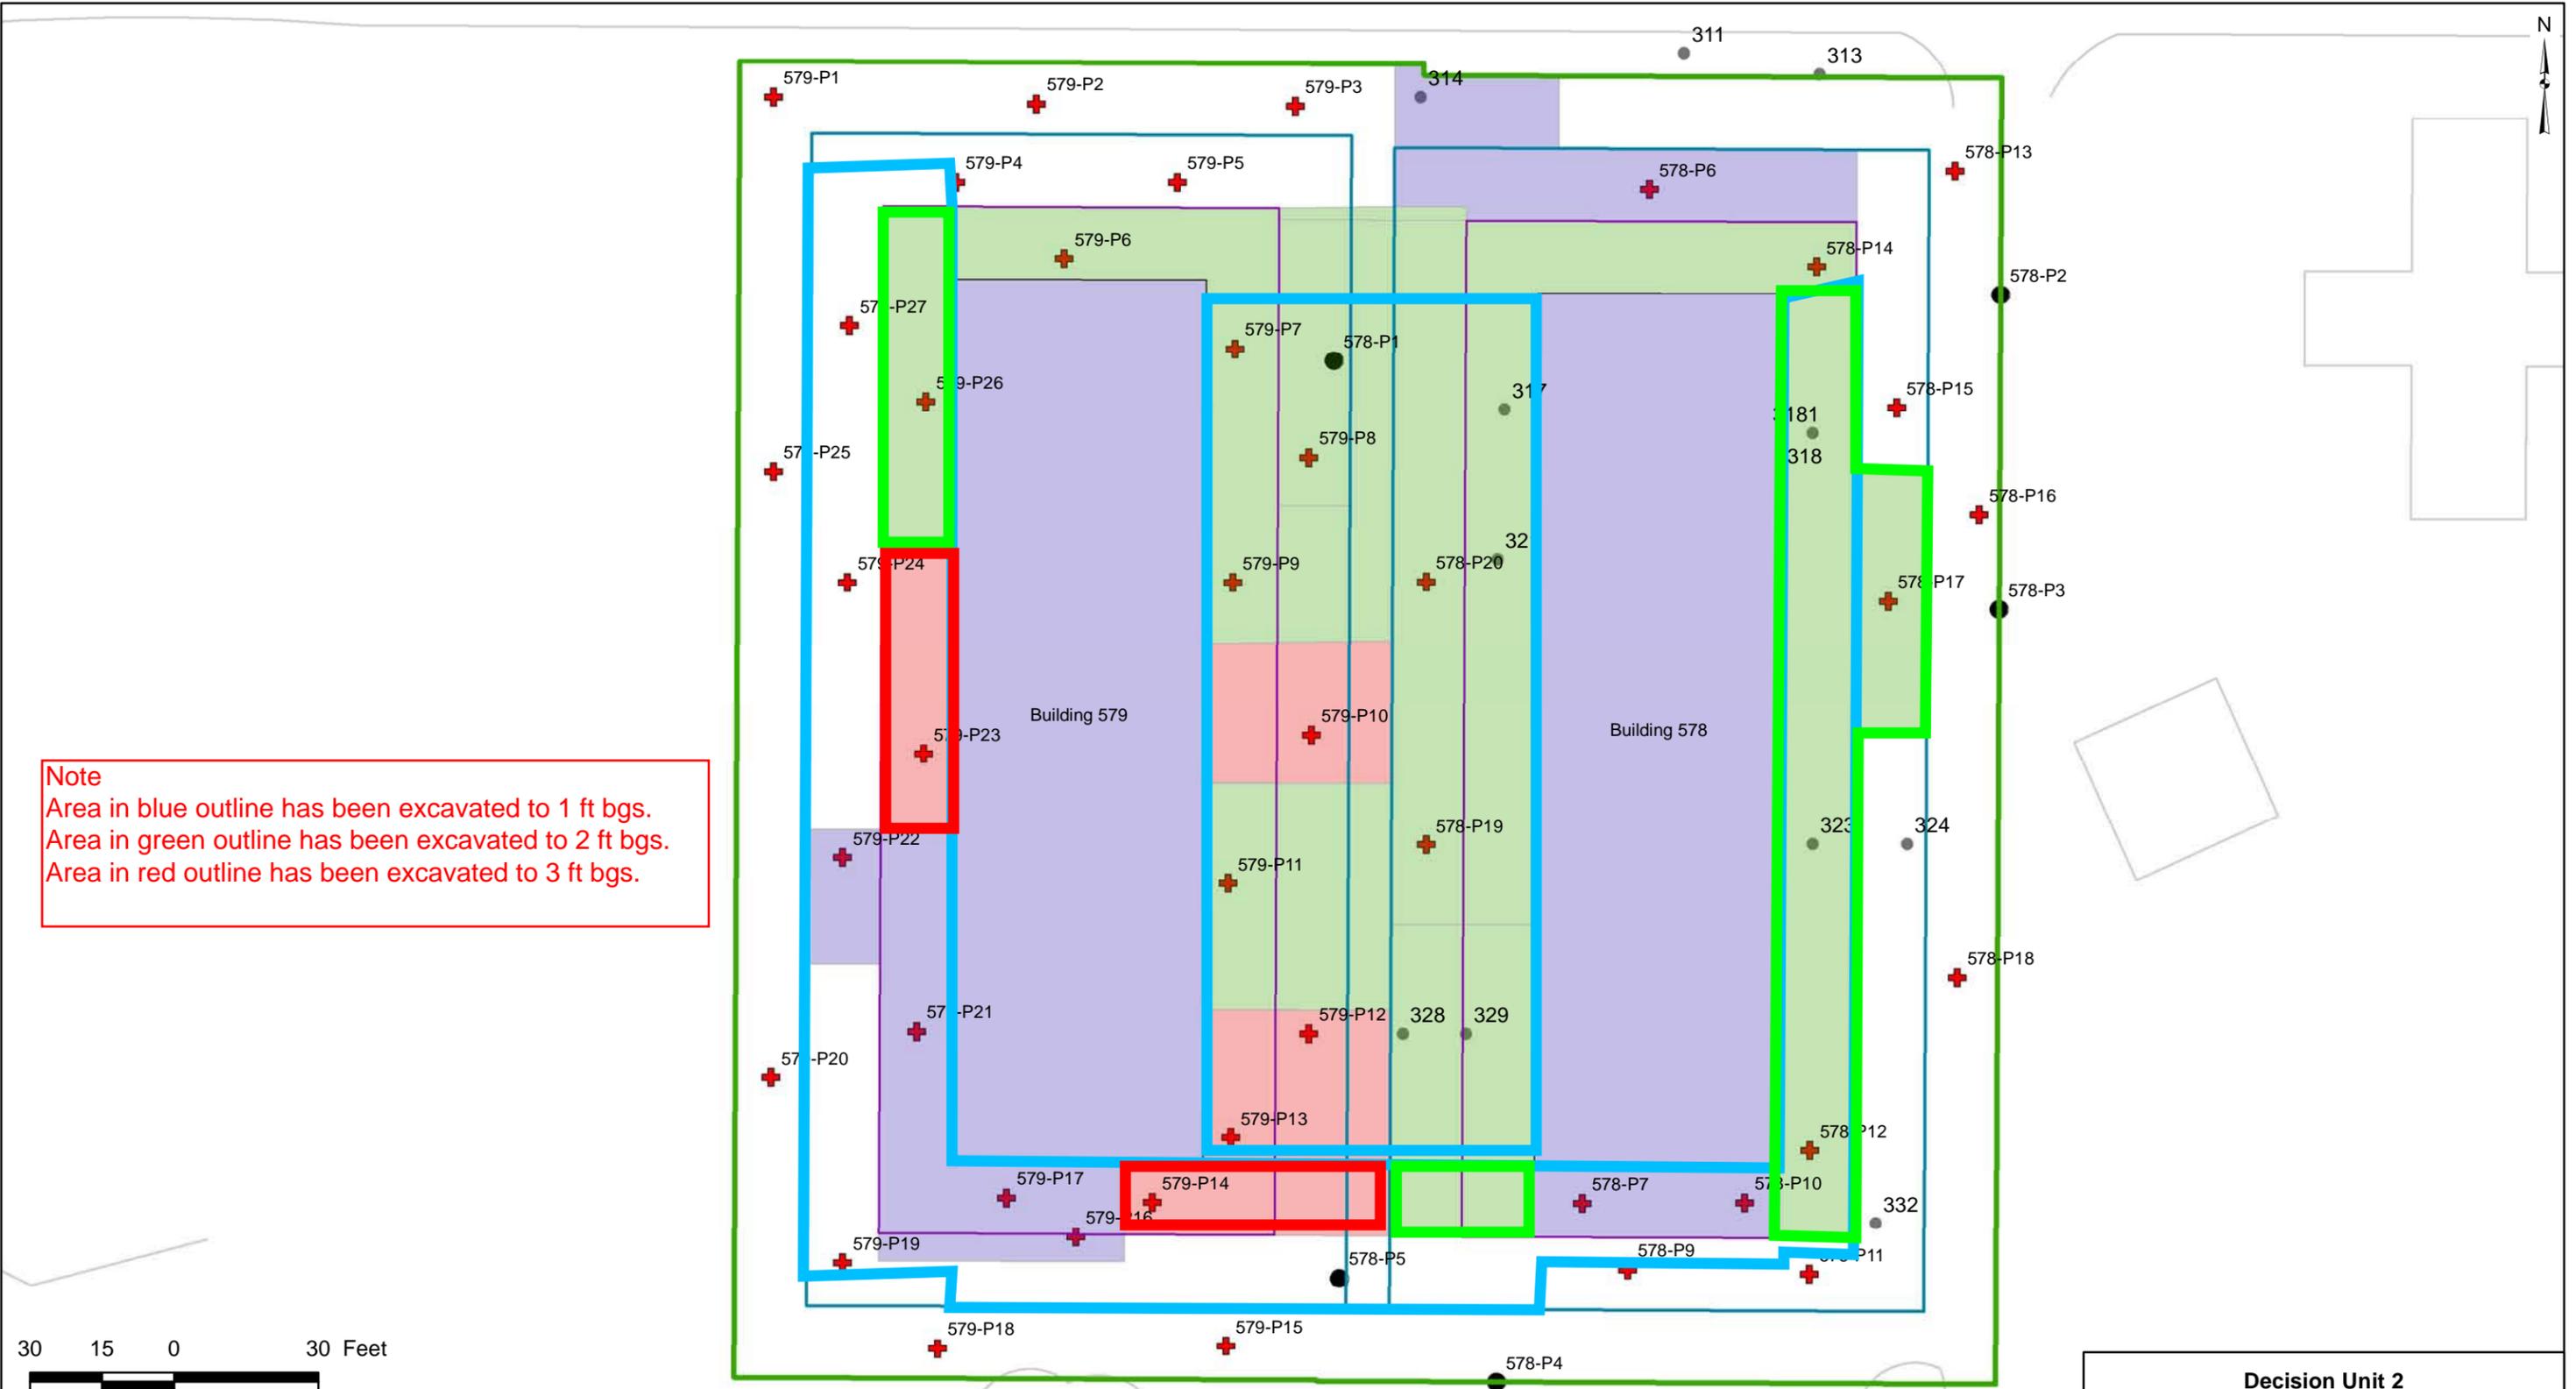
Note
 Area in blue outline has been excavated to 1 ft bgs.
 Area in green outline has been excavated to 2 ft bgs.
 Area in red outline has been excavated to 3 ft bgs.
