**2013 ANNUAL REPORT
CERCLA NON-TIME CRITICAL
REMOVAL ACTION**

**MIDWAY ATOLL NATIONAL WILDLIFE REFUGE
MIDWAY ISLAND
Contract No. F11PC00327**

28 February 2014

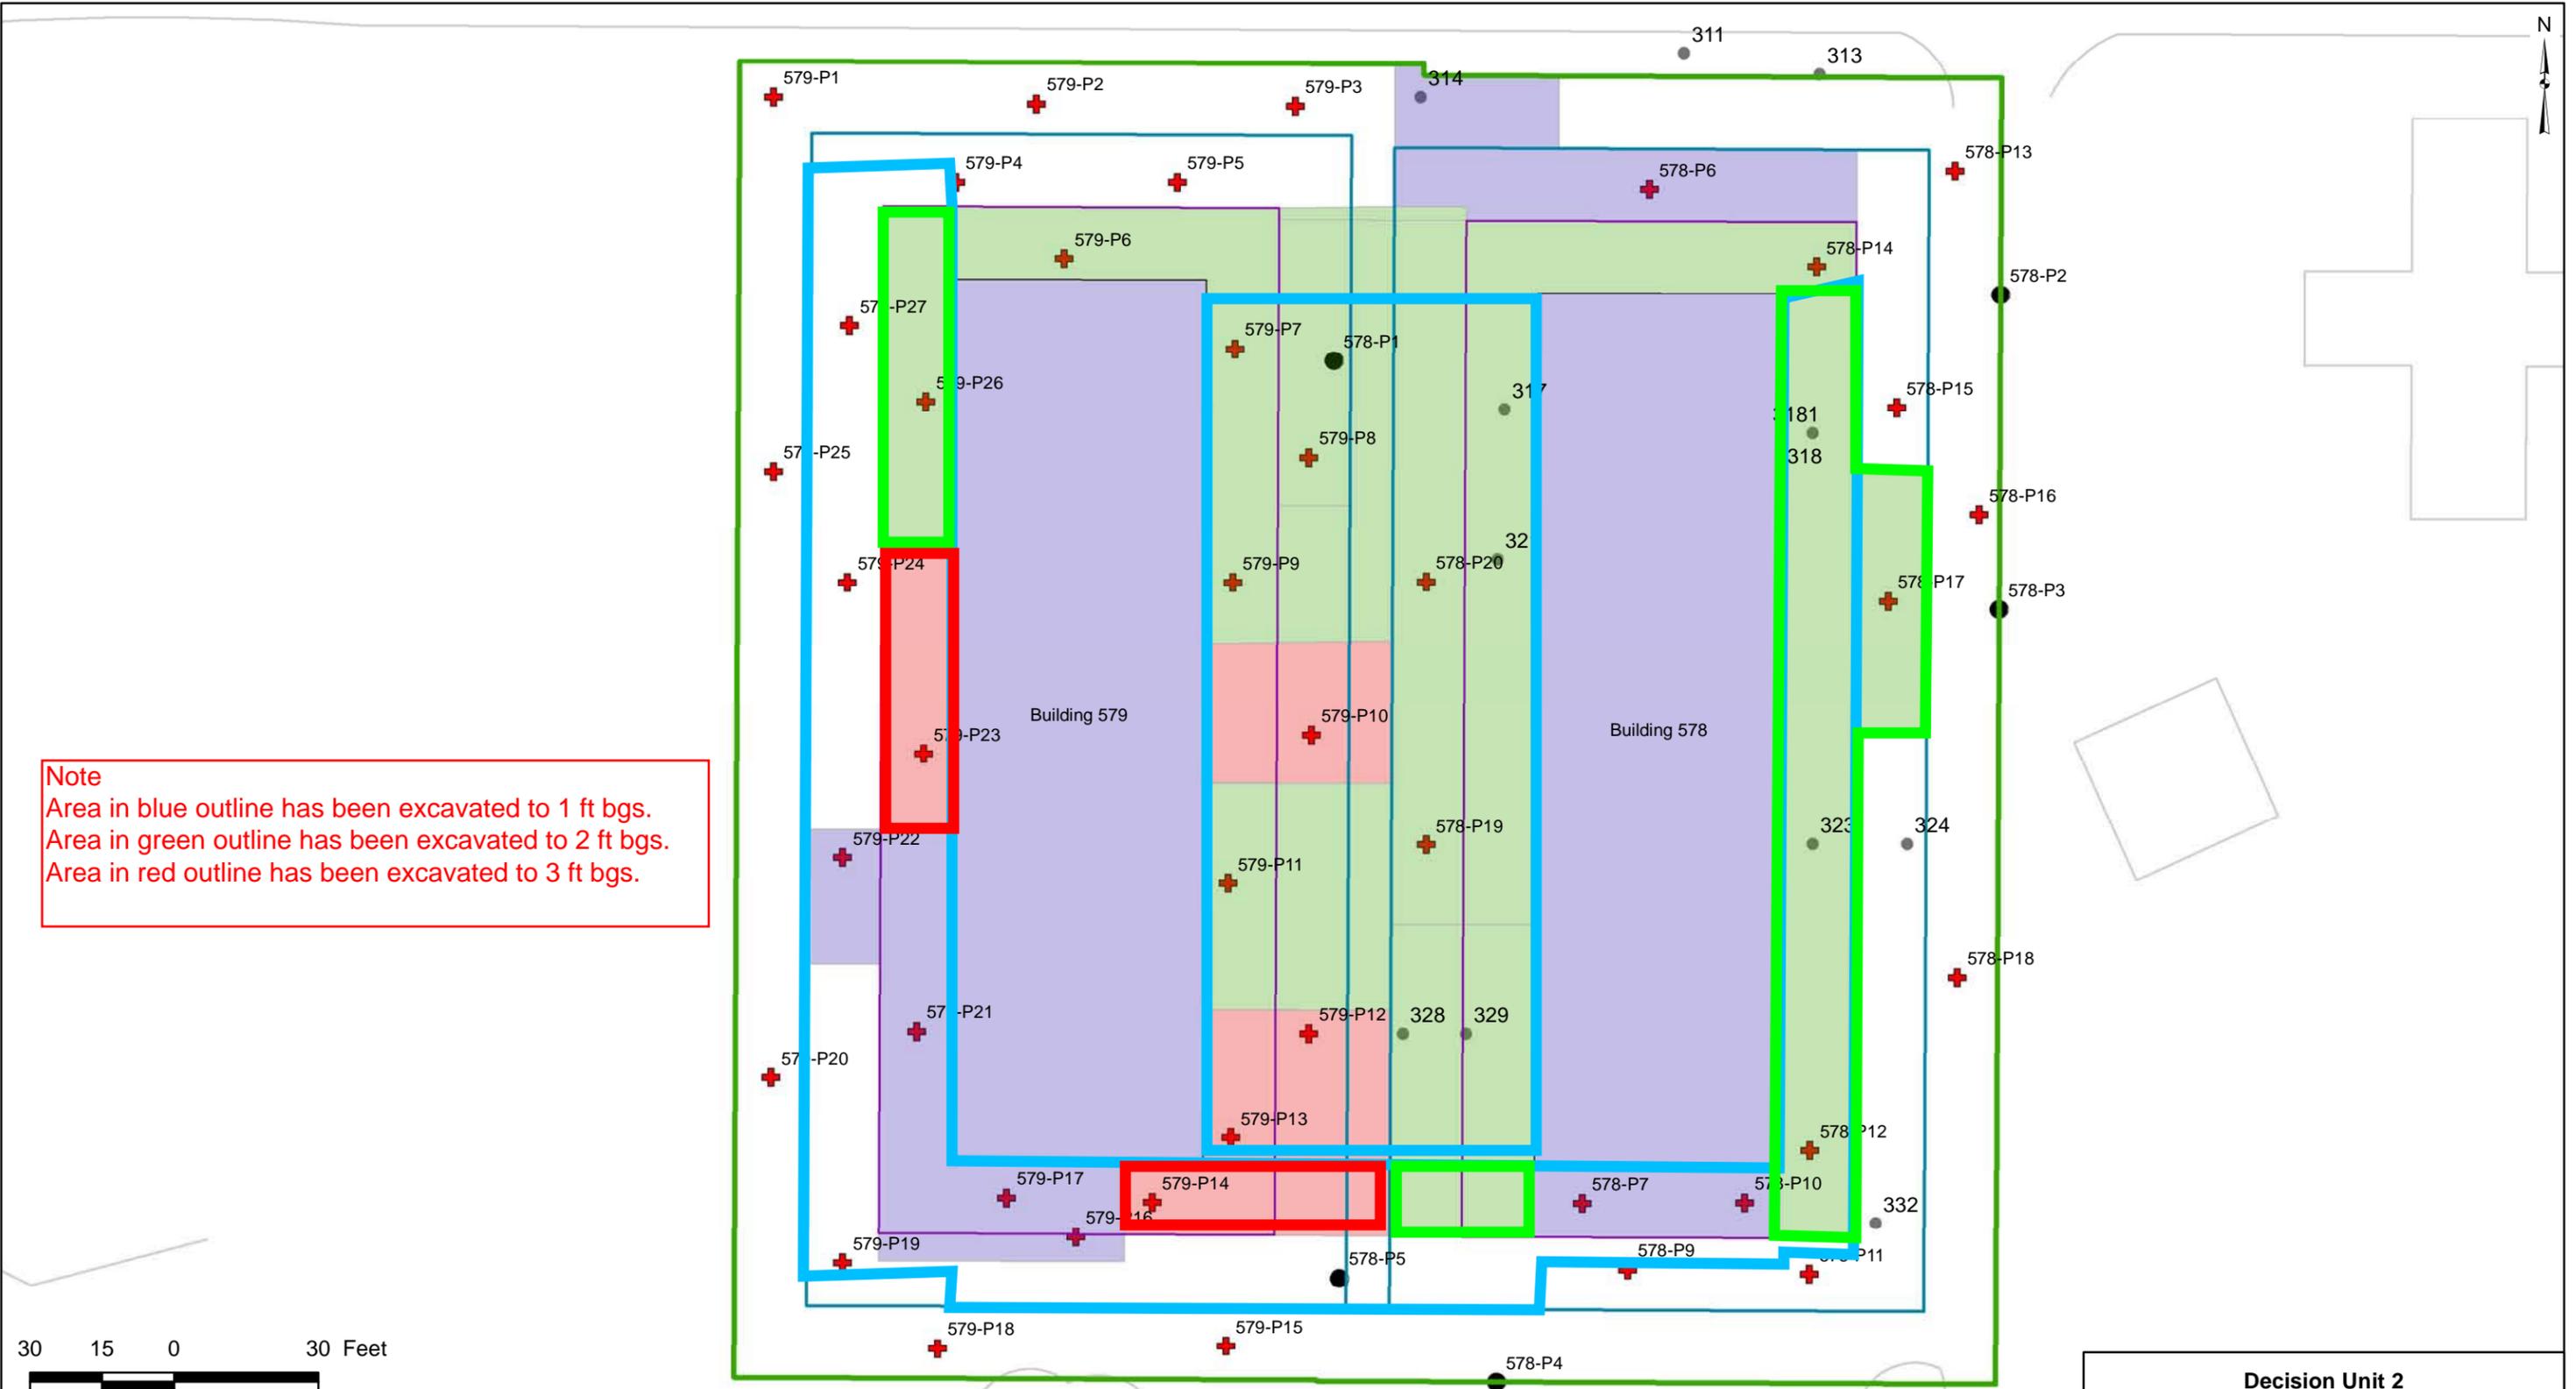
Note
 Area in blue outline has been excavated to 1 ft bgs.
 Area in green outline has been excavated to 2 ft bgs.
 Area in red outline has been excavated to 3 ft bgs.

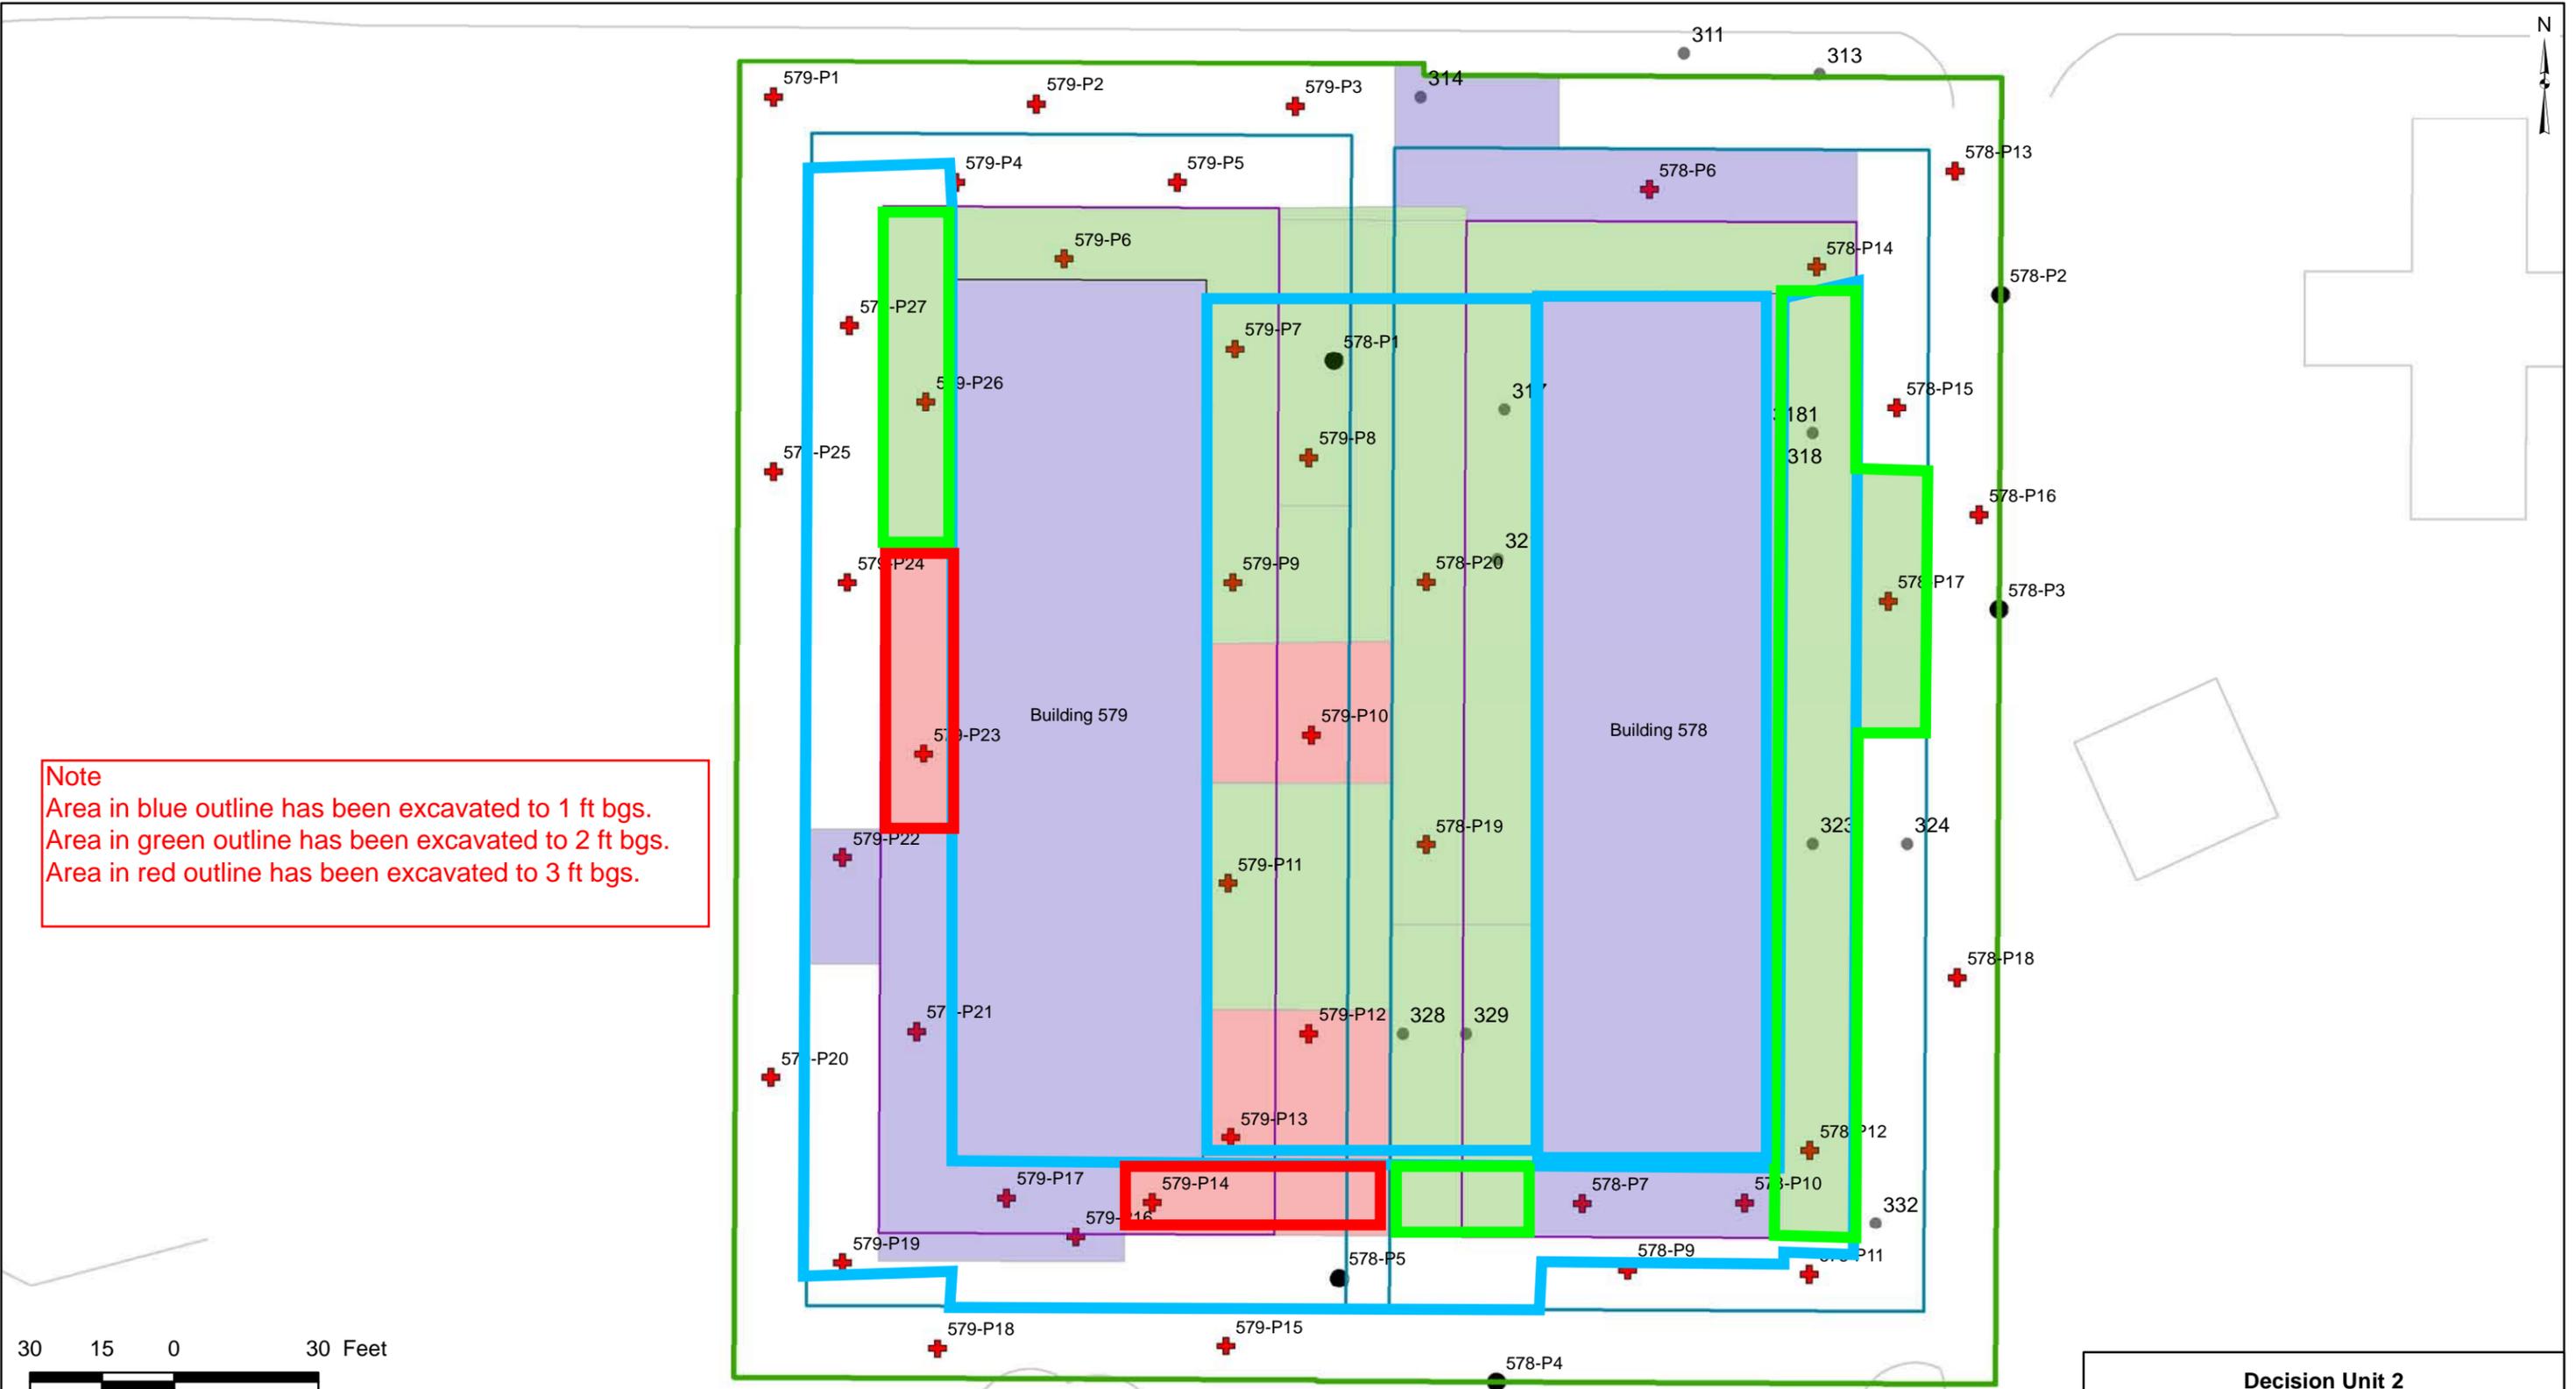
Note
 Area in blue outline has been excavated to 1 ft bgs.
 Area in green outline has been excavated to 2 ft bgs.
 Area in red outline has been excavated to 3 ft bgs.

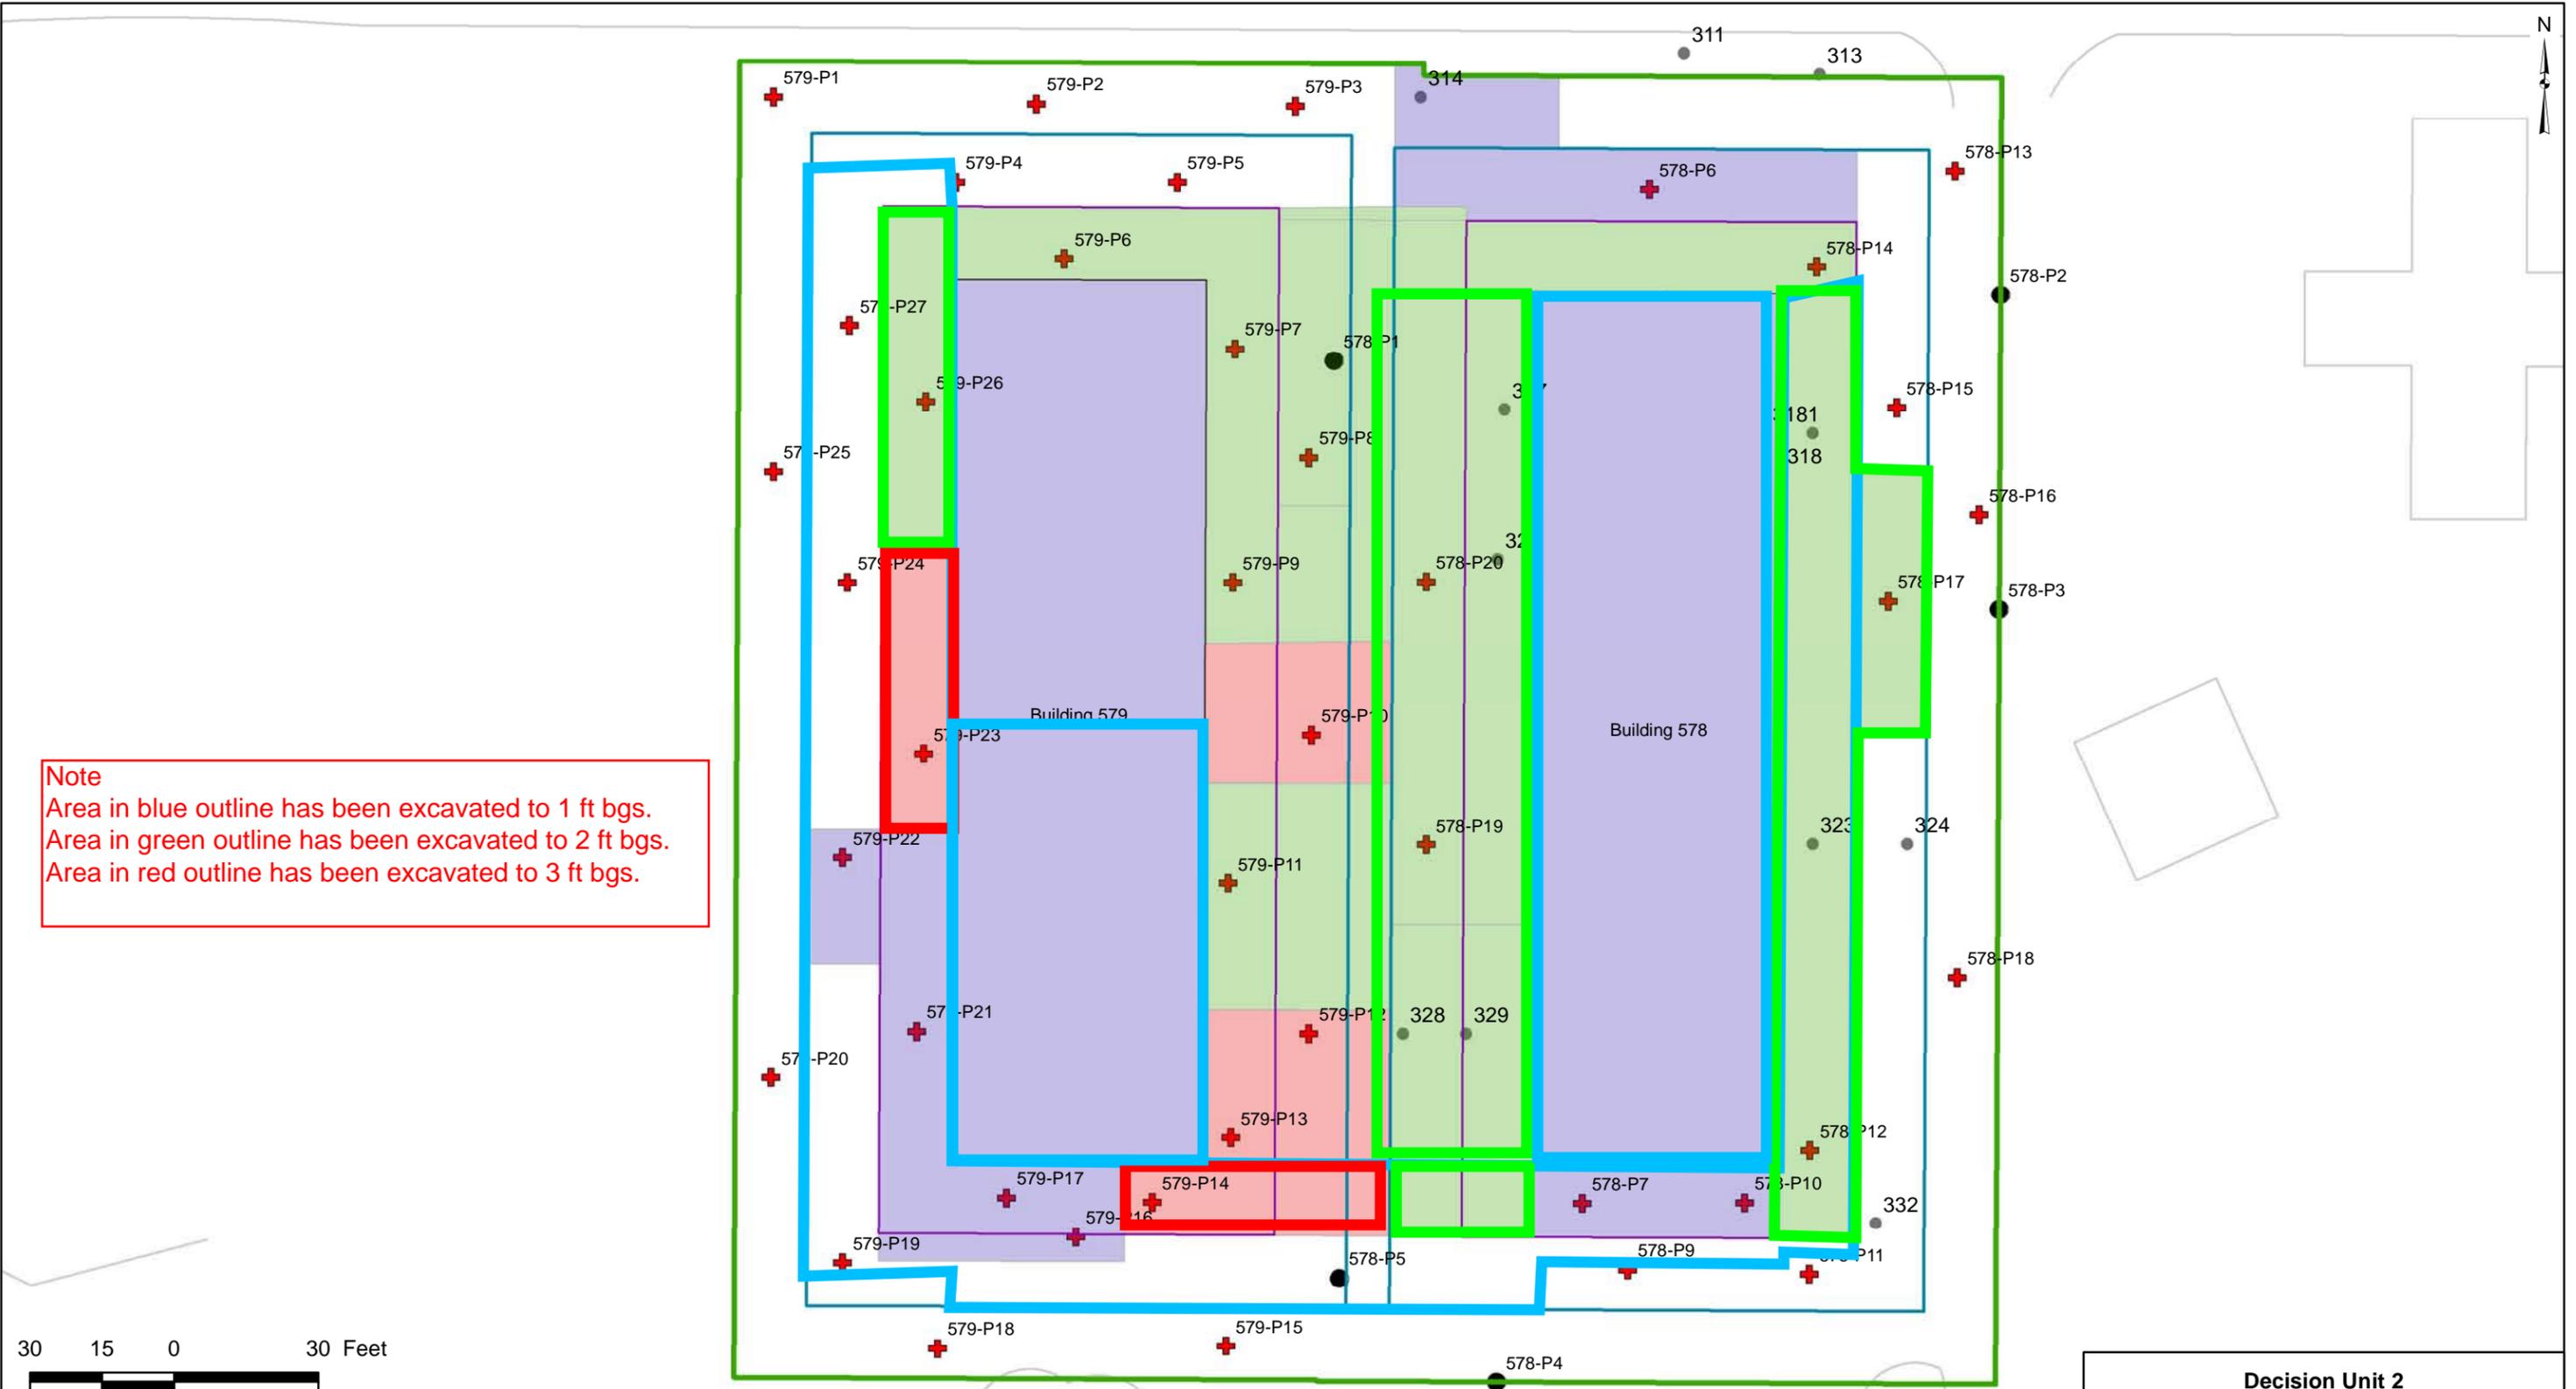
Note
 Area in blue outline has been excavated to 1 ft bgs.
 Area in green outline has been excavated to 2 ft bgs.
 Area in red outline has been excavated to 3 ft bgs.

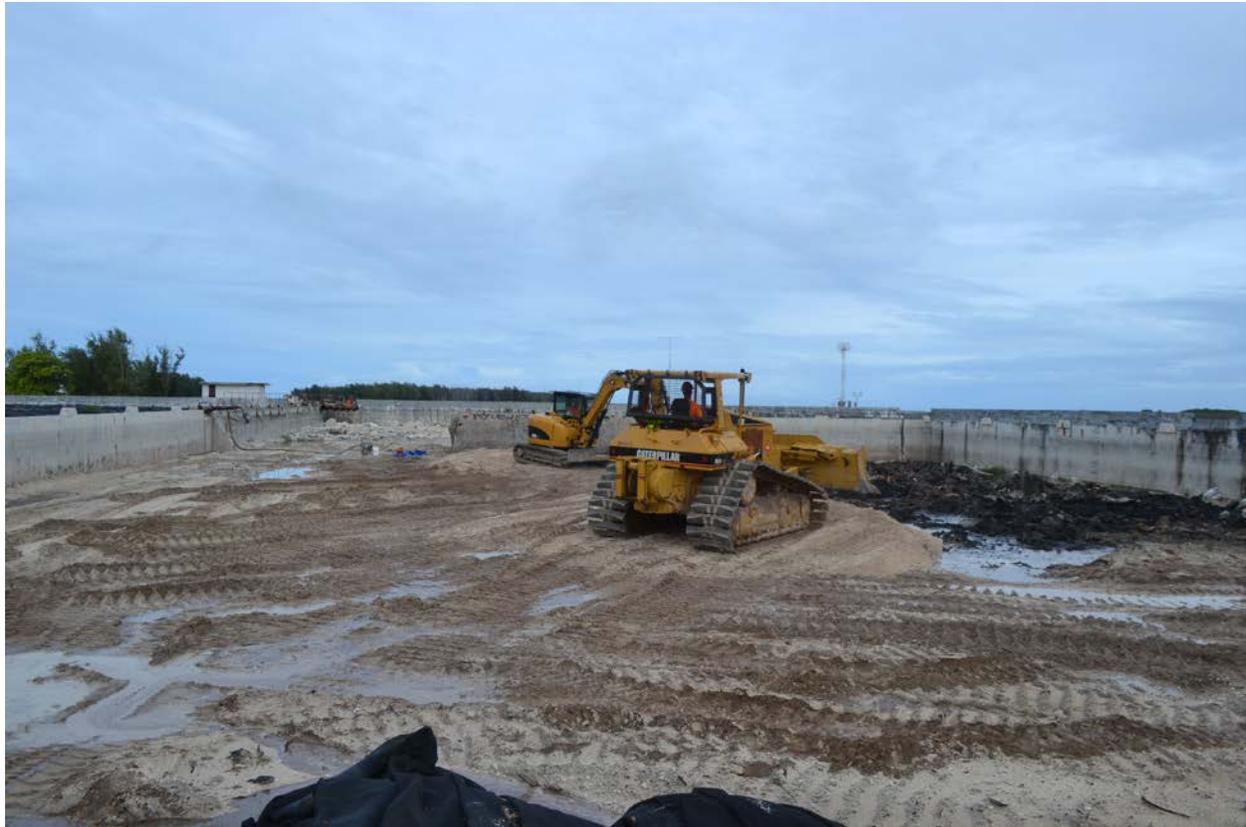
Photo 01: View of SW cell in R2 unit – Prior to treatment of ash with Maectite.

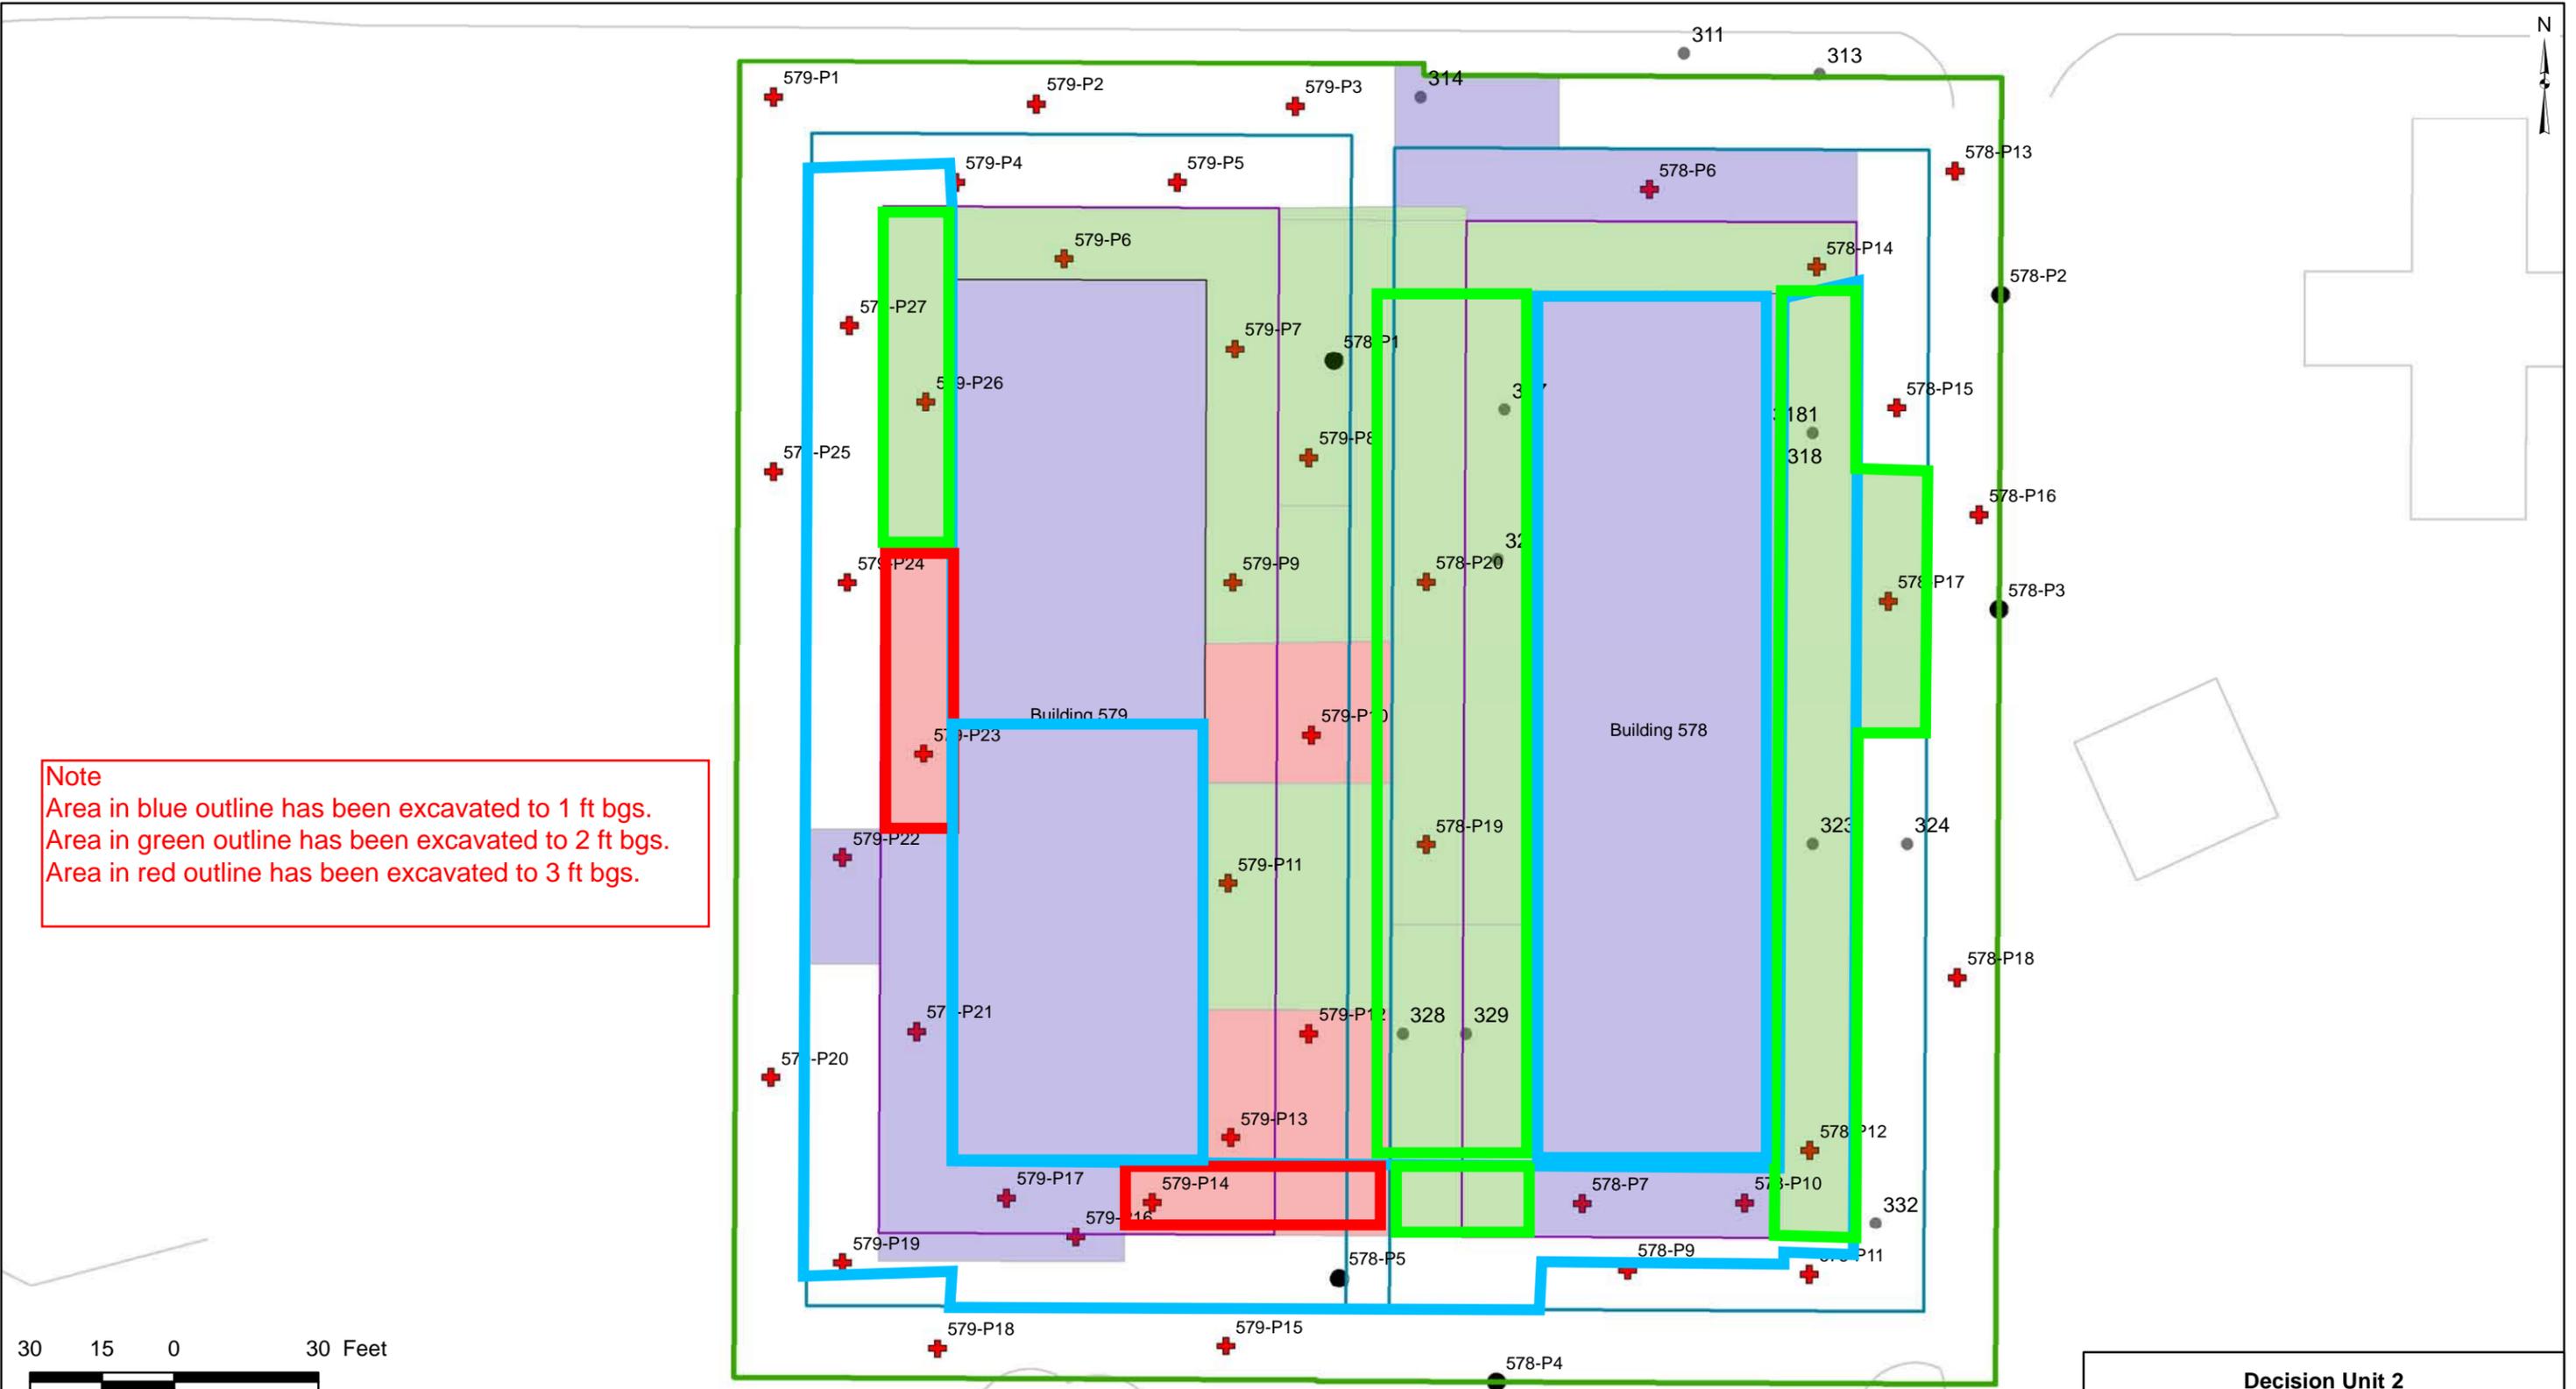
Note
 Area in blue outline has been excavated to 1 ft bgs.
 Area in green outline has been excavated to 2 ft bgs.
 Area in red outline has been excavated to 3 ft bgs.

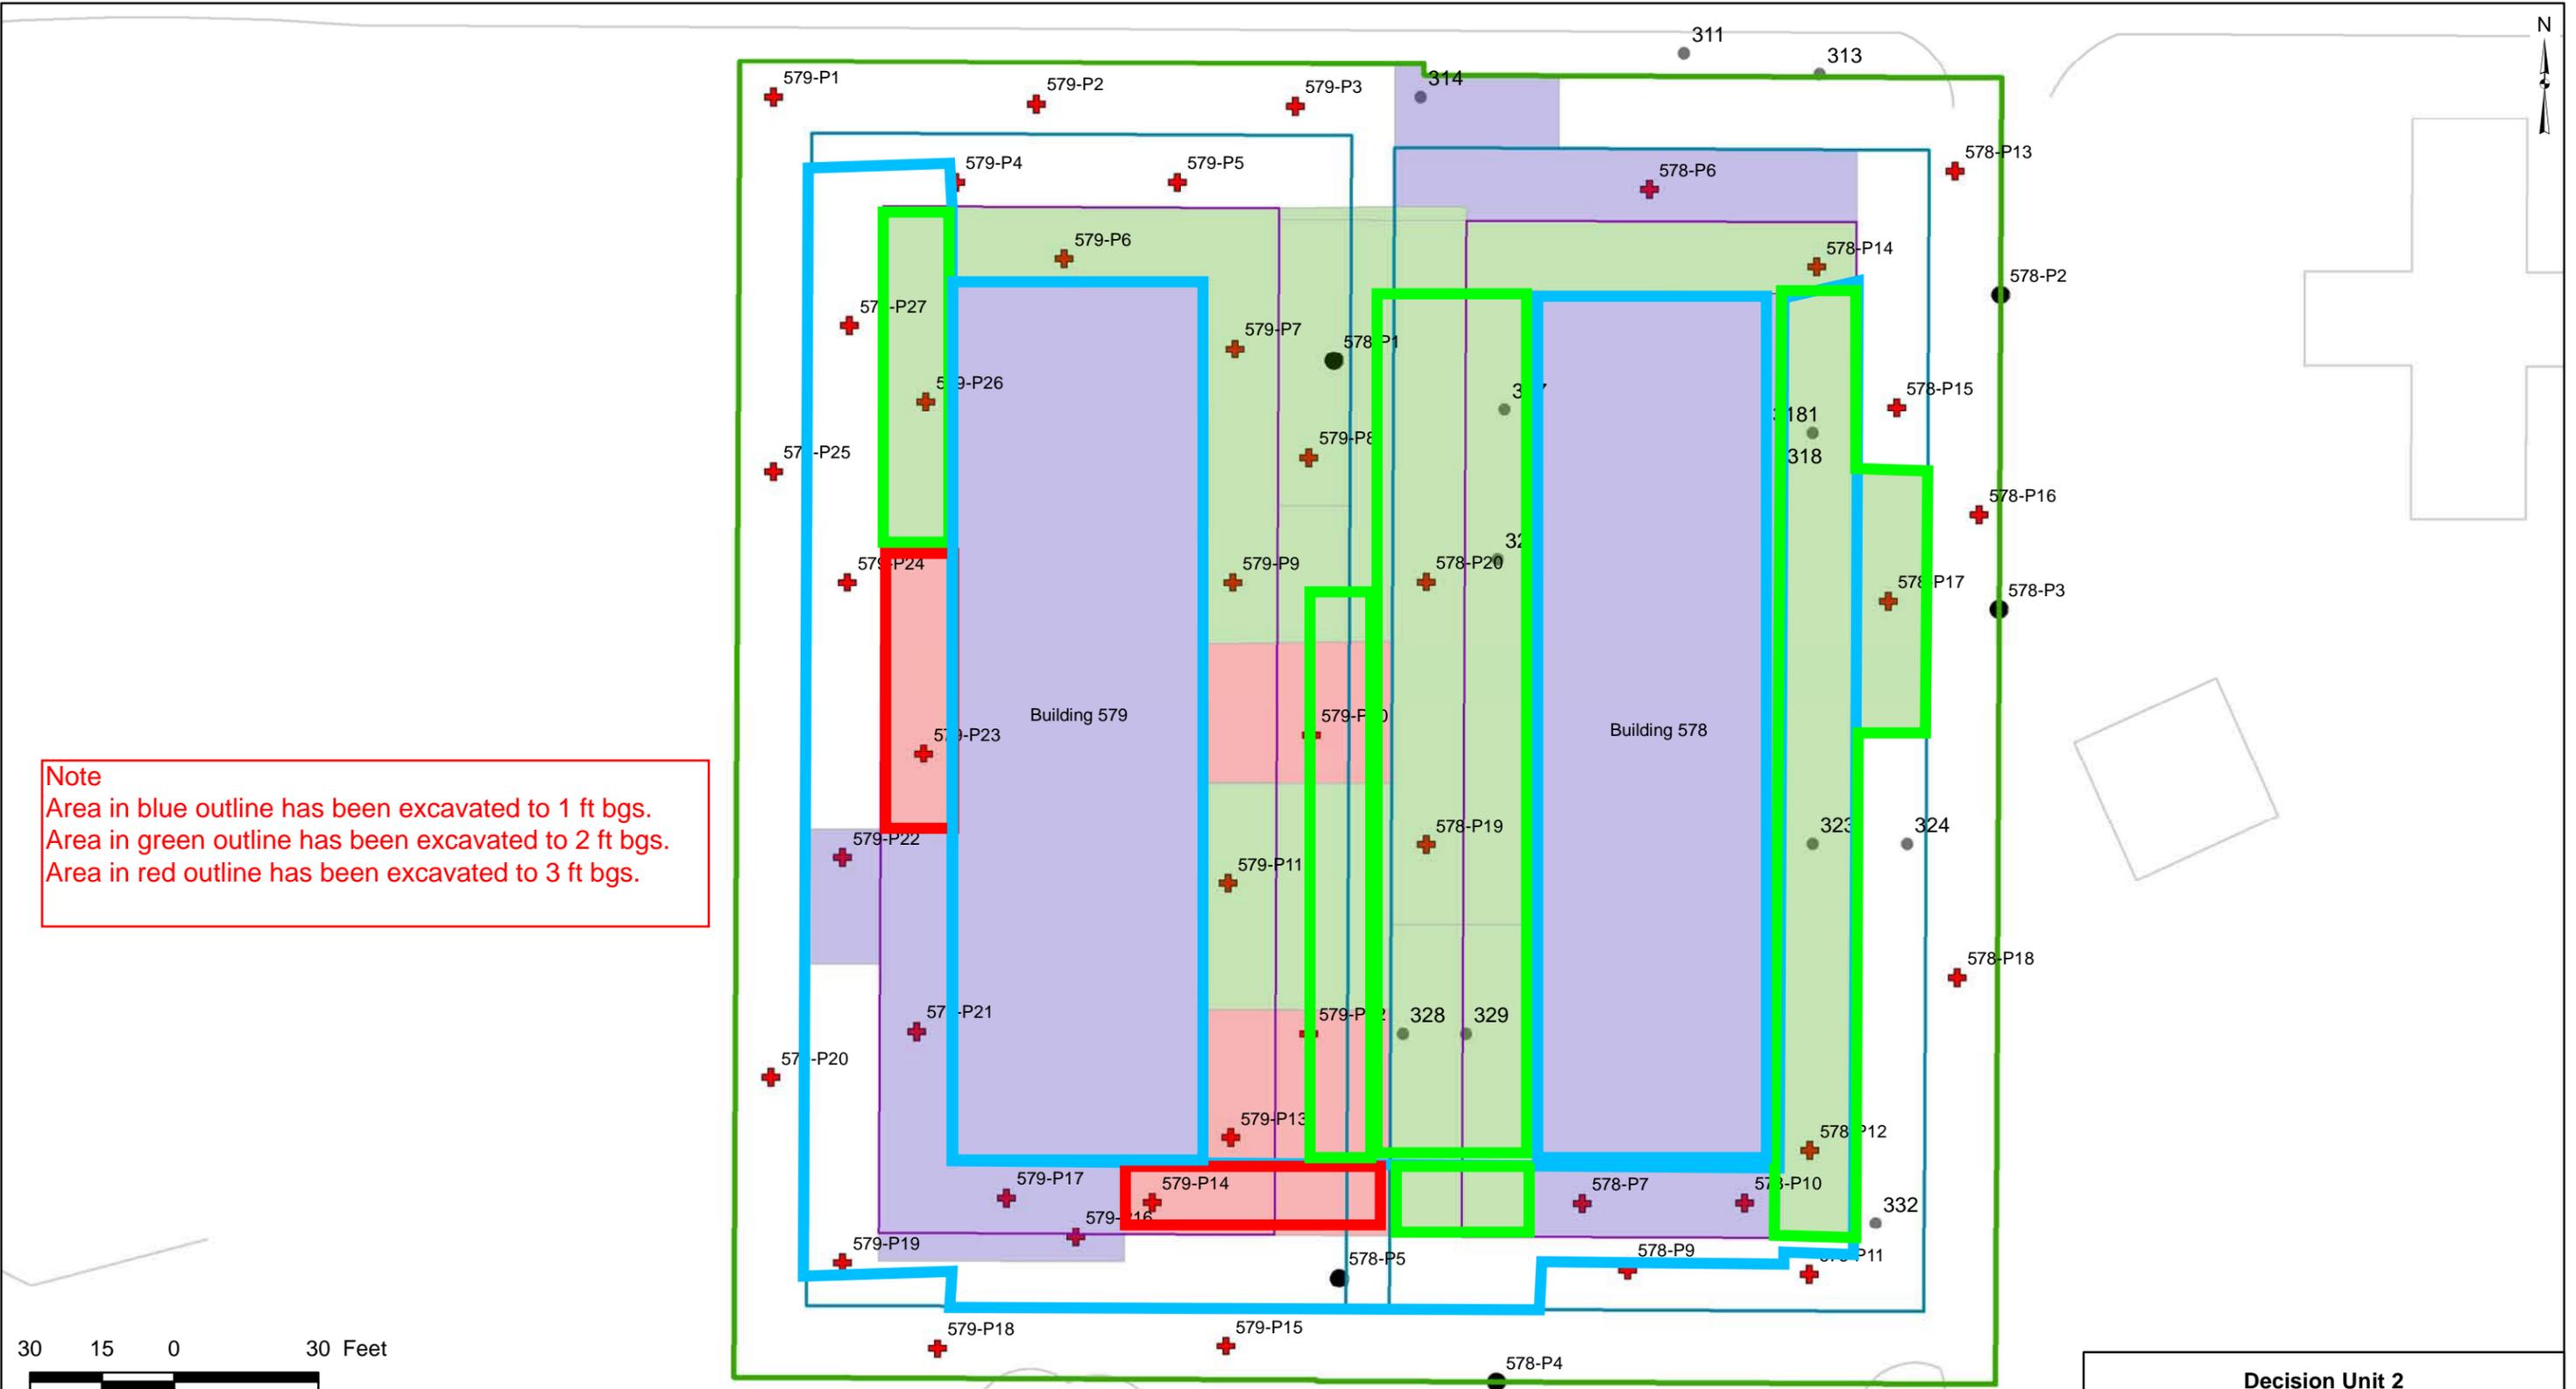
Note
 Area in blue outline has been excavated to 1 ft bgs.
 Area in green outline has been excavated to 2 ft bgs.
 Area in red outline has been excavated to 3 ft bgs.

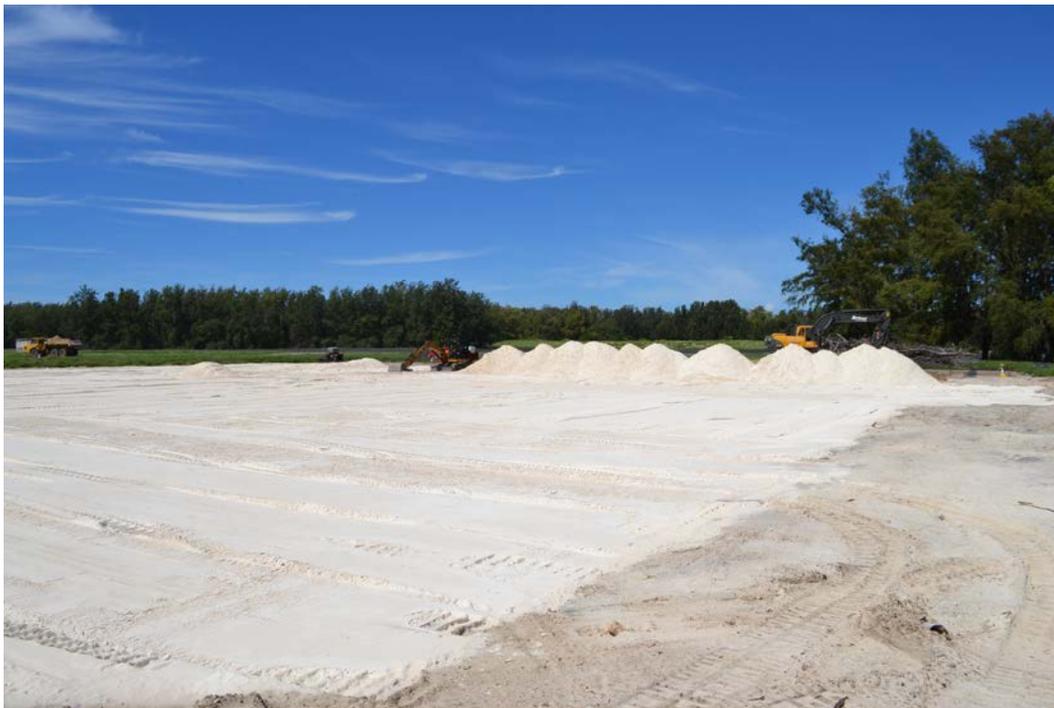
Photo 04: View of extreme SE corner of DU2.

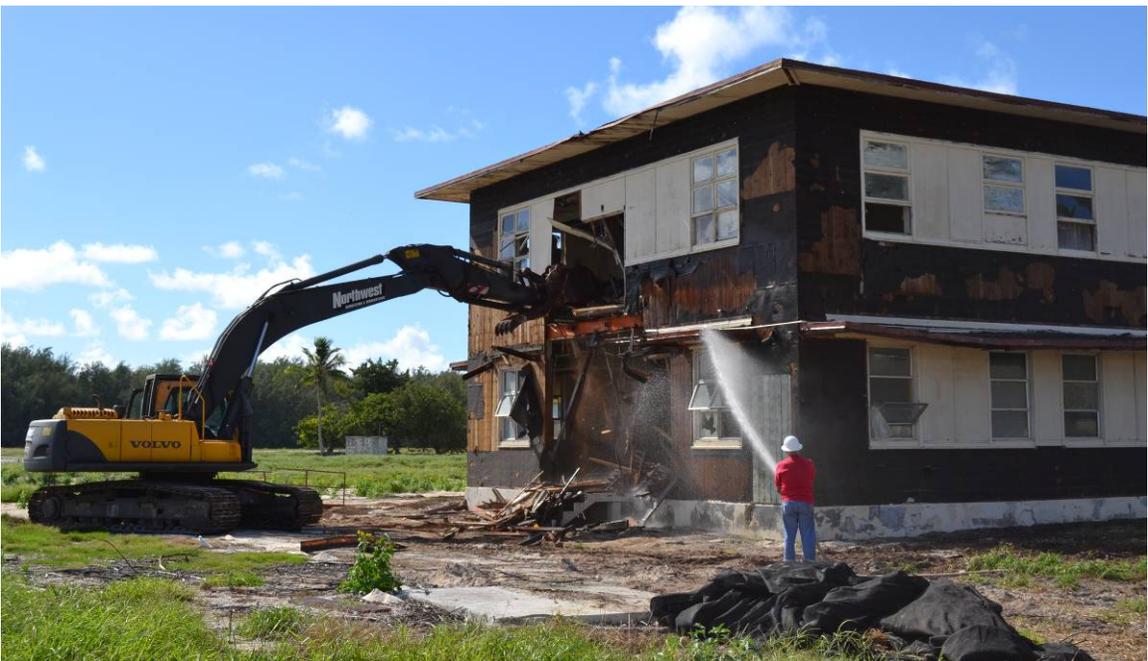
Photo 3: 9/4/13 – View northwest; Building 579. Demolition begins, photo shows dust abatement with water (from fire hose).

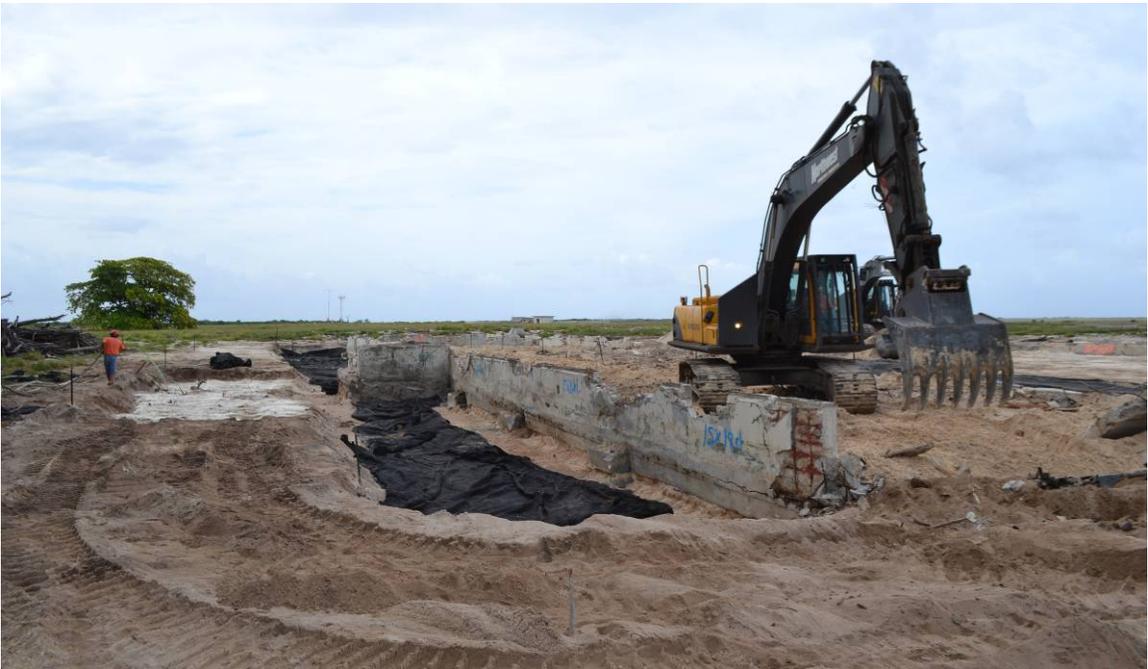
Photo 14: 9/27/13–View south; east of Building 578. View of multi-level excavation and soil treatment areas.
