APPENDIX B IMPLEMENTATION PLAN

**Seawall Long-Term Maintenance Program
Henderson Field Airport
Midway Atoll National Wildlife Refuge/
Battle of Midway National Memorial**

APRIL 2018

**US FISH AND WILDLIFE SERVICE
Midway Island National Wildlife Refuge
AND
FEDERAL AVIATION ADMINISTRATION
Western-Pacific Region**

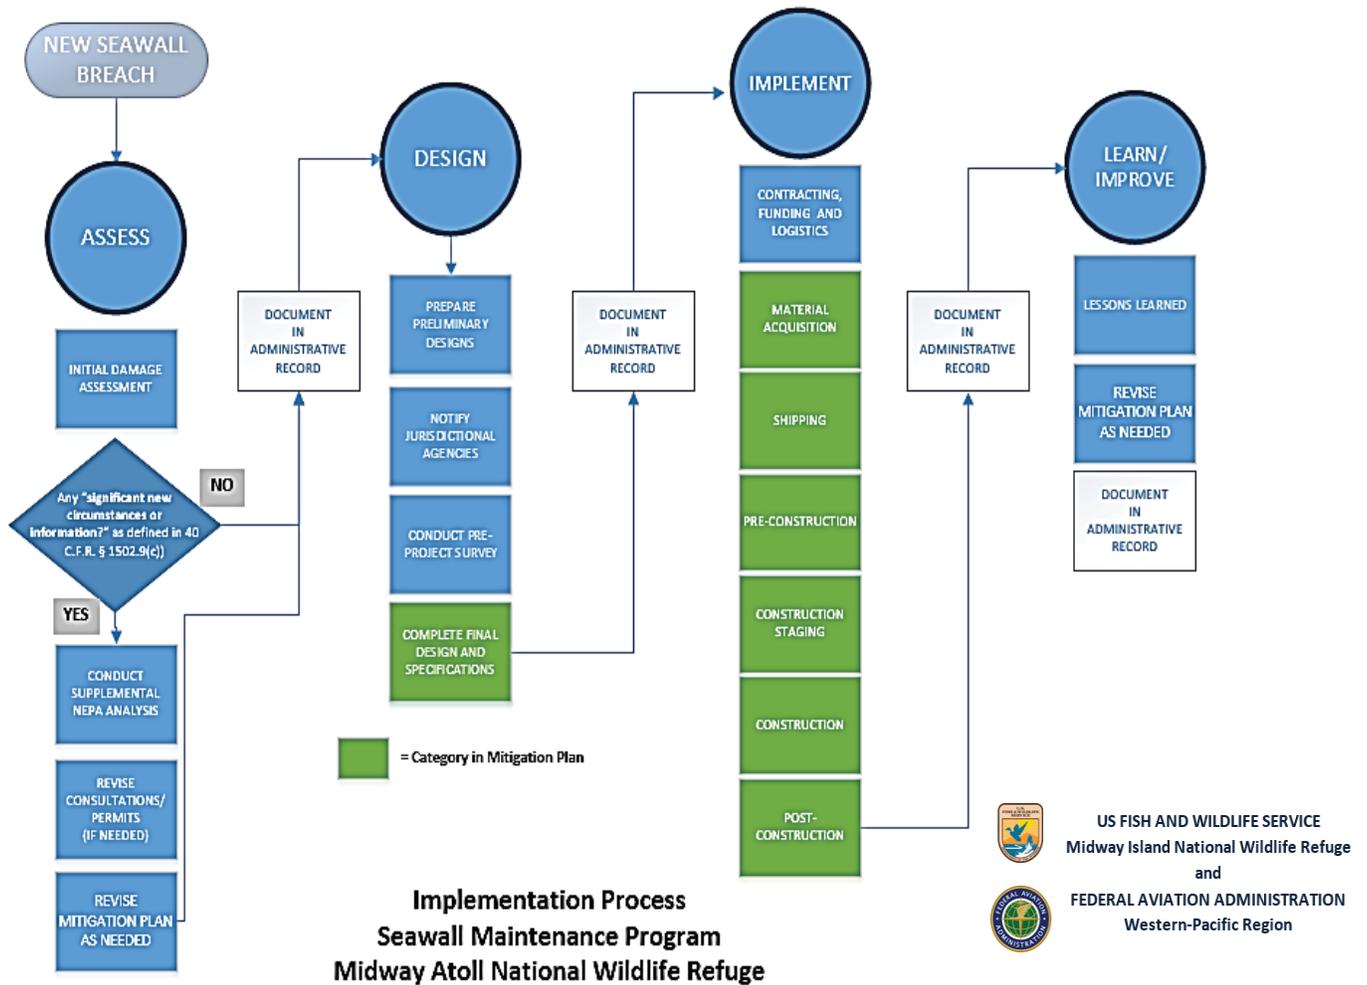
The chart on the following page illustrates the seawall repair implementation process and indicates the steps that include the environmental measures identified in this plan. As shown on the chart, the Service will document each of the four main phases in a NEPA administrative record it will maintain for its actions related to the seawall maintenance and repairs.

The Service will conduct repairs as sections of the seawall fails over the ten-year planning period (2016-2026). Because specific locations and extent of repairs needed along the approximately 1-mile long seawall are unknown, the Service established an implementation process that begins when a new failed section of seawall is discovered. This process includes four main phases:

1. Assess the situation, where the Service will determine the extent of needed repairs and whether any “significant new circumstance or information” requires additional environmental review, revised permits, or environmental measures.
2. Design, where the Service will determine appropriate designs for repair and notify jurisdictional agencies.
3. Implement, where the Service will fund and issue contracts for construction. This phase contains the construction steps and associated environmental measures contained in this plan.
4. Learn/Improve where the Service will identify any “lesson learned” and revise this Implementation Plan, as needed.

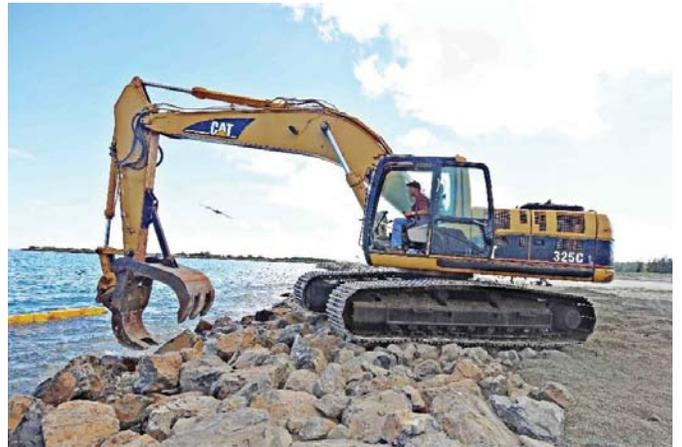
Land-based construction during 2014 repair

For the seawall maintenance program, the Service will avoid impacts on the marine environment by minimizing the project footprint and by conducting all work from land, rather than from barges and vessels. Table 1 provides the specific environmental measures that will be included in each repair design.

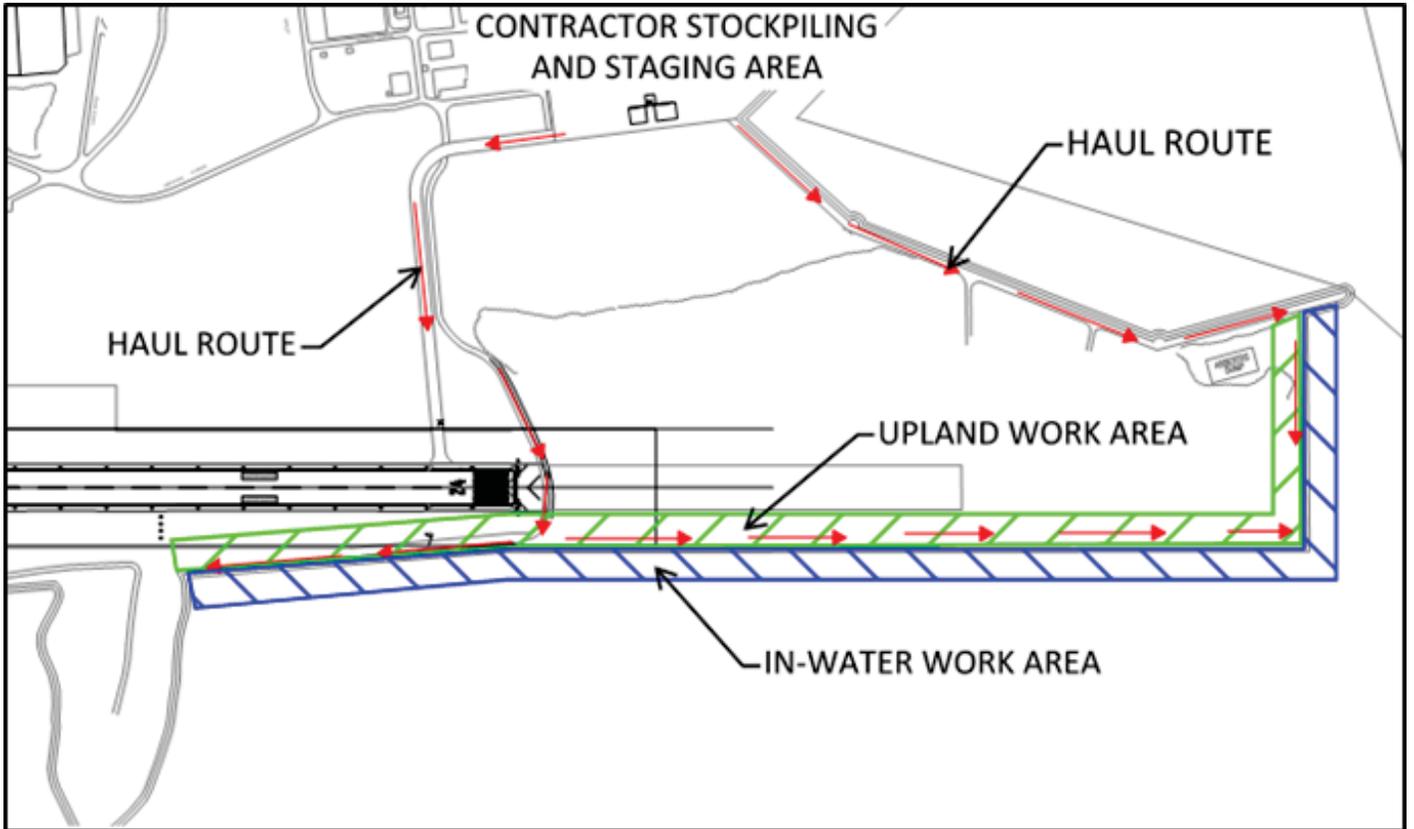
Proposed staging area and haul route

Construction materials may require storage on Sand Island for several weeks or even months prior to construction, depending on construction windows established to protect birds and on the logistics of getting materials and crews to the island. If barged early, the rock and other construction materials would be loaded onto trucks and

driven to a temporary stockpile area void of any environmental concerns, as confirmed and approved by Refuge staff.

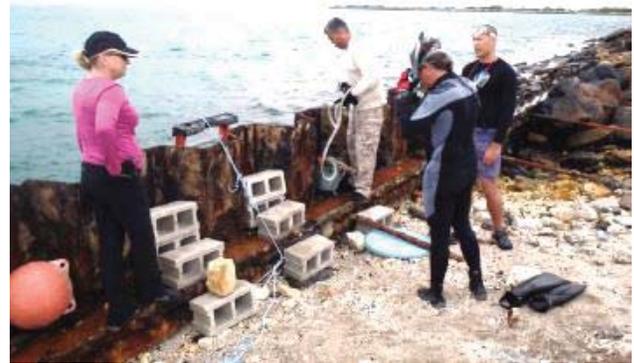
Coral translocation efforts prior to 2014 repairs

CORAL RELOCATION	PRE-9	NMFS ESA 2017	Relocate, prior to the start of construction, the coral and macroinvertebrates present within the project area that would be damaged by construction (both in the direct fill footprint and adjacent to this, if appropriate) to an area that would not be disturbed (i.e., not alongside unrepaired sections of the seawall or other areas likely to be disturbed at some point in the future).	Refuge Manager		
	PRE-10	PMNM BMP	Coral team will follow General Storage and Transport Protocols for Collected Samples (PMNM BMP #006)	Refuge Manager		
	PRE-11	PMNM BMP	Coral team will follow Disease and Introduced Species Prevention Protocol for Permitted Activities in the Marine Environment Pāpāhānaumokuākea Marine National Monument (PMNM BMP #011) for specific protocols for the proper management of coral sampling equipment, coral samples, and dive equipment.	Refuge Manager

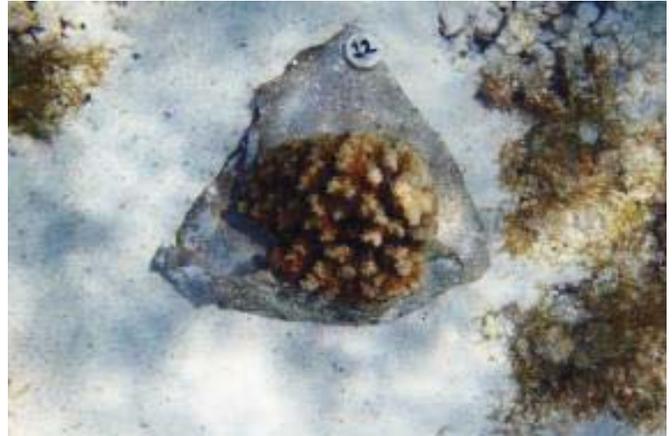
A coral transplanted as part of the 2014 seawall repair is numbered as part of ongoing post-construction monitoring

MEASURE	ID	SOURCE	DESCRIPTION	RESPONSIBLE AGENCY/ROLE	REQUIRED ACTION	DATE COMPLETED AND INITIAL
CORAL RELOCATION	POC-1	EFH 2013	Post-construction, provide information on the species, size and the total amount of any corals impacted from the salvage operations. Offset this resource loss, including the loss of EFH bottom habitat. If the overall unavoidable loss is minimal, NMFS would support environmental measures offset involving removal of long-standing uncolonized debris in areas adjacent to the project fill footprint to future damage to the corals and marine resources in the area. Other compensatory environmental measures alternatives may also be appropriate.	Refuge Manager and Post-construction team	Document in monitoring report,
