## Rhode Island National Wildlife Refuge Complex

## Farewell to the Shack on Sedge Island

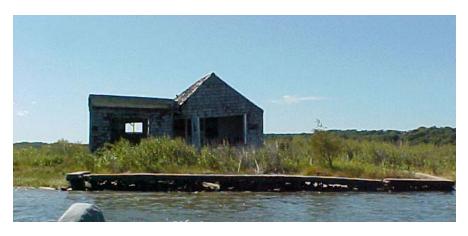
The building was a remnant of a once larger building which had partially collapsed, had been vacant for decades, and was in poor condition. When the Service purchased Sedge Island in 2004, a determination was made that the building was not reasonably repairable. The sill plates had rotted, the concrete pilings were failing, the roof no longer functioned, portions of the floor were missing, and some walls were leaning.

The Building on Sedge Island, circa 2006, John H. Chafe National Wildlife Refuge

Because, in our opinion, that the next sizable storm could cause the shack to fail, the building was beyond repair, and further that equipment would be available to take the materials safely off the island, we decided to remove the building remnant at this time. If it was to remain, we doubt it would have lasted one more year. We have no plans to replace the structure; the site will be restored to native vegetation.
