Habitat Restoration of the Bogg's Bend Unit on the Sacramento River National Wildlife Refuge

Final Environmental Assessment

July 2015

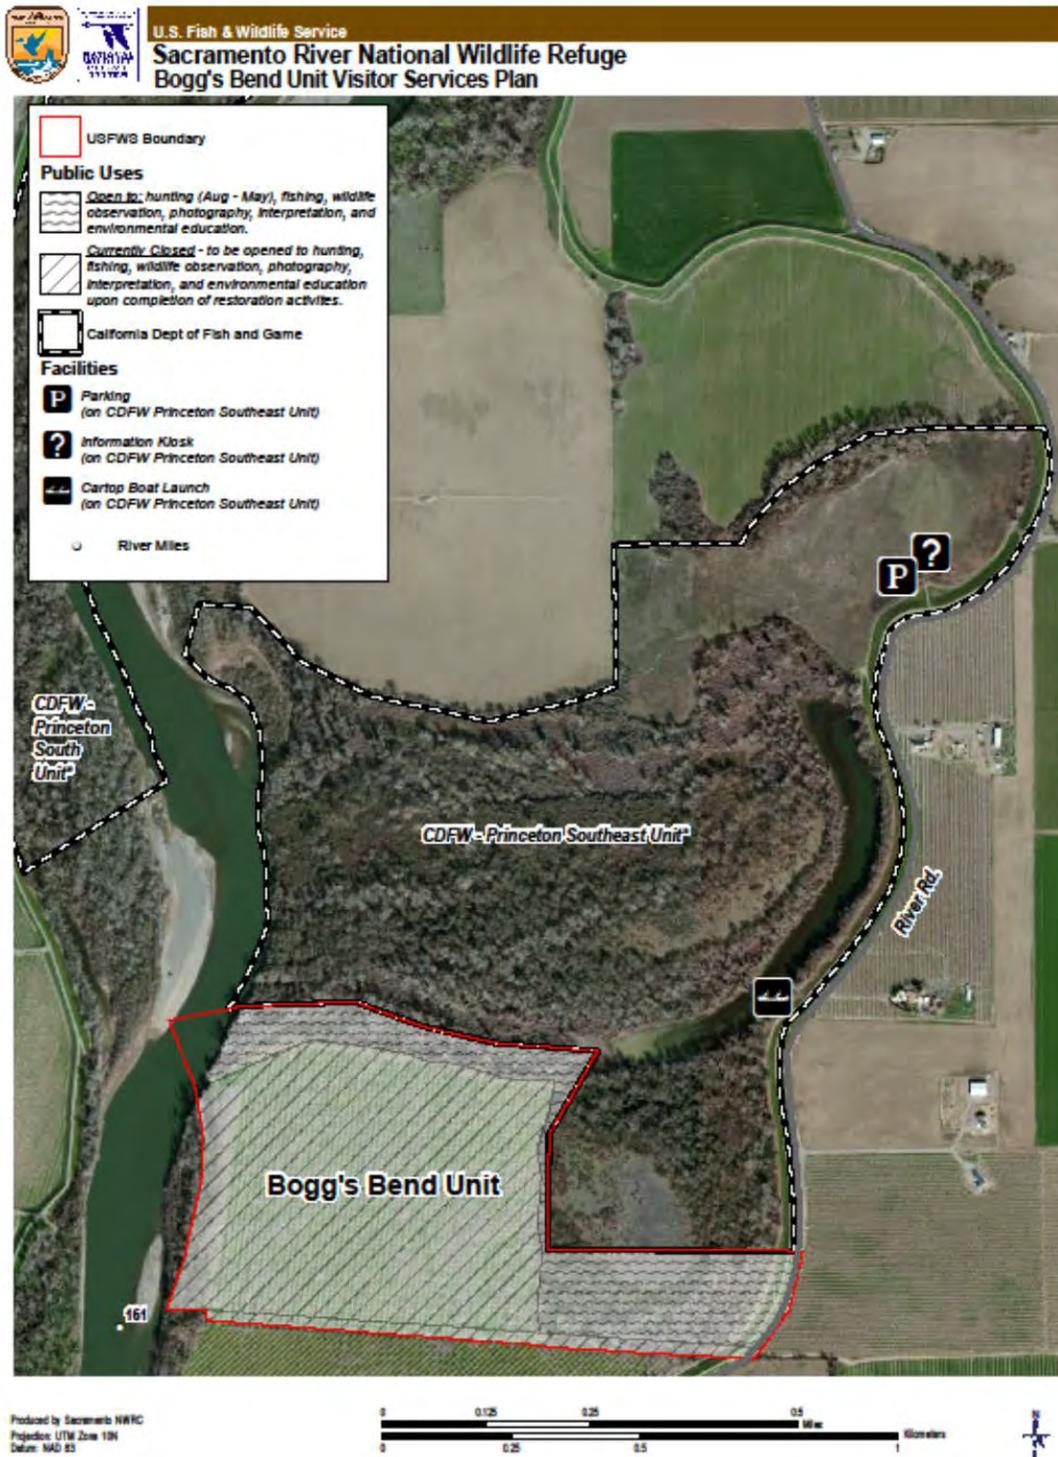
Figure 4. Visitor Service Opportunities on the Bogg's Bend Unit

Management of the Bogg's Bend Unit will be consistent with the Sacramento River National Wildlife Refuge Final CCP (June 2005) and SRNWR CCP Bogg's Bend Amendment (Appendix D). Accordingly, the Bogg's Bend Unit will eventually be open to six priority uses -hunting, fishing, wildlife observation, photography, interpretation, and environmental education- (Figure 4). However, these six priority uses will be deferred on a portion of the Unit until habitat restoration has been completed. Two information kiosks will be developed, parking area improvements will be implemented, public use signs will be installed, and interpretive brochures will be provided. The Service is coordinating/ partnering with the CDFW to develop a plan to improve existing facilities and cooperatively manage the visitor services facilities on the CDFW's Sacramento River Wildlife Area Princeton Southeast Unit to provide access to the Service's Bogg's Bend Unit of the Sacramento River National Wildlife Refuge (MOU 2005). No new facilities will be developed as recommended in the 2008 Colusa Subreach Planning Report. Access to the Service's newly opened Bogg's Bend Unit will be limited to the CDFW access points and a closed area will remain in place along the private property adjoining the Refuge on the southern boundary to reduce impacts to adjacent landowners (Figure 4).

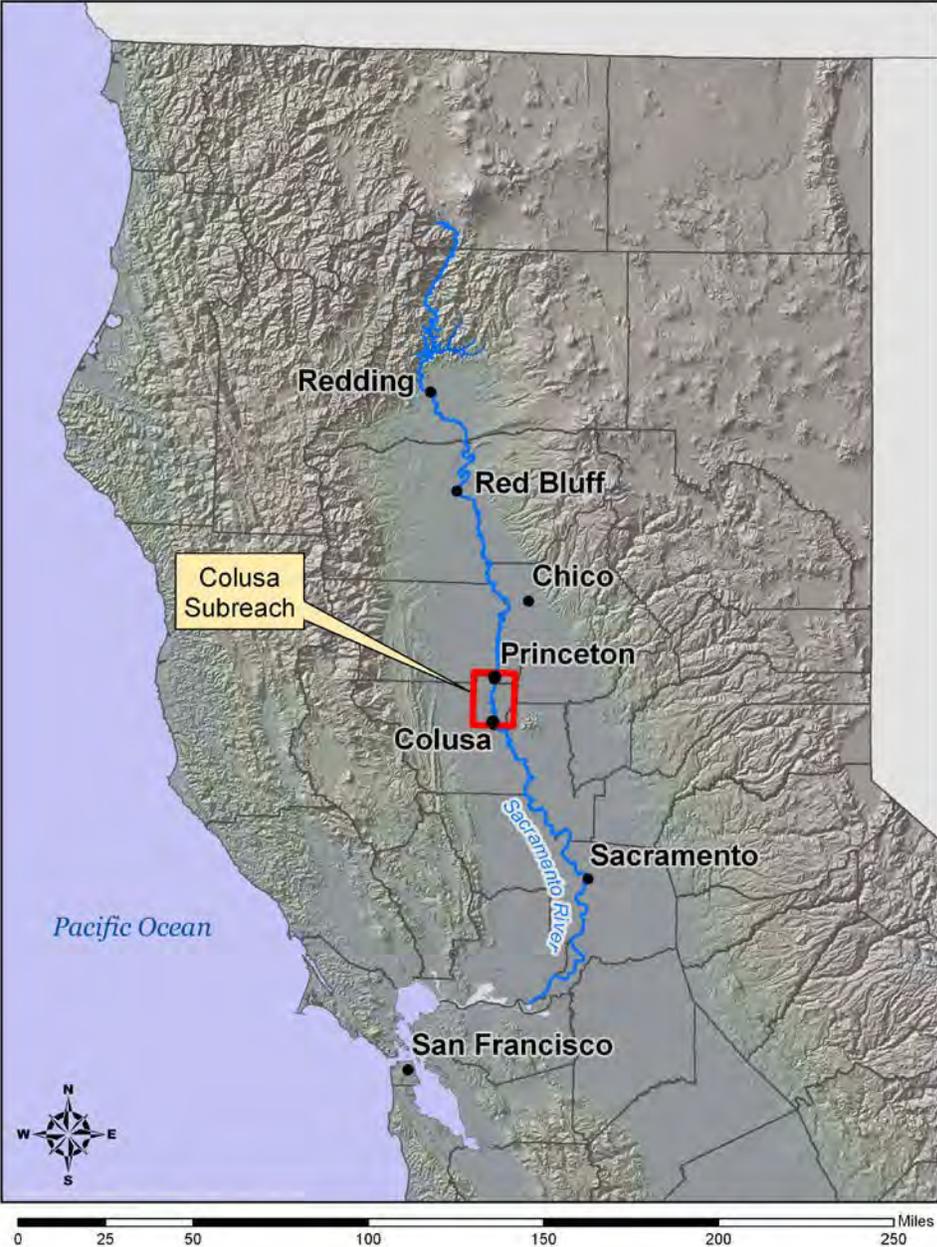
Figure 1. Location of the Colusa Subreach along the Sacramento River within California's Great Central Valley.

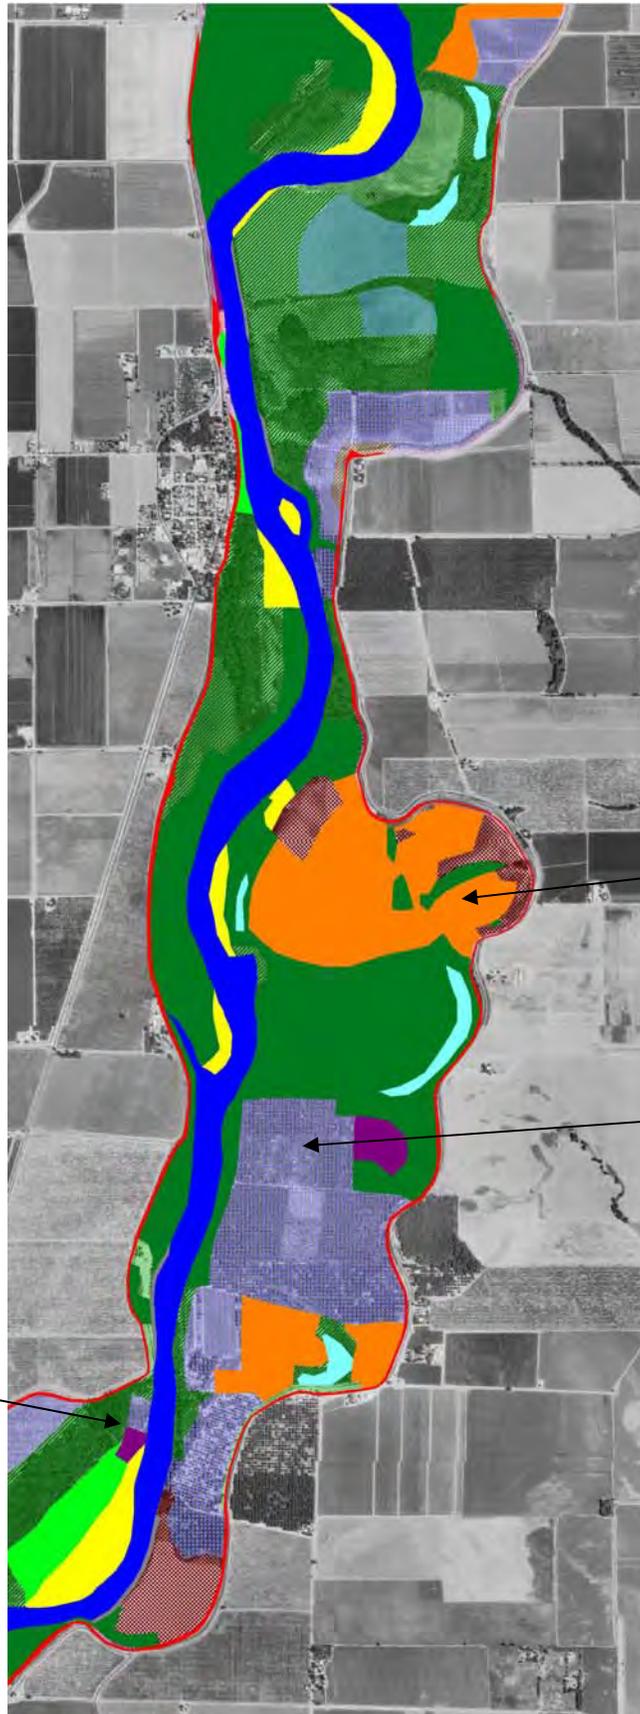
Appendix B – Land Use Figures Existing Conditions

- Disable
- levee
- scrub
- Orchard
- sparse_trees
- light_riparian
- riparian
- dirt/gravel
- cobble
- Structure
- channel
- grass12
- sandbar
- Oxbow
- crops
- rock-riprap
- sandba0-PE20
- pilot_channel
- bare_earth_PE20
- material_20
- savannah

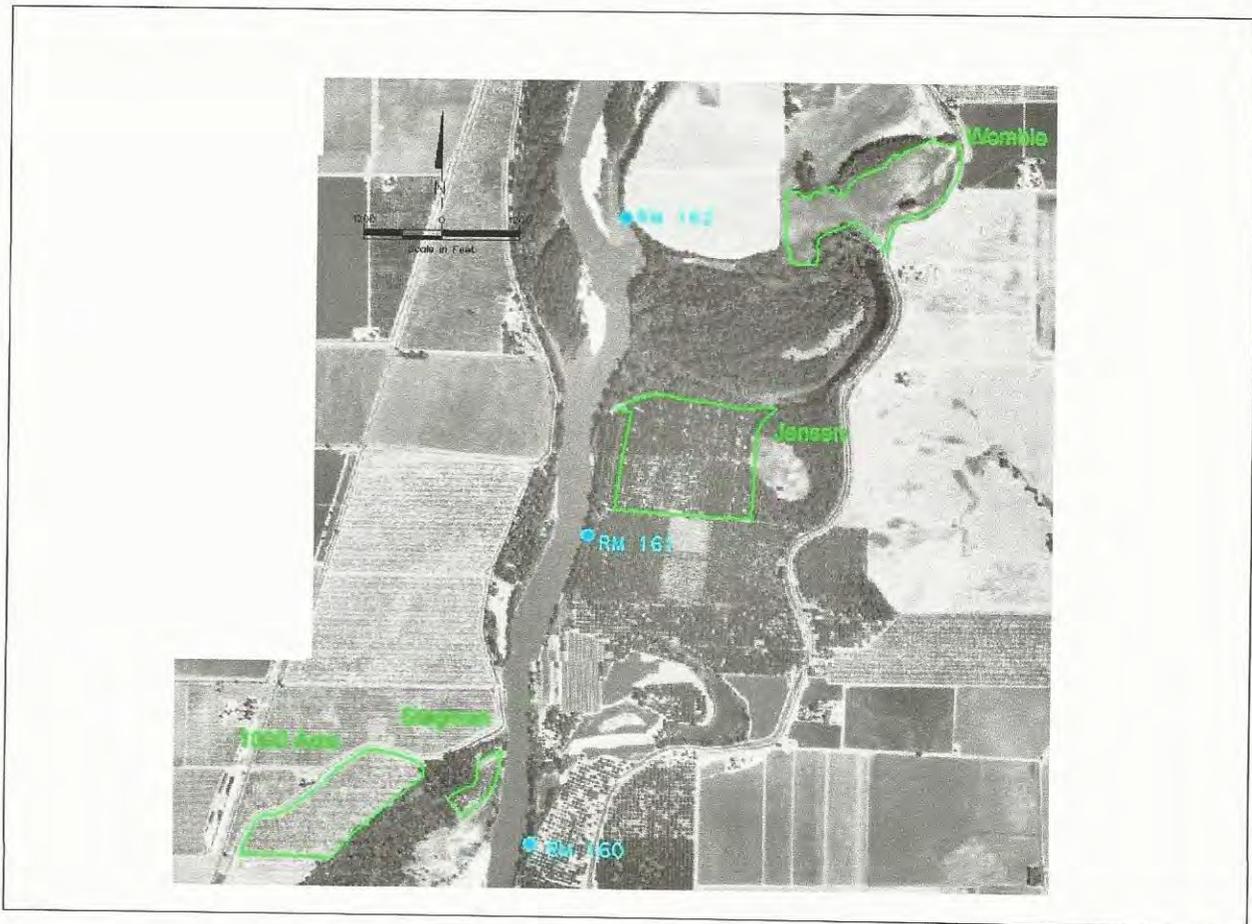
The following figure is from the original report and shows the location of the Boggs Bend Unit located just upstream of river mile (RM) 161.0 on the right over bank of the Sacramento River floodplain inside the project levees. The property is approximately 82 acres and the existing land use at the time of the modeling was orchard. The proposed conversion was to a mix of riparian forest and a grassland/shrub.

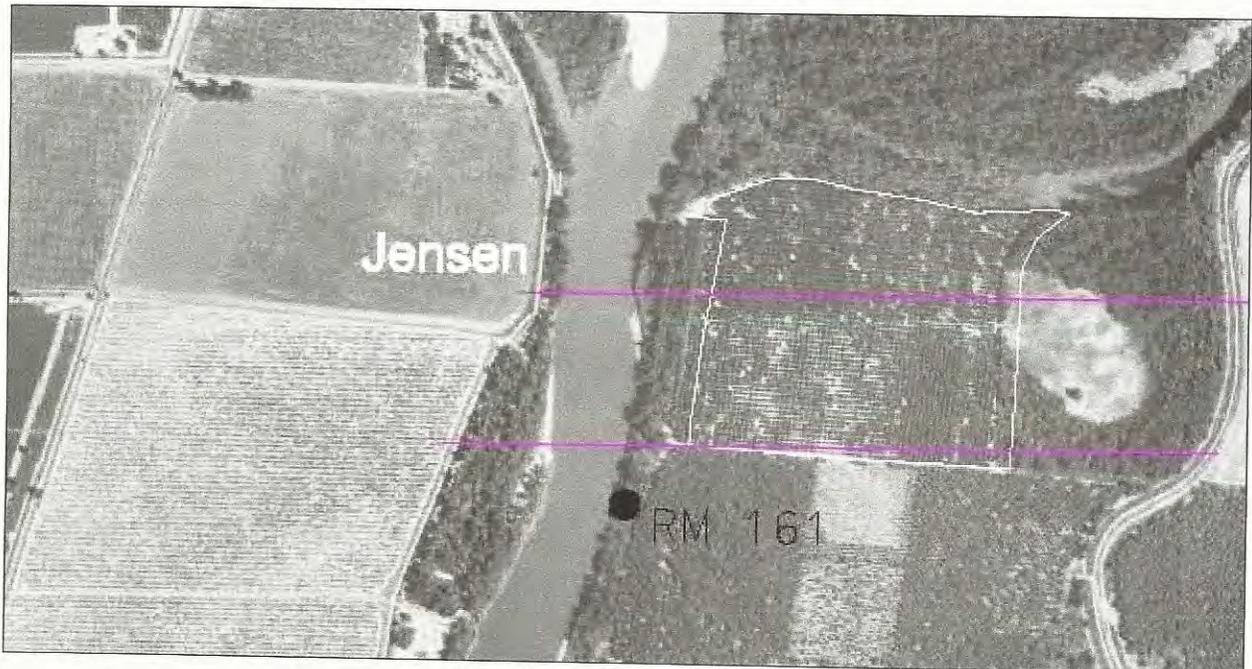
There are two small area of less than 0.1 ft differential that was noted in the original model and two river cross sections were cut across the river and floodplain to take a more detailed look at these differences in water surface for the proposed restoration planting. The location of these cross sections is shown below and the results shown graphically on the following pages.

The detailed examination did find a small increase of 0.05 ft isolated within the parcel itself and on the downstream cross section. However this increase is limited to a small area near the eastern edge of the Jensen parcel and does not extend to the levee. The result is that there is no impact on existing freeboard at the levee.
