DRAFT ENVIRONMENTAL ASSESSMENT
OF THE
POTENTIAL EFFECTS
OF
DECATUR UTILITIES
STRATFORD ROAD WASTEWATER LIFT STATION REPLACEMENT
TO
WHEELER NATIONAL WILDLIFE REFUGE

U.S. Fish and Wildlife Service
Wheeler National Wildlife Refuge Complex
2700 Refuge Headquarters Road
Decatur, Alabama

August 24, 2015

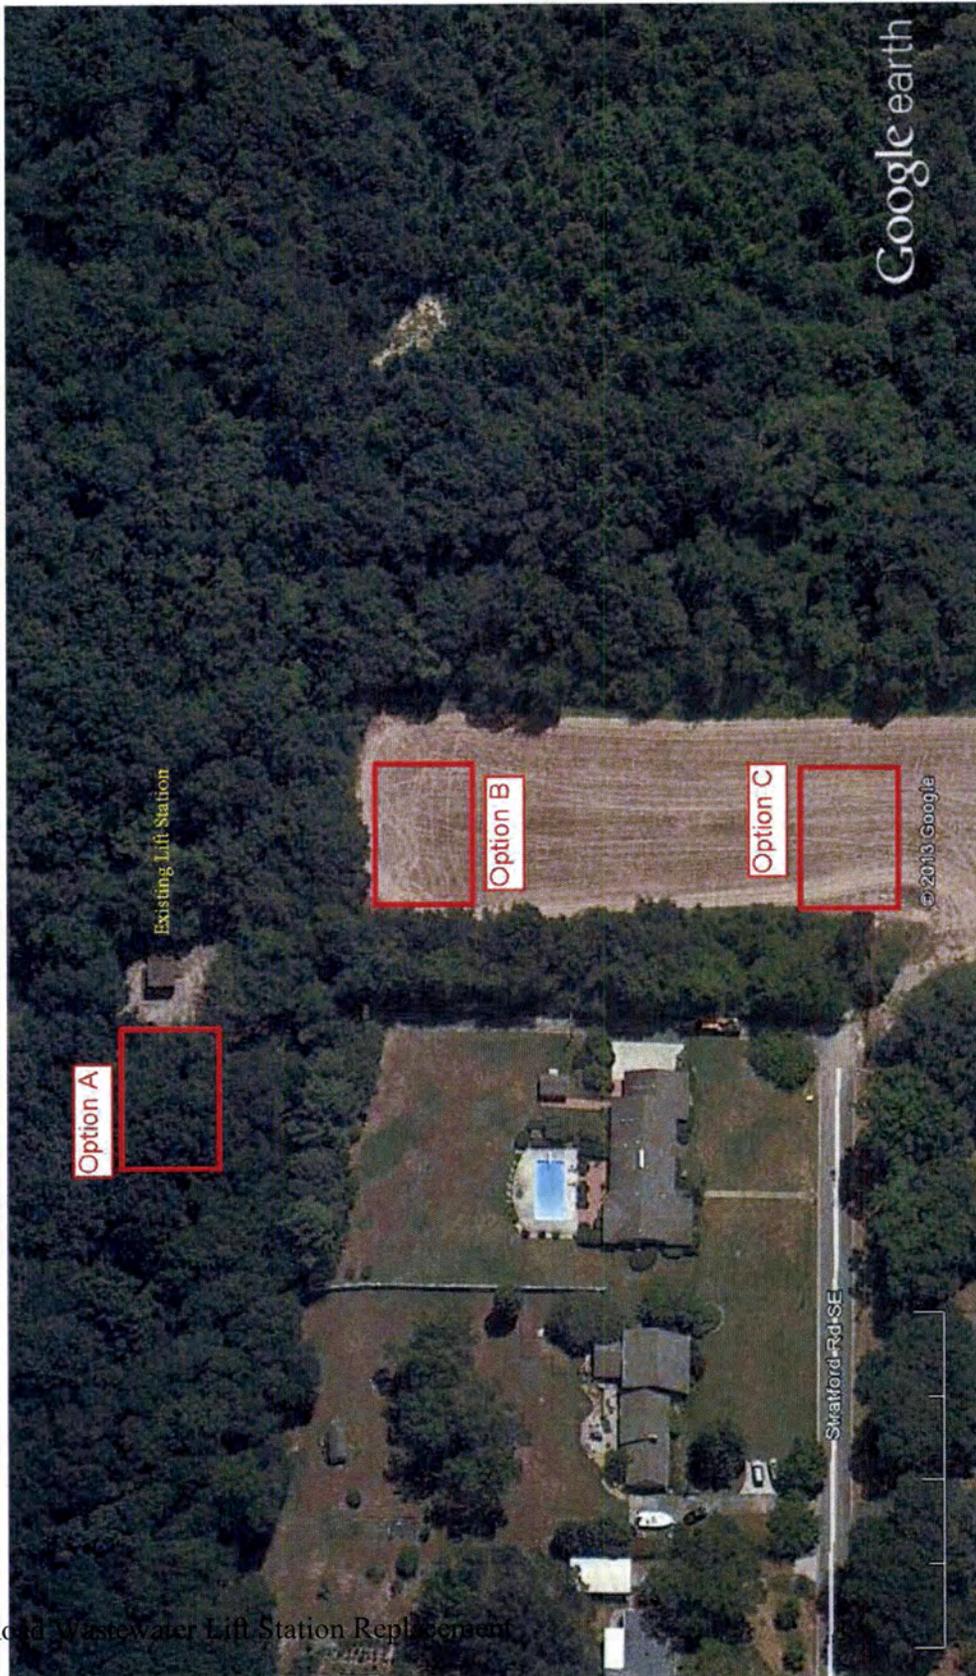
Figure 1. Options Considered for Construction Site of Stratford Road Wastewater Lift Station

During early planning, three options for the site of the proposed new lift station were considered. Figure 1 depicts general locations and sizes of the area required for construction of the new lift station, exclusive of associated facilities. Option 2 was selected because it would be located in an existing agricultural field, requiring the clearing and maintenance of the smallest amount of forested habitat, while providing needed facility security.

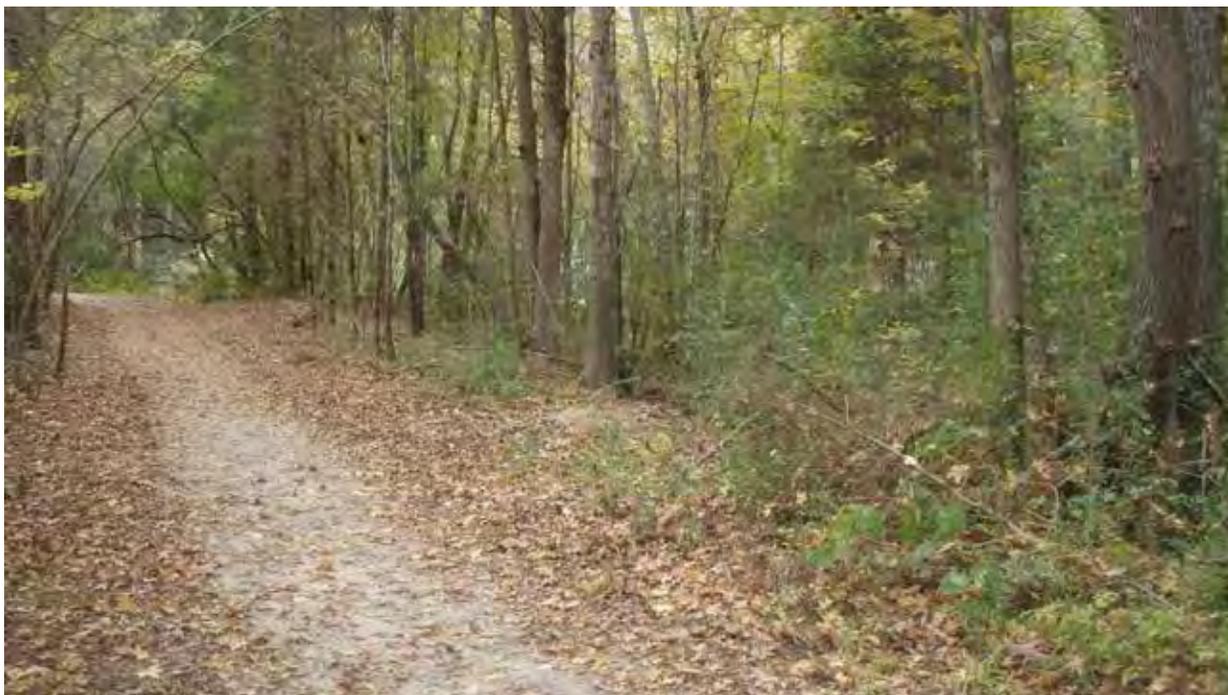
Figure 7. Photograph of 1MG1041, facing west.

Site 1MG1041 is a prehistoric and historic artifact scatter located within a floodplain (Figures 7-8). The site is 460 m (1509 ft.) northwest of Flint Creek, which has been flooded by the Wheeler Reservoir since 1936 (Tennessee Valley Authority 2013). The site encompasses portions of an agricultural field, a recreational trail, and an artificial drainage, and covers an area of approximately 330 m². Only a small portion of the land within the boundary remains undisturbed. The soils in this area consist of the Monongahela fine sandy loam complex, which is described as well drained and found on slopes up to 6 percent (Natural Resources Conservation Service 2013). Typical site stratigraphy consisted of two strata: a 10-cm thick yellowish brown (10YR 5/4) silty clay loam overlying a yellowish brown (10YR 5/6) silty clay.

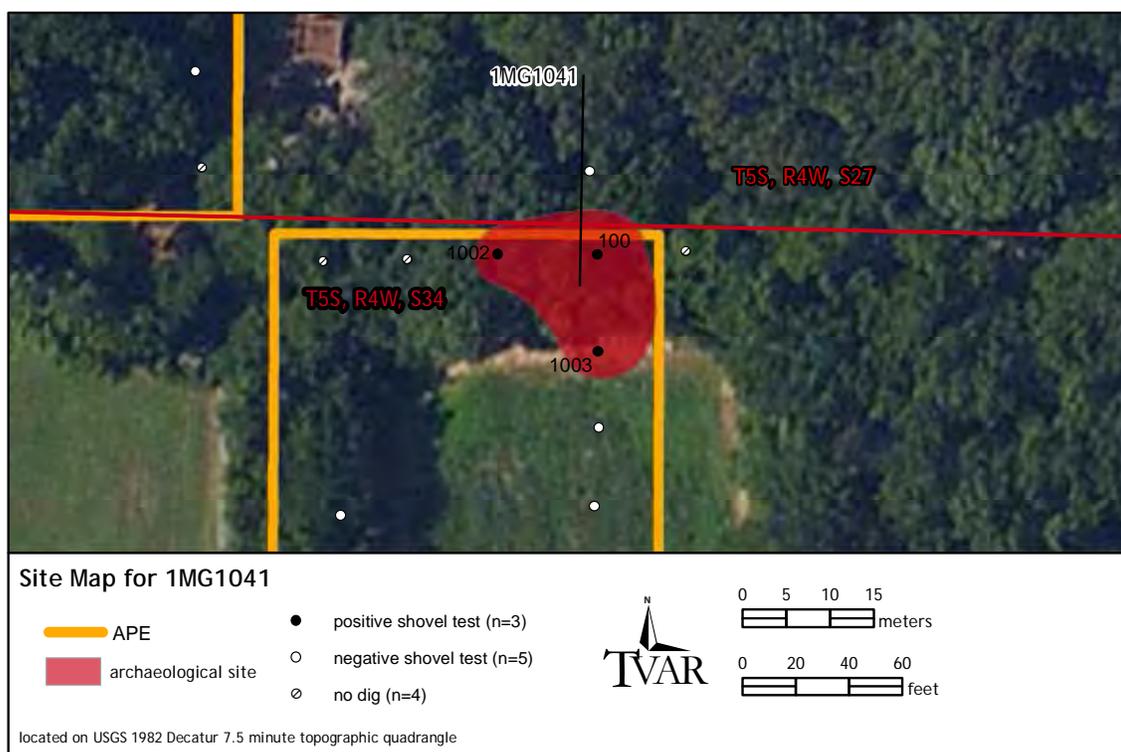
Figure 8. 1MG1041 site map.

A total of six shovel tests were conducted across the site, three of which yielded artifacts. A total of five artifacts were recovered from these tests, including one piece of chipped-stone debitage, two pieces of clear container glass, a piece of slag, and a brick fragment. Artifacts were recovered from a maximum depth of 30 cm below the surface with a concentration in the upper 12 cm across the site.

- Shovel Test 100 (0-12 cmbs)
 - 1 0.29 g 1/4-inch debitage, chert (undifferentiated)
 - 1 0.34 g clear container glass
- Shovel Test 1002 (10-30 cmbs)
 - 1 0.2 g clear container glass
 - 1 0.63 g slag
- Shovel Test 1003 (0-12 cmbs)
 - 1 0.86 g brick fragment

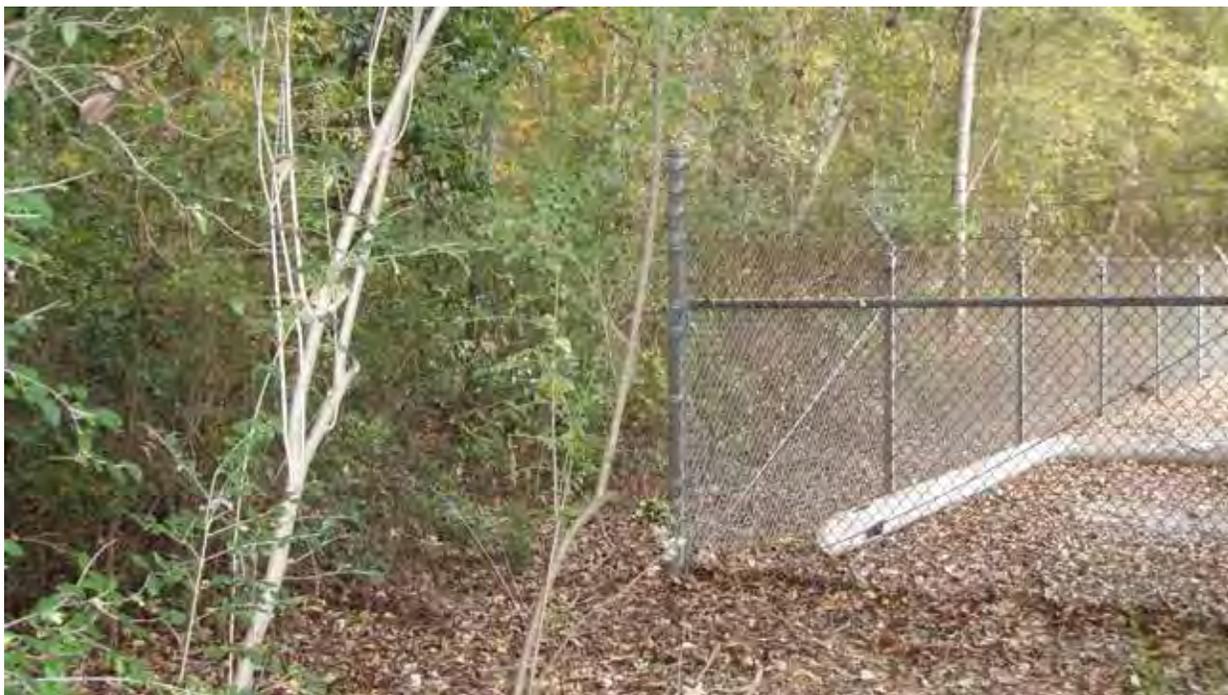
Figure 9. Photograph of isolated find, facing northeast.

A single isolated find was encountered during the current survey. This was located approximately 5 m (16.4 ft.) north of the current pumping station (Figure 9). Two pieces of clear container glass were recovered from the initial positive shovel test; however, no additional cultural material was recovered from subsequent delineation shovel testing, and a scatter of modern garbage was observed in close proximity to the pumping station.

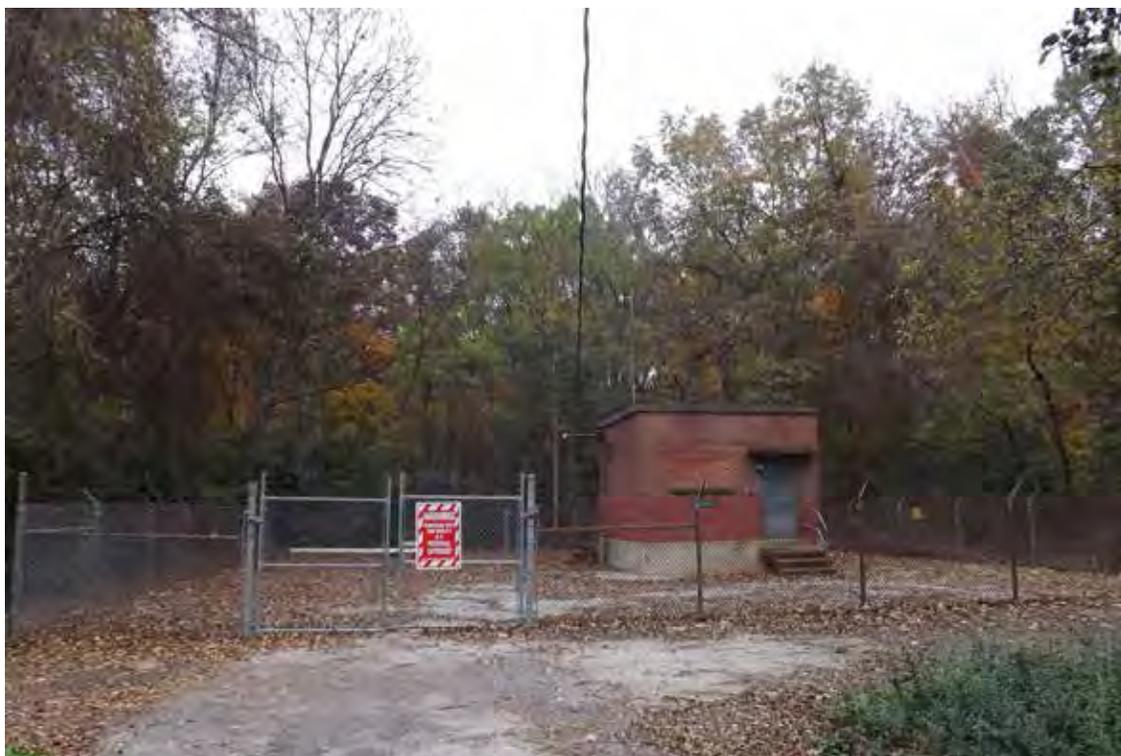
Figure 10. View of the architectural APE to the north.

On November 12, 2013, TVAR conducted a historic architectural survey of the APE, which resulted in the identification of no previously unrecorded architectural resources, other than the modern brick pumping station depicted in Figure 10. This structure was constructed in the early to mid-1970's, as it is first depicted on the USGS 1976 Decatur 7.5 minute topographic quadrangle. TVAR recommends no additional investigation of aboveground resources in connection with the proposed undertaking.
