# **The Physical and Biological Effects of Engineered Logjams (ELJs) in the Elwha River, Washington**

*Executive Summary*

*Salmon Recovery Funding Board (SRFB)  
Interagency Committee for Outdoor Recreation (IAC)*

April 1, 2007

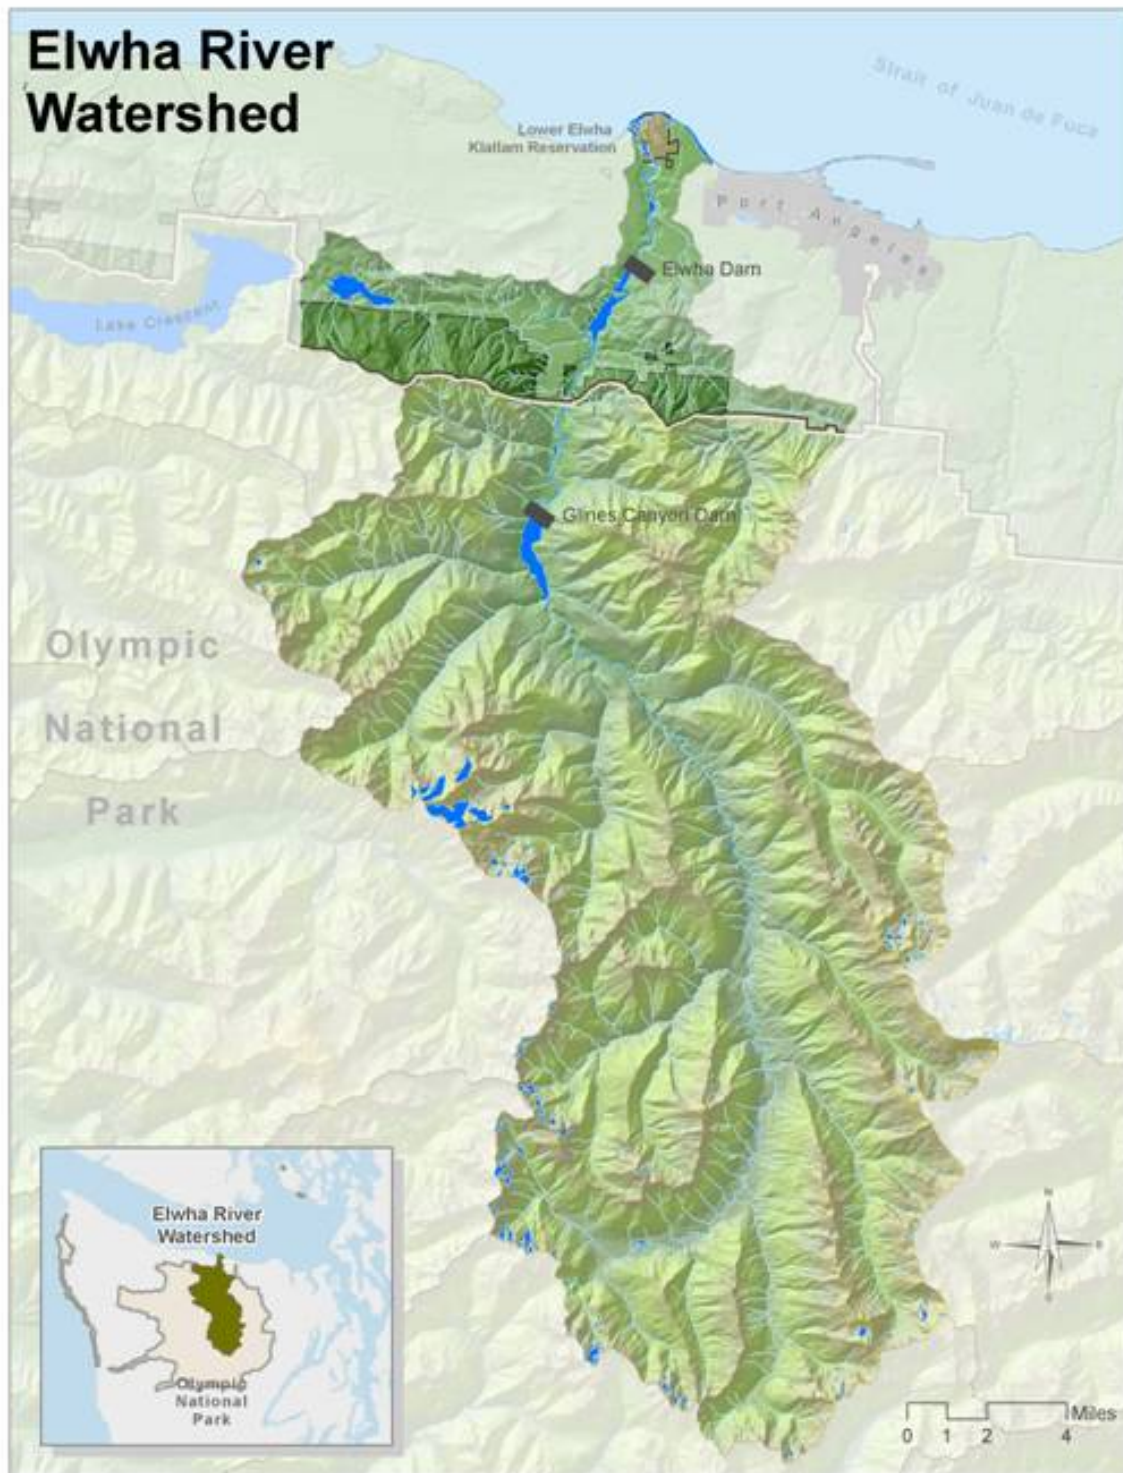
Figure 1. The Elwha River watershed depicting the percentage of the watershed in Olympic National Park and mainstem hydroelectric dams.

The Elwha River drains a 313 mi<sup>2</sup> watershed on the Olympic Peninsula with its headwaters radiating off the slopes of Mt Olympus. The Elwha flows north to its confluence with the Strait of Juan de Fuca with over 85% of the watershed protected within the boundaries of Olympic National Park (Figure 1). Mainstem hydroelectric dams were constructed without fish passage facilities at river miles 4.9 in 1912 (Elwha) and 1925 (Glines Canyon) reducing the habitat accessible to anadromous fish by over 90%. Additionally, the dams have altered the natural physical processes that sustain and create habitat in large alluvial rivers. The dams have significantly reduced the supply of sediments and large wood to the middle and lower reaches of the river and its floodplain. Human activities such as floodplain logging, diking and channelization contributed to a loss of physical complexity and habitat below the dams. Downstream of the dams there has been a reduction in the river's sinuosity and incision of the mainstem channel that has diminished connectivity to its floodplain (Pohl 1999). Spawning gravel has disappeared from much of the lower river as the river's ability to transport bed-load has exceeded recruitment from new sources. As a result, the Elwha Rivers legendary fish runs that included 10 species of Pacific salmon have declined to very low levels. Two species of fish (Chinook and bull trout) are listed as threatened under the Endangered Species Act and a third (steelhead) is proposed for listing.

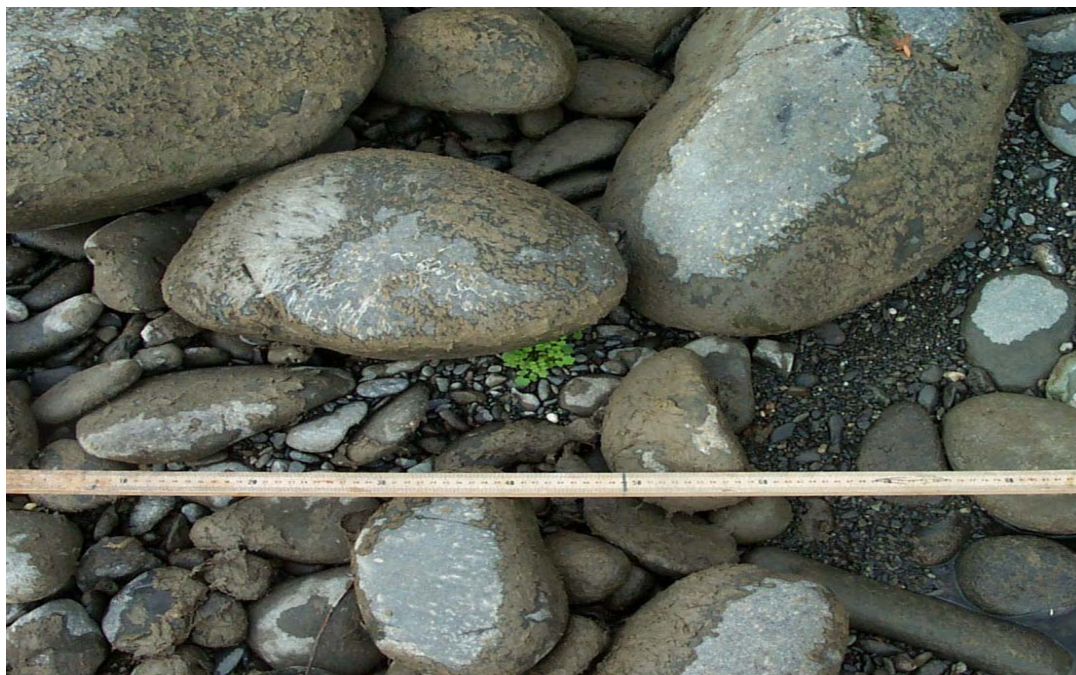
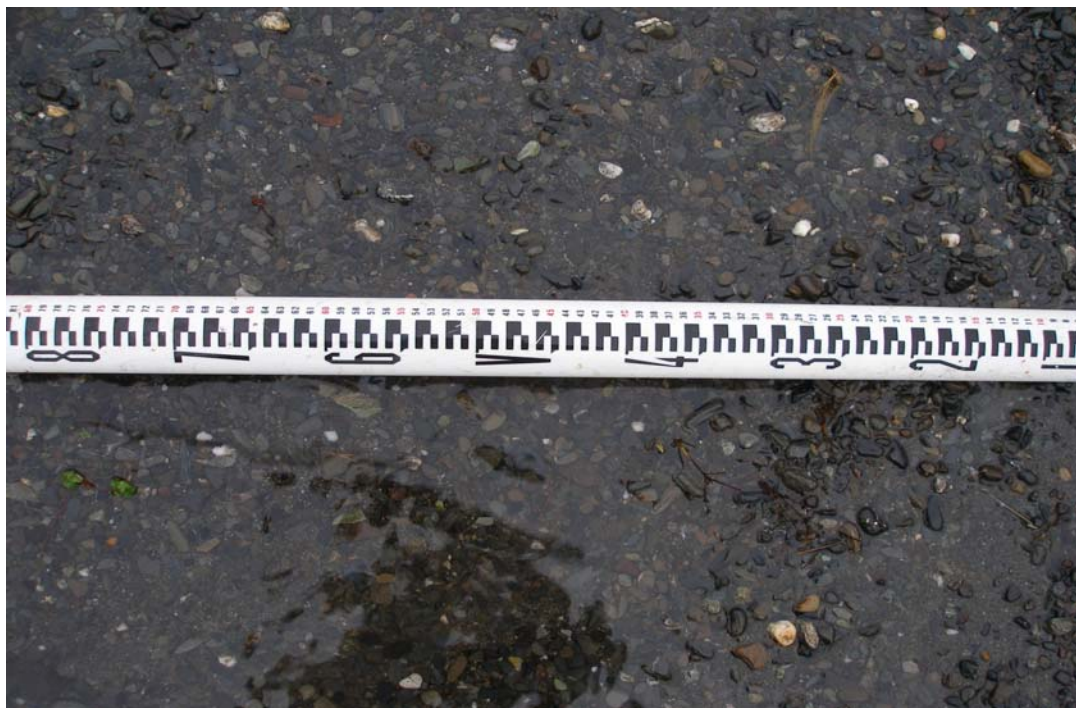
Figure 16. Substrate on bar associated with engineered logjam #04-1, Elwha River. Top Photo taken fall 2002. Bottom photo taken winter 2007.

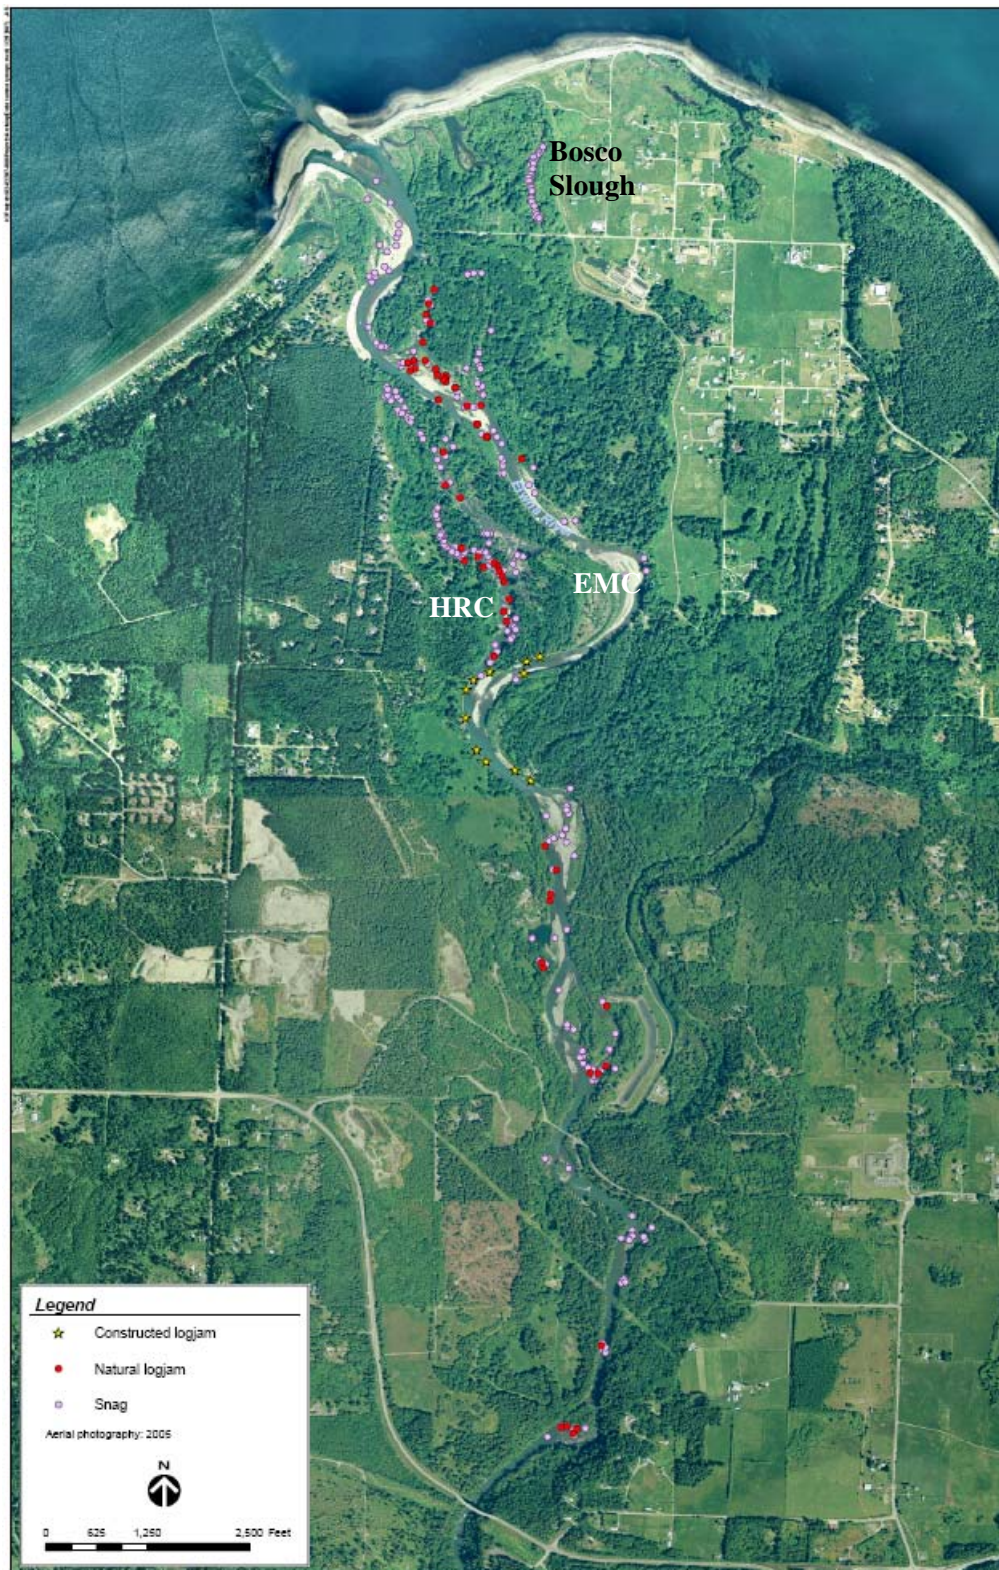
Figure 19. 2001 Lower Elwha wood inventory. Note the near absence of wood in the EMC, particularly when compared to the HRC.

During the first year of monitoring all wood was newly identified and had a “found” status. There was no pre-existing database to compare where the LWD came from and how it has moved. The inventory found a total of 301 pieces of LWD (snags) in the system. Of these pieces, 232 were identified as “key” pieces and 69 were identified as “loose” pieces (Table 6). Racked pieces were not categorized during the first year of wood monitoring except where accumulated in logjams. A total of 56 individual logjams with a total volume of 34,346 m<sup>3</sup> were also measured and located. Snag density was greatest within the HRC and side channels in the lower river, including Bosco Slough, a blind tidal slough (Figure 19). Almost all these snags appear to be locally derived from adjacent riparian areas and not recruited from upstream. Natural logjam density greatest in the lower portion of the EMC near the outlet of the HRC (Figure 19).

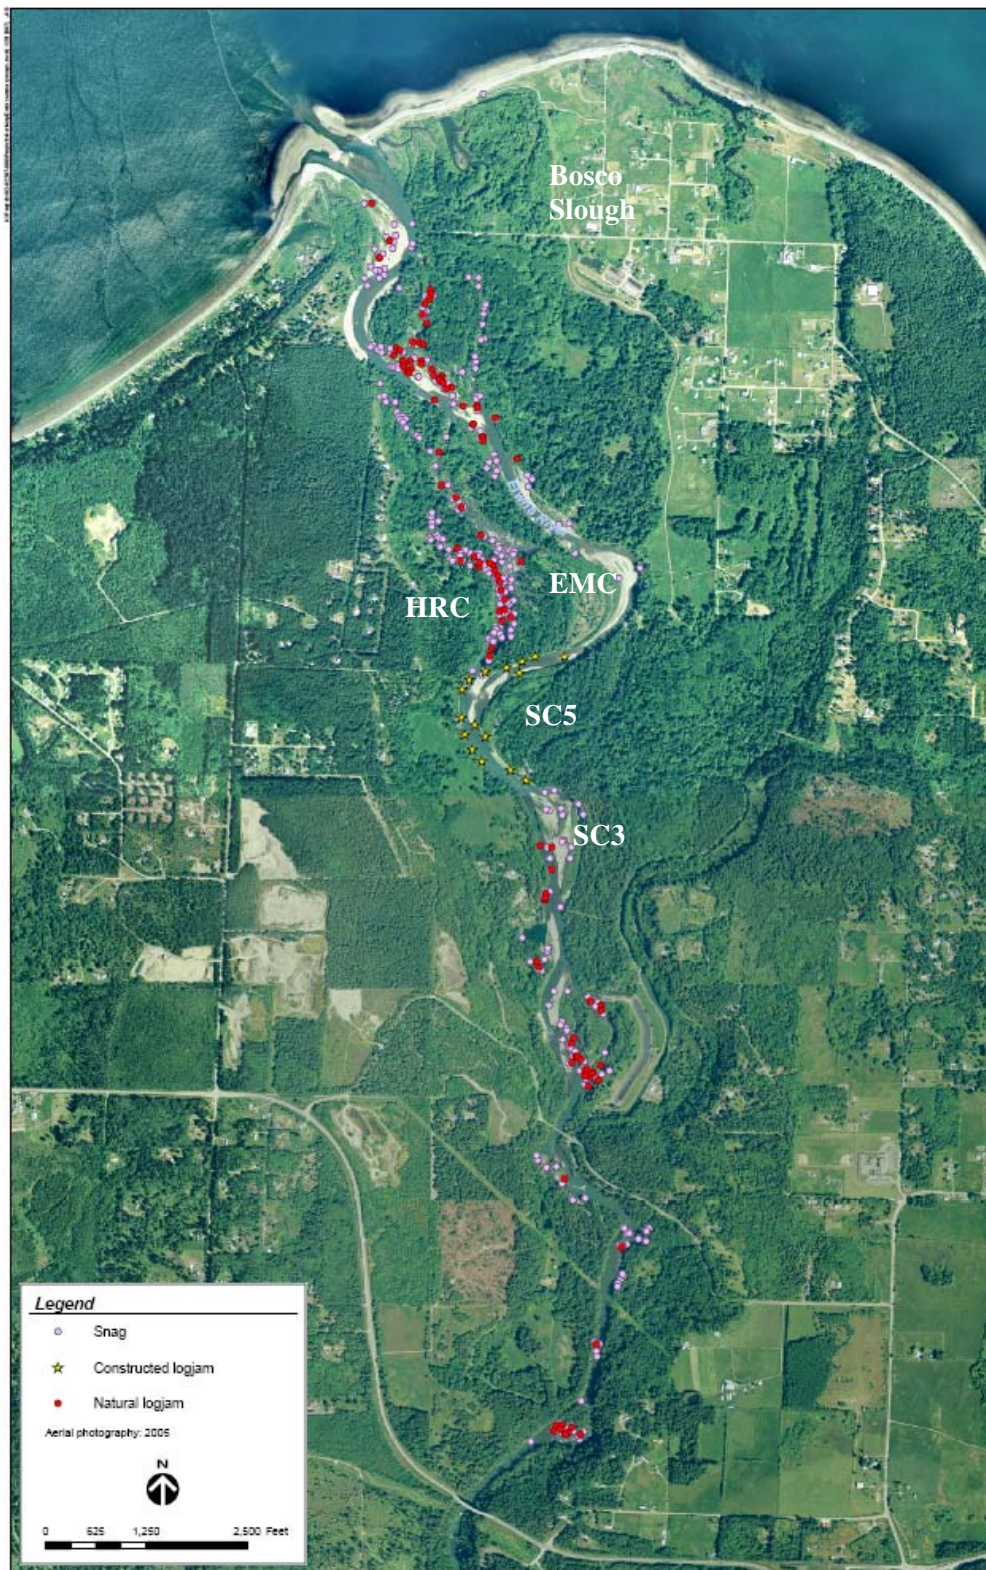
Figure 20. 2002 Lower Elwha wood inventory. Wood loading in the HRC has increased significantly since 2001, primarily from local recruitment, with no change in the EMC.

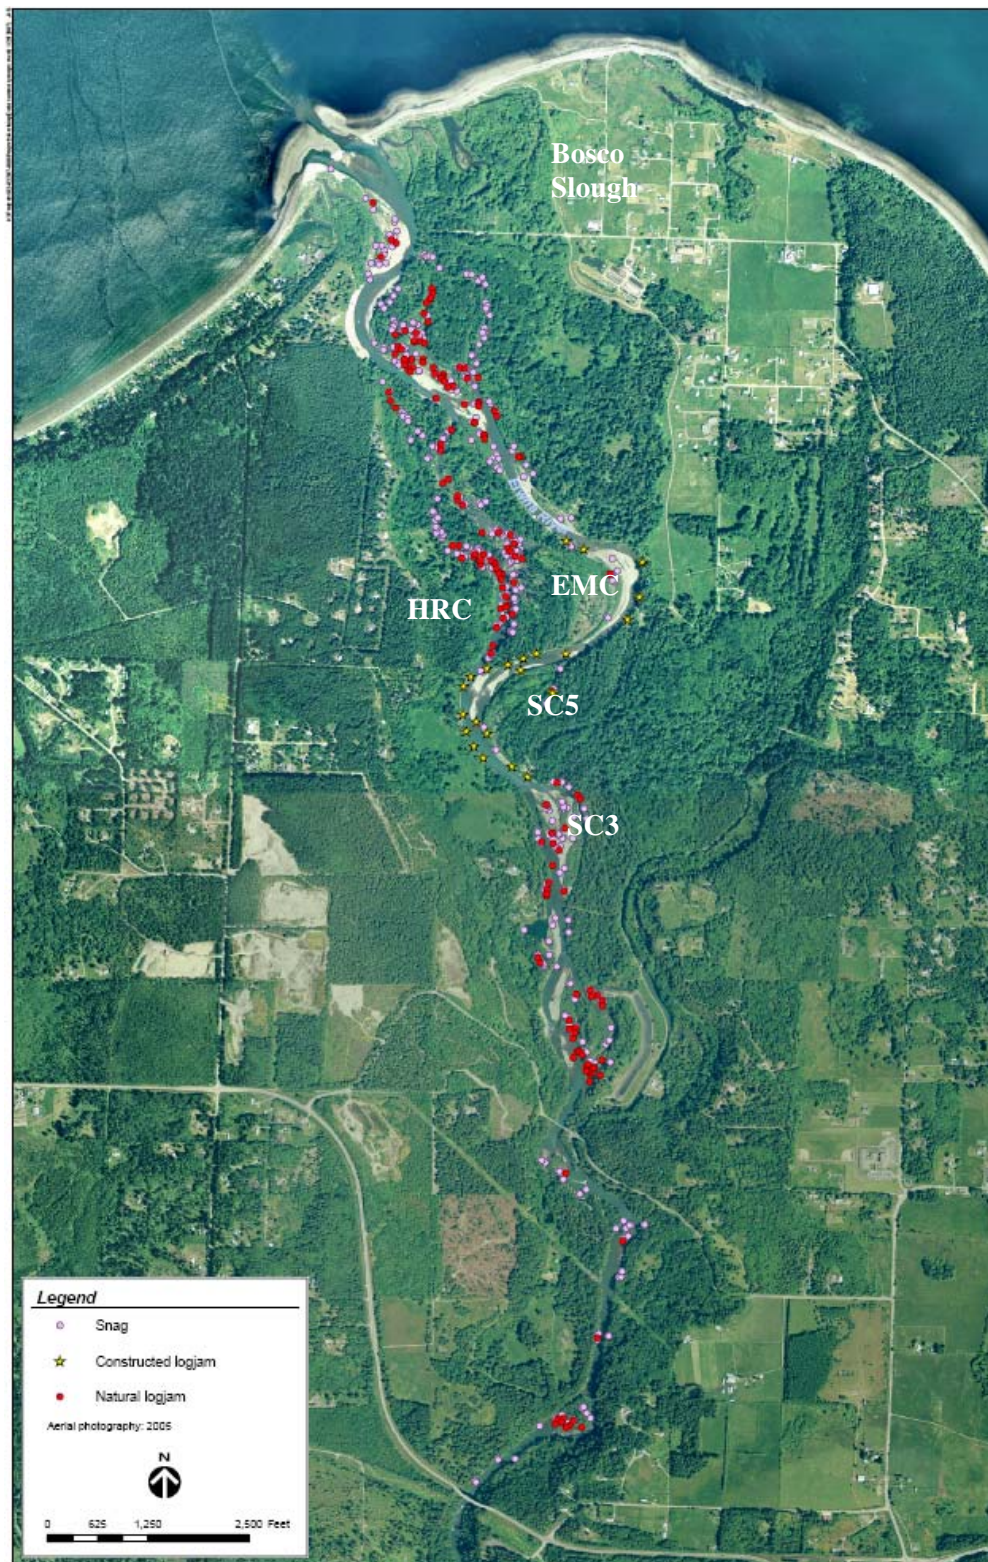
Figure 21. 2004 Lower Elwha wood inventory. Small increase in EMC, coincident with ELJs in the EMC. No major change in HRC, but a large increase upstream of Sisson property.

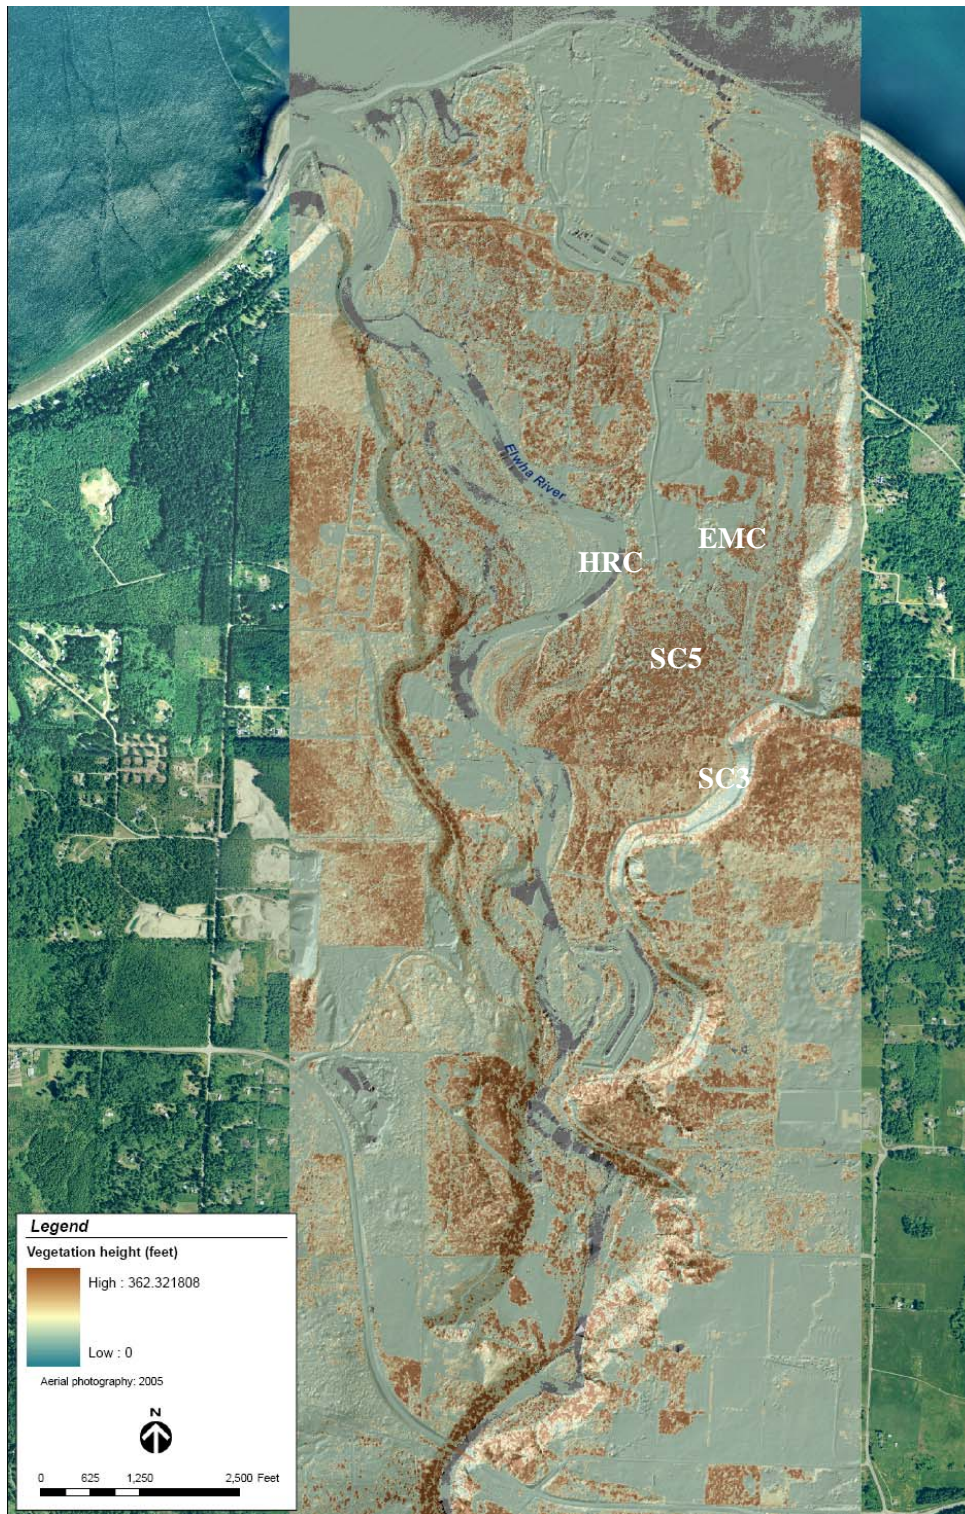
Figure 24. . Height of riparian trees based on differencing of first return and bare earth LiDAR (2004). Note the presence of large trees along the HRC and East of SC3 and SC5.

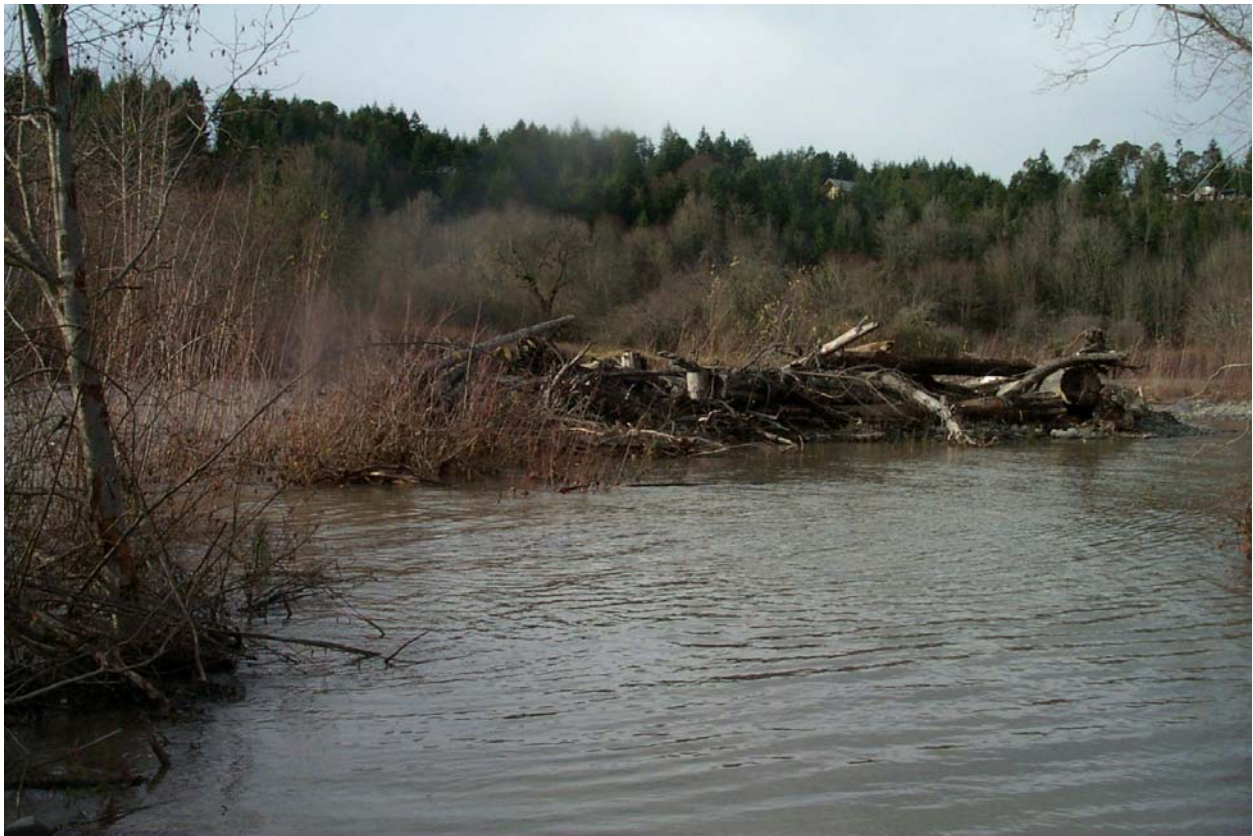
Figure 35. Elwha engineered logjam 99-1 during winter 2000 flood, looking West from right bank.

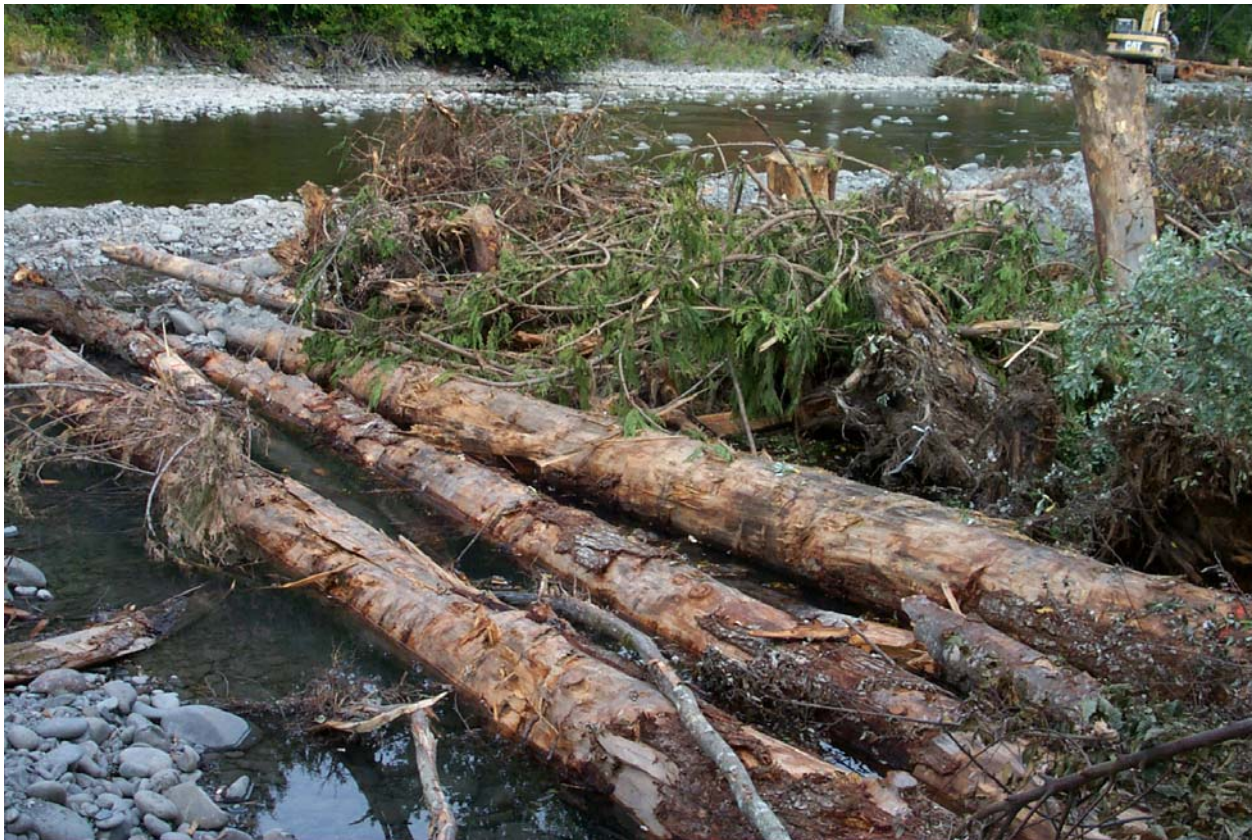
Figure 36. Elwha engineered logjam #01-1 immediately after completion, fall 2000.

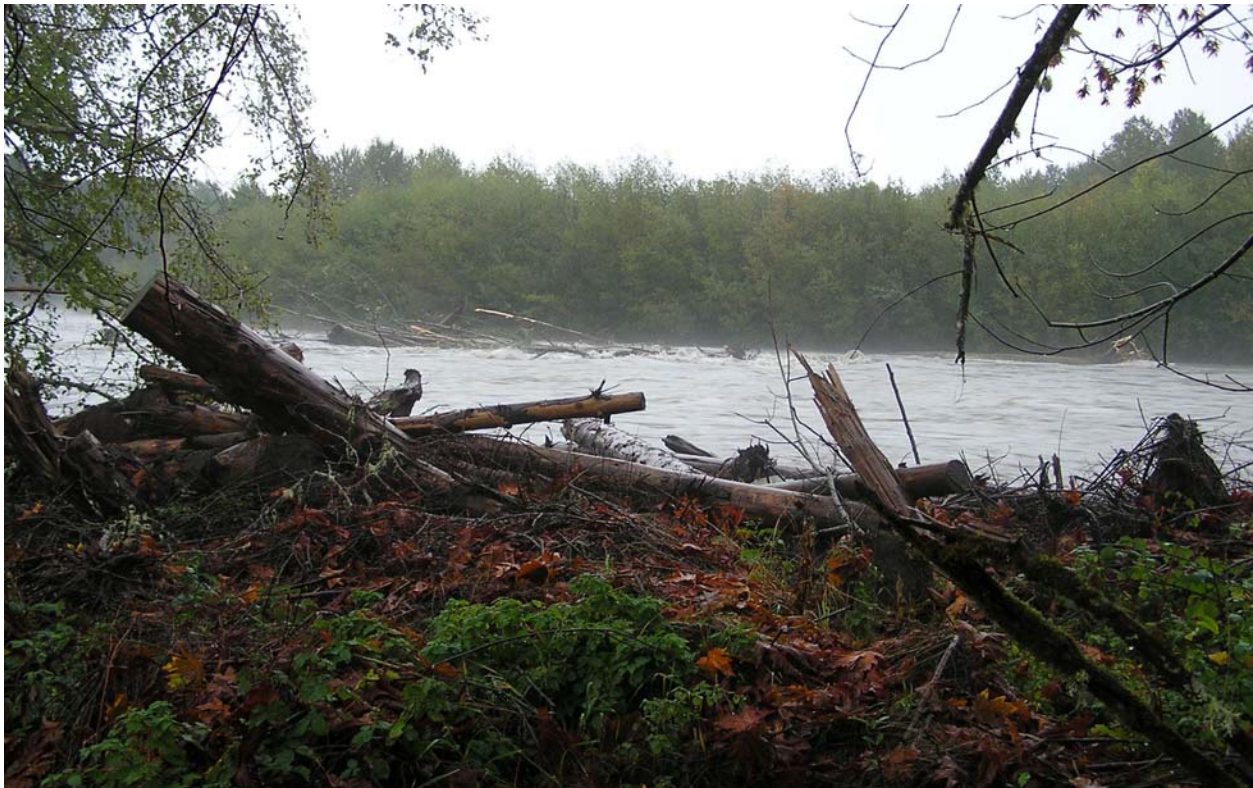
Figure 37. Elwha engineered logjams #02-4 (foreground) and 02-1 (across river) during October 2003 flood. Photo looking East from left bank.

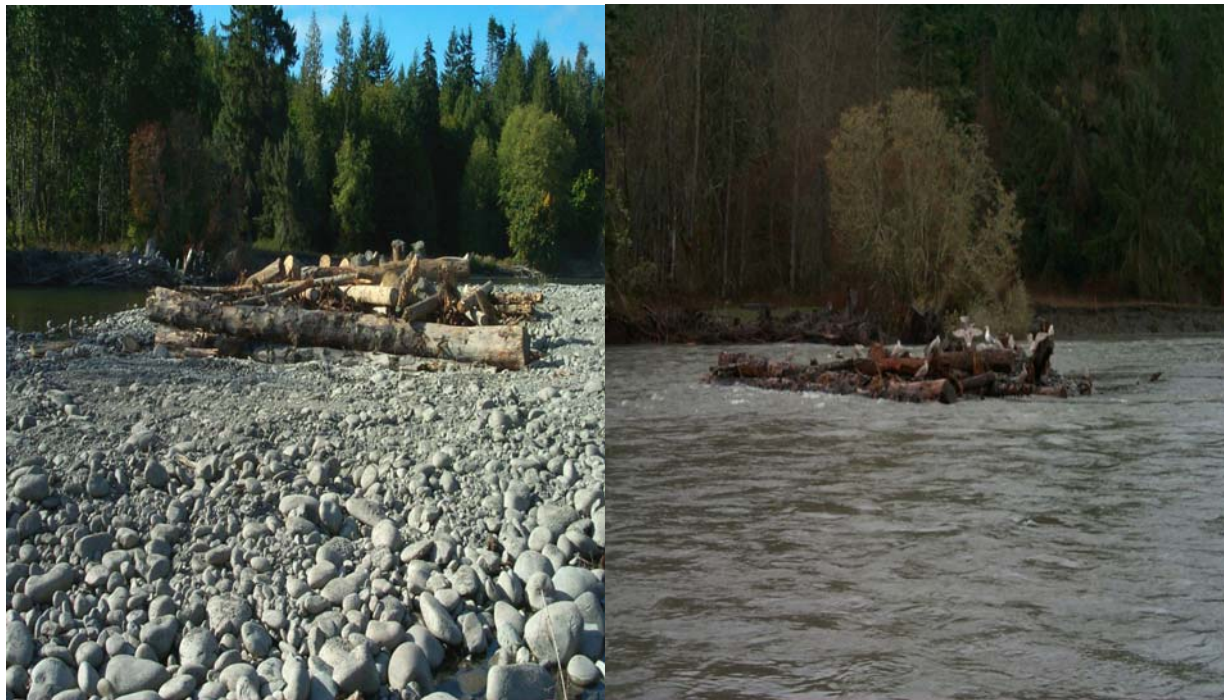
Figure 38. Elwha engineered logjam 02-2 immediately following construction in 2002 (left) and at typical winter discharge. Photos are looking Northwest in the direction of flow.

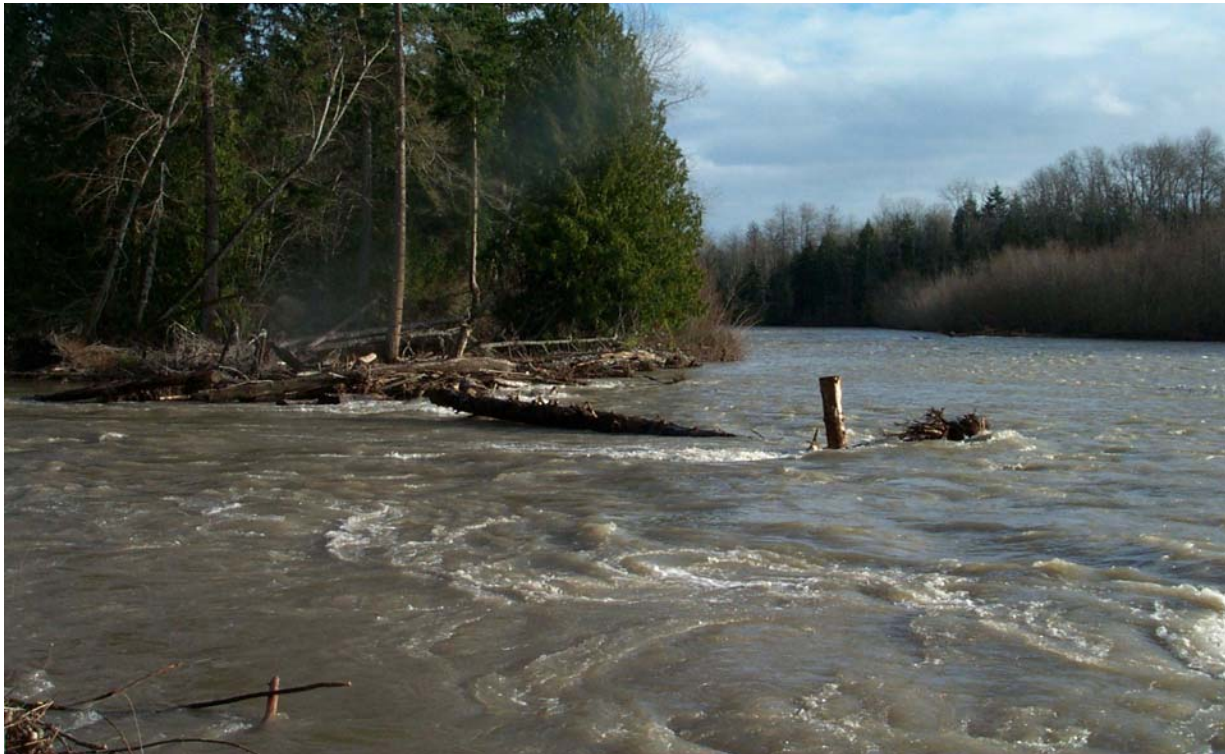
structure appeared stable with no signs of damage from high flows or racked material (Figure 39).

Figure 39. Elwha engineered logjam #99-5 splitting flow between Hunt Road Channel (HRC) and East mainstem channel (EMC), winter 2000. Photo is looking Northeast down EMC.

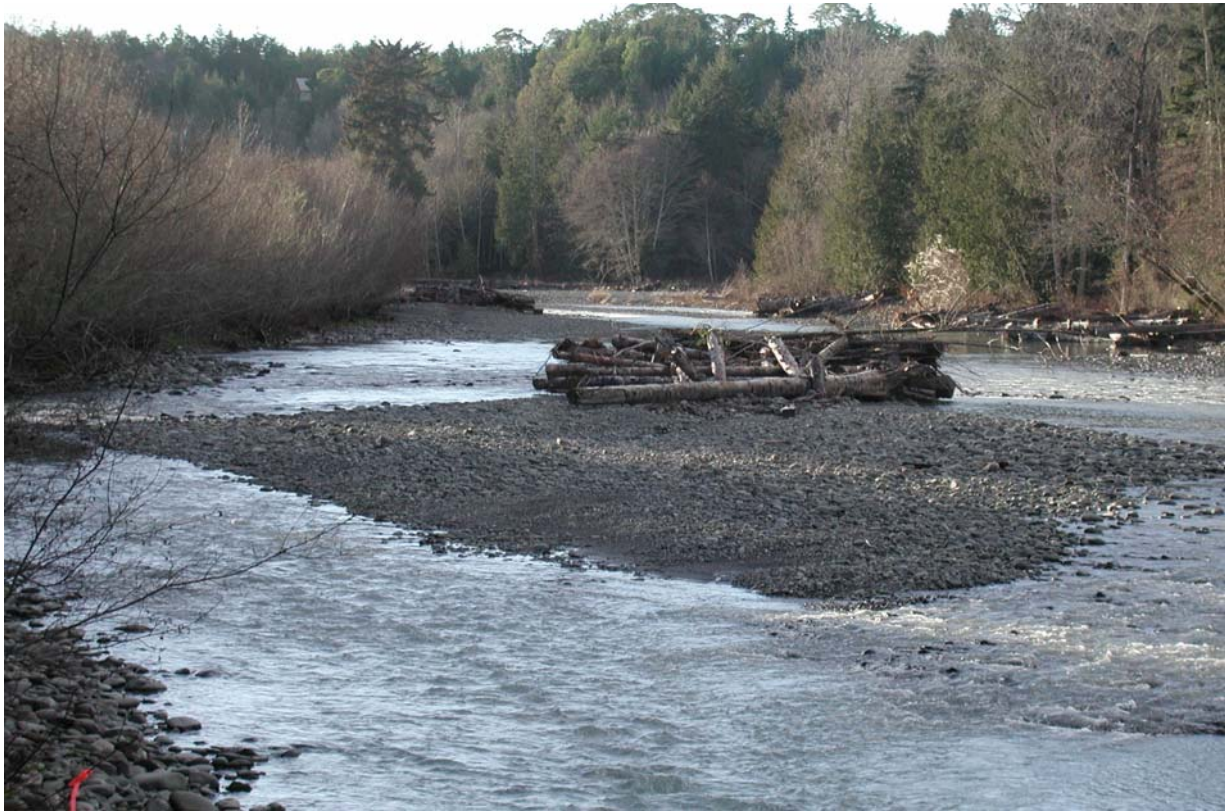
Figure 40. Elwha engineered logjam #02-5, December 2005, three years after construction. Note large gravel bar behind structure. Photo is looking West-Southwest up the EMC from the right bank.

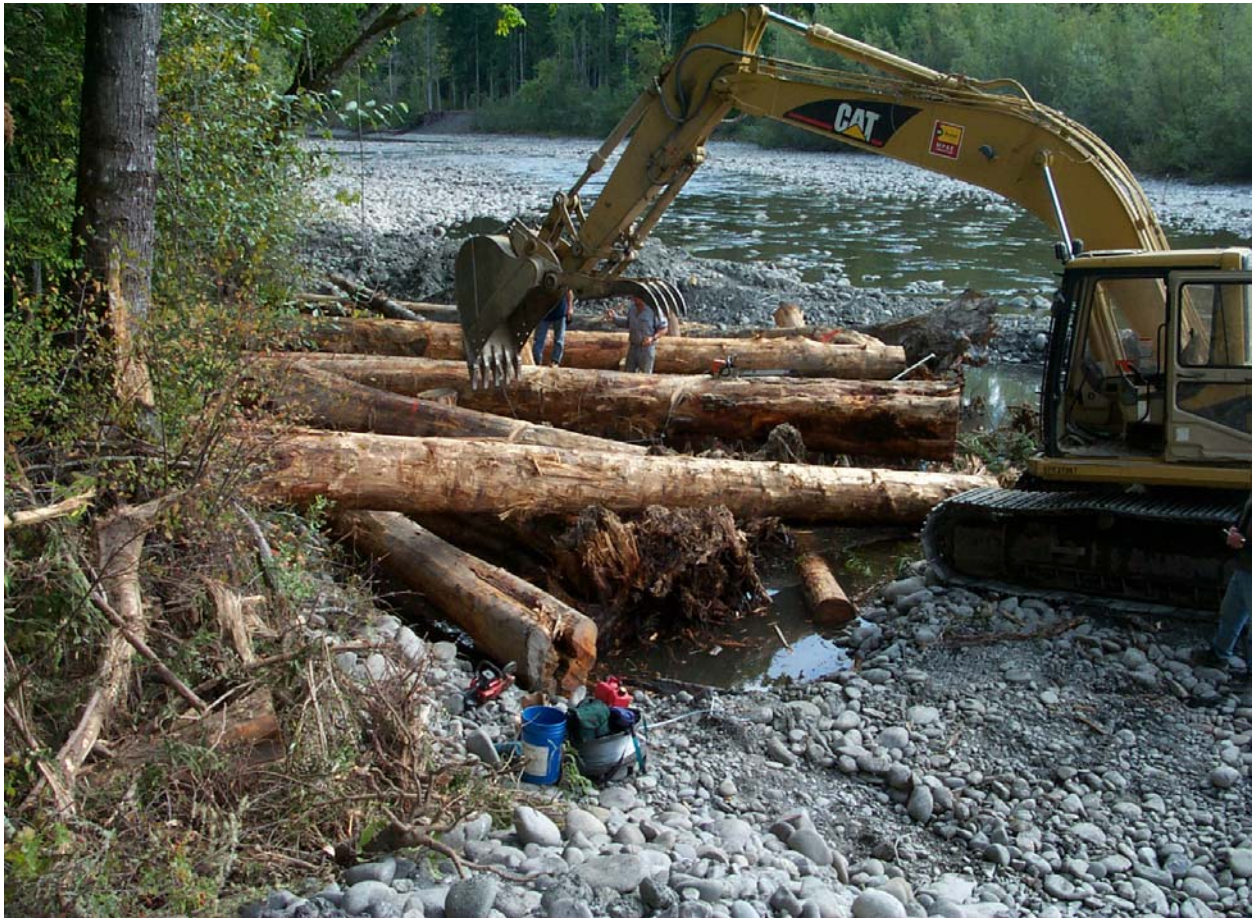
Figure 41. Elwha engineered logjam #01-3 during construction, August 2001. Photo taken from the left bank looking East-Northeast (downstream).

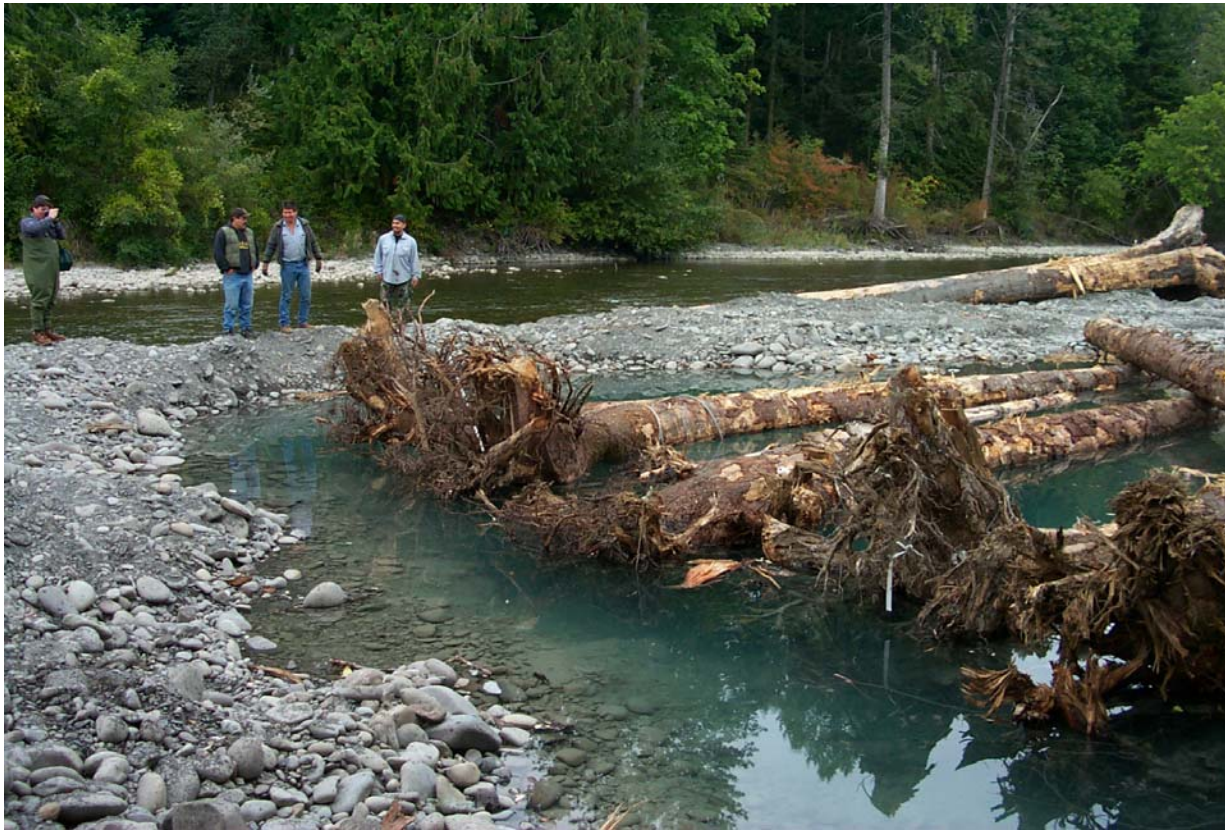
Figure 42. Elwha engineered logjam #01-1 during construction, August 2001. Photo from right bank looking North across the EMC.

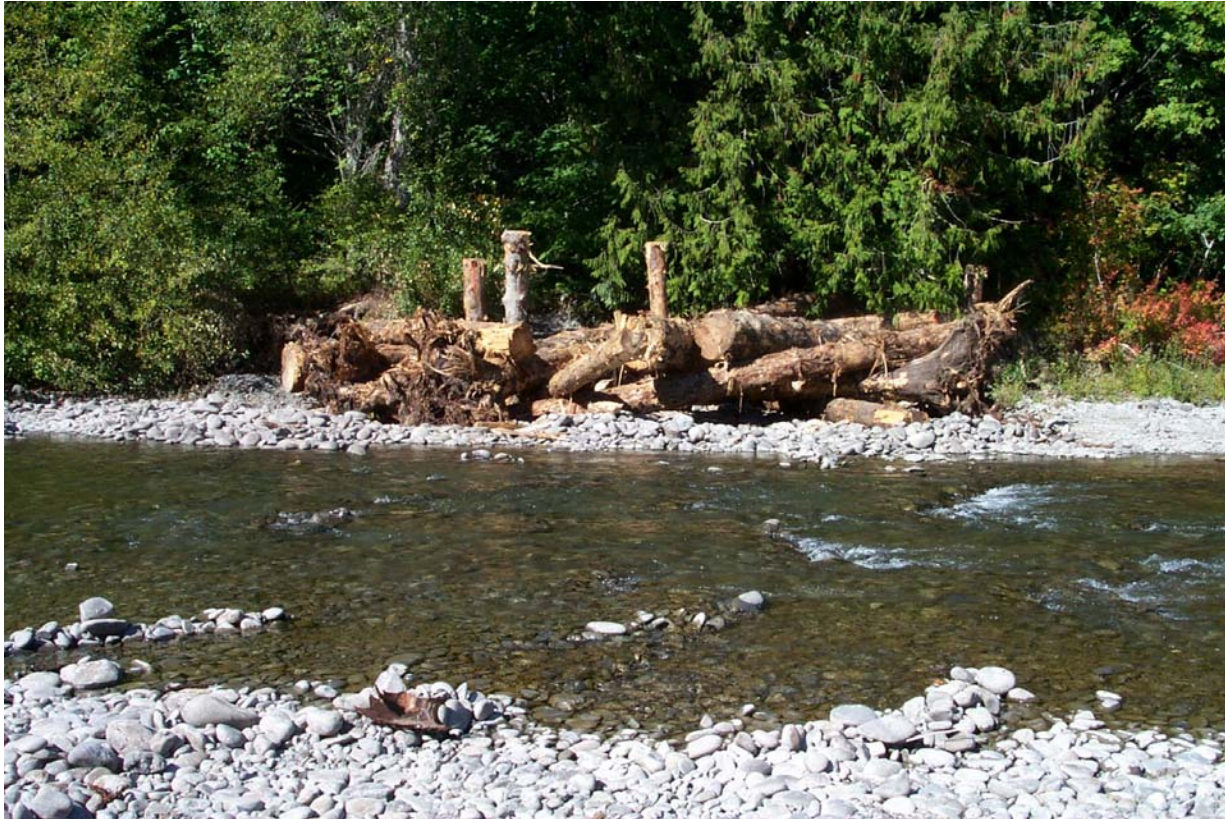
Figure 43. Elwha engineered logjam #02-3 located on left bank of EMC, immediately following construction, September 2003. Photo taken from right bank looking North across EMC.

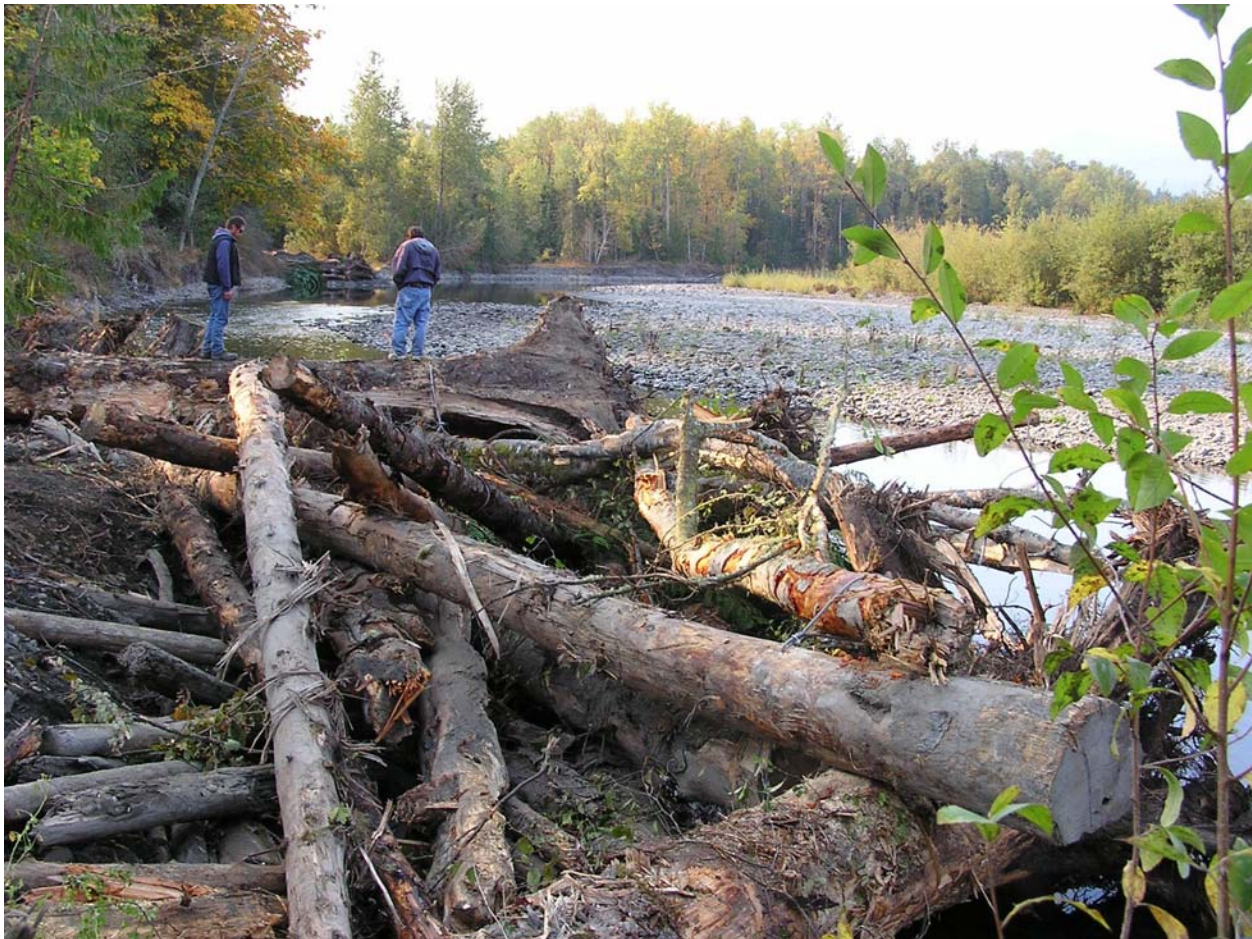
Figure 44. Elwha engineered logjam #03-1 immediately following construction, August 2003. Photo taken from right bank of EMC looking South (upstream). ELJ 03-2 is visible in background (left center of photo).

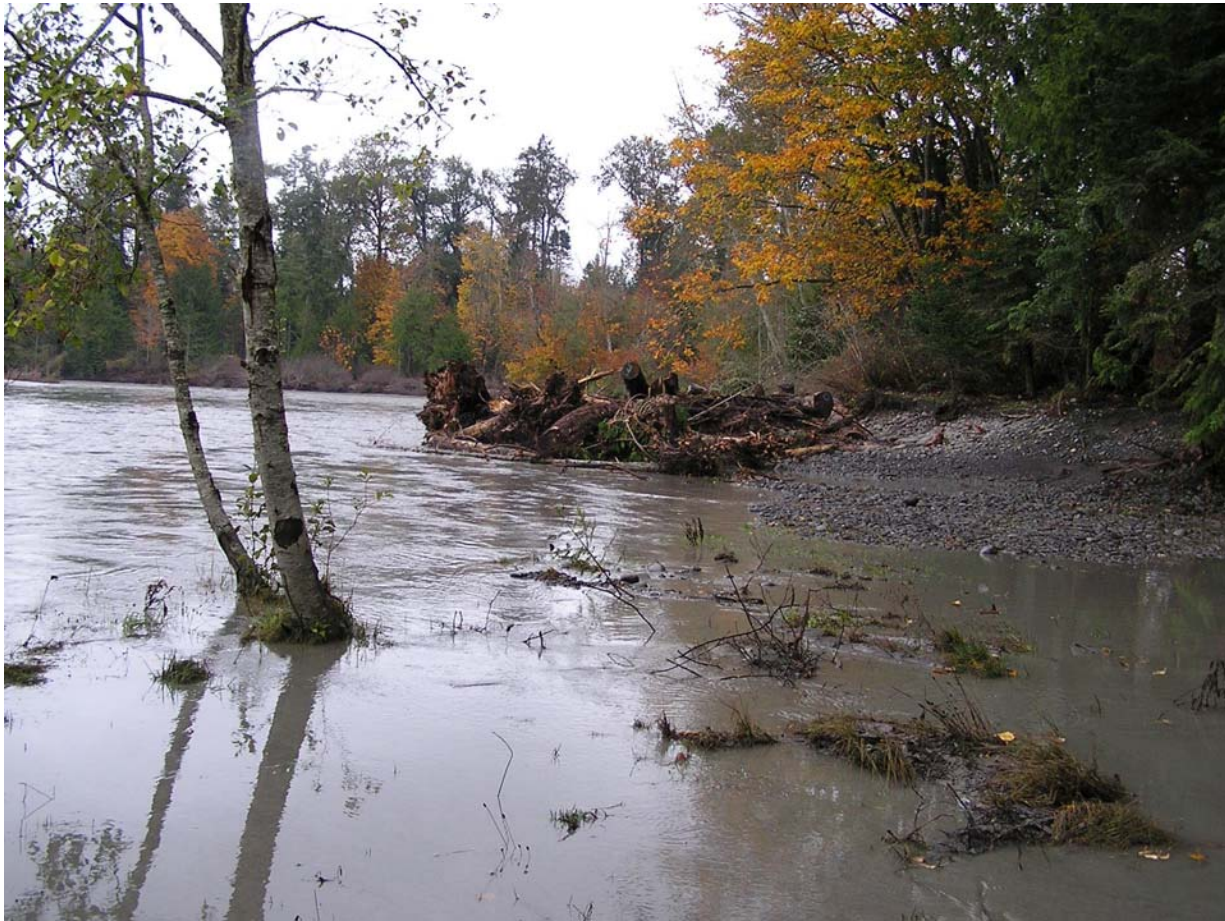
Figure 45. Elwha engineered logjam #03-2, winter 2004. Photo taken from right bank looking North (downstream).

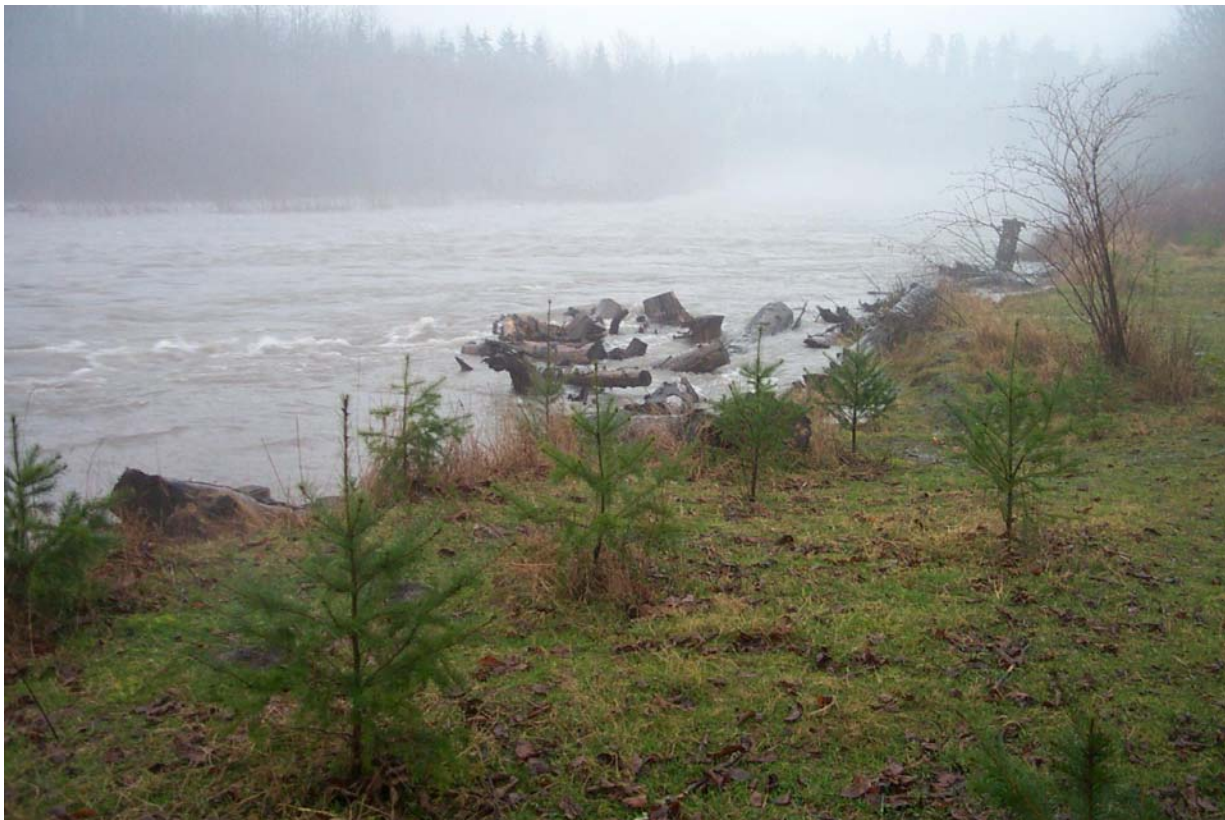
Figure 46. Elwha engineered logjam #99-2 situated along Sisson property at bankfull flow, winter 2002. Photo taken from left bank looking South (upstream).
